MULTI-DISCIPLINE CONDITION ASSESSMENT REPORT

REFURBISHMENT OF CARGO WAREHOUSE AND CARGO OFFICES: CONTRACT NO 560.04/2015

Project number: ORT.560.04/2015

Date prepared: 15 October 2018

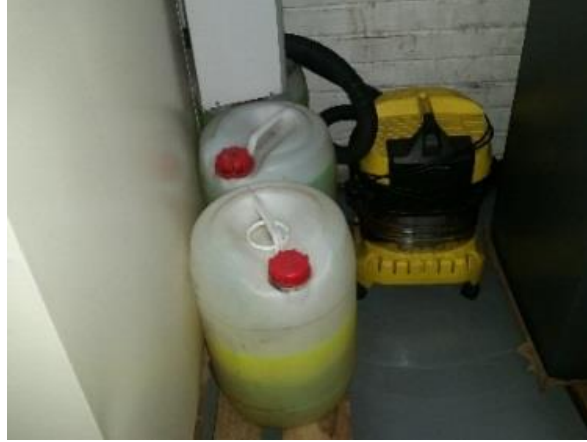
- Improper storage of HCS

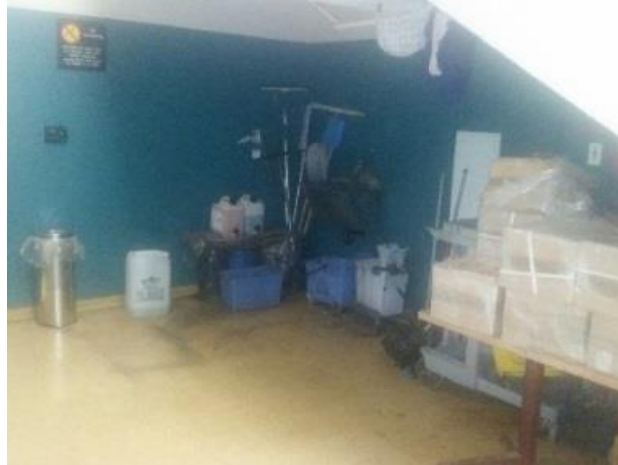
- Improper storage of HCS

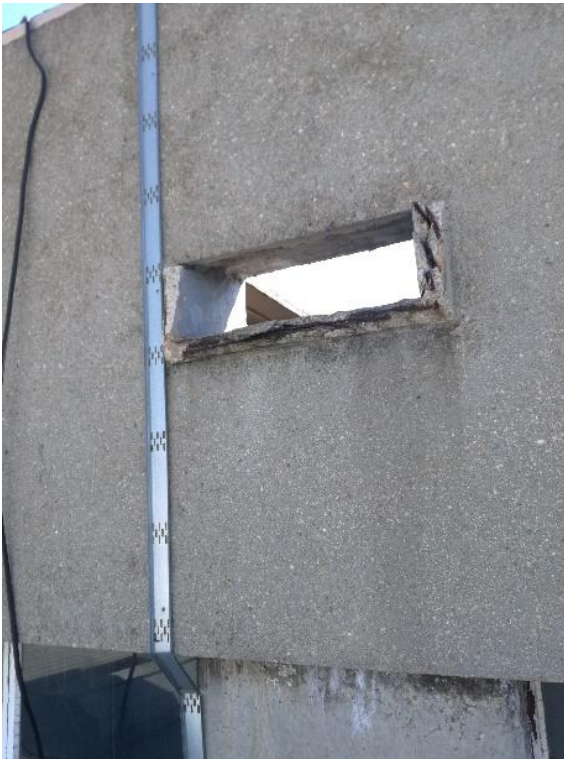
- The emergency overflow concrete overhang has disintegrated, and the rebar is exposed (see image below) at roughly 30% of all the channel roofs.
 - **Remedial:** Refer to defect D1. The reinforcement has to be cut back and not be exposed. It is suggested that the overflow must be replaced with a new concrete overflow channel.

Figure 22 Disintegrated concrete emergency overflow

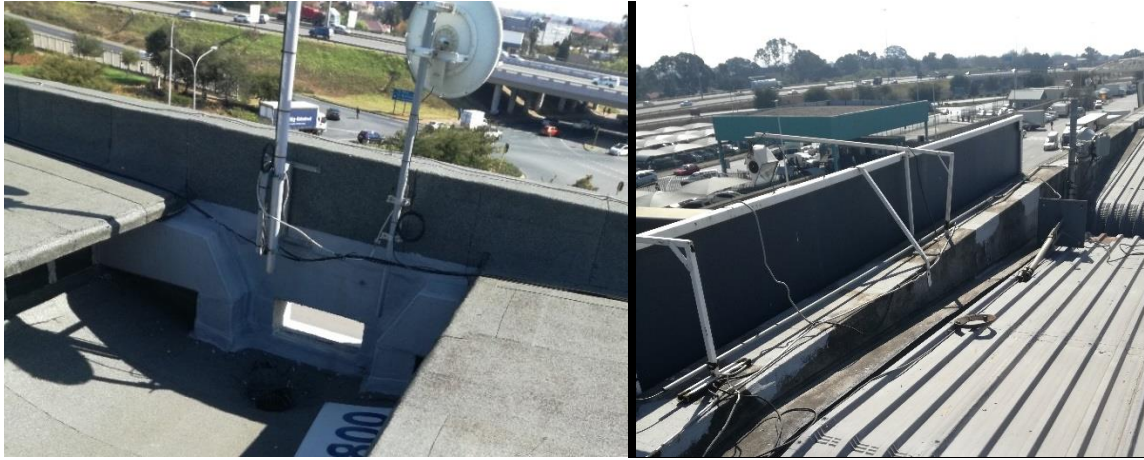
Figure 23 Steel masts on roof level

- **Remedial:** Refer to masts remedial as per section 2.2.1.13 on page 174 of the Cargo Offices.

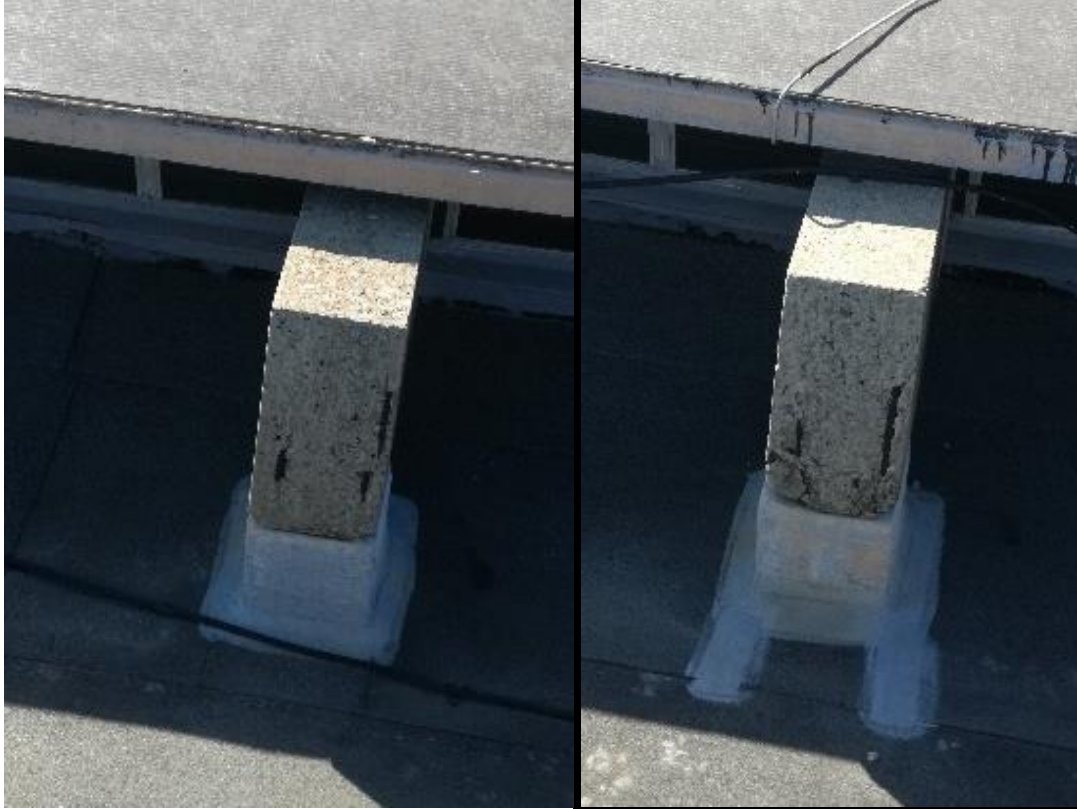
- The roof level has been constructed with precast concrete beams for most of the roofs. The concrete beams are fixed to the concrete columns (assumed to be doweled together). Roughly 24% of the reinforcement cover for the beams are insufficient at the support ends (4 out of 17 beams). The lack of cover have started to expose the beam reinforcement over time and rust is present at the exposed reinforcement.
 - **Remedial:** Refer to defect D1 to repair the concrete

Figure 24 Exposed roof beam reinforcement

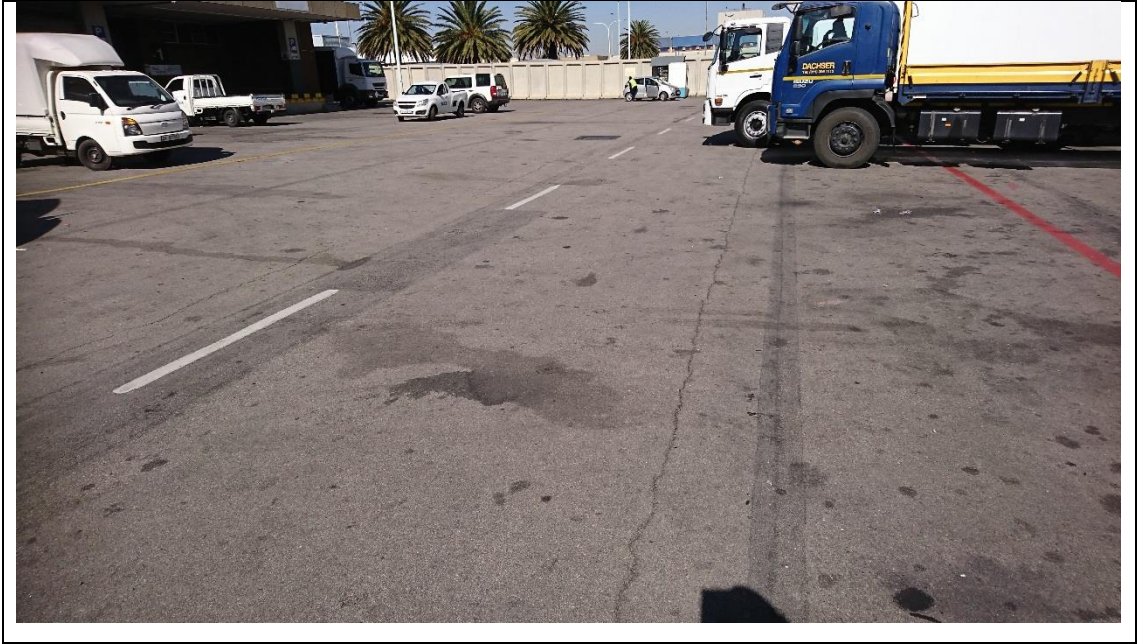
Figure 26 Longitudinal cracks in Cargo Warehouse loading area.

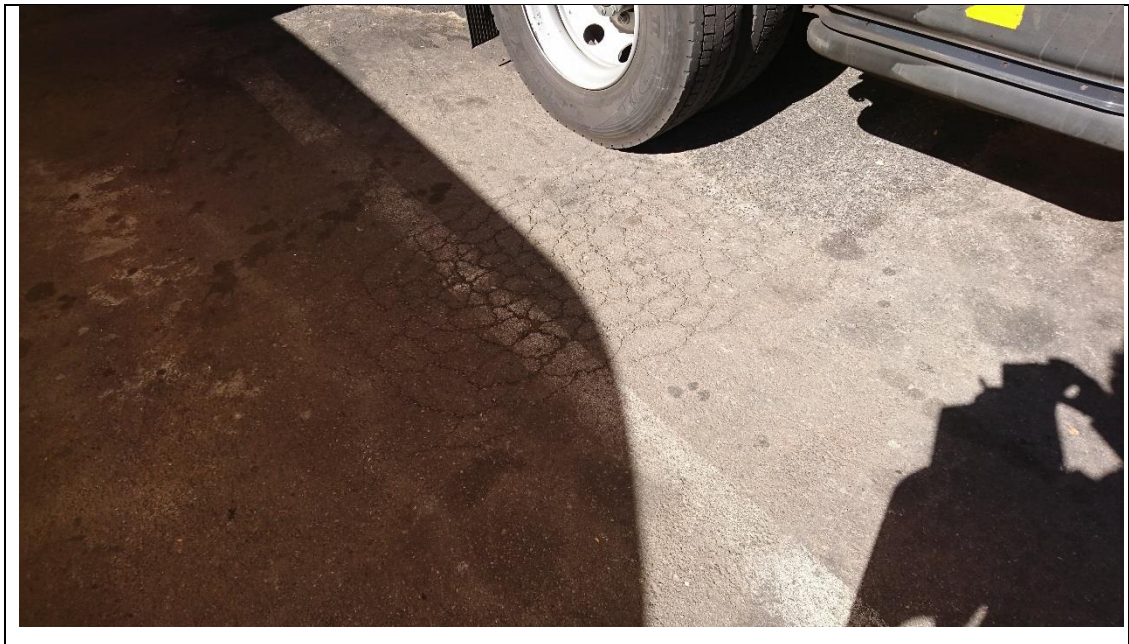
Figure 27 Local pavement failure

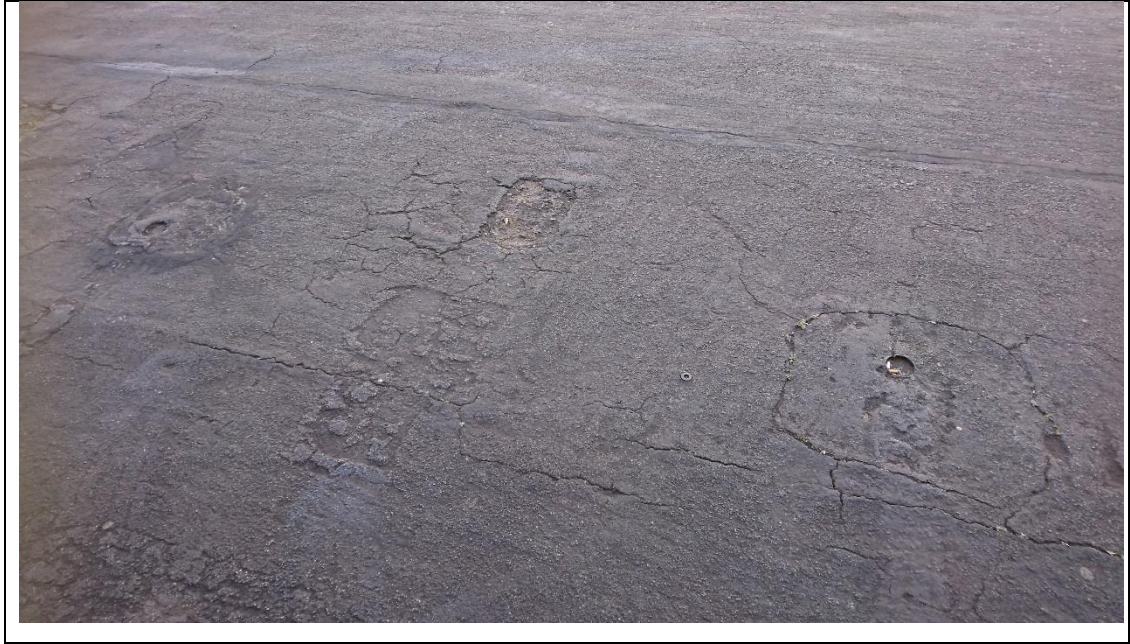
Figure 28 Section pavement failure

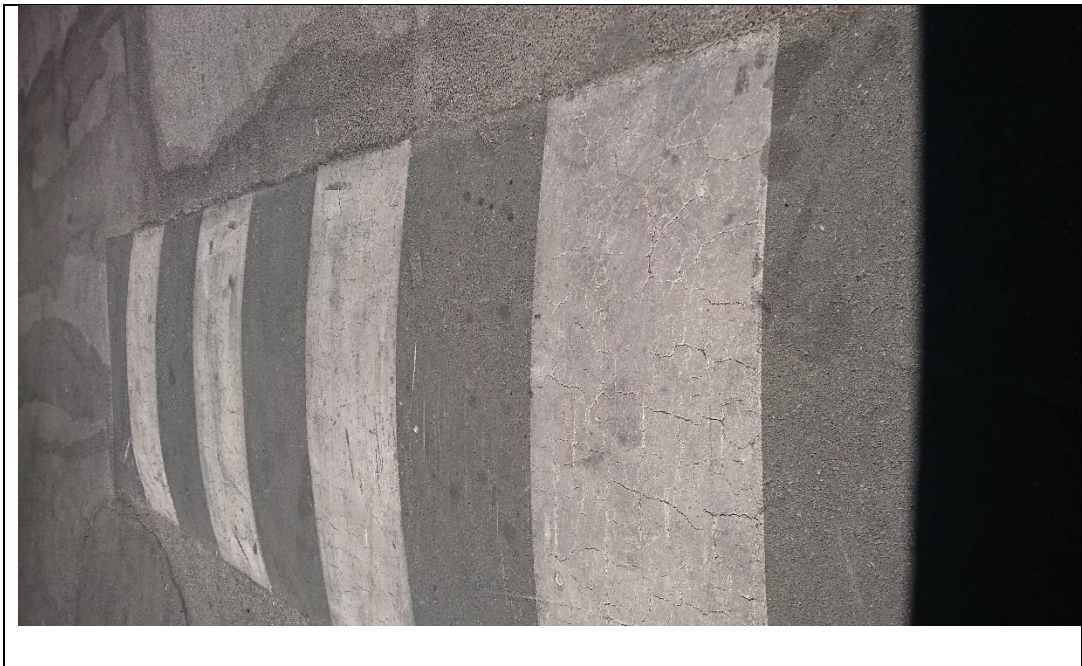
Figure 30 Road marking in poor state, cracked.

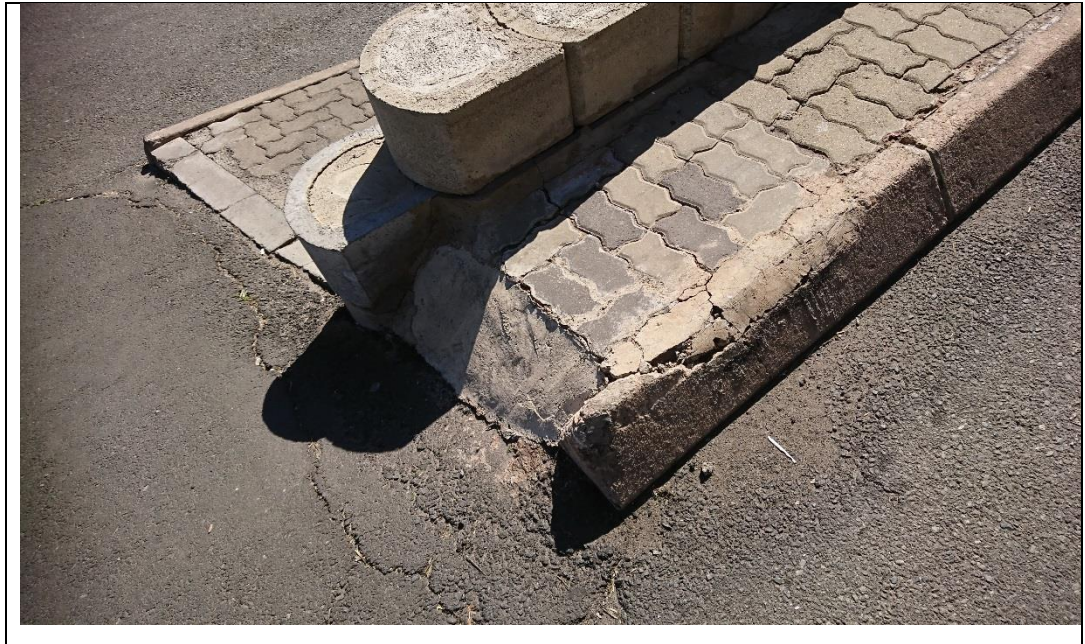
The kerbs are in fairly condition with minor damages as shown in Figure 31 below.

Figure 31 Poor kerb condition

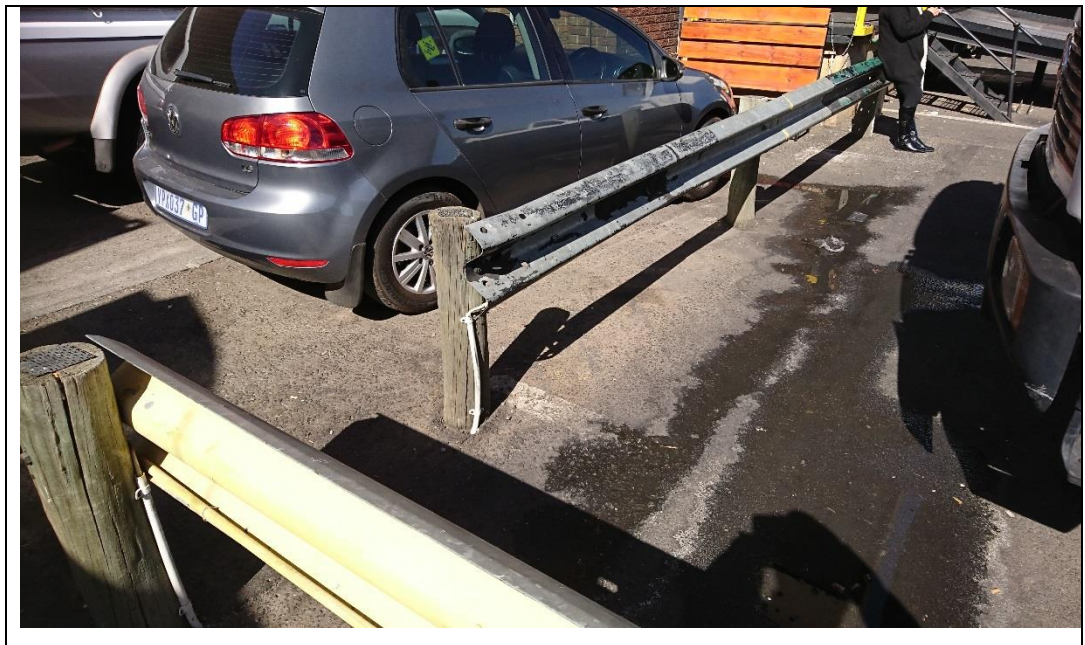
Figure 32 shows guardrails which are in a poor damaged state.

Figure 32 Guardrails

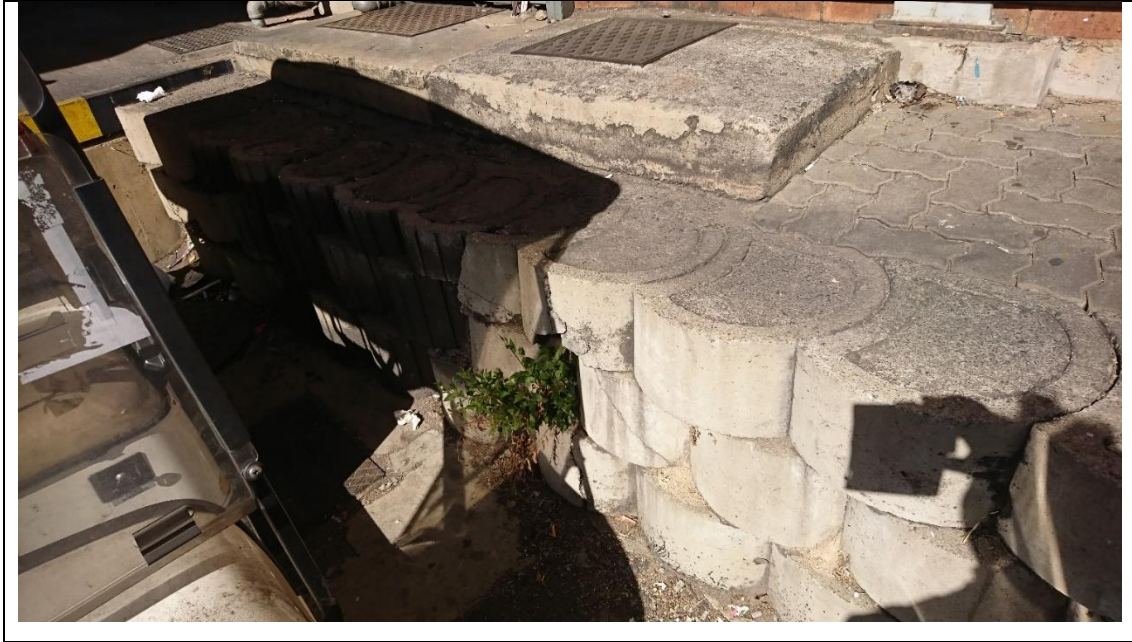
There are two sections where existing Loffelstein retaining wall block structures have damaged blocks. See Figure 18 below.

Figure 33 Damaged Loffelstein blocks.

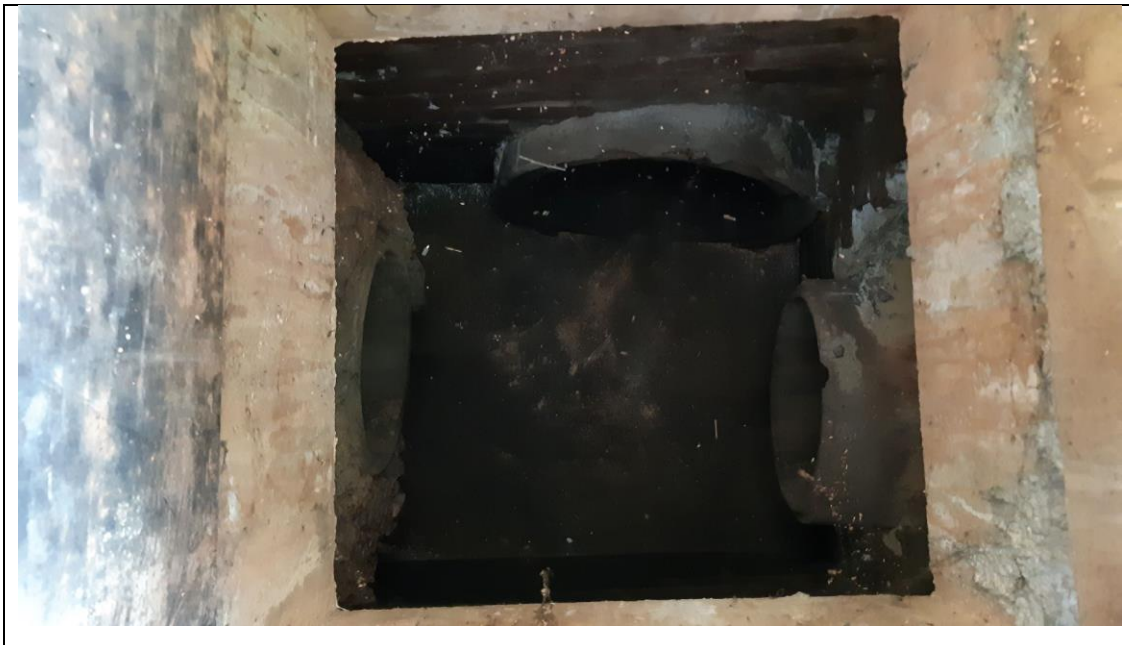
Figures 34 and 35 below show the typical external and internal condition of the stormwater manholes in the Cargo Warehouse loading area. The external condition is fair and the internal condition poor.

Figure 35 Manhole internal condition

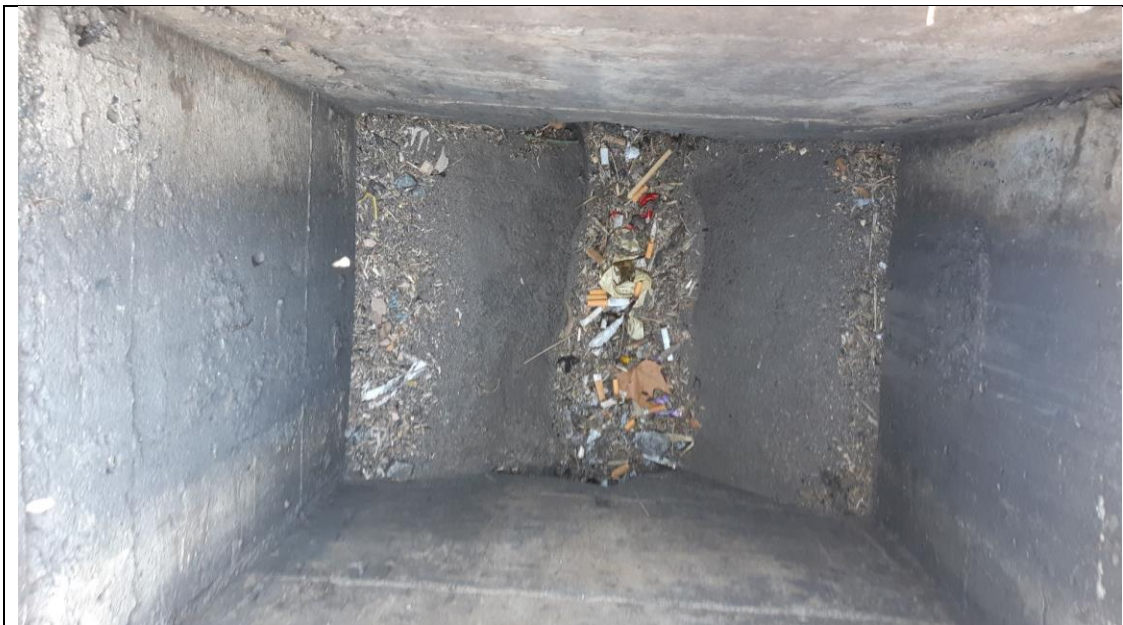
Generally the grid inlets internally show signs of partial blockage due to the presence of debris. Externally the grids on the inlets show little or no sign of damage. A typical grid inlet is shown in Figures 36 and 37 below.

Figure 37 Good condition grid inlet with debris

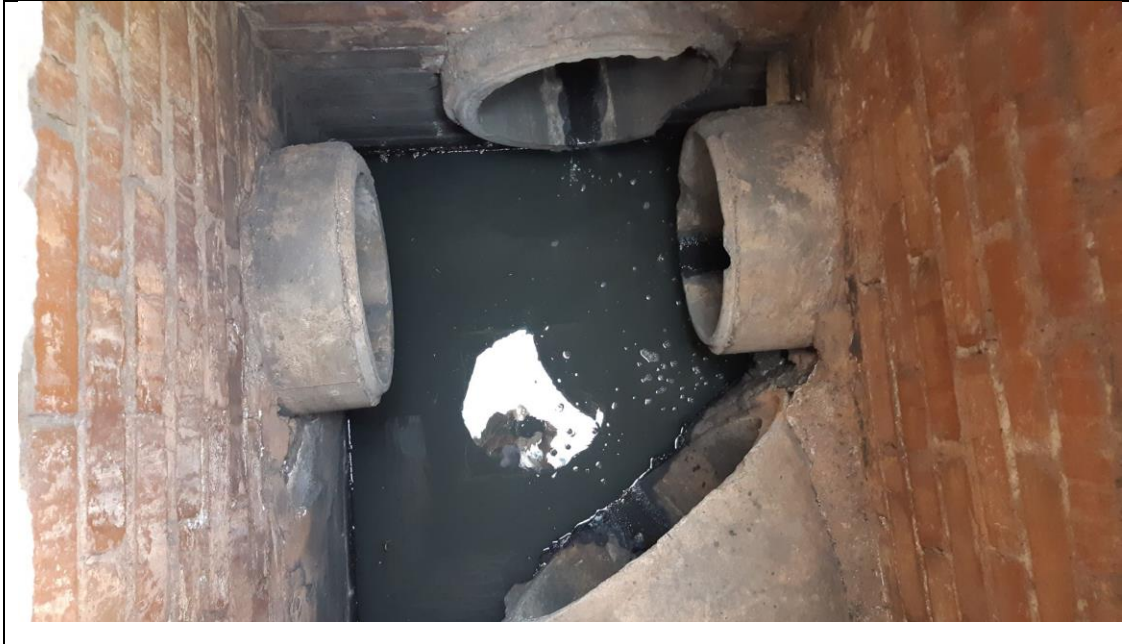
Figure 39 Manhole with stagnant water inside.

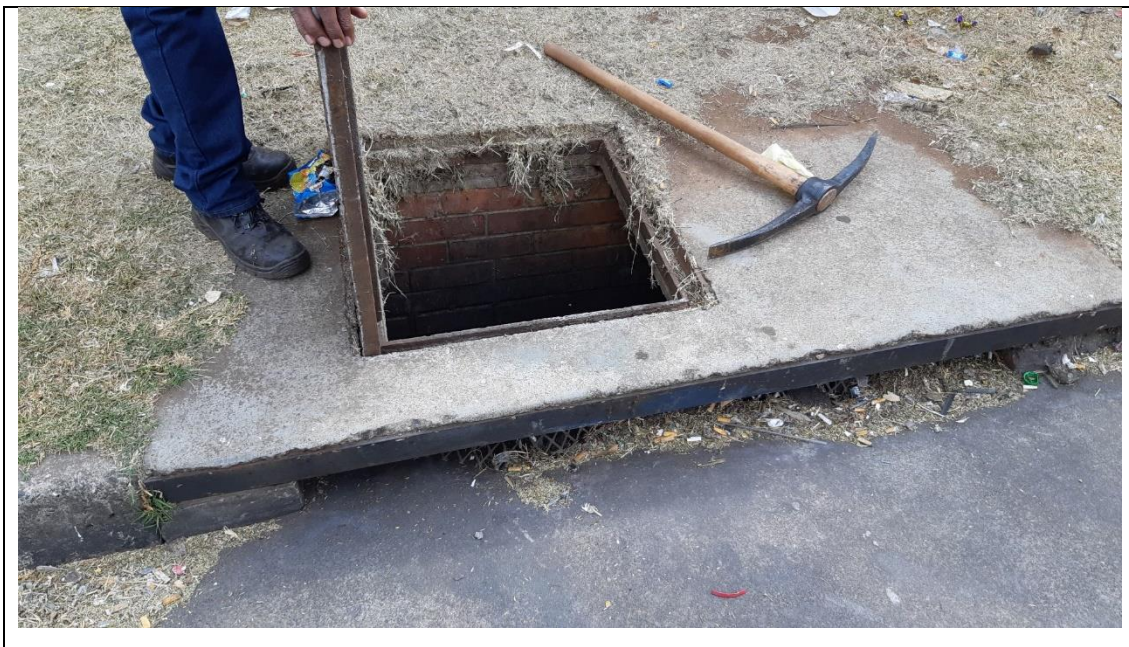
Figures 40 and 41 below shows a kerb inlet structure with a very narrow kerb inlet opening. The manhole is blocked by debris. Concrete repairs to the opening of the structure and site clearing works are required.

Figure 40 Kerb inlet with narrow opening

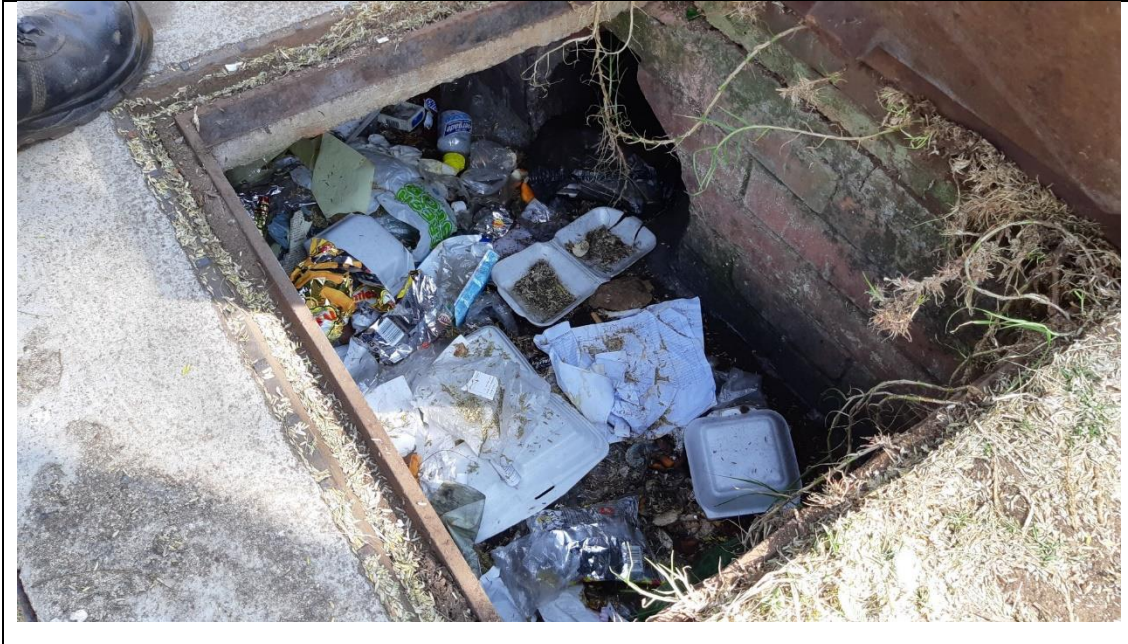
Figure 41 Partially blocked kerb inlet manhole

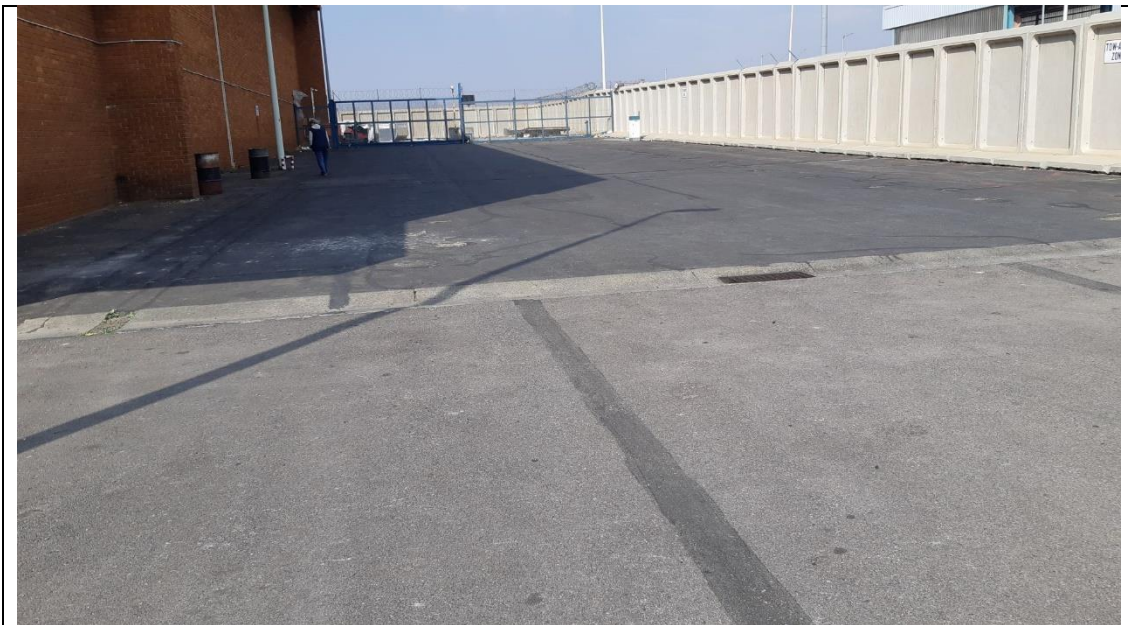
South of the Cargo Warehouse there is concrete surfaced lined channel draining into a grid inlet. The channel is damaged – concrete cracks, spalling, edge breaks and no fill in the concrete joints. See Figure 42 and Figure 43 below.

Figure 42 Surface drain with minor structural damages

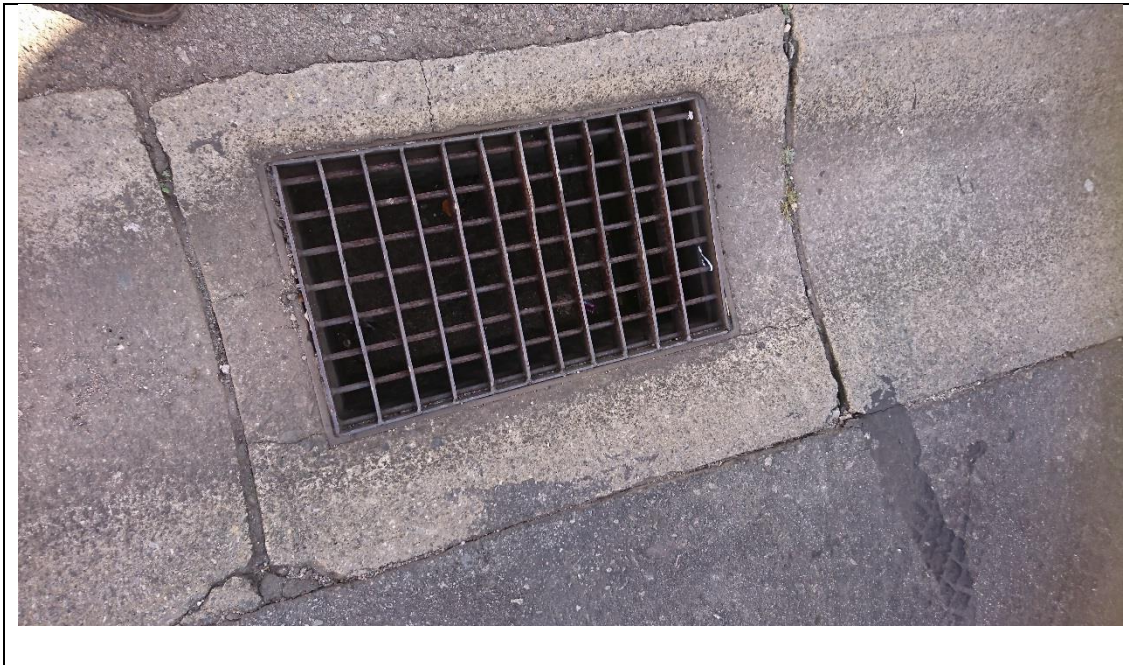
Figure 43: Damaged concrete channel with grid inlet

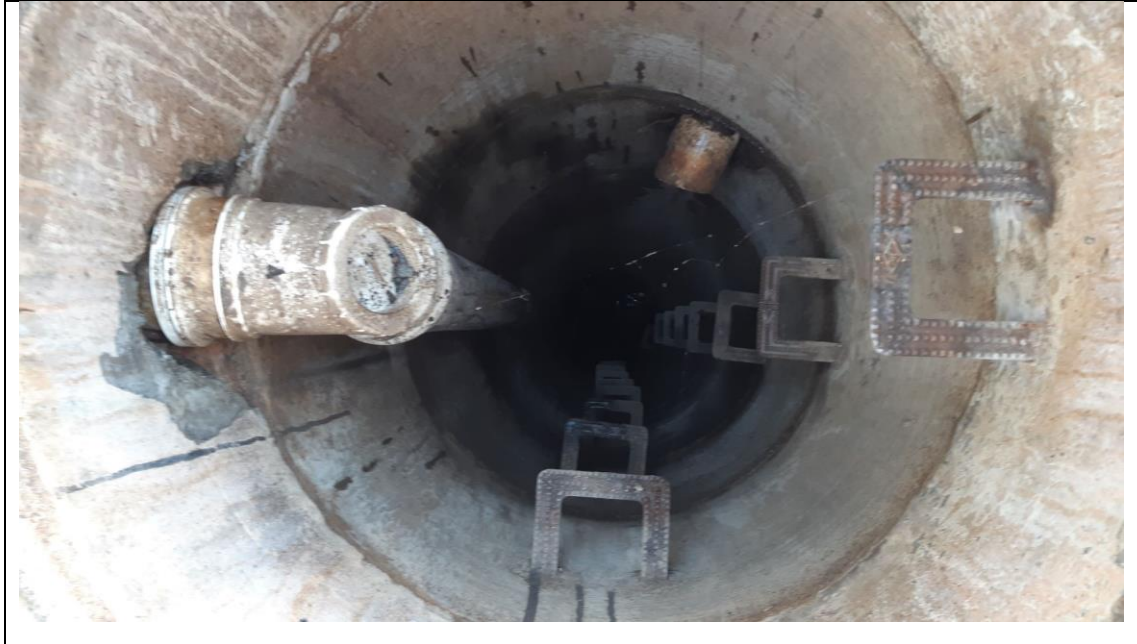
Figures 45 and 46 show the good sewer manhole external condition and the fair internal condition. The joints between the sewer manhole rings need repairs. Since the manhole is very deep, the condition of the benching and sewer pipes could not be established. Further investigations in the form of camera inspections are recommended. Some joints between manhole rings need repair.

Figure 46 Typical fair condition of sewer manhole. Concrete cracks can be seen around sewer inlet pipe

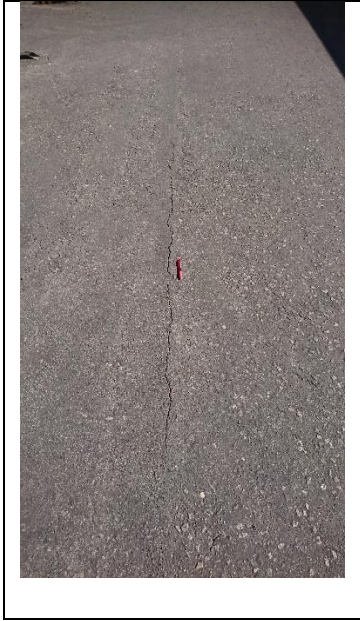
Figures 48 and 49 below show the longitudinal cracks and stone loss in the area. It is recommended to seal the cracks first before construction of a new surface seal.

Figure 48: Longitudinal cracks

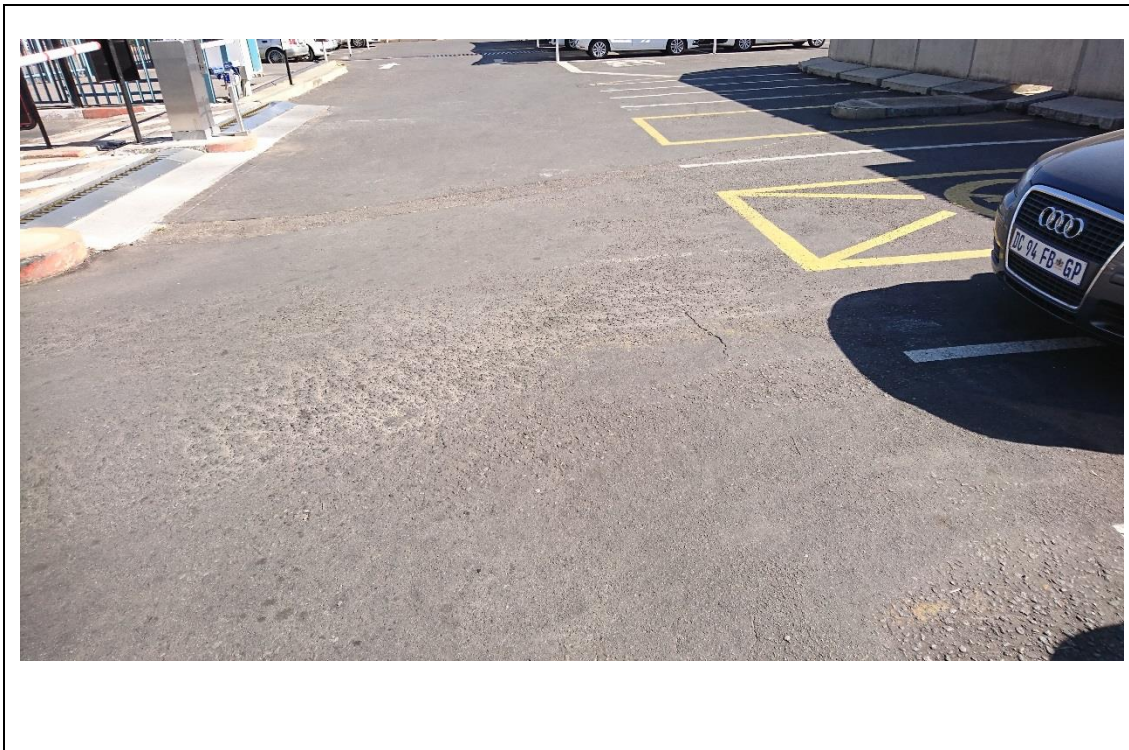
Figure 49: Stone loss at entrance and exits

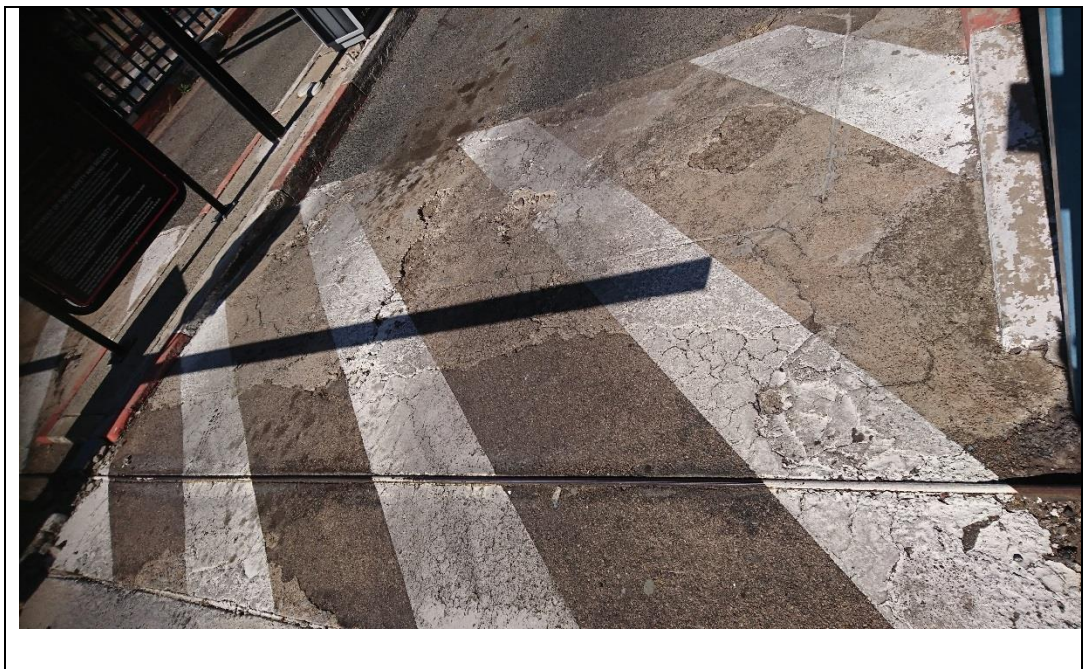
Figure 50: Damaged speed hump
