CONDITION ASSESSMENT REPORT FOR THE (former) OFFSHORE WAREHOUSING PROPERTY AT BAYHEAD PARK

Project Name : Condition Assessment (38 Kobe Road)

Owner : Transnet National Ports Authority

Print Date: 19/06/2023

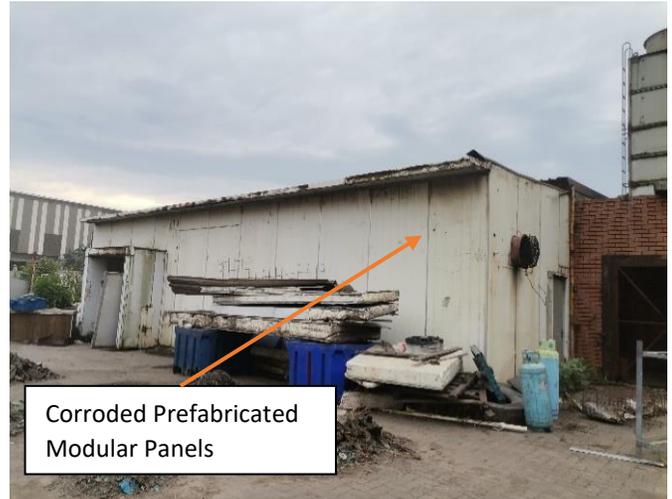
Figure 3: Canteen (Fish shop)

The canteen (Fish Shop) building illustrated on Figure 3 is constructed of approximately 50% brick walls, and 50% prefabricated modular panels which seem to be an addition to the original brick structure. This building is separated into 2 units, the canteen, and the refrigeration plant building.

- The fish shop has a length of 15m and a width of 10,4m which makes an area of approximately 156m² of the canteen building, and the cooling system building is approximately 36.85m².
- The prefabricated panels forming the addition of the canteen are in poor condition, which is evidence of prolonged exposure to the natural elements.
- Detail of the inside of the canteen could not be observed as the inside of the building was not accessible.

- e) The general drainage system on the property was not identified, hence the scope for refurbishing the property must include the establishment of a comprehensive drainage system.
- f) Demolish and remove the canteen (fish-shop) building and the adjoining brick wall, including the “cooling tower” and other equipment.
- g) Refurbish the brick wall, floors, doors, and windows.
- h) Structural Assessment of the foundation of the buildings must be conducted by a Professional Service Provider.
- i) The electrical and Mechanical and Electrical Infrastructure is badly vandalized. To prevent vagrants from further entering the facility TNPA needs to scrap all the remaining steel from the HVAC and electrical panels as they attract attention.

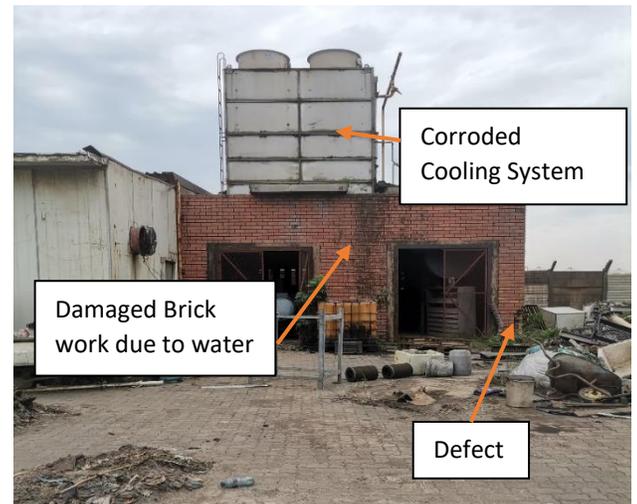
Figure 4: Refrigeration plant building

- The adjoining brickwork building has an area of approximately 36,85m².
- The adjoining building next to the canteen building is constructed of 100% clay bricks and has a cooling system on the roof. The brickwork of this building has water damage causing the dark stains.
- The cooling system is corroded due to its exposure to an atmosphere high in sodium chloride.
- This building has a concrete roof and seems to be in good condition.
- There are doors missing for this building, and the gates are damaged.

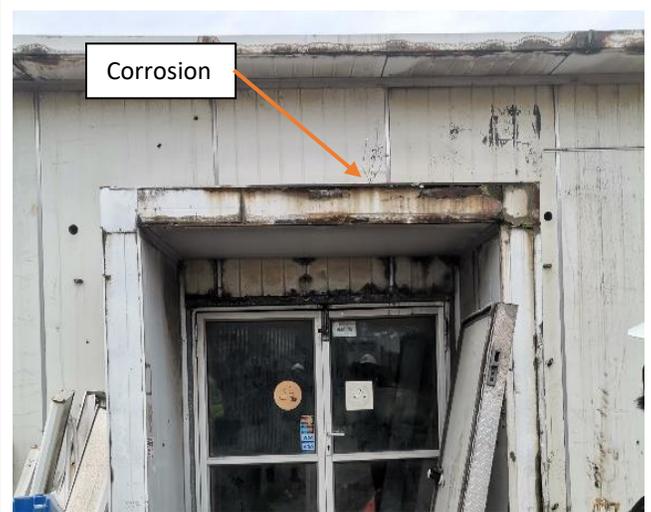
Figure 5: Canteen entrance door

- Figure 5 shows the doorway of the prefabricated part of the fish shop.
- The prefabricated panels have been affected by corrosion due to its unmaintained exposure to the water and environment.

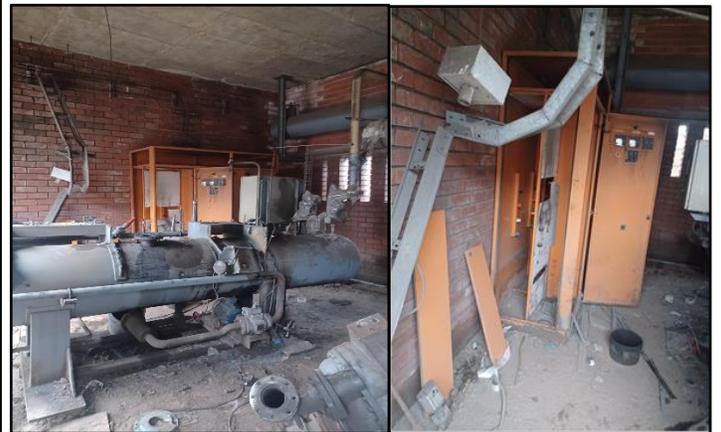
Figure 6: Electrical Equipment

- Figure 6 shows the state of the equipment in the plantroom.
- Control Panel Stripped.
- Cooling Tower Vandalized & Corroded.

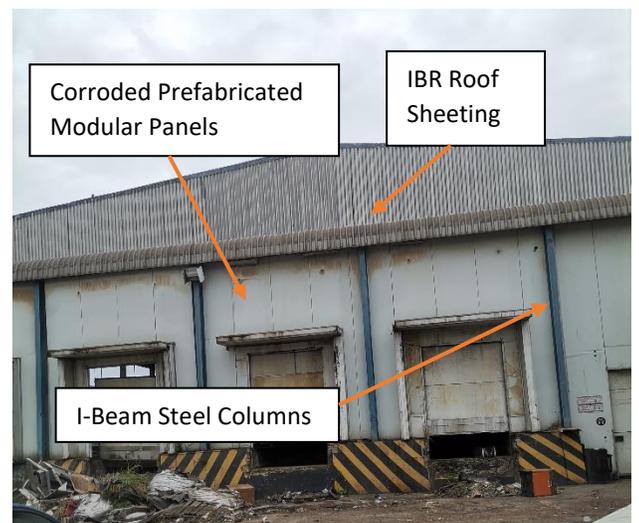
Figure 7: Exterior view of the ex-Offshore warehouse

- The warehouse served as a cold storage facility; it has a floor area of 1575 m².
- Structural elements that make up the ex-offshore warehouse are 60% wall cladding, 25% brickwork, 15% prefabricated modular panels, I-beam steel columns, and a roof sheeting supported by steel rafters (I-beam).
- It consists of insulated sliding doors.
- The marine environment increases corrosion in steel structures as it is known for high levels of humidity and high salt content in water particles.

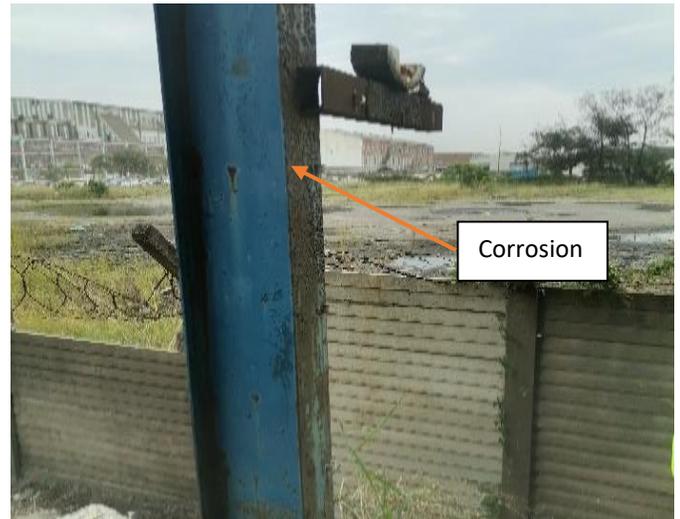
Figure 8: Steel column

- The steel columns are of 3mm thickness, 30cm x 17cm in length, width respectively and are spaced 5m apart.
- Some of the steel columns in this warehouse are not in good condition as shown in Figure 6, they are corroded due to exposure to the marine environment.

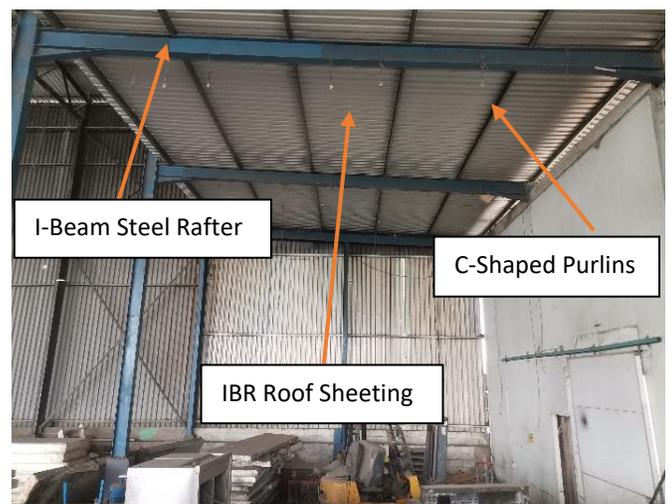
Figure 9: Interior view of a mono-pitched loading section

- The loading section has a floor area of 250m² and made of a concrete slab.
- It has an IBR sheeting utilised for the roof, c-shaped steel purlins and I-beam steel rafters supporting the roof structure.
- The steel material in this section is in good condition.

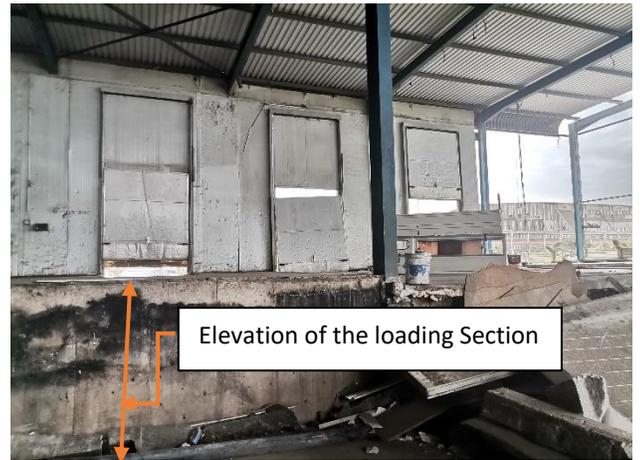
Figure 10: Concrete slab elevation of the loading section

- The loading section has an elevation of 1,6m, 25m in length and 10m wide.
- Water leaks onto the side of the loading section (see Figure 8) can damage the foundation given that concrete foundations are porous.
- Steel structures in this section of the warehouse are in good condition.

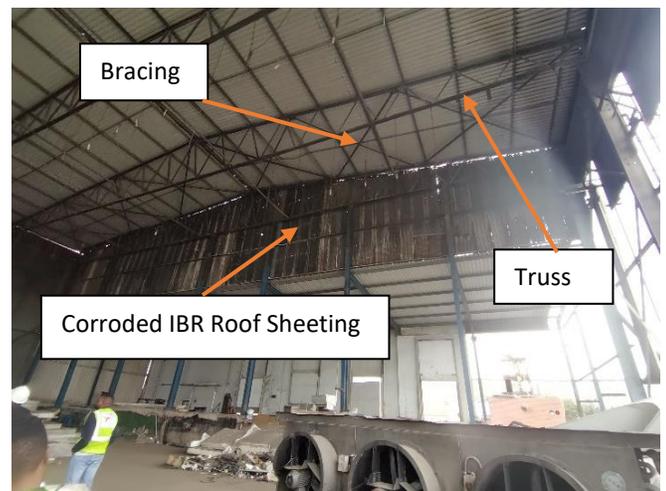
Figure 11: Interior view of the roof

- Structural steel members that were utilized to support the internal side of the roof are trusses, hollow bracings, c-shaped purlins, and I-beam rafters.
- The external part of the roof is 100% roof sheeting.
- The portal frames are spaced at 5m apart (center-to-center) and extend over a span of 35m in total.
- Corrosion was identified on the roof sheeting as shown in figure 10.

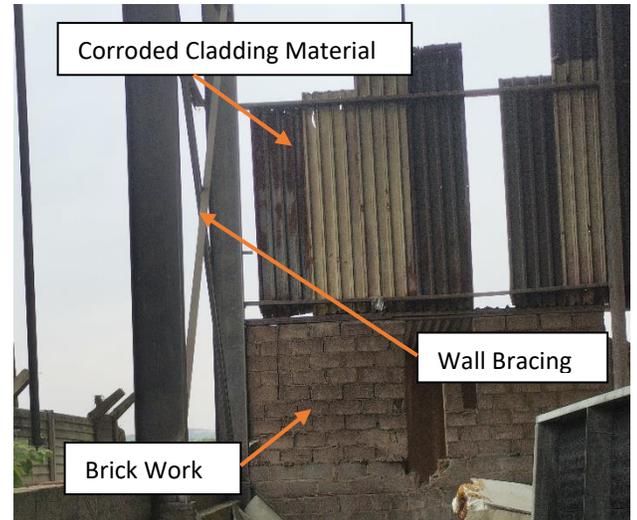
Figure 12: Wall (inside the warehouse)

- The warehouse is only braced at the end panels along the sides excluding the loading section (see figure 8 and 11).
- The wall cladding is damaged, partitioning parts of it have come off and the material is corroded.
- The brick work is exposed and affected by water leaks.

- a) The Admin Building's Steel balcony, railings and staircase needs to be replaced.
- b) The corroded and missing steel cladding in the warehouse must be replaced.
- c) Steel members (purlins, sag bars, girders, column, etc.) to be further assessed to establish residual strength of members, however there were no major visible defects observed during the investigation, just minor corrosion.
- d) Organize the necessary equipment (scaffolding or otherwise) for the inspection of the roof drainage system.

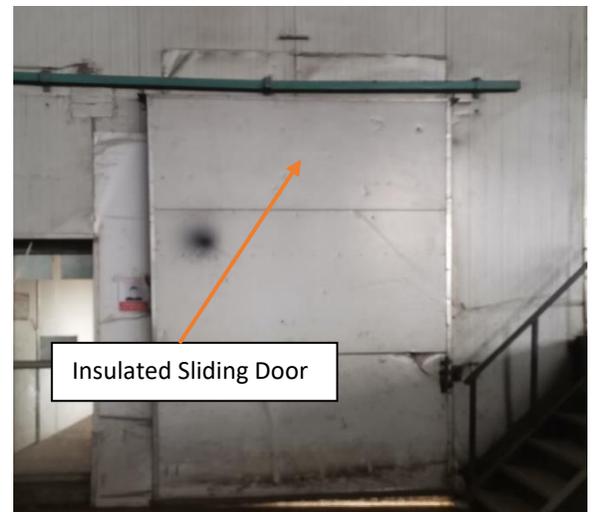
Figure 13: Damaged sliding doors of warehouse

- The doors are not in a good condition as shown in figure 12. The doors do not slide properly, and corrosion was identified on steel parts of the door.
- Some doors have fallen off.

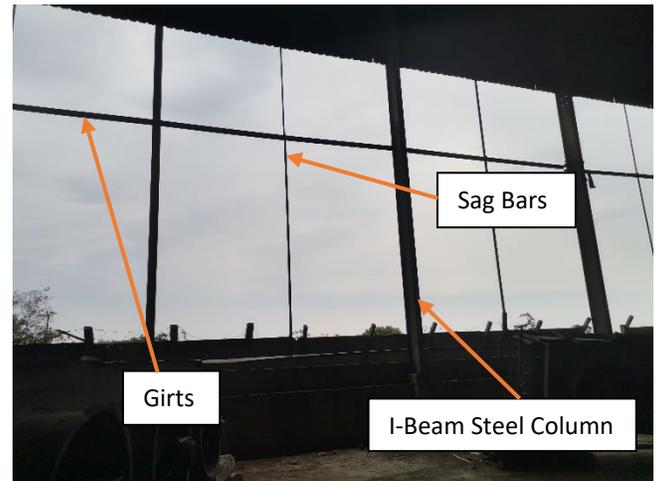
Figure 14: Interior steel members

- Girts are of a channel section of steel and sag bars are of an angle section type of steel.
- The steel members shown in figure 13 are in a good condition and however,
- The wall cladding on the sides has come off (see figure 13).

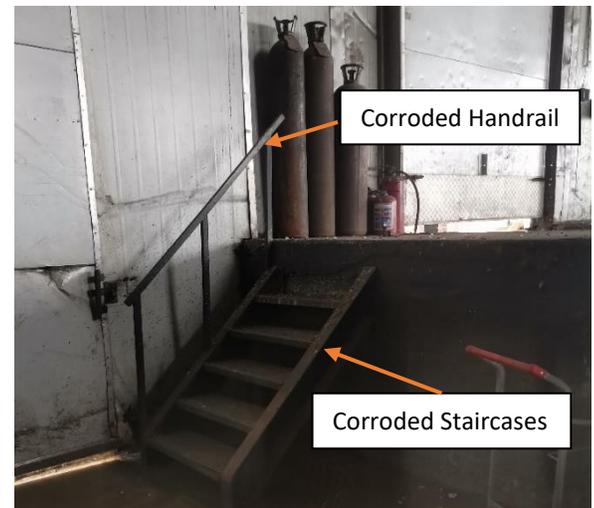
Figure 15: Steel staircase and handrail

- Handrails and the staircases are corroded therefore are not in a good condition.
- There is no allowance between the staircase and the door.
- The steps of this staircase are too close and too small, this may have been done to accommodate the small space in which they are located. In the case of an emergency, these stairs may be risky as people may fall.

Steel Stairs and Handrails	39%	Not safe	Replace with wide stairs for safety.
Concrete Floor	80%	Safe	Minor repairs required.
Electrical Equipment/Installations	39%	Not Safe	Must be scrapped

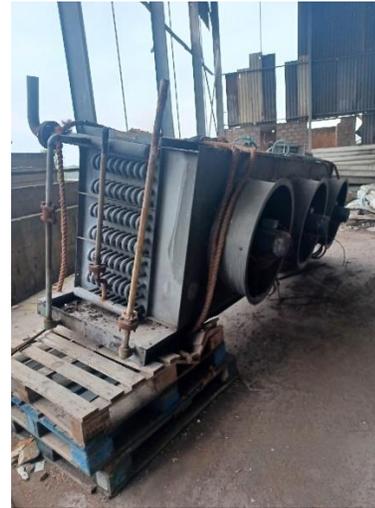
Figure 16: Damaged Cooling Fan

- Figure 16 shows the damaged Cooling Fans on the floor removed from the ducting.

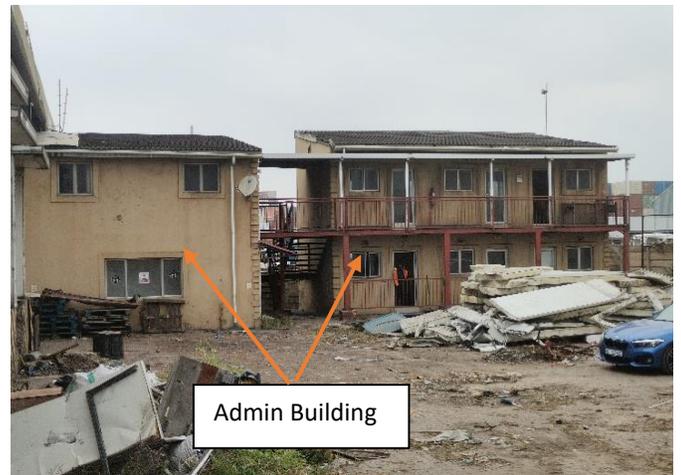
Figure 17: Admin building (front view)

- Figure 15 shows the front view of the admin building, which seems to be structurally sound.
- This admin building is approximately 98m² and is a 2-story building.
- From this picture no defects can be identified.

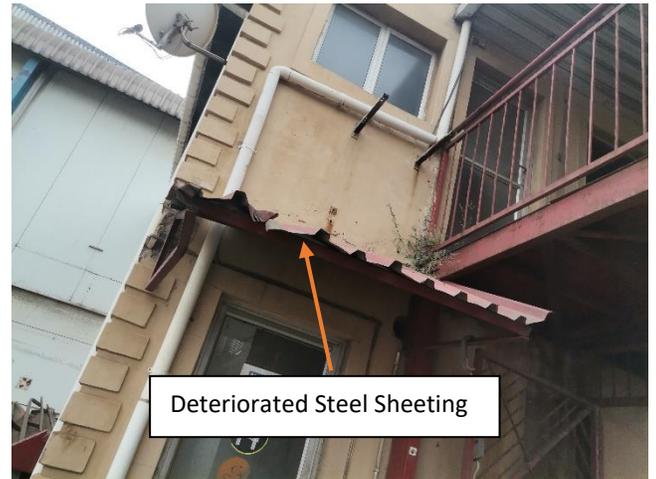
Figure 18: Deteriorated steel sheeting

- The steel sheeting used to cover the entrance to the ablutions and prevent it from rain is starting to deteriorate due to the lack of maintenance and harsh winds and other environmental factors it is exposed to as it is located near the ocean.

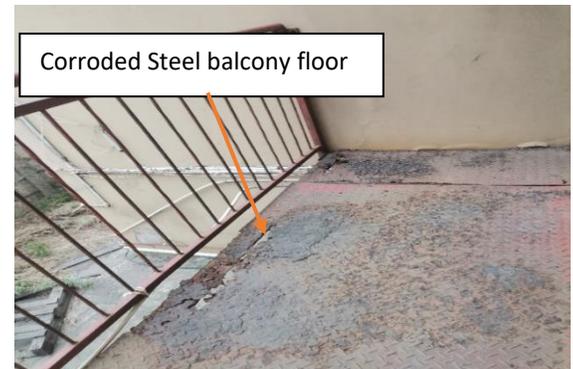
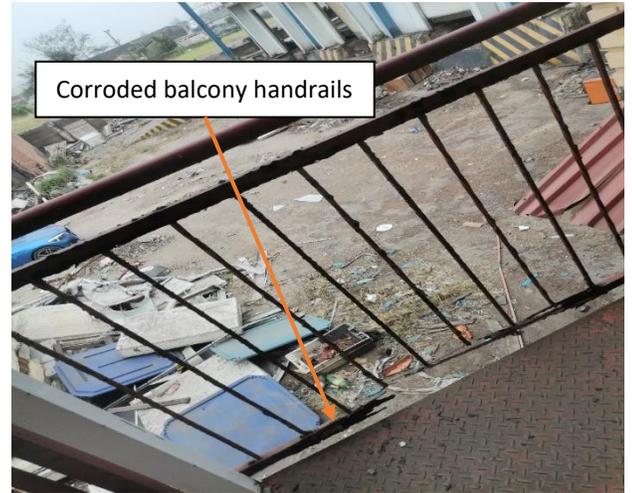
- Figure 17 and 18 show the corrosion of the steel components of the admin building.
- Most of the corroded parts have broken off on their own making the balcony and staircase unsafe for use, and thus the 1st floor is not accessible.

Steel Railing	39%	Not Safe	Material needs to be replaced
Steel Balcony	20%	Not Safe	Major upgrades need to be done
Roof	70%	Safe	Leaks need to be closed

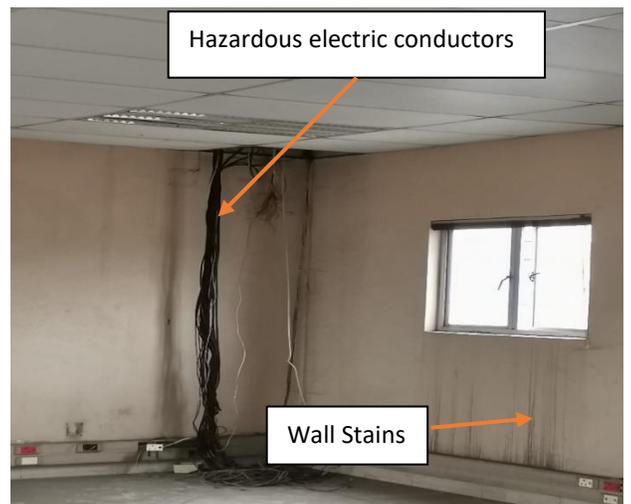
Figure 21: Exposed electrical cables

- One of the rooms used as offices has electric cables that are left hanging from the ceiling which may have been previously used for the security systems or network systems.
