**PROJECT PARTICULAR SPECIFICATION:  
STRUCTURAL ASSESSMENTS**

**PS STR**

**UMHLANGA WASTEWATER TREATMENT WORKS  
EMERGENCY REMEDIATION WORKS**

**Contract No. WS7741**

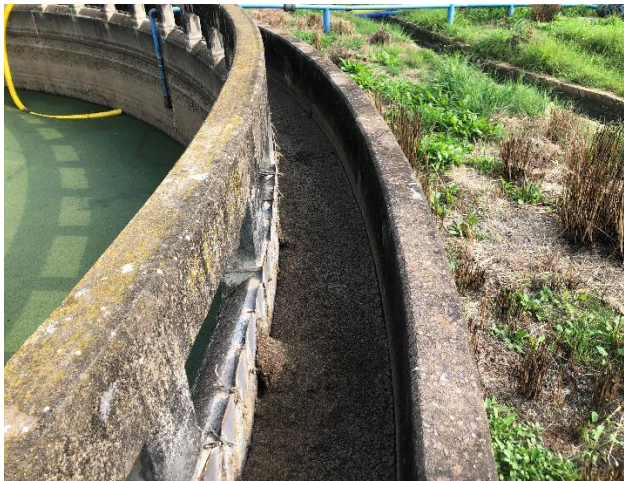
1. Minors cracks on the outer ring. (signs of leakage) (refer to photo No. 04, 05 & 06).
2. Deposition of sludge on half-way across the channel, this meant the clarifier is tilted to one side. (refer to photo No. 01 & 02).
3. Could not inspect the floor slab because of effluent. (structural damage unknown) (refer to photo No. 03).

Clarifier (1) Photo 01-Sludge Deposition

1. Engagement with the Geotechnical engineer and specialist to assess the cause of the tilt (whether its settlement or uplift) and design recommendations on how to rectify the Tilt. A detailed survey is required to determine by how much the clarifier has tilted and whether this tilt affects its operations or functionality.

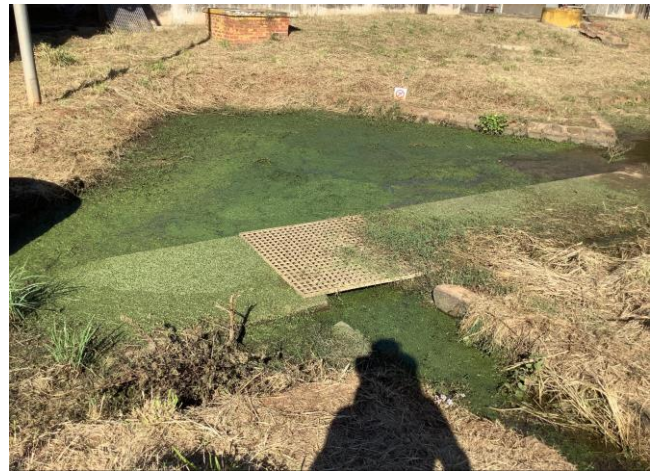
Clarifier (1) Photo 01-Sewage spill

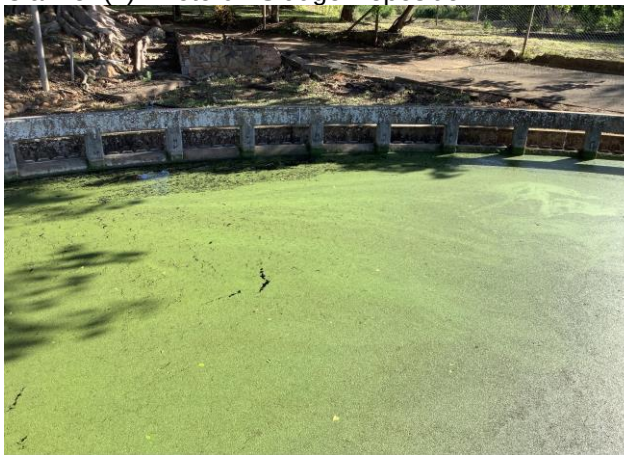
Clarifier (1) Photo 01-Shows Tilt

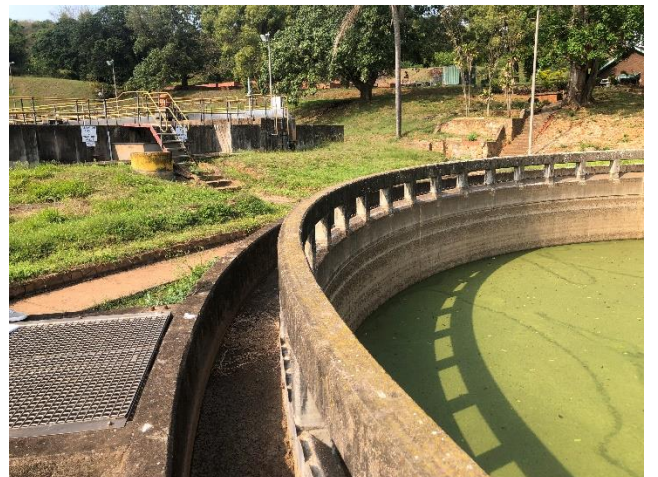
Clarifier (1) Photo 02-Sludge Deposition

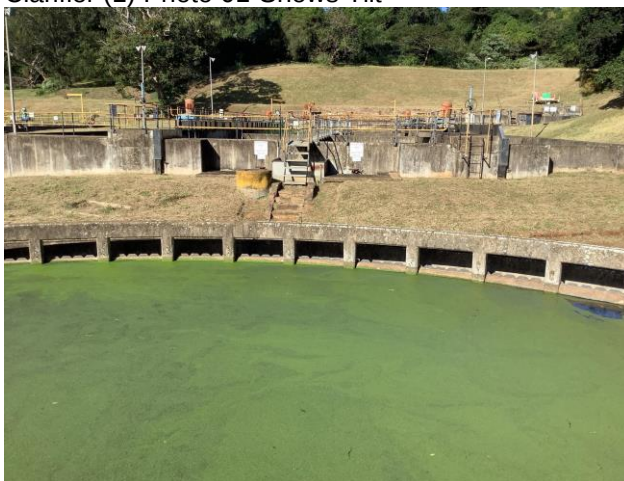
Clarifier (1) Photo 01-Shows Tilt

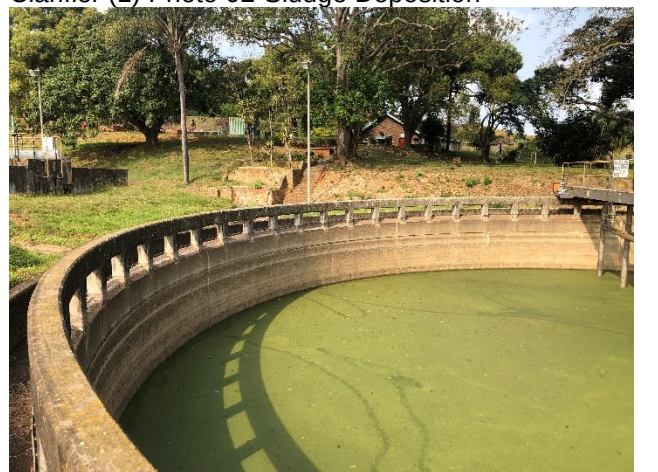
Clarifier (1) Photo 03-Water in Clarifier.

2. Unfortunately, the Clarifier (1) floor slab could not be inspected for any structural damage due to effluent in the tank/clarifier. Only upon successful drainage of the clarifier (1), it would be possible for full visual assessment to be carried out.

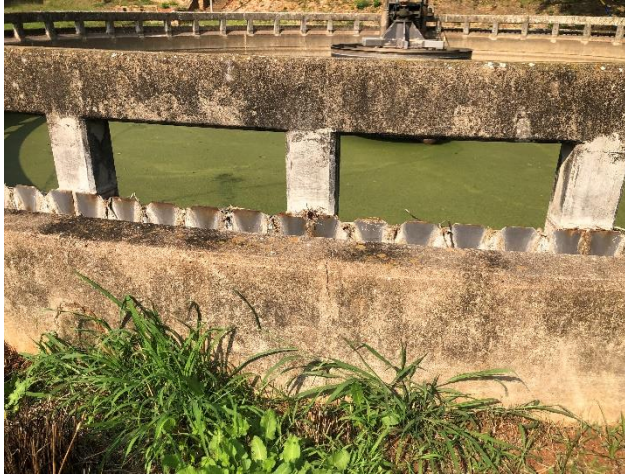
Clarifier (1) Photo 04-Outer wall cracks (0.2-0.3mm)

3. It was noted from the operations personnel that every time the clarifier drained, the water filled up the structure suggesting that there might be surrounding ground water seepage into the Clarifier. It is recommended that further investigation to be carried out, from the visual assessment there is indication of cracking of internal walls which might result in ground water seepage.

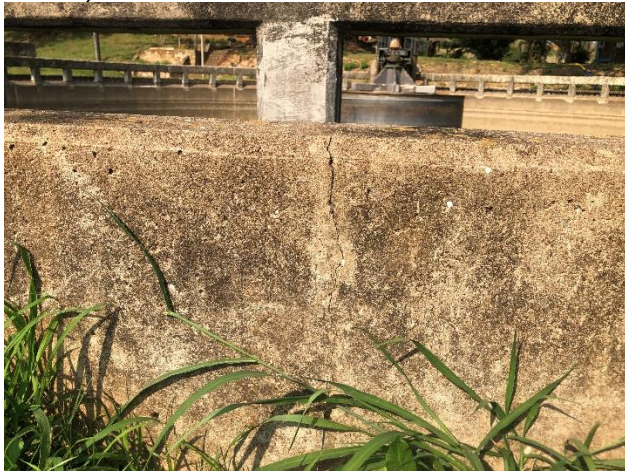
Clarifier (1) Photo 05-Outer wall cracks (0.2-0.3mm)

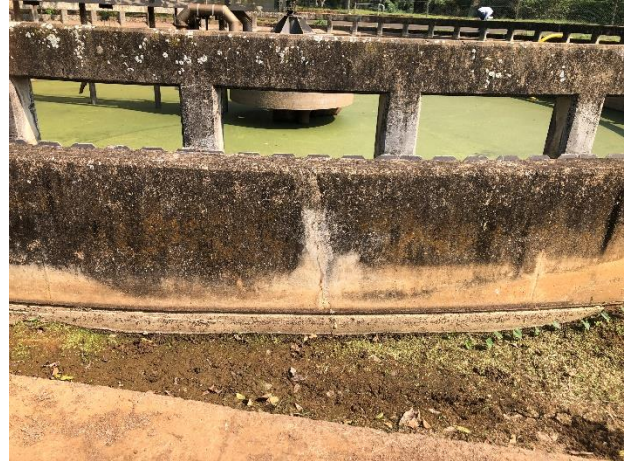
Clarifier (1) Photo 06-Outer wall cracks (0.2-0.3mm)

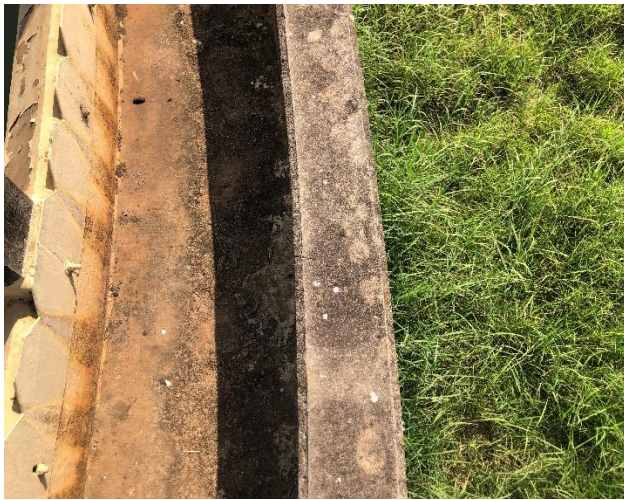
1. Minors cracks on the outer ring. (sign of leakage) (refer to photo No. 7,8 & 9)
2. Could not inspect the floor slab because of effluent. (structural damage unknown) (refer to photo 10)
3. Small diameter hole on the side of the tank

Clarifier (2) Photo 07-Outer wall cracks (0.2-0.3mm)

1. Seal or close the small diameter hole on the using non shrink grout or similar approved.
2. The clarifier floor slab could not be inspected for any structural damage due to effluent in the tank/clarifier, upon successful drainage of the clarifier, it would be possible for full visual assessment to be carried out.
3. It was noted from the operations personnel that every time the clarifier drained, the water filled up the structure suggesting that there might be surrounding ground water seepage into the Clarifier. It is recommended that further investigation to be carried out, from the visual assessment there is indication of cracking of internal walls which might result in ground water seepage.

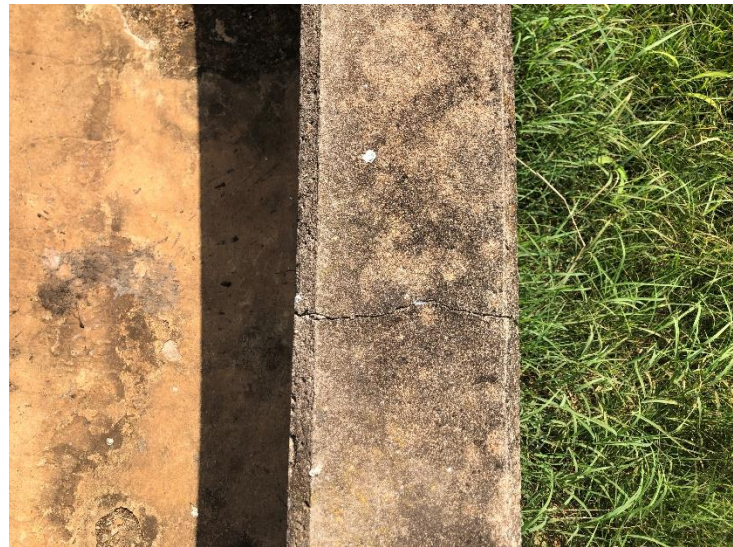
Clarifier (2) Photo 08-Outer wall cracks (0.2-0.3mm)

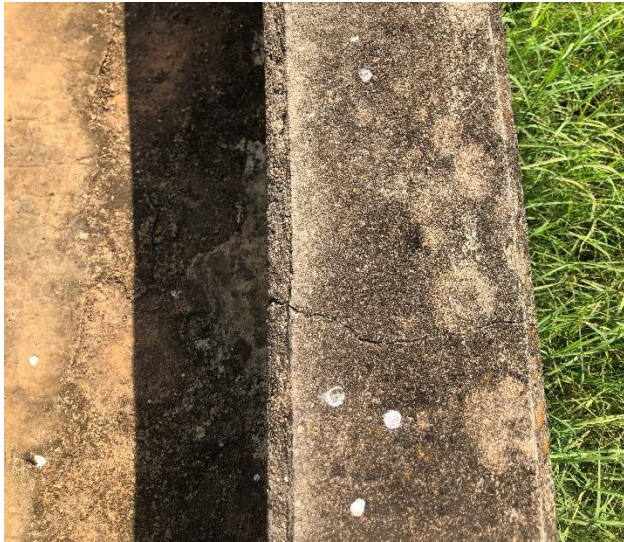
Clarifier (2) Photo 09-Detail outer wall cracks (0.2-0.3mm)

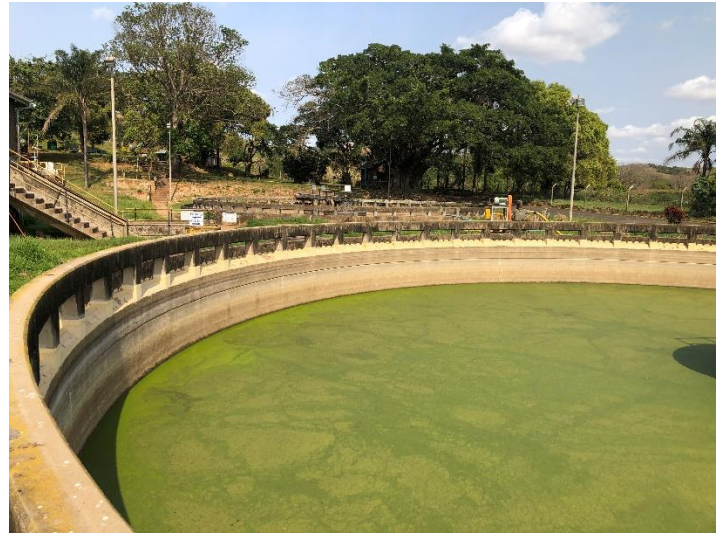
Clarifier (2) Photo 10-Water in Tank

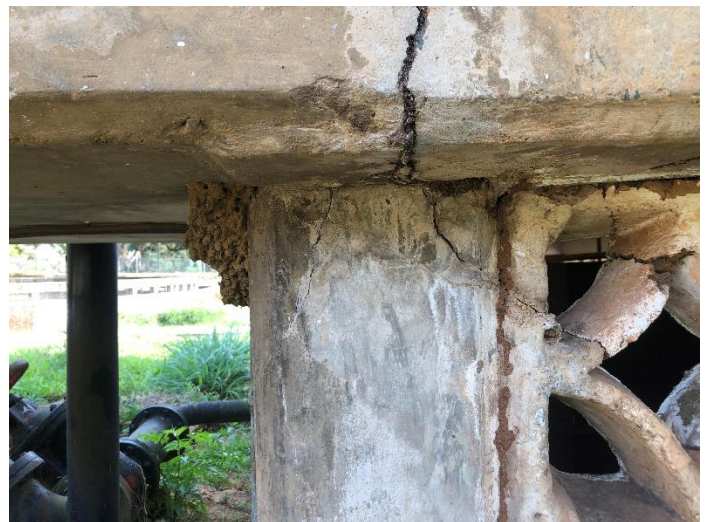
On the assessment of the Screw Pump Room it depicted signs of spalling probably due to the suspended slab restrained to columns below. Cracks have developed at the interface of column and slab, with the column having vertical and inclined cracks, on the other end column-beam connection both elements are cracked, with column having vertical cracks and beam with single diagonal crack. (refer to photo No. 12)

Expansion joint on the suspended slab opened/failed. (refer to photo No. 12)

Screw Pump Room Photo 12-Failed expansion Joint and column spalling

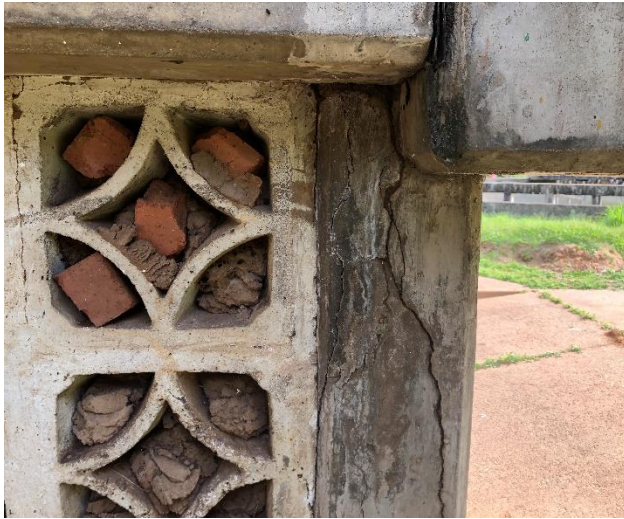
Screw Pump Room Photo 13-Failed expansion Joint and column spalling

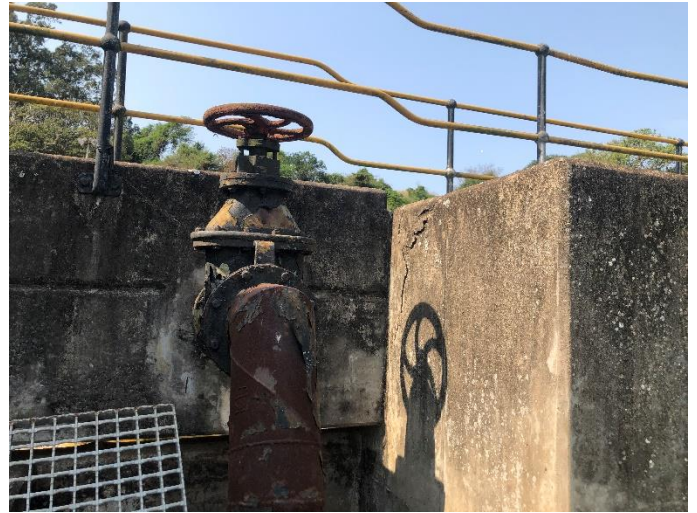
Screw Pump Room Photo 15-Beam Spalling

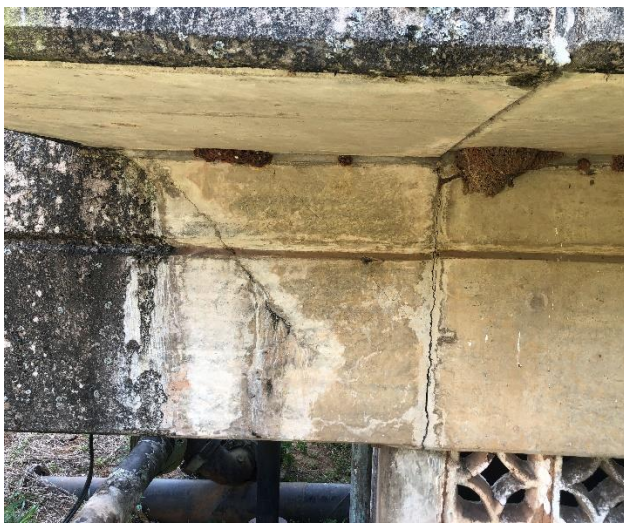
Screw Pump Room Photo 14-Diagonal crack on beam

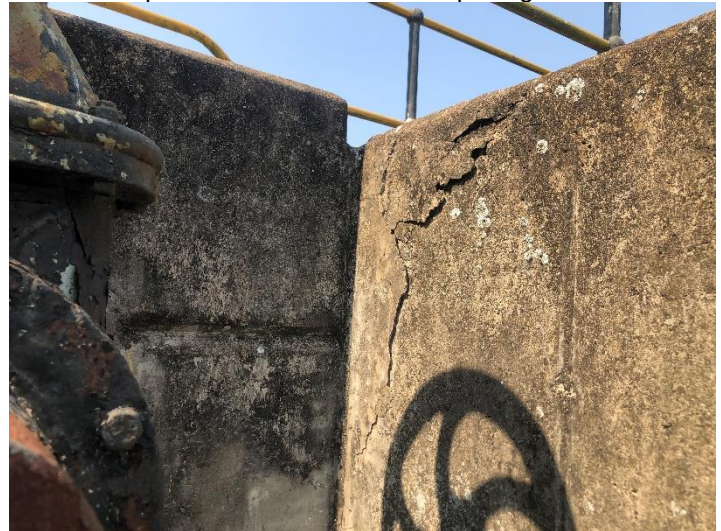
Screw Pump Room Photo 16-Deatil Beam spalling
