Mbani Projects Pty (Ltd) is appointed by Department of Agriculture in Free State Province to conduct geotechnical investigation to establish whether the ground conditions within the vicinity of ATDC Dam are suitable for development of a retain dam and the access road.

The objective of this investigation is to conduct the geotechnical investigation within the construction site and locate quarry/borrow pit site for fill material.

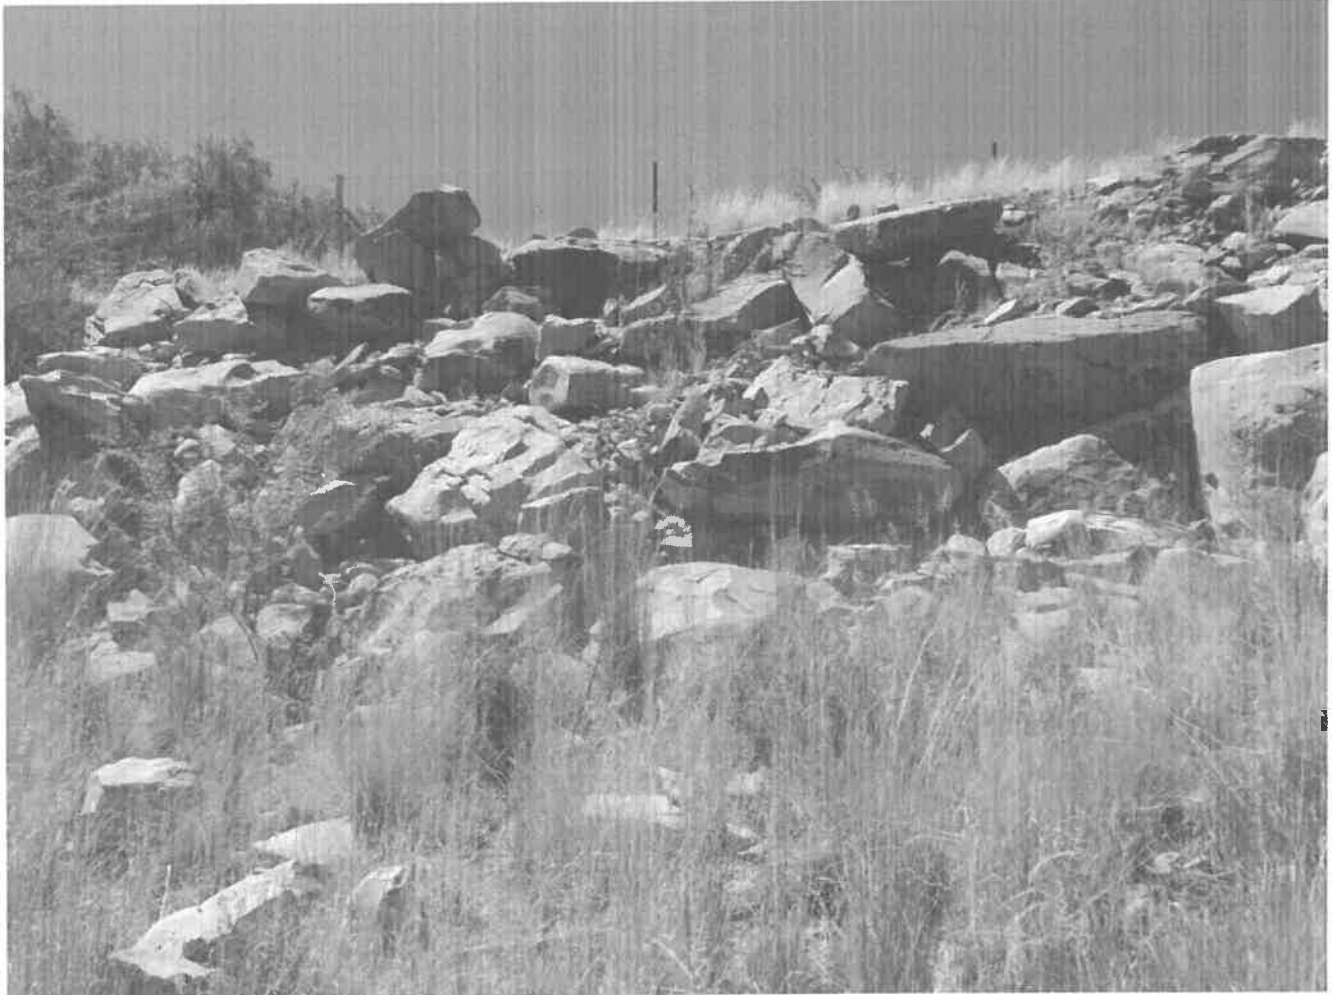
Picture 1. Illustrates SANDSTONE boulders within borrow 1.

The SANDSTONE for the retain walls of the dam has been allocated within borrow pit 1 by GPS coordinate 30°37'37.62"S 25°28'27.88"E.

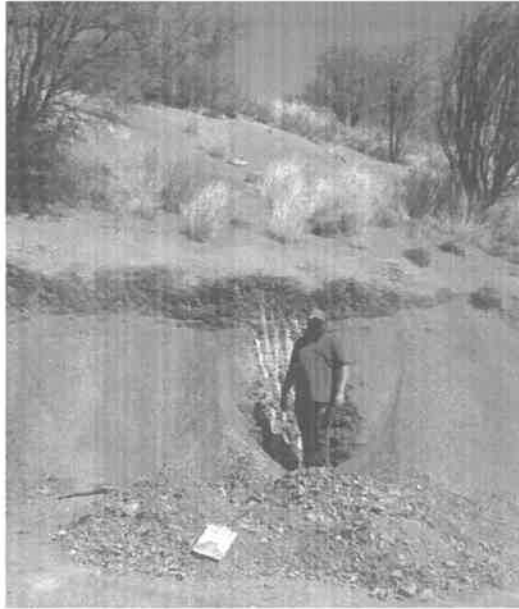
Picture 2. Pit test 1 (GPS coordinate 30°37'31.78"S 25°28'49.19"E) within the borrow 2.

This is pit test 1 (GPS coordinate 30°37'31.78"S 25°28'49.19"E) within borrow pit 2.

It illustrates the MUDSTONE rock occurring in reddish brown to greyish blue.

It has been earmarked for the aggregate for the road subbase construction as well as the wearing course or crown of the road..

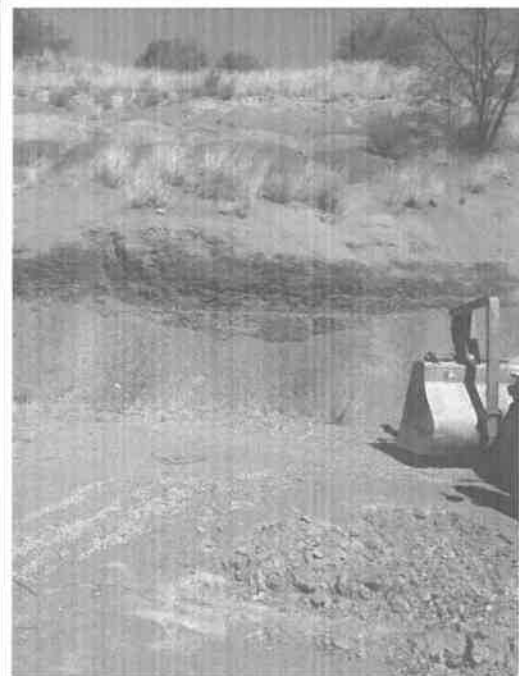
Picture 3. Pit test 2 (GPS coordinate 30°37'30.78"S 25°28'52.04"E) within the borrow 2.

This is pit test 2 (GPS coordinate 30°37'30.78"S 25°28'52.04"E) within the borrow 2.

It illustrate the alternative material for CLAY required for the core of the dam construction.

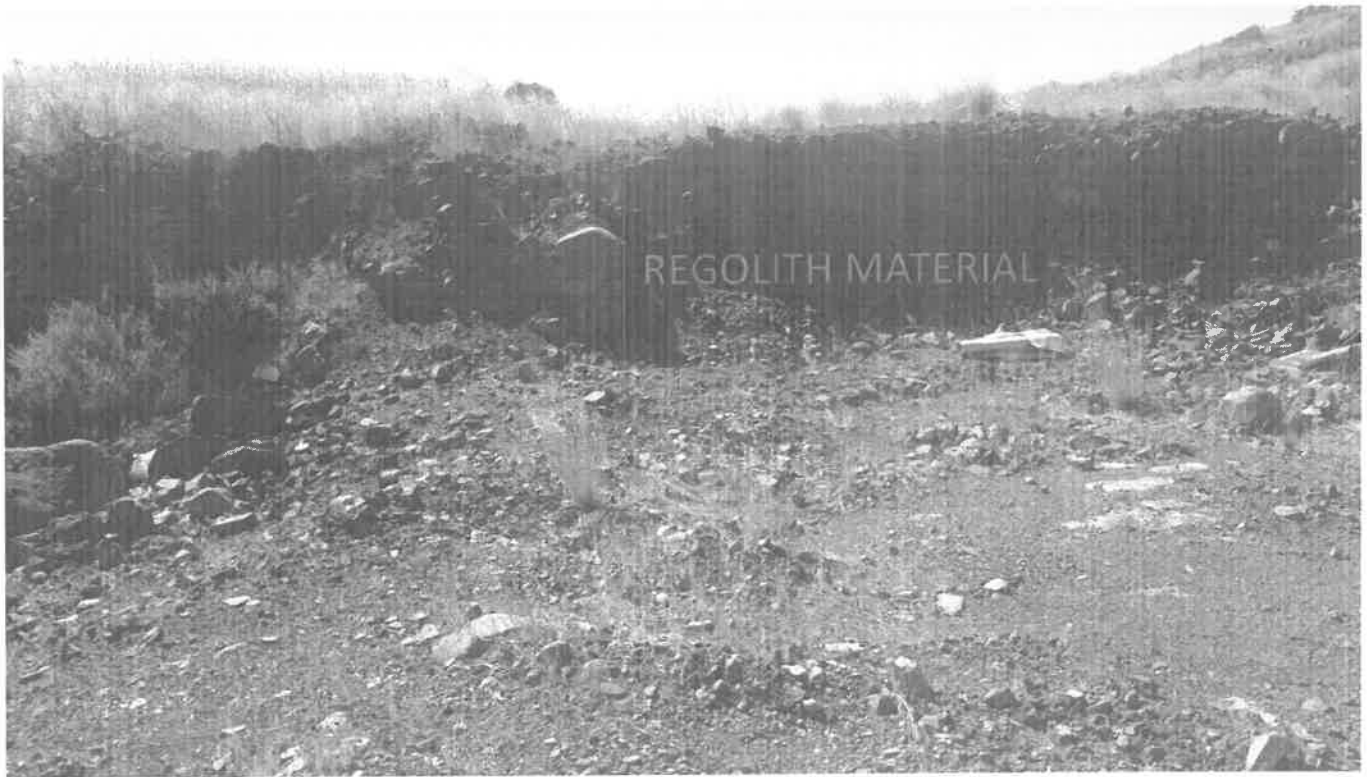
Picture 4. Illustrates test pit 1 ( by GPS coordinate 30°36'40.46"S 25°28'59.43"E) within borrow pit 3.

This is test pit 1 ( by GPS coordinate 30°36'40.46"S 25°28'59.43"E) within borrow pit 3.

This borrow pit has been selectively excavated, previously.

Unweathered rock, MUDSTONE, need to be drilled and blasted.

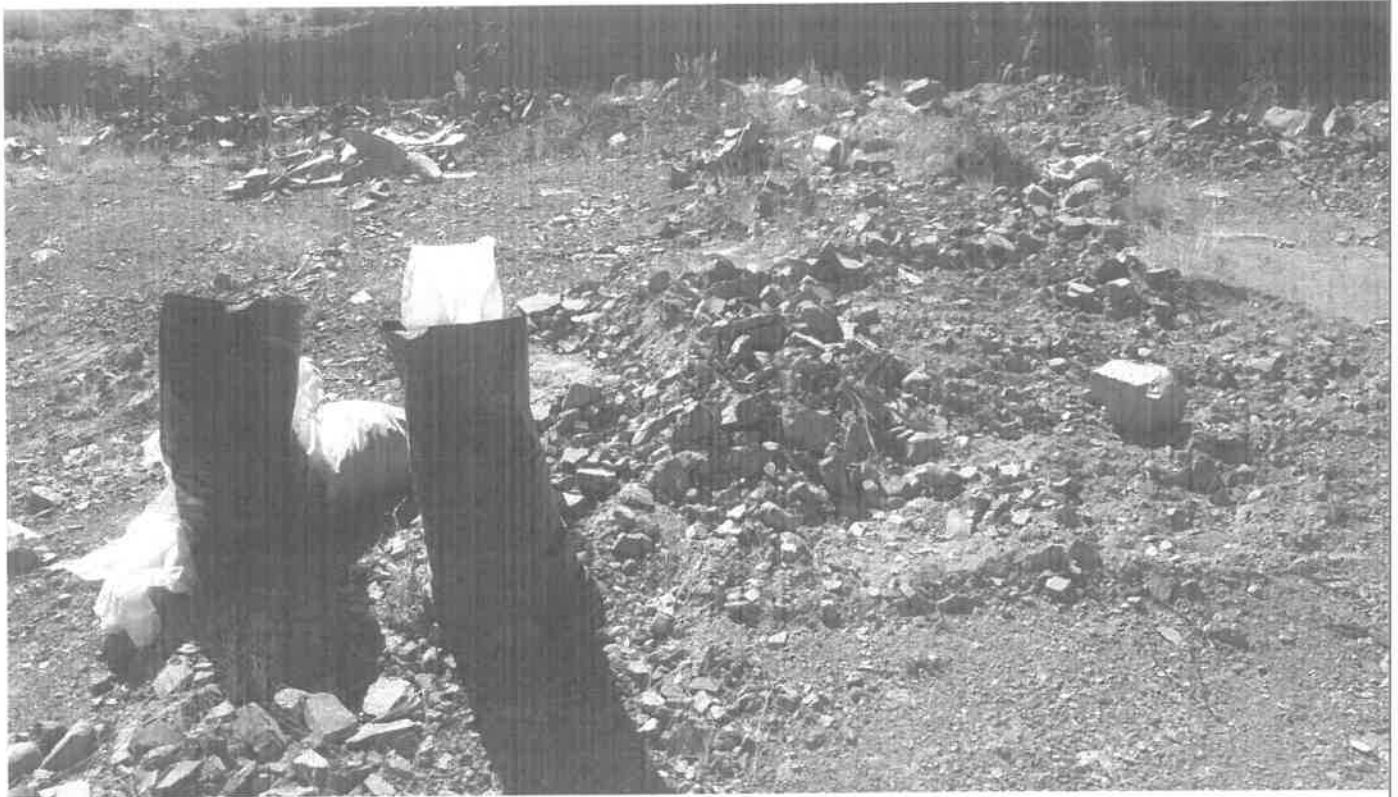
Picture 5. test pit 2 (by GPS coordinate 30°36'39.06"S 25°29'0.22"E) within borrow pit 3.

This is test pit 2 (by GPS coordinate 30°36'39.06"S 25°29'0.22"E) within borrow pit 3.

This borrow pit has been selectively excavated, previously.

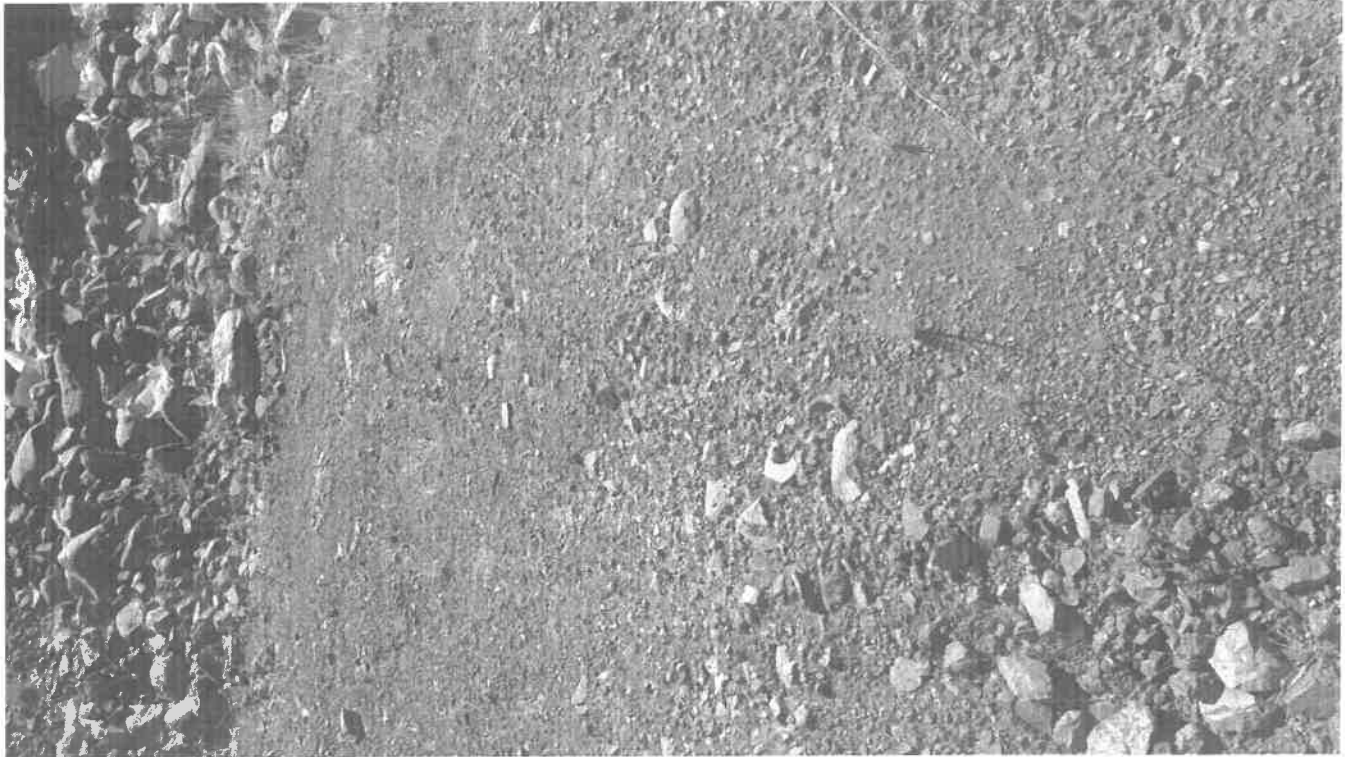
Picture 6. Illustrates test pit 1 (by GPS coordinate 30°36'40.20"S 25°28'31.32"E) within borrow pit 4.

This is test pit 1 (by GPS coordinate 30°36'40.20"S 25°28'31.32"E) within borrow pit 4.

This borrow pit has been selectively excavated, previously.

No rock dust matrix observed, but mainly top soil present.

Unweathered rock, MUDSTONE, need to be drilled and blasted in order to be excavated.

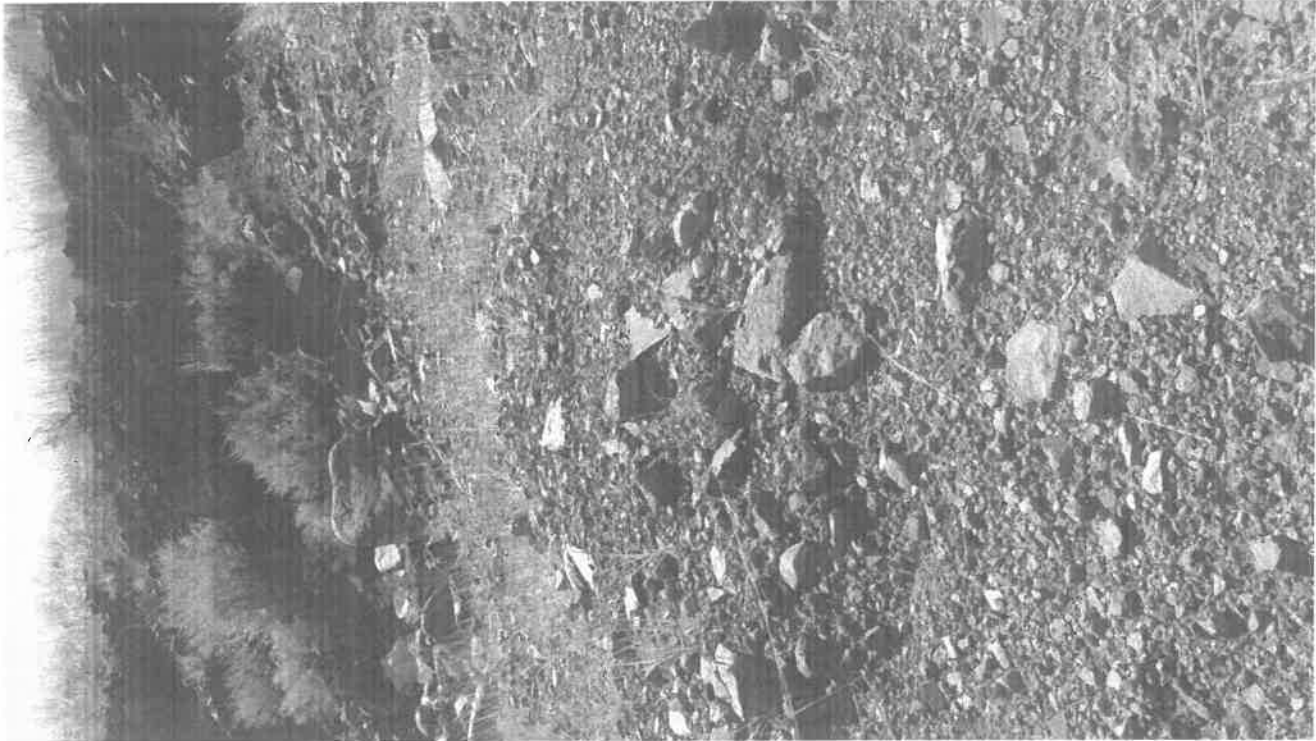
This is test pit 2 (by GPS coordinate 30°36'37.86"S 25°28'32.68"E) within borrow pit 3.

This borrow pit has been selectively excavated, previously.

No rock dust matrix observed, but mainly top soil present.

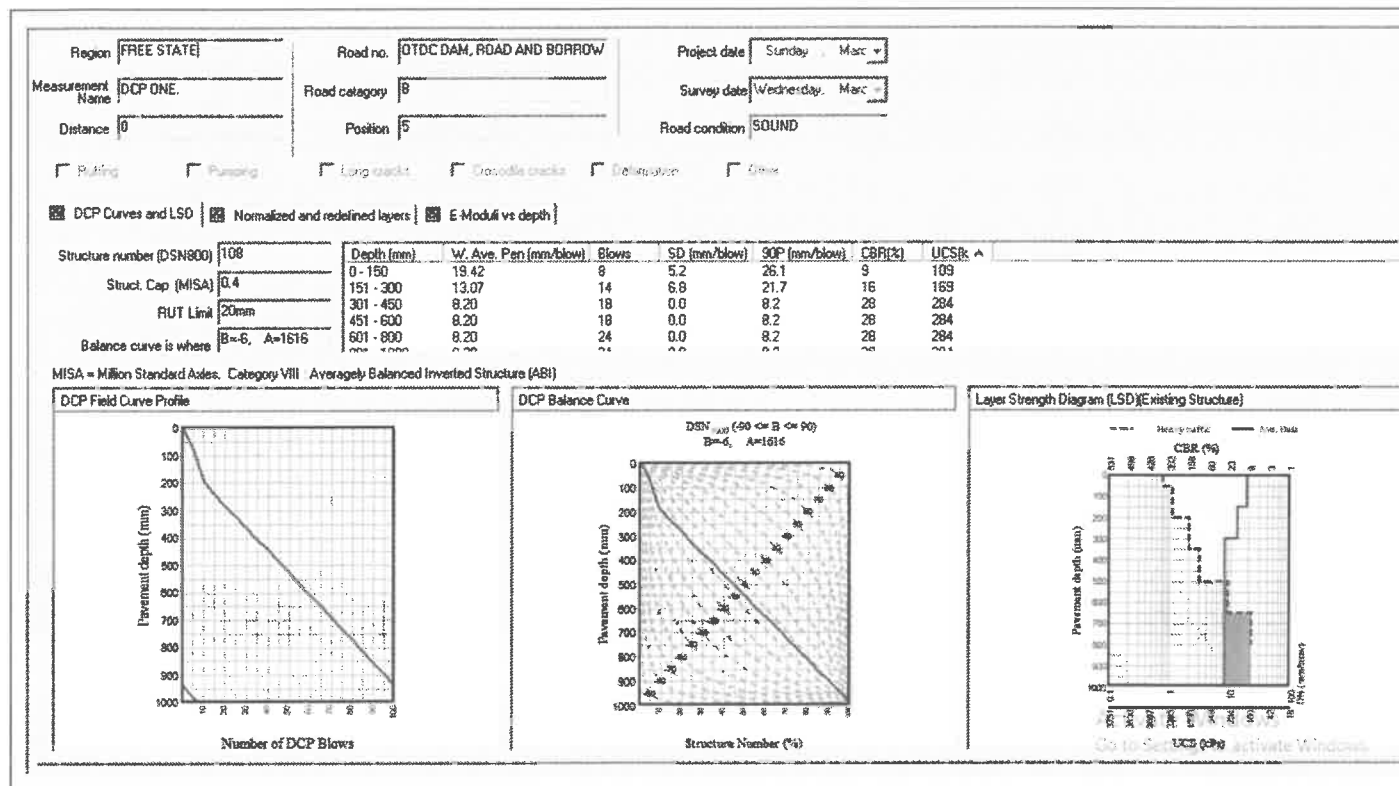
Figure 10 The summary of the representative DCP test results and interpretation within the construction site.

The DCP test further depicts homogeneous alluvial SILT, i.e. no boulders or rocks that disturbed the penetration within the construction site. See the above figure for further engineering properties.

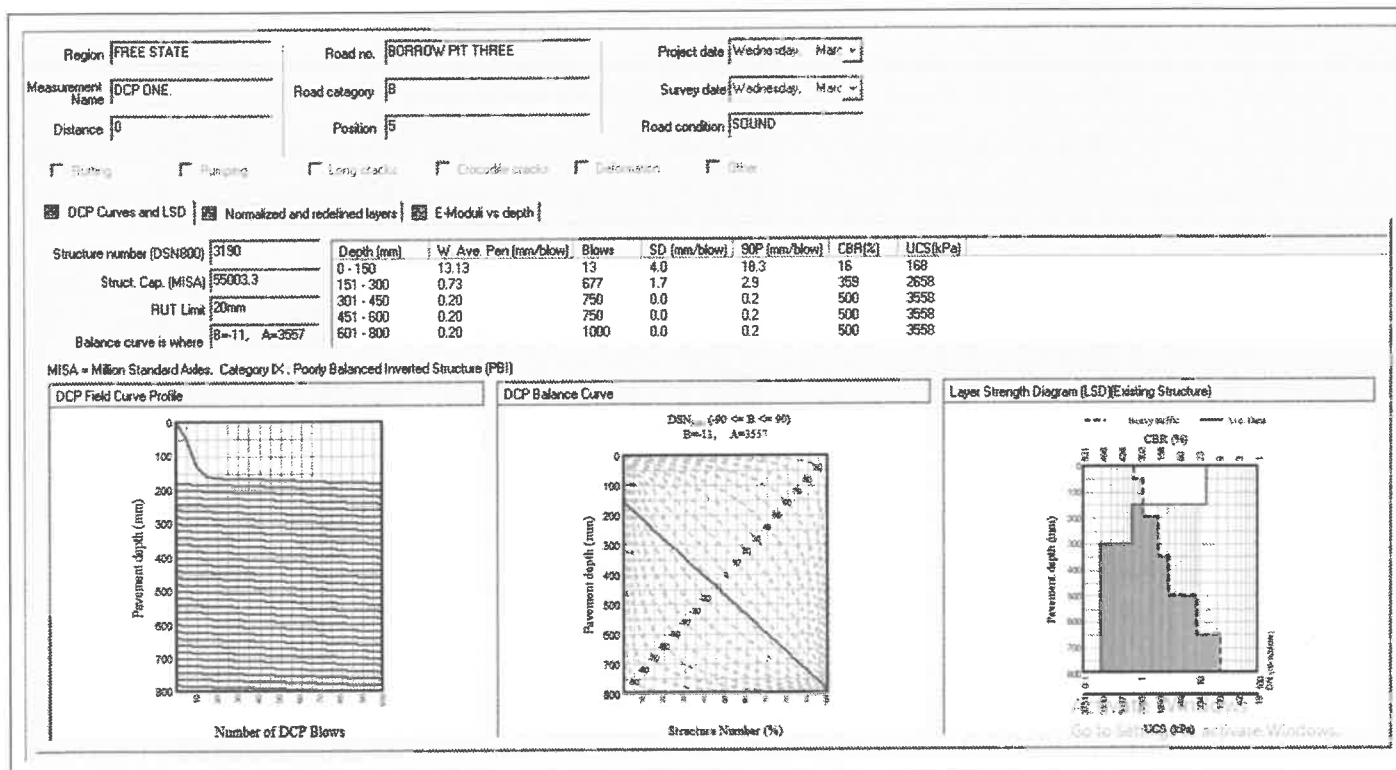
Figure 11. The summary of the representative DCP test results and interpretation within borrow pit. The DCP test penetrated top soil and immediately intersect refusal at 189 mm due to the bed rock. NB DCP TEST 2 WITHIN BORROW PIT 2, 3 AND 4 IS DISCARDED, DUE TO ROCK OUTCROPS.
