## ANNEXURE A: PICTORIALS

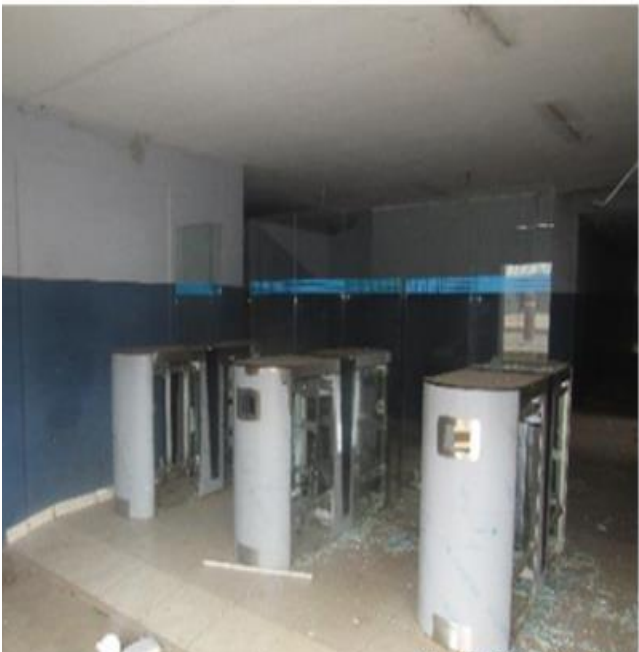
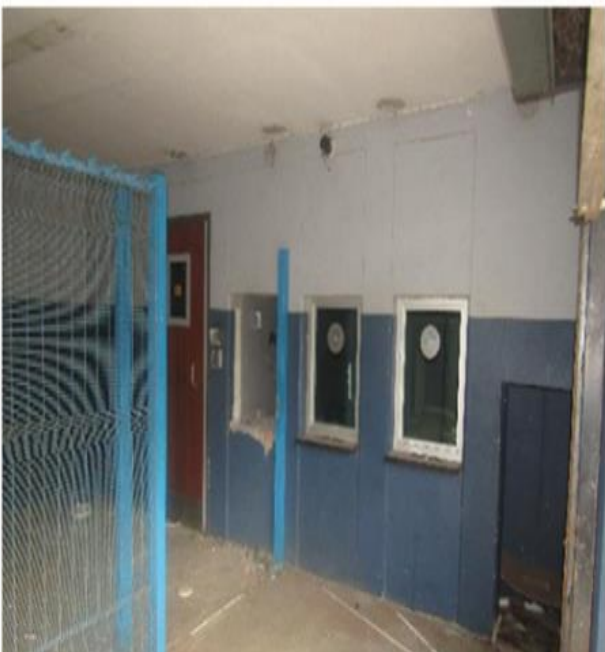
| | | <p>Speed gates and ticket sales area are vandalised</p> |

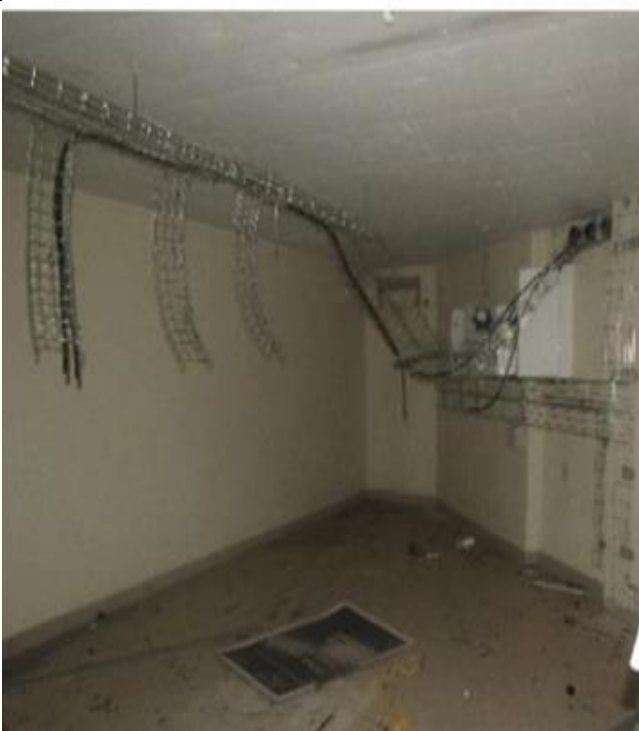
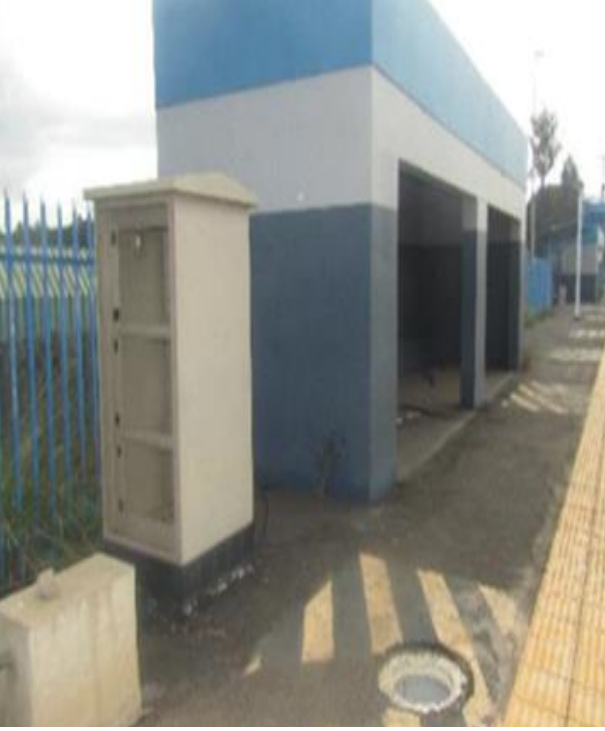
| | | <p>Electrical cables and kiosk stripped</p> |

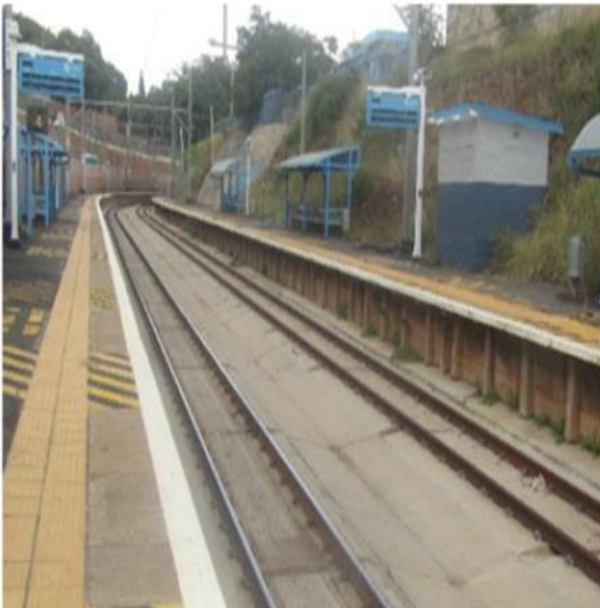
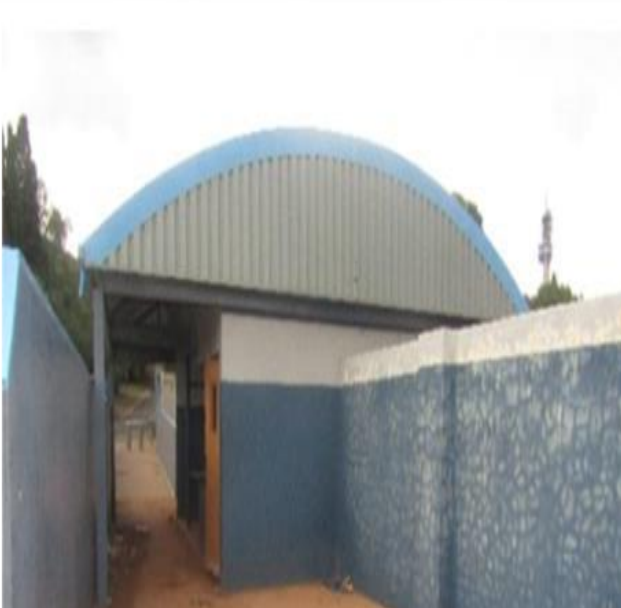
| <p>Loftus Versfeld Station</p> | | |

| | | <p>External painting and platform worn out, painting and resurfacing required</p> |

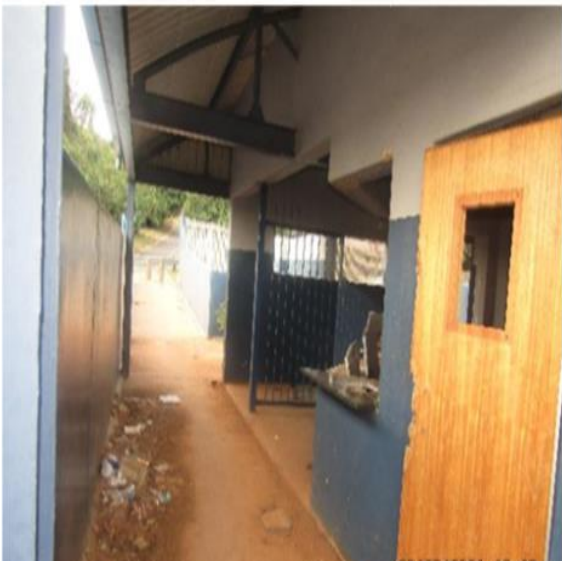
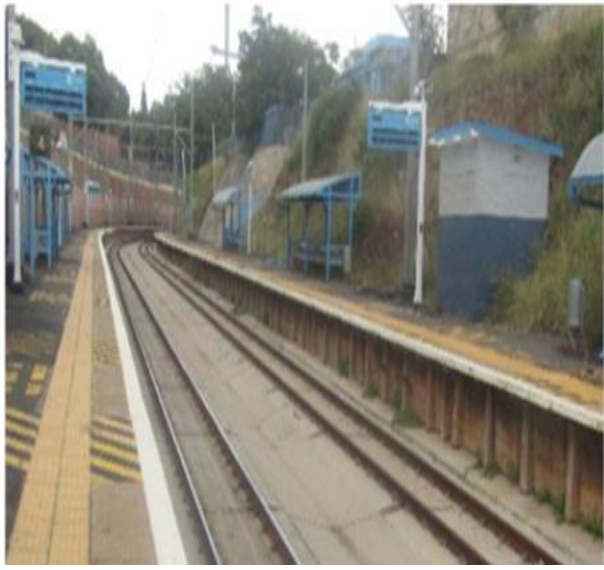
| | | <p>Existing doors, walls and counters are vandalised</p> |

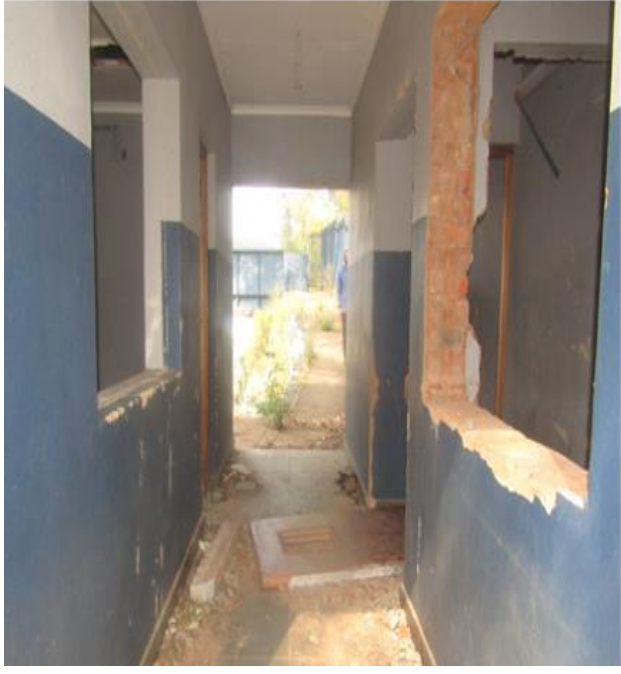
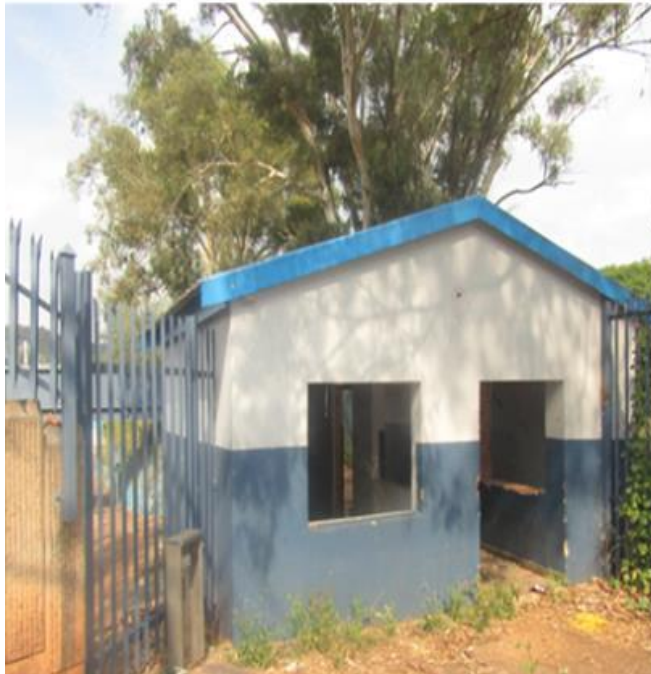
| <p><b>Walker Station</b></p> | | |

| | | <p>Existing structures are vandalised</p> |

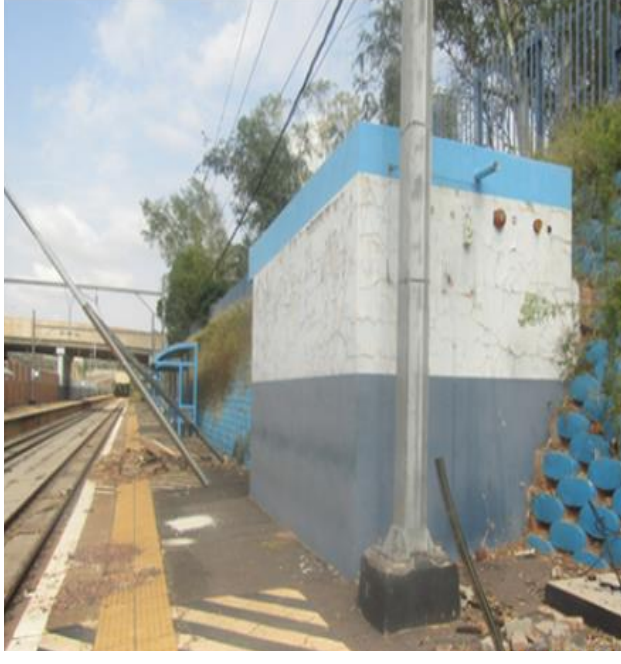
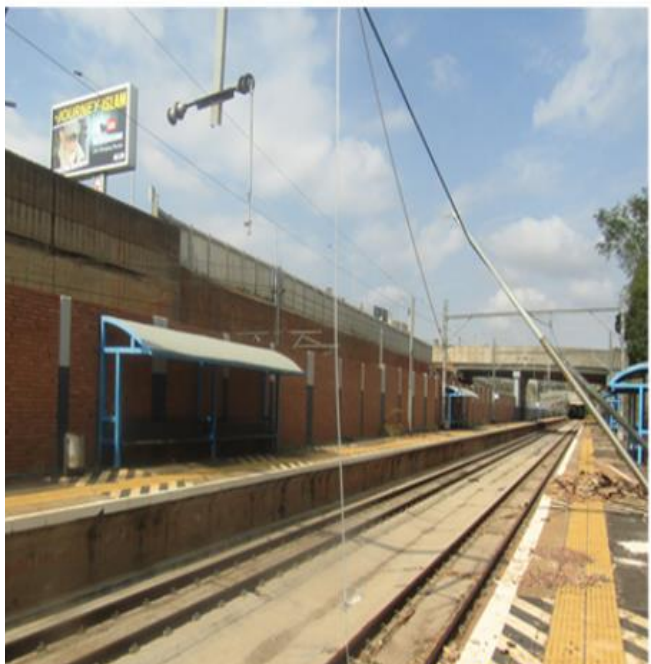
| | | <p>Platforms and commuter shelters are damaged</p> |

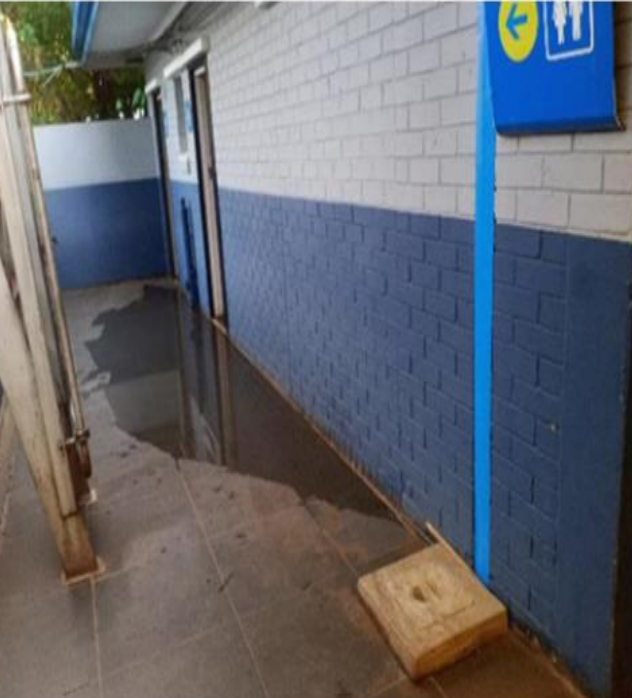
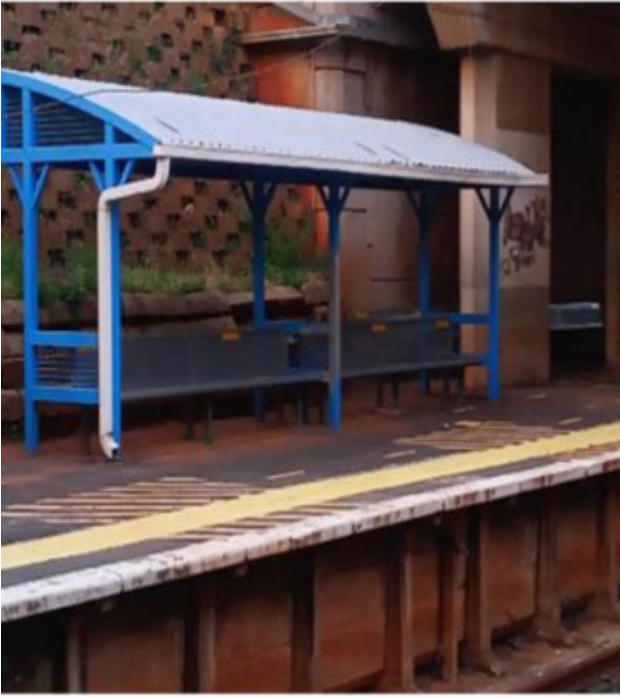
| <p><b>Mears Station</b></p> | | |

| | | <p>Water flooding at the ablution area and commuter shelters need to be refurbished</p> |

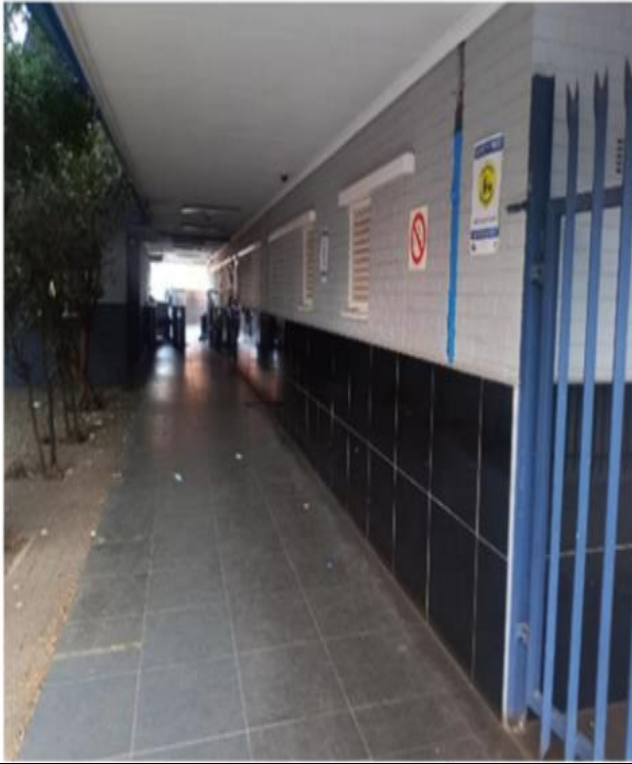
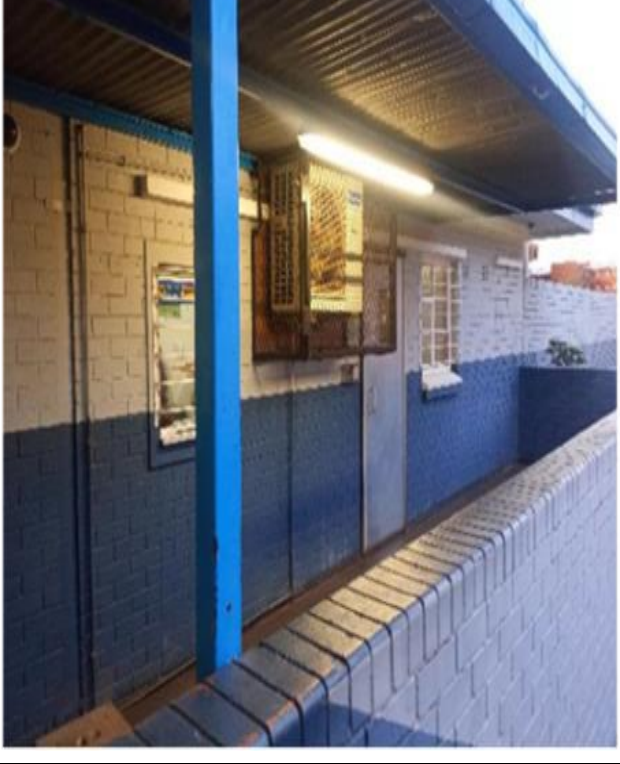
| | | <p>Painting worn out and paving need to be refurbished</p> |
