## ANNEXURE A: PICTORIALS

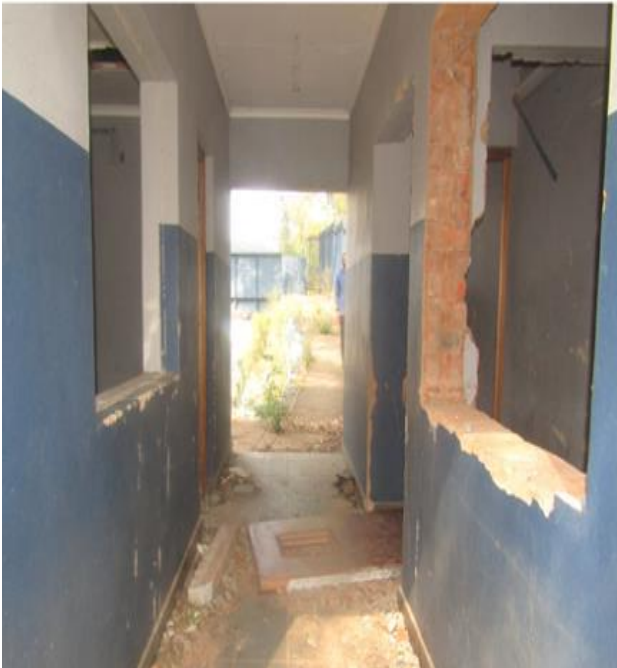
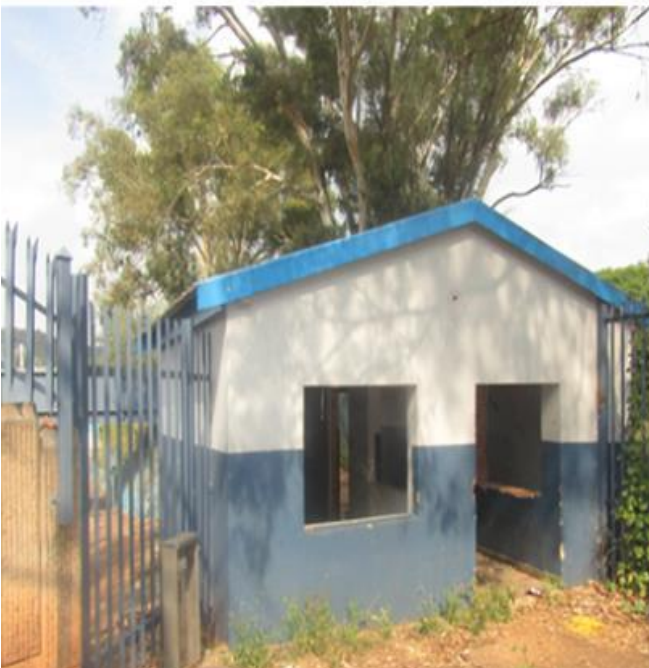
| <p><b>Walker Station</b></p> | | |

| | | <p>Existing structures are vandalised</p> |

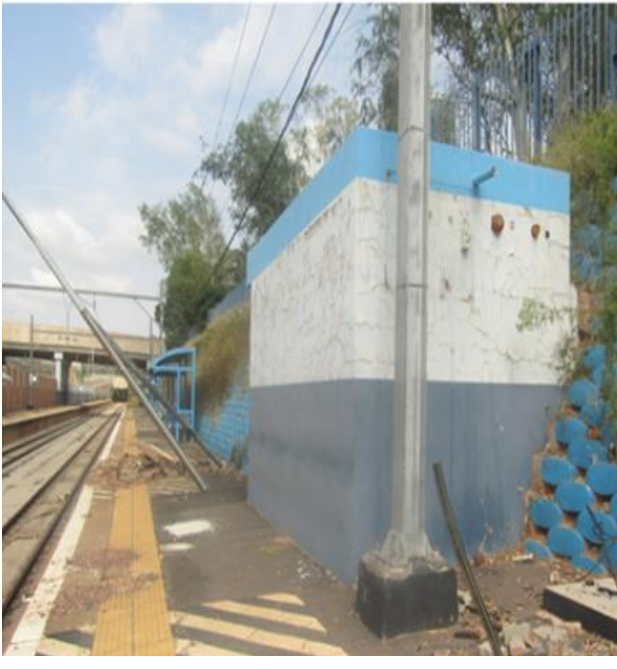
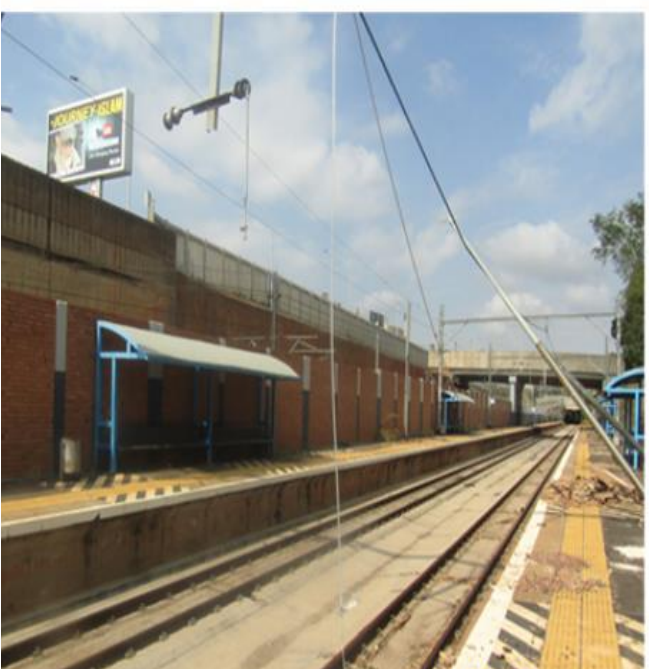
| | | <p>Platforms and commuter shelters are damaged</p> |

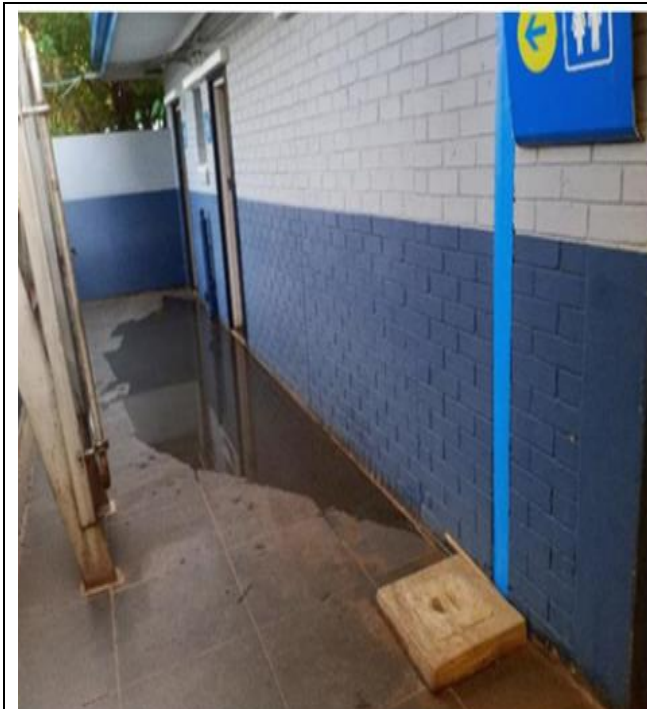
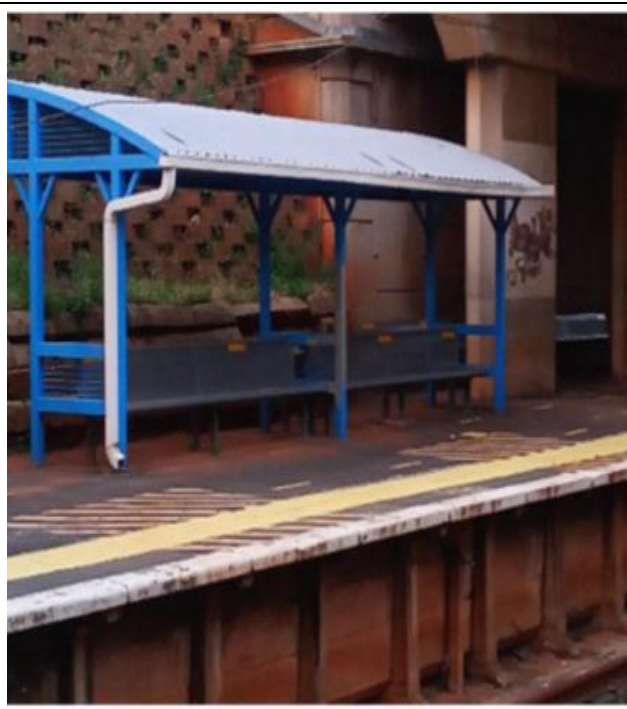
| <p><b>Mears Station</b></p> | | |

Water flooding at the ablution area and commuter shelters need to be refurbished

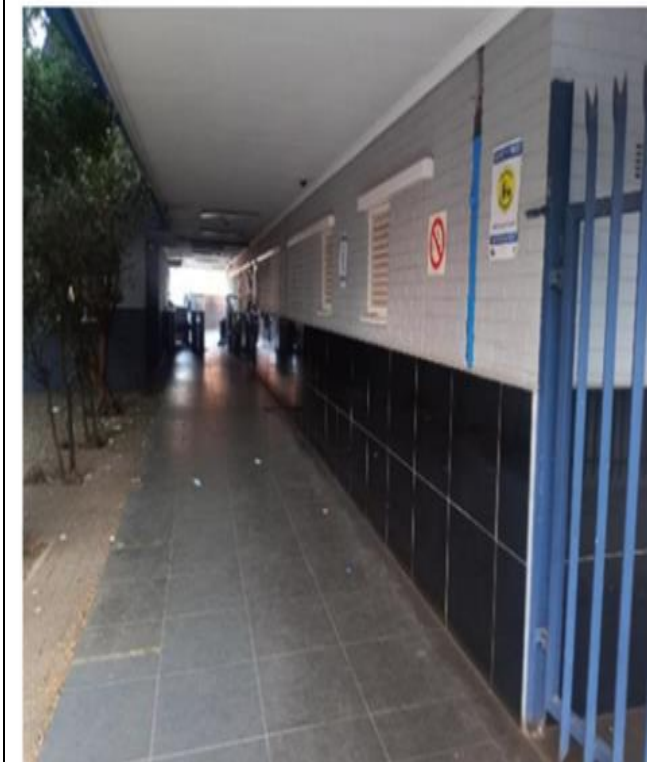
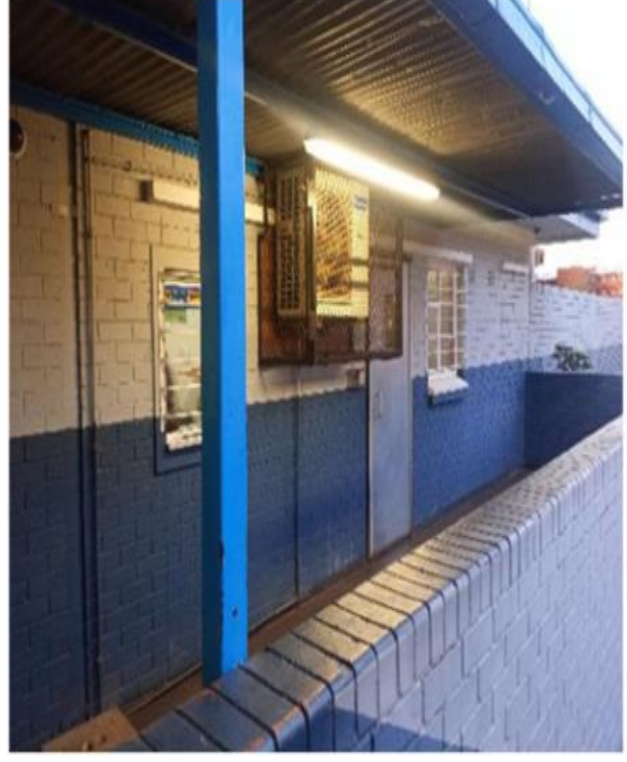
Painting worn out and paving need to be refurbished
