### **DESCRIPTION: WATERPROOFING REPAIRS OF ROOFS AND SKYLIGHTS**

PetroSA is seeking proposals from accredited and qualified waterproofing service providers for the repairs of the Parow building’s roofs and skylights. The repairs should comply with all relevant standards and regulations.

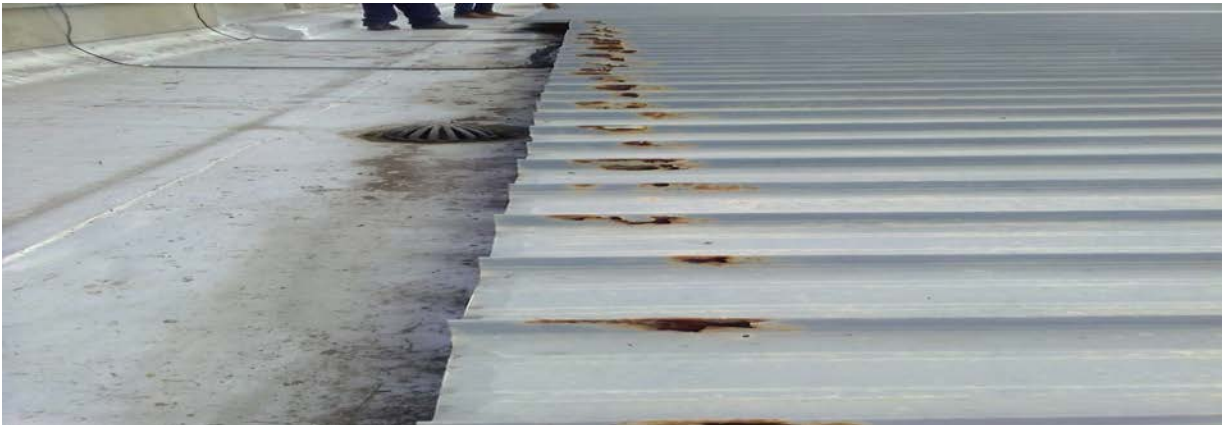
Pic 1

##### **2.1.1.1 Roof Level – Above open walkway**

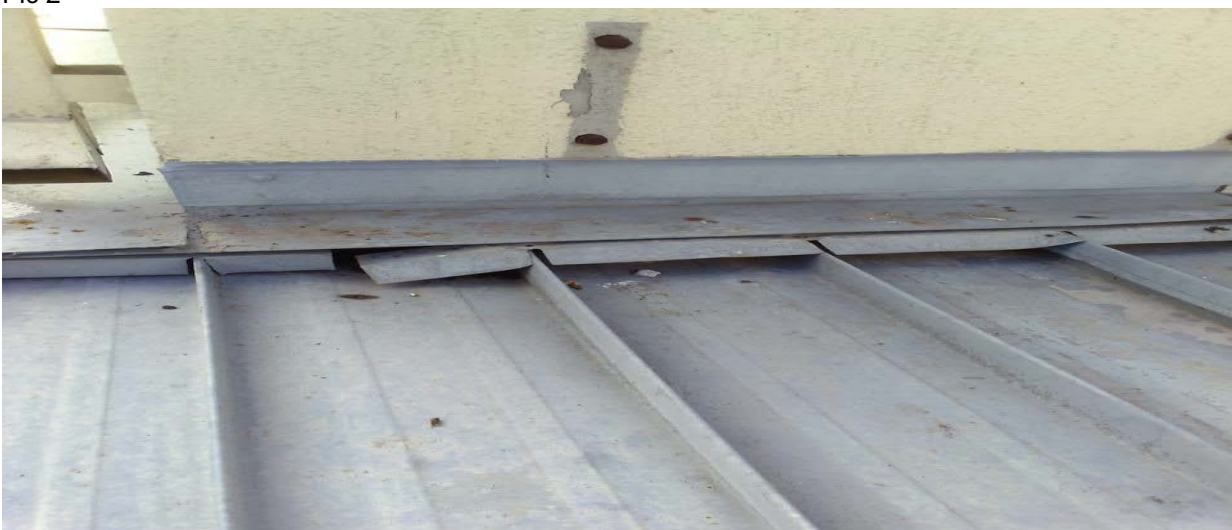
Pic 2

#### 2.1.1.2 Roof perimeter walls at Walkway area below

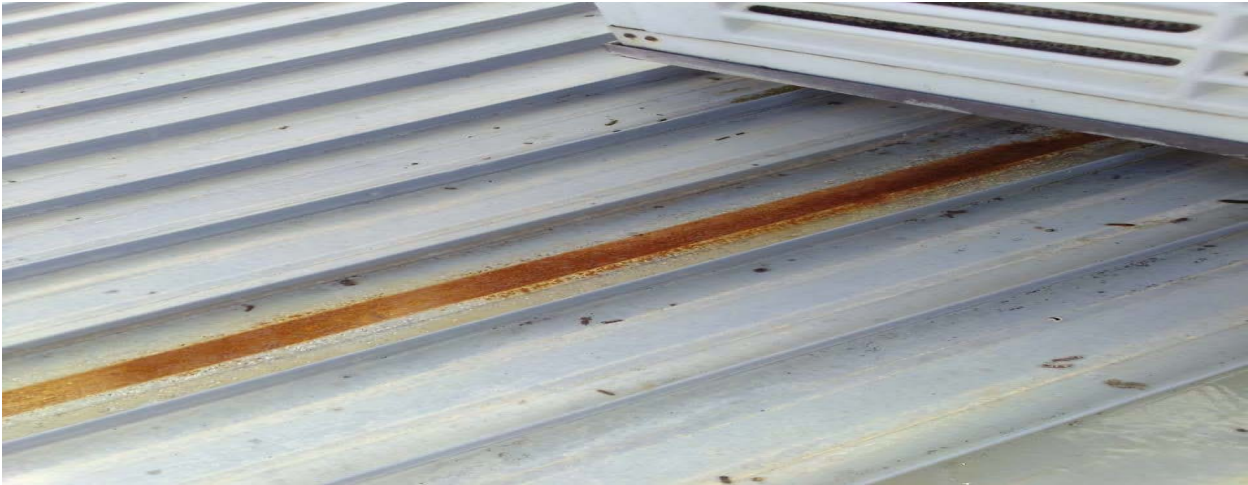
Pic 3

### 2.1.1.3 Roof at Air conditioning

- Water running from aircon pipes.

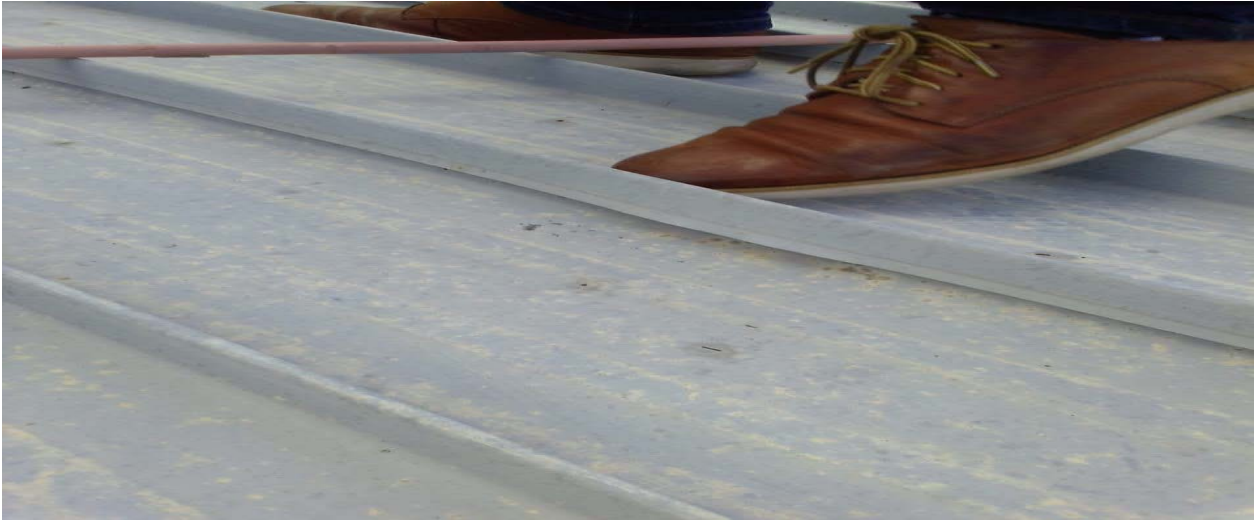
Pic 4

#### 2.1.1.4 Roof sheets Bended

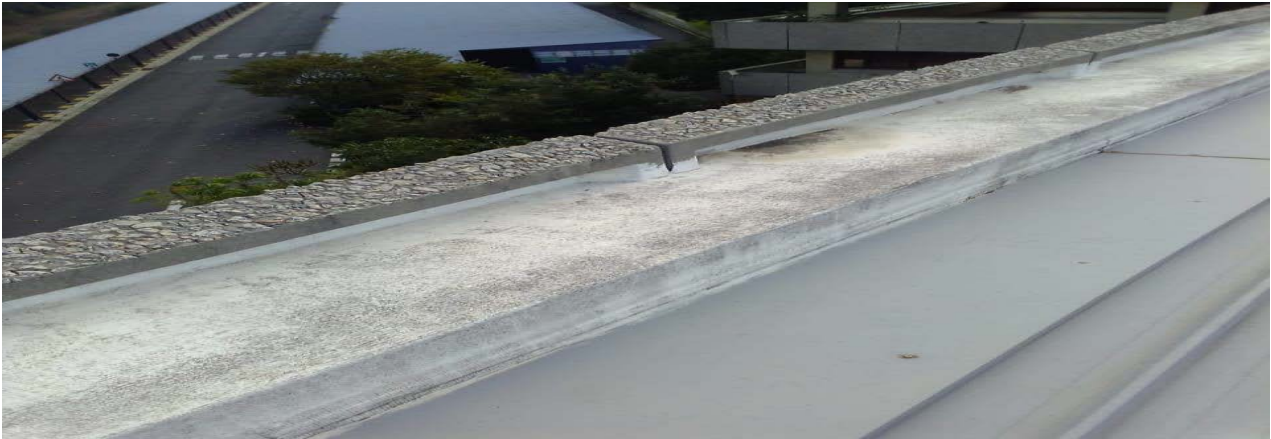
Pic 5

### 2.1.1.5 Roof perimeter

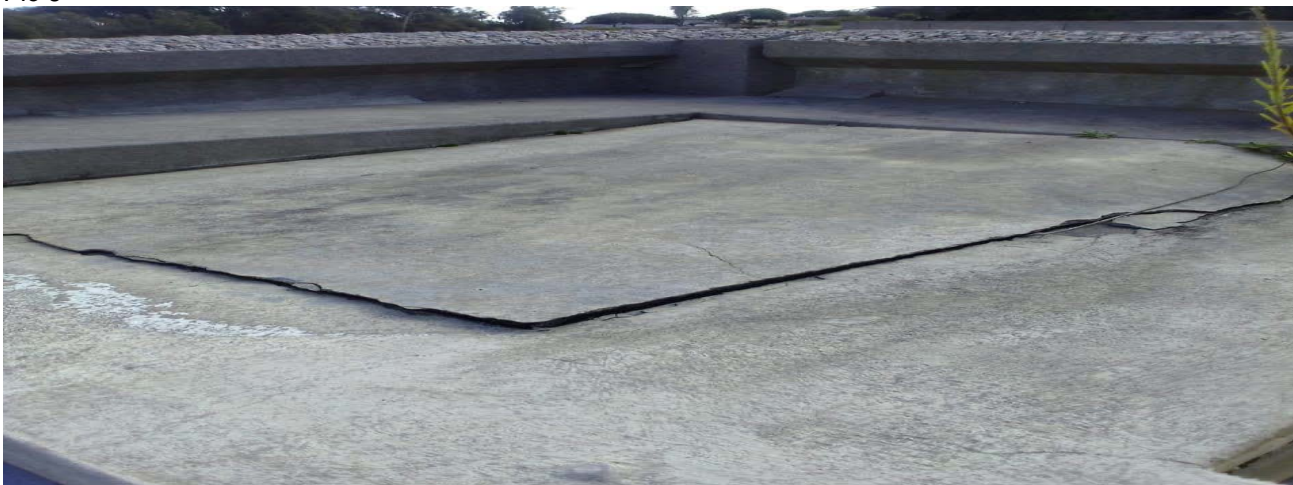
Pic 6

### 2.1.1.6 Roof Corner offices at open walkway below

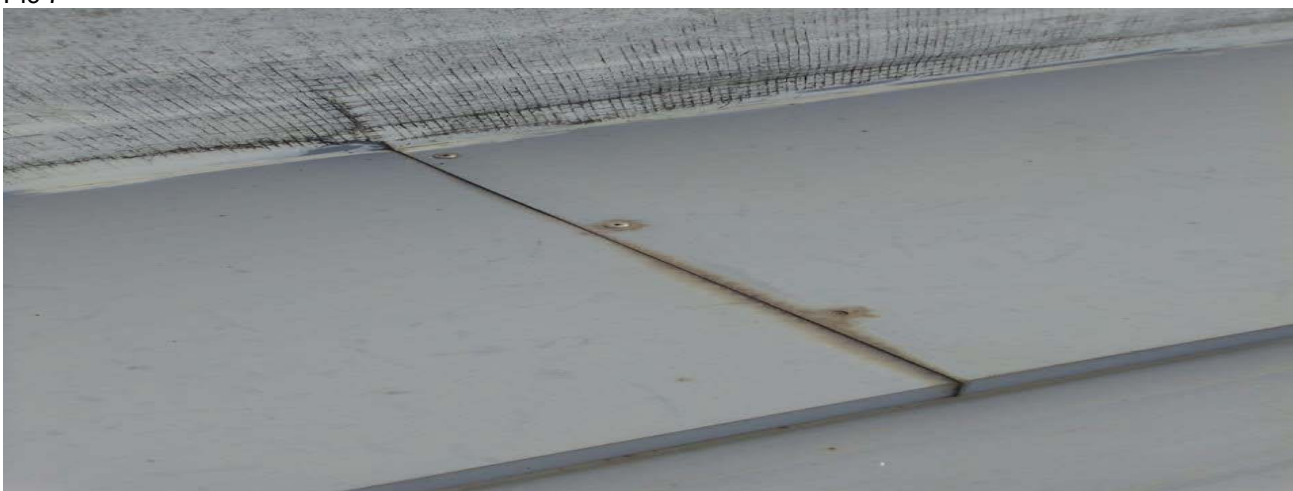
Pic 7

### 2.1.1.7 Roof Side wall flushing

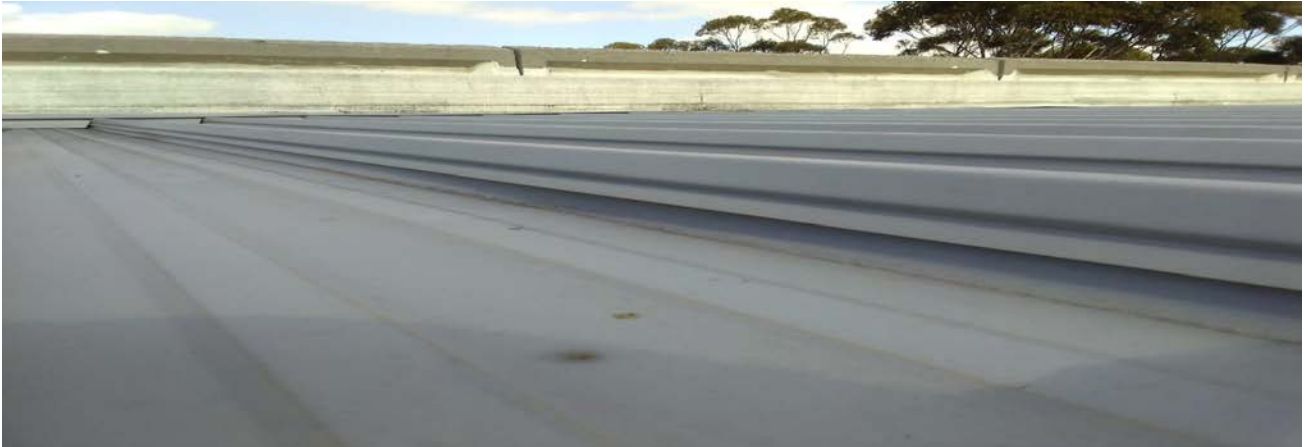
Pic 8

### 2.1.1.8 Roof above CFO's office

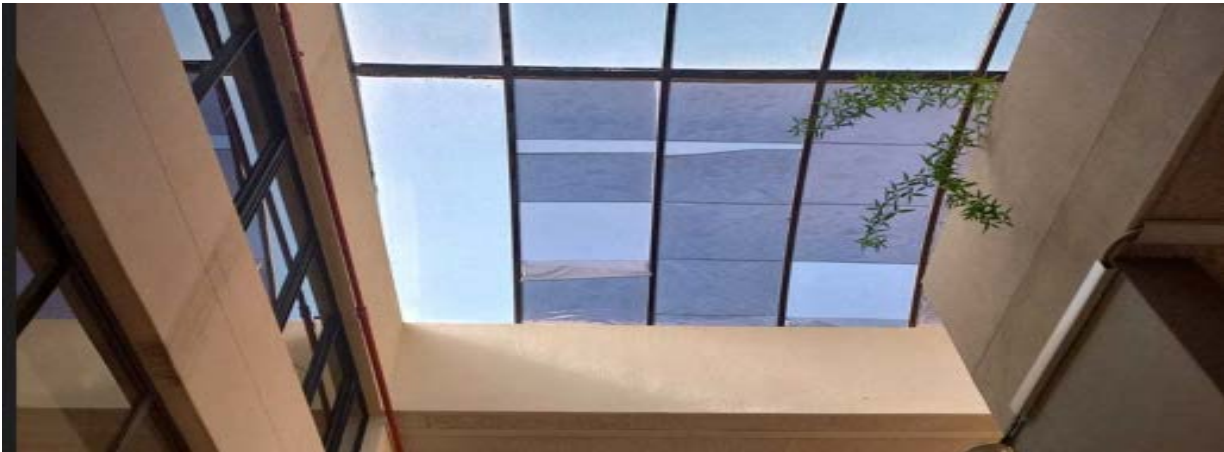
Pic.9

### 2.1.1.9 Skylights

- Remove existing perished rubber from skylights, replace and seal with structural silicone.

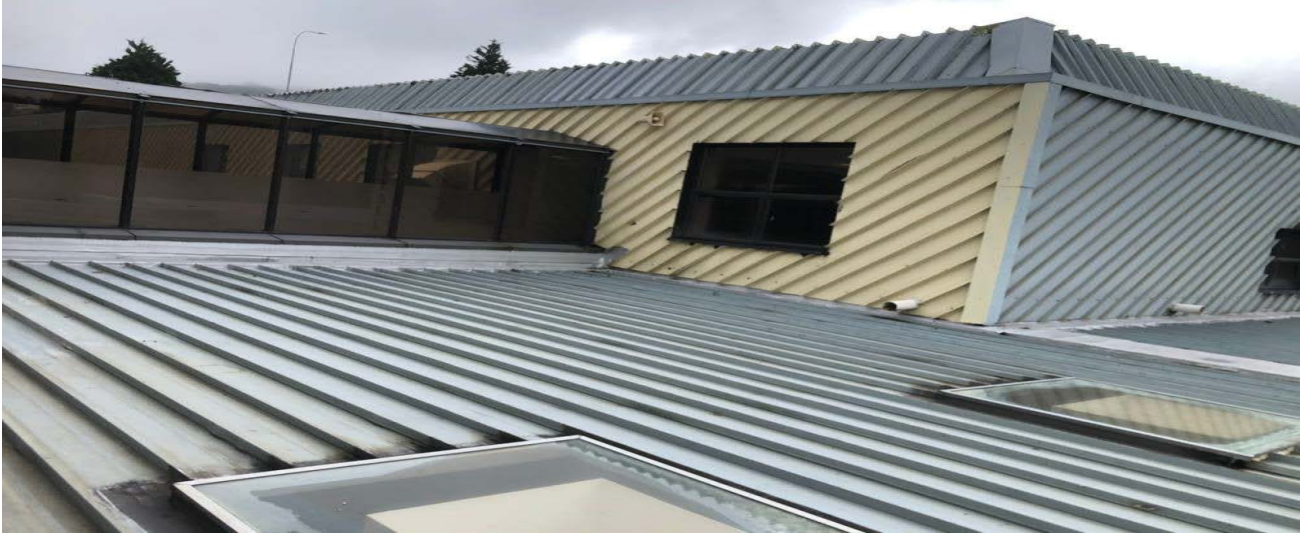
Pic. 10

### **2.1.2.1 Roof Level – Above offices next to open plan offices**

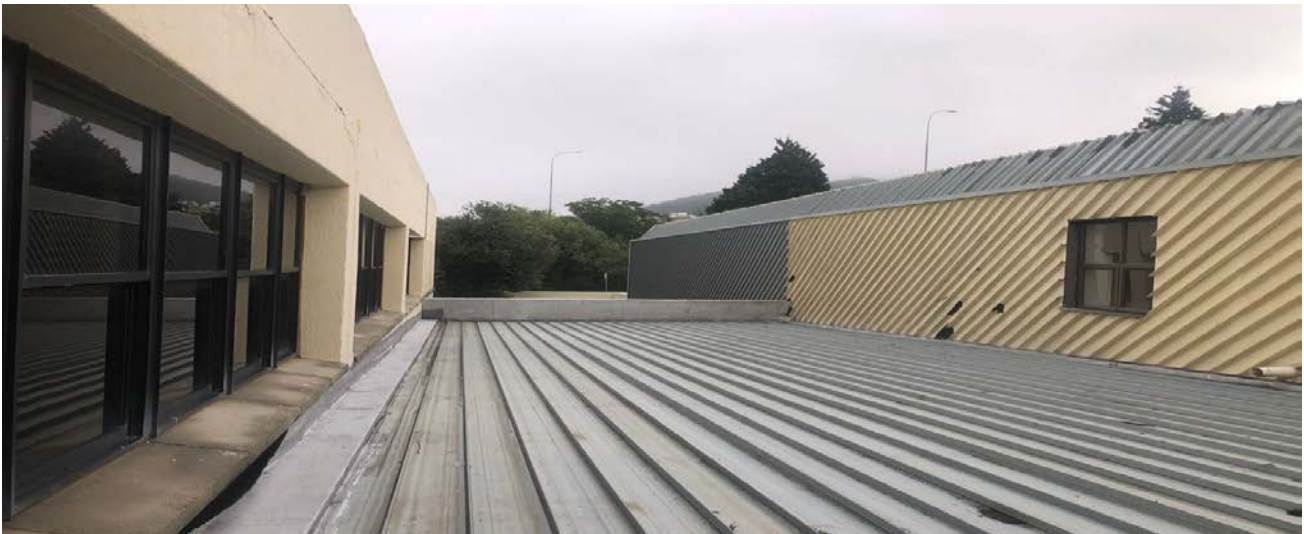
Pic.11

### **2.1.2.2 Roof Level – Above open offices plan offices**

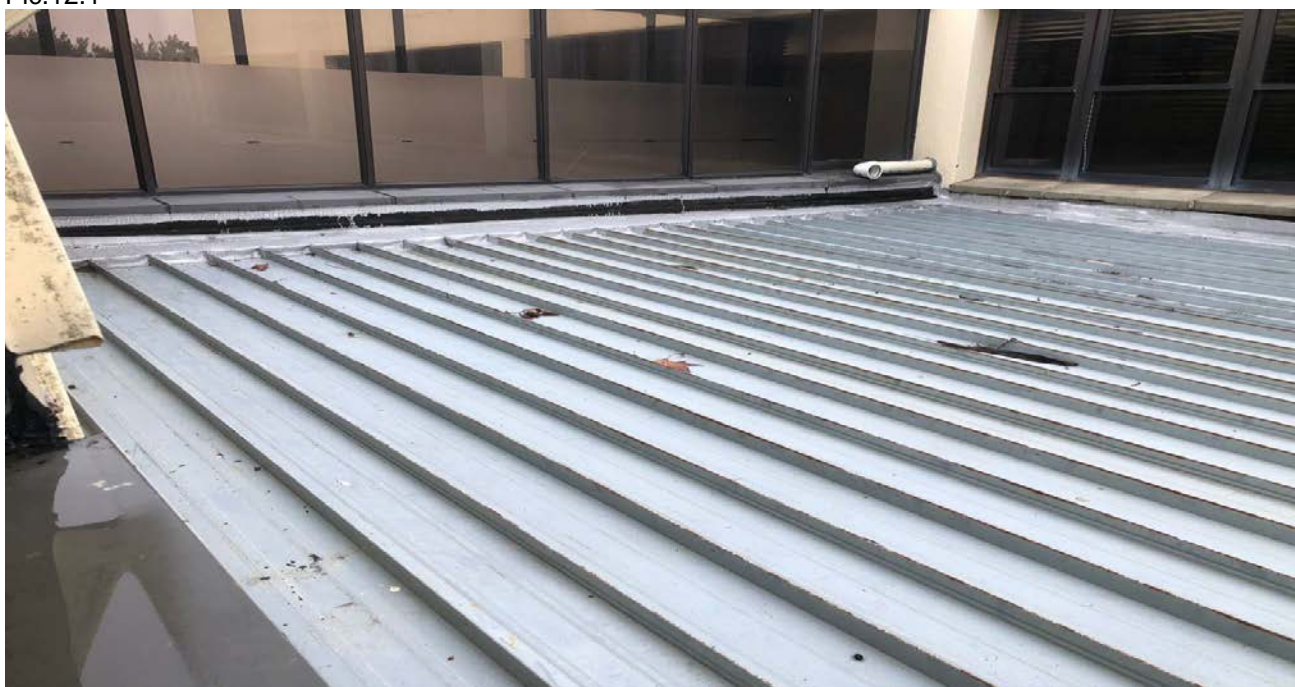
Pic.12.1

### 2.1.2.3 Roof Level – Above open offices plan offices

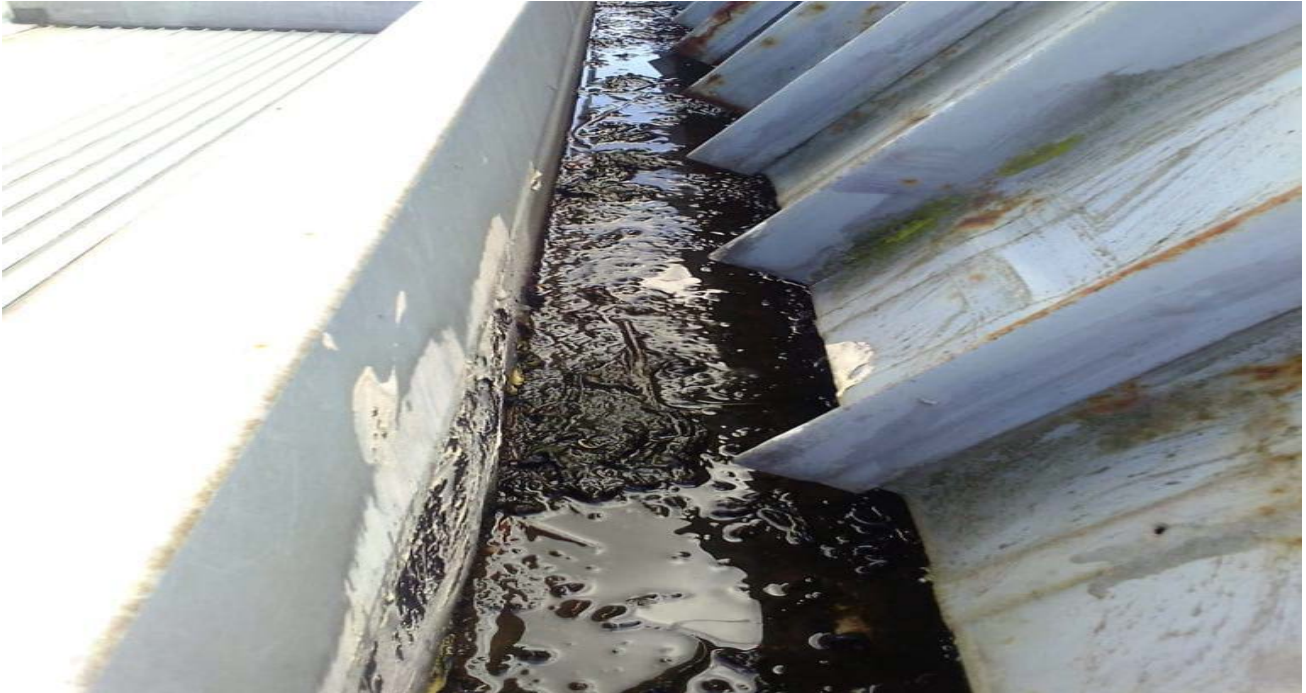
Pic.13

#### 2.1.2.4 Box gutter damages

- Rusted completely, need to be replaced,

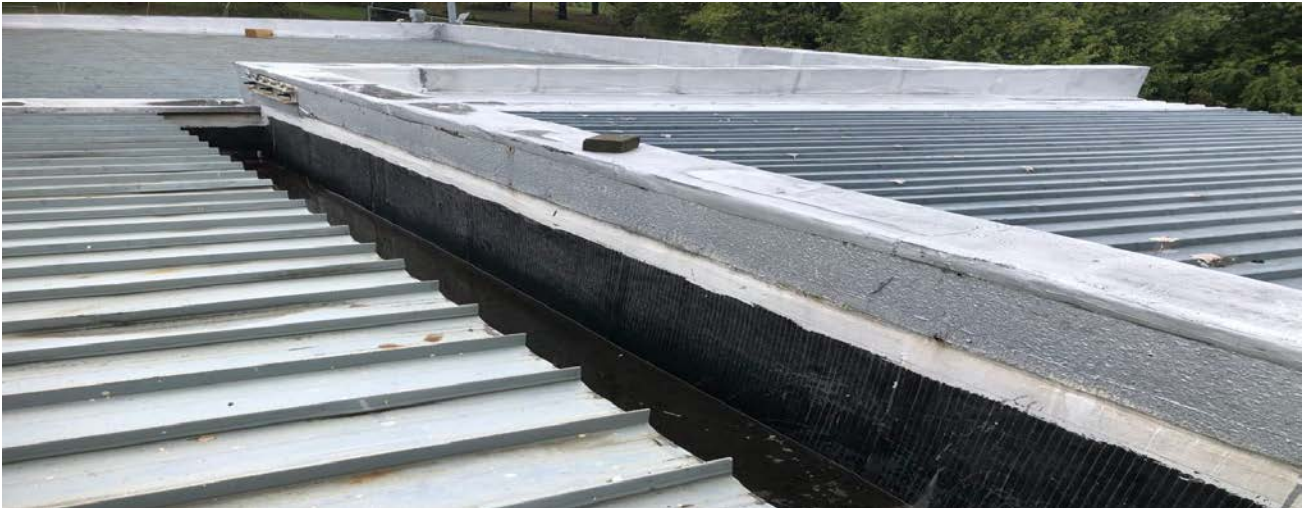
Pic.14

#### 2.1.2.5 Concrete Box gutter above corner offices on Ground Floor

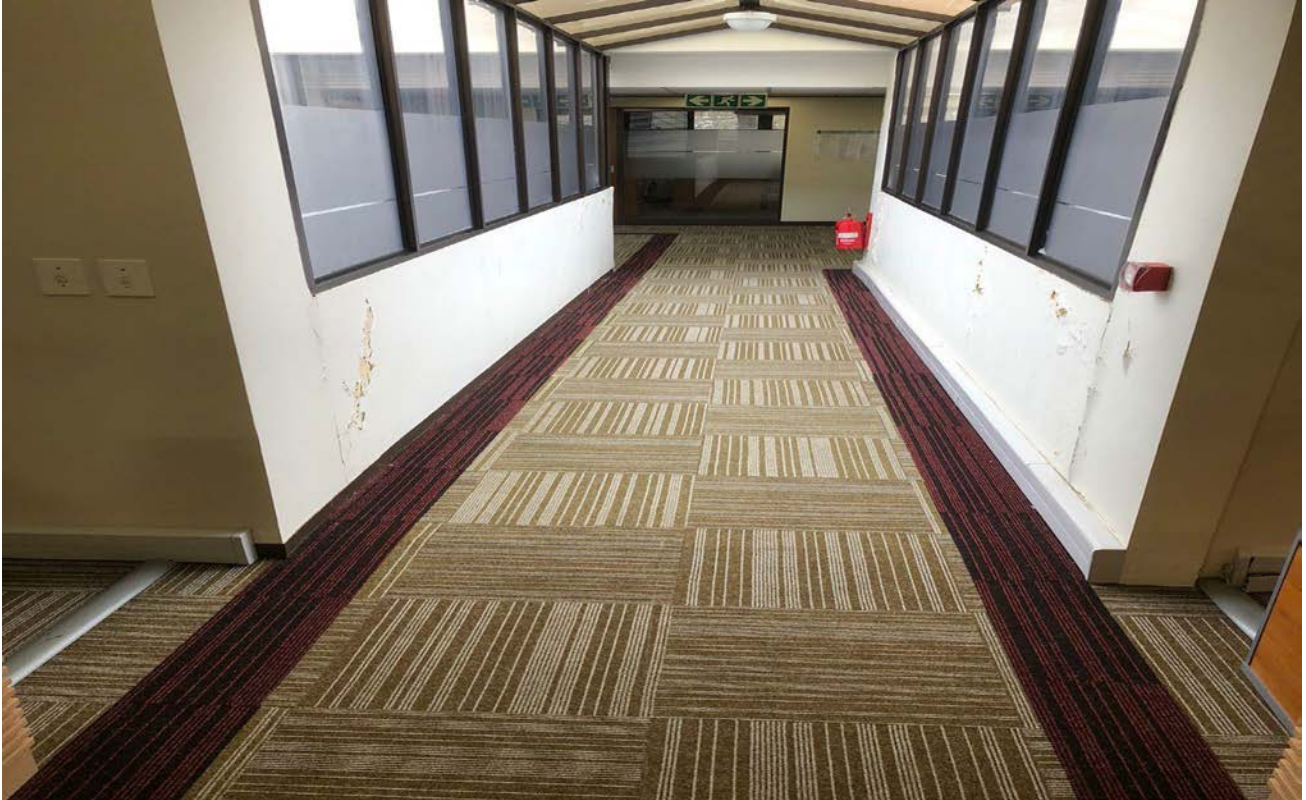
Pic.15

#### **1st Floor Passage**

Strip water damaged wall, reskim and paint walls
