# **REHABILITATION OF MARETLWANE NORTH ASBESTOS MINE: RE-ADVERTISEMENT**

**CONTRACT MTK 19/2022**

**SITE INFORMATION**

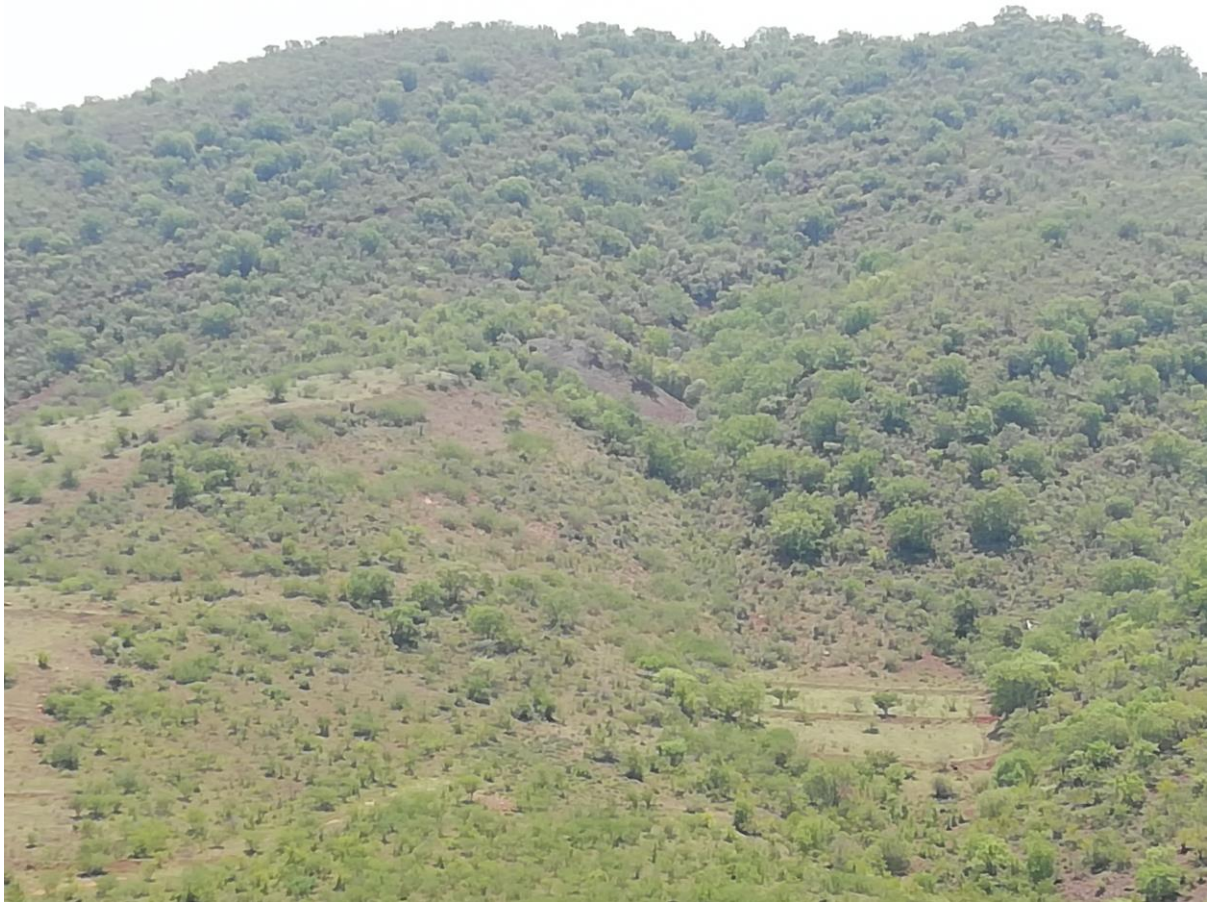
**Main Asbestos dump**

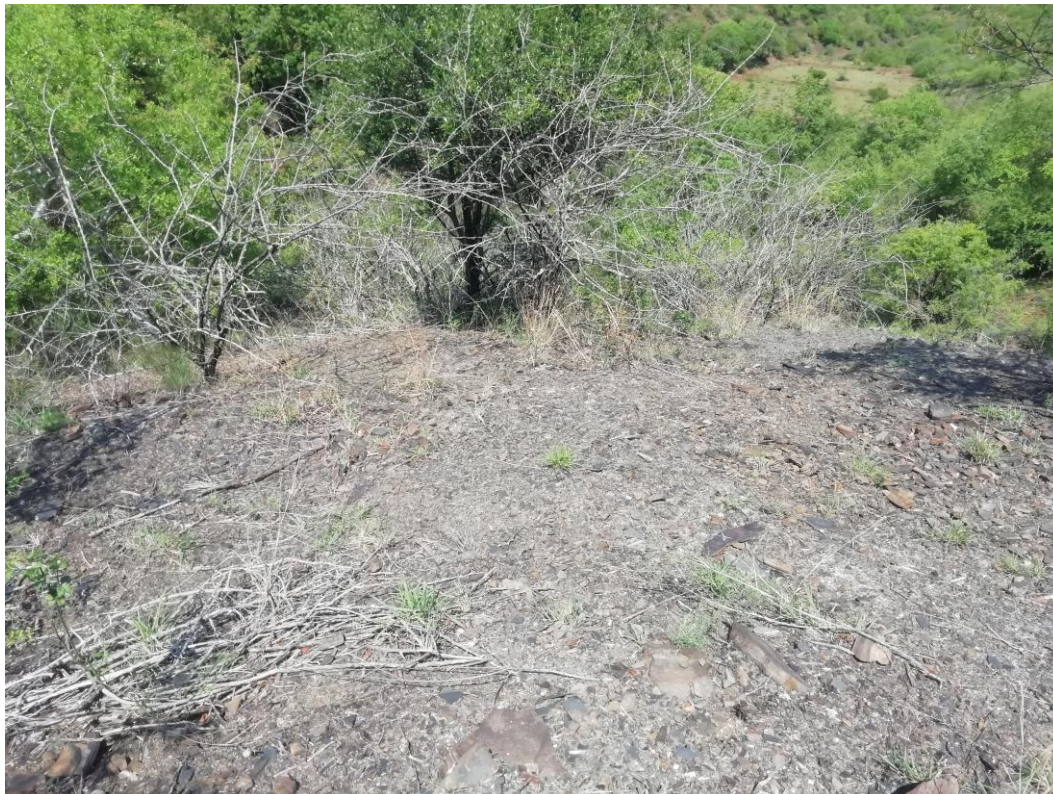
**Asbestos contaminated dump area**

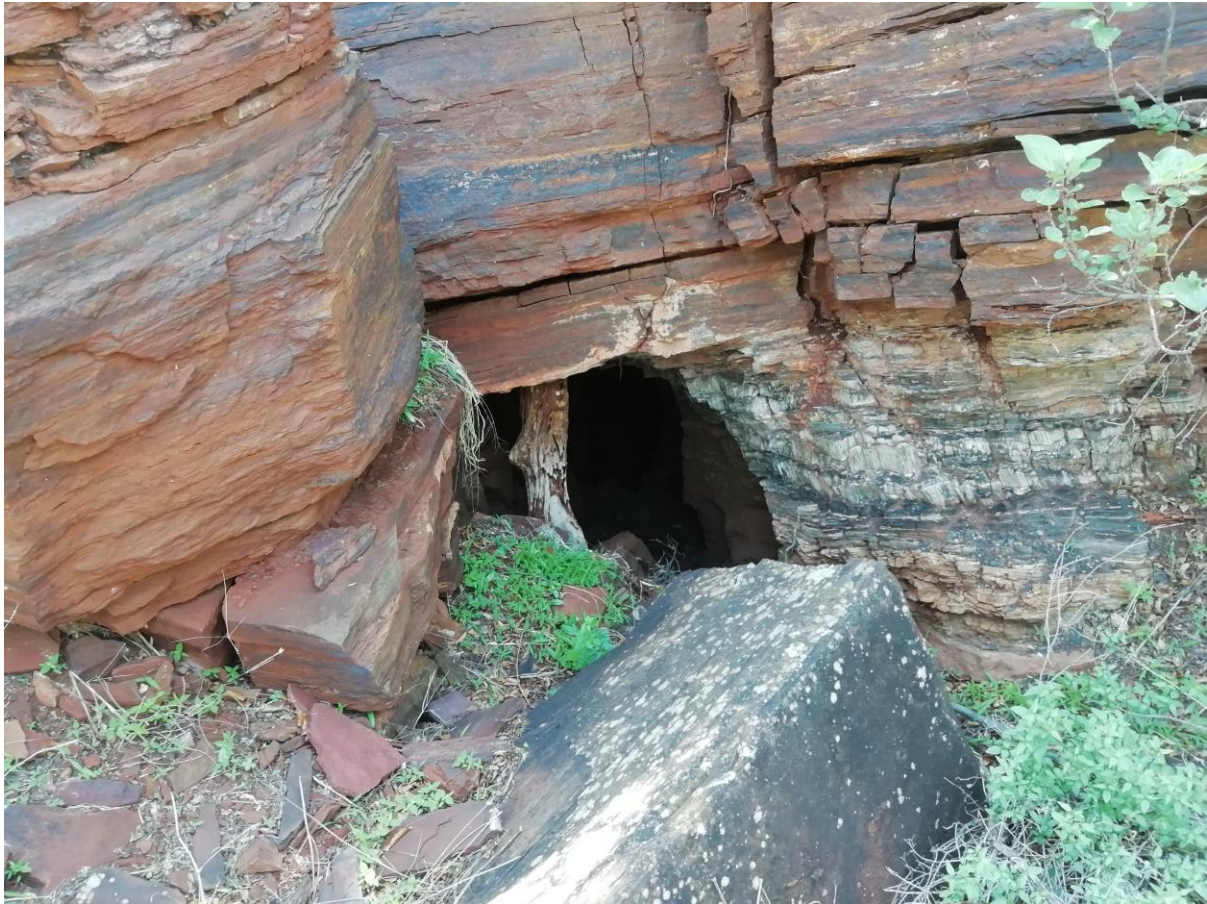
**Adit to be closed**

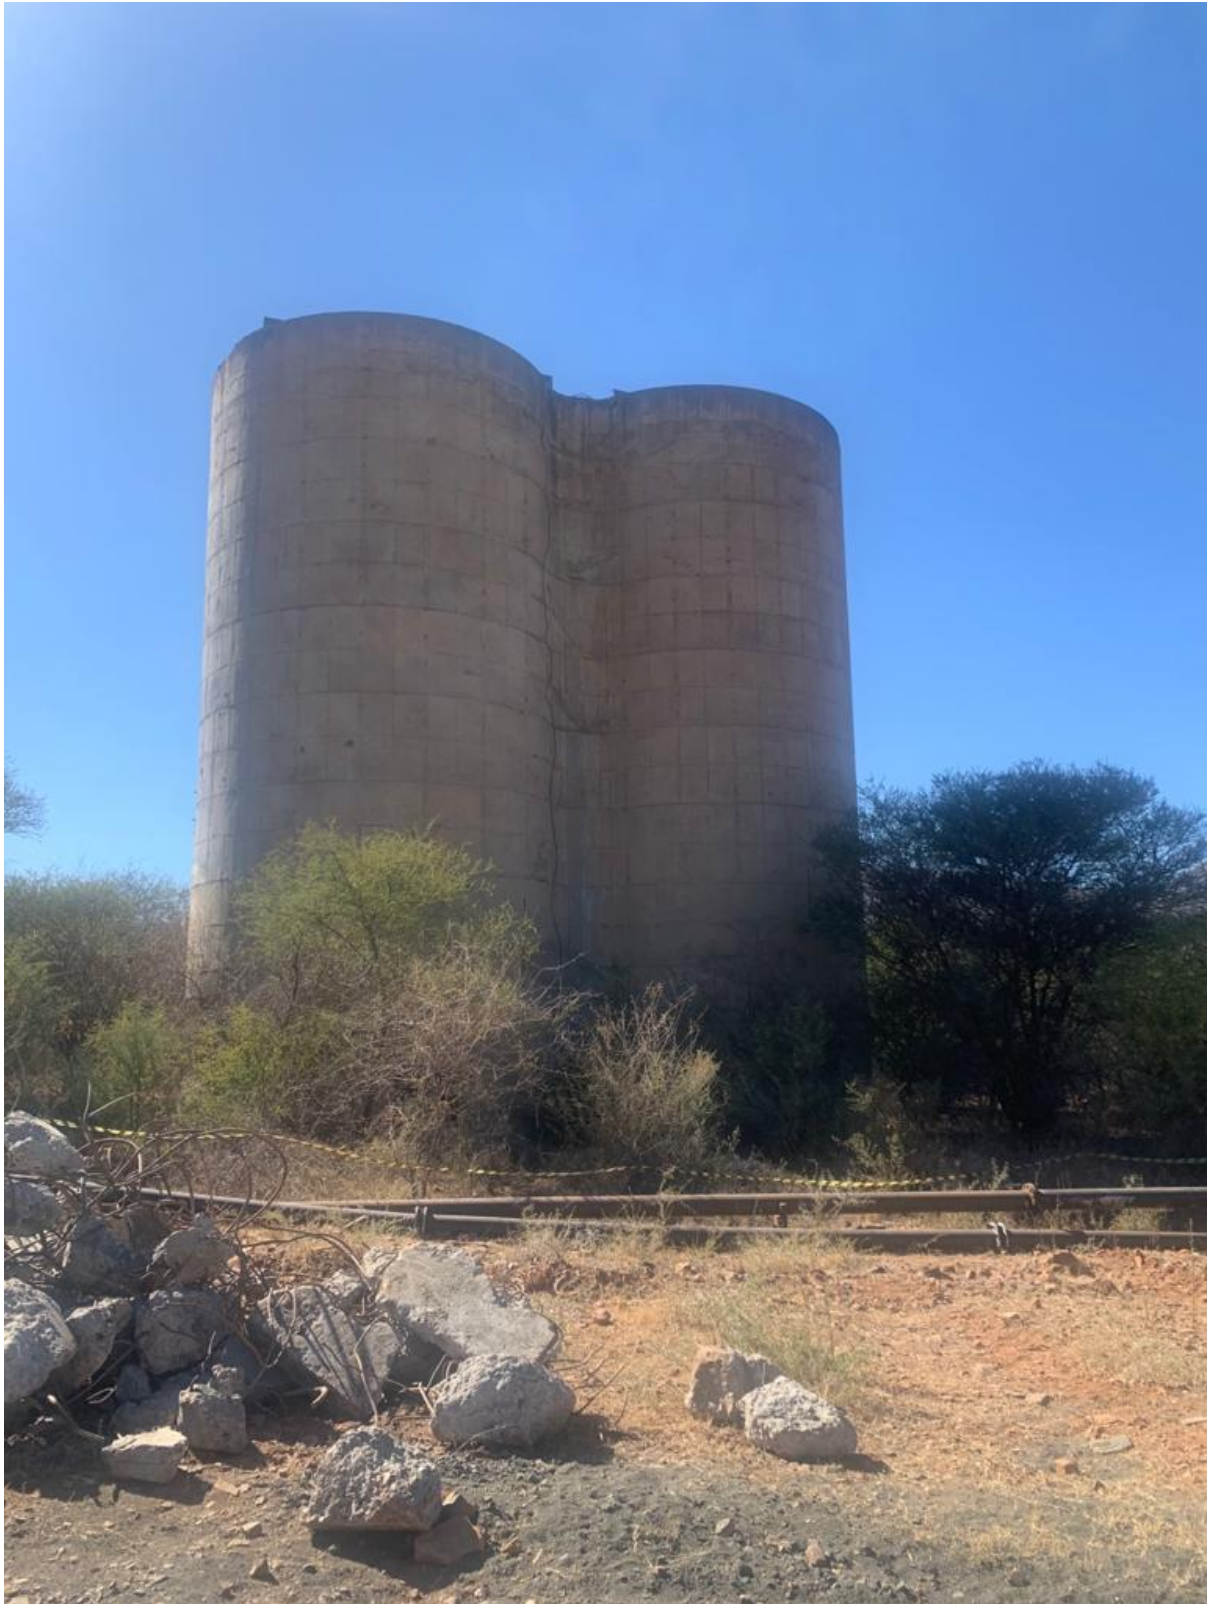
**Existing Storage Silo's to be demolished.**
