VGI CONSULTING

**WALTLOO FUEL FARM STRUCTURES
GEOTECHNICAL INVESTIGATION**

Report No.: JW053/12/D328 – Rev 1

MARCH 2012

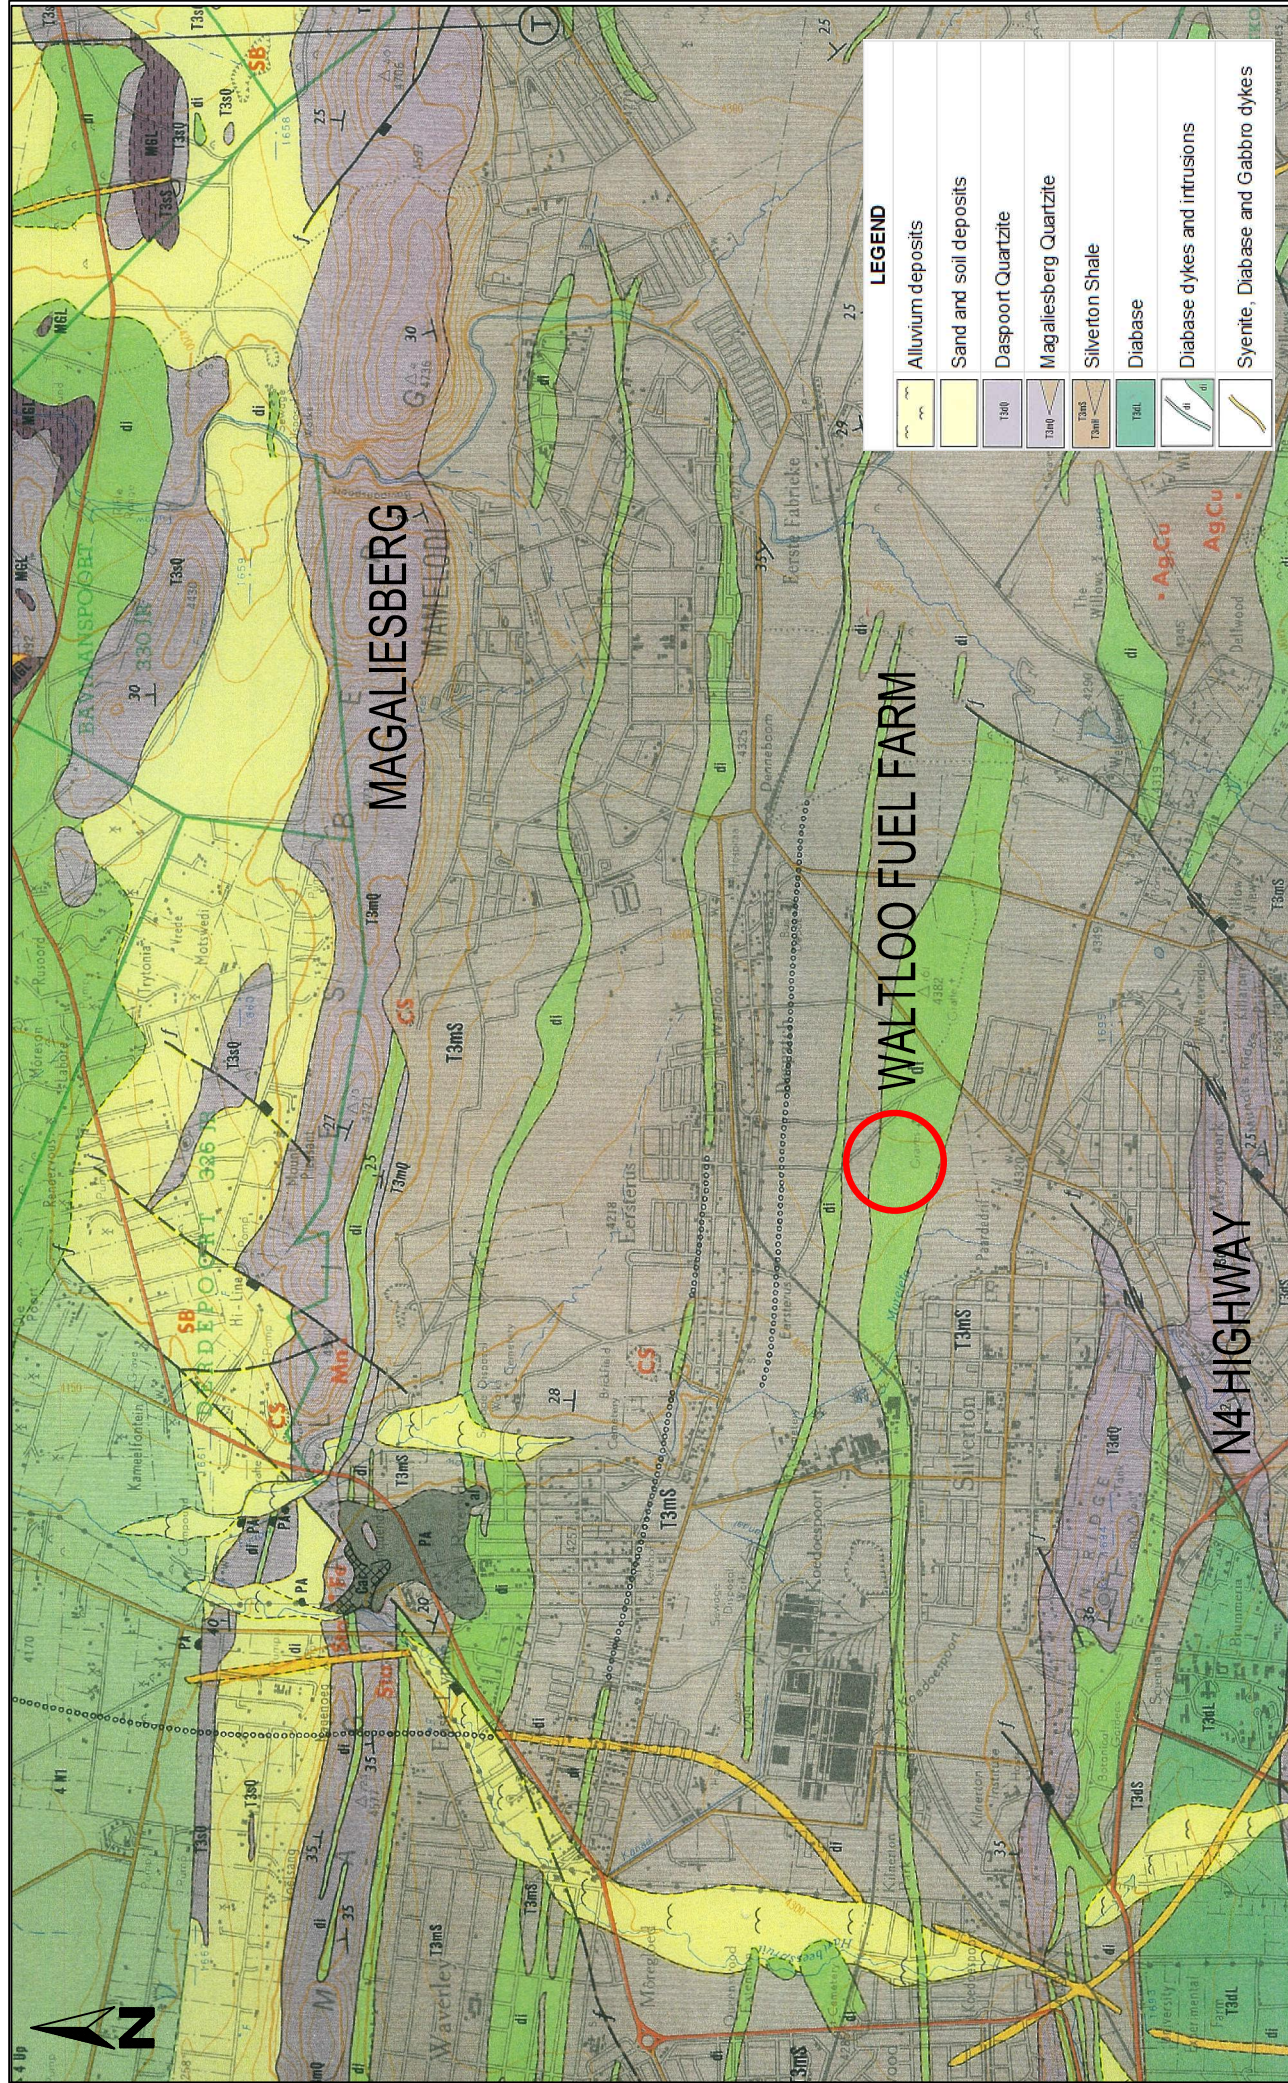
VGI CONSULTING WALTLOO FUEL FARM REGIONAL GEOLOGY OF SITE

During the investigation it was noted that the shale bedding planes dip in a northerly direction at an angle of 20° to 30°. This was confirmed by the 1 in 50 000 geological map of the area shown in Figure 2 which give bedding dip angles varying between 25° to 35°.

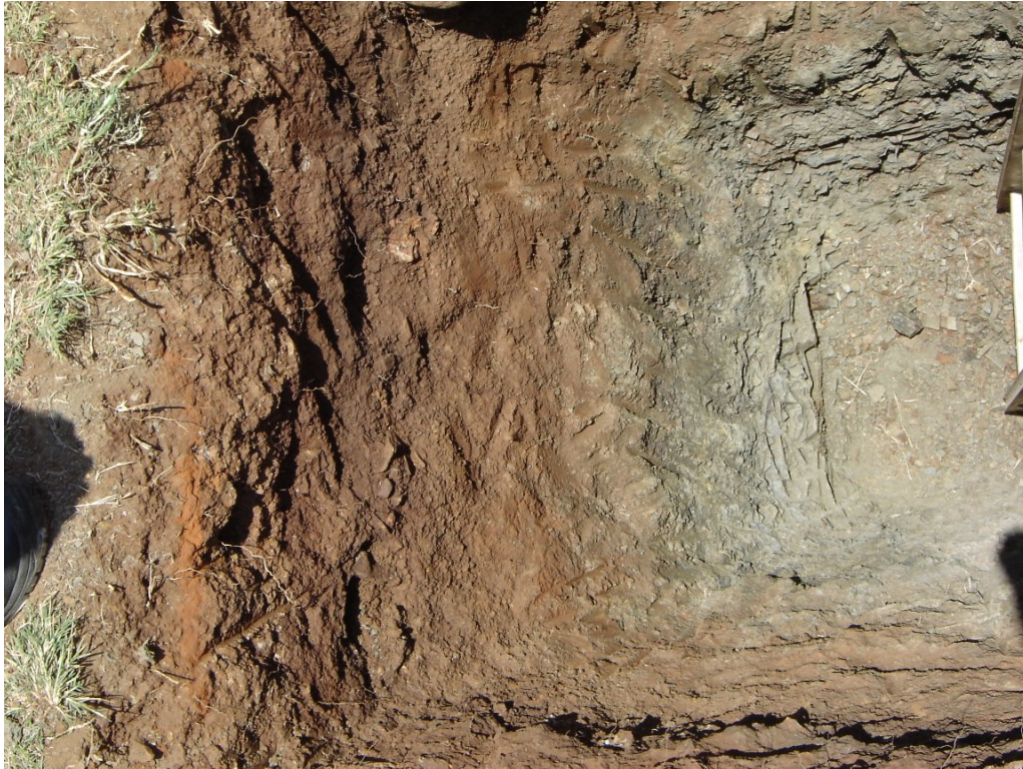
Photo 1 – Reddish hillwash, residual shale and shale rock.

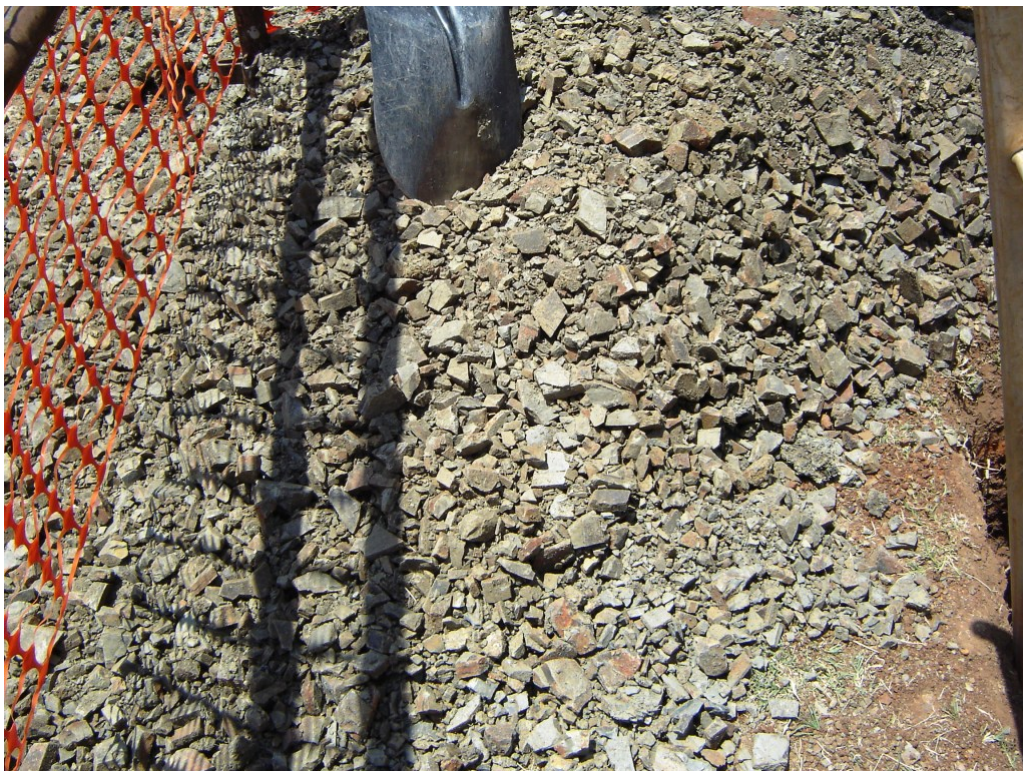
Photo 2 - Shale rock excavated as gravel from testpit
