## IZIKO SOUTH AFRICA MUSEUMS

### DESCRIPTION OF THE WORKS AND TECHNICAL SPECIFICATIONS FOR THE SOUTH AFRICA MUSEUM 2025 UPGRADE

**PREPARED BY:** OSMOND LANGE ARCHITECTS

# DESCRIPTION OF THE WORKS AND TECHNICAL SPECIFICATIONS FOR UPGRADING THE FOYER & PUBLIC BATHROOMS

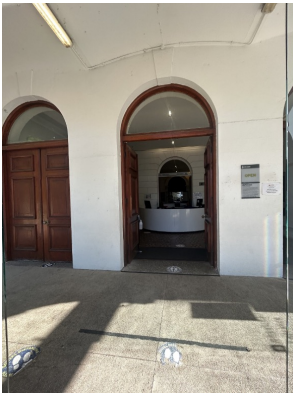
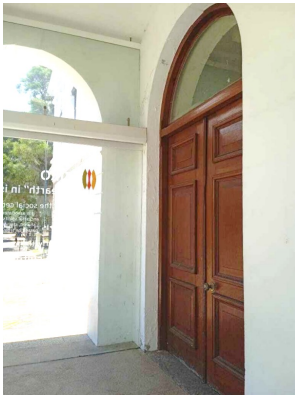
**Ref 1**

1. **Door:** Varnished timber three-panel double door with single-pane fanlight transom window. Doors are in relatively good condition but show signs of wear and tear. The transom windows are in good condition but need some cleaning. It is noted that the interior face of the door and transom window casing have been painted white to match the foyer wall. Refer to pack 1, photo ref: 1-2.

1. **Service & repair doors:** All timber entrance doors with transoms will be serviced and re-varnished.
  - 1.1 Cover glass panes with a protection layer during the servicing of the frames to protect the original glazing.
  - 1.2 Remove existing varnish on the frames by sanding/using a paint stripper. Neutralise the paint stripper according to the manufacturer's instructions. Allow the wood to dry completely. Sand until smooth. Remove dust with a clean, dry cloth. Then wipe with mineral turpentine. Oiled wood: Sand until smooth. Then, scrub well with Woodoc Steel

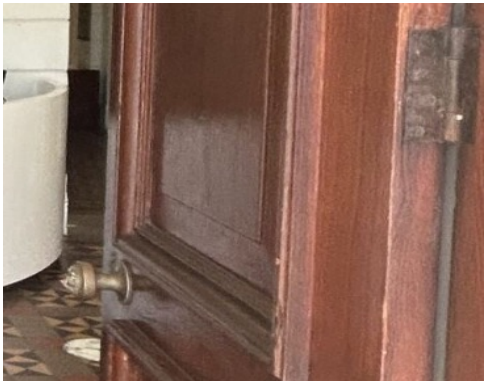
**Ref 3**

2. **Ironmongery:** Brass ironmongery is in an acceptable condition and needs cleaning and care. In need of a clean. Refer to pack 1, photo ref: 3.
3. **Floor:** Heritage tile. It is in an acceptable condition considering its age and foot traffic volumes. However, some tiles need to be fixed or chipped and need attention. Refer to pack 1, photo ref: 4.

**2. Service & clean ironmongery:** All entrance door ironmongery to be serviced and cleaned.

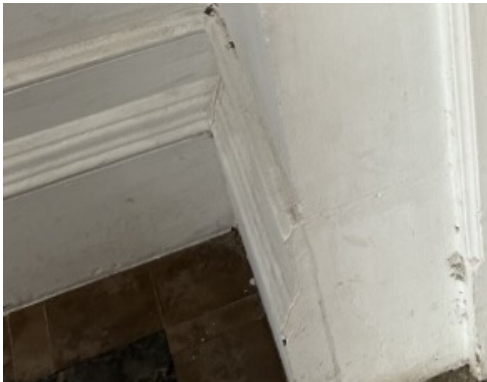
**Ref 5**

4. **Skirting:** This is decorative heritage lime plaster band skirting. It shows signs of wear and tear, needs repairs in some areas, and needs a new coat of paint. Refer to pack 1, photo ref: 5.

**4. Repair and repainting of skirting:** Existing heritage lime plaster skirting is to be repaired and repainted to match the existing undamaged skirting. Existing plaster in other areas appear to be in sound condition.

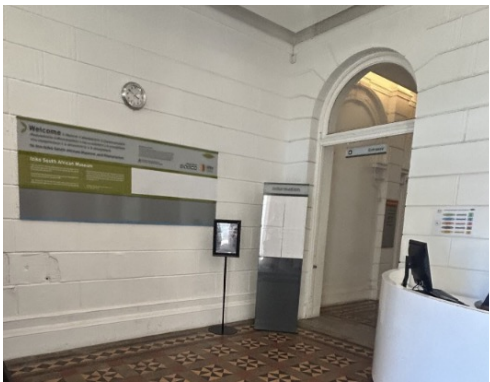
**Ref 6**

5. **Wall:** Decorative heritage lime plaster with a white paint finish. The plaster along some of the edges of the interior archways leading to the reception area is damaged, and some other areas also need attention. Refer to pack 1, photo ref: 6.

### **5. Repair and repainting of walls:** Heritage lime-plastered walls are to be repaired and repainted to match the existing undamaged walls. Existing plaster in other areas appear to be in sound condition.

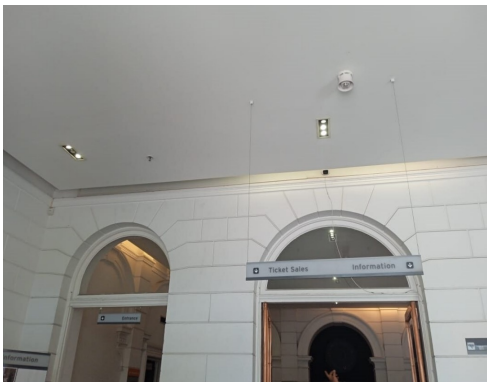
**Ref 7**

6. **Ceiling:** Modern flush plastered suspended ceiling offset from wall edge to protect heritage cornice. Noted the modern ceiling hides services. The ceiling is in good condition. Refer to pack 1, photo ref: 7.

- 6. Ceiling:** Existing suspended ceiling to be renovated. New lighting to be installed per Electrical engineers' specifications and details. The ceiling is to be repainted after the installation of the new lighting.

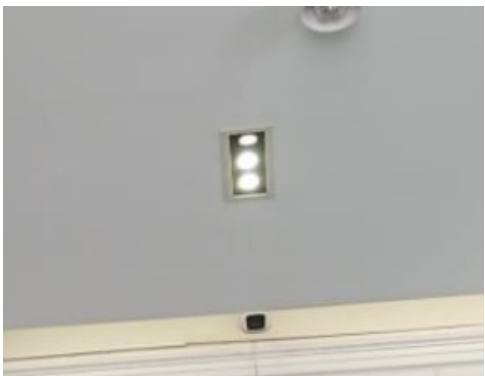
**Ref 8**

7. **Lighting:** Tripple downlights are recessed into a flush plaster-suspended ceiling. The lights are in working condition. Refer to pack 1, photo ref: 8.

**Install New Lighting:** Lighting will be integrated per the electrical engineer's details. Existing lighting positions to be upgraded and installed as per electrical engineers' specifications.

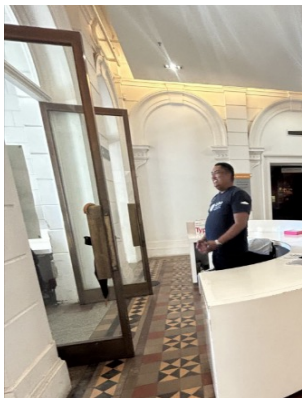
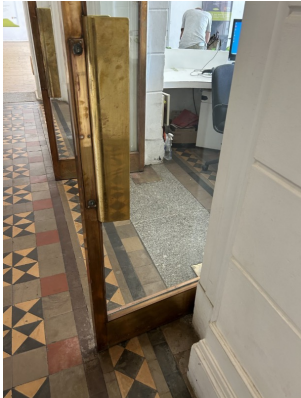
**Ref 1**

1. **Door:** In the central archway is a full-glass double door with a copper frame and white-painted, timber-cased single-pane fanlight transom. The doors are in relatively good condition but show wear and tear. The transom window is in good condition but needs some cleaning. Refer to pack 1, photo ref: 9.

1. **Removal of doors:** The existing full-glass double door with a copper frame will be carefully removed before the commencement of any work and stored as directed by Iziko. Care must be taken during the removal and storage of the door to ensure no damage occurs to the historic door or its surroundings. Existing timber frame located in the arches are to be kept as is.
2. **Cleaning of floor tiles:** Clean historic tiles according to the specific instructions from the Iziko exhibition team.
3. **Repair and repainting of skirting:** The plaster skirting will be repaired and repainted to match the existing undamaged skirting. The existing plaster in other areas seems to be in sound condition, but further assessment will be required to identify whether the plaster is a cement or lime-based mix.

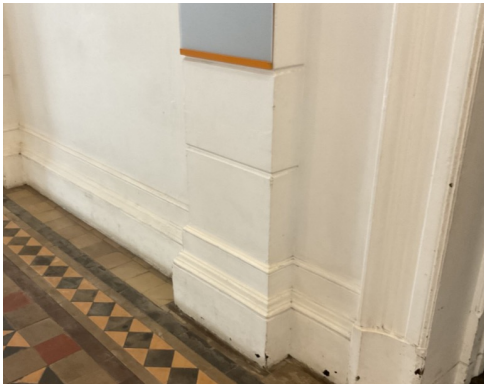
**Ref 4**

2. **Floor:** Heritage tile. It is in an acceptable condition considering its age and foot traffic volumes. However, some tiles need to be fixed or chipped and need attention. Refer to pack 1, photo ref: 11.

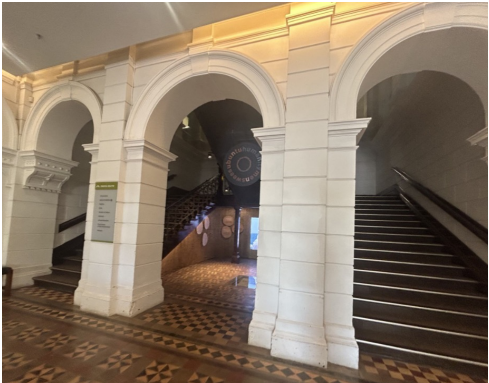
**Ref 6**

4. **Wall:** Decorative plaster and mouldings are made of various wall openings with a white paint finish. Some of the decorative plaster and mouldings are damaged along the edges. Repairs and a new coat of paint are needed. Refer to pack 1, photo ref: 13 - 14.

- 4. Repair and repainting of wall:** The decorative plaster will be inspected for damage. Damaged areas will be repaired and repainted to match the existing ones. The existing plaster in other areas is in sound condition, but further assessment will be required to identify whether the plaster is a cement or lime-based mix.

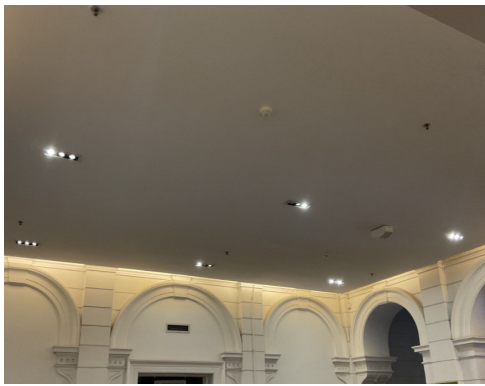
**Ref 7**

5. **Ceiling:** Modern flush plastered suspended ceiling offset from wall edge to protect heritage cornice. Noted the modern ceiling hides services. The ceiling is in good condition. Refer to pack 1, photo ref: 15.

- 5. Ceiling:** Existing suspended ceiling to be renovated. New lighting to be installed per Electrical engineers' specifications and details. The ceiling is to be repainted after the installation of the new lighting.

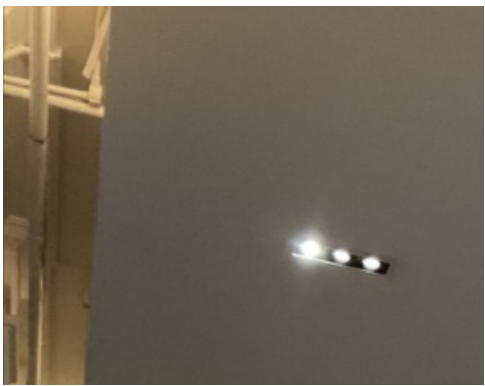
**Ref 8**

6. **Lighting:** Tripple downlights are recessed into a flush plaster-suspended ceiling. The lights are in working condition. Refer to pack 1, photo ref: 16.

**Install New Lighting:** Lighting will be integrated per the electrical engineer's details. Existing lighting positions to be upgraded and installed as per electrical engineers' specifications.
