## Annexure C3.2 Scope of Work

**BID No.: 10408676**

**BID Description: Design and erect old dosing plant roof**

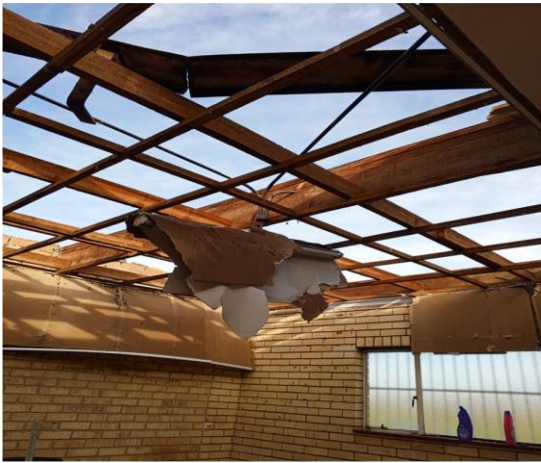
Strong winds damaged 70% of the roof. The roof sheets, trusses, ceiling, and lights got damaged.

*Figure 1: Damaged roof and ceiling*

- Design and install the new roof (trusses, rafters, purlins, fascia between 1mm – 2mm, bracing, branderling etc.)
- Supply and install roof sheeting – chromadek - Kalahari red colour.
- Supply and install drainage – roof to slope to one side allowing rainwater drainage to go behind the building.
- Repair 3 – 5 courses of the brickwork to accommodate the new roof.
- Install a minimum of three down pipes.
- Install rhino light ceiling with 75mm cornice.
- Supply and install, lights and plugs (1.2 m fluorescent cubes) according to the required standard of lighting for MCC rooms and tearoom.
- Supply roof installation certificate from a competent person
- Supply and design the build - in drawings approved by an engineer. The drawings should include soft copies and hard copies.

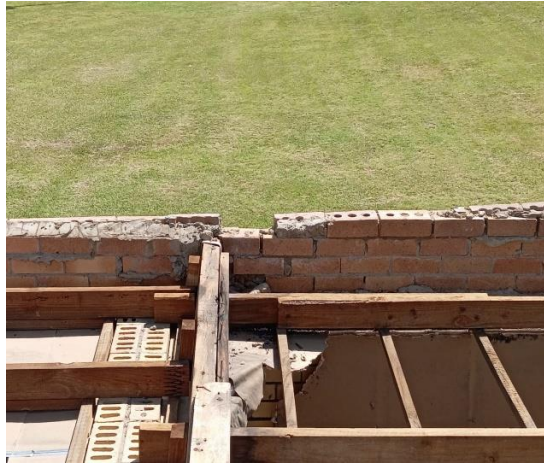
*Figure 2: Damaged roof trusses and walls*
