## **Preliminary Geotechnical Investigation Phase 1 and 2**

The Eastern Cape Department of Transport appointed BMK to provide additional geotechnical services for the proposed upgrade of the Gali River crossing. The works include constructing a major culvert bridge to improve the road link between the R410 and DR08592 in the Chris Hani District Municipality and villages beyond the crossing.

The Gali Bridge project is located in the Chris Hani District Municipality, within the Emalahleni Local Municipality in Lady Frere. The crossing is situated on District Road DR08592.

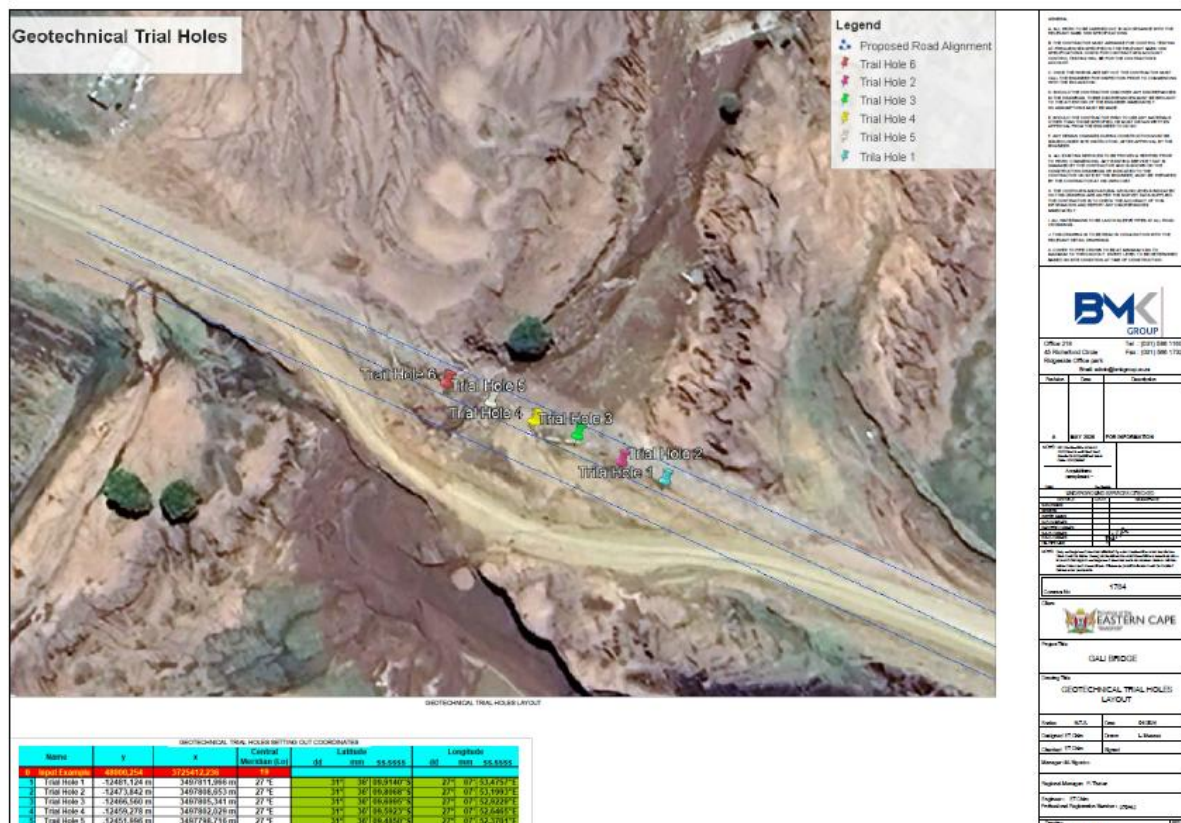
The recovered materials indicate broadly similar subsurface profiles at the bridge sites. The sequence generally comprises occasional sand fill identified in the test

pits, underlain by colluvium (hill wash), alluvial soil and boulder deposits, and residual soils overlying either Karoo dolerite or Adelaide Formation sandstone and siltstone bedrock. Bedrock was encountered at depths of approximately 4–6 m, transported sand and boulders extended from the surface to about 1.5 m, and hard to very hard rock was intersected at depths of approximately 2–8 m.

Overall, the ground conditions are suitable for the proposed development, with no geotechnical constraints that would prevent construction. Raft foundations on engineered fills are recommended, along with scour protection and upstream riverbed management.
