**A PHASE ONE GEOTECHNICAL REPORT ON THE REMAINDER OF THE  
FARM PALMIETFONTEIN 3750 IN DANNHAUSER FOR A PROPOSED NEW  
INDUSTRIAL TOWNSHIP ESTABLISHMENT**

Report Number: 2019/J018/KVD

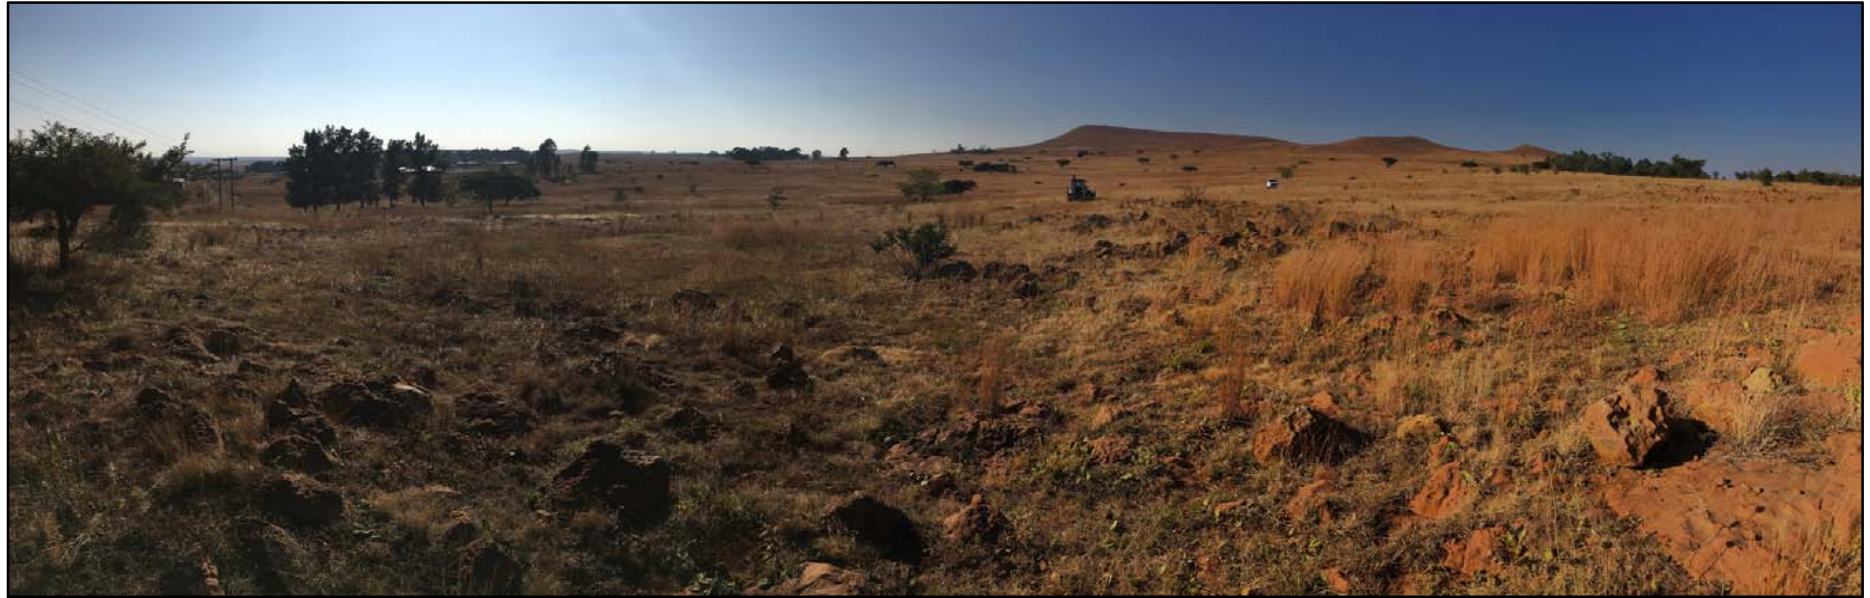
**PHOTO 1**

Photo 1: Site Conditions shows typical site conditions at the time of the site investigation.

**SITE CONDITIONS**

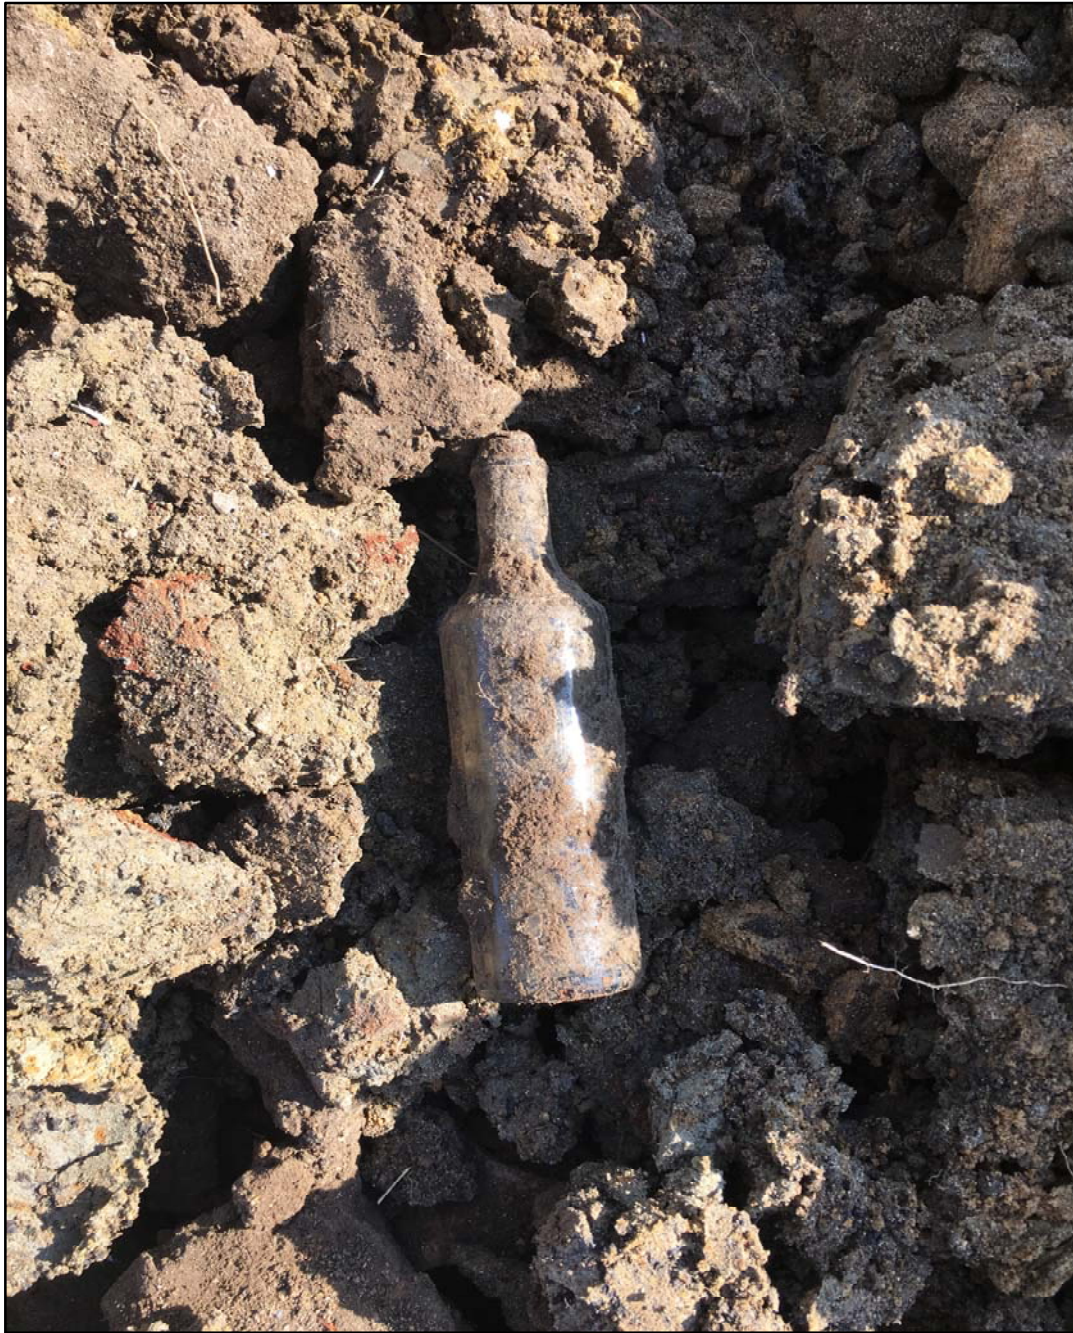
PHOTO 2

- *Fill Material:* The fill materials were encountered in limited trial holes; however site observation proved that there are numerous localised pockets of fill or rubble deposited across the study area. While most of the fill deposits are surficial, on some occasions it was found to extend to notable depth in the soil profile. The fill typically consisted of rubble mixed in soil material. Photo 2 shows a typical example of fill material which consisted of a soil matrix but also contained foreign objects such as bottles. The fill material was not sampled due to its mixed composition. Based on the foreign matter included in the fill horizon, it is deduced that some of these materials are at least four or five decades old. Remaining rubble largely consisted of surface dumps of mixed refuse and construction waste (e.g. broken concrete slabs etc.).

TYPICAL FILL MATERIAL

- *Fill Material:* The fill materials were machine excavatable with relative ease. However, it was noted that some of the construction rubble that had been dumped on the site is fairly coarse (i.e. broken concrete slabs, etc.) and would be difficult to manage using smaller plant equipment.

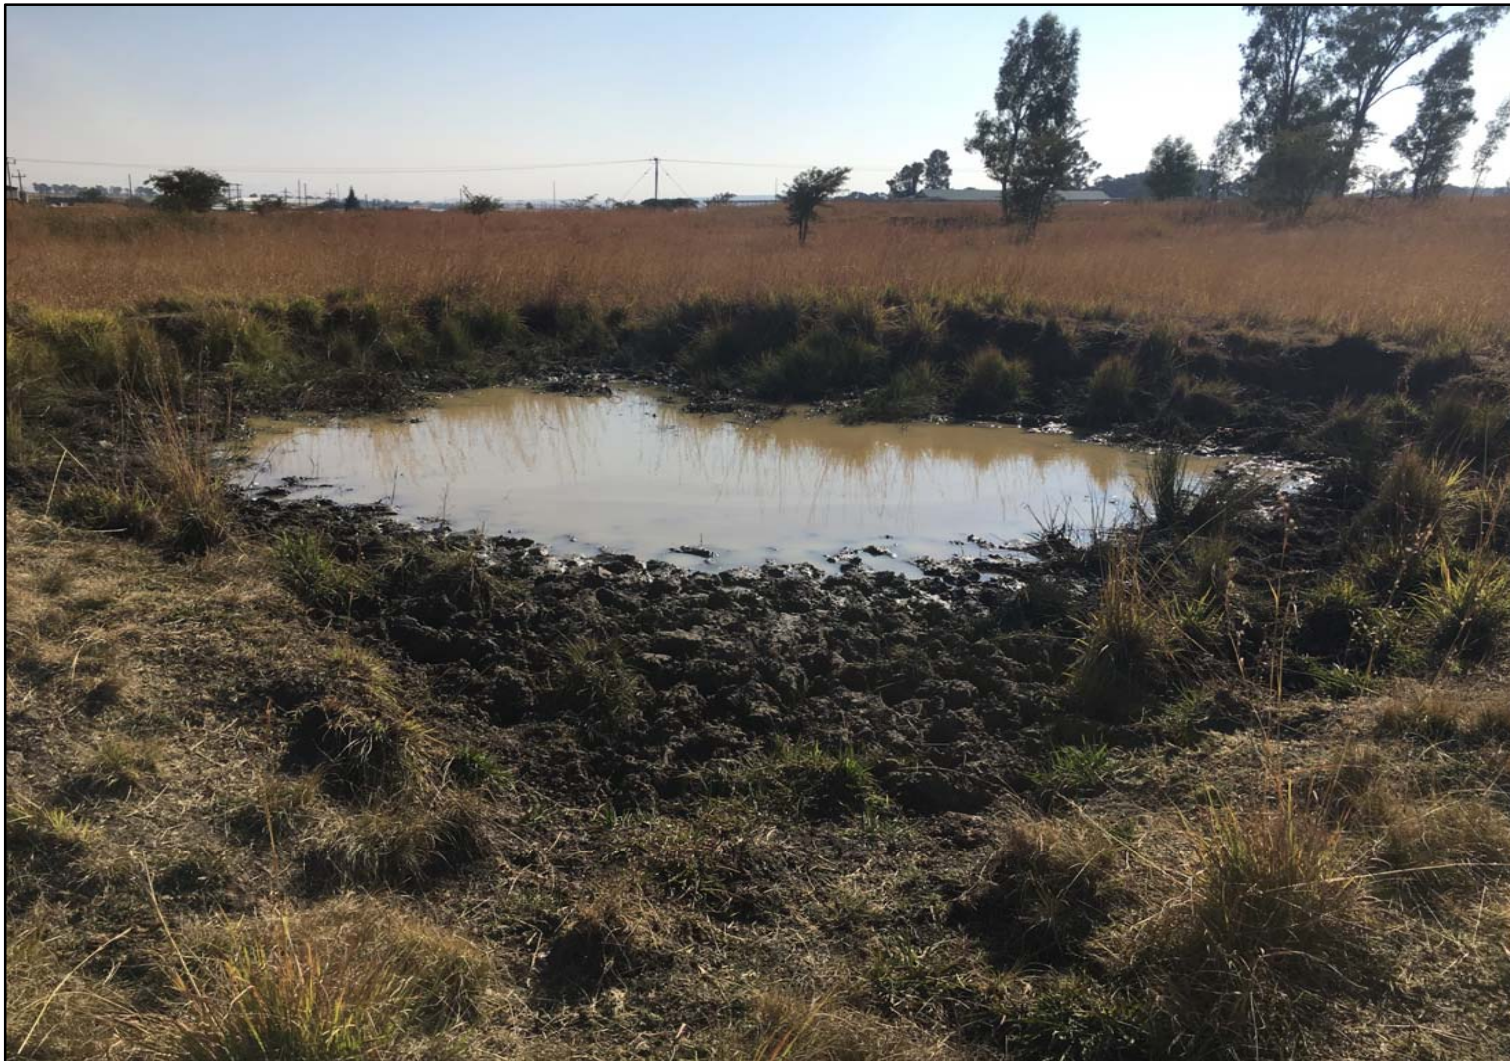
**PHOTO 3**

Site observations further suggest that drainage may be problematic on a seasonal basis and that surface water accumulation may occur. At least one localised depression was found to be filled with water and it should be considered that the investigation was conducted in the middle of winter, when such conditions are most likely to be absent. A further indicator of poor drainage is a trench excavated along the north western most boundary of the site, which appears to serve as a cut-off trench. This will be discussed in more detail later in the report.

**WATER-FILLED SURFACE DEPRESSION**

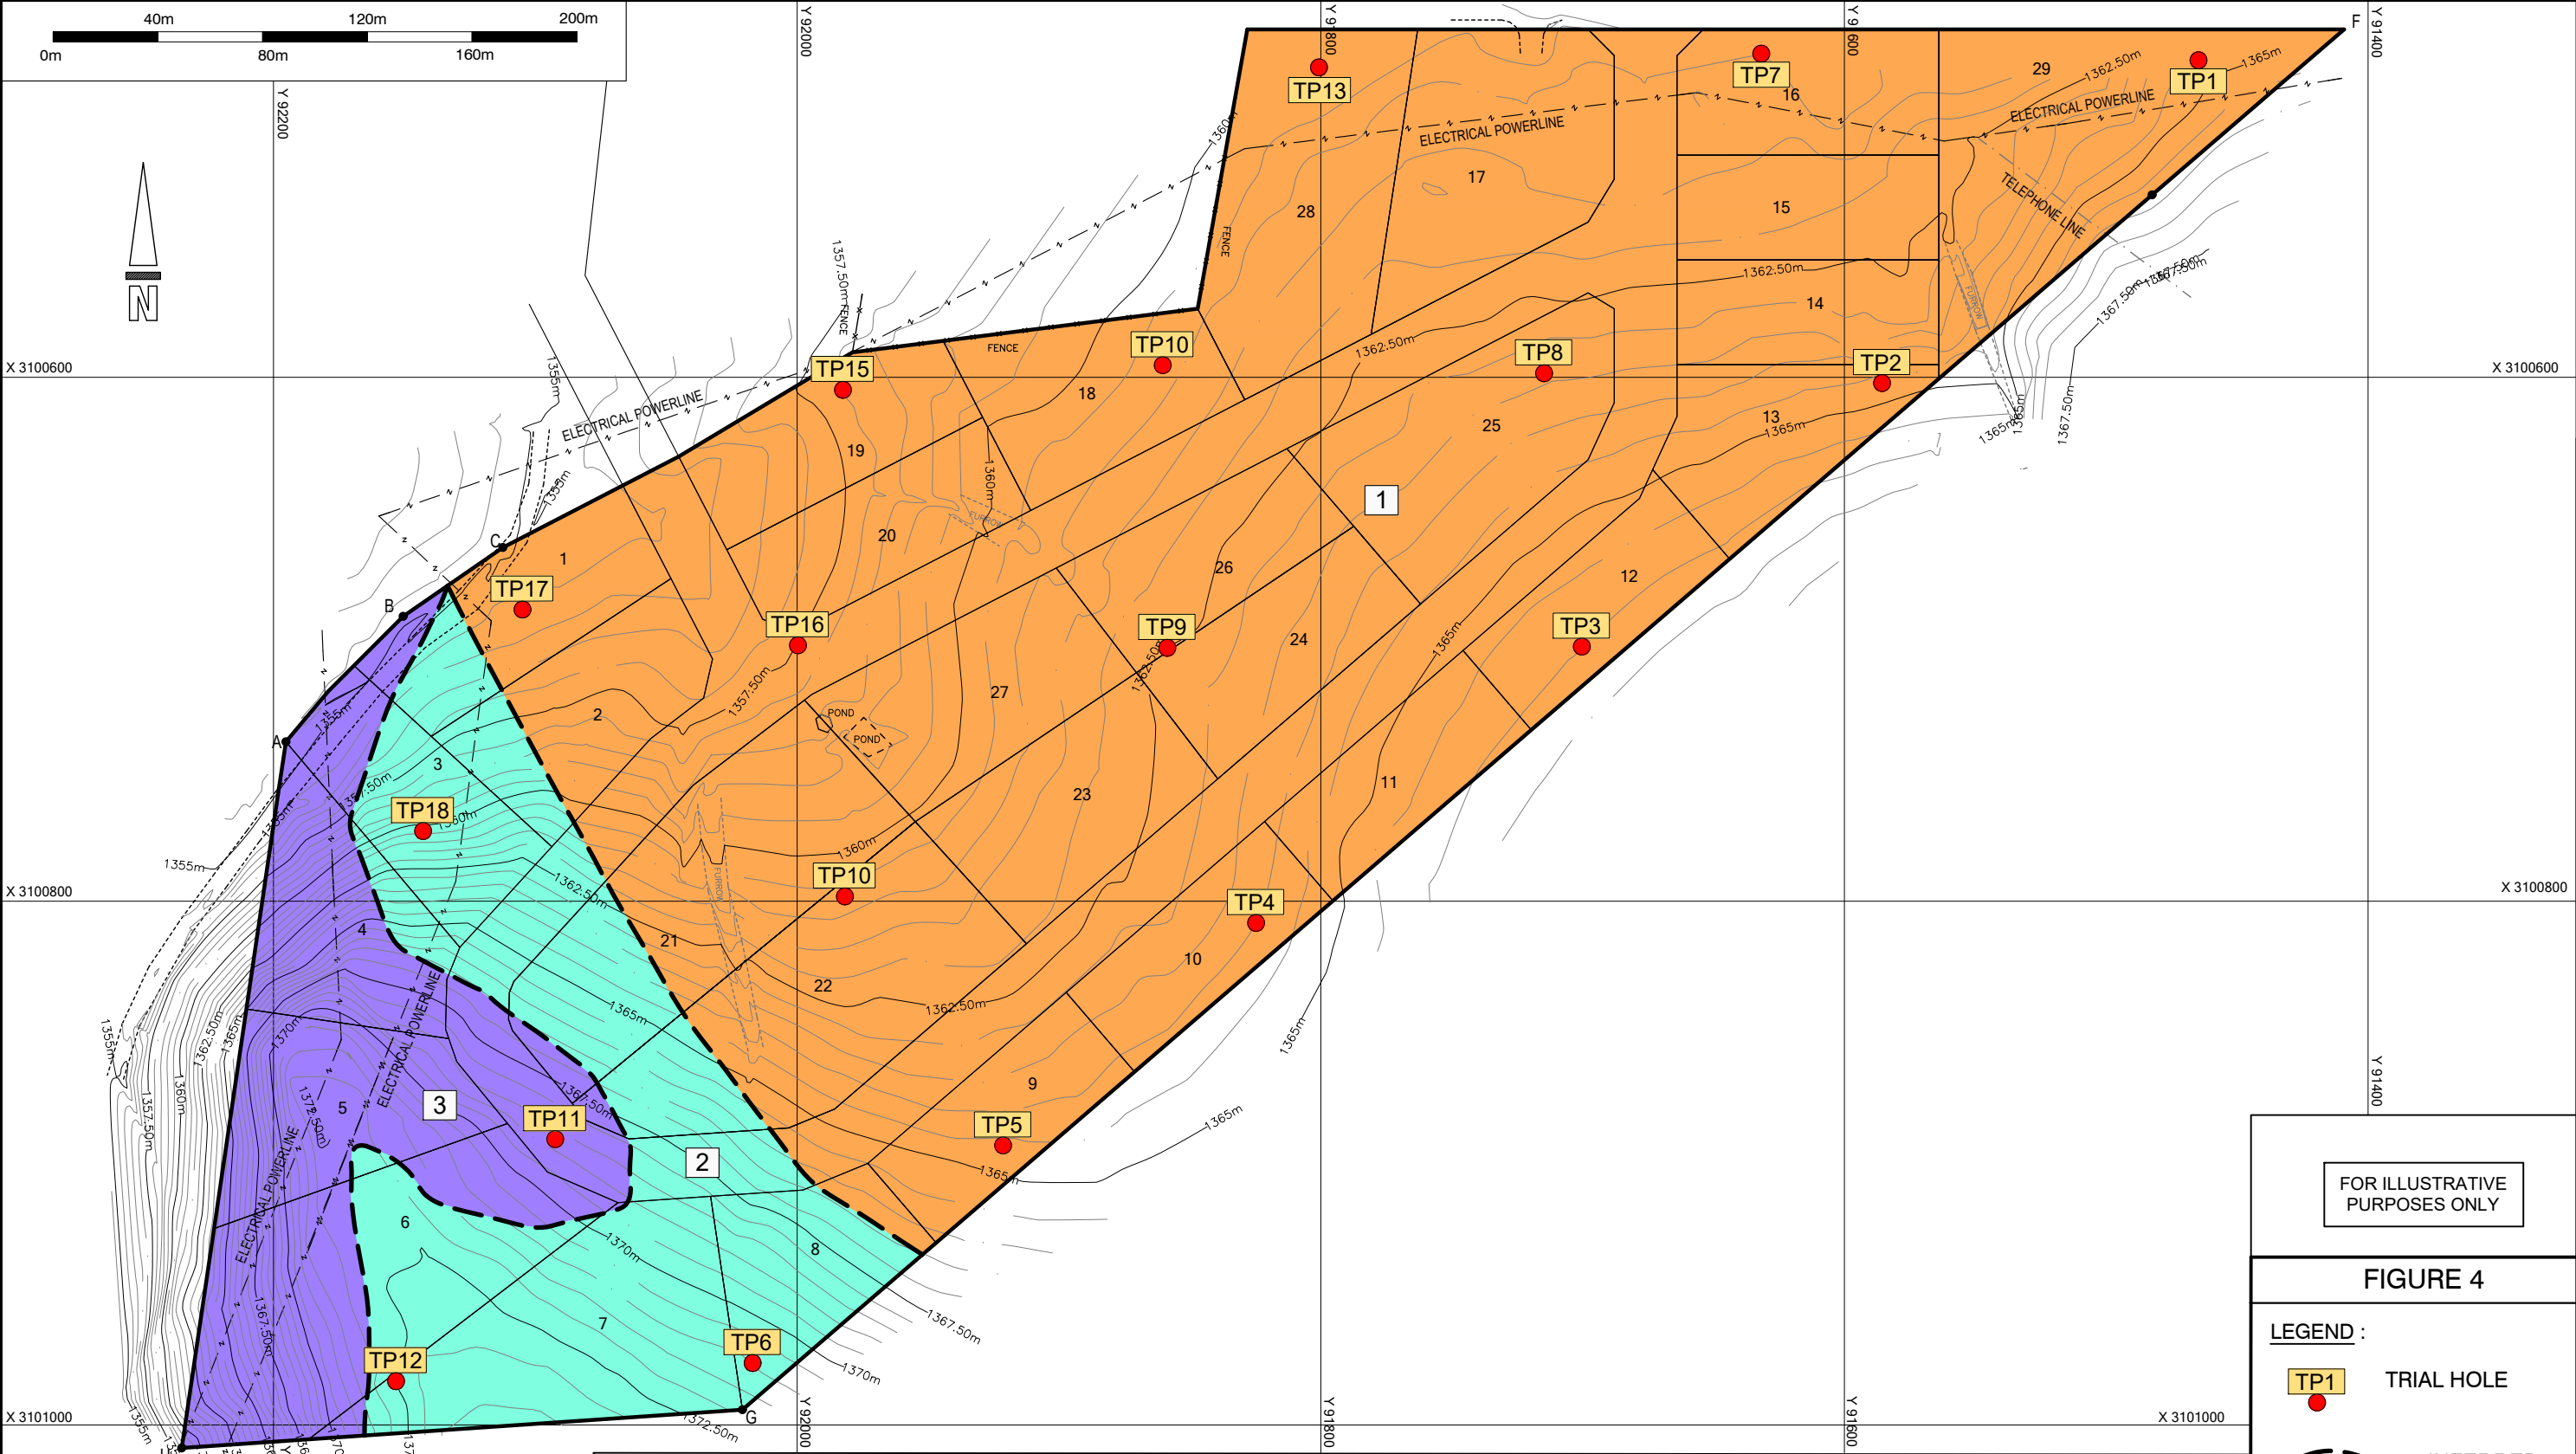
- *Zone 2: **H1/S2**:* The second zone essentially forms a buffer between zone 1 and zone 3. Profiles in this zone are associated with residual dolerite which has moderate expansiveness and high susceptibility to settlement. As a result, soil movement is expected to be a combination of up to 15mm unrestrained heave and consolidation settlement in excess of 20mm, even at relative low foundation loads. Soil horizons in this zone are plagued by the inclusion of large corestones (i.e. cobbles and boulders) which may affect founding conditions.

- *Zone 3: **S1/R**:* This zone includes the western-most part of the site and is characterised by limited soil cover (which is sometimes entirely absent) overlying shallow dolerite bedrock. Soil horizons also contain abundant corestones. This zone is also characterised by steep gradients (to be discussed in following sections) and bedrock outcrop.

The zonation is illustrated in Figure 4: Geotechnical Zoning. The indicated boundary lines between the individual zones are inferred and must not be considered as a set boundary. It is essential that the zoning be refined during the phase two investigation.

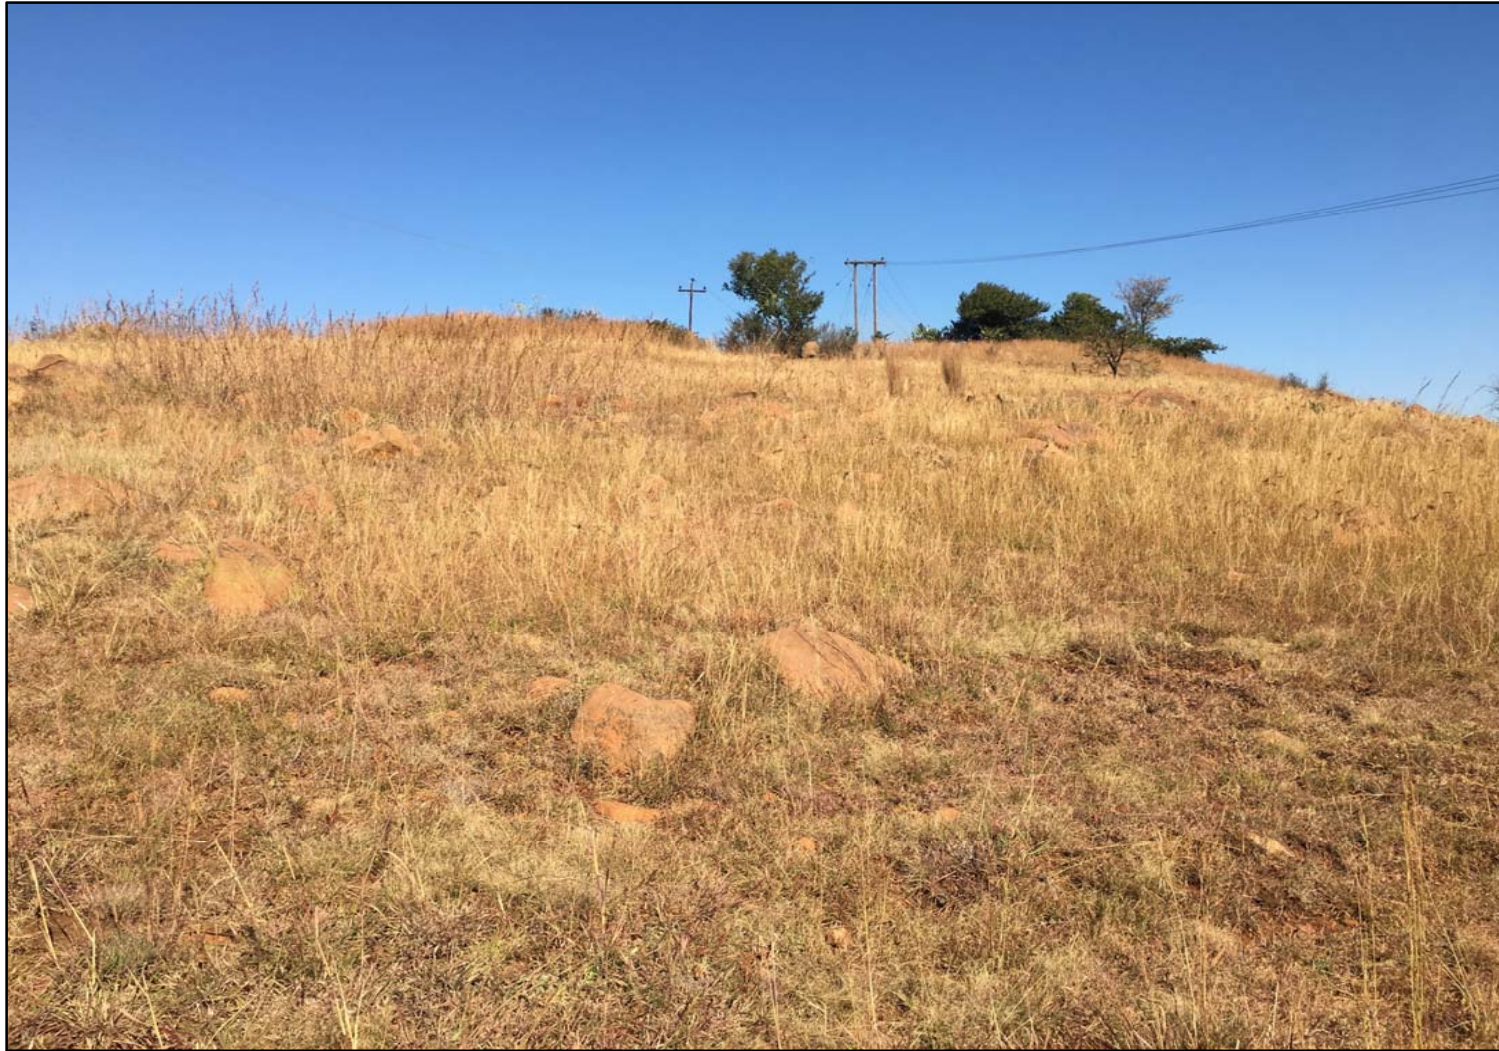
**PHOTO 6**

- *Areas of Steep Slopes and Rock Outcrop:* Large parts of the western side of the study area are characterised by bedrock outcrop and associated steep slopes, as illustrated in Photo 5 and Photo 6. To complicate matters, the contact between geotechnical zones 2 and 3 is not clear, as zone 2 is associated with abundant dolerite boulders and cobbles, while zone 3 is associated with bedrock outcrop. It is therefore difficult to discern (on surface) which rock materials constitute bedrock and which constitute loose lying boulders protruding the surface.

**STEEP SLOPES, WESTERN BOUNDARY**
