Geotechnical Investigation Report

October 2024

**Investigation for the Proposed upgrade of
the Trenance 3 Reservoir site in Ward 59.**

EGE2024-19: Assessment for the upgrade of the Trenance 3 Reservoir site in Ward 59- KZN Province

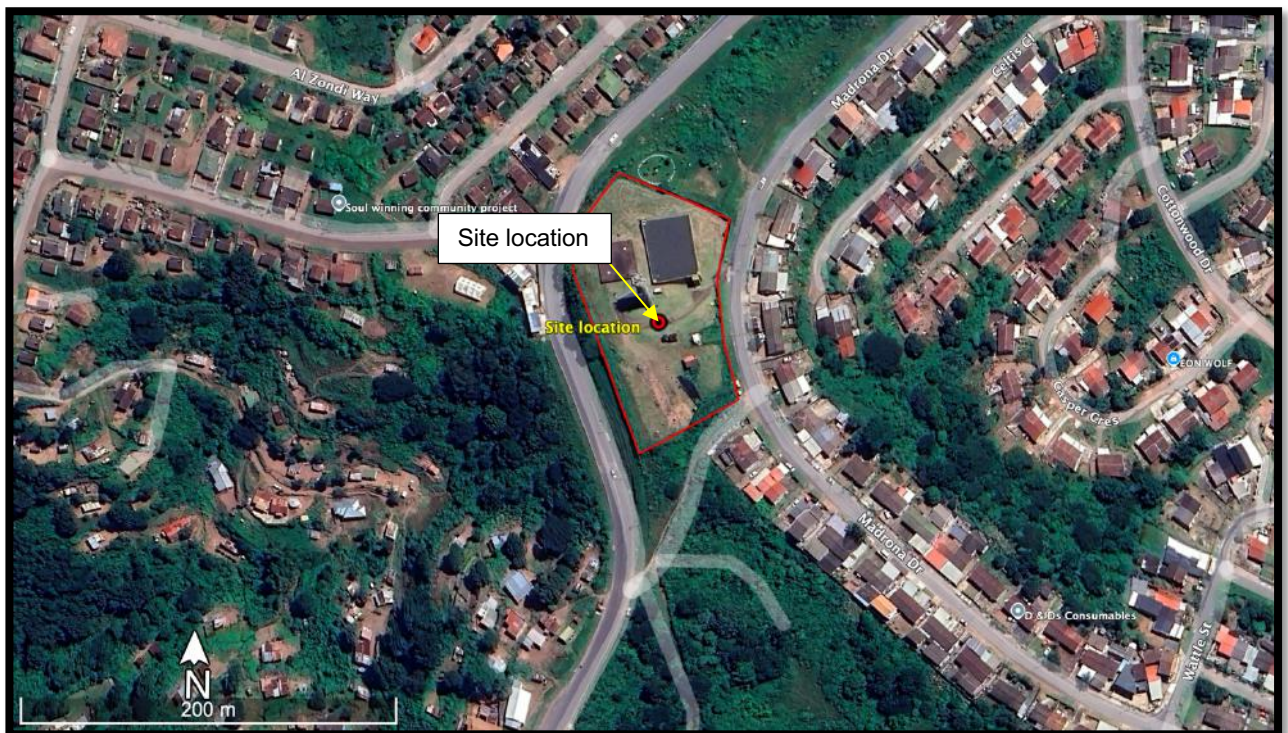
Figure 1: Showing the investigated area (red boundary) for the proposed development.

The proposed development is located at Trenance 3 Reservoir in Ward 59 eThekweni Municipality in KwaZulu Natal Province. It is accessible via Jabu Ngcobo Drive (M27), and by taking the Cottonwood Drive off-ramp, turn left to Madrona Drive to get to Trenance 3 Reservoir. The proposed development has a reservoir and associated infrastructure is shown in Figure 1 below.

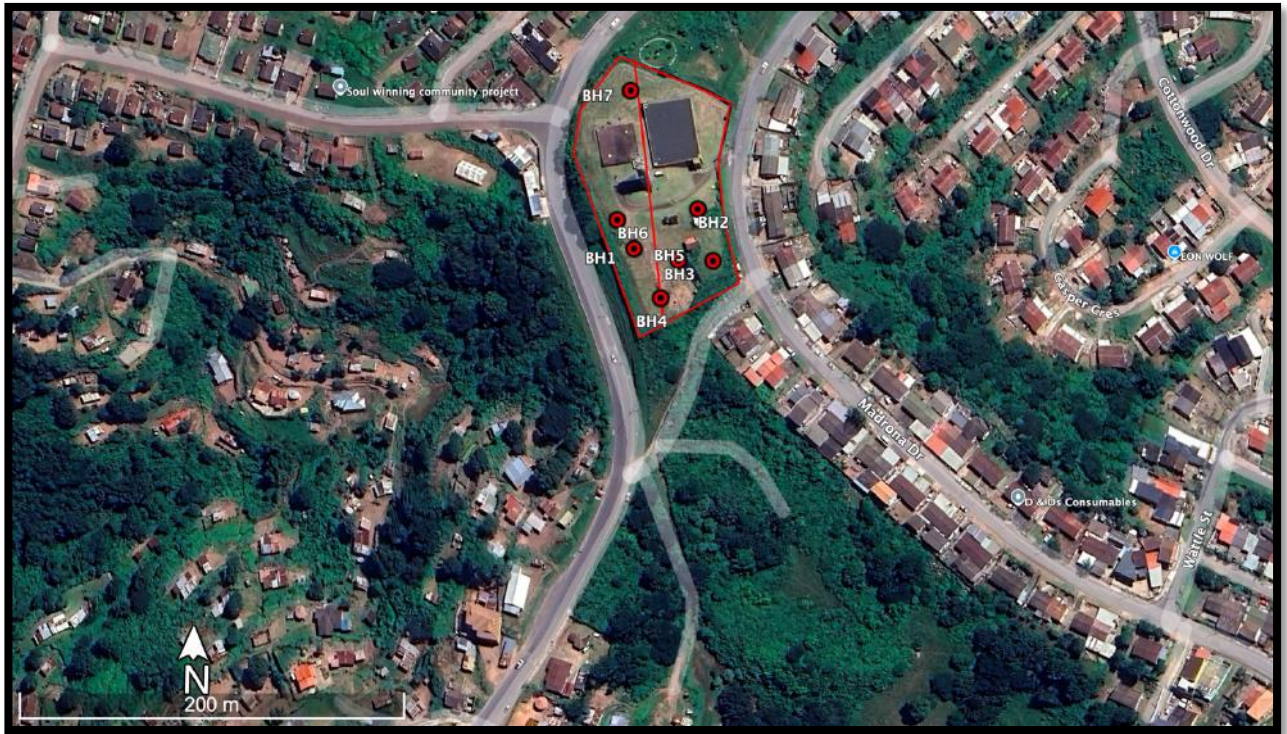
Figure 5: Showing the line where the below geological cross-section was drawn from

The results from the boreholes drilled on site reveal that the area is underlain by the fill layer, followed by the minor patches of the transported layer, residual layer, and then bedrock. The geological North - South cross-section through the site is shown in Figure 6 below, while the line (redline) where the cross section is drawn from is shown in Figure 5 below.

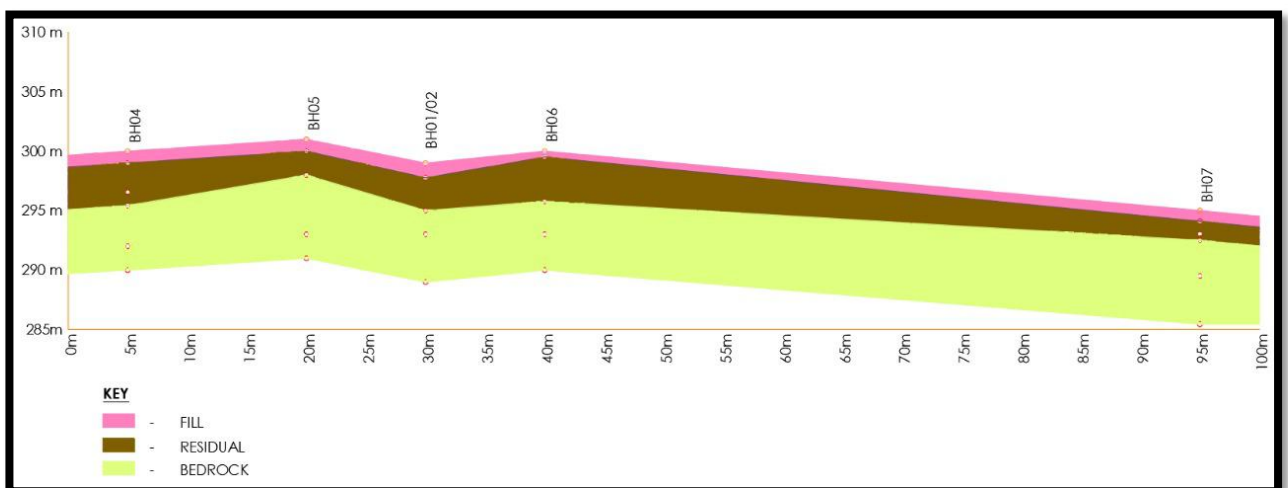
Figure 6: The N-S geological cross section across the site.

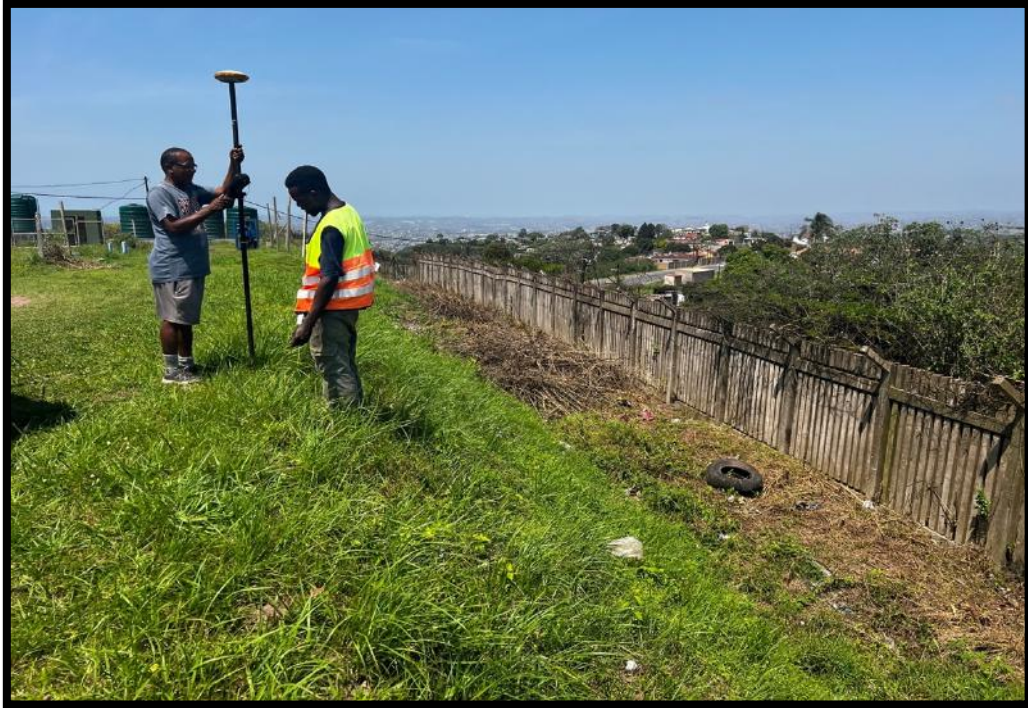
Figure 7: Showing the surveyor marking borehole positions at the site.

The importance of a professional surveyor marking boreholes on a site, emphasizes both precision and the multifaceted nature of geological investigations. Figure 7 below shows the surveyor marking the borehole positions at the site

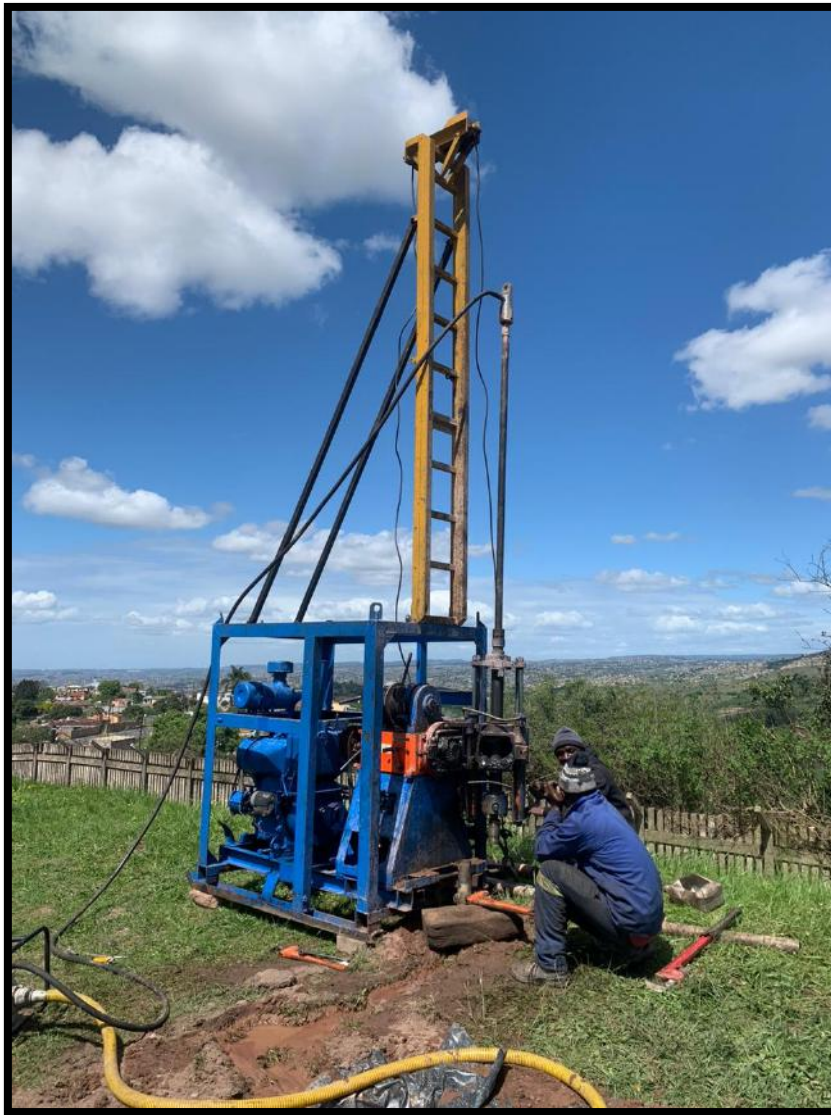
Figure 8: Showing the borehole drilling equipment at the site.

Seven (7 No) rotary core borehole drilling was carried out by a specialist geotechnical drilling contractor, in accordance with accepted South African Standards (CSRA, 1993. Standard Specifications for subsurface Investigations). The borehole was drilled through the sandstone bedrock to a depth of 10m. The borehole was logged in accordance with accepted South African practice (South African National Standard. Profiling, Percussion Borehole, and Core Logging in Southern Africa SANS 633:2012).

The position of the borehole is listed below in Table 1 with the detailed borehole log attached in Appendix B. The Figure 8 below shows the borehole drilling equipment during the drilling proposes at the site.

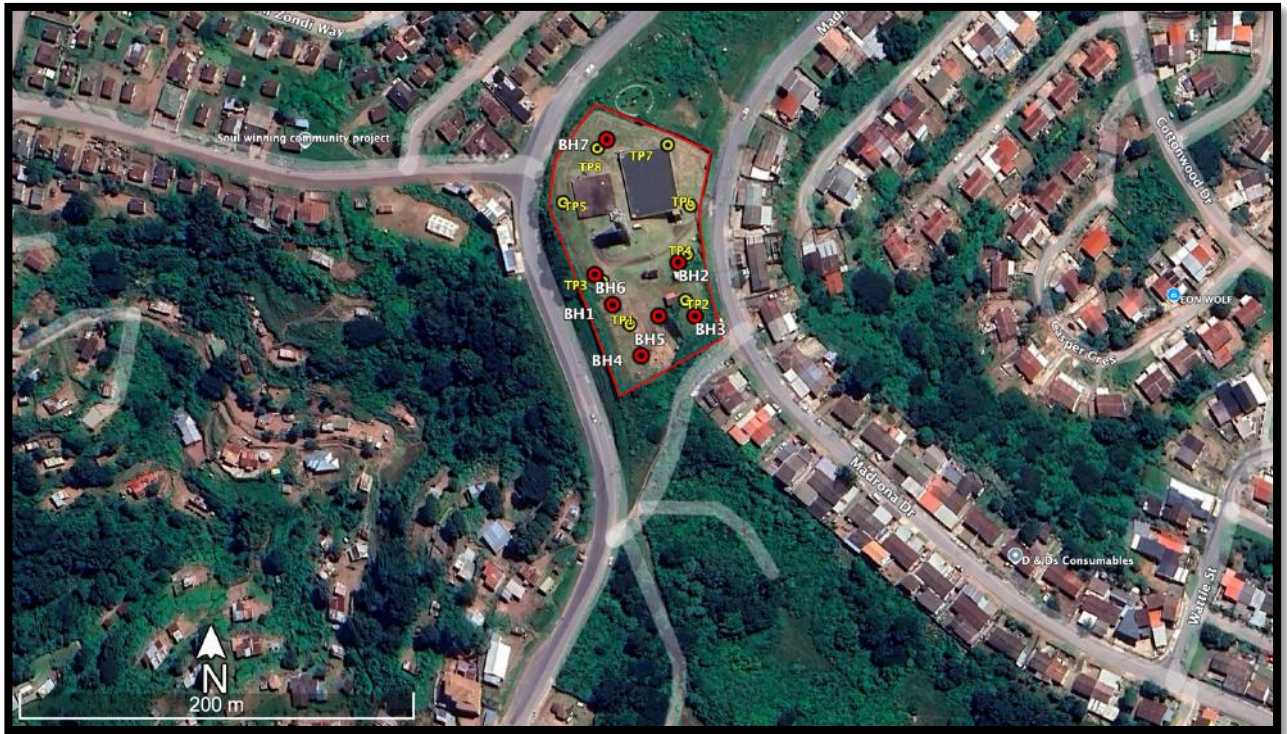
Figure 9: Showing the test pit (red dots) and borehole (yellow dots) position at the site.

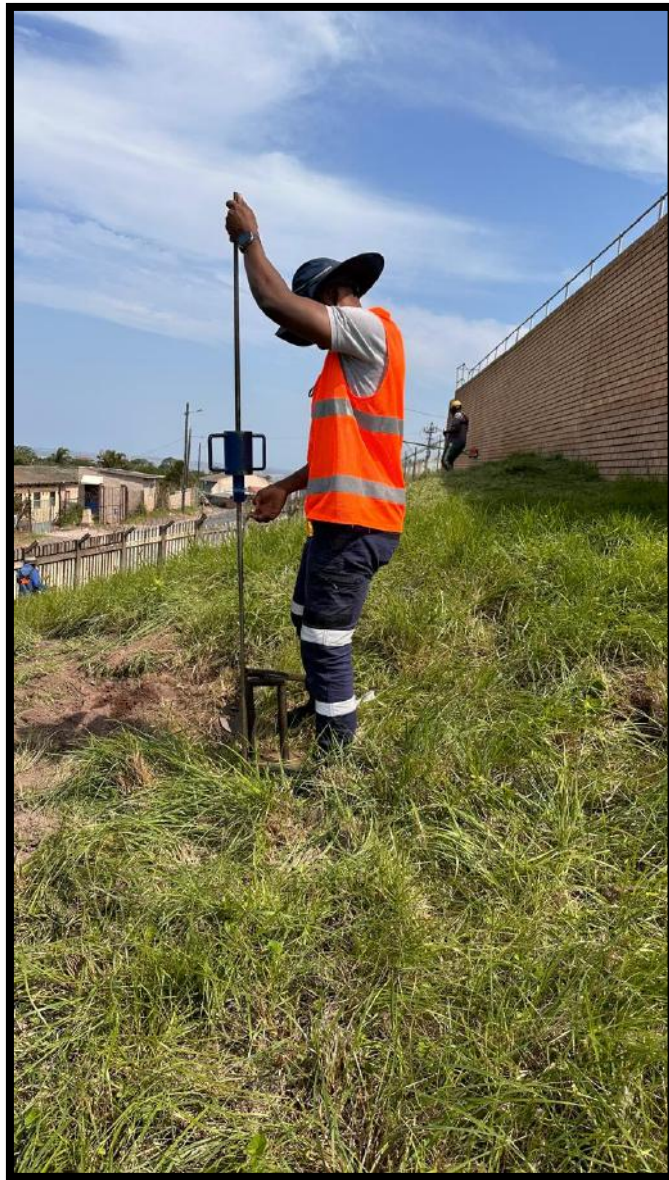
Figure 10: Showing the DCP testing undertaken at the site.

The in-situ field testing was conducted using Standard Penetration Test (SPT) with each borehole and Dynamic Cone Penetrometer (DCP) tests adjacent to each test pit. The SPTs and DCPs were conducted to determine the consistency of the in-situ material to the maximum depth of 3.5m. The N-values from the SPT results are presented in Appendix B and the DCP results are attached in Appendix D of this report. Figure 10 below shows a typical DCP undertaken adjacent to the excavated test pit on site

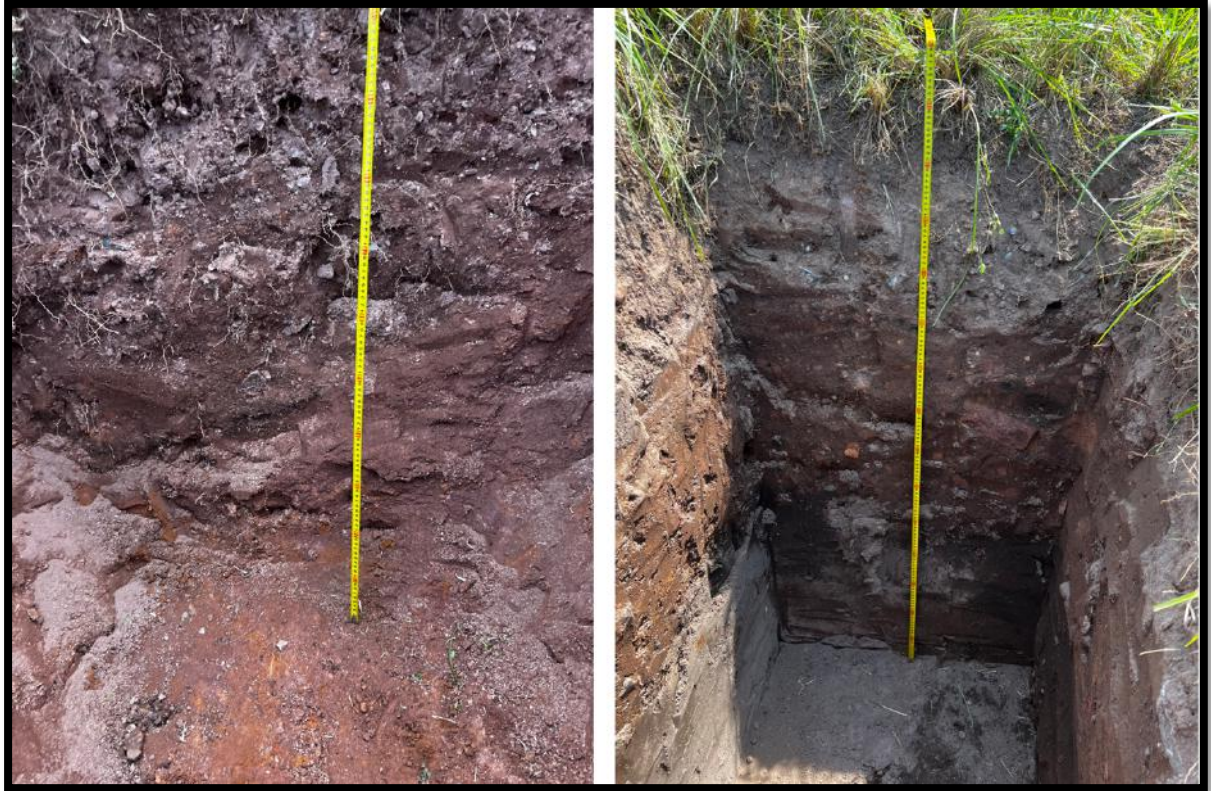
Figure 11: Showing the fill, transported, residual material, and sandstone exposed in the test pit at the site.

The fill layer was encountered in all the excavated test pits at the site, except for test pit 6, this layer was described as moist, light greyish brown and light purplish brown, gravelly silty sand with traces of soft sandstone fragments and root. The layer has a loose to medium-dense consistency.

The transported layer was removed in most of the test pits due to the previous earthworks activity. It was intercepted overlain by a fill layer at the site and was described as moist greyish brown, silty sand with roots. The consistency was profiled as being loose to medium dense. This layer has a thickness of 0.40m.
