NMISA Building 4W Clean room site assessment and recommendation report

1 INTRODUCTION

2.1. Assessing the condition of the cleanroom and laboratory

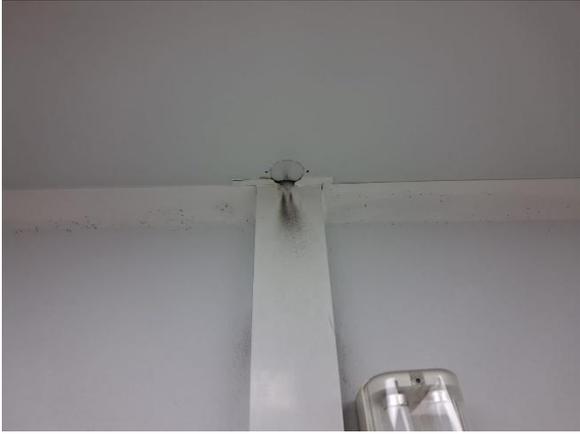
Figure 1: Air leakage on the electrical trunking

Figure 1: Air leakage on electrical trunking

Electrical trunking within a cleanroom must be airtight and flush with adjacent surfaces. Visible air leakage indicates a loss of pressure integrity, which compromises the controlled airflow regime required by ISO 14644. This condition also presents a contamination risk due to unfiltered air ingress and particulate accumulation.

All wall, ceiling, and service penetrations must be sealed flush using cleanroom-compatible sealants. Panel joints, especially in the ceiling, must be resealed to eliminate air leakage paths.

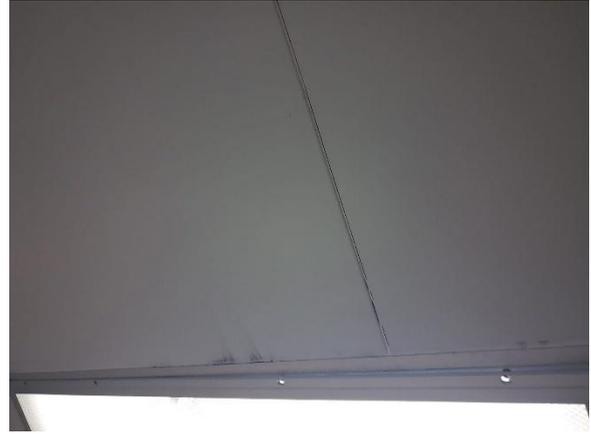
Figure 2: Seal around the lights not in good condition

Figure 2: Seal around light fittings not in acceptable condition

Light fittings in cleanrooms must be fully sealed and flush mounted. Deteriorated or incomplete sealing creates crevices where contaminants may accumulate and allows air leakage into the cleanroom envelope, violating GMP requirements for cleanable, sealed surfaces.

Light fixtures must be resealed to ensure they are airtight and flush with ceiling panels, eliminating air leakage and contamination traps.

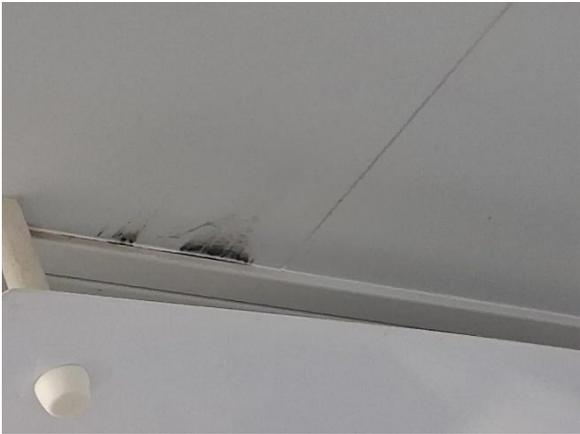
Figure 3: Seal on the supply air grilles showing signs of leakage

Figure 3: Seal on supply air grilles showing signs of leakage

Supply air grilles must be airtight to maintain unidirectional airflow and pressure cascades. Leakage at the perimeter of the grilles disrupts airflow patterns, reduces filtration effectiveness, and compromises ISO 14644 airflow performance criteria.

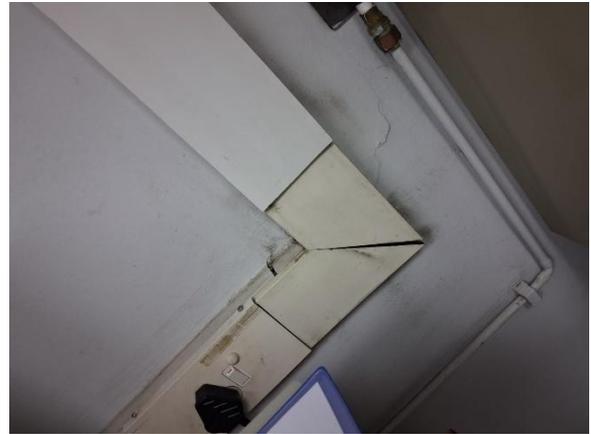
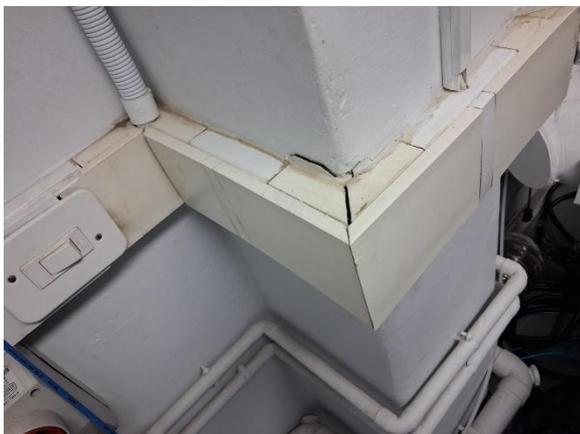
Figure 4: Electric trunk not in good condition

Figure 15: Poorly installed electrical trunking

Figure 4 & 15: Electrical trunking not in acceptable condition

Poorly installed or damaged electrical trunking introduces gaps, sharp edges, and unsealed joints. This condition prevents effective cleaning and creates contamination traps, which is not compliant with GMP cleanroom construction principles.

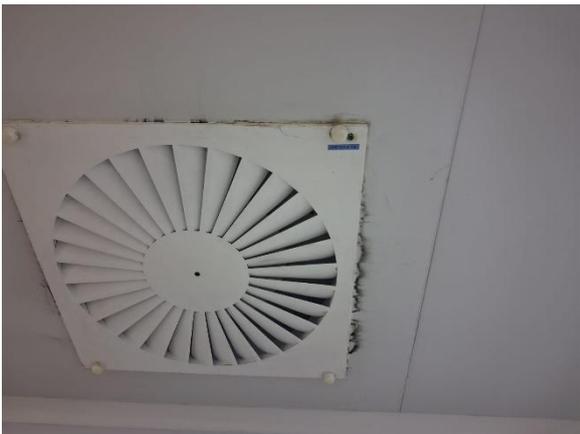
Figure 5: Supply grill inside cleanroom showing air leakage on the sides

Figure 5: Supply grille inside cleanroom showing air leakage on sides

Air leakage around supply grilles indicates improper sealing and installation. This results in uncontrolled airflow paths, turbulence, and potential particulate ingress, undermining cleanroom classification and pressure control requirements.

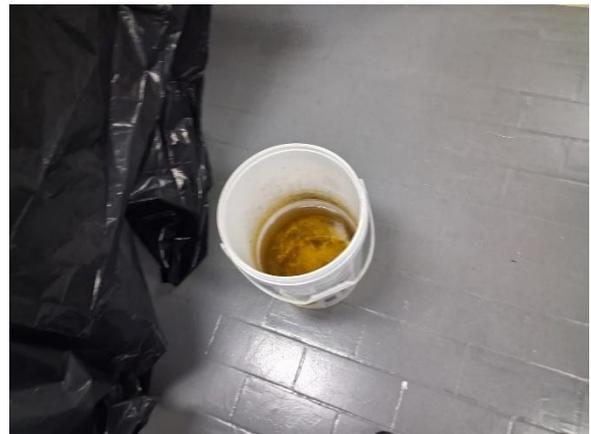
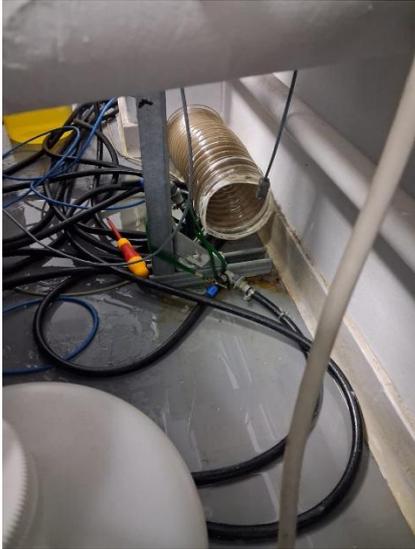
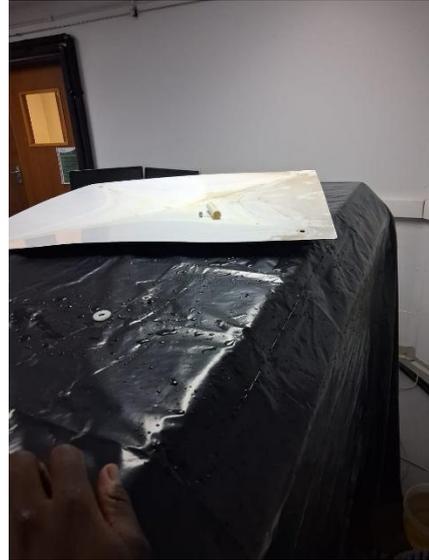
Figure 6: Water leaking into cleanroom from the supply air grilles

Figure 7: Water leaks on the lab floor leaking from the supply air diffuser

Figure 8: Water on the supply diffuser from the AHU

Figure 6, 7 & 8: Water leaking into cleanroom from supply air grilles

Standing water on the cleanroom floor presents a severe contamination and safety risk. Floors must remain dry, smooth, and cleanable. This condition indicates HVAC system deficiencies, likely due to condensation or poor sealing around the AHU as shown on figure 31.

Water ingress within a cleanroom is a critical non-conformance. Moisture promotes microbial growth, damages finishes, and compromises GMP hygiene requirements. Supply air systems must not introduce condensate or water into controlled areas.

All sources of water ingress identified at supply diffusers, AHU components, walls, and floors must be investigated and rectified. This may include correcting condensation issues, improve drainage, or repair leaking services. Alternatively, replacing the entire AHU will eliminate this water ingress into the facility.

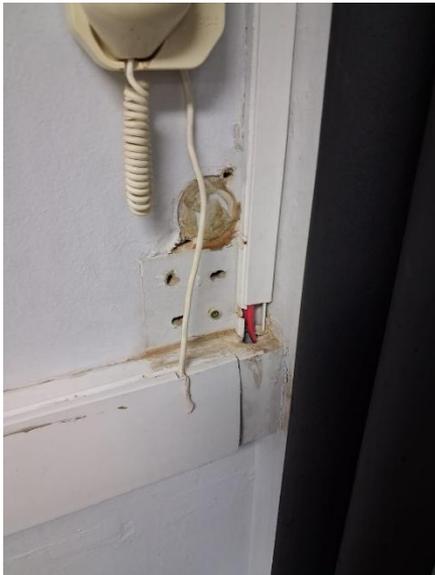
Figure 9: Wall not in good condition for cleanroom standard

Cleanroom walls must be smooth, impervious, non-shedding, and easy to clean. Damaged or uneven wall surfaces create contamination traps and are not compliant with ISO 14644 and GMP facility design requirements.

Walls, ceilings, and floors showing water damage must be repaired or replaced using materials suitable for cleanroom environments to prevent microbial growth and surface degradation.

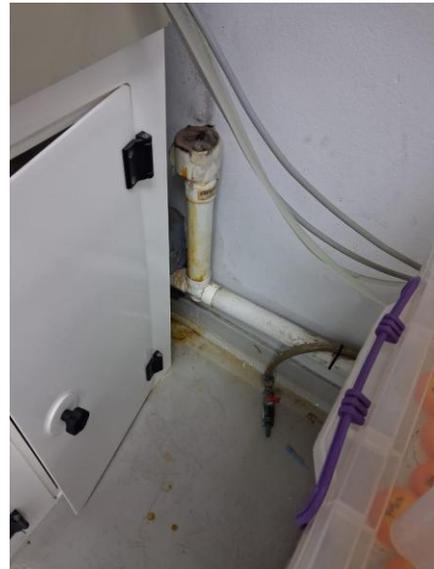
Figure 10: Plumbing not in good condition

Figure 10: Plumbing installation not in acceptable condition

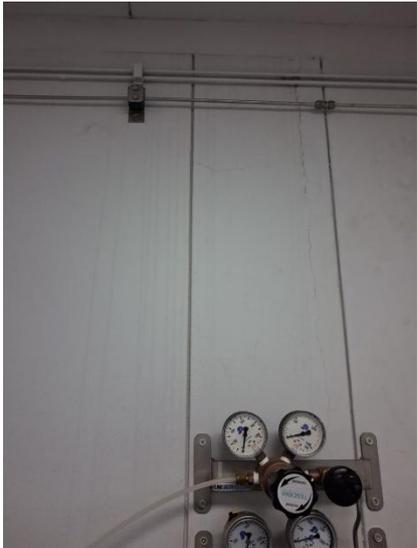
Figure 11: Water leakage marks on the wall

Figure 11: Water leakage marks on wall

Visible water staining indicates historical or ongoing moisture intrusion. This compromises surface integrity and increases the risk of microbial contamination, which is unacceptable under GMP environmental control requirements.

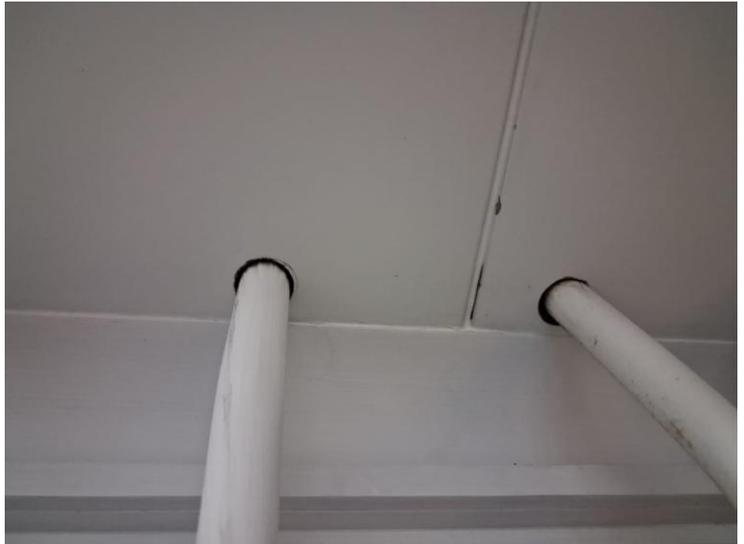
Figure 12: Pipes not sealed

All service penetrations through cleanroom walls must be fully sealed and flush. Unsealed pipe penetrations allow air leakage and particulate migration, compromising pressure integrity and cleanroom classification.

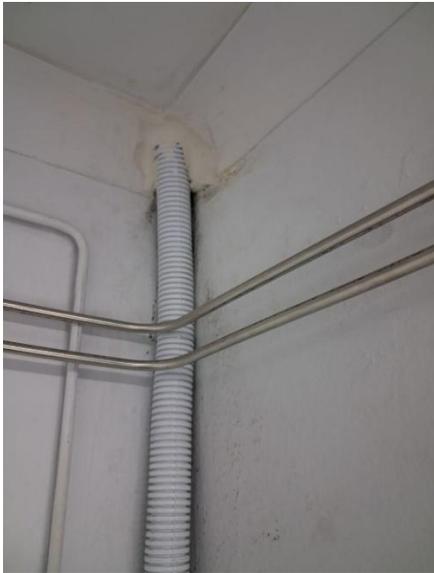
Figure 13: Electrical conduit not sealed properly

Improperly sealed electrical conduits create air leakage paths and contamination risks. GMP requires all conduits to be sealed to maintain pressure differentials and prevent dust accumulation.

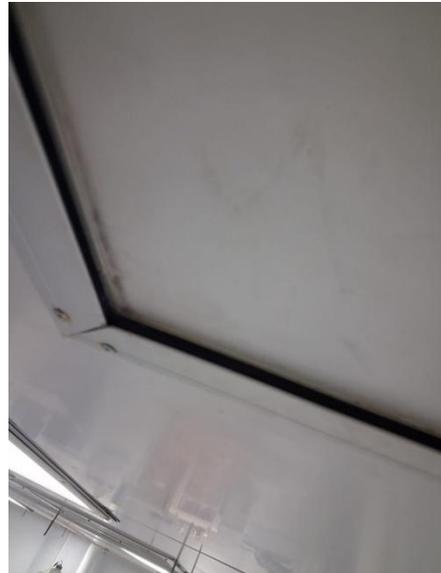
Figure 14: The trap door inside laboratory does not seal properly

Trap doors must maintain the same airtightness and surface integrity as surrounding ceilings. Poor sealing allows uncontrolled air leakage to the ceiling void, disrupting airflow control and pressure regimes.

All trap doors within the cleanroom ceiling must be fitted with proper gaskets and sealed to the same standard as the surrounding ceiling to prevent air leakage into the ceiling void. These must be installed with proper clamps for effective air tightness.

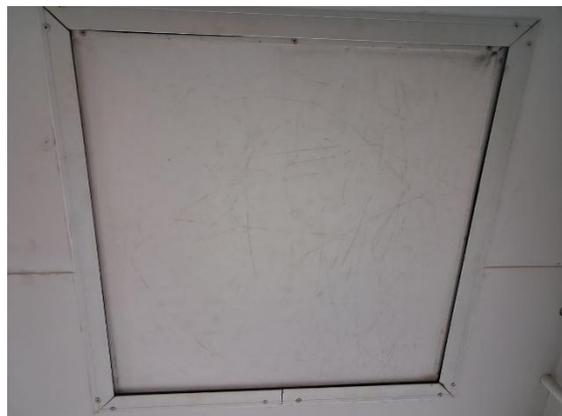
Figure 16: Air leakage on the trap doors to the ceiling void

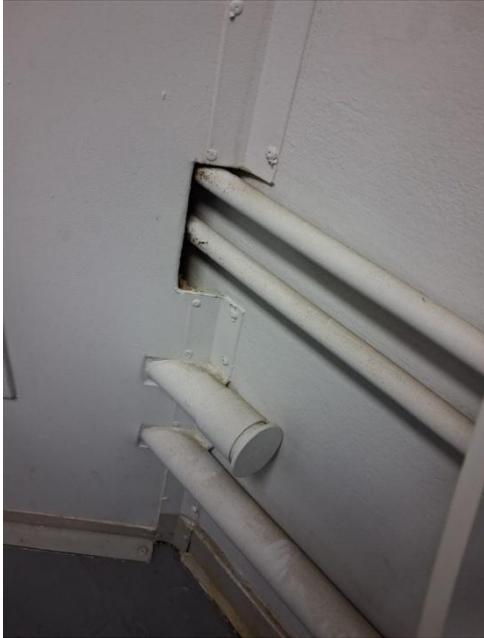
Figure 17: The wall not sealed

Unsealed wall joints and interfaces allow air leakage and particulate ingress. Cleanroom walls must be continuous, sealed, and impervious to ensure environmental control and compliance with GMP standards.

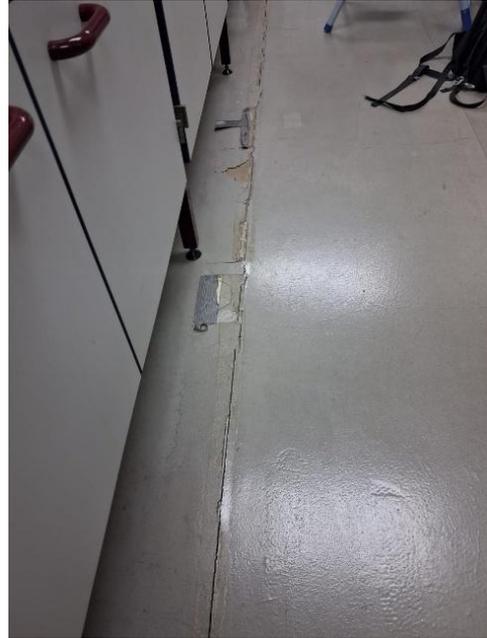
Figure 18: Floor has visible cracks

Figure 18: Floor with visible cracks

Cleanroom floors must be seamless, crack-free, and easy to clean. Cracks act as contamination traps and may harbour microorganisms, making this condition non-compliant with both ISO 14644 and GMP flooring requirements.

7.6. Repair or Replace Cracked Flooring

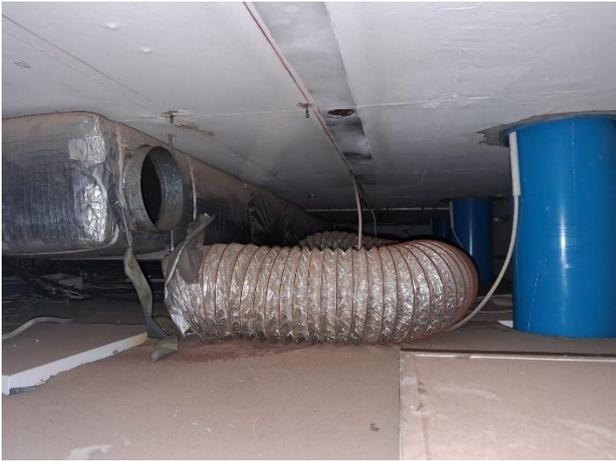
Figure 19: Supply air ducting disconnected from the main HVAC system

Figure 19: Flexible supply air ducting disconnected from the main HVAC system

During the site inspection, it was observed that a section of the supply air ducting was disconnected from the main HVAC system, this is due to the material of the duct (flexible). This condition resulted in uncontrolled air delivery and reduced airflow to the cleanroom, adversely affecting air change rates, pressure differentials, and overall filtration performance, with direct implications for cleanroom classification and compliance with ISO 14644. On the final day of the assessment, the disconnected duct section was reconnected by our technician to improve airflow distribution. Following this intervention, a slight increase in the measured air change rates and airflows was observed.

7.3. Replace Flexible Duct In the supply air system

It is recommended that all flexible ducting installed within the supply air system be removed and replaced with rigid, cleanroom-appropriate ductwork. Flexible ducting is prone to air leakage, pressure losses, internal contamination, and difficulty in effective cleaning, which can adversely affect airflow distribution, filtration performance, and pressure control.

Replacement ductwork should be constructed from smooth, airtight, and durable materials suitable for cleanroom applications, with all joints properly sealed and supported in accordance with good engineering practice. Implementing rigid ducting will improve airflow consistency, reduce leakage, enhance cleanability, and support stable pressure cascade control, thereby contributing to compliance with ISO 14644 and GMP cleanroom requirements.

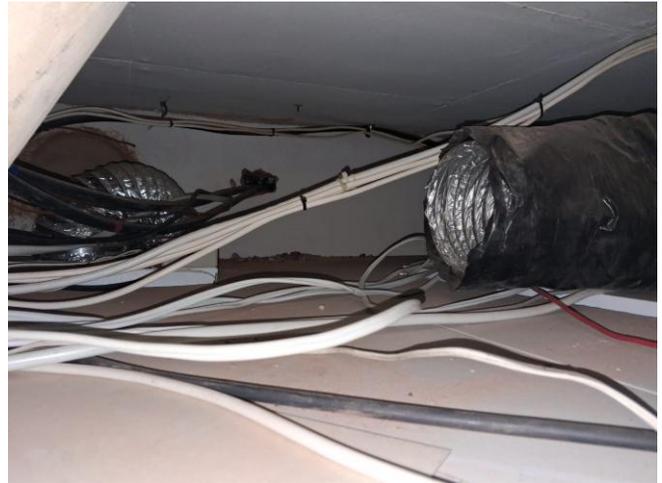
Figure 20: Wires in the ceiling void are unsafe

Figure 20: Unsafe wiring in the ceiling void

Exposed and unsecured wiring presents both a safety hazard and a contamination risk. GMP requires

services to be safely installed, protected, and routed to prevent dust accumulation and accidental damage.

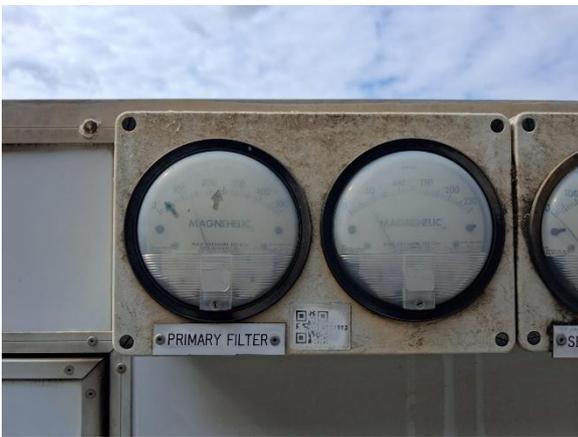
Figure 21: Unclear primary filter gauge

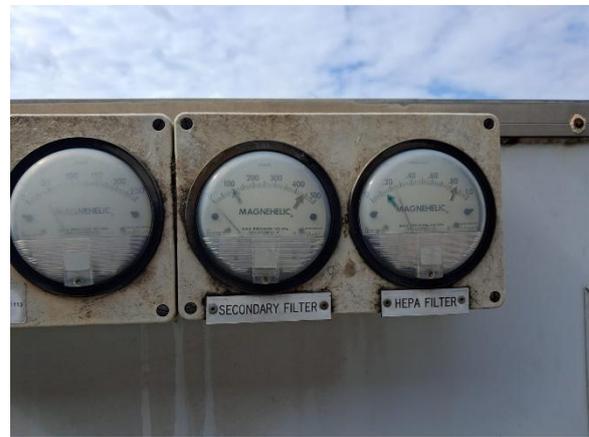
Figure 22: Unclear secondary and HEPA filter gauges

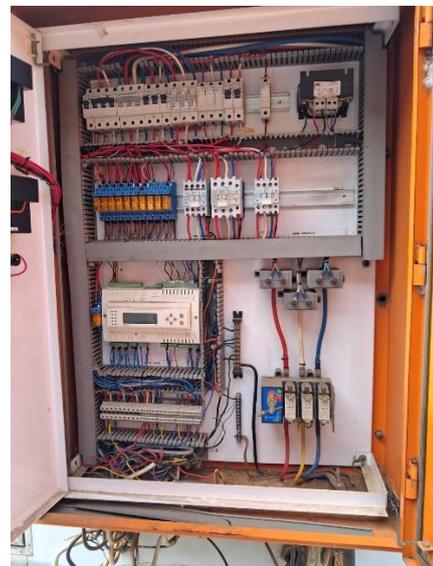
Figure 24: Control panel

Control panels are required to provide clear operational status indication and functional alarms to ensure effective control of cleanroom environmental conditions in accordance with ISO 14644. During the inspection, the control panel was found to be non-functional. The associated distribution box was observed to be in poor condition, with unsafe and poorly arranged wiring, presenting both operational and safety concerns. In addition, the voltage and amperage meters were not functioning, preventing effective monitoring of electrical and system performance. These deficiencies significantly reduce the ability to maintain and verify controlled environmental conditions within the cleanroom.

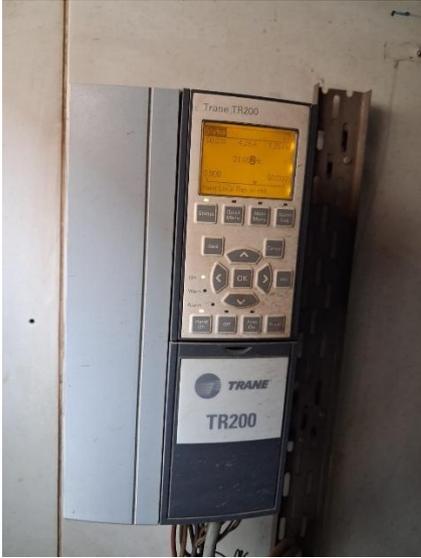
Figure 25: VSD is running on manual

Operation of the Variable Speed Drive (VSD) in manual mode prevents automatic control of airflow, pressure differentials, and air change rates. GMP and ISO 14644 require stable, controlled operation with monitored and validated setpoints. At the time of inspection, the VSD was operating in manual mode at approximately 30% output, limiting the system's ability to maintain consistent airflow performance and controlled environmental conditions within the cleanroom.

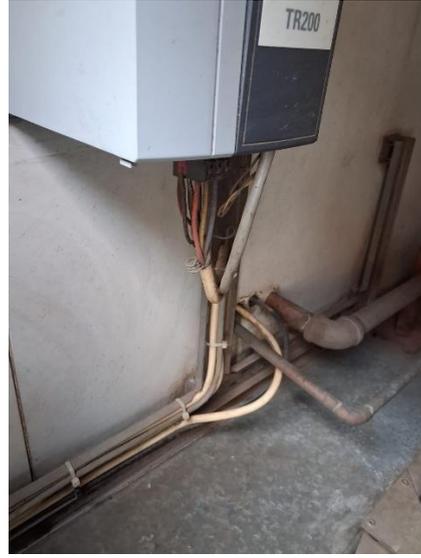
Figure 26: Unsafe and exposed wiring inside the AHU

Exposed wiring within the AHU presents a risk of electrical failure, contamination, and maintenance-related damage. All internal wiring must be secured, enclosed, and protected in accordance with good engineering practice.

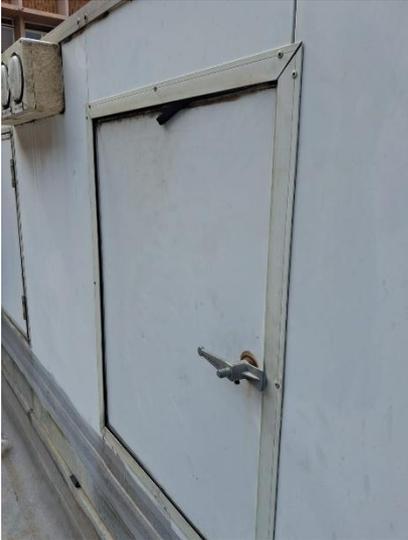
Figure 27: AHU doors showing leakage

Figure 28: AHU inside penetrations not sealed

Figure 27 and 28: AHU doors showing air leakage

AHU casings are required to be airtight to prevent bypass air and to maintain filtration integrity. Air leakage was observed at the AHU access doors, reducing system efficiency and allowing unfiltered air to enter the supply air stream. In addition, unsealed penetrations were identified within the AHU casing, providing further pathways for air leakage and contamination. These conditions compromise pressure control and filtration effectiveness, in violation of ISO 14644 system integrity requirements. Furthermore, visible water marks were noted on and around the access doors, indicating previous or ongoing water ingress, which presents a risk of corrosion, microbial growth, and degradation of internal components, further impacting HVAC performance and cleanroom compliance.

Based on the results of the worst-case testing, it is recommended that the existing AHU be replaced with a suitably sized and controlled unit designed to meet the full supply air demand under maximum exhaust loading. The replacement AHU shall be capable of maintaining stable airflow rates and pressure differentials in accordance with ISO 14644 and GMP requirements during all operating conditions.

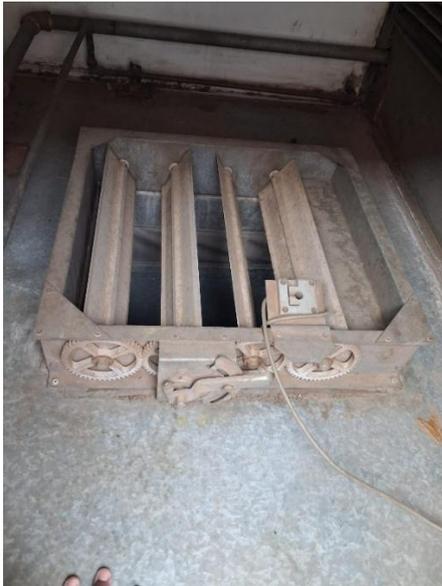
Figure 29: Return damper inside the AHU shows signs of rust

Figure 29: Return air damper inside AHU showing signs of rust

Rust indicates corrosion and material degradation. Corroded components can shed particulates into the air stream and are not acceptable for GMP-controlled environments where cleanable, corrosion-resistant materials are required.

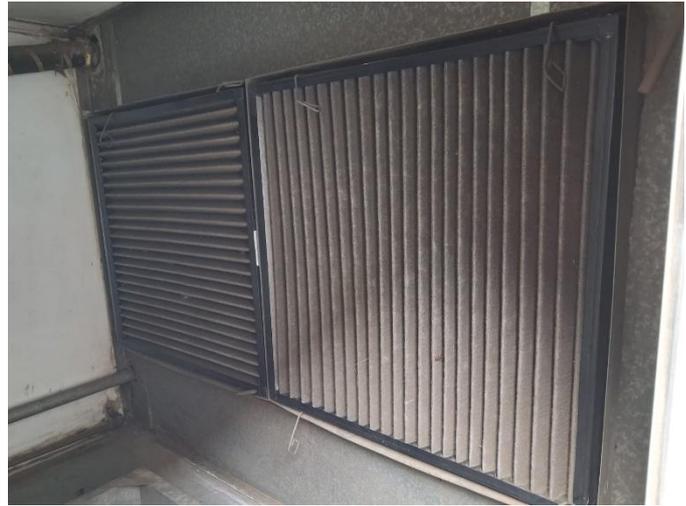
Figure 30: Worn out gasket around the Primary filter frame

Figure 30: Worn gasket around primary filter frame

A damaged or worn gasket allows air bypass around the filter, reducing filtration efficiency. This directly compromises HEPA filtration integrity and cleanroom air quality.

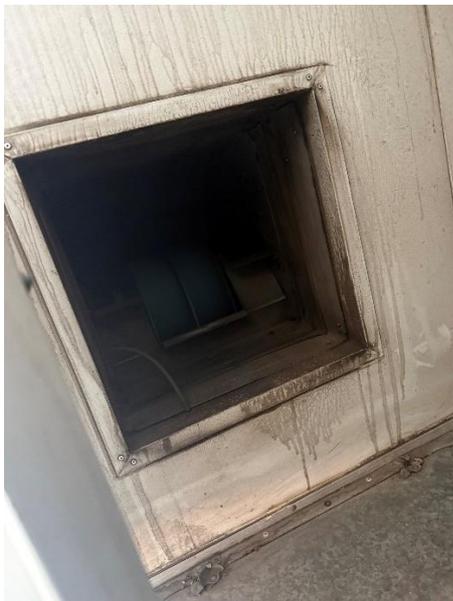
Figure 31: Water mark leakages in the AHU

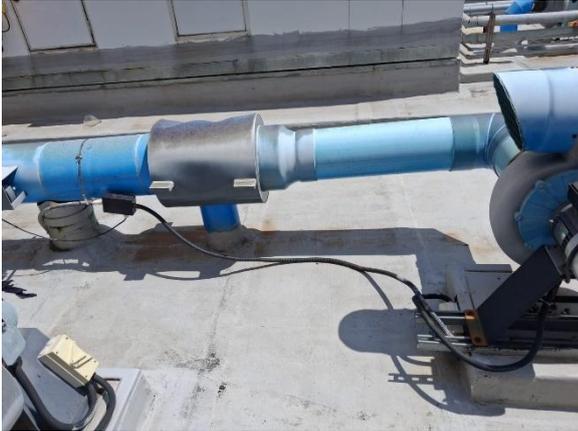
PVC ducting is generally not suitable for GMP cleanroom HVAC systems due to its potential to degrade, accumulate static, and be difficult to clean. Ductwork should be constructed from smooth, durable, cleanroom-compatible materials.

Figure 32: PVC ducting

Figure 31: PVC ducting used for extraction

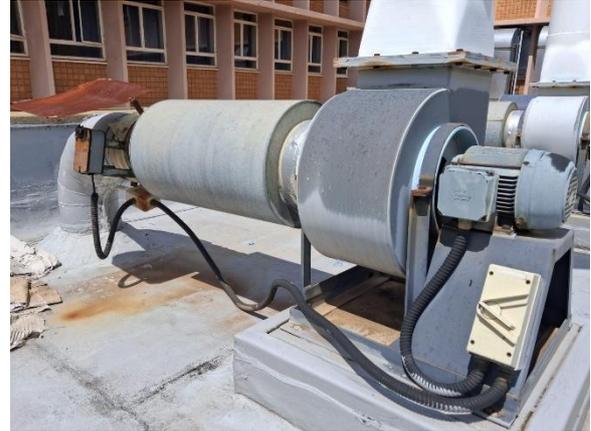
Poorly installed fan housing and exposed wiring increase the risk of mechanical failure and contamination. All components must be securely mounted, enclosed, and designed for cleanroom service conditions.

Figure 33: fan housing and electrical wiring

Unsafe wiring and inadequately protected fan components present safety risks and increase contamination potential. Extraction systems must be robust, sealed, and compliant with good engineering and GMP practices.

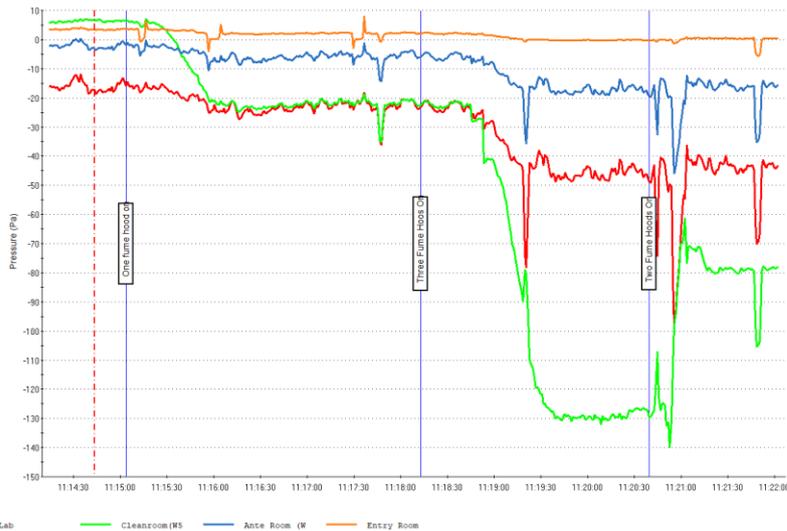
Figure 35: Graph showing the pressures with all fume hoods not in operation

At the start of the monitoring period, all the fume hoods were switched off, with the Entry Room remaining slightly positive, the Ante Room operating at a moderate negative pressure, and the Cleanroom and Laboratory operating at more negative pressures relative to adjacent spaces. Minor fluctuations are observed, consistent with normal operational variability.

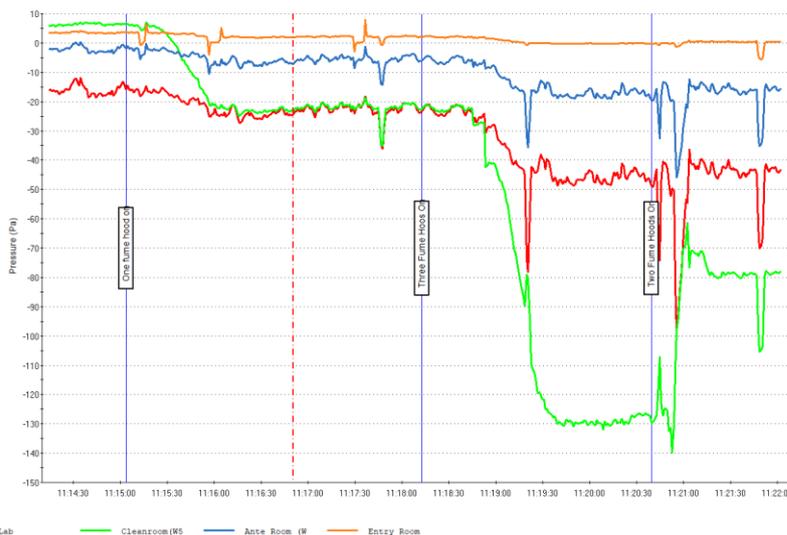
Figure 36: Graph showing the pressures with one fume hood running

When a single fume hood is switched on, a small but noticeable change in room pressures is observed. The Laboratory experiences an increase in negative pressure, while the Cleanroom shows a negative pressure. The Ante Room pressure also decreases slightly, indicating that the additional exhaust demand is being drawn from adjacent spaces. Although the general pressure cascade direction is largely maintained, the reduction in cleanroom pressurisation indicates a weakening of pressure control rather than an acceptable operating condition.

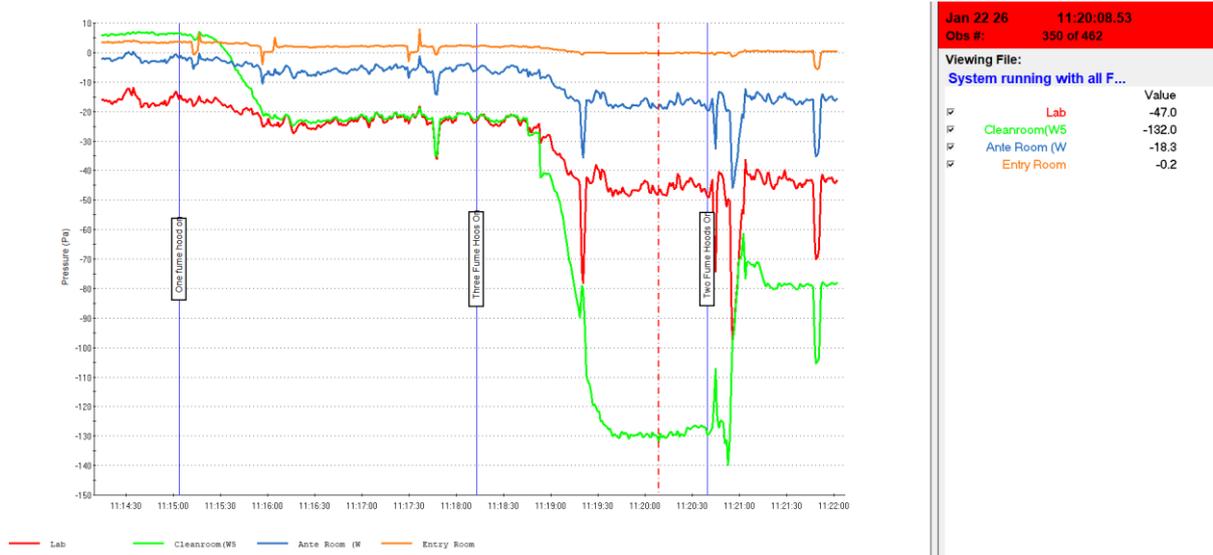
Figure 37: Graph showing the pressures with two fume hoods running

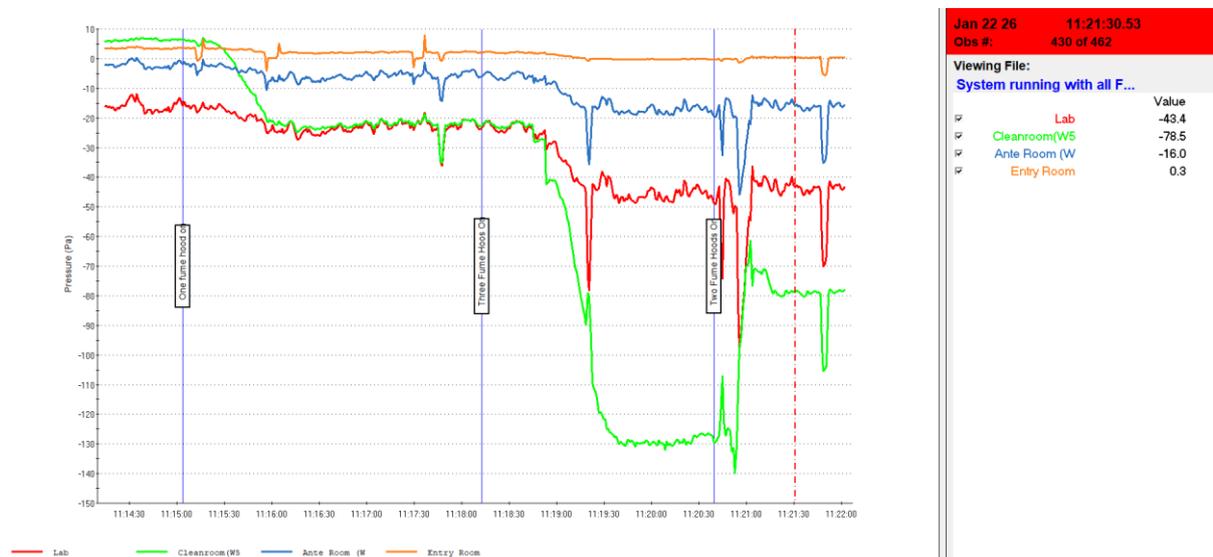
The most severe pressure fluctuations were observed when three fume hoods were operated simultaneously. During this condition, rapid pressure drops and recoveries occurred, indicating instability within the HVAC control system and a limited ability to respond dynamically to increased exhaust demand.

Figure 38: Graph showing the pressures with three fume hoods running

After observing the pressures when the 3 fume hoods are running, it was noted that this scenario resulted in a significant drop in pressure in the cleanroom, we therefore switched off one fume hood to observe the impact this would have on the system. After switching off one fume hood to have 2 fume hoods running, we noted a slight increase in pressure which still results in a negative pressure state of the cleanroom. This behaviour indicates that the combined exhaust demand from the fume hoods exceeds the available supply air capacity, resulting in excessive depressurisation of the controlled spaces. The Cleanroom becoming increasingly negative represents a deviation from the

It is recommended that variable exhaust control be implemented on the fume hood exhaust system to regulate extraction airflow in response to actual demand. The pressure trend observed during the assessment demonstrated that fixed exhaust volumes, particularly during simultaneous operation of multiple fume hoods, result in excessive depressurisation of the Cleanroom and Laboratory, indicating a lack of dynamic control.

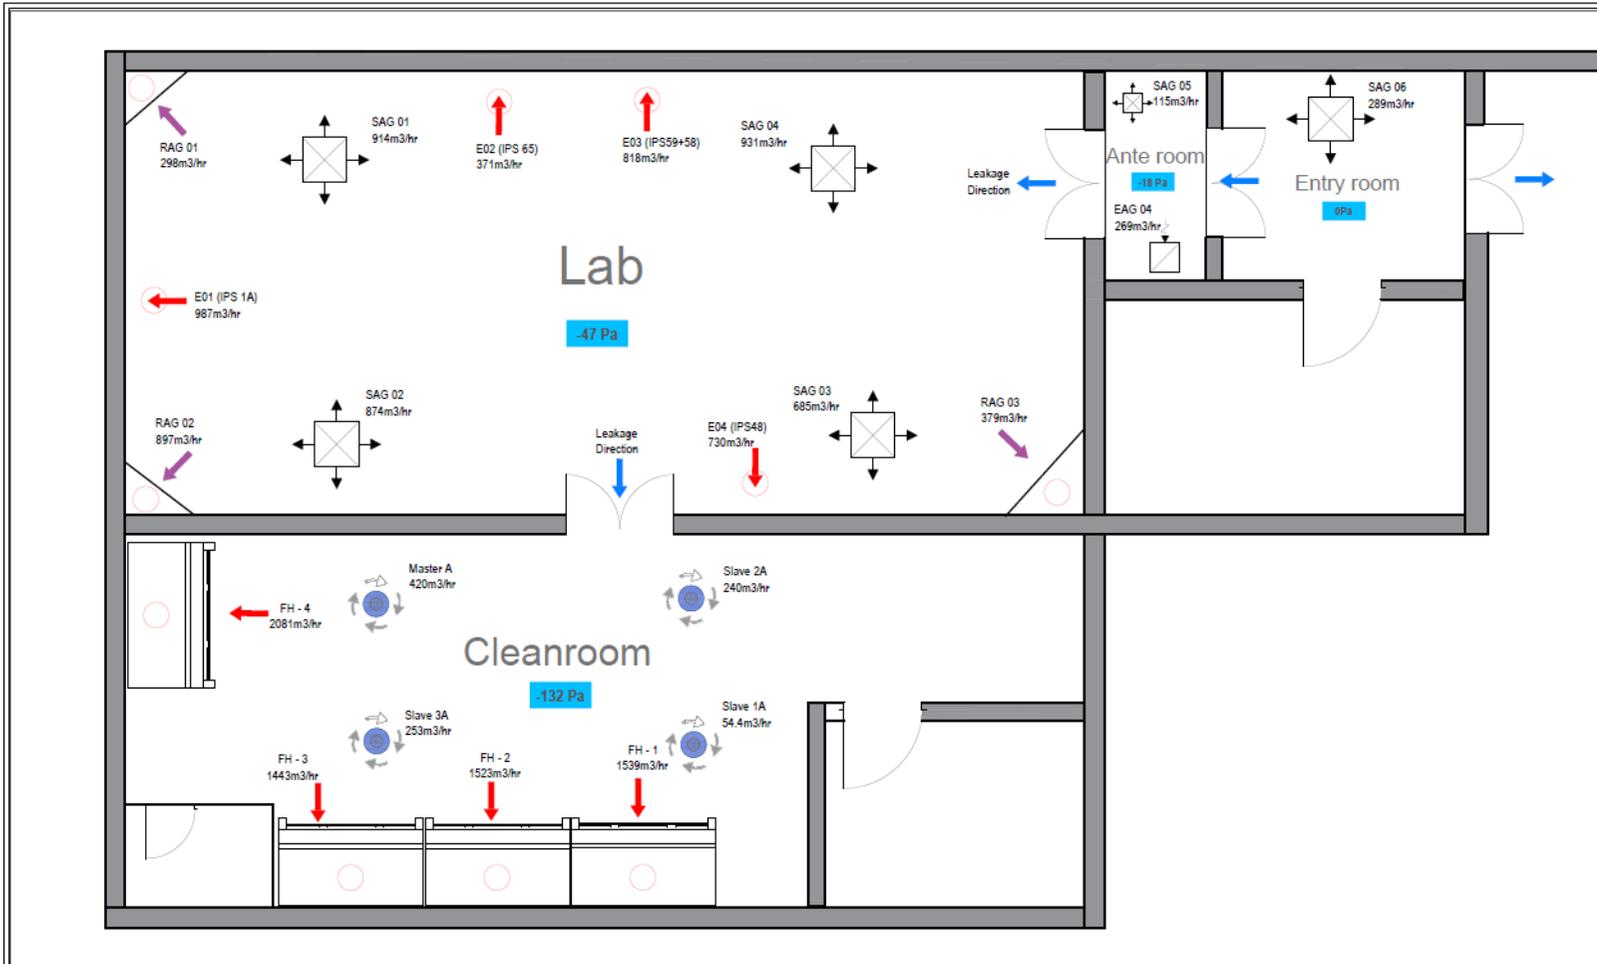
Airflow Schematic Current Operating Condition

The above airflow schematic illustrates the current operating condition of the cleanroom, laboratory, ante room, and entry room as assessed during the site inspection and performance testing. The schematic presents the measured supply, return, and exhaust airflow rates, together with the corresponding room pressures recorded **while fume hoods FH-1, FH-3, and FH-4 were in operation**.

The Cleanroom is served by multiple fume hoods, and the combined exhaust demand from **fume hoods FH-1, FH-3, and FH-4** exceeds the supply air delivered to the space. This results in severe depressurisation of the Cleanroom, as evidenced by the measured room pressure and the airflow leakage paths indicated at door interfaces and envelope penetrations. Airflow arrows on the schematic confirm that air is being drawn from adjacent areas, including the Laboratory and Ante Room, into the Cleanroom to compensate for the shortfall in supply air.

The Laboratory is similarly affected, operating under negative pressure due to a combination of exhaust airflows and insufficient supply compensation. Although supply and return air grilles are present, the measured airflow rates are inadequate to counterbalance the exhaust demand and envelope leakage, resulting in uncontrolled airflow paths and pressure instability.

Overall, the airflow schematic demonstrates that, under the tested operating condition with fume hoods FH-1, FH-3, and FH-4 in operation, the existing HVAC system is unable to maintain stable airflow balance and pressure differentials. This finding directly supports the conclusions drawn from the pressure trend analysis and confirms the need for system upgrades to achieve compliance with ISO 14644 and GMP requirements.
