Scope of Work

Title:	Scope of Work for the Dredging of Document Identifier:	15ENG GEN-2317
	the Dams at Tutuka Power Station

Area of Applicability: Tutuka Power Station

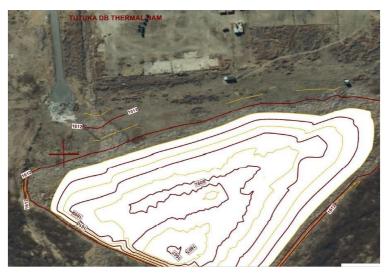
Figure 2: DB Thermal Dam Survey

The Tutuka Rain Readiness report, which was compiled in 2014 by Jeffares and Green, stated that the DB Dam Capacity was $99141.7m^3$ after a bathymetric survey was conducted. Figure 2 illustrates the DB Thermal dam survey showing the contours, which formed part of the Tutuka Rain Readiness Report.

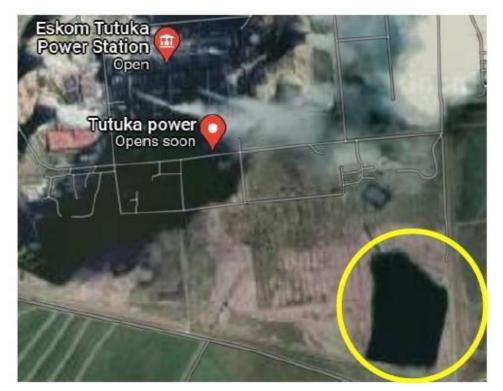
Figure 4: Steinmuller Water Dam

The Steinmuller Water dam is located within the perimeter of the power station at the southeast of the station [Figure 4]. Furthermore, the water recovery system is composed of two electric pumps. Diesel pumps are used when required under emergency circumstances to lower the dam level to prevent overflowing. Measuring/Stilling wells have been constructed which will aid in monitoring the dam level ultimately promoting healthy dam management. An assessment of Steinmuller Dam integrity and water quality as well as a bathymetric survey were conducted in October 2019. The original capacity of the dam was 204 857 m³ and according to the bathymetric survey conducted in 2019 the dam capacity was 182 835 m³ [Figure 5]. This proves that there is siltation occurring at the dam and dredging will be required. Furthermore, over 55% of the dam has been covered in dam weed and reeds which has limited the capacity of the dam. The dam bed has been silted up over the years which has contributed to the overall decrease in capacity of the dam. It would be in the interest of the Power station to increase the capacity of the dam by dredging the dam and removing the current dam weed and reed beds. The dam is also a catchment of any overflowing water from cooling tower 4 & 5, rainwater, mine transfer house (wet coal and washing effluent), coal settling ponds overflow and water leaks from the dust suppression pipe to ash disposal to name few.

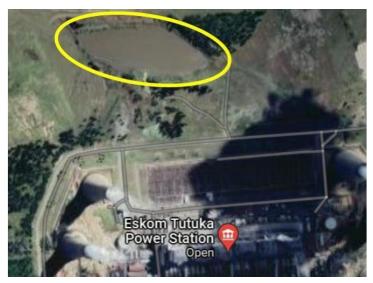
Figure 6: North Clean Dam

The North Clean Dam is located to the north side of the station [Figure 6]. The dam receives storm water runoff from areas adjacent to the Power Station. The original capacity of the dam was 191 400 m³. The dam is also a catchment of any overflowing water from cooling tower 3 & 6 and rainwater. There is currently no permanent recovery infrastructure at the Dam. Furthermore, the water recovery system is composed of two electric pumps. Diesel pumps are used when required under emergency circumstances to lower the dam level to prevent overflowing. Measuring/Stilling well has been constructed which will aid in monitoring the dam level ultimately promoting healthy dam management. A bathymetric survey of the dam was conducted in November 2019 and the dam volume below the dam waterline was 38767 m³.

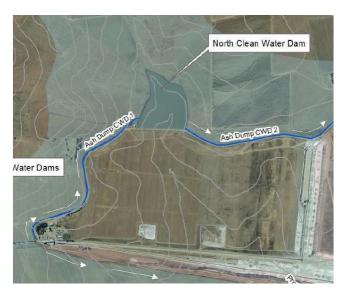
Figure 13: Ash Dump North Clean Water Dam

The Ash Dump North Clean Water Dam is located north of the ash dump and its capacity is 362368m³. A bathymetric and lidar survey of the dam was conducted in August 2020 and its capacity at that time was found to be 331237.1m³. Inflow into the dam is from the Ash Dump Clean Water Diversion channel and from surface run from the adjacent catchment areas. Figure 14 displays the Ash Dump North Clean Water Dam.
