MATERIALS INVESTIGATION

ESKOM TUTUKA POWER STATION- SCRAPYARD AREA

Client: RESONANT ENVIRONMENTAL

Job No: 25059a

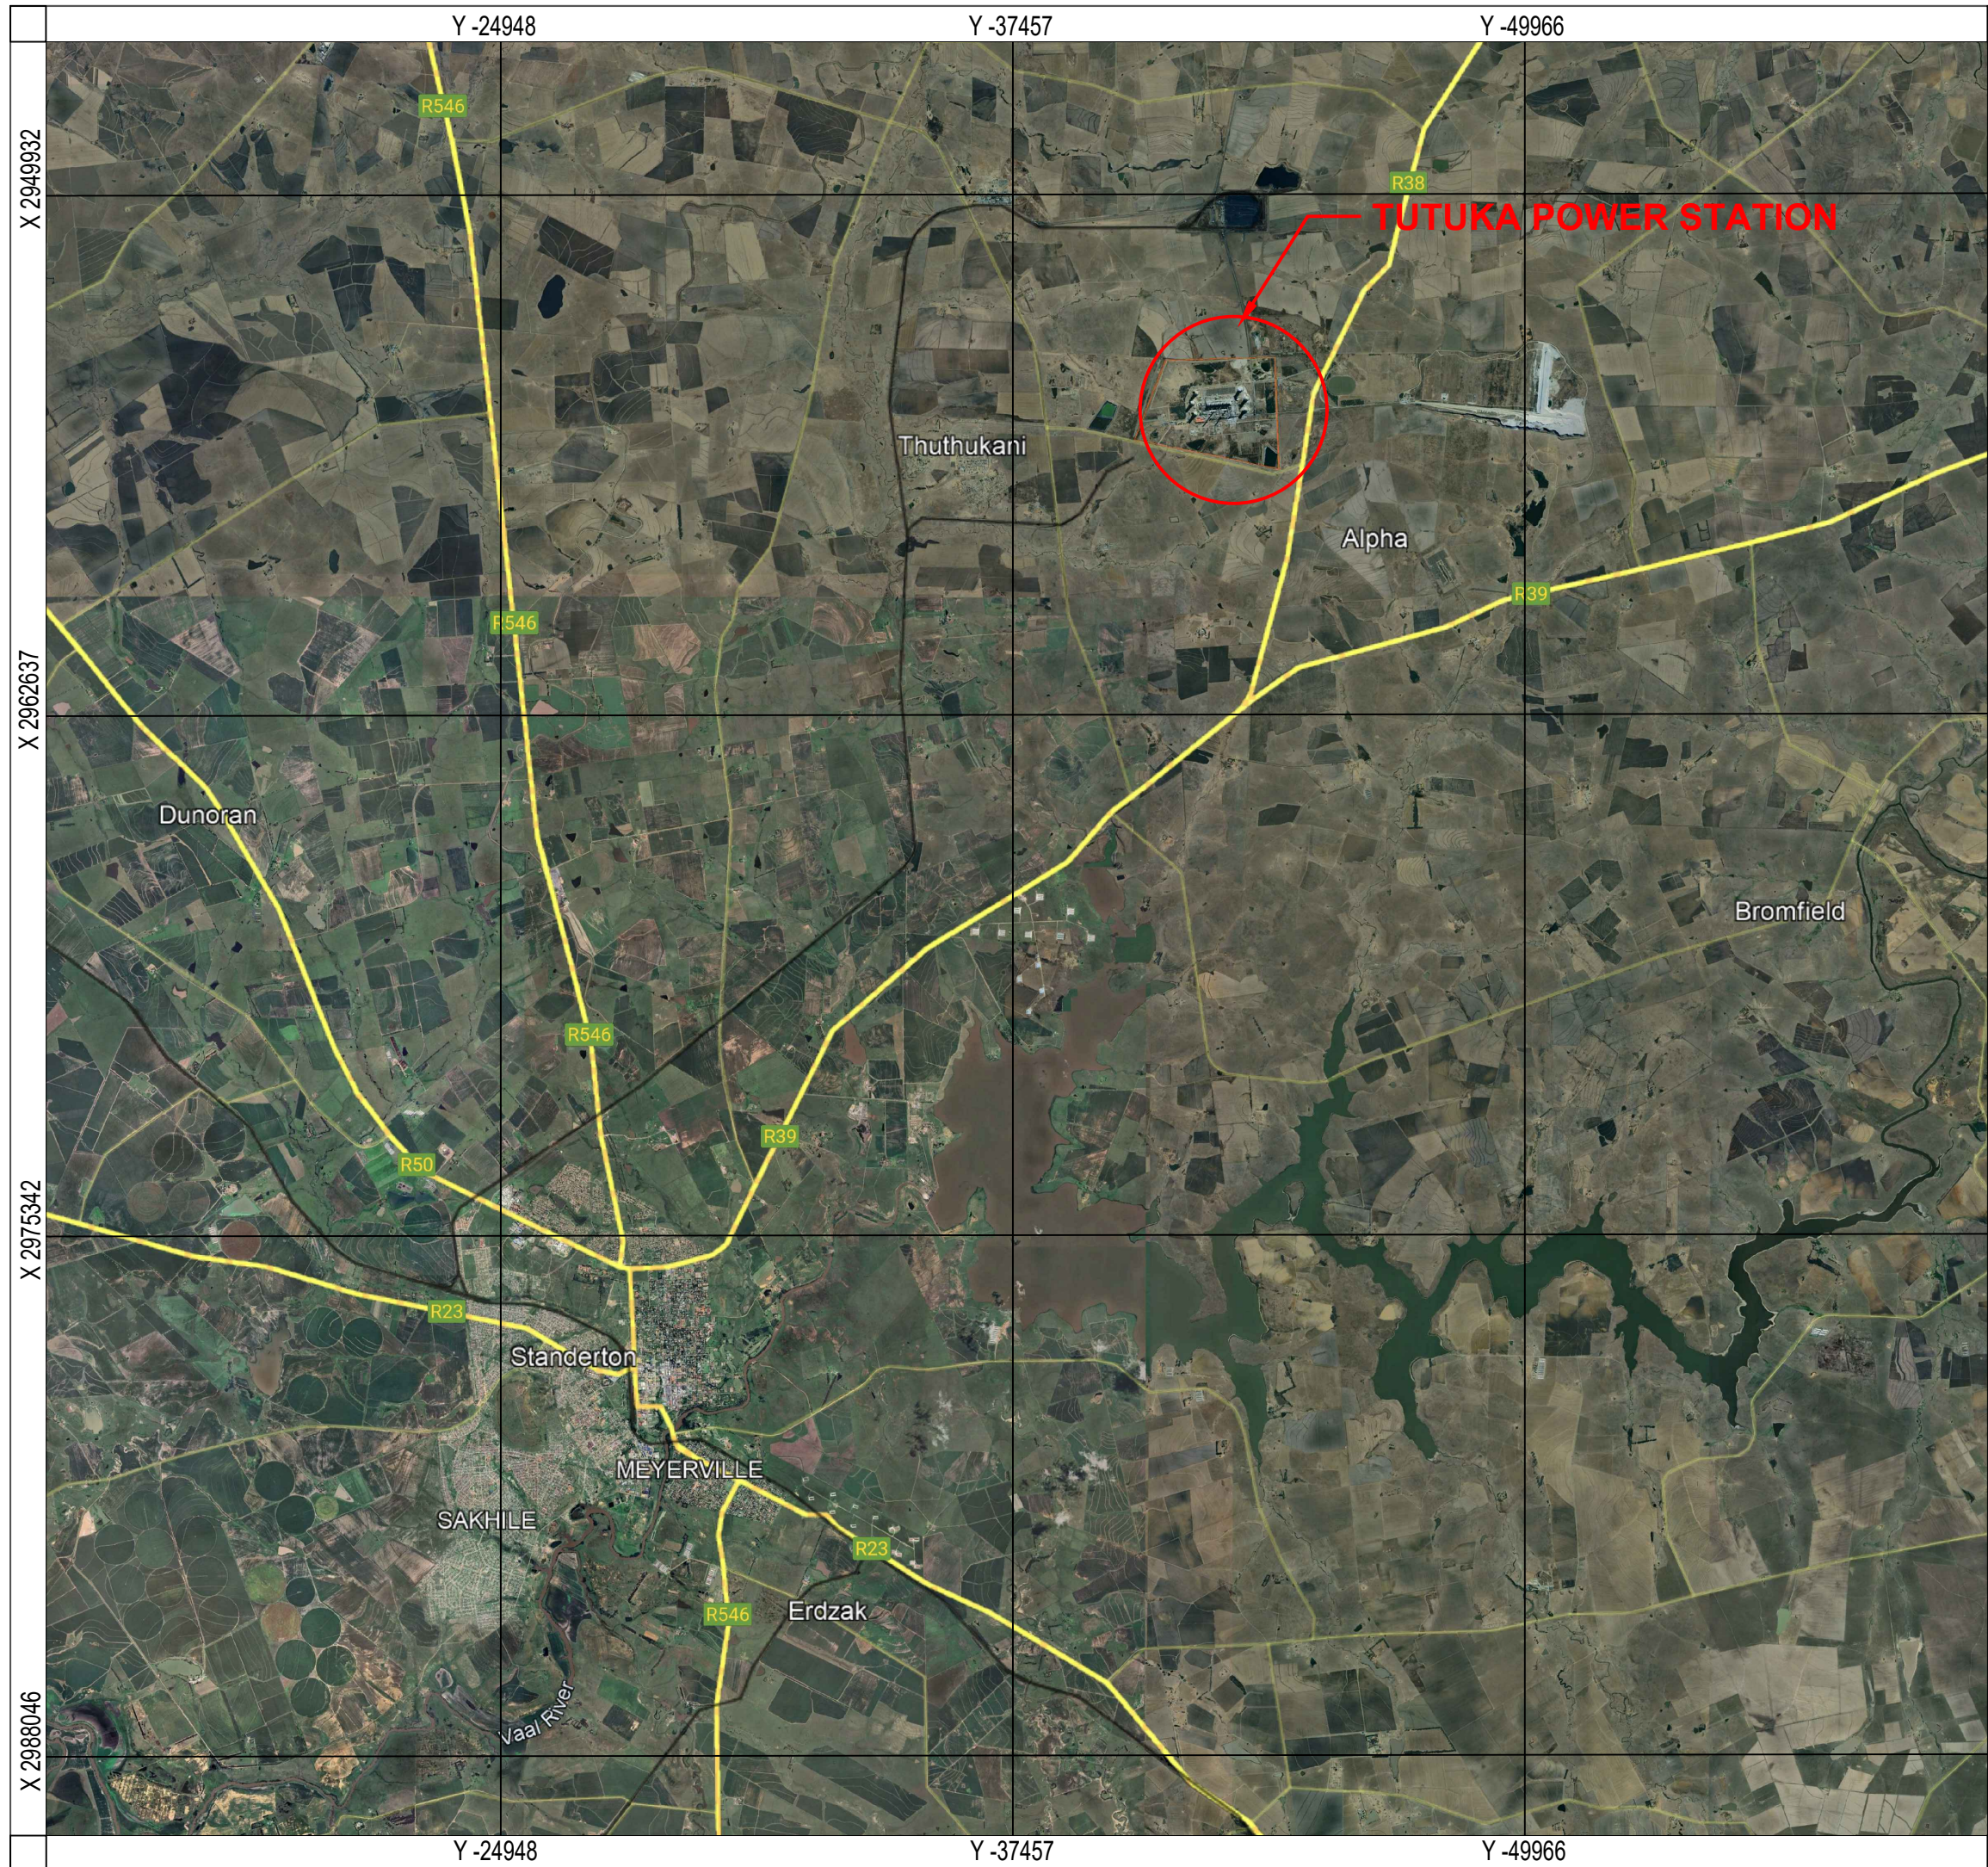
Site Locality
 Extract of 1:100 Google Earth
 Aerial Photograph

The test pit locations are indicated on the site layout plan attached as appendix 1, whilst the detailed soil profiles and site photographs are attached as appendix 4 and 6 respectively.

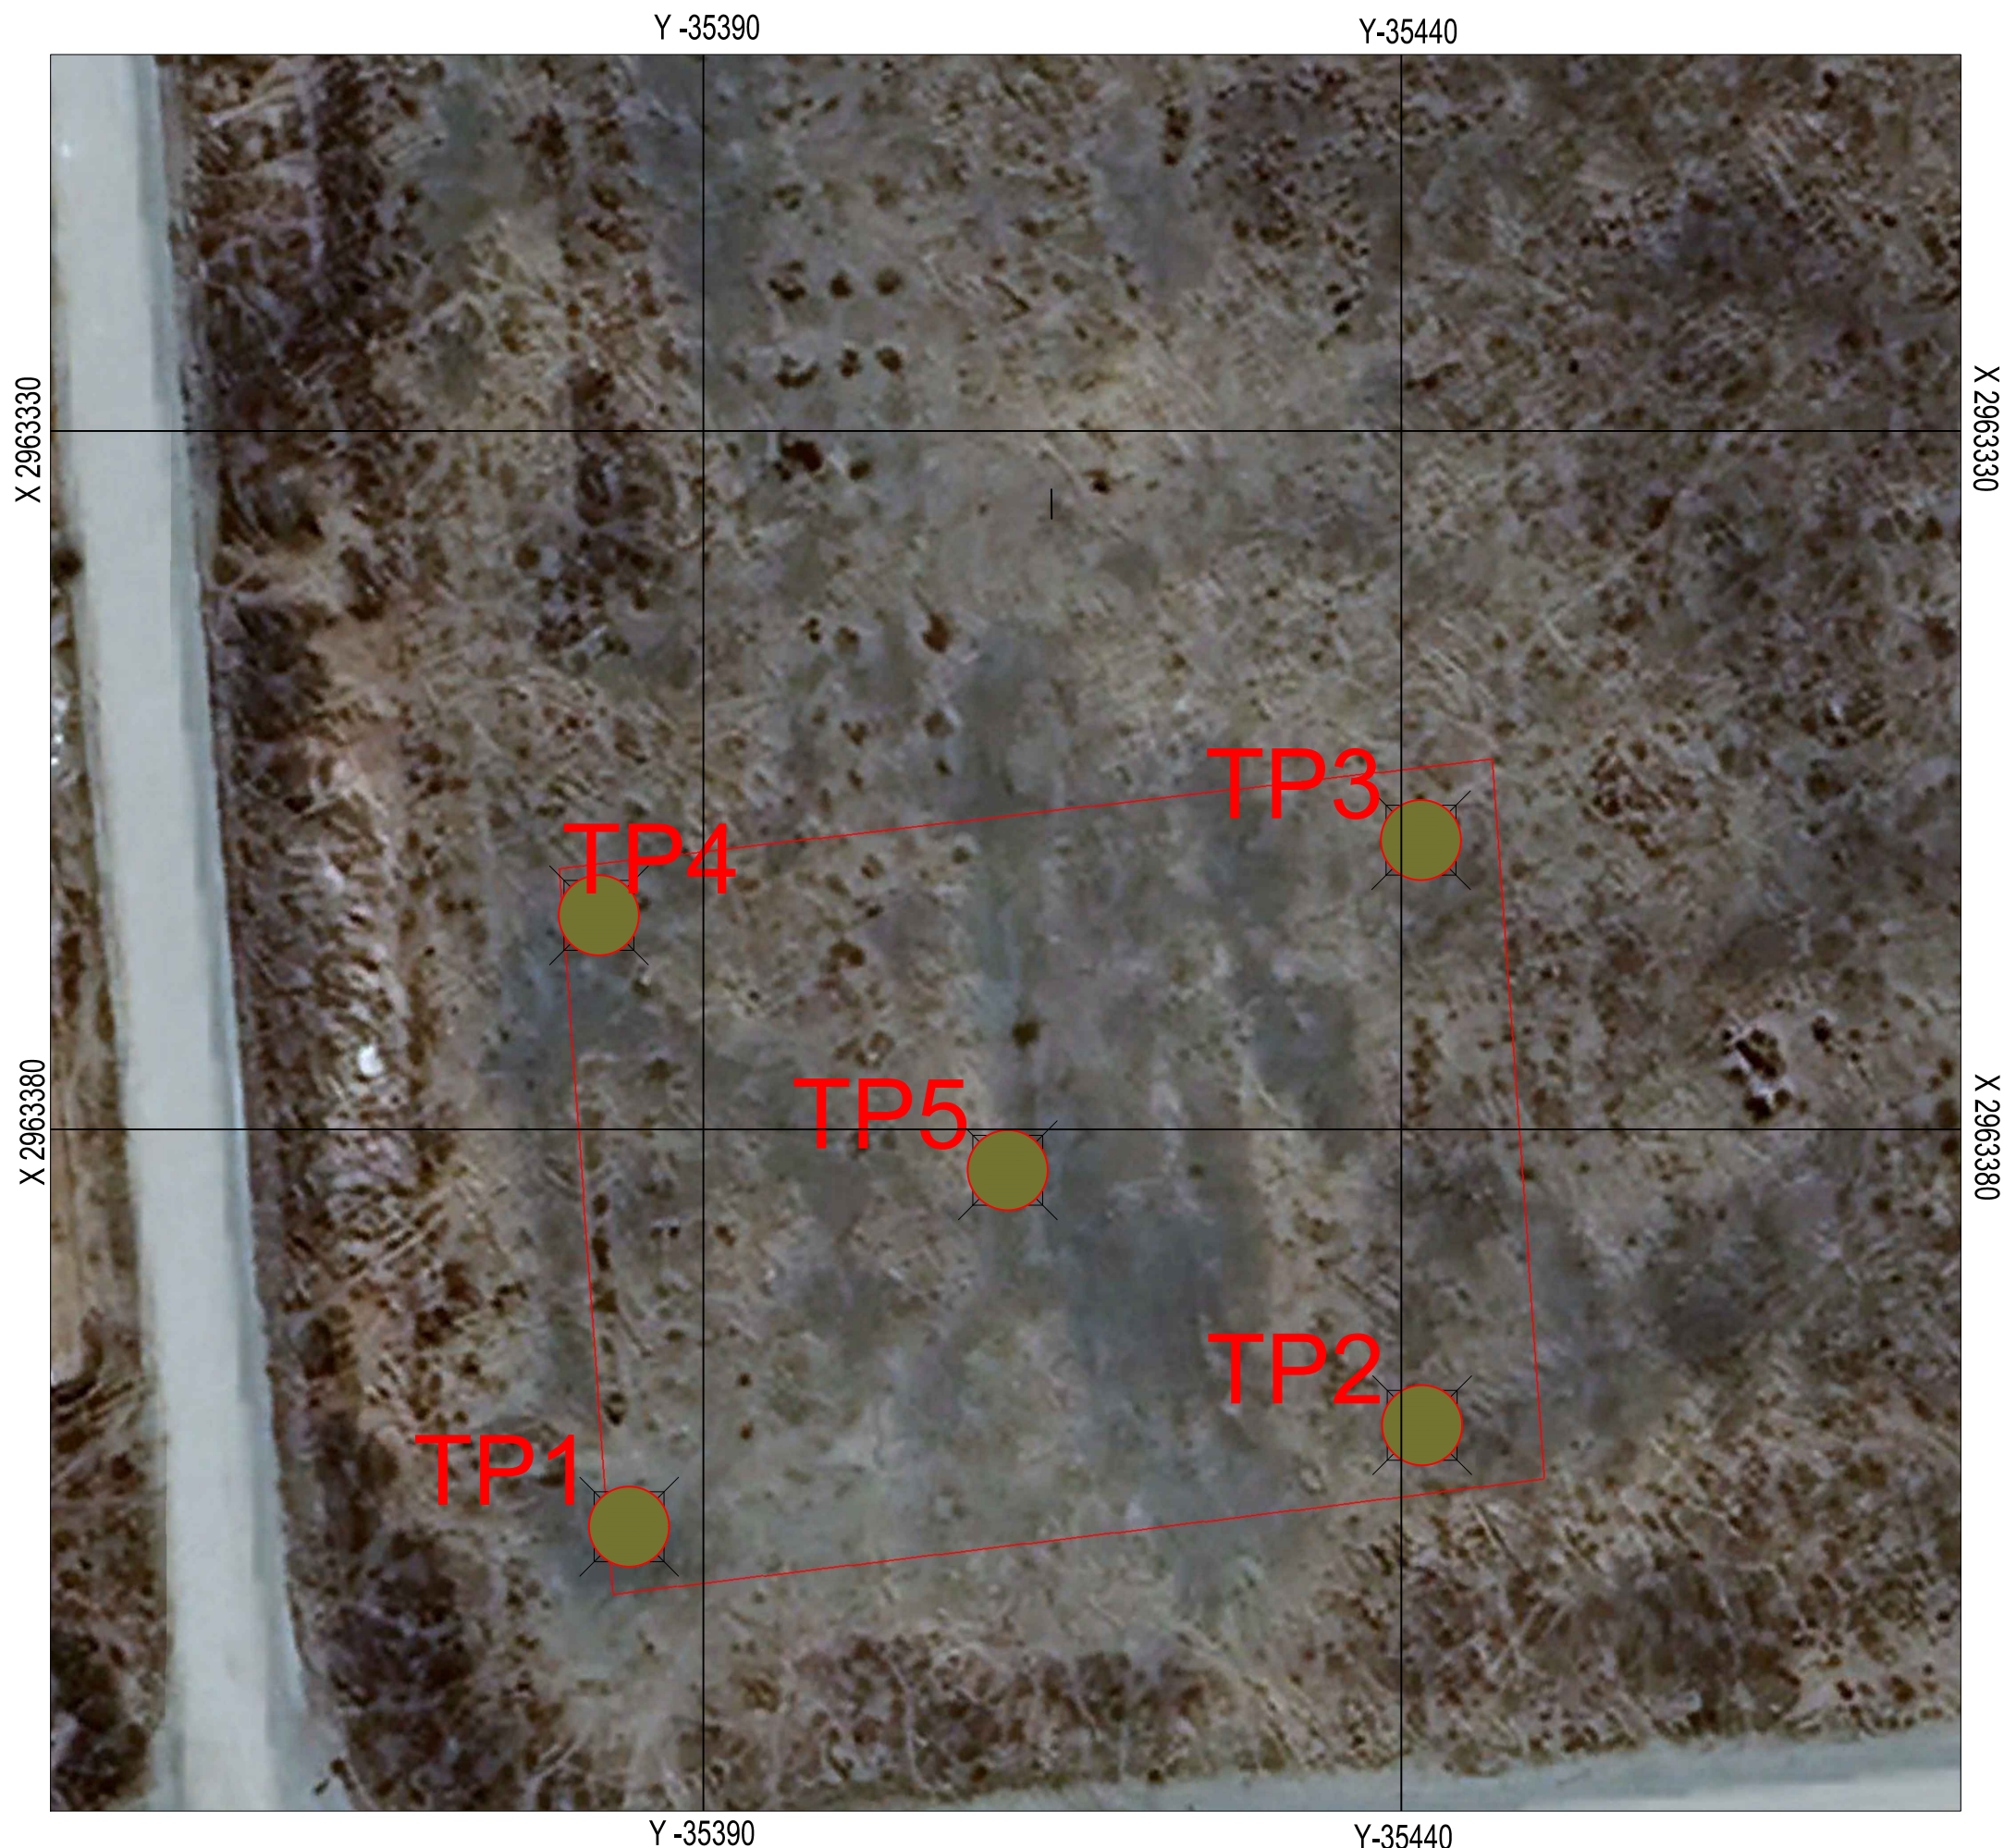
APPENDIX 2

REGIONAL GEOLOGY MAP

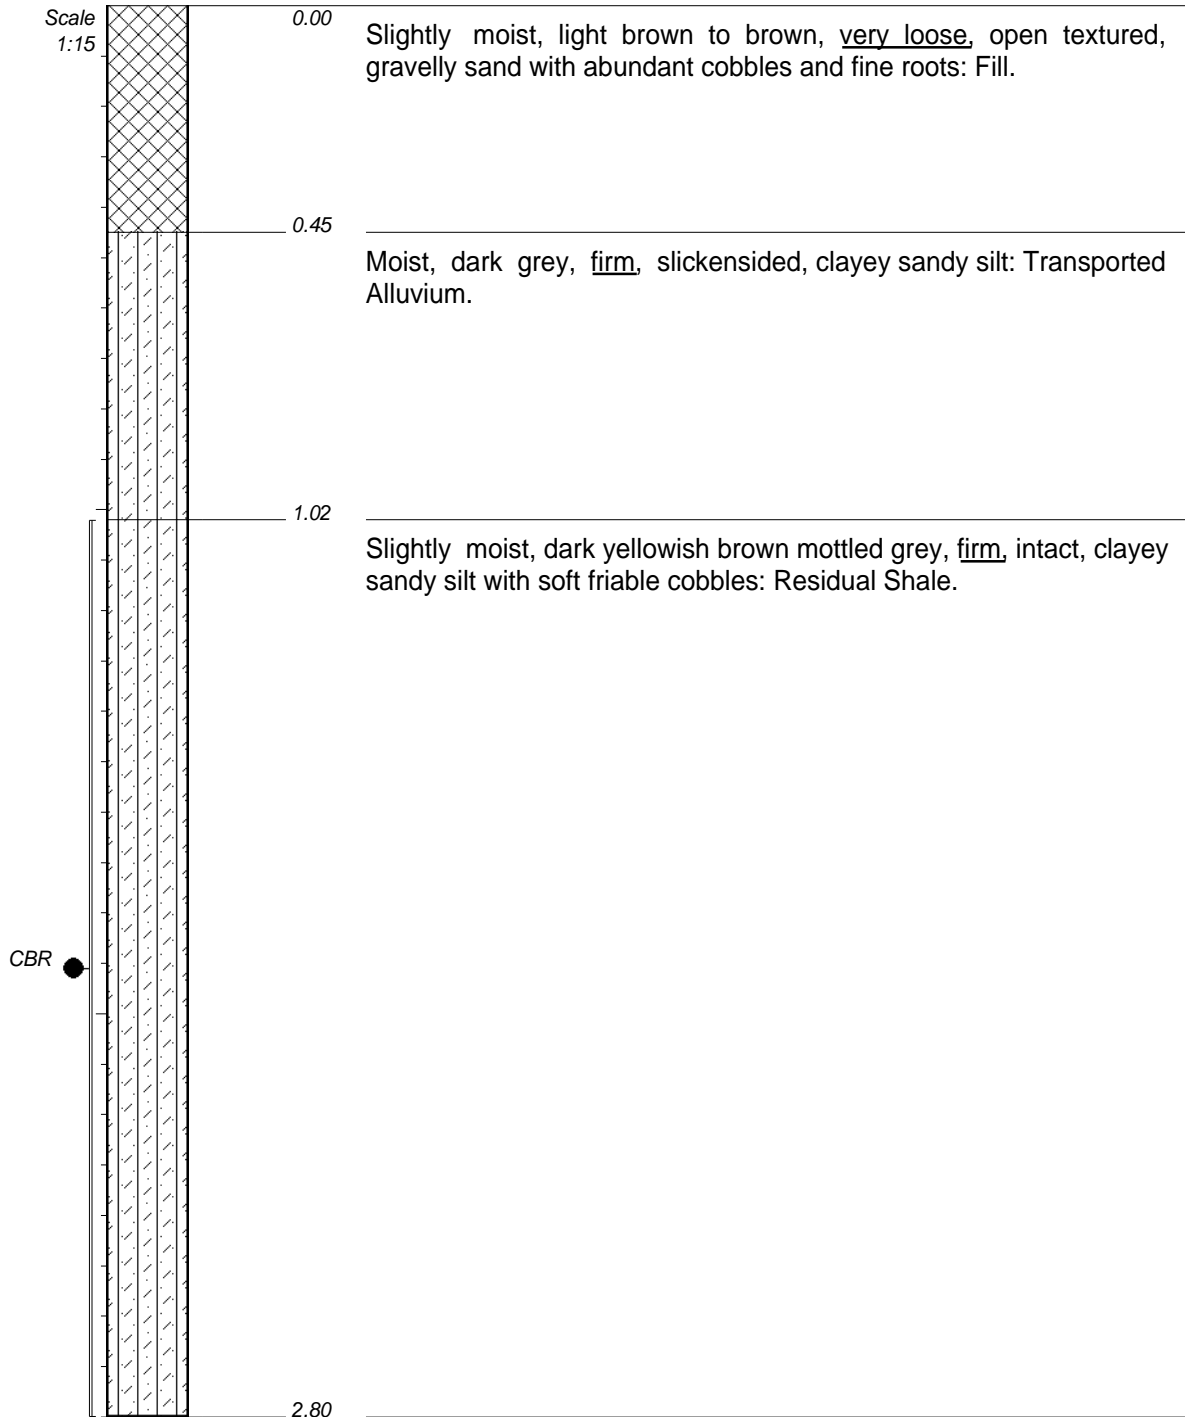
HOLE No: TP1
Sheet 1 of 1

- 1) EOH @ 2.8m
- 2) No water seepage observed
- 3) Disturbed sample CBR @ 1.02--2.8m

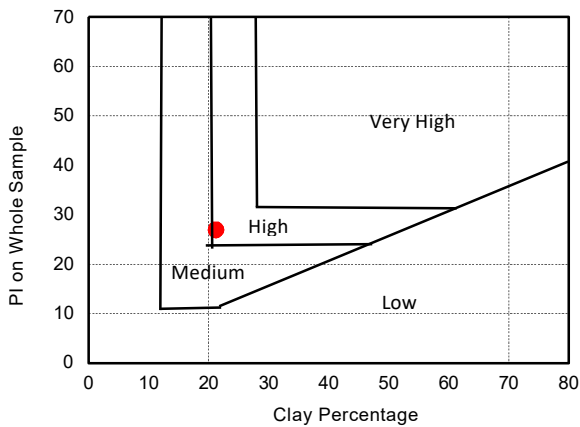
Clay (<0.002)	21,29
0.002 < Silt < 0.06	46,27
0.06 < Sand < 2.0	32,41
Gravel > 2.0	0,03
% less than 0.075	72,20

ACTIVITY CHART

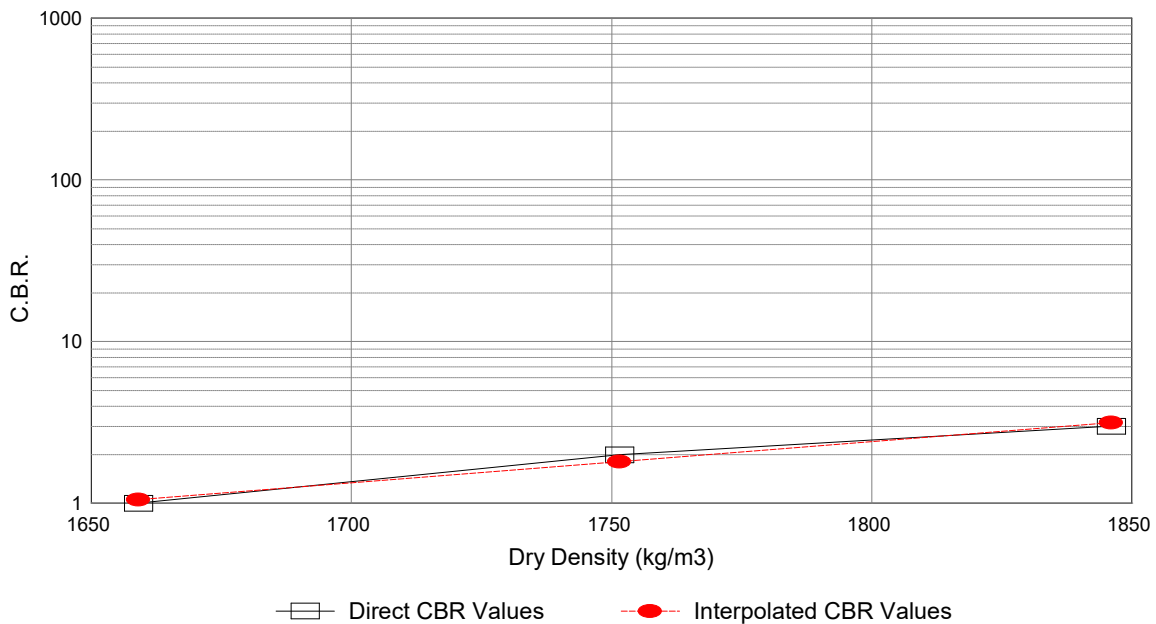
Client	Resonate Enviromenta		
Location	Tutuka Power Station	TP 2 @ 0,3 - 0,9m	
Date	11 April 2025	Test No	774
Job No	25059	Checked By	SM
Calibration Date	08 July 2024	Calibration Certificate	9480

Percentage Mod AASHTO	100,1	95,0	90,0
CBR @ 2.54mm	3	2	1
CBR @ 5.08mm	3	2	1
CBR@ 7.62mm	3	2	1
Average Moisture Content (%)	11,0		
Percentage Swell	1,15	1,26	1,36

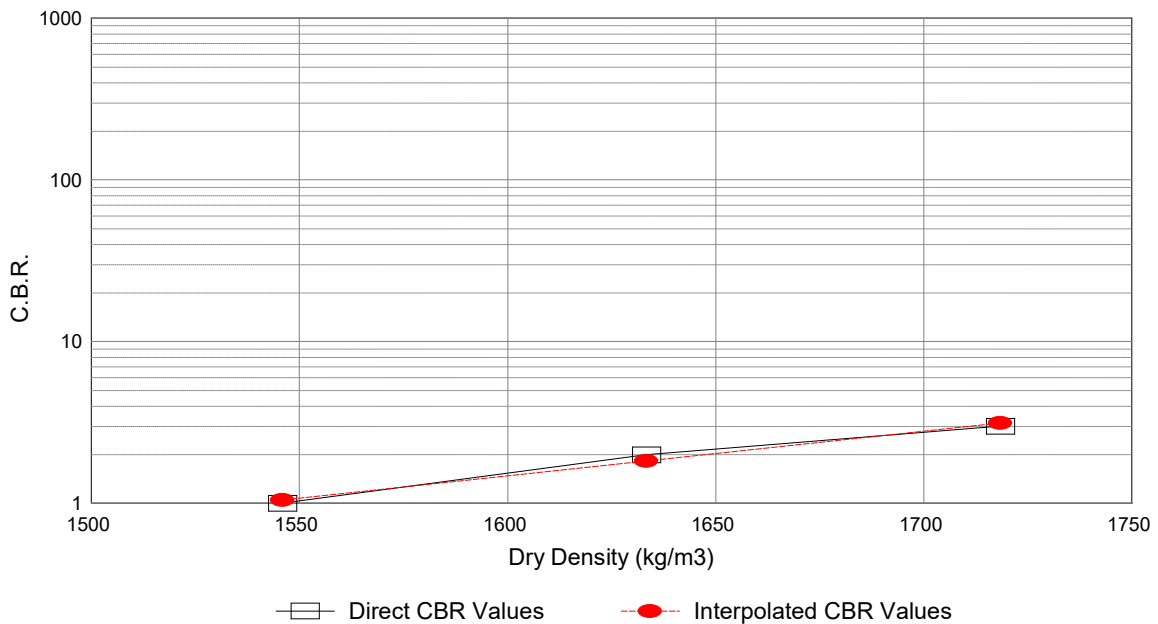
Client	Resonate Enviromenta		
Location	Tutuka Power Station	TP 2 @ 0,9 - 1,6m	
Date	11 April 2025	Test No	776
Job No	25059	Checked By	SM
Calibration Date	08 July 2024	Calibration Certificate	9480

Percentage Mod AASHTO	100,0	95,0	89,9
CBR @ 2.54mm	3	2	1
CBR @ 5.08mm	3	2	1
CBR@ 7.62mm	3	2	1
Average Moisture Content (%)	17,6		
Percentage Swell	1,10	1,18	1,26

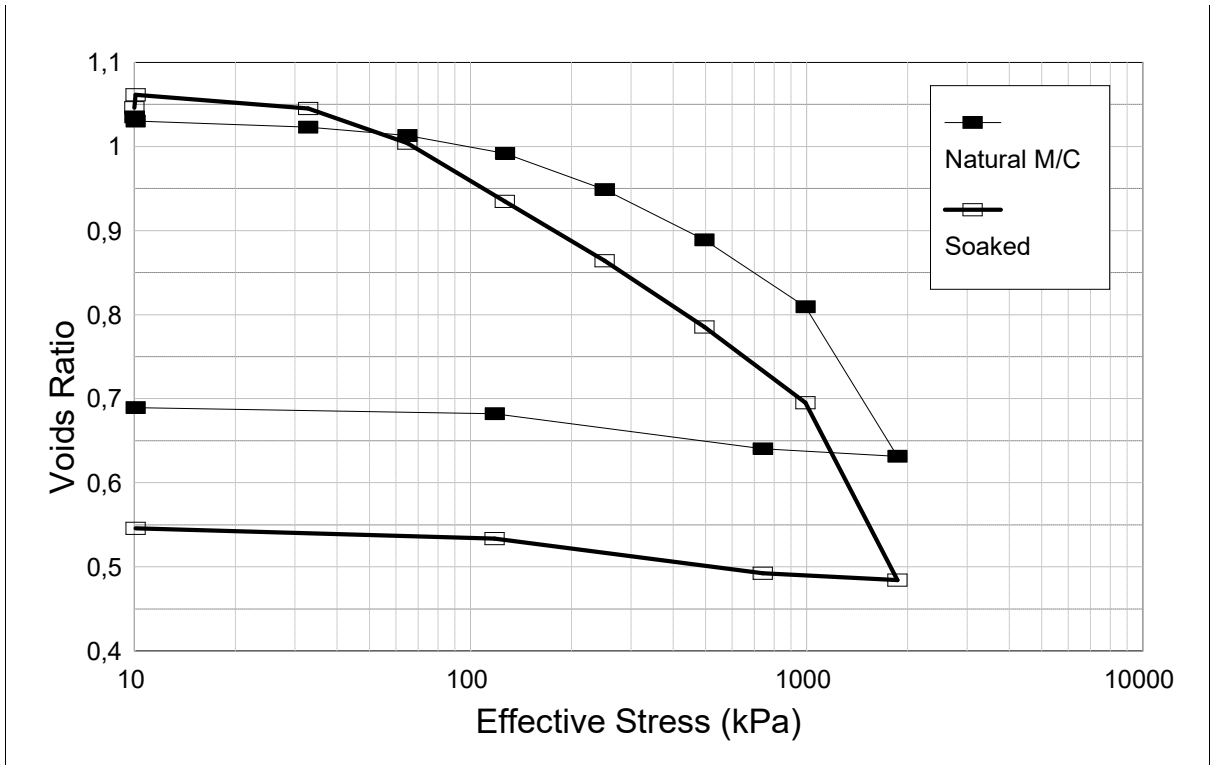
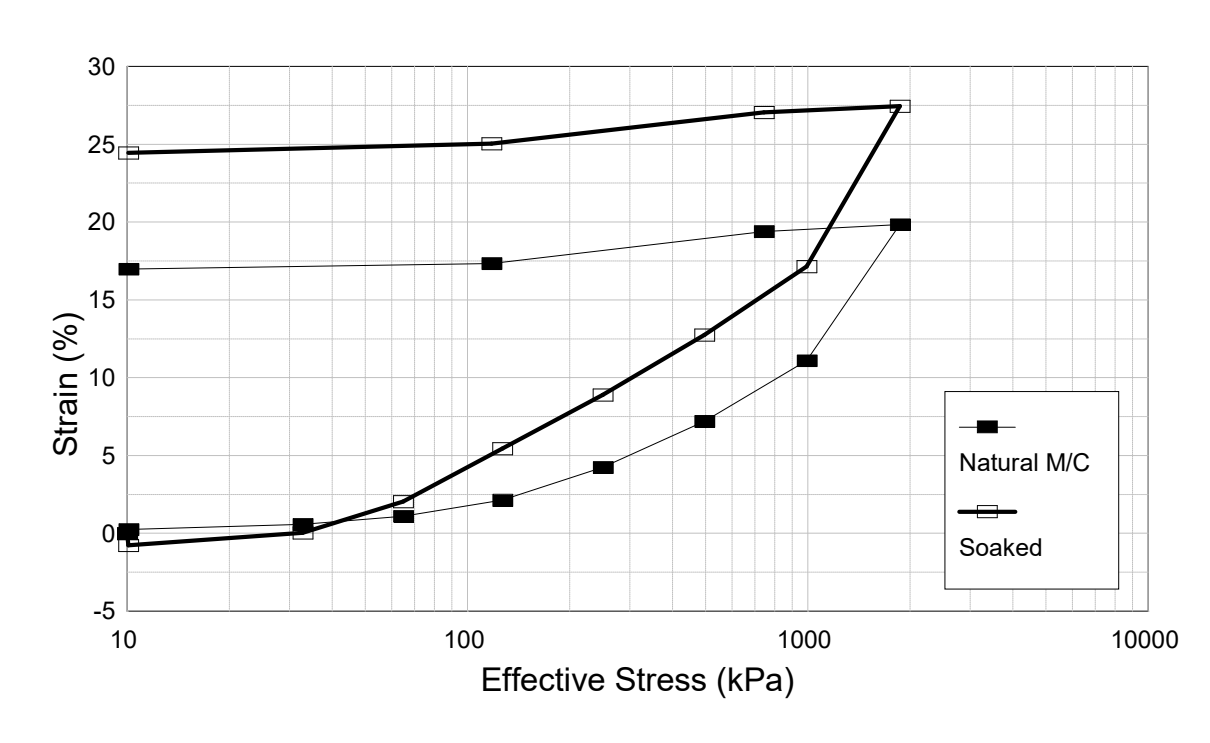
Test No: 777

Client	Resonate Enviromenta		
Location	Tutuka Power Station	TP 4 @ 0,5 - 1,1m	
Date	11 April 2025	Test No	777
Job No	25059	Checked By	EB

VOIDS RATIO v EFFECTIVE STRESS

STRAIN v EFFECTIVE STRESS

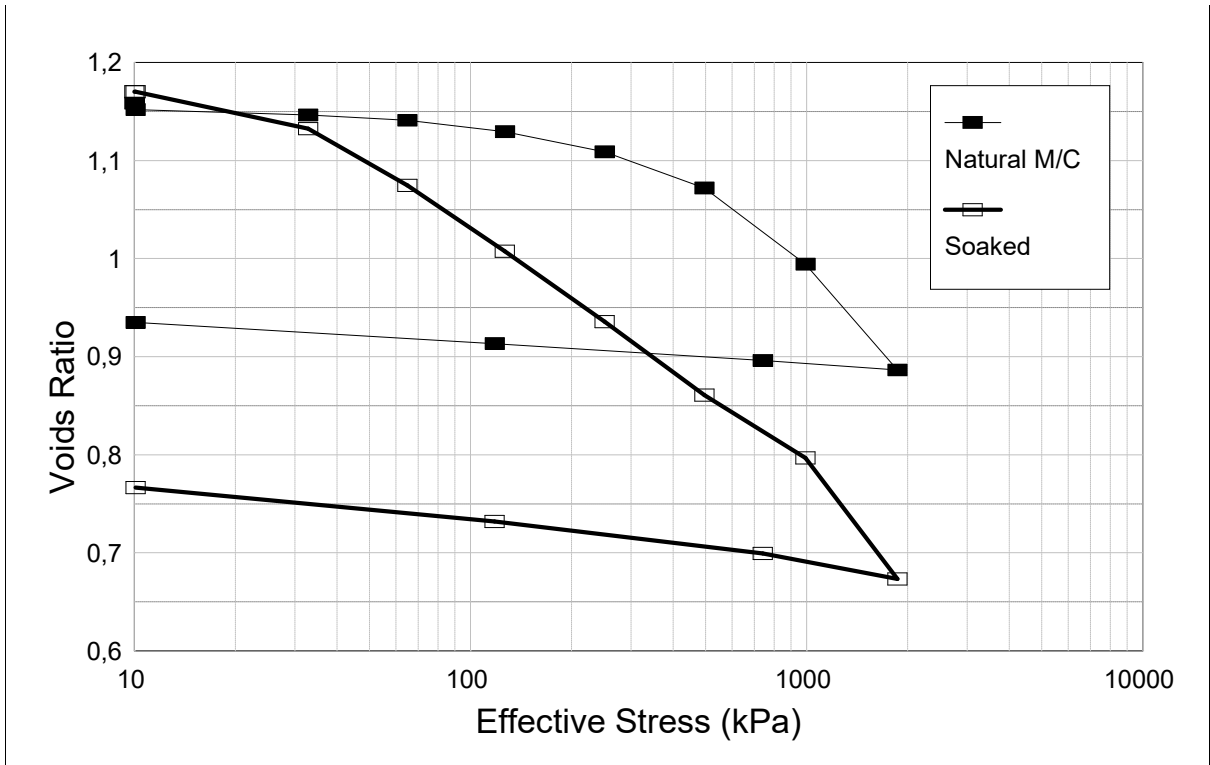
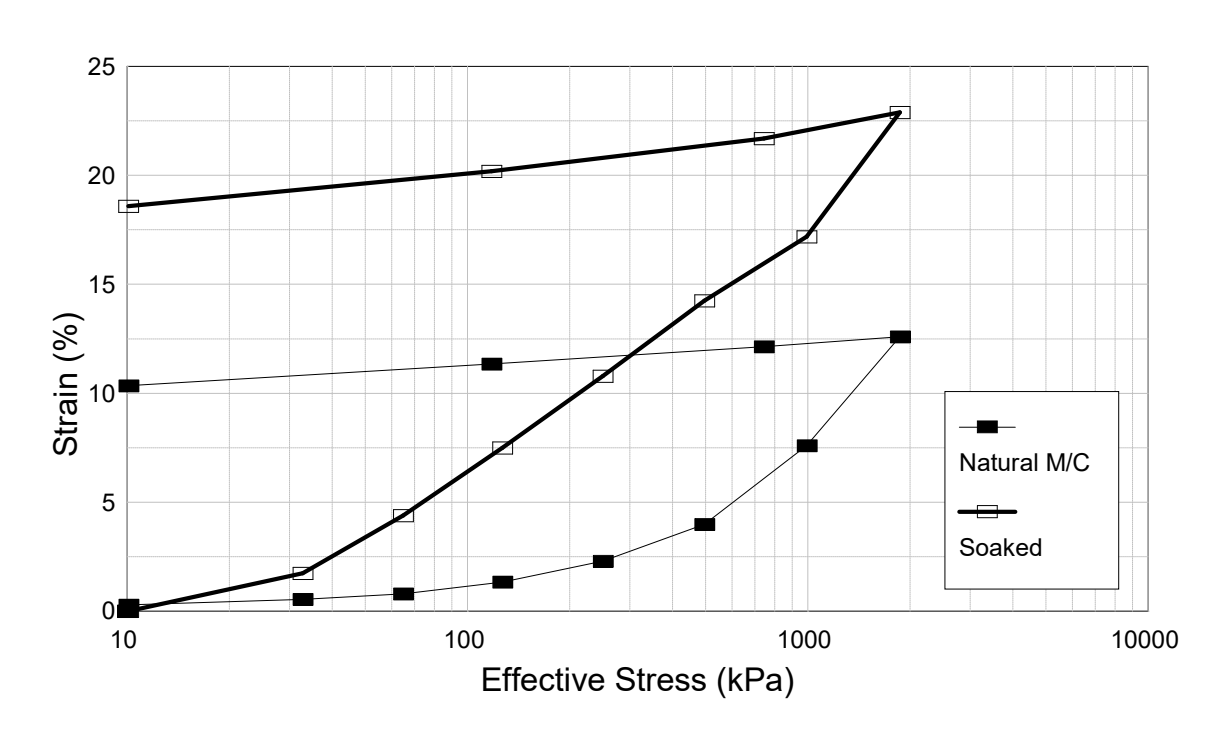
Test No: 779

Client	Resonate Enviromenta		
Location	Tutuka Power Station	TP 4 @ 1,1 - 1,7m	
Date	11 April 2025	Test No	779
Job No	25059	Checked By	EB

VOIDS RATIO v EFFECTIVE STRESS

STRAIN v EFFECTIVE STRESS

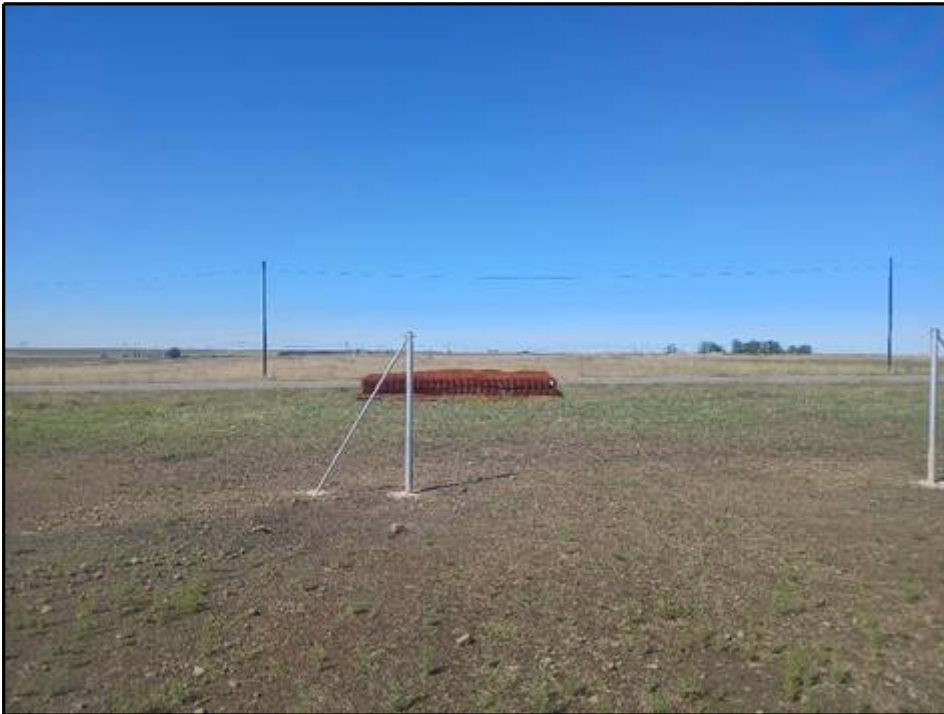
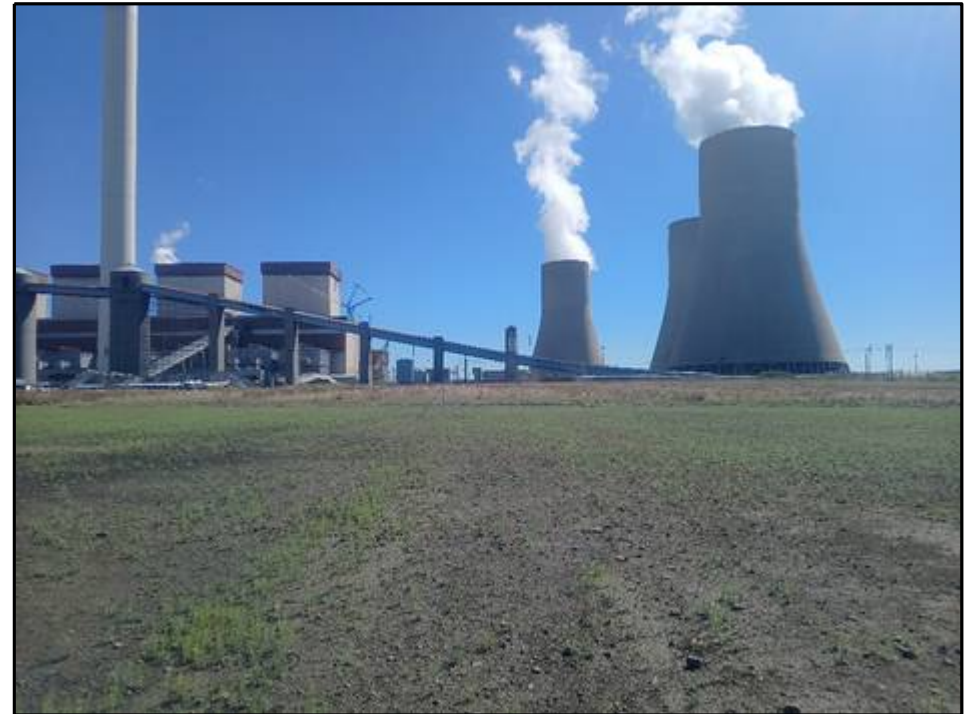
Overall View of the site - Scrapyard

At the time of investigation, the site was clear of vegetation although very short veld grass occurring as patches on the ground were observed. General photographs of the site can be found in Appendix 6.

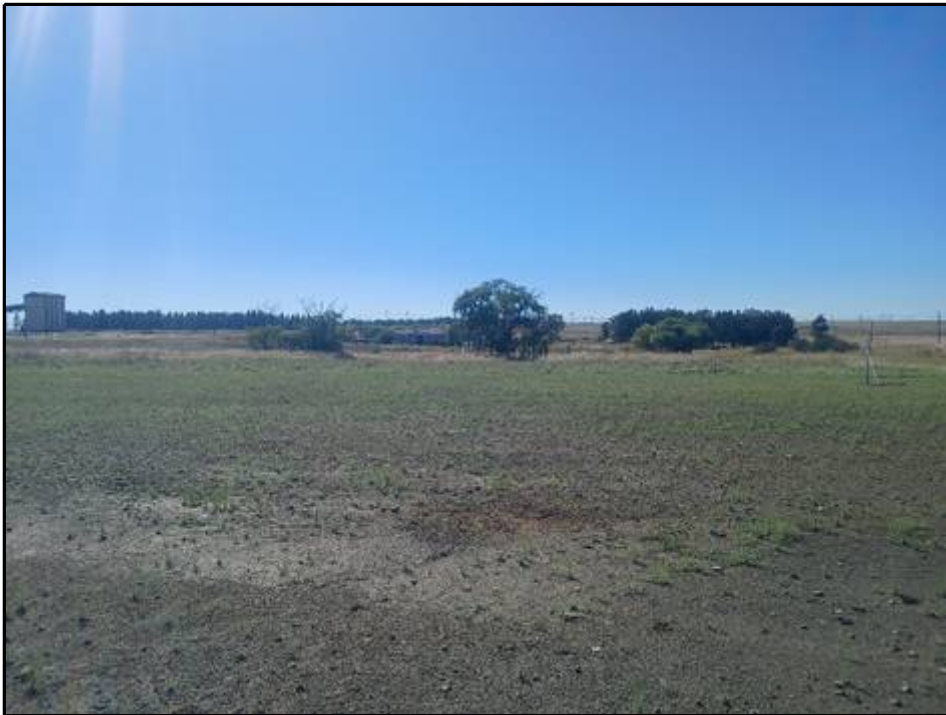
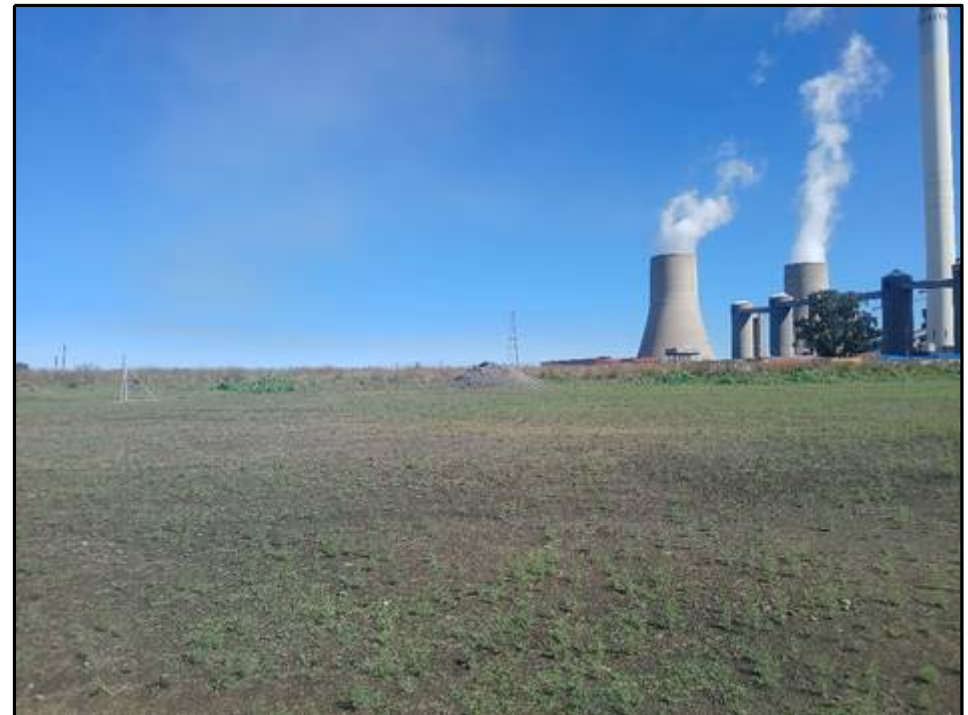
Overall View of the site - Scrapyard

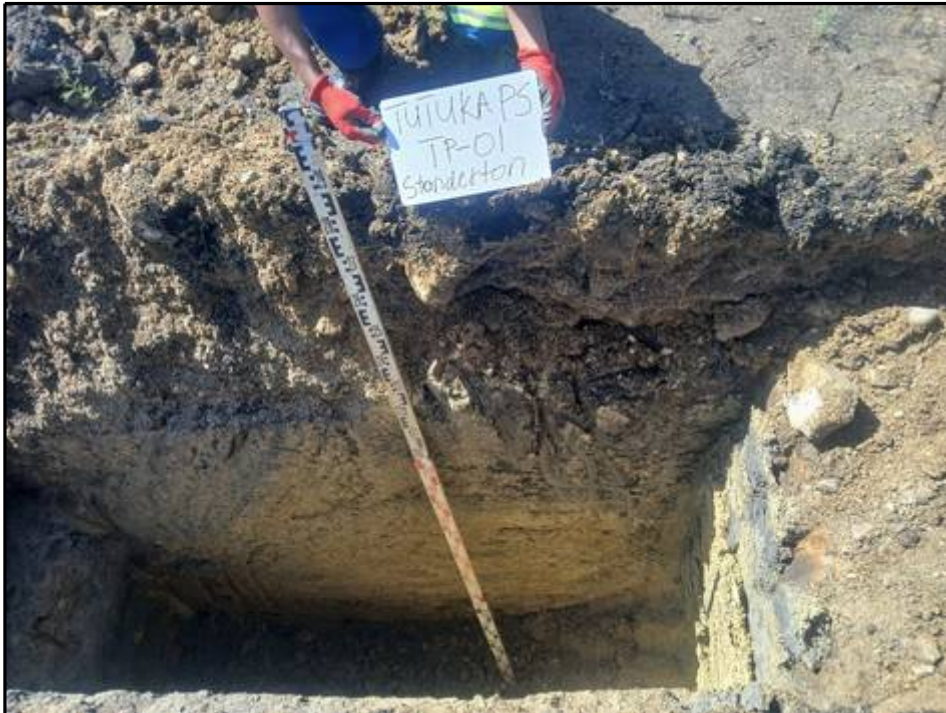
Soil Profile as observed in TP-01

A fill horizon was intersected in all of the test pits from current ground level having an average thickness of 0.4m. The material generally comprises a moist, light brown, very loose sandy gravel, with abundant cobbles and fine grass roots.

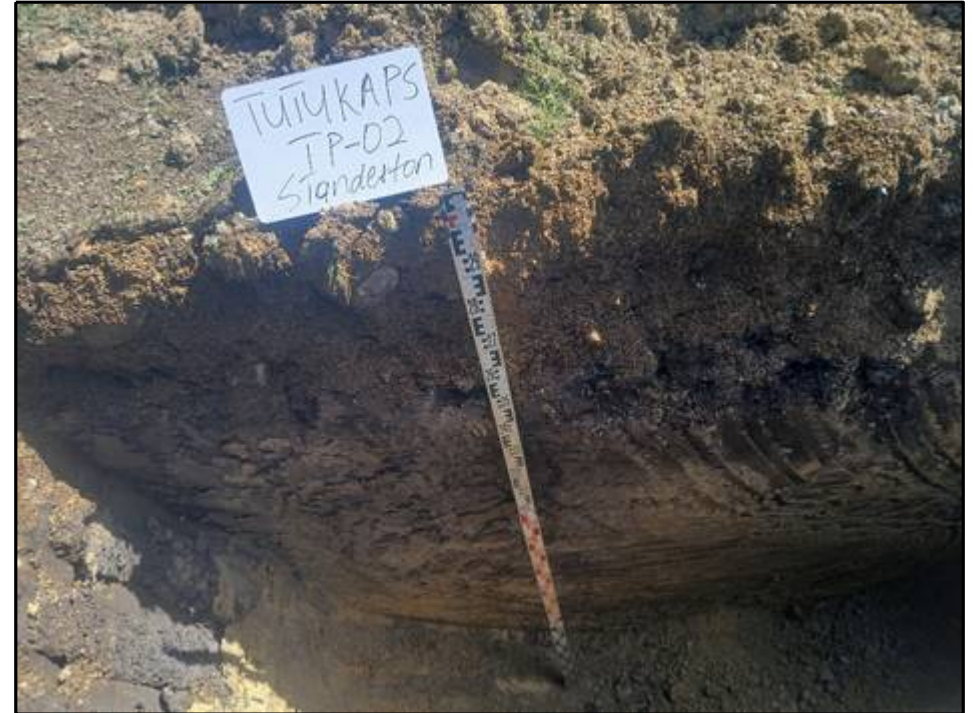
Soil Profile as observed in TP-02

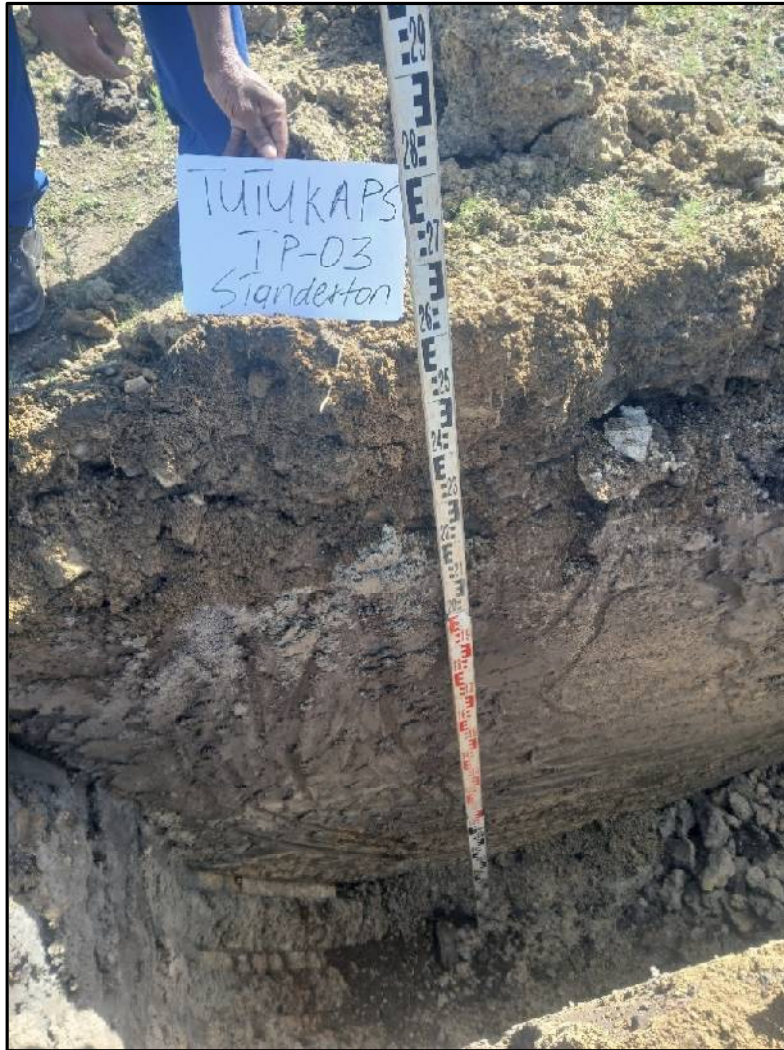
Soil Profile as observed in TP-03

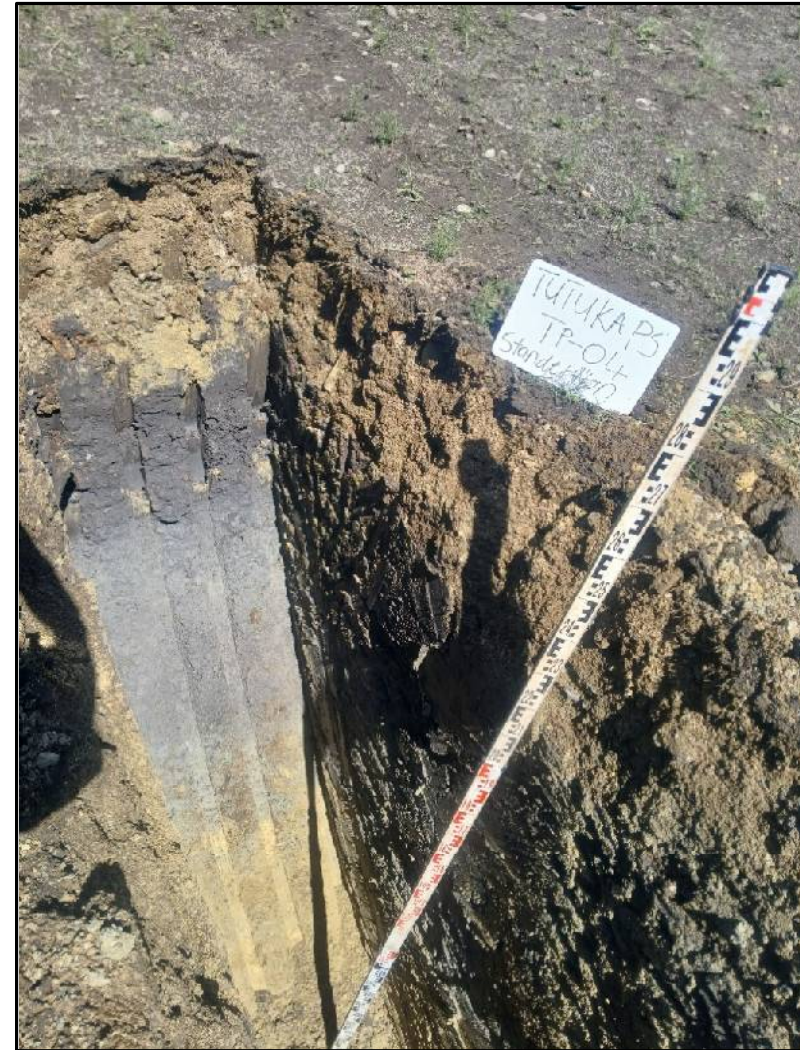
Soil Profile as observed in TP-04

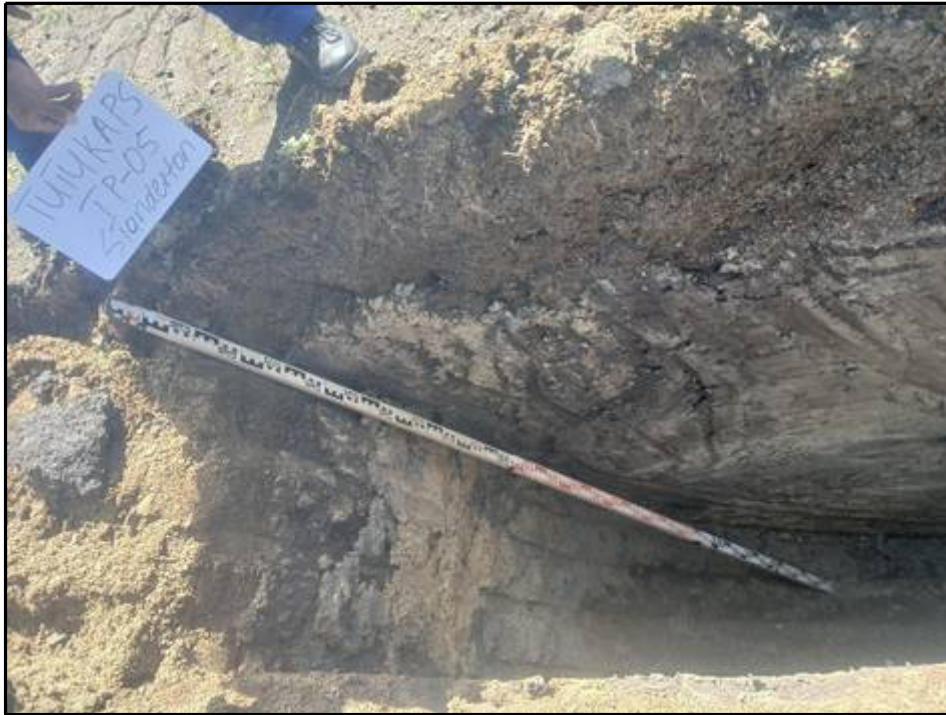
Soil Profile as observed in TP-05
