***GEOTECHNICAL REPORT***

***NEW FIRE WATER INSTALLATION  
TRANSNET PIPELINES  
WITBANK DEPOT  
MPUMALANGA***

***Requested by  
GreyJones (Pty) Ltd***

***Project GA1062R1/2025  
September 2025***

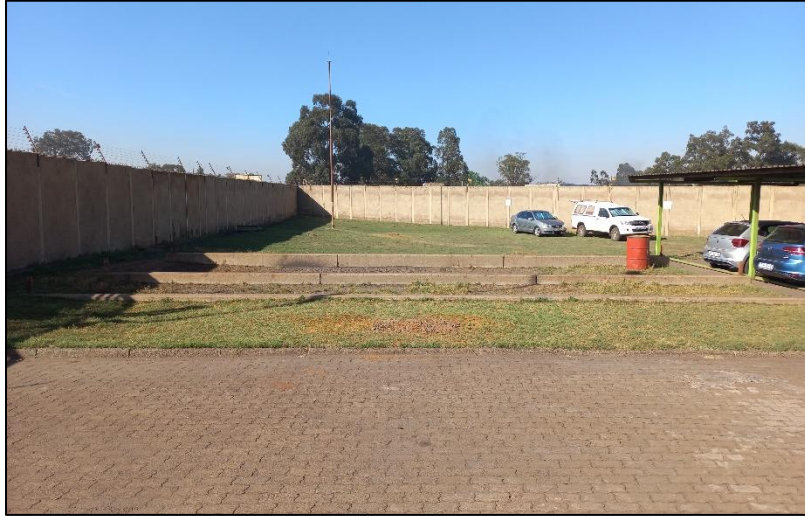
**Picture 1:** Looking south across the area where the new tanks and pump room will be located, in the southern corner of the site.

The proposed position for the new tanks and pump house, located in the southern corner of the site, comprises an open grass area. The grassed area lies alongside the staff parking area. This area is bounded to the east and south west by the boundary wall of the depot. This area is bounded to the north by the depot's substation. Some concrete foundations are located in the northern portion of the area, alongside covered parking bays. The development will overlap both of these existing features.

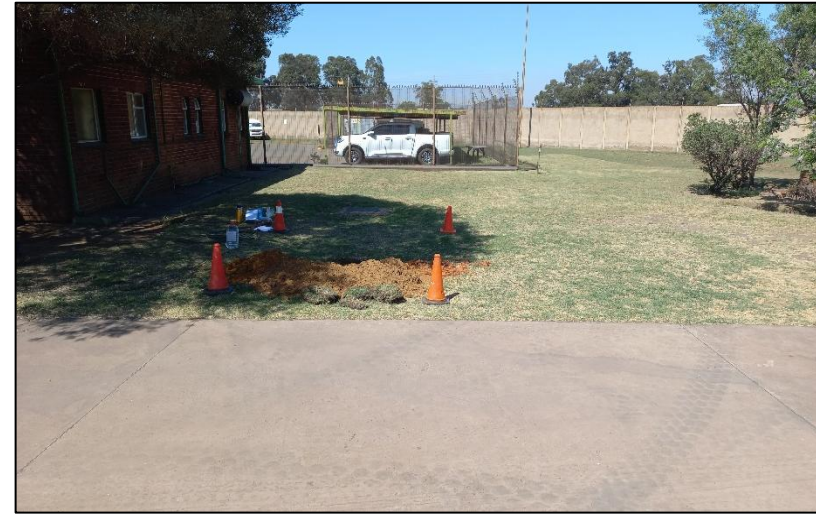
**Picture 2:** Looking south along the alignment of the new pipe racking and bridge, which will pass alongside the existing change rooms.

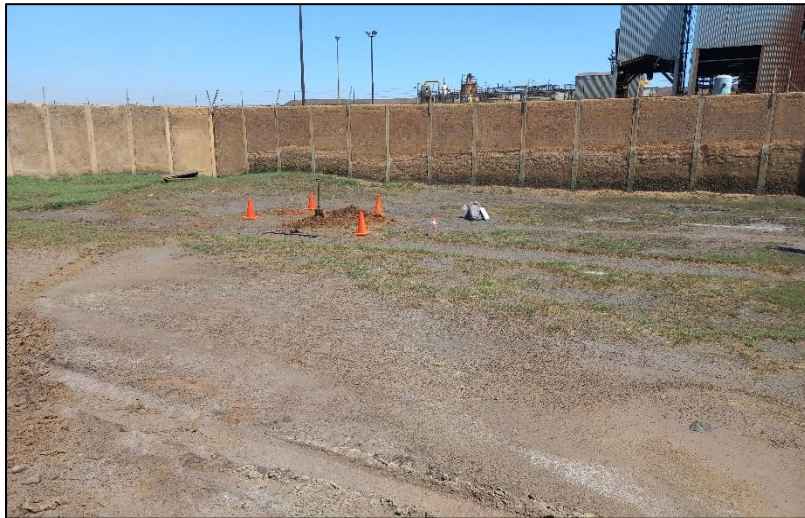
**Picture 3:** Looking west towards the proposed valve bank position on the western edge of the site. This area appears to suffer from frequent flooding.

The ground surface across the site was noted to have dried salt deposits, caked over the exposed surface soils. This, with the occurrence of a number of clogged surface drains, suggest that the site is periodically flooded. This was confirmed by staff members working at the facility. As such, the provision of surface drainage measures around the new infrastructure will be of paramount importance for this development. Subsoil drainage will have a limited effect owing to the shallow groundwater table.

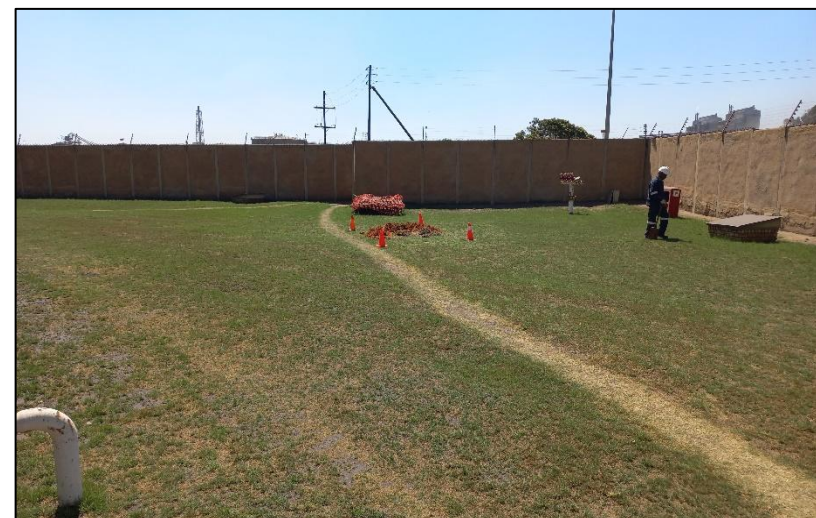
**Picture 4:** Looking north across the proposed valve bank which will be positioned in the north eastern corner of the site.

A thin layer of topsoil was encountered at surface at the position for the north eastern valve bank. This layer is 0.4m thick and comprises grey brown, fine grained, slightly clayey silty sand with some roots and gravel. The bulk fill observed across the rest of the site is absent in this position.

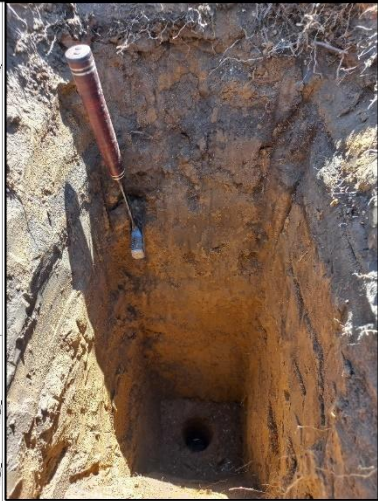
| Depth | Description | |
|---|---|---|
| 0.00 | <b>FILL</b><br>Dry to slightly moist, grey brown, medium dense, intact, fine to medium grained; Slightly CLAYEY SILTY SAND - Fill with roots and gravel. | |
| 0.30 | <b>FILL</b><br>Slightly moist, light khaki orange, loose becoming very loose with depth, intact, fine to medium grained; CLAYEY SILTY SAND - Fill with some roots. | |

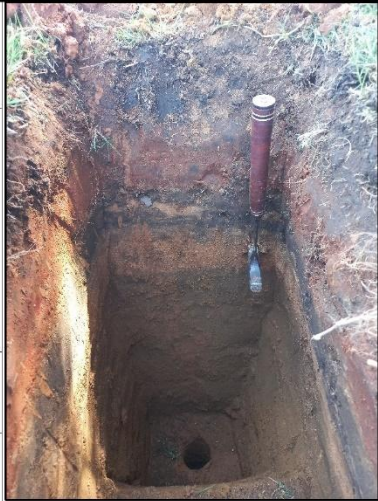
| Depth | Description | |
|---|---|---|
| 0.00 | <b>FILL</b><br>Slightly moist, dark brown becoming red with depth, medium dense, intact, fine to medium grained; Slightly CLAYEY SILTY SAND - Fill with abundant roots at surface. | |
| 0.40 | <b>FILL</b><br>Slightly moist, light khaki orange, loose becoming very loose with depth, intact, fine to medium grained; CLAYEY SILTY SAND - Fill with some roots. | |

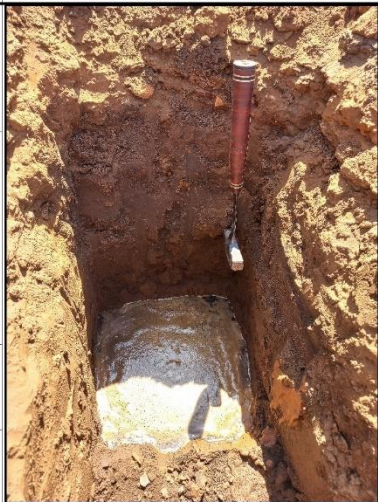
| Depth | Description | |
|---|---|---|
| 0.00 | <b>FILL</b><br>Slightly moist, brown with orange blotches, medium dense, intact, fine to medium grained; SILTY GRAVELLY SAND - Fill. | |
| 0.30 | <b>FILL</b><br>Moist, dark brown, loose, intact, fine to medium grained; Slightly CLAYEY SILTY SAND - Fill. | |
| 0.80 | <b>FILL</b><br>Wet, dark brown, loose, intact, fine to medium grained; Slightly CLAYEY SILTY SAND - Fill. | |

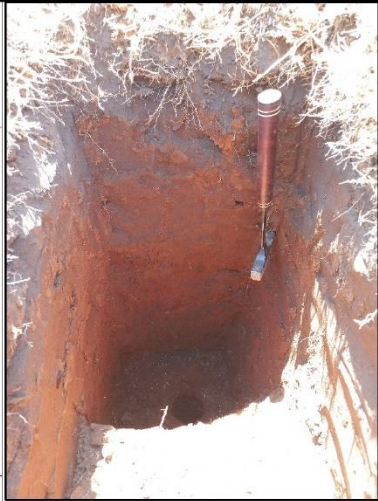
| Depth | | Description | |
|---|---|---|---|
| | 0.00 | <b>Slightly CLAYEY SILTY SAND</b><br>Dry to slightly moist, grey brown, medium dense, intact, fine grained; Slightly CLAYEY SILTY SAND - Topsoil with roots and gravel. | |
| 0.5 | 0.40 | <b>Slightly CLAYEY SILTY SAND</b><br>Slightly moist, reddish brown, loose, intact, fine to medium grained; Slightly CLAYEY SILTY SAND - Residual with some roots. | |

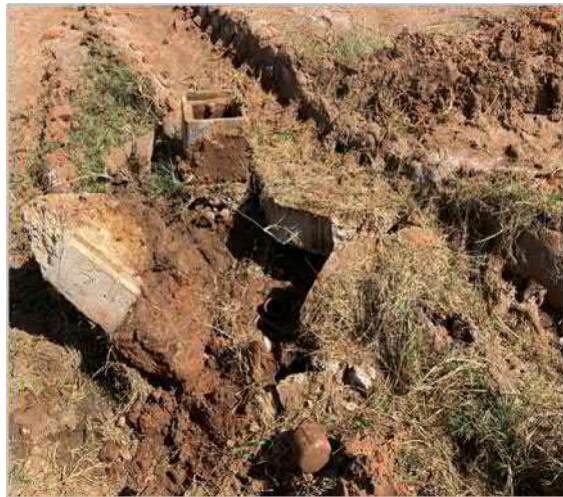
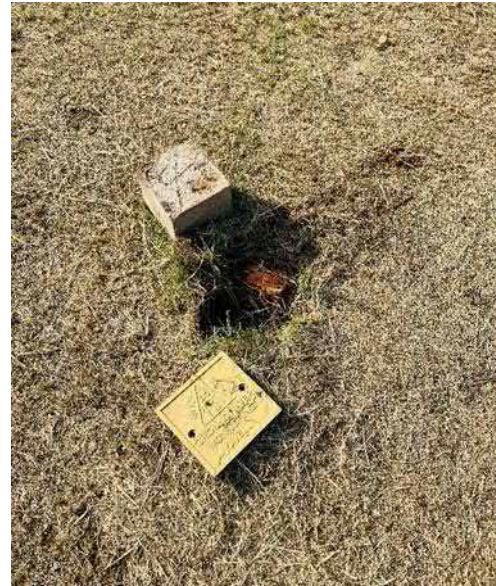
**Figure 4 - 2: Photo A: Manhole cover for missing Monitoring well MW9, Photo B: Condition of the destroyed manhole cover on monitoring well MW6.**

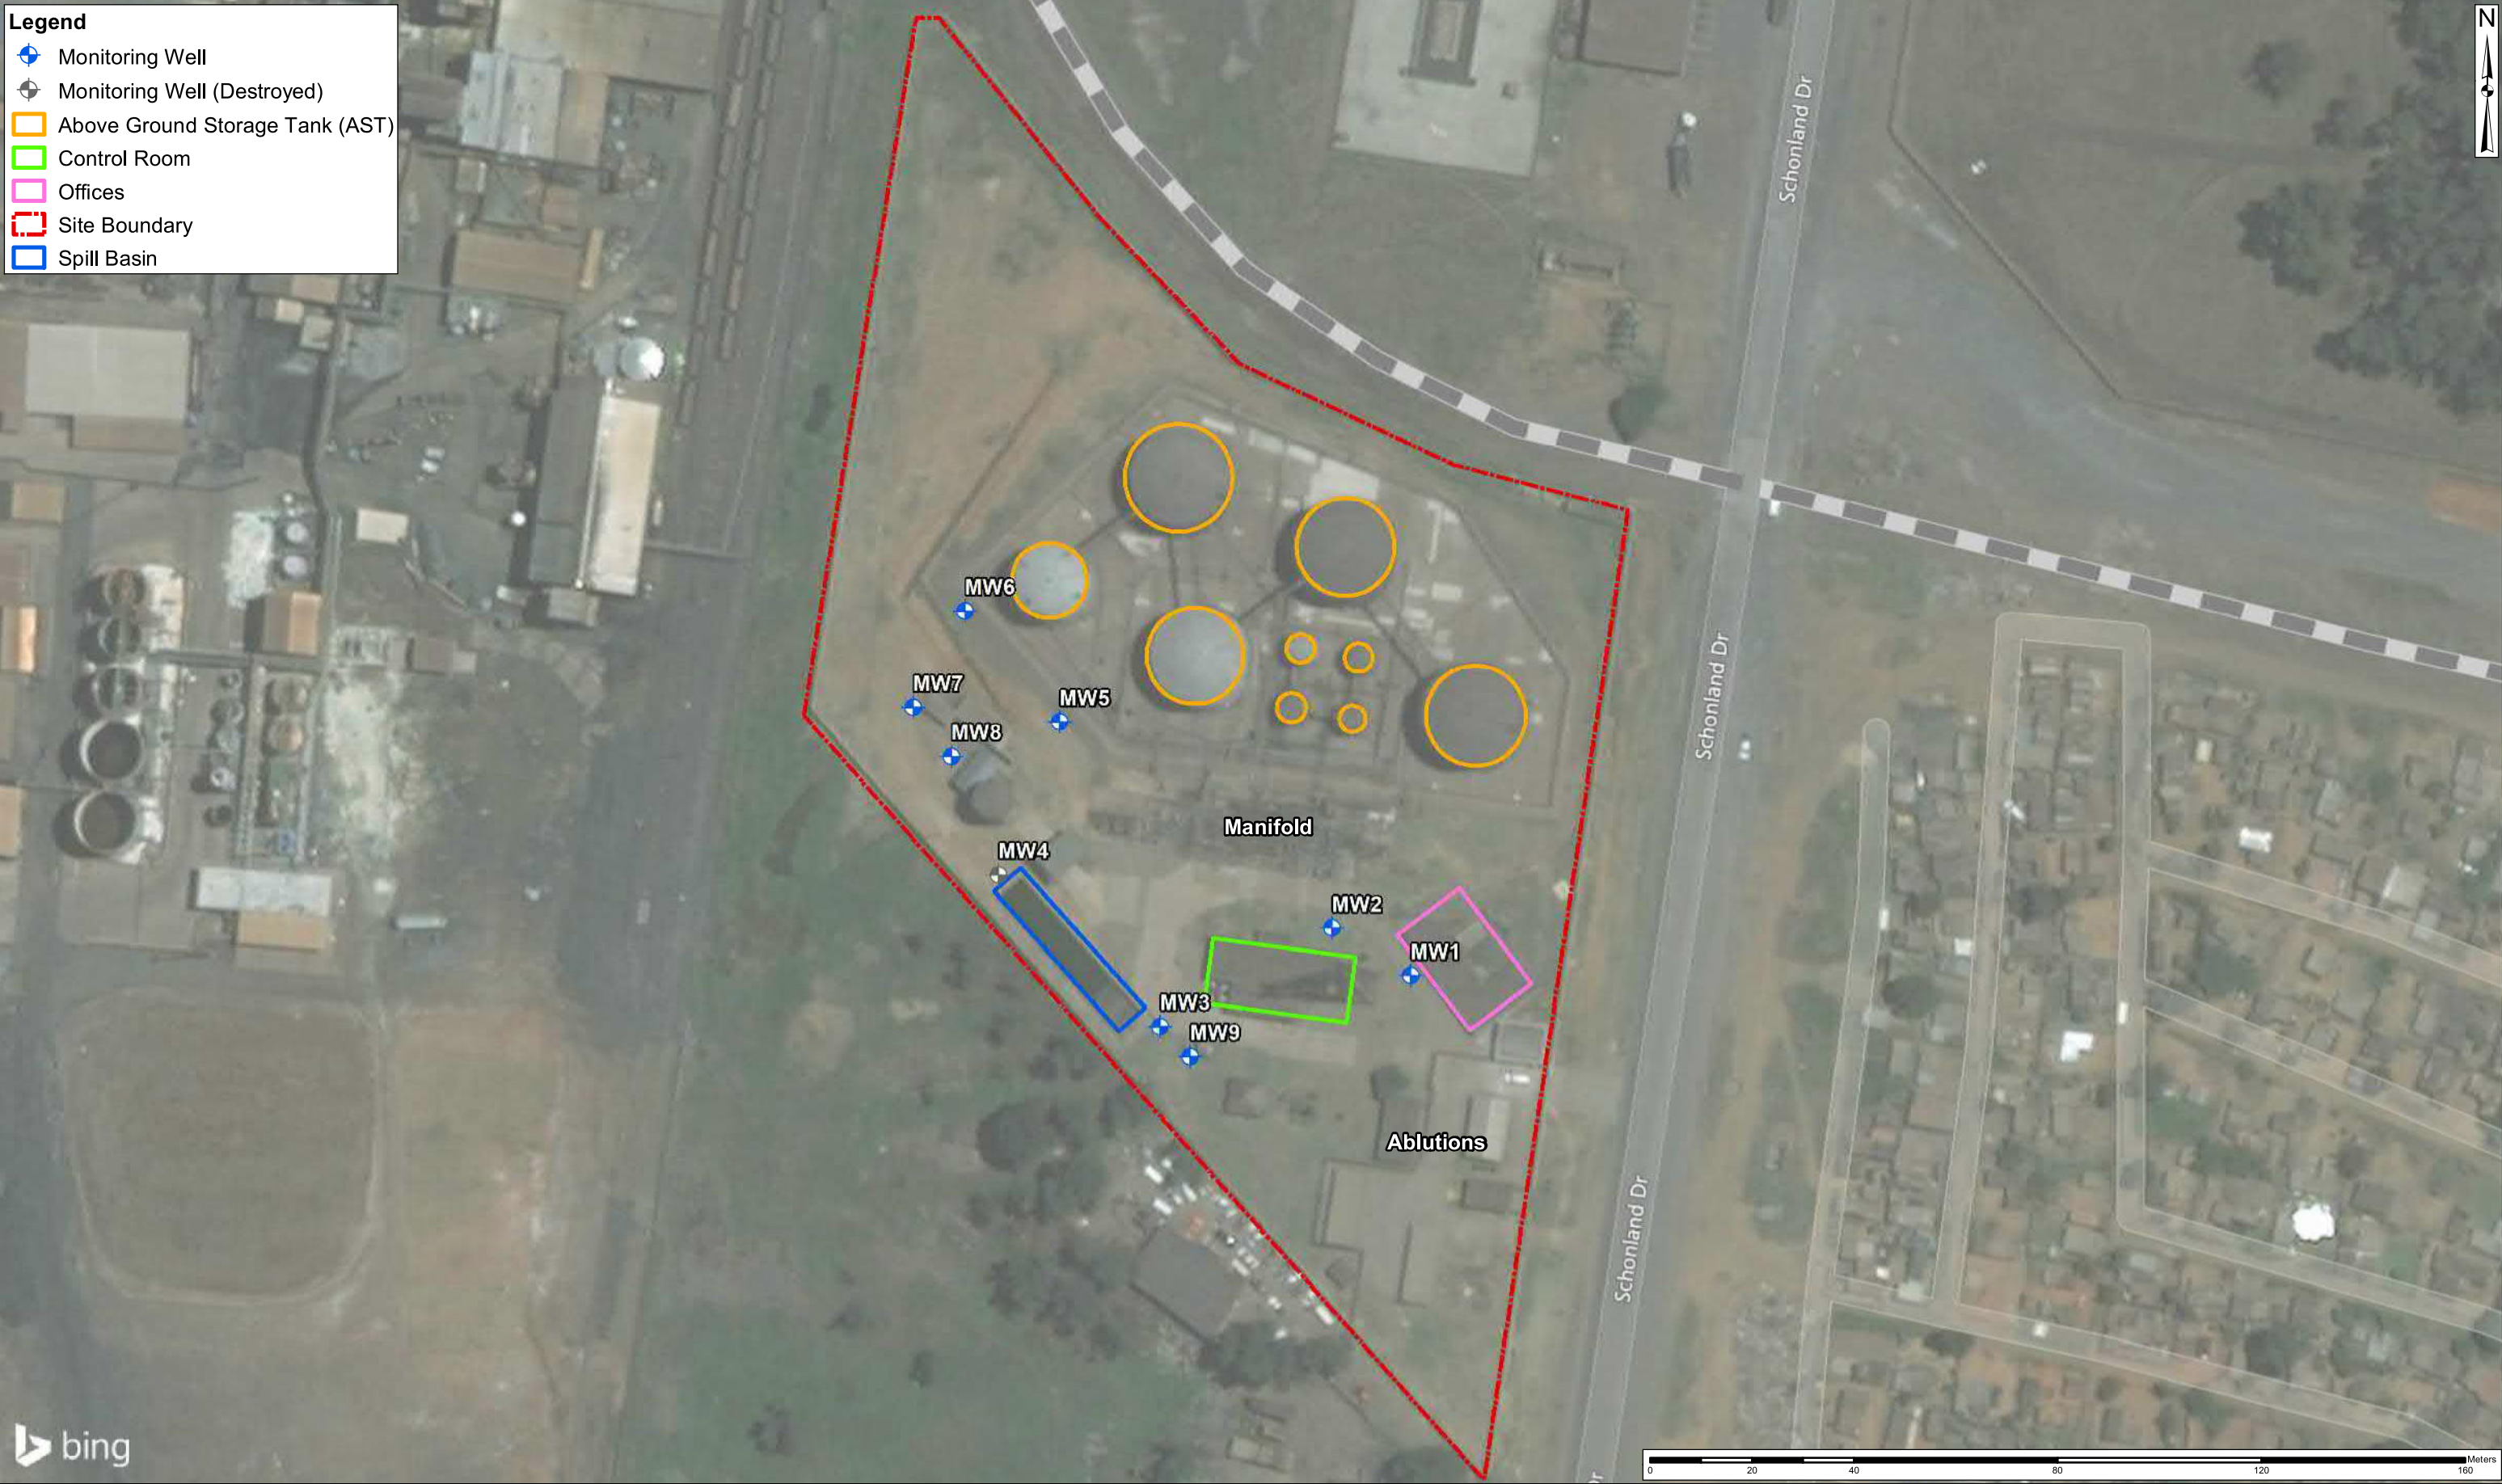
| Map Title: | Site Layout | Projection: Transverse Mercator<br>Datum: Hartebeesthoek 1994<br>Central Meridian: 29.0 | Sources:<br><br>Site Layout: AECOM 2020 |
