**NORMARC ILS**

# **ILS ASSESSMENT REPORT**

**OR Tambo International Airport  
Glide Path 03R scalloping problem**

**SSR 15010/Rev.1.0/16-Apr-15**

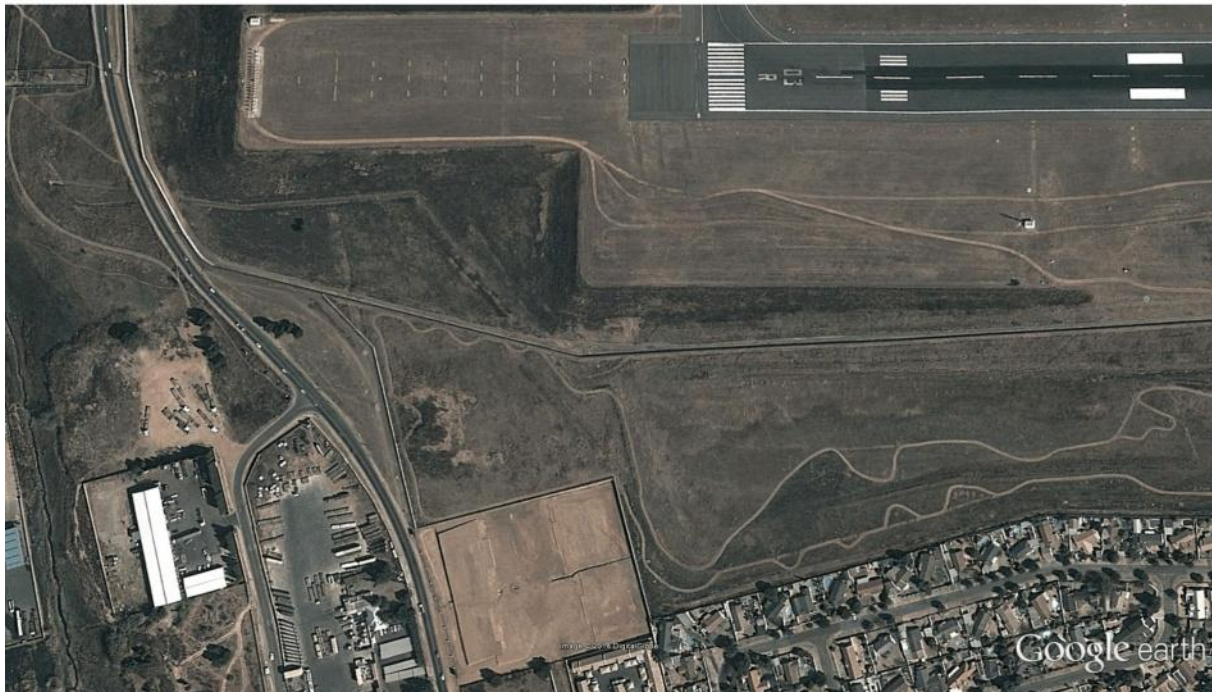
The scalloping problem developed from late 2013 to July 2014. The development of the problem is shown in Figure 1 to Figure 3. The figures show Flight Inspection recordings of the structure combined with aerial images from Google Earth. As can be seen, a building complex was developed in the vicinity of the Glide Path when the problem emerged. Figure 1 shows the situation before start of the construction of the buildings, no scalloping problem. Figure 2 shows the situation when the buildings were partly finished and Figure 3 shows the situation as it is today.

7. September 2013

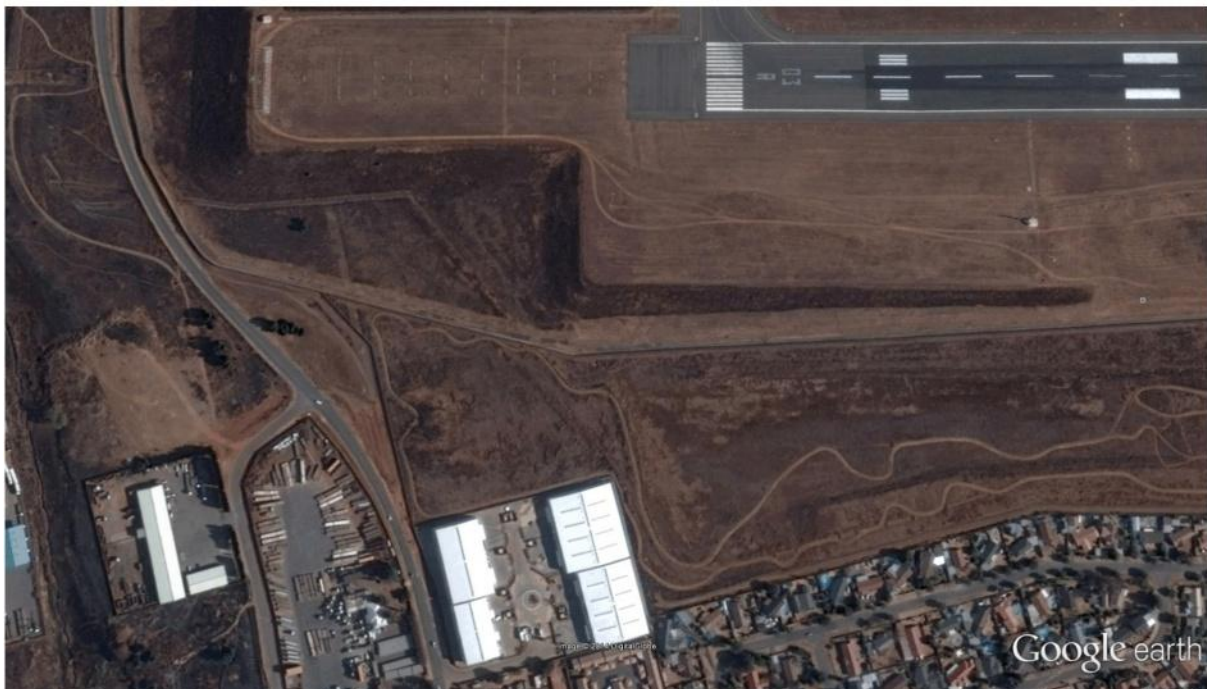
Figure 3

5. July 2014

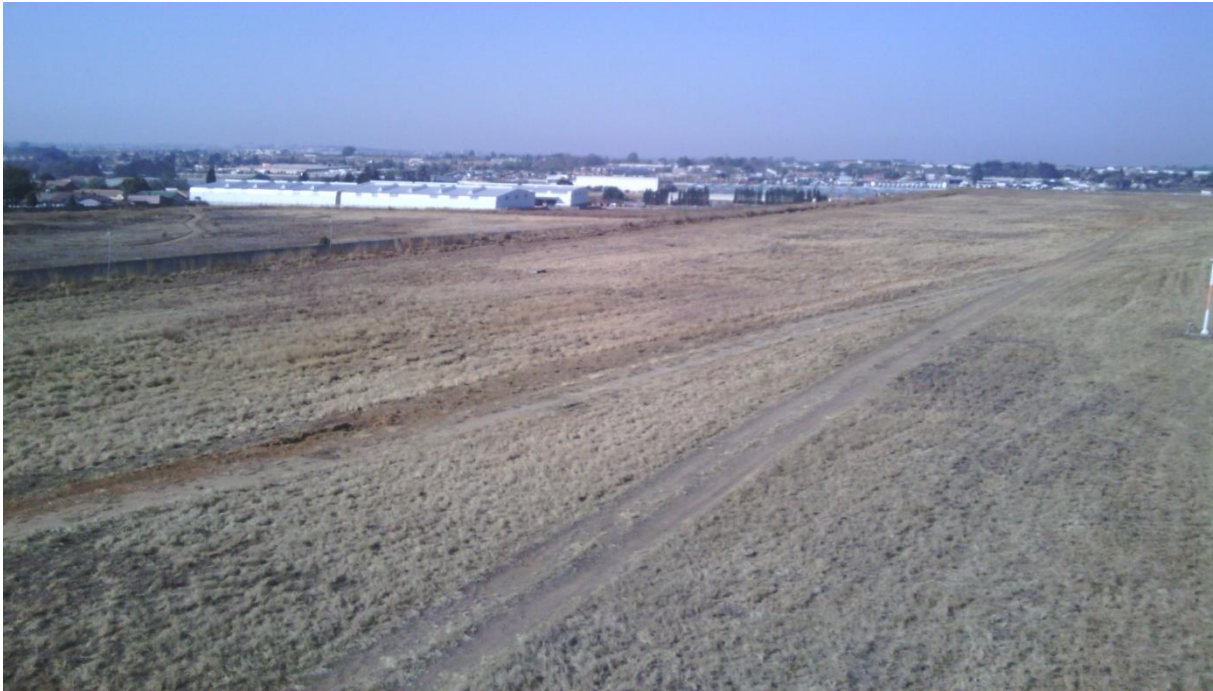
**Figure 4**  
The buildings seen from the Glide Path antenna

The new buildings can be seen in more detail in Figure 4 and Figure 5.

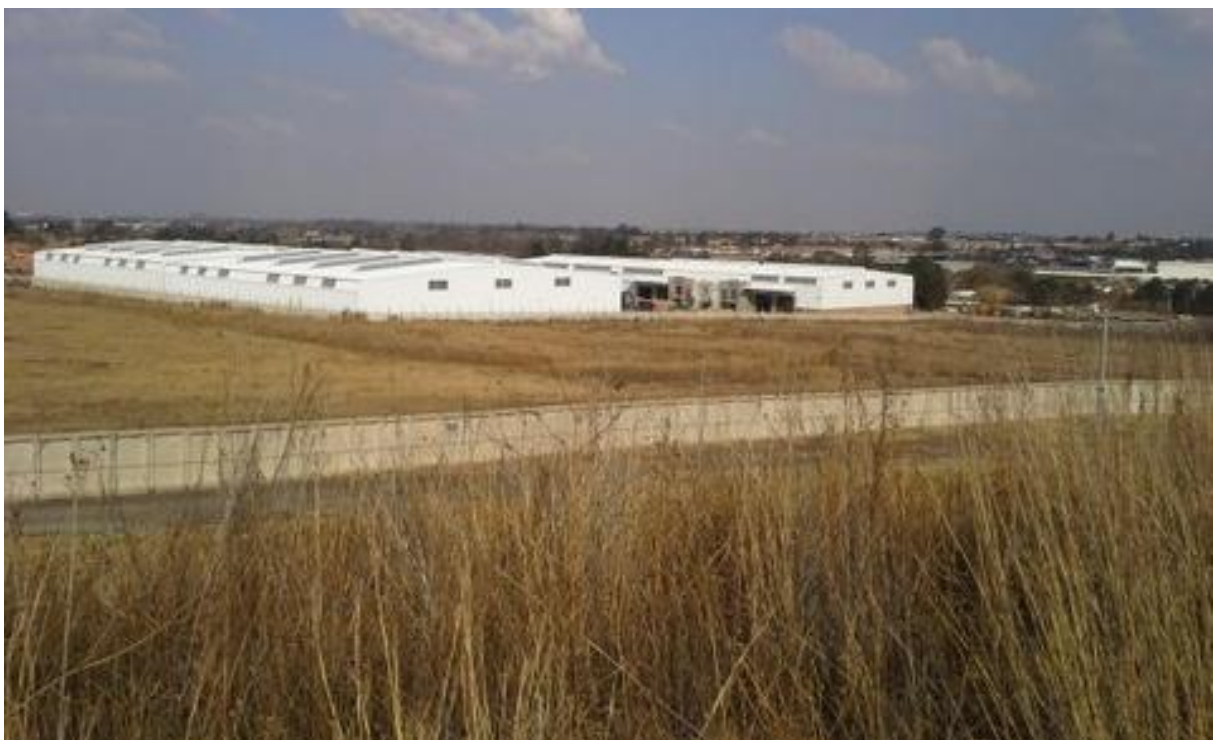
**Figure 5**  
A closer look of the buildings
