Report to EnviroPro Environmental Consulting (Pty) Ltd on a Preliminary Geotechnical Appraisal carried out for the Mfume Low Level Crossing over the Lovu River between Ndaya and Embothimuni, KwaZulu-Natal

Project No.: 19-157/4R01

Date Issued: August 2019

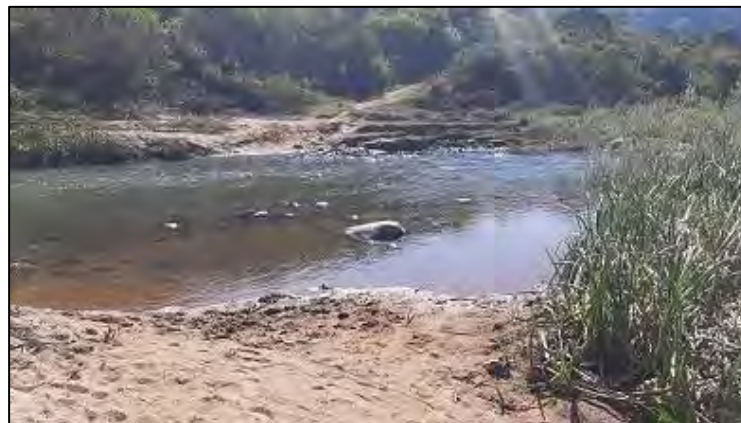
Plate 1: Site at the Lovu river showing the current gravel tracks used by pedestrians and cows

Topographically, there is a relatively steep gradient (20-30°) towards the river from the south along the access road (Plate 2) before becoming gently sloping closer to the sandy river bank on the north of the river channel. On the northern portion of the site the man-made footpath follows descends steeply sloping ground (10-15°) towards the river from the North (Plate 1). The Lovu River channel here is wide albeit shallow.

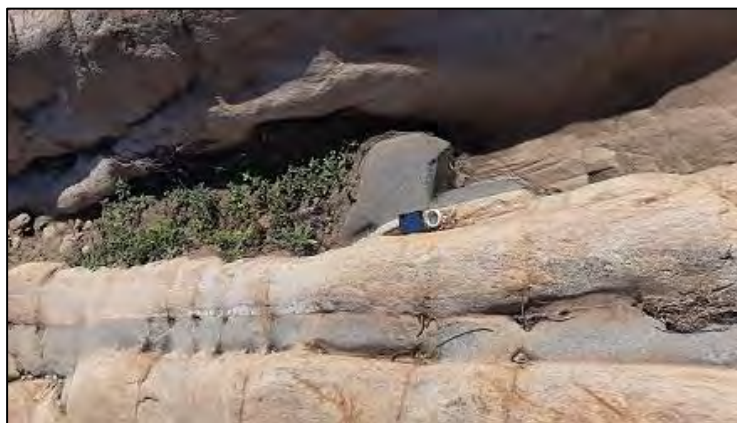
Plate 4: Gneiss bedrock exhibiting banding along the southern side of the Lovu river close to the existing dirt road. Mapumulo Metamorphic Suite

Banded gneisses are shown by abundant outcrop adjacent to the river (Plate 4). These rocks are described as light brownish grey banded dark grey, speckled white and black, slightly to medium weathered, closely to moderately jointed, at least medium hard rock biotite-feldspar GNEISS.

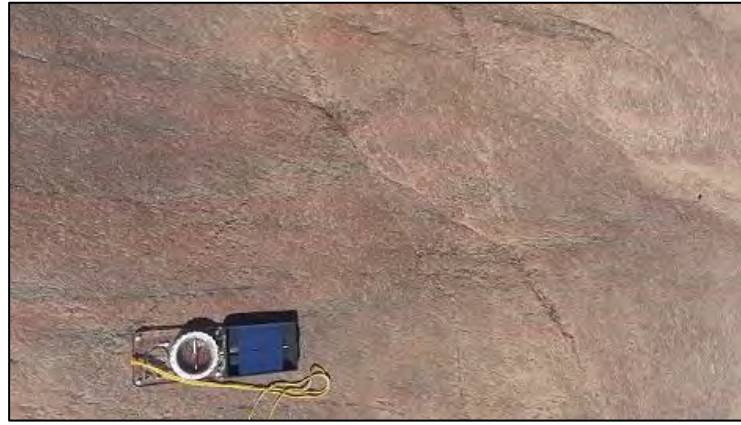
Plate 5: Gneiss bedrock within the Lovu river showing pink micro-banding

Further inspection along the river bed and within the river showed light grey streaked pink, slightly to medium weathered, moderately jointed, at least medium hard rock quartz-feldspar GNEISS.
