LETABA LAB (Pty) Ltd
CIVIL ENGINEERING MATERIALS LABORATORY

GEOTECHNICAL INVESTIGATION: RURAL RESIDENTIAL TOWNSHIP DEVELOPMENT MATOPORONG, REDDERSBURG

Letaba Lab
16/04/2014

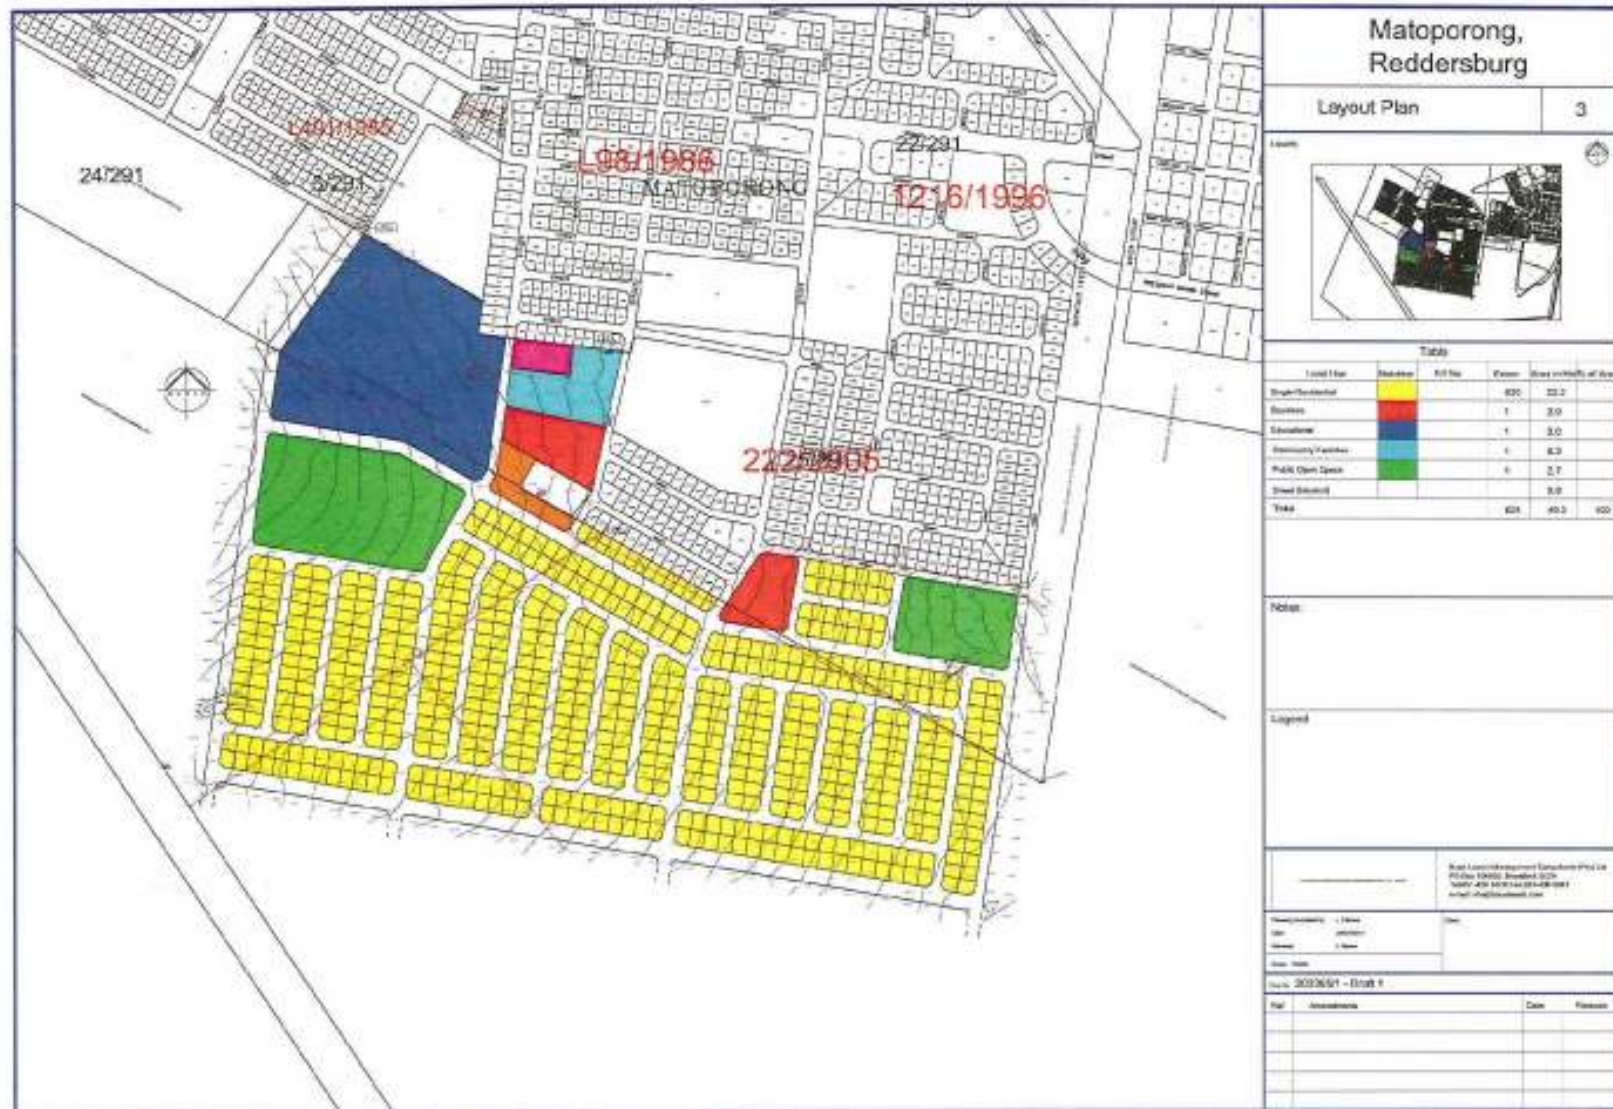
Figure 3: Site Layout Provided by the Client

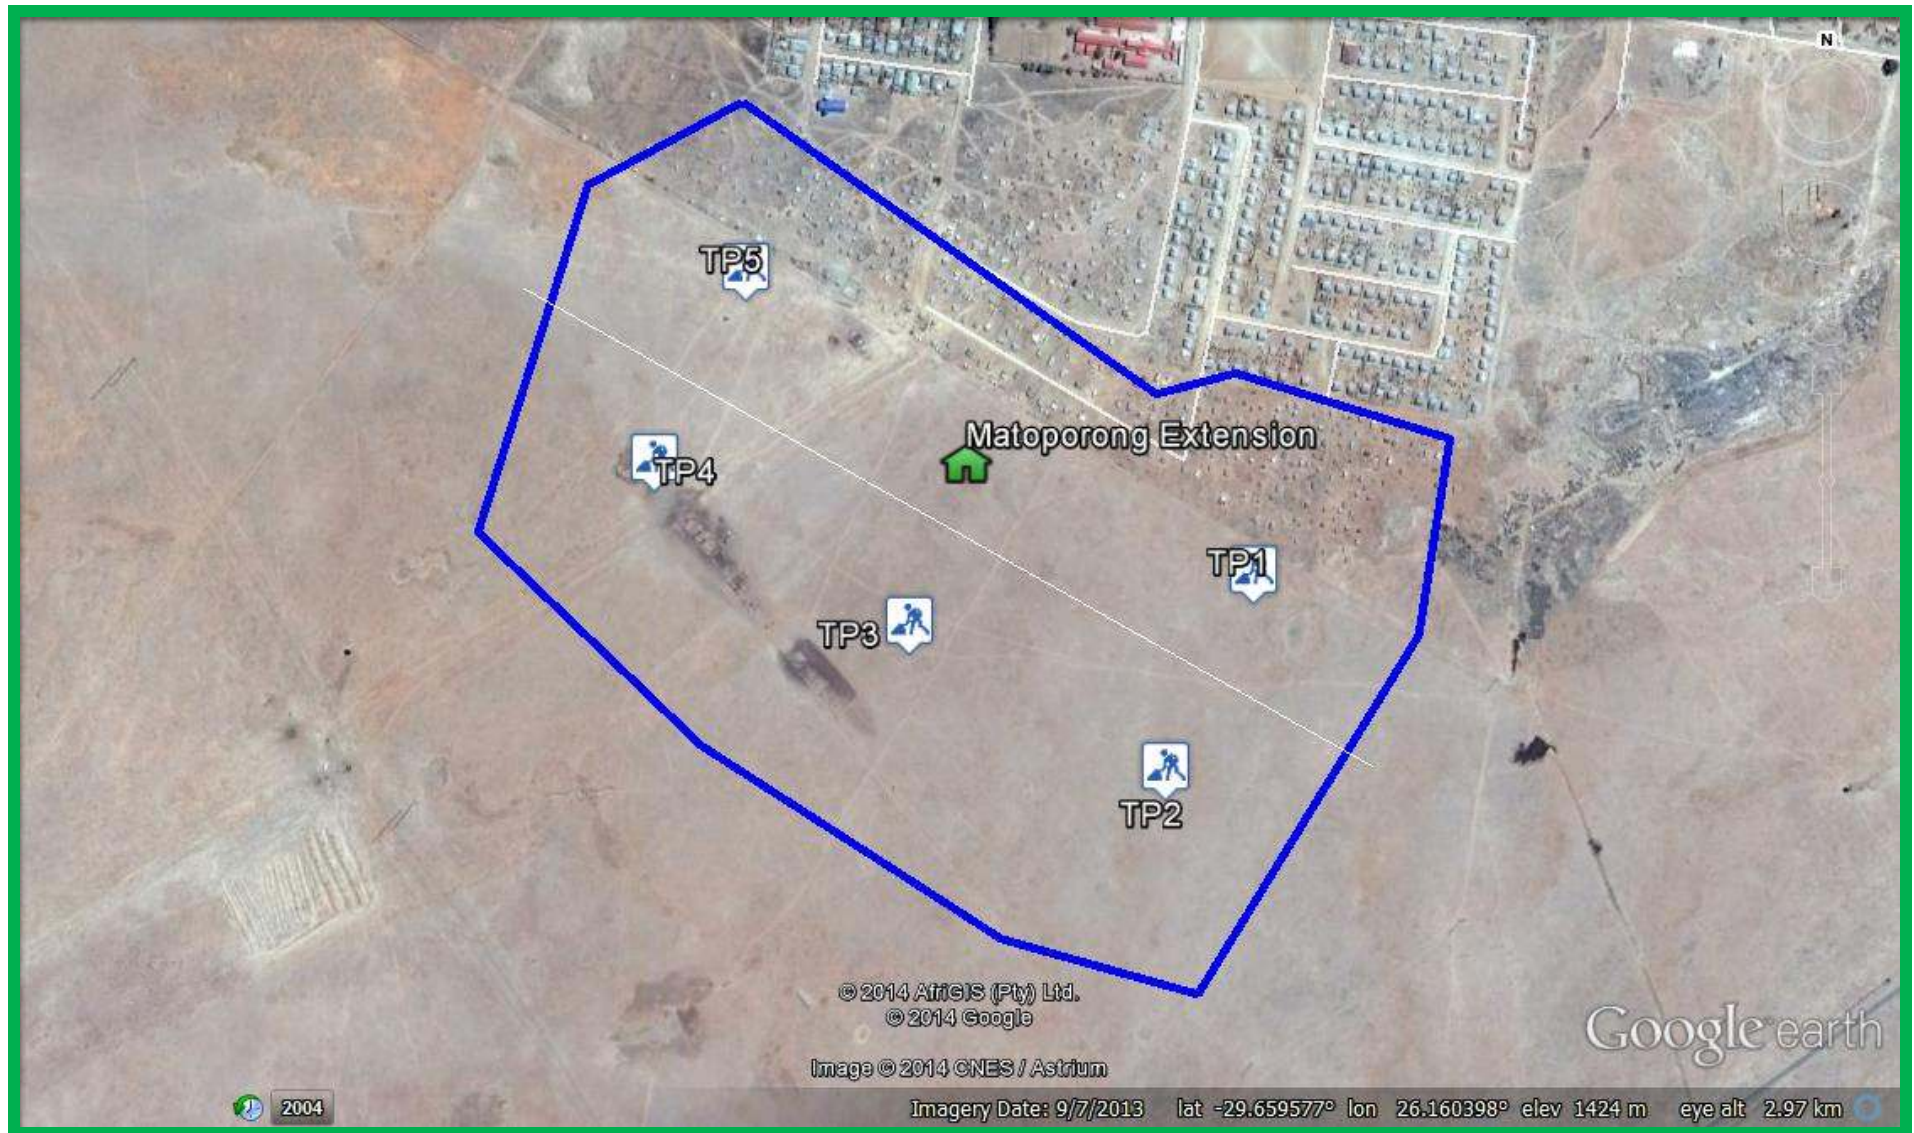
Figure 5: Study Area- Layout Map

The field work phase was done by Letaba Lab Bloemfontein on the following date: 2014/03/26. Test pits and DPL tests were placed throughout the study area in such a way as to accurately describe the general soil conditions occurring within the boundaries of the study area. The succession of soil and rock layers exposed within the test pits were logged and a series of detailed photographs were taken of the different soil layers, and samples were taken of the soil- and rock material deemed to be important to the proposed development. (Figure 5)

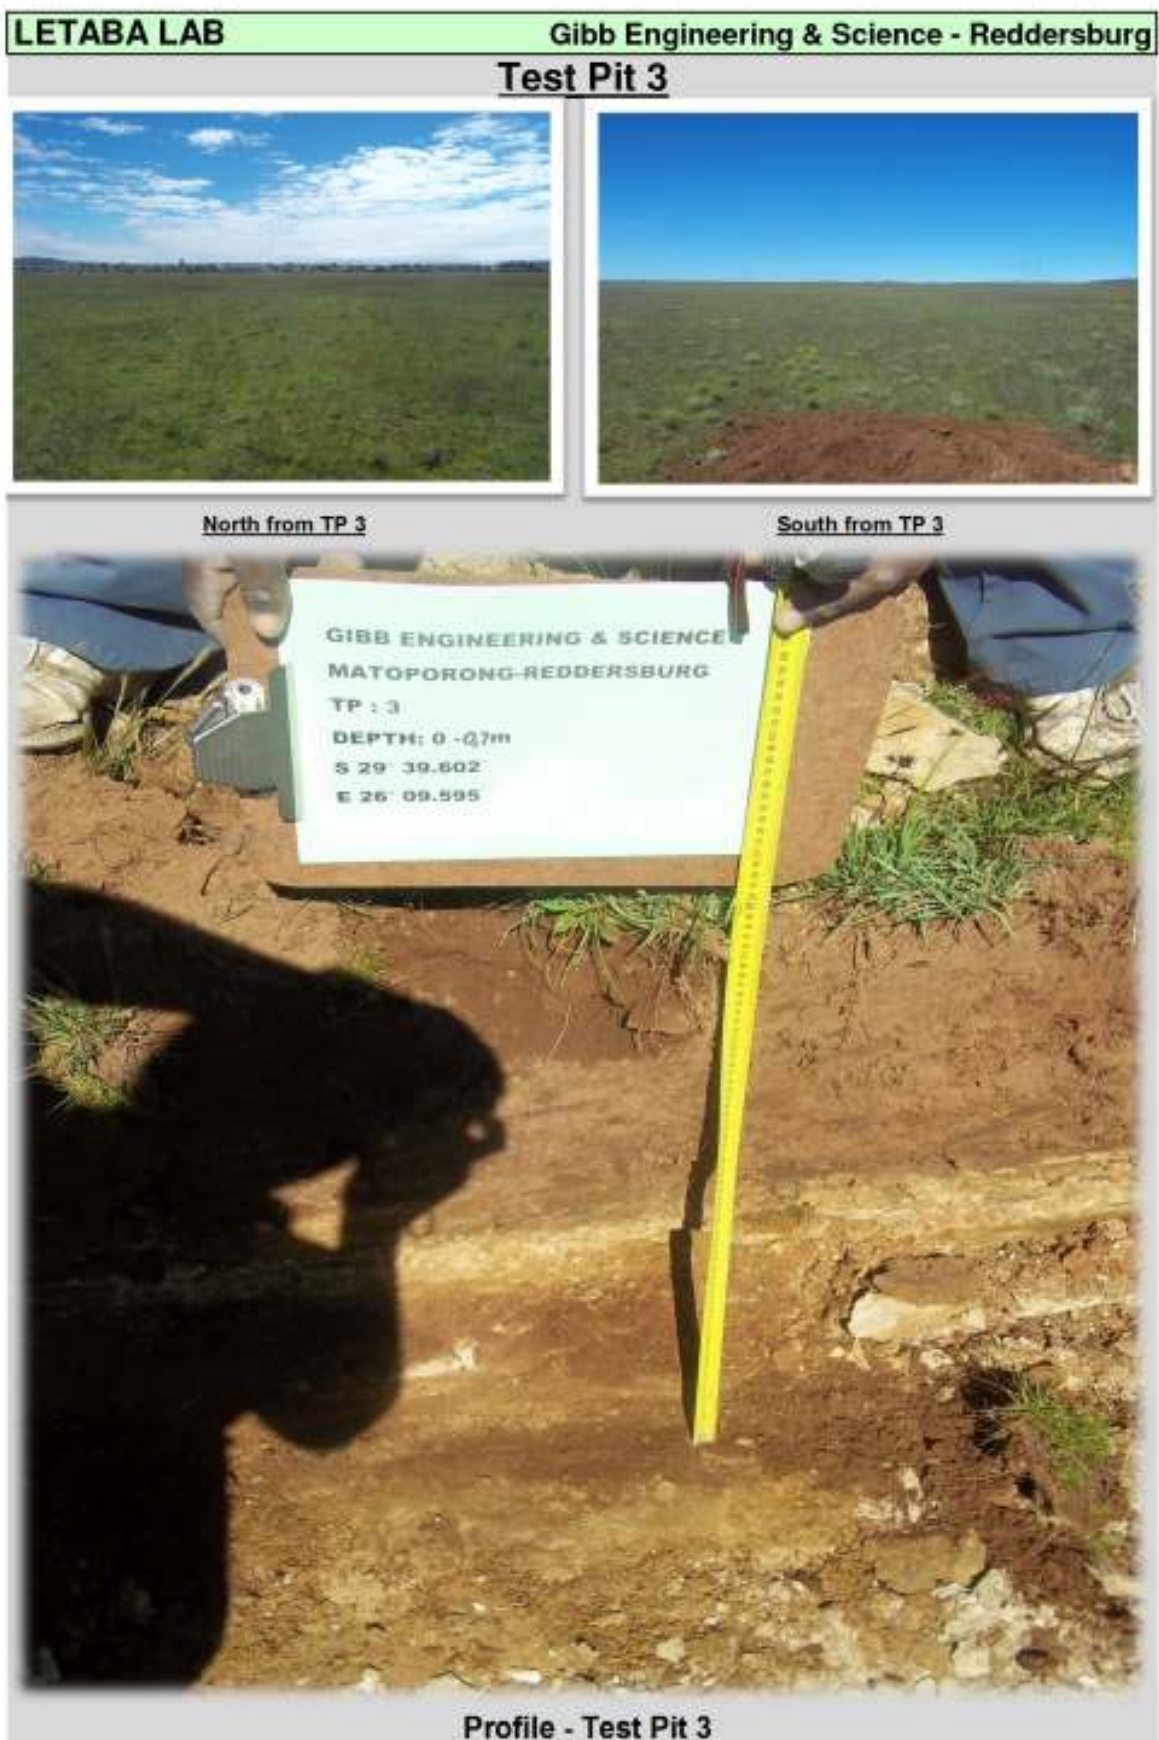
SOIL PROFILES FOR Gibb Engineering & Science - Reddersburg

slightly moist dark Reddish Brown , loose , silty/clayey sand , transported - roots :-
Sample No : 1980/3

slightly moist dark Yellowish Brown stained Reddish Orange, very dense , sub-angular
sandstone, residual - roots and Refusal with TLB :- Sample No : 1980/4

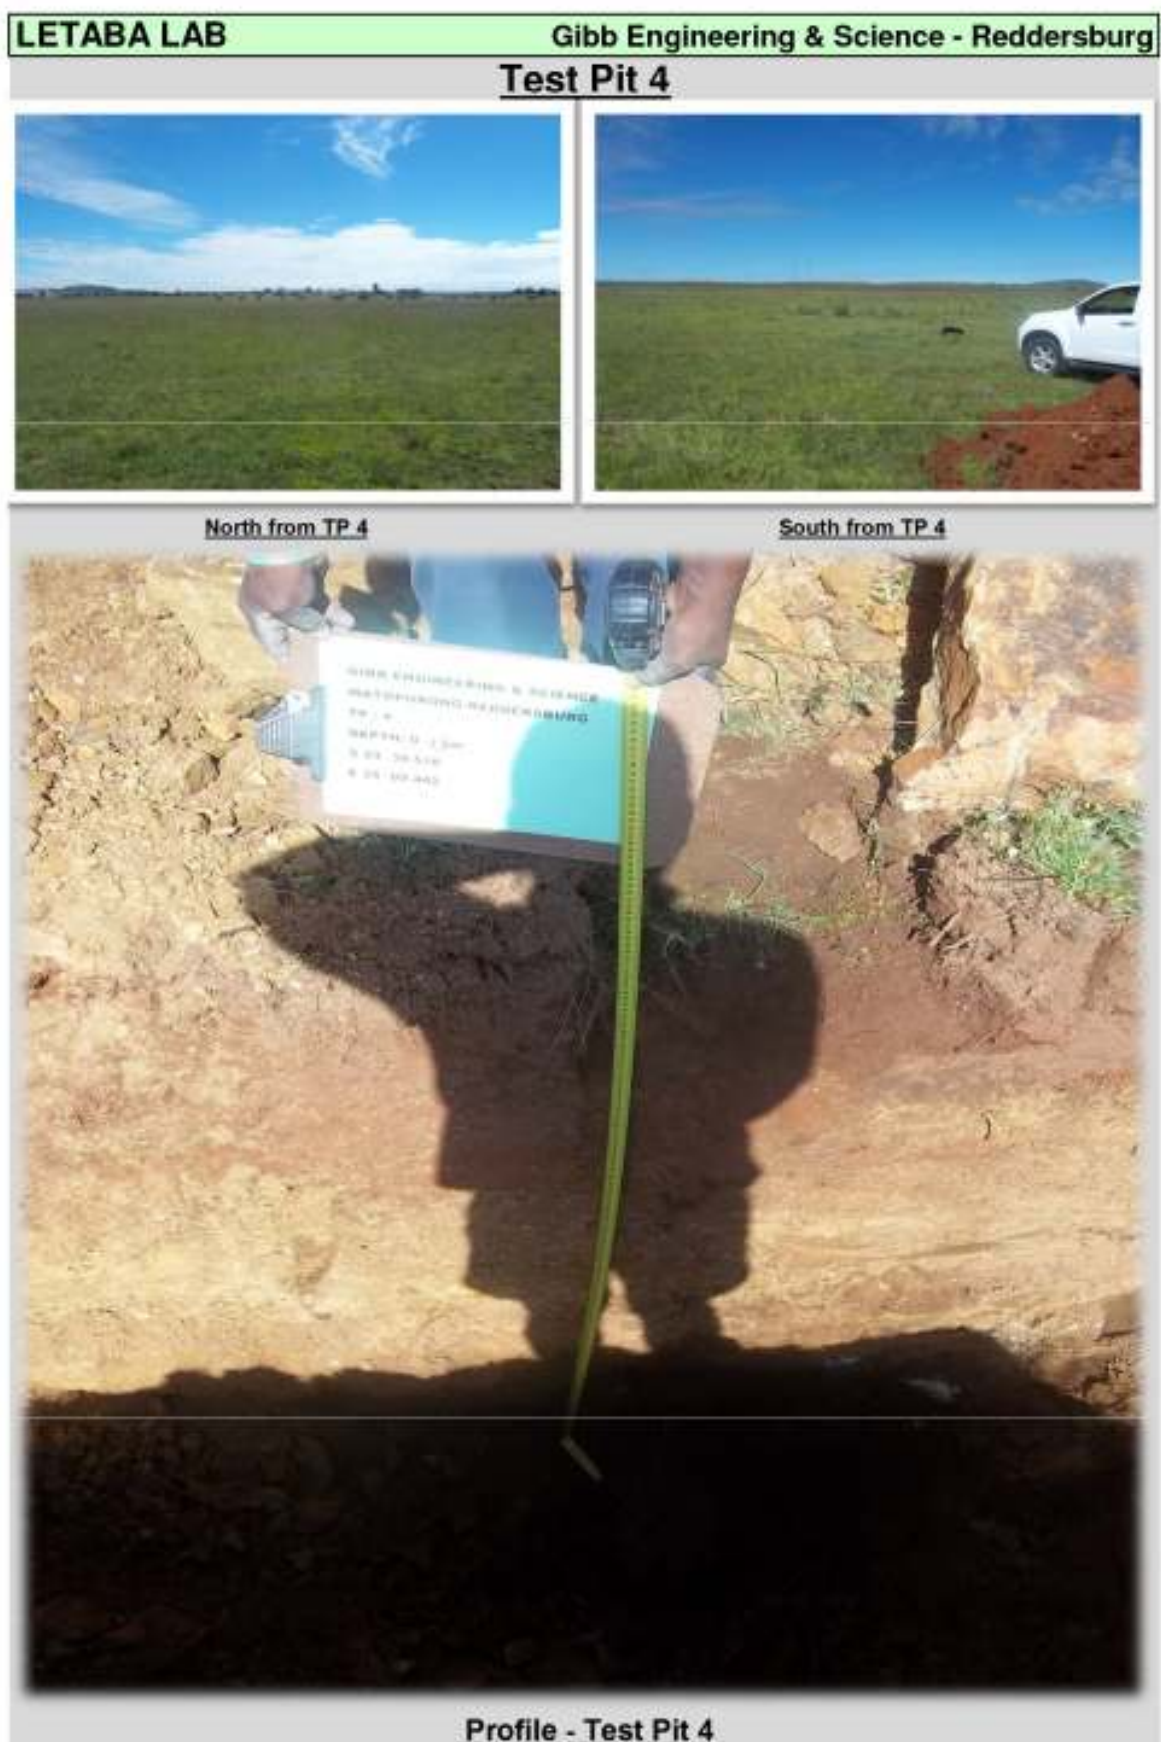
Gibb Engineering & Science - Reddersburg

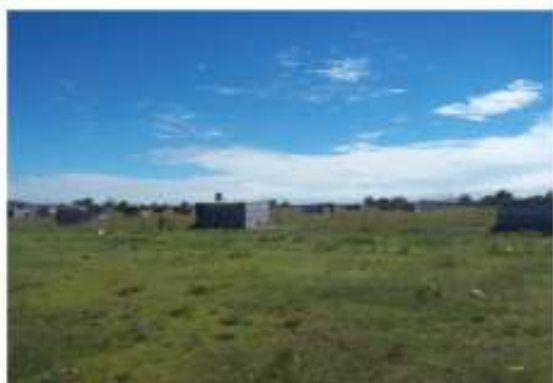
North from TP 5

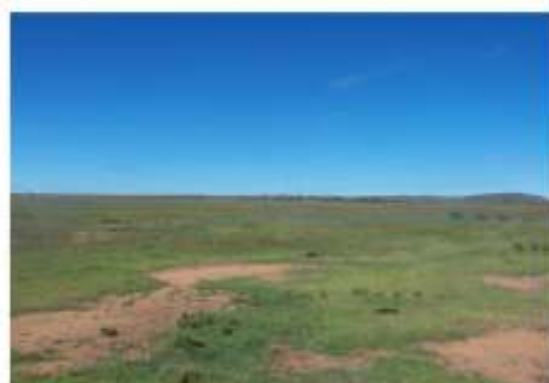
South from TP 5

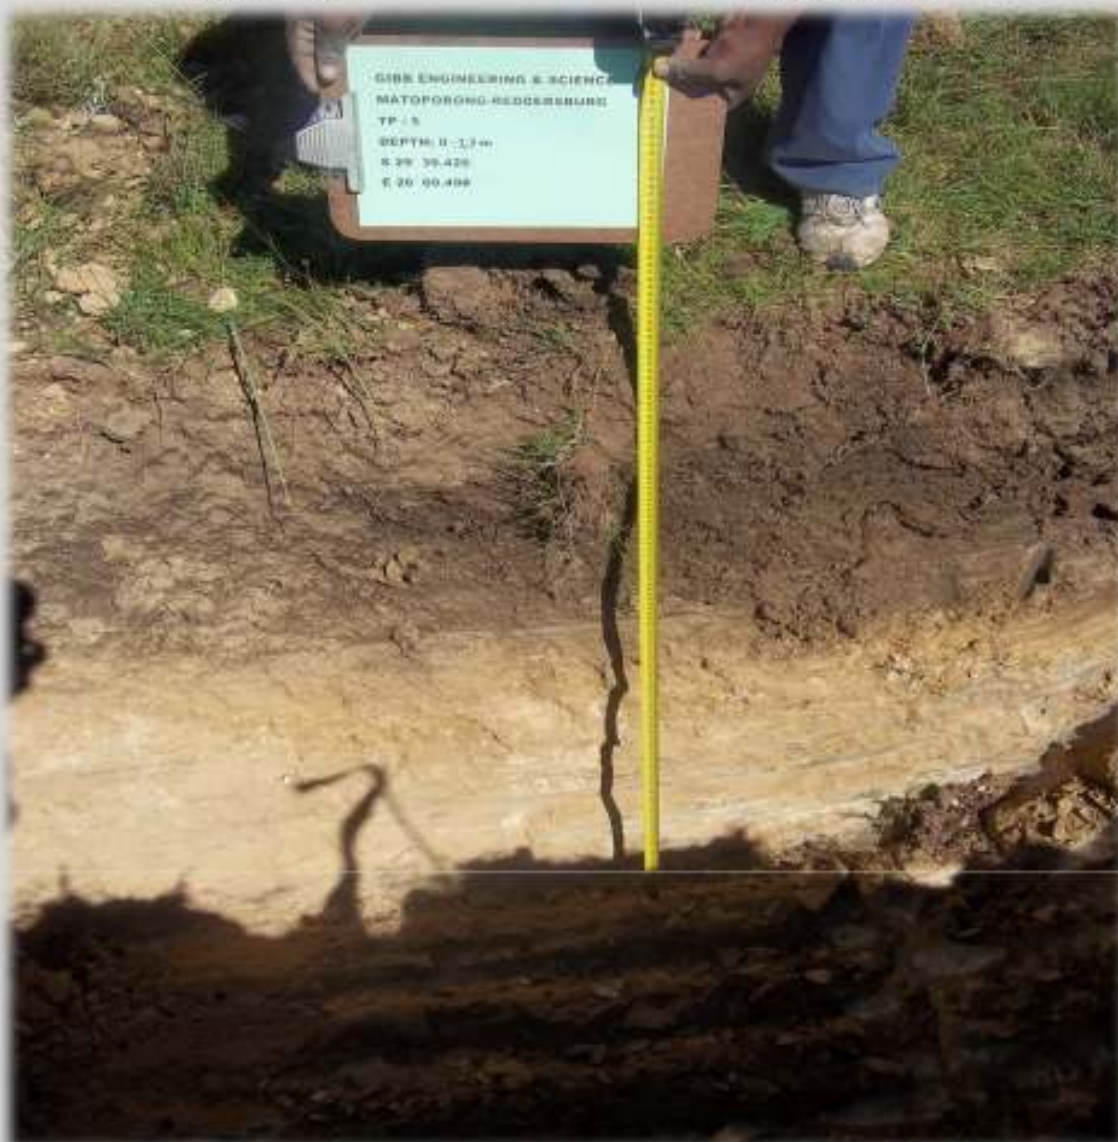
Profile - Test Pit 5

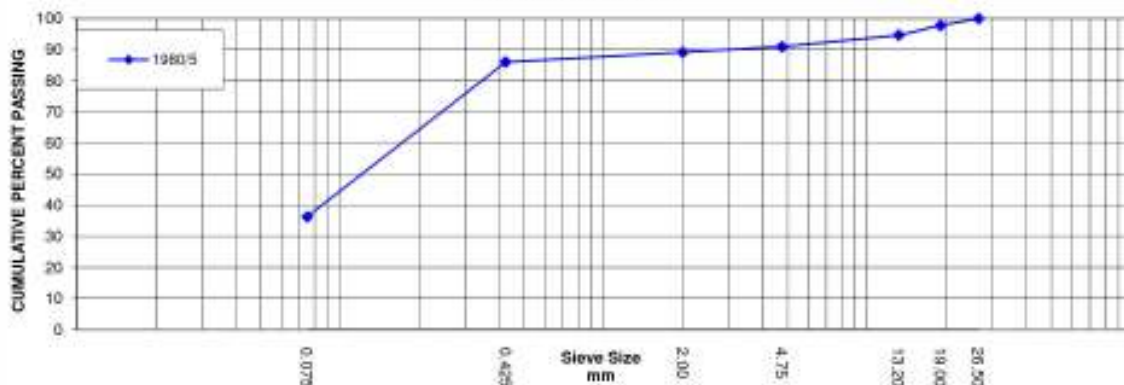
GRADING ANALYSIS

Effective size (mm):	<0.075
Uniformity co-eff.:	171
Curvature co-eff.:	0.6
Oversize Index:	0
Shrinkage Product:	301
Grading co-eff.:	9.9

Coarse Sand (<2.0>0.425mm):	3.1%
Fine Sand (<0.425>0.075mm):	49.7%
Material <0.075mm:	36.3%

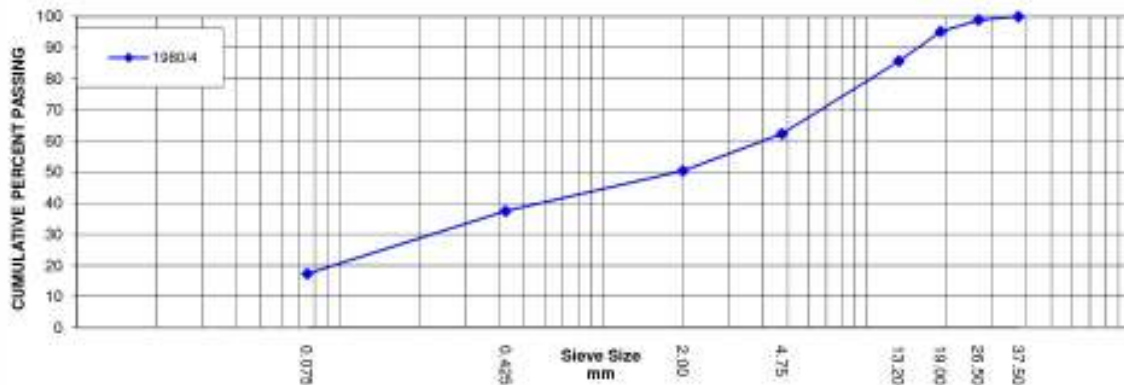
GRADING ANALYSIS

Effective size (mm): **<0.075**
Uniformity co-eff. : **4019**
Curvature co-eff. : **12.4**
Oversize Index : **0**
Shrinkage Product : **277**
Grading co-eff. : **30.2**

Coarse Sand (<2.0>0.425mm) : **12.9%**
Fine Sand (<0.425>0.075mm) : **20.2%**
Material <0.075mm : **17.3%**

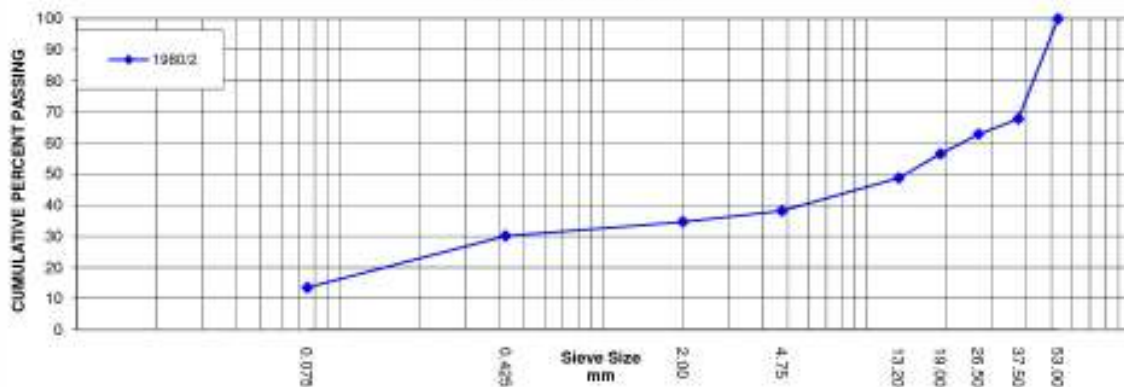
GRADING ANALYSIS

Effective size (mm):	<0.075
Uniformity co-eff.:	22817
Curvature co-eff.:	7.7
Oversize Index:	32
Shrinkage Product:	229
Grading co-eff.:	10.7

Coarse Sand (<2.0>0.425mm):	4.5%
Fine Sand (<0.425>0.075mm):	16.6%
Material <0.075mm:	13.5%
