ACSA - AA2073 -INSTALLATION OF BULK SERVICES AND ACCESS ROAD AT CAPE TOWN INTERNATIONAL AIRPORT'S PRECINCT 3

February 13 2023

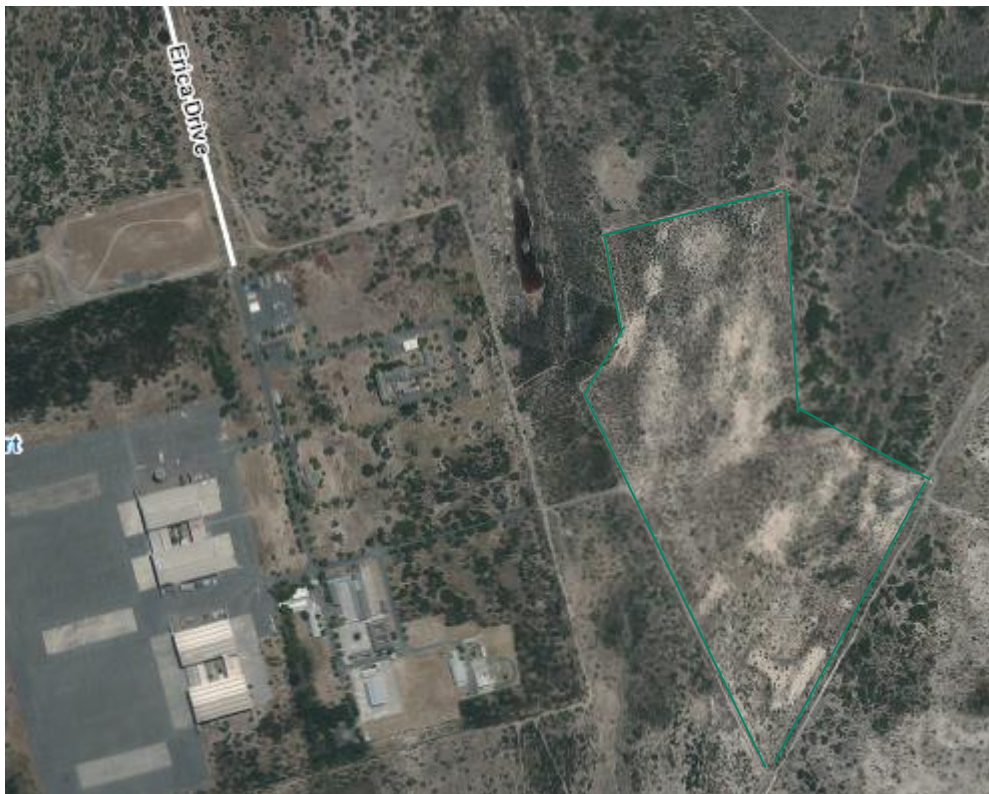
Figure 1: Aerial image of the proposed site(From City of Cape Town Map viewer)

The site is located west of the security check point on Erica Drive at 33°57'38.81"S latitude and 18°37'11.82"E Longitude. The site is bordered by Cape Town international airport in the west and semi-arid undulating land in the south and east with a nature reserve in the north.

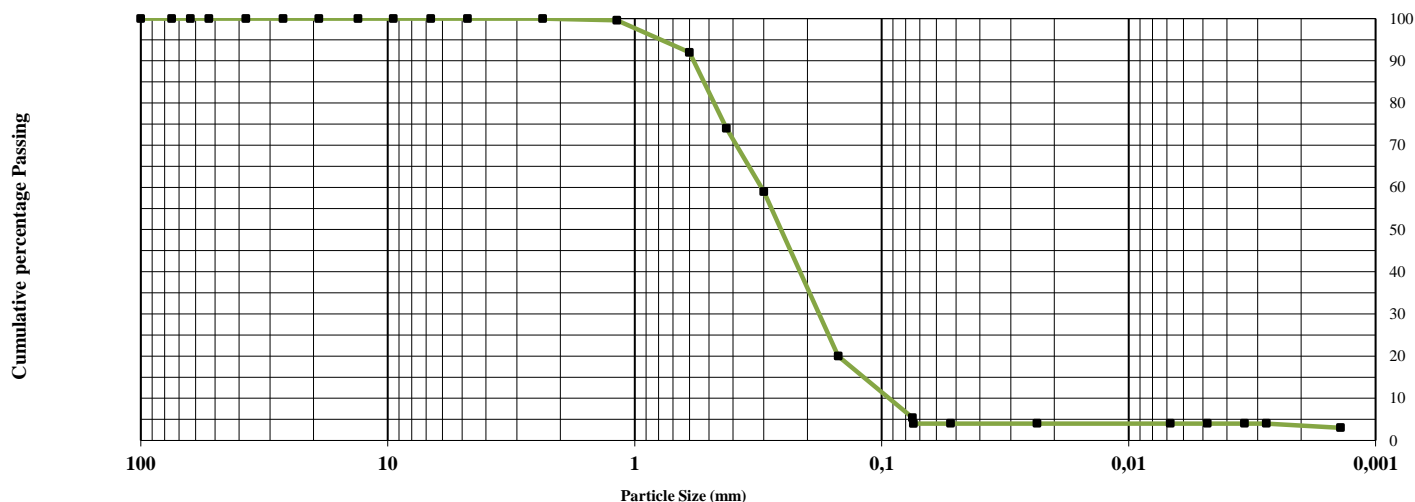
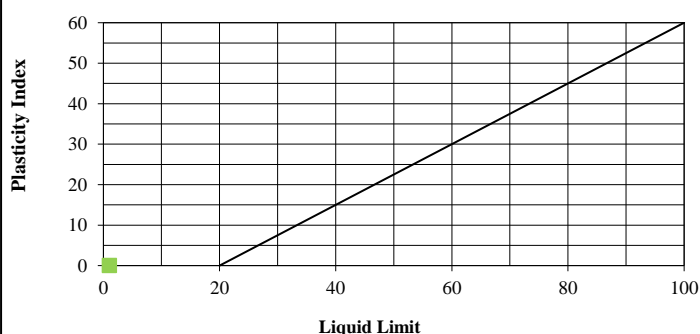
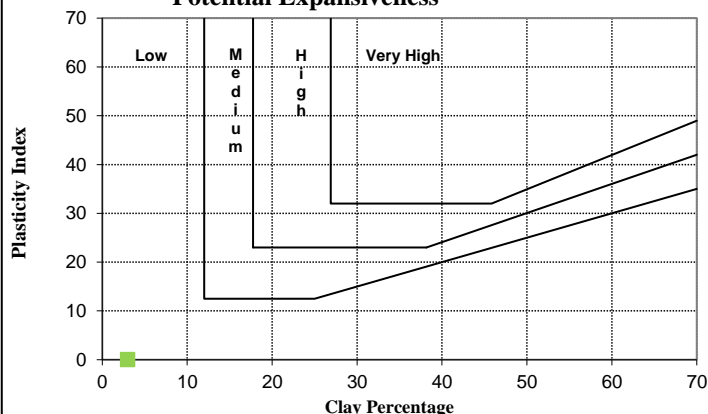
Particle Size Distribution

OMC%	12,2	COMP MC	% SWELL	100%	98%	97%	95%	93%	90%
MDD(KG/M ³)	1844	12,2	0,0	22	19	17	14	12	9

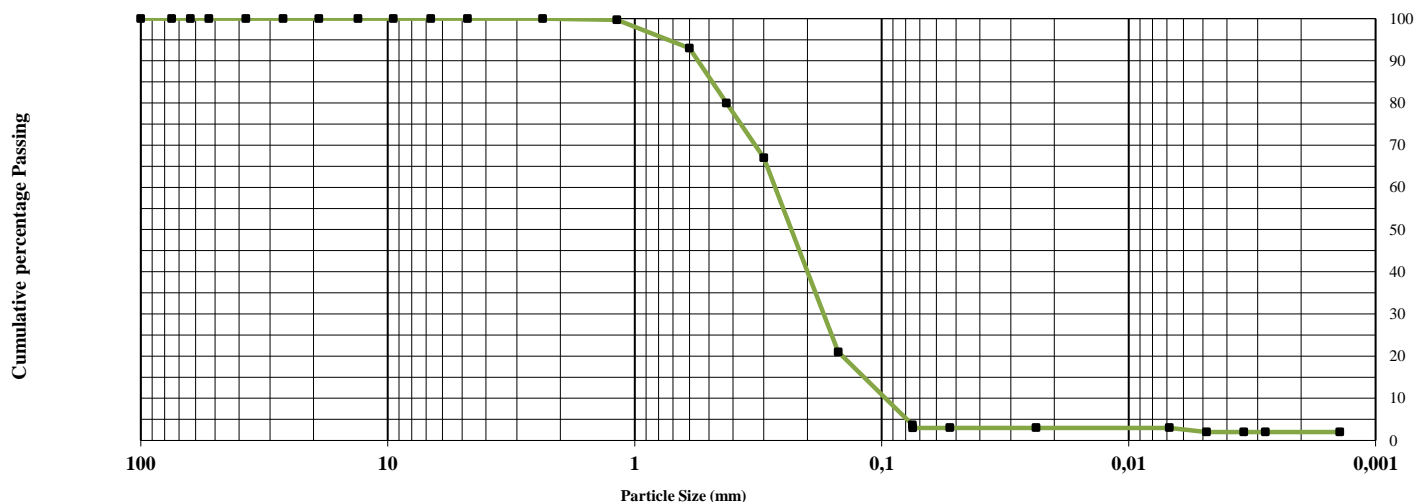
Particle Size Distribution

OMC%	10,3	COMP MC	% SWELL	100%	98%	97%	95%	93%	90%
MDD(KG/M ³)	1760	10,3	0,0	20	16	14	11	9	6

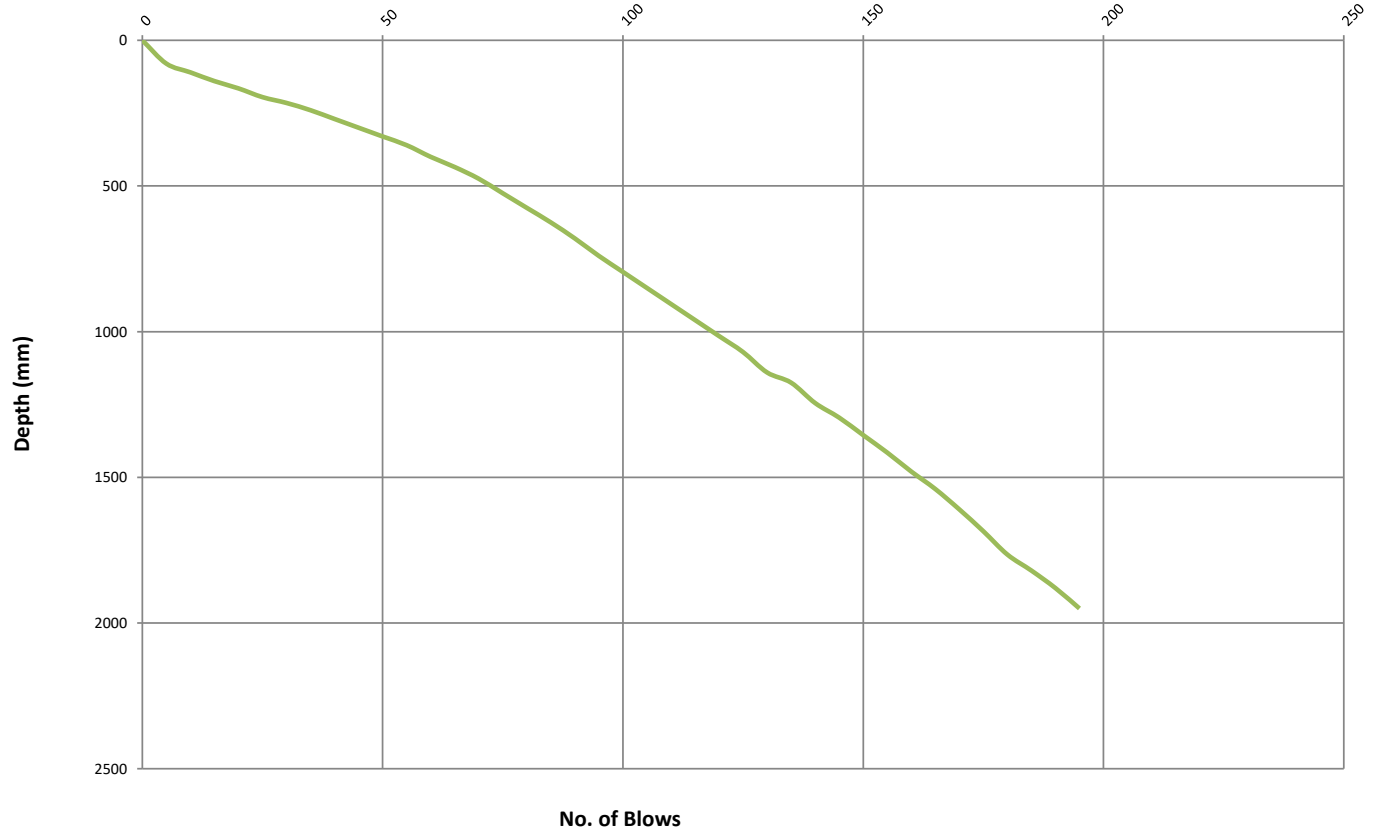
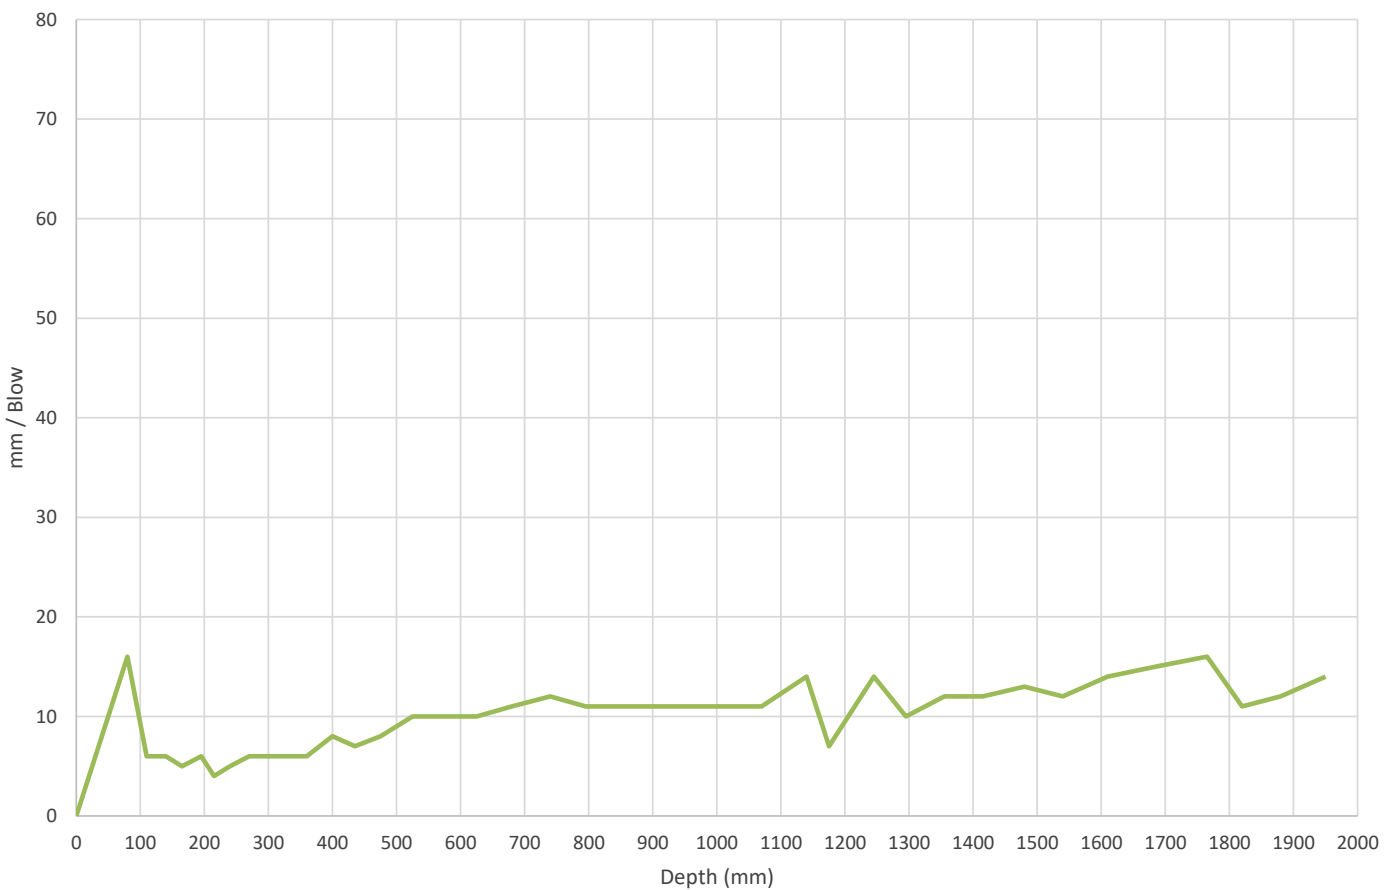
GRAPHICAL REPRESENTATION / DYNAMIC CONE PENETROMETER TMH6 ST6

Number of Blows	Depth (mm)	Corrective Depth (mm)	Penetration Tempo	Structure Nr. (dn) mm/blow
0	105	0		
5	185	80	80	16
10	215	110	30	6
15	245	140	30	6
20	270	165	25	5
25	300	195	30	6
30	320	215	20	4
35	345	240	25	5
40	375	270	30	6
45	405	300	30	6
50	435	330	30	6
55	465	360	30	6
60	505	400	40	8
65	540	435	35	7
70	580	475	40	8
75	630	525	50	10
80	680	575	50	10
85	730	625	50	10
90	785	680	55	11
95	845	740	60	12
100	900	795	55	11
105	955	850	55	11
110	1010	905	55	11
115	1065	960	55	11
120	1120	1015	55	11
125	1175	1070	55	11
130	1245	1140	70	14
135	1280	1175	35	7
140	1350	1245	70	14
145	1400	1295	50	10
150	1460	1355	60	12
155	1520	1415	60	12
160	1585	1480	65	13
165	1645	1540	60	12
170	1715	1610	70	14
175	1790	1685	75	15
180	1870	1765	80	16
185	1925	1820	55	11
190	1985	1880	60	12
195	2055	1950	70	14

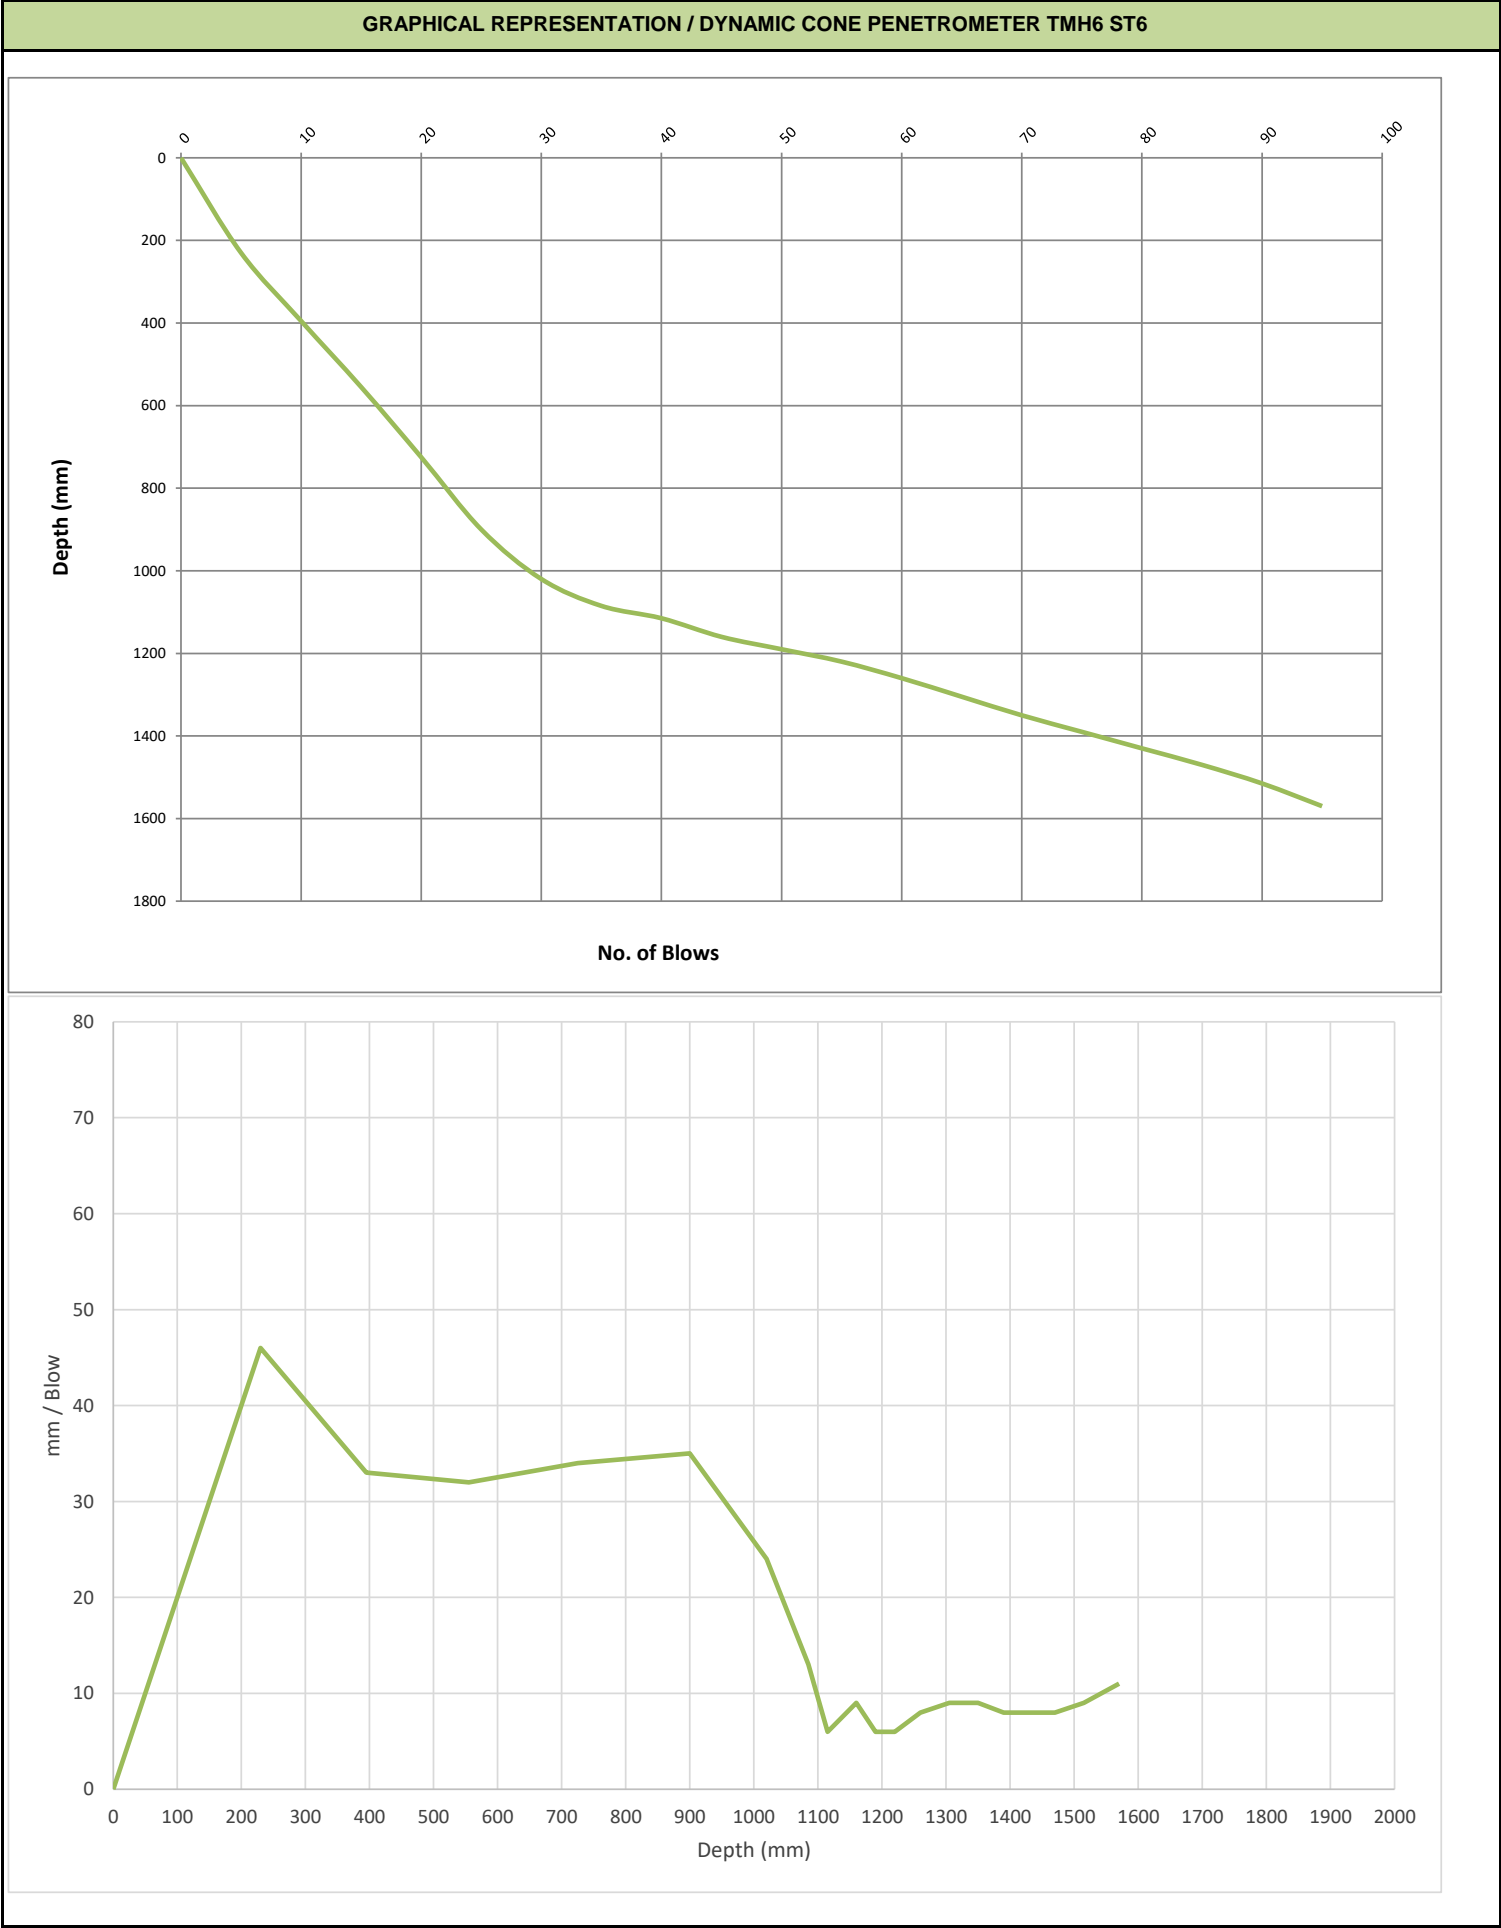
PROJECT:	ACSA	LEVEL:	NGL
TEST POSITION:	TH4	FOUNDATION:	N/A
TEST DEPTH:	*DCP 2 m (This is not a standard nor an accredited Method)	STARTING DEPTH:	465mm
MATERIAL TYPE:	Sandy Materials	Max. penetration depth:	1570mm
CONSTRUCTION TYPE:	Structural	REFUSAL:	None
INSTRUMENT (DCP) SET No:	DCP 2m - BT2/0008	NOB/TEST:	5
DATE TESTED:	09/02/23

Number of Blows	Depth (mm)	Corrective Depth (mm)	Penetration Tempo	Structure Nr. (dn) mm/blow
0	465	0		
5	695	230	230	46
10	860	395	165	33
15	1020	555	160	32
20	1190	725	170	34
25	1365	900	175	35
30	1485	1020	120	24
35	1550	1085	65	13
40	1580	1115	30	6
45	1625	1160	45	9
50	1655	1190	30	6
55	1685	1220	30	6
60	1725	1260	40	8
65	1770	1305	45	9
70	1815	1350	45	9
75	1855	1390	40	8
80	1895	1430	40	8
85	1935	1470	40	8
90	1980	1515	45	9
95	2035	1570	55	11

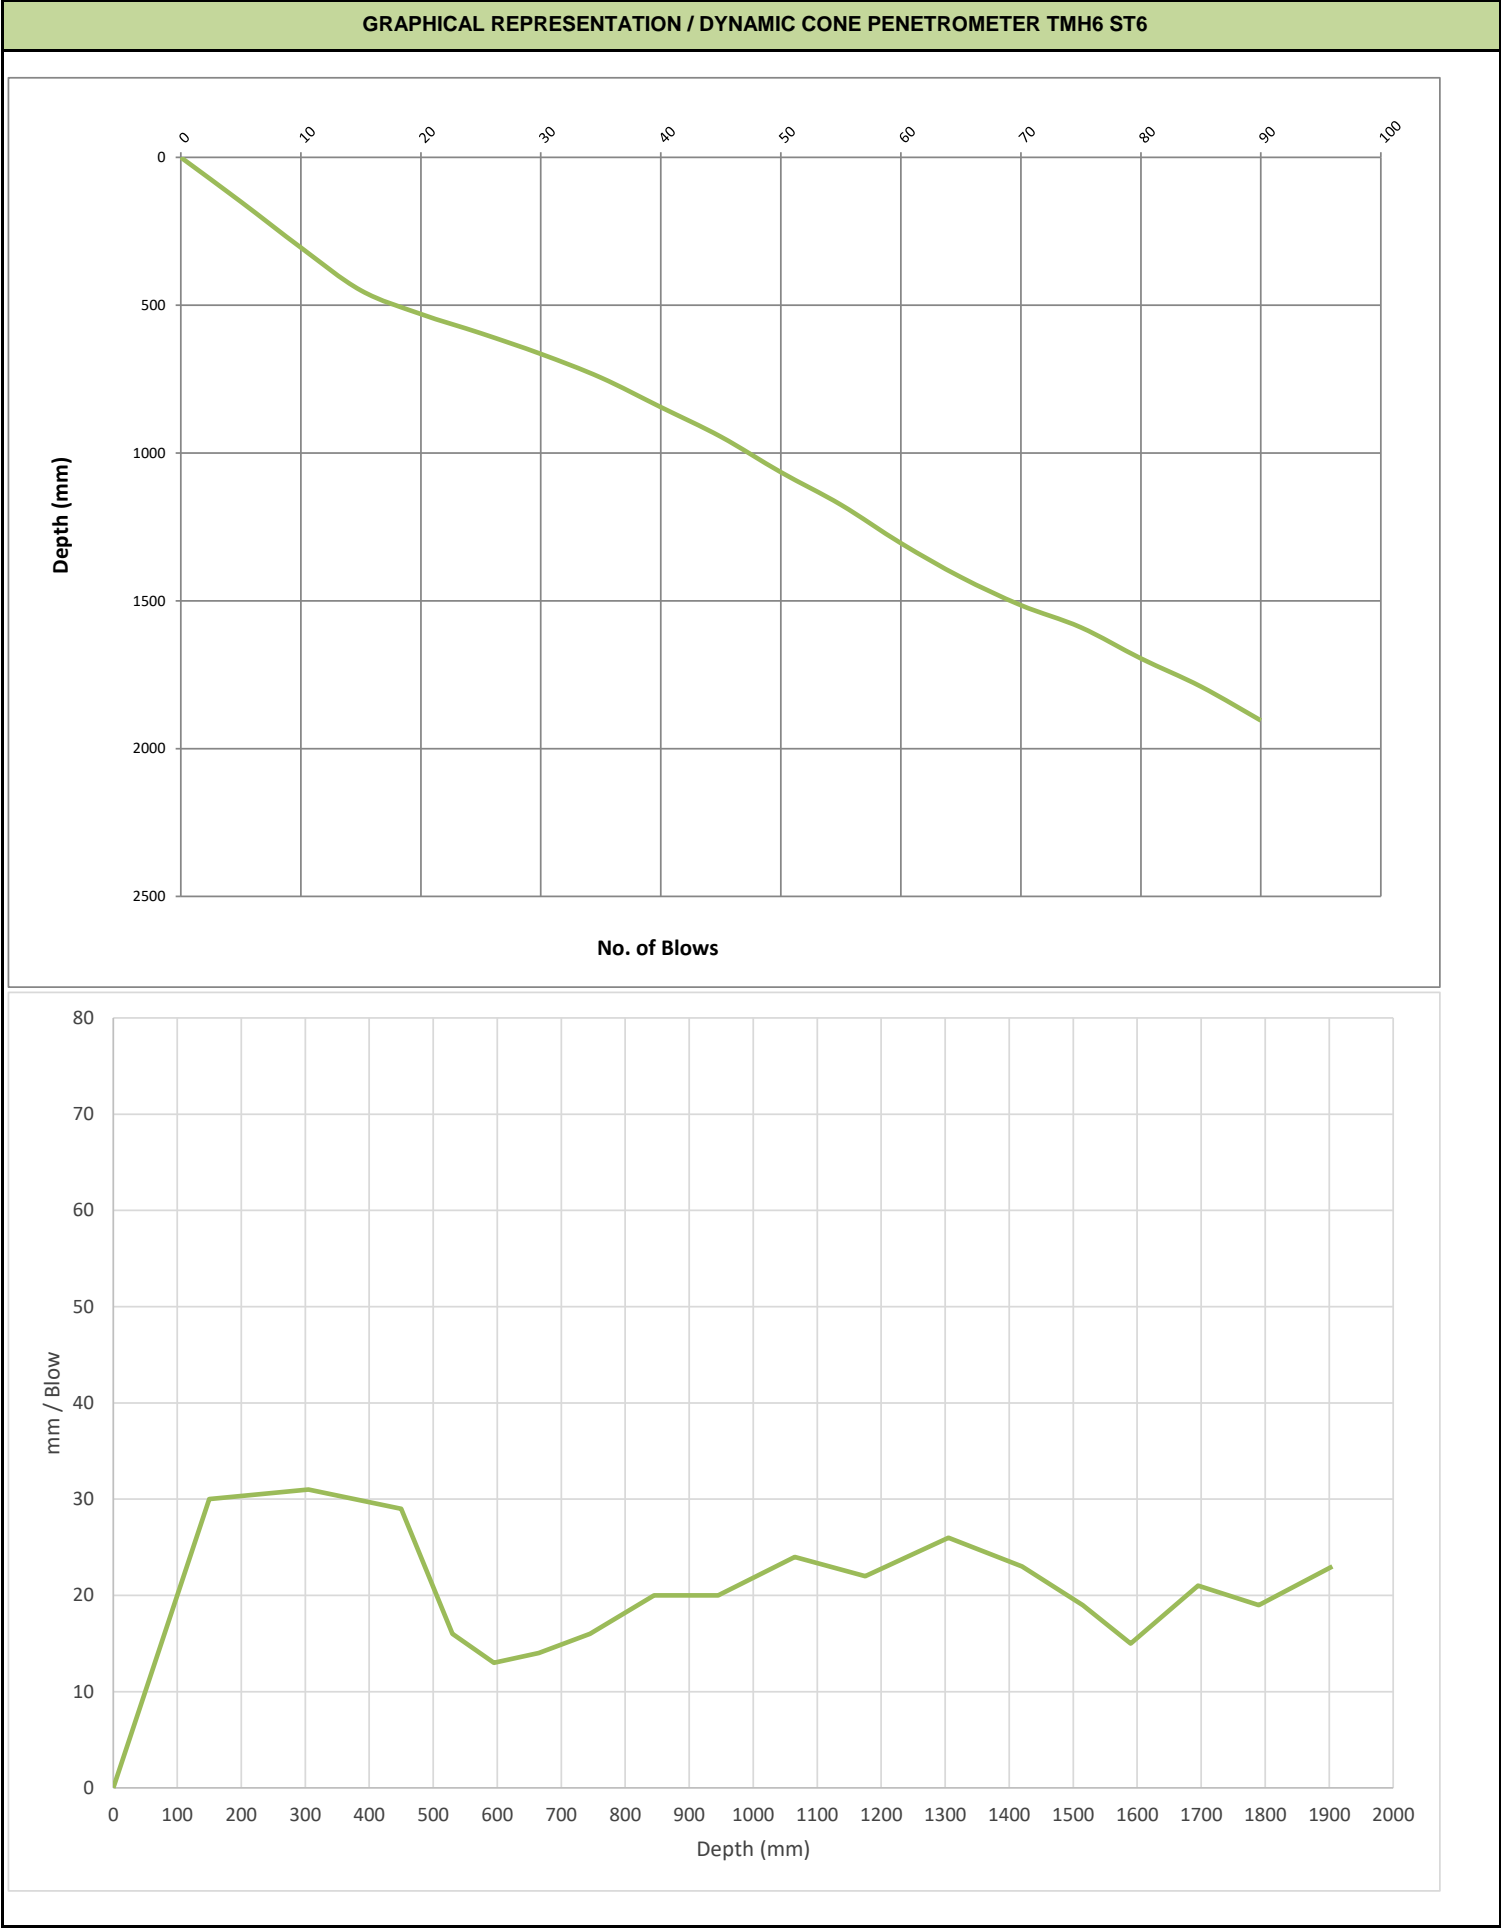
PROJECT:	ACSA	LEVEL:	1.4m BNGL
TEST POSITION:	TP5	FOUNDATION:	N/A
TEST DEPTH:	*DCP 2 m (This is not a standard nor an accredited Method)	STARTING DEPTH:	140mm
MATERIAL TYPE:	Sandy Materials	Max. penetration depth:	1905mm
CONSTRUCTION TYPE:	Structural	REFUSAL:	None
INSTRUMENT (DCP) SET No:	DCP 2m - BT2/0008	NOB/TEST:	5
DATE TESTED:	09/02/23

Number of Blows	Depth (mm)	Corrective Depth (mm)	Penetration Tempo	Structure Nr. (dn) mm/blow
0	140	0		
5	290	150	150	30
10	445	305	155	31
15	590	450	145	29
20	670	530	80	16
25	735	595	65	13
30	805	665	70	14
35	885	745	80	16
40	985	845	100	20
45	1085	945	100	20
50	1205	1065	120	24
55	1315	1175	110	22
60	1445	1305	130	26
65	1560	1420	115	23
70	1655	1515	95	19
75	1730	1590	75	15
80	1835	1695	105	21
85	1930	1790	95	19
90	2045	1905	115	23
