MATIMBA POWER STATION ASH DUMP

GEOTECHNICAL INVESTIGATION

FINAL GEOTECHNICAL REPORT

Project No: 30100825/01

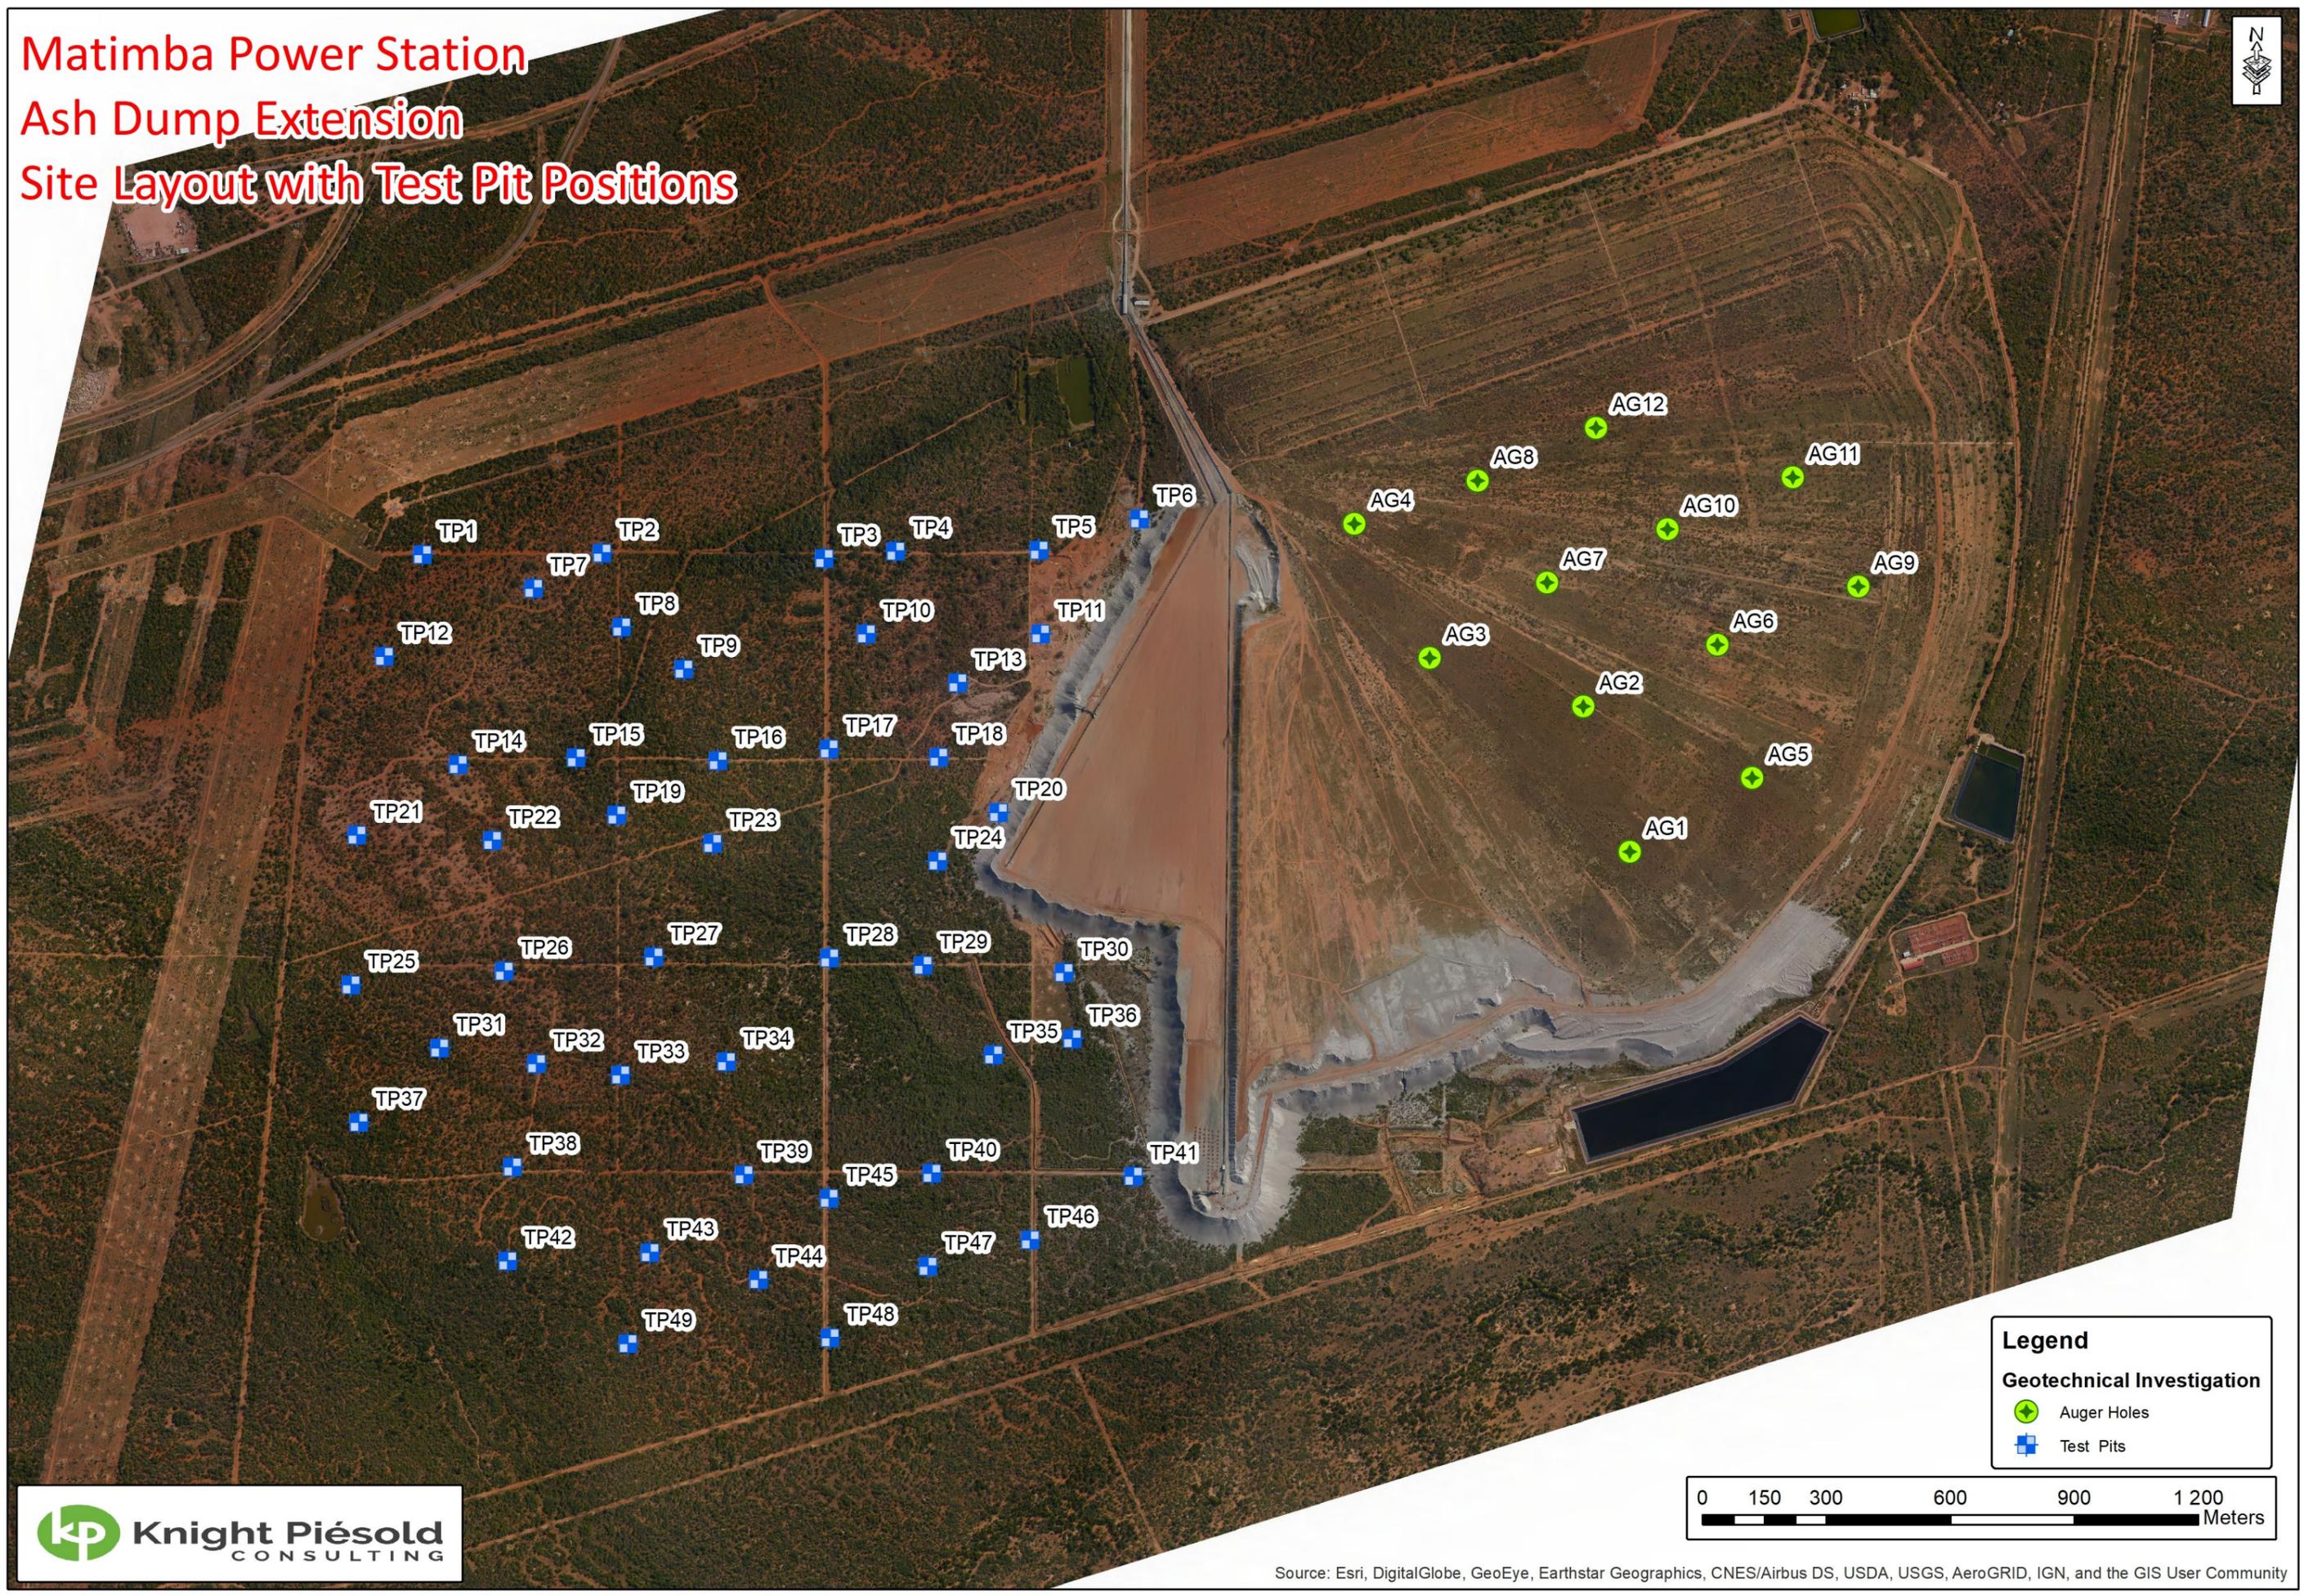
Matimba Power Station Ash Dump Extension Site Layout with Test Pit Positions

The existing ash dump (eastern portion) is approximately halfway through deposition on the designated eastern site area and the geotechnical investigation was required for the western part of the ash dump extension. Figure 1 provides the site layout. The foundations of the ash dump will be lined according to national requirements.

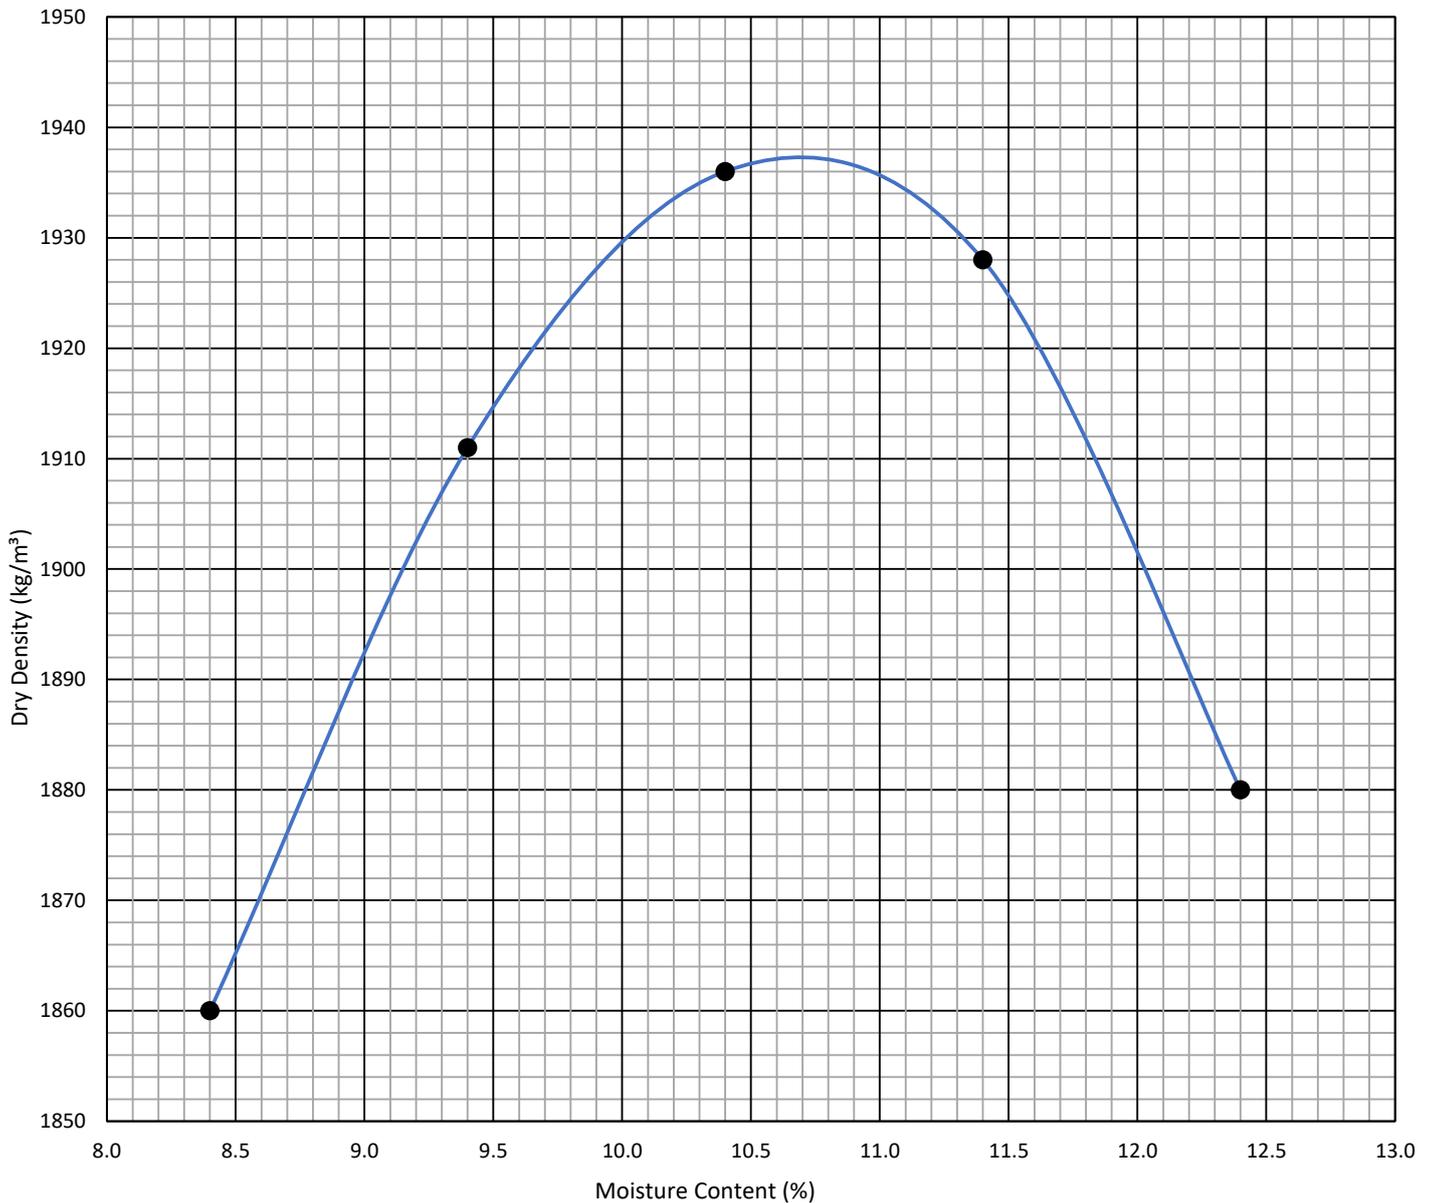
Moisture Content (%):	8.4	9.4	10.4	11.4	12.4			
Dry Density (kg/m ³)	1860	1911	1936	1928	1880

The Standard Proctor Maximum Dry Density (MDD) for colluvium varies between 1942kg/m³ and 2088kg/m³ (average of 2055kg/m³) with an Optimum Moisture Content of 7% to 11%. The soil compacted to 95% of MDD has an internal friction angle of 34° with a zero cohesion. At the same compaction the soil has a coefficient of permeability (k-value) of 1,9 x 10⁻⁴ cm/s to 2 x 10⁻⁵ cm/s.

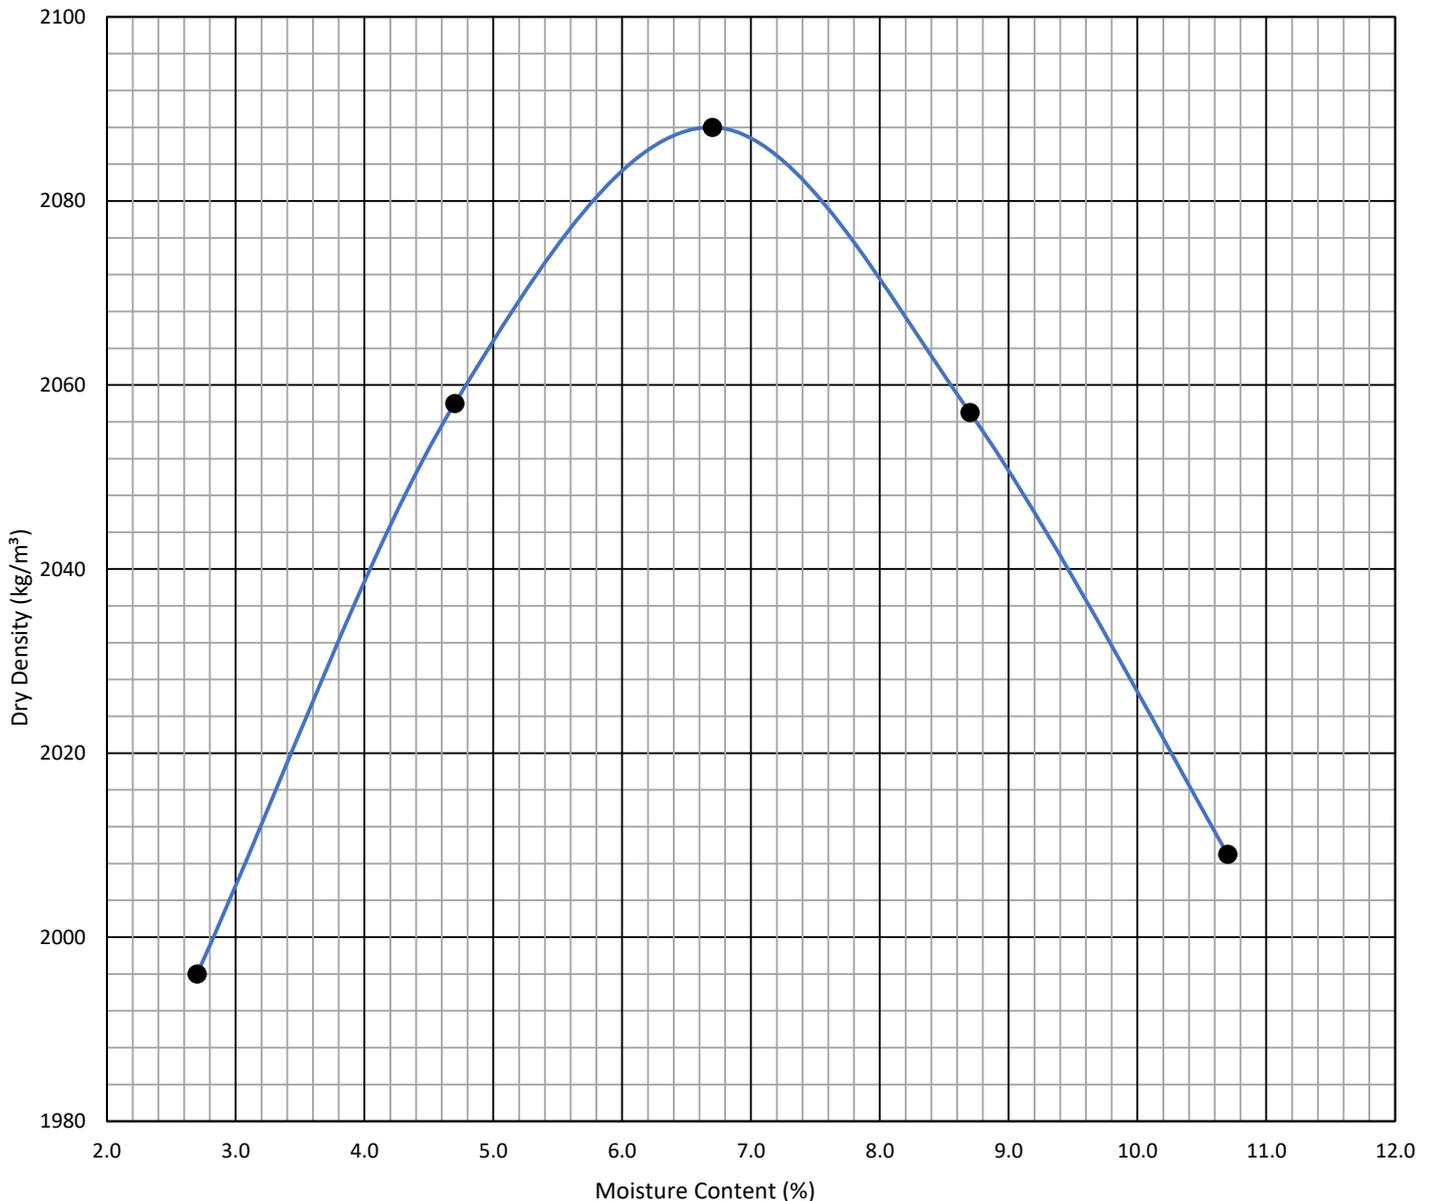
Moisture Content (%):	2.7	4.7	6.7	8.7	10.7			
Dry Density (kg/m ³)	1996	2058	2088	2057	2009

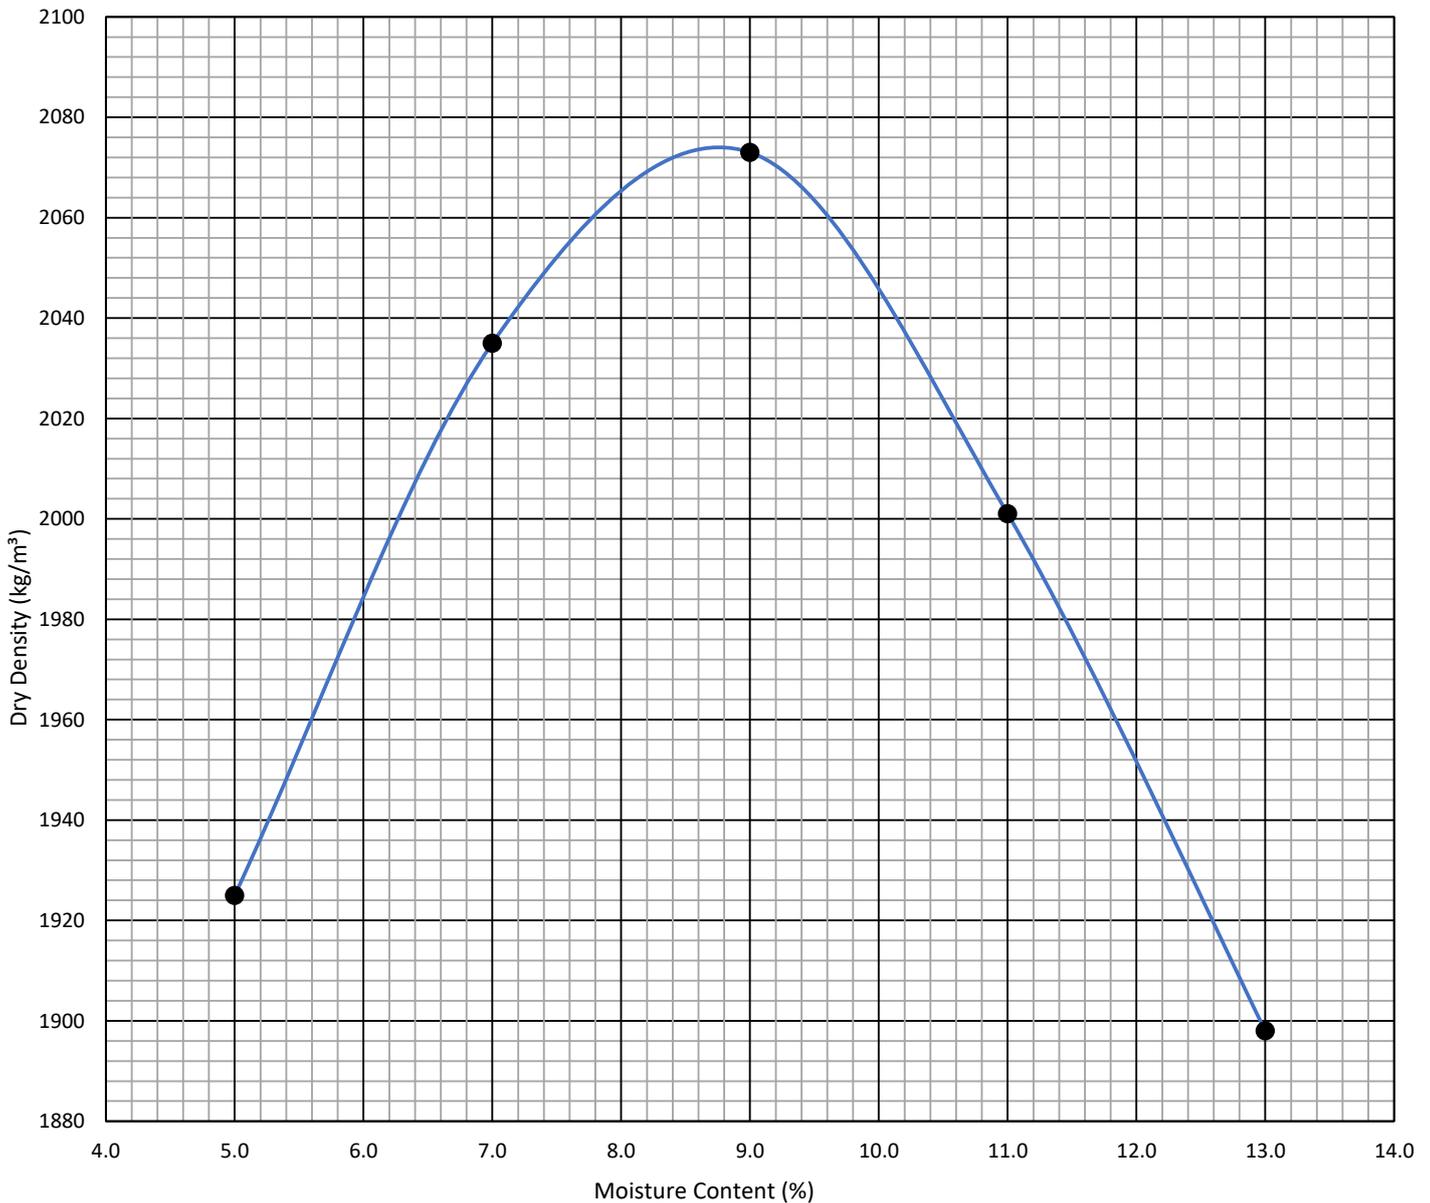
Moisture Content (%):	5.0	7.0	9.0	11.0	13.0			
Dry Density (kg/m ³)	1925	2035	2073	2001	1898

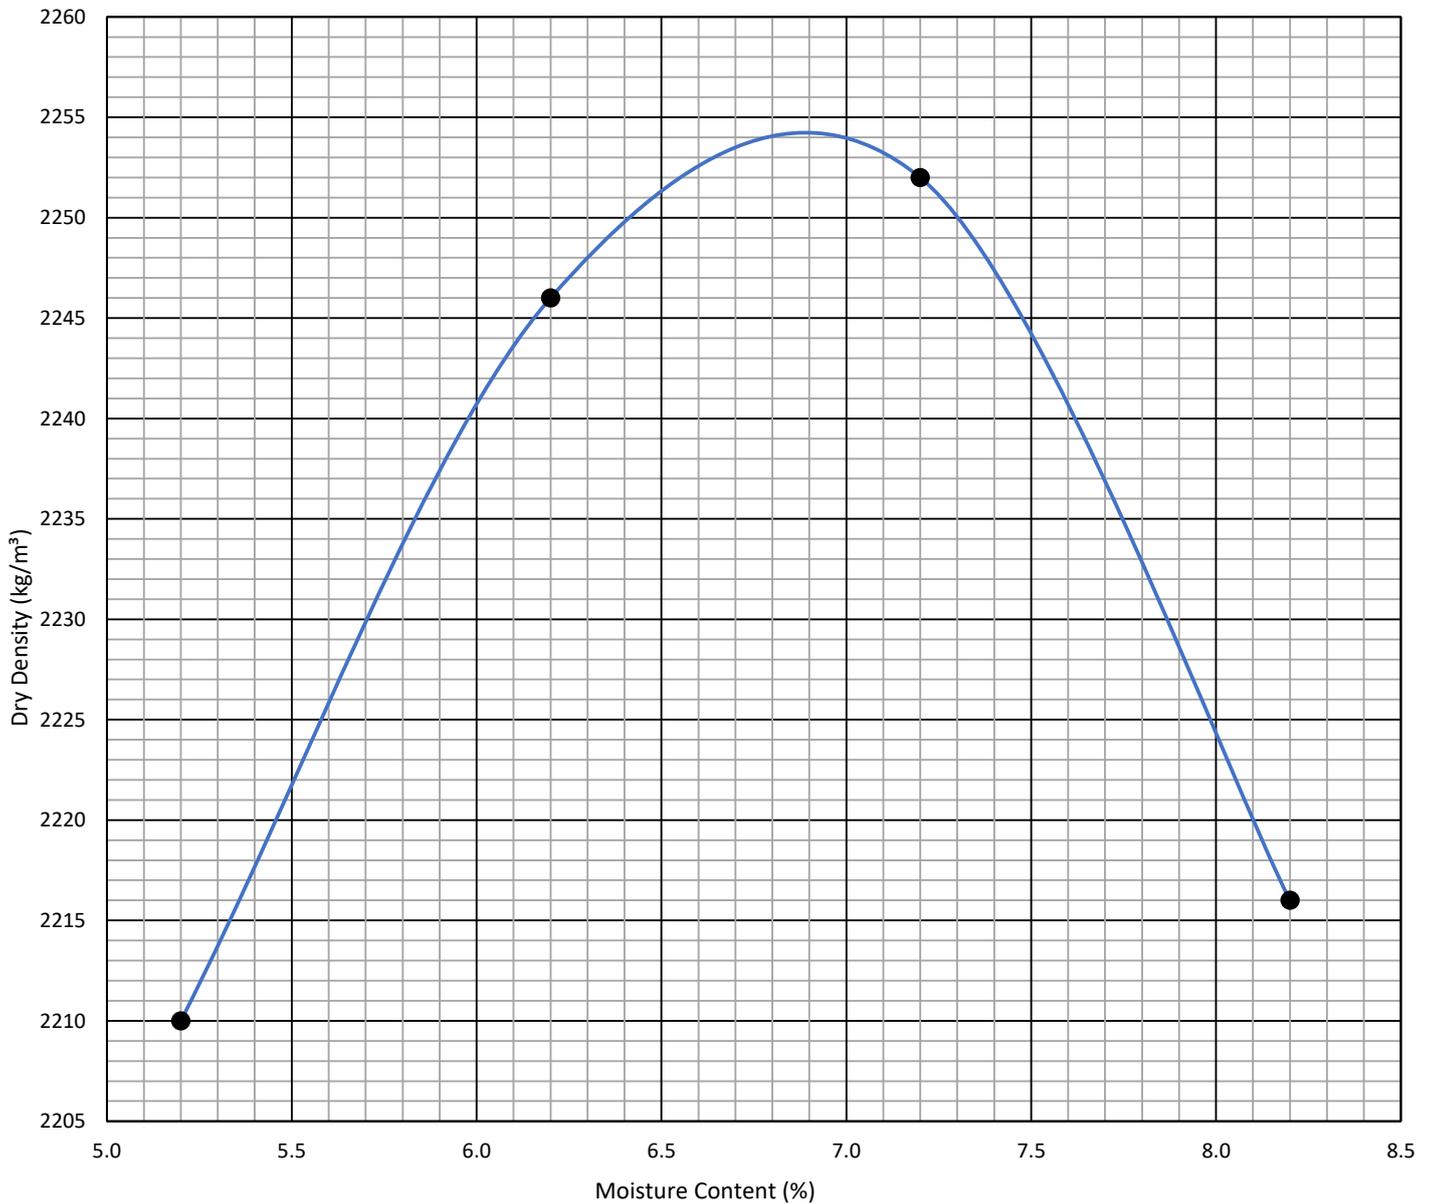
Moisture Content (%):	5.2	6.2	7.2	8.2				
Dry Density (kg/m ³)	2210	2246	2252	2216

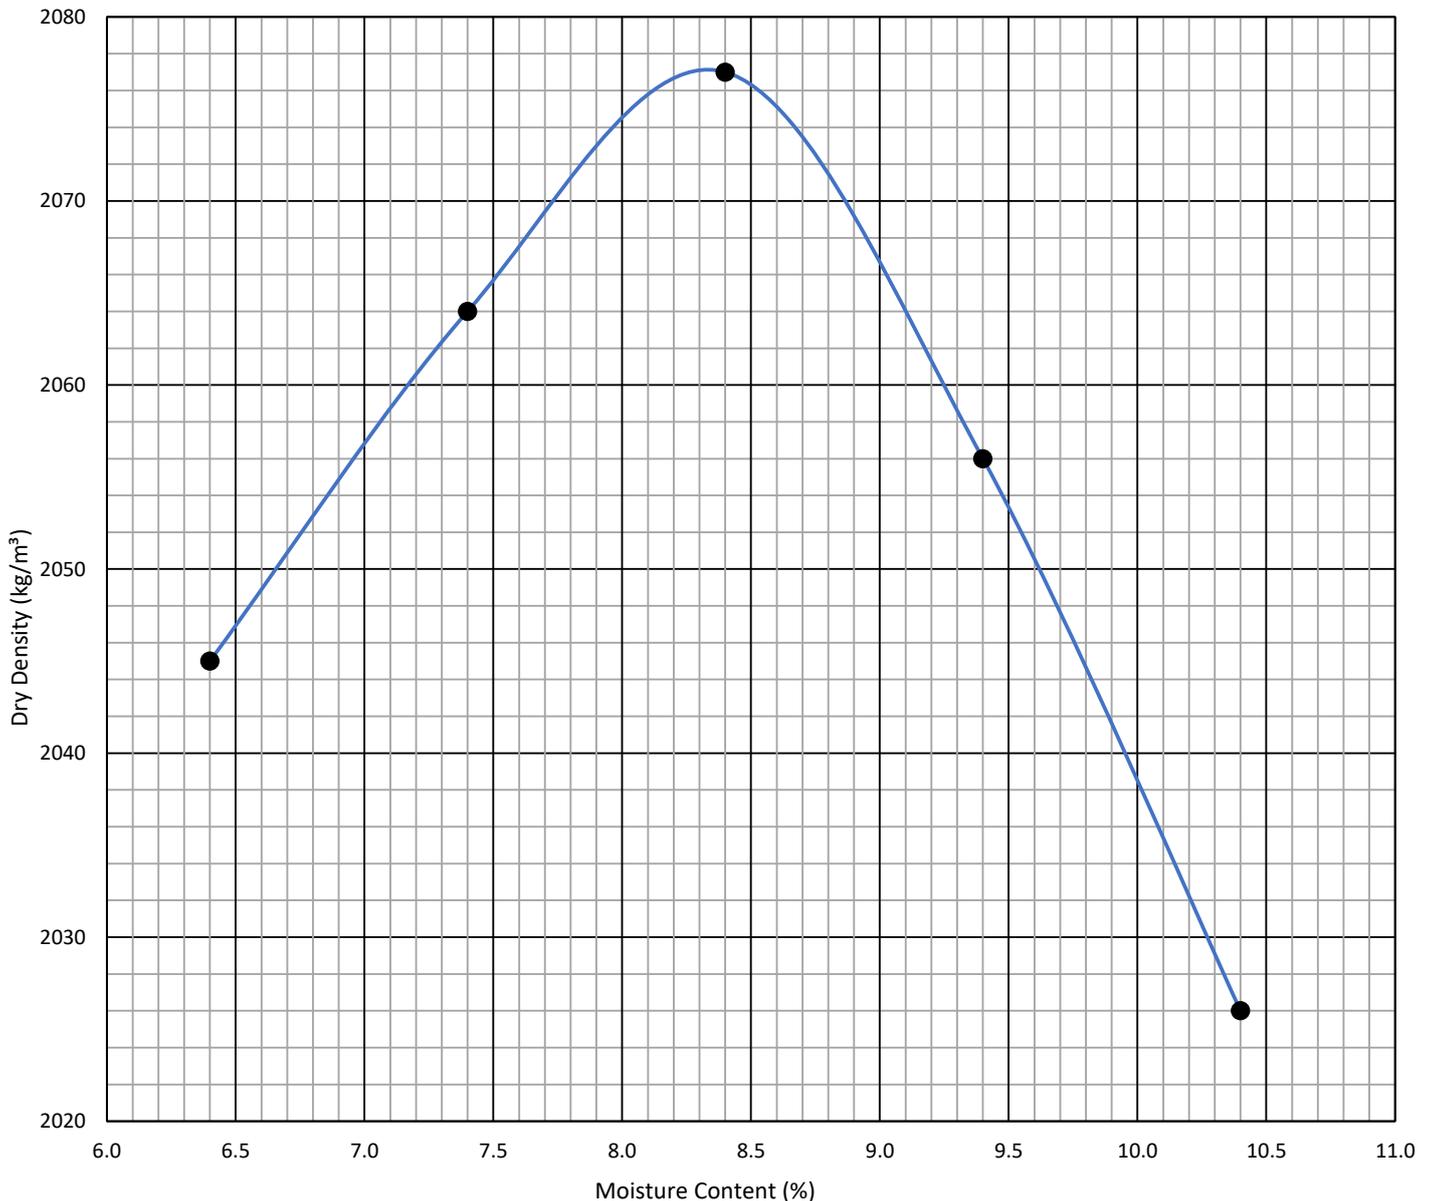
Moisture Content (%):	6.4	7.4	8.4	9.4	10.4			
Dry Density (kg/m ³)	2045	2064	2077	2056	2026

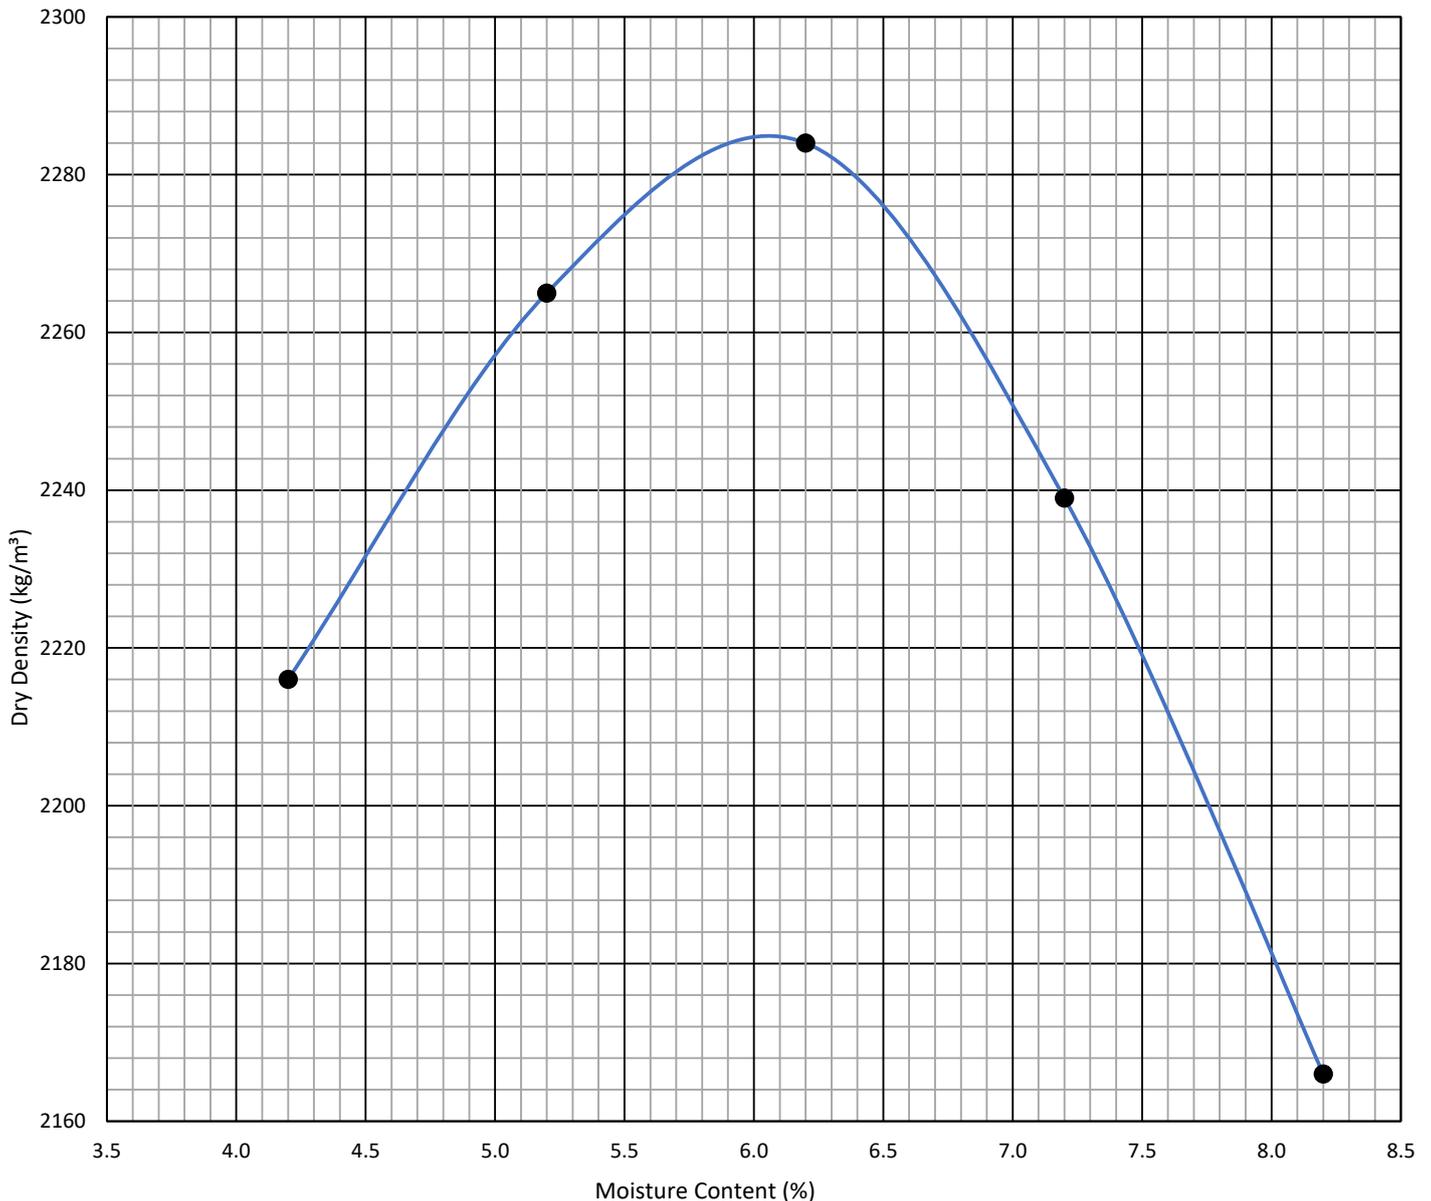
Moisture Content (%):	4.2	5.2	6.2	7.2	8.2			
Dry Density (kg/m ³)	2216	2265	2284	2239	2166

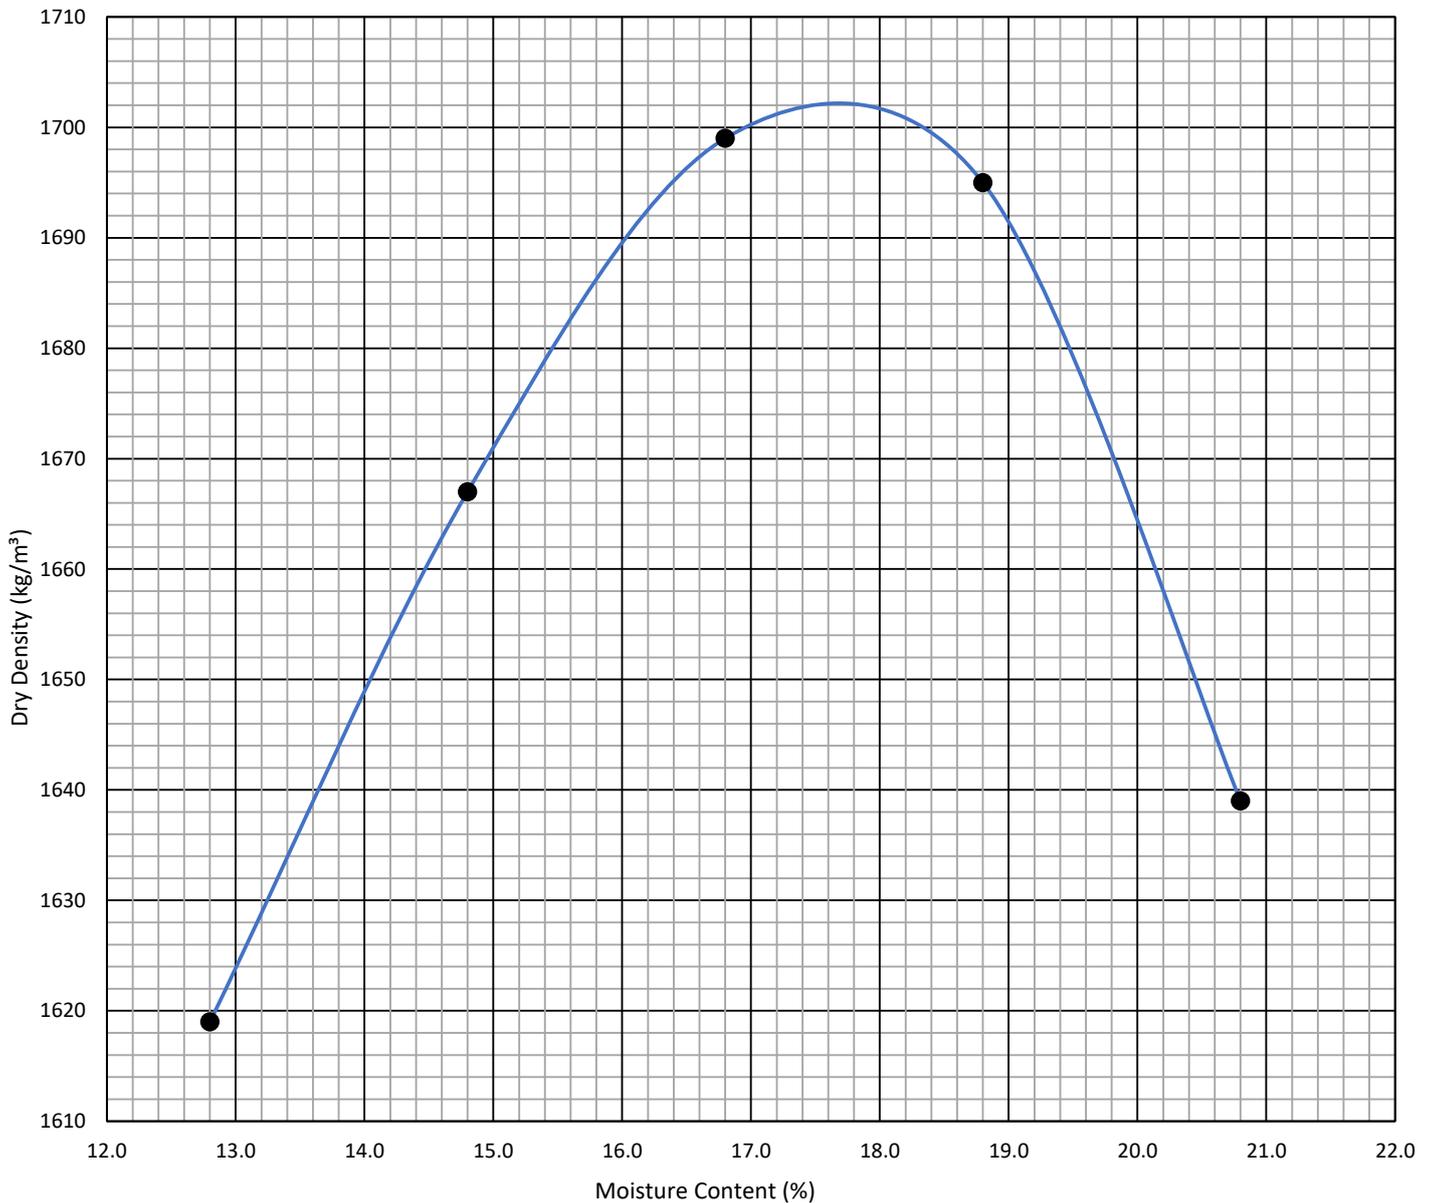
Moisture Content (%):	12.8	14.8	16.8	18.8	20.8			
Dry Density (kg/m ³)	1619	1667	1699	1695	1639

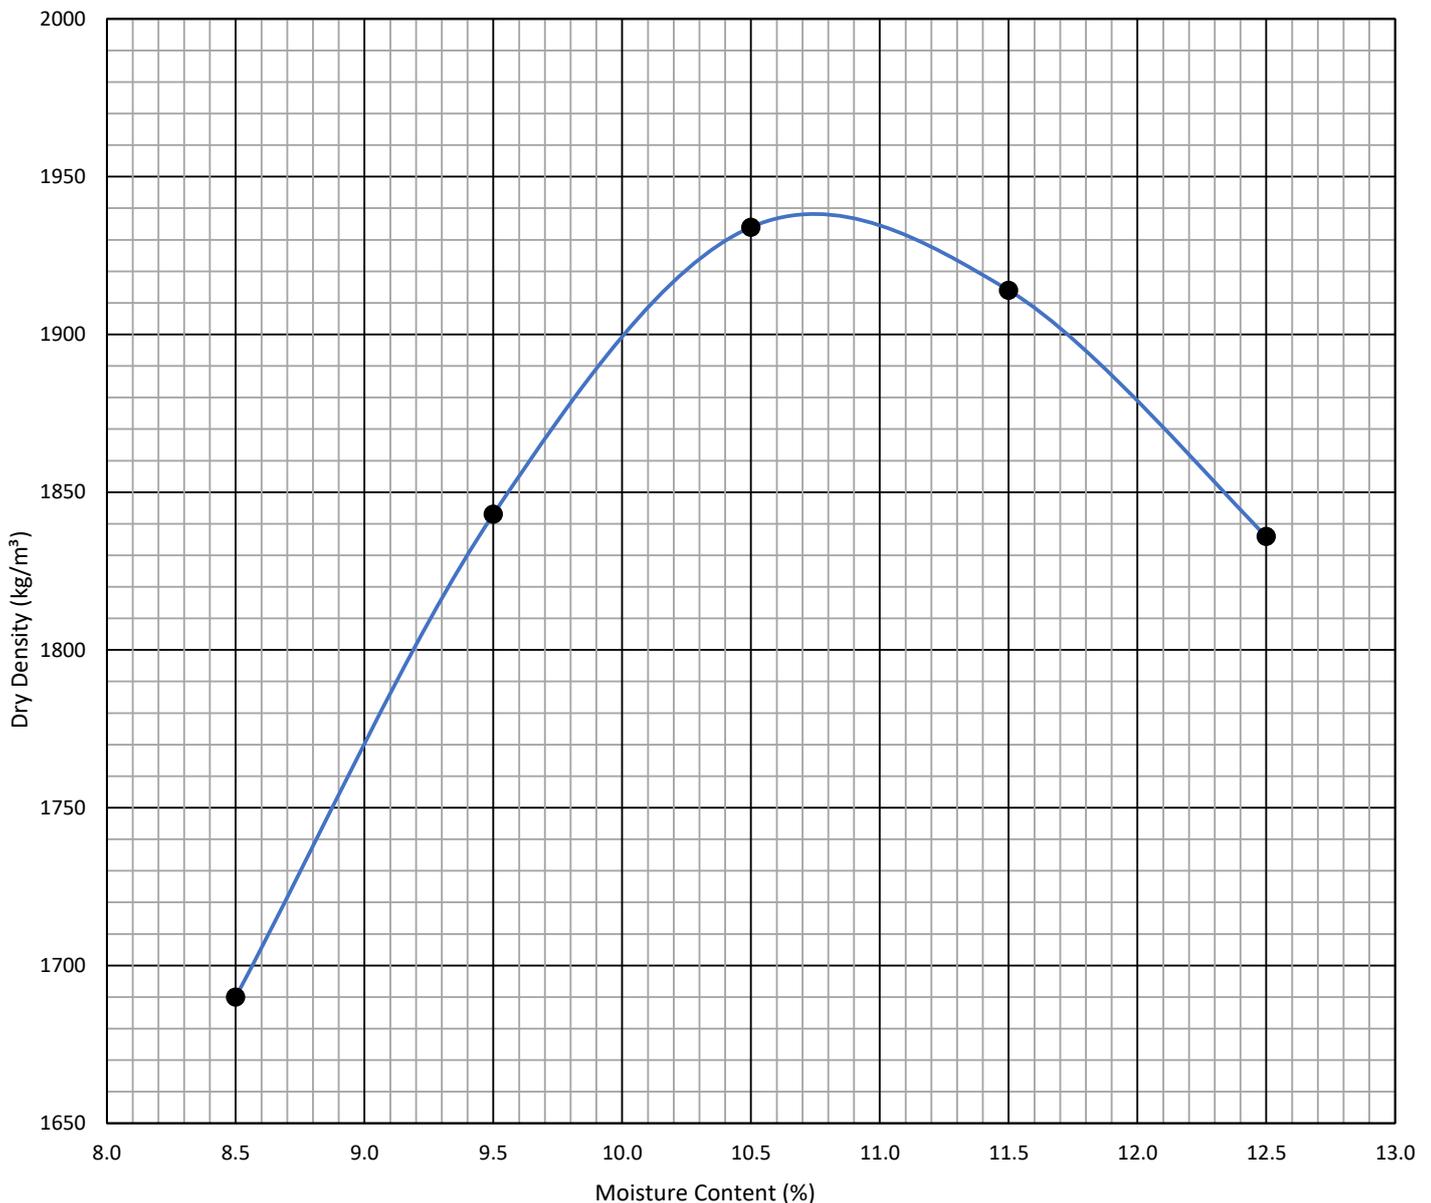
Moisture Content (%):	8.5	9.5	10.5	11.5	12.5			
Dry Density (kg/m ³)	1690	1843	1934	1914	1836

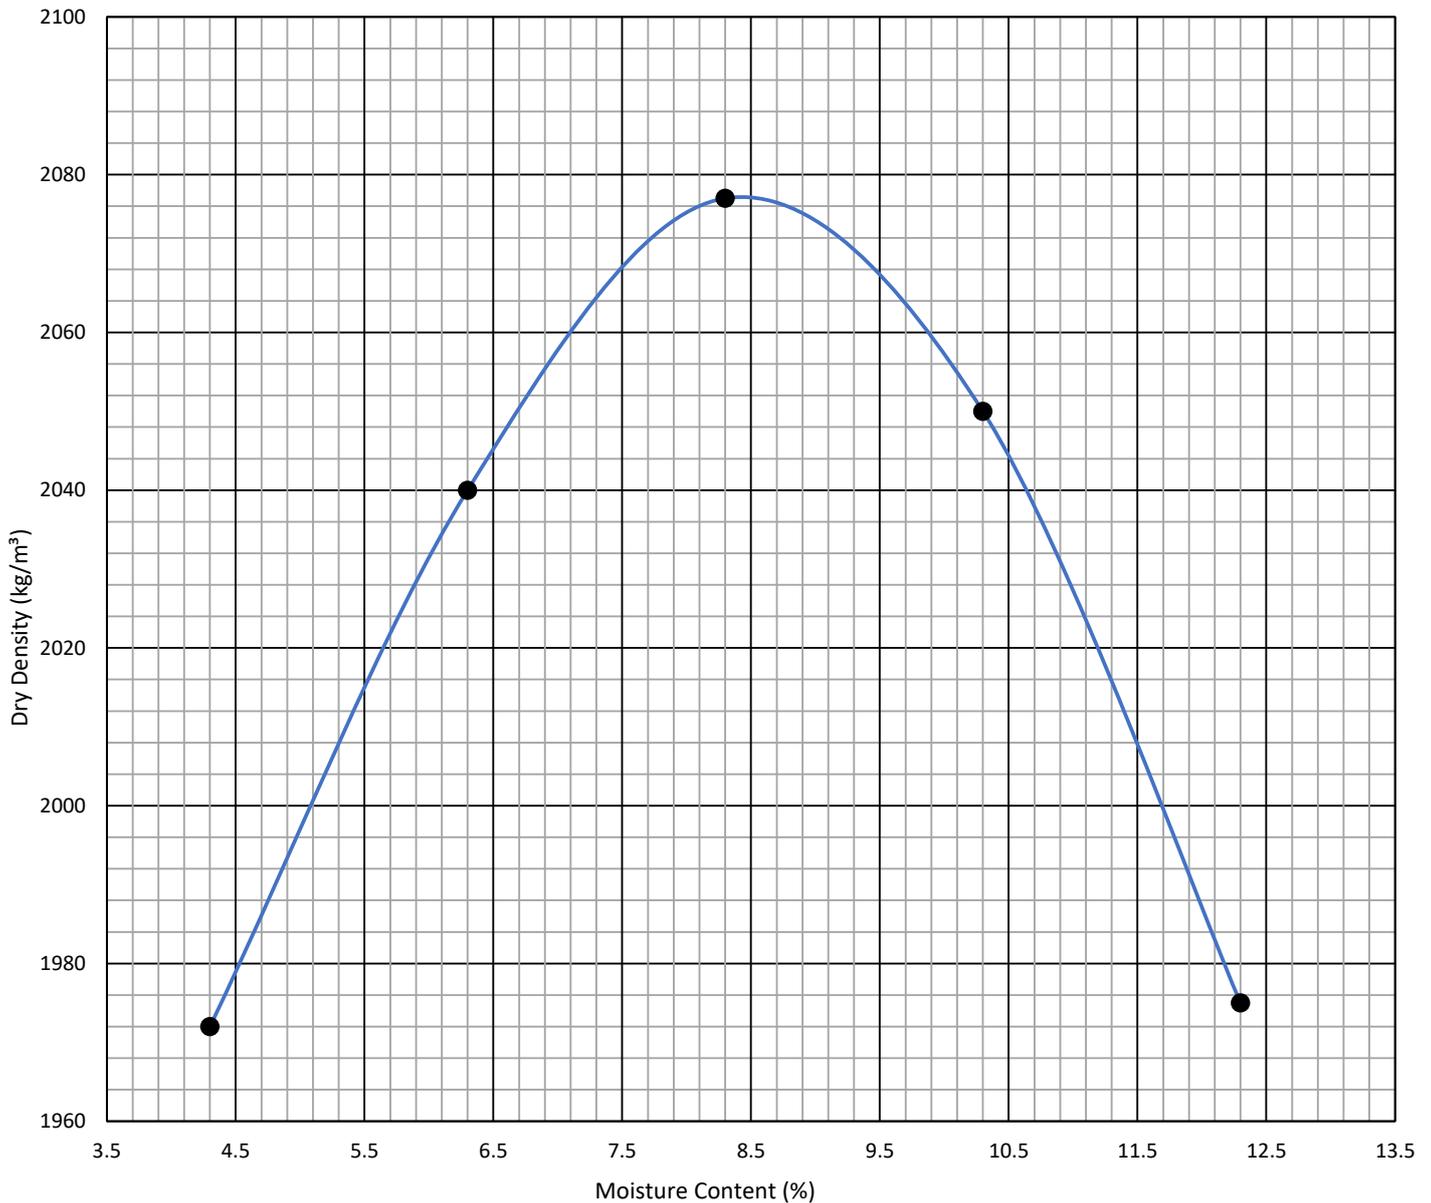
Moisture Content (%):	4.3	6.3	8.3	10.3	12.3			
Dry Density (kg/m ³)	1972	2040	2077	2050	1975

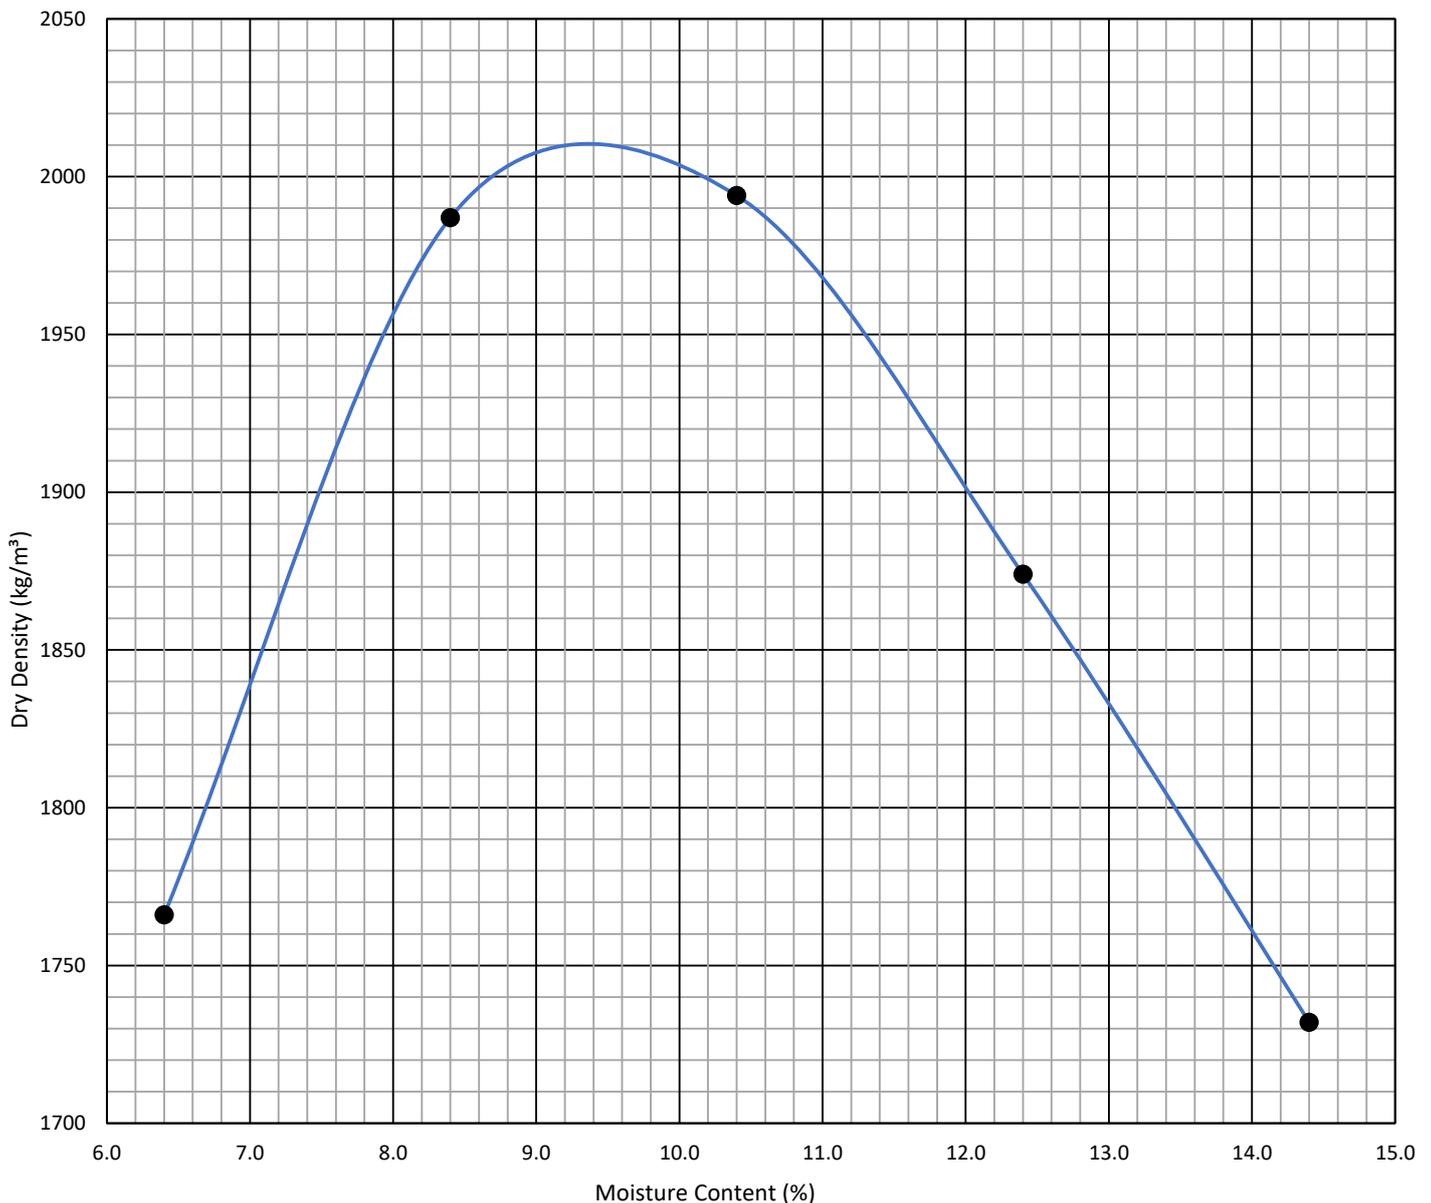
Moisture Content (%):	6.4	8.4	10.4	12.4	14.4			
Dry Density (kg/m ³)	1766	1987	1994	1874	1732
