MATIMBA POWER STATION ASH DUMP

GEOTECHNICAL INVESTIGATION

FINAL GEOTECHNICAL REPORT

Project No: 30100825/01

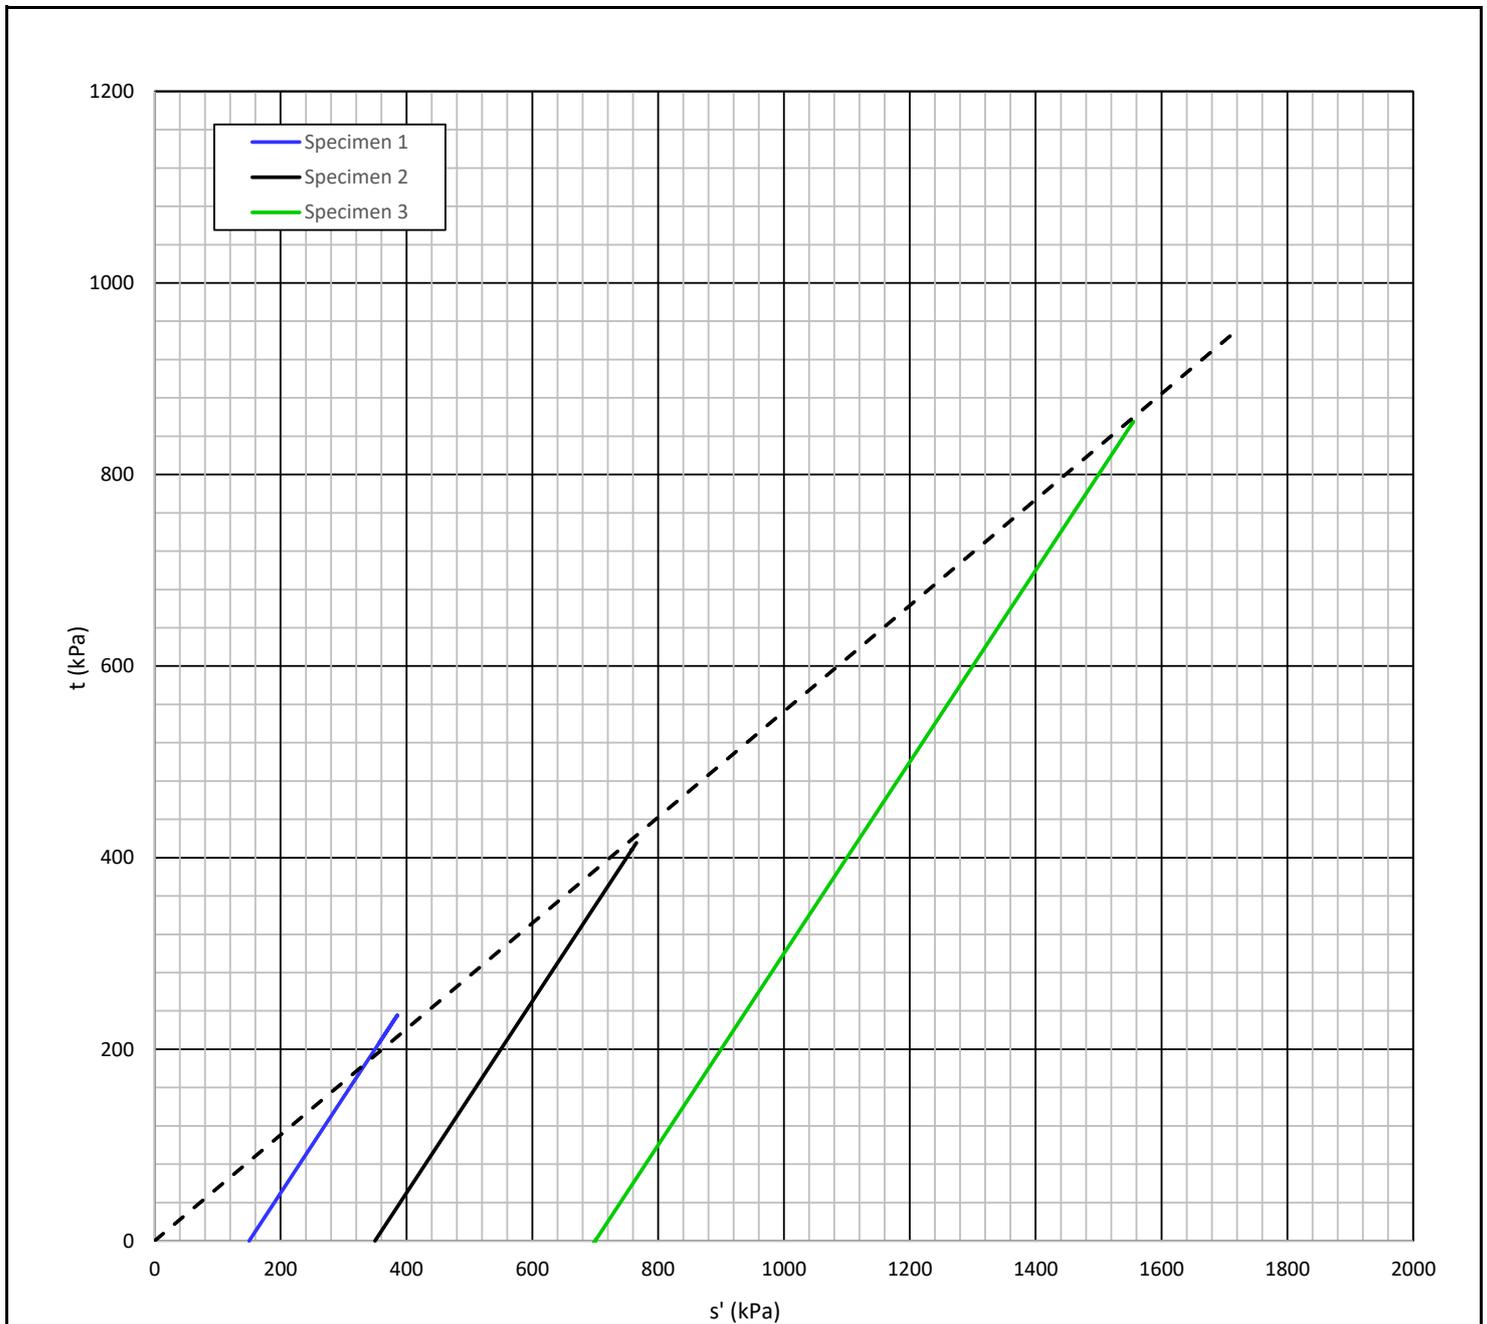
ϕ'	Deg.	34
c'	kPa	0

The colluvium may be utilised for embankment construction materials since the material has relatively high strength characteristics (internal friction angle of 34°). However, the clay content of the soil is low, and the material comprises a low coefficient of permeability (less than 1×10^{-5} cm/s). The colluvium is also suitable as general or bulk fill above the foundations for preparation of the liner.

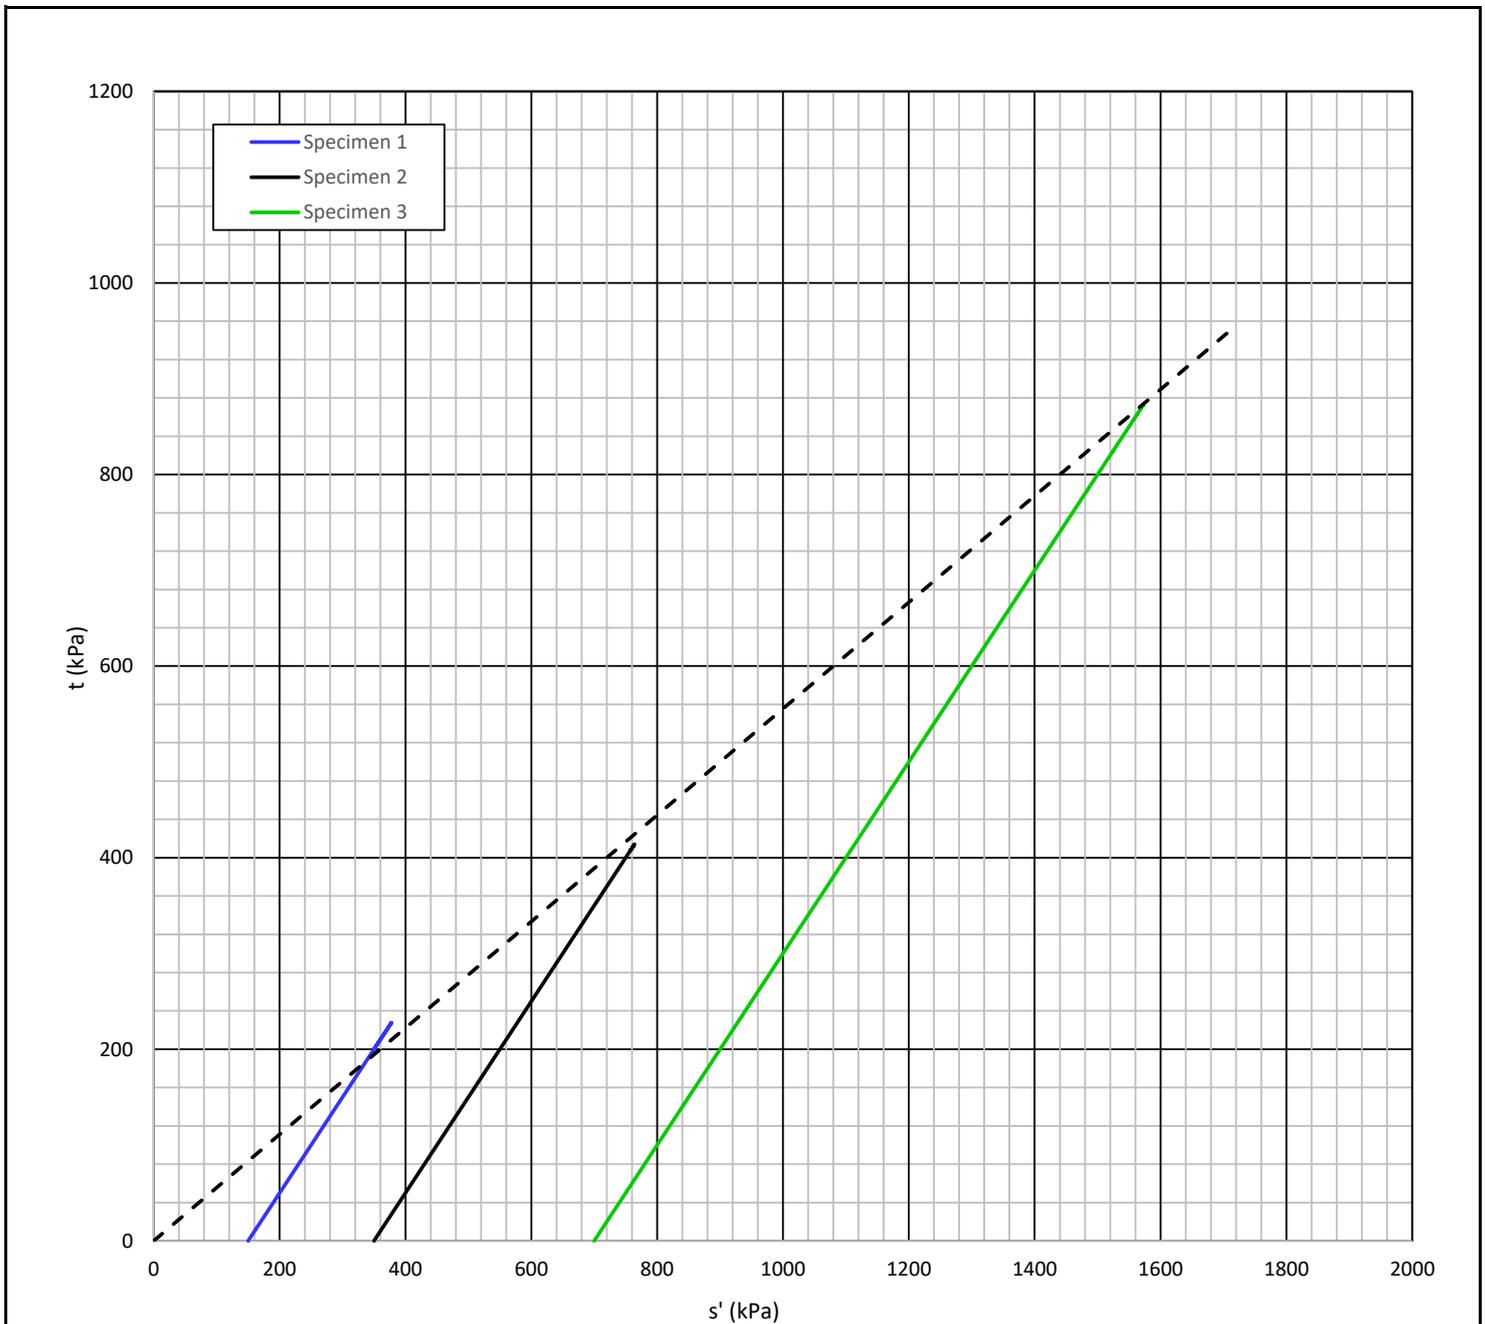
ϕ'	Deg.	34
c'	kPa	0

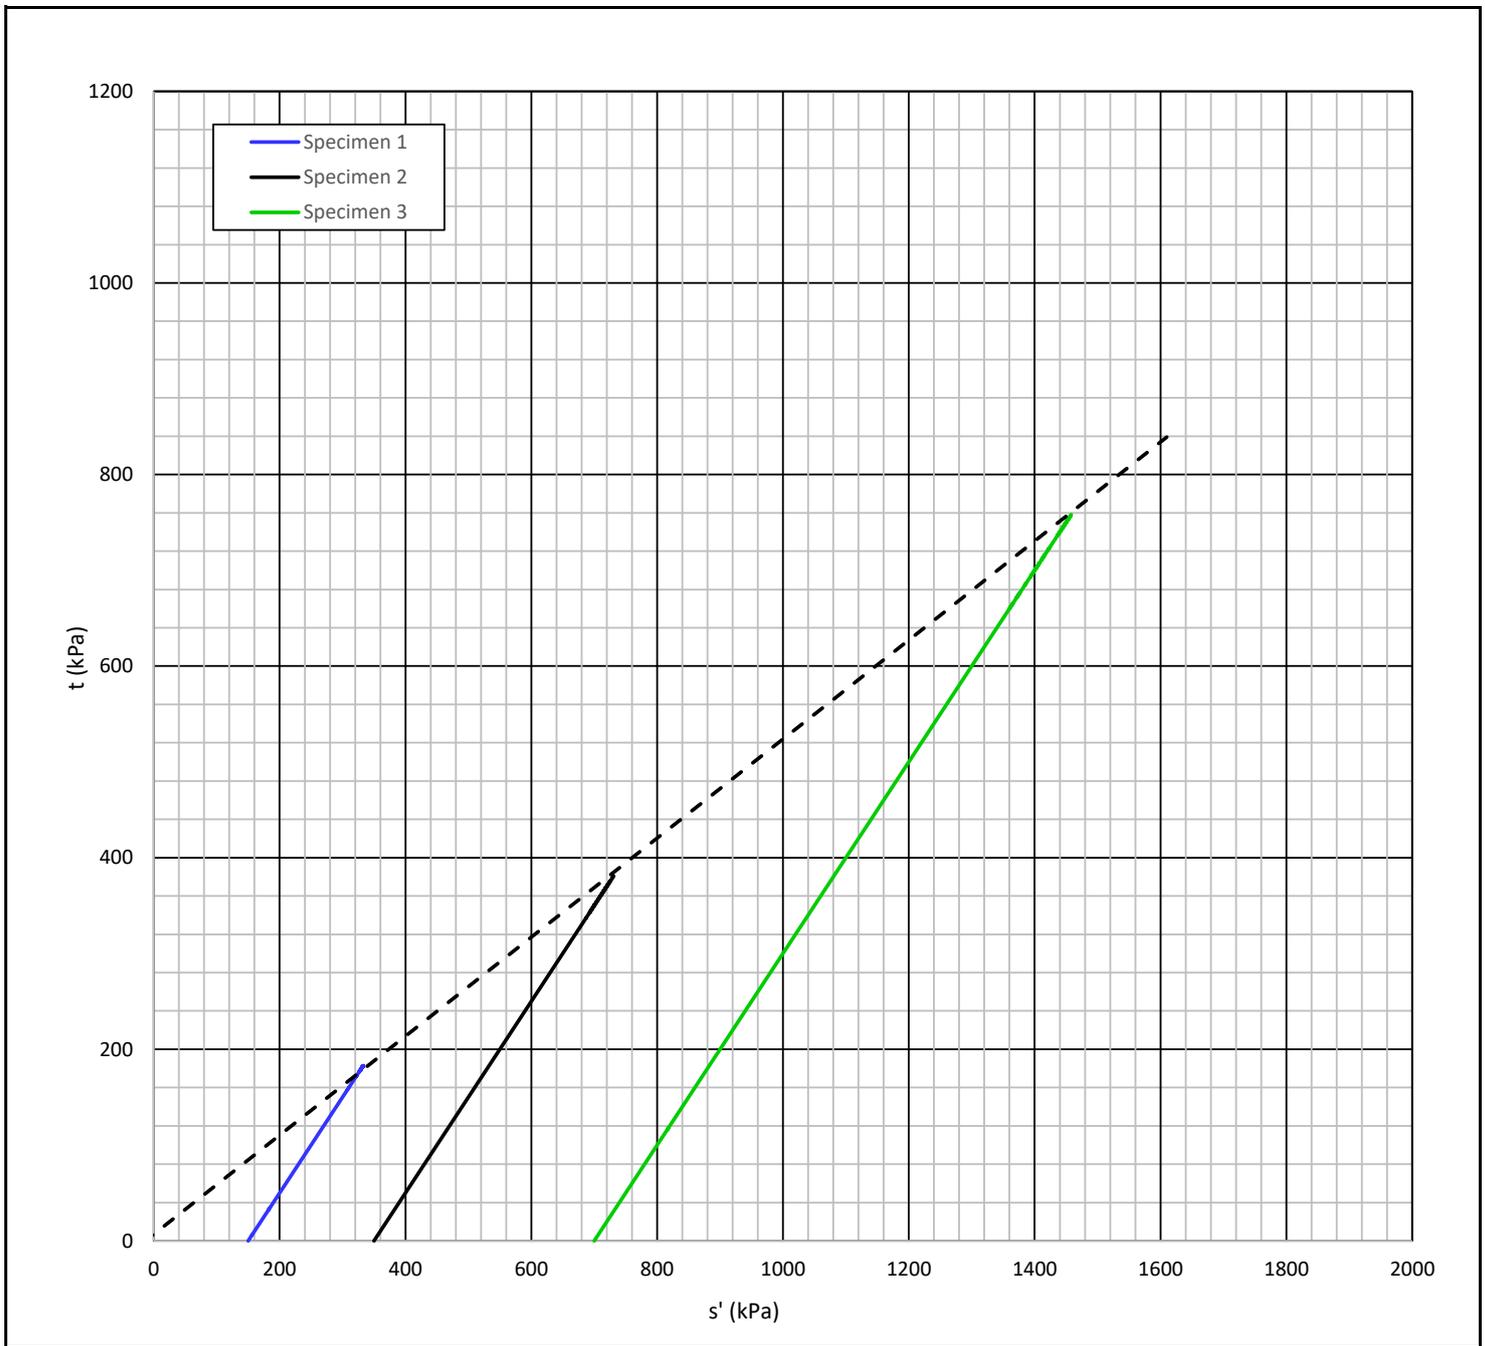
ϕ'	Deg.	31
c'	kPa	8

The residual sandstone soil has slightly lower strength characteristics but contains suitable clay content. This residual soil appears to be more suitable for the construction of berms or embankments since it has a coefficient of permeability of 1×10^{-8} cm/s. The residual sandstone is also suitable for backfilling on foundations below the liner.
