## Annexure C3.2:

### 1. Scope of work

**Remove old Pantograph, supply and install new pantograph and commission overhead crane.**

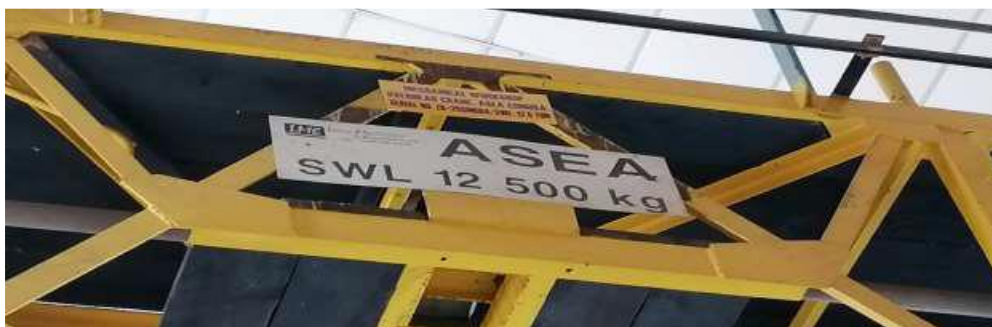
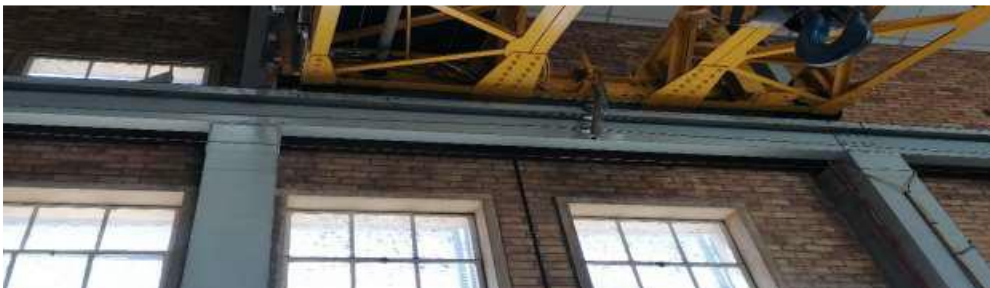
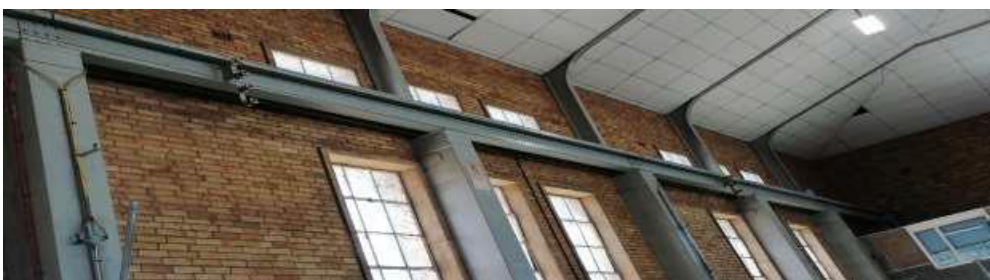
The overhead crane was installed in the early 50s and is supplied from the open 4 wire system with the pantograph supporting the carbon brushes mounted on the pipe connected to the structure of the crane. The overhead crane in the mechanical workshop is used to load and off load spares and equipment like pumps, motors etc.

The pantograph hooked on the structure and broke off, bending the supporting pipe that supports the brush holders.

The pantograph system is very old, hence require replacement.

Supply, install and commission new Pantograph for Mechanical workshop.

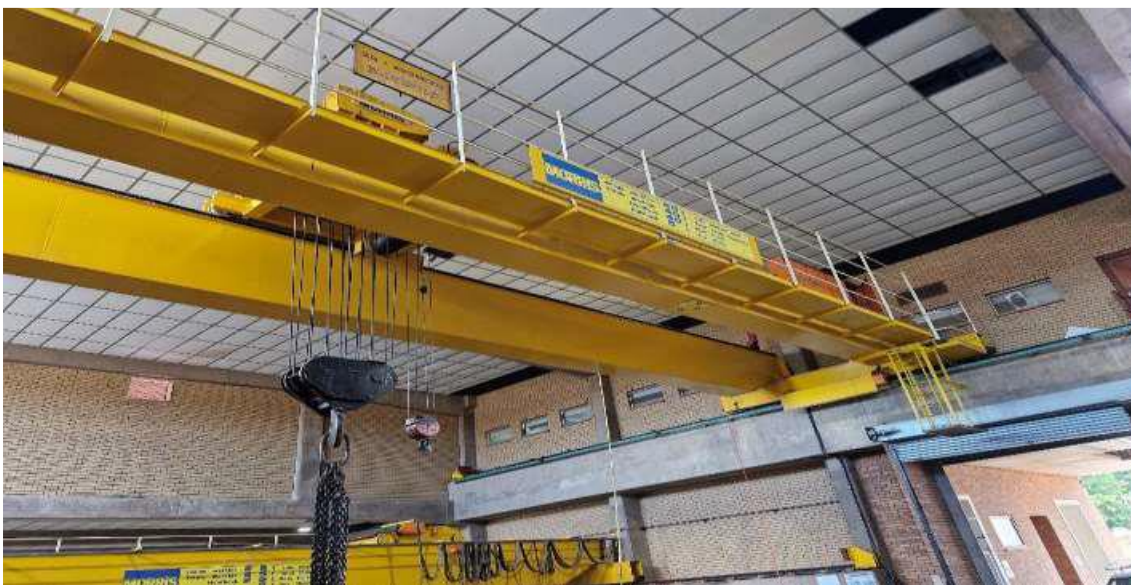
Figure 1: Picture of the 40T Crane

The Overhead crane at Engine Room 4B below was installed in the 80s and is using current carriers for its operation. The current carriers are house in a hard plastic material which have now become brittle and are cracking. The wear on the carrier housing has caused the crane to fail and thus need to be replaced with the same or identical ones for the crane to be brought back to full use.

Crane make: Morris

Capacity:40 ton

Serial no: ZB =40SMG02

The scope of work is to Supply 3 current carriers, install and commission the crane with new current carriers.

Supply 3 current carriers' unit, install and commission current carriers on crane at 4a Loading Bay

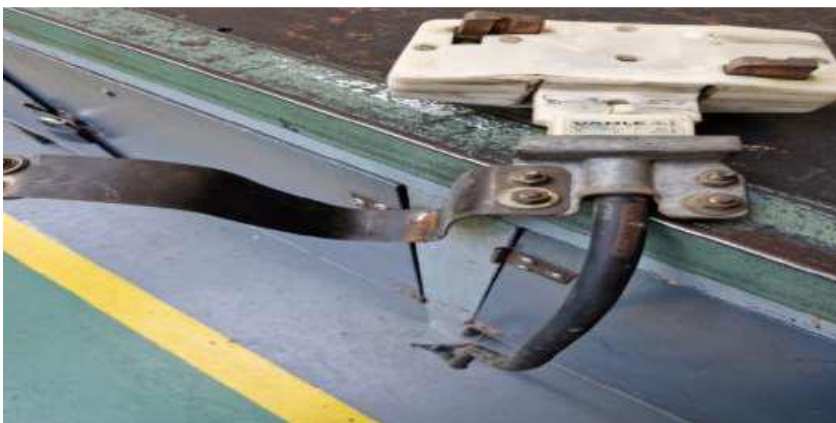
Figure 2: Damaged current carrier front view

see attached pictures above. The above current carriers are defective.

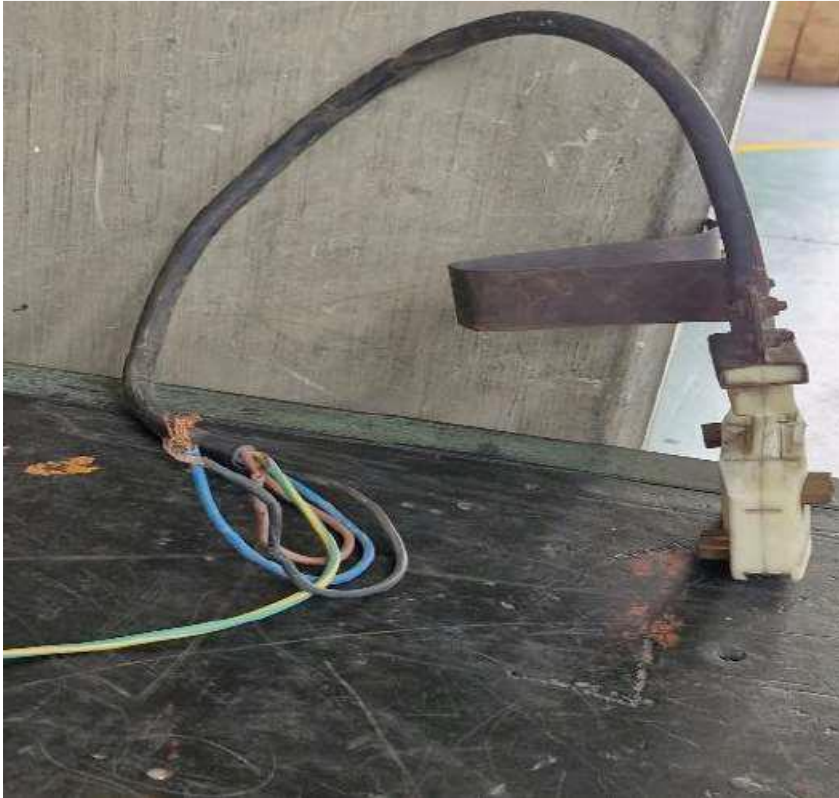
Figure 3: Current carrier side view

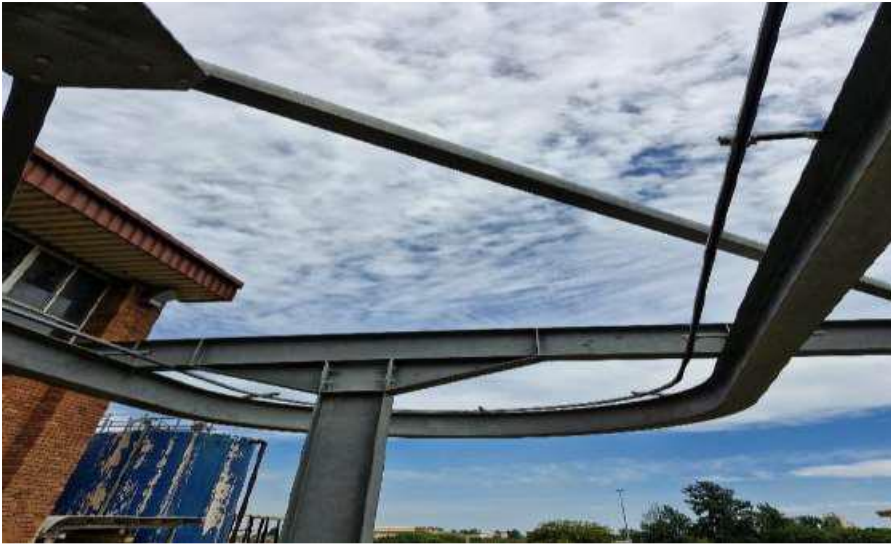
The Central Sludge hoist below was installed in 2019. The hoist is supplied from the trailing cable supported by hangers running on the C – Track. The track is constructed in a U-Shape to allow the hoist to be used in the front and back of the sumps/tanks. One of the U bend curves is damaged and needs to be replaced. A section of the C – track is missing and needs replacement.

*Figure 4: Damaged C-Track curve*

Replace "C" track curve and damaged "C" track rails also replace all cable carriers on the structure.

One off "C" track curve

Supply and install C track Bend

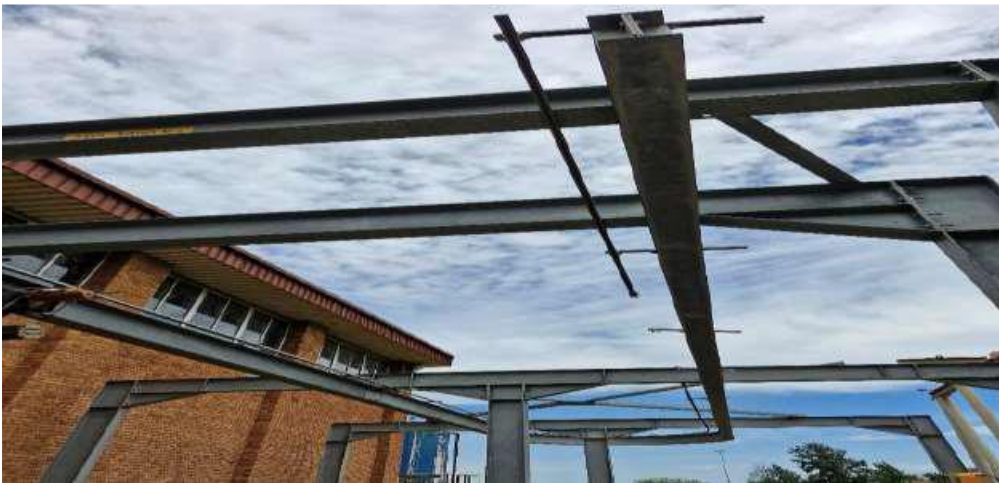
*Figure 5: Missing C-Track portions*

Eight off lengths of "C" track Rails

Supply and install cable carriers. For c track rails

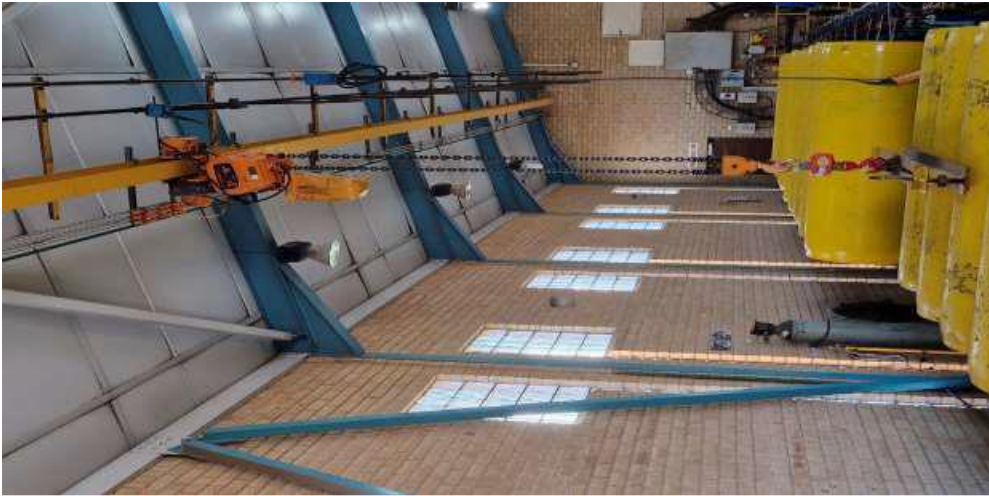
Stn.4B Chlorine North side and south side,Supply and install 3 ton hoist unit with transmitter,receiver remote controller and pendent also provide a load test certificate for the unit.N.b the hoist unit shall be two speed.

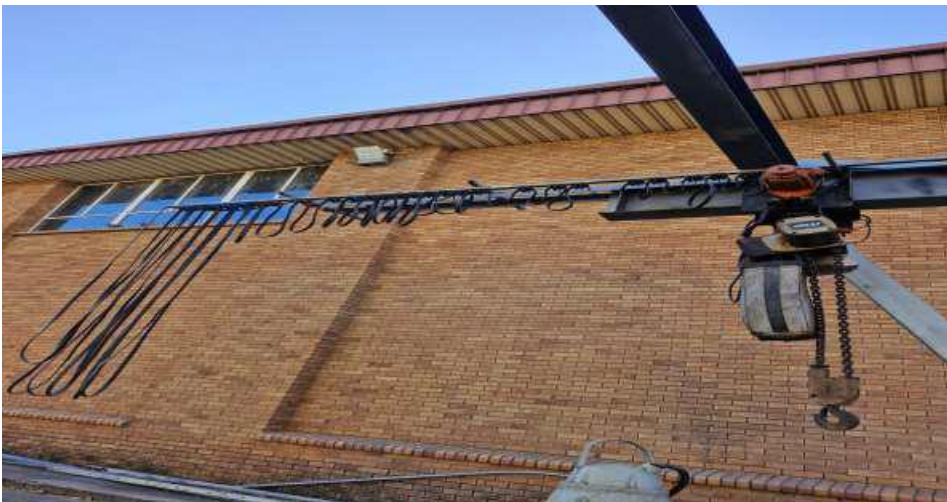
Line 08:

4stn. Central sludge dams 3 ton hoist braking system is replace brakes, and service and load
