Boegoebaai Port: Preliminary Geotechnical Investigation (Quarry and Near Port Area): Final Report Rev1

PRDW and Nako Iliso

Report Number 526679 / 529671

August 2018

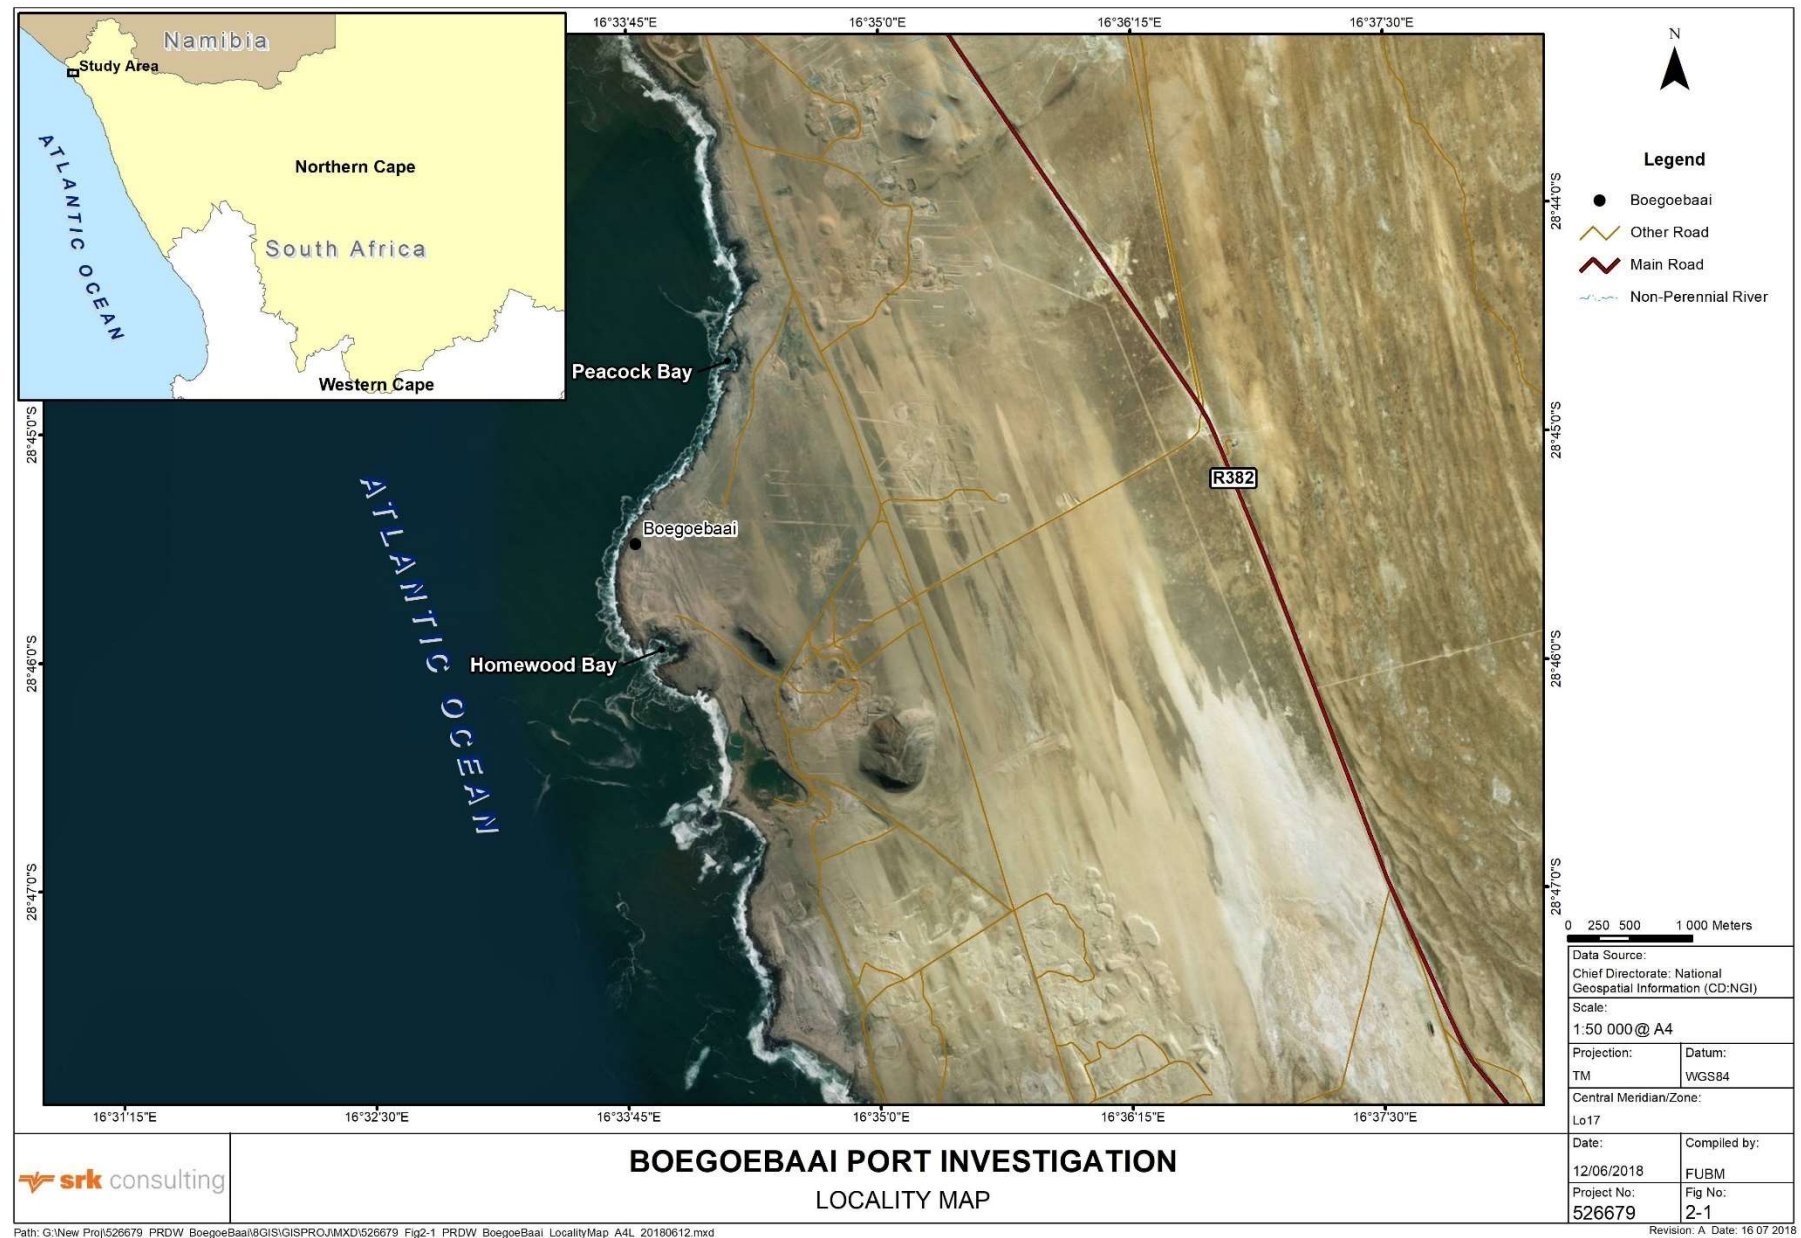
The project locality plan is shown in Figure 2-1.

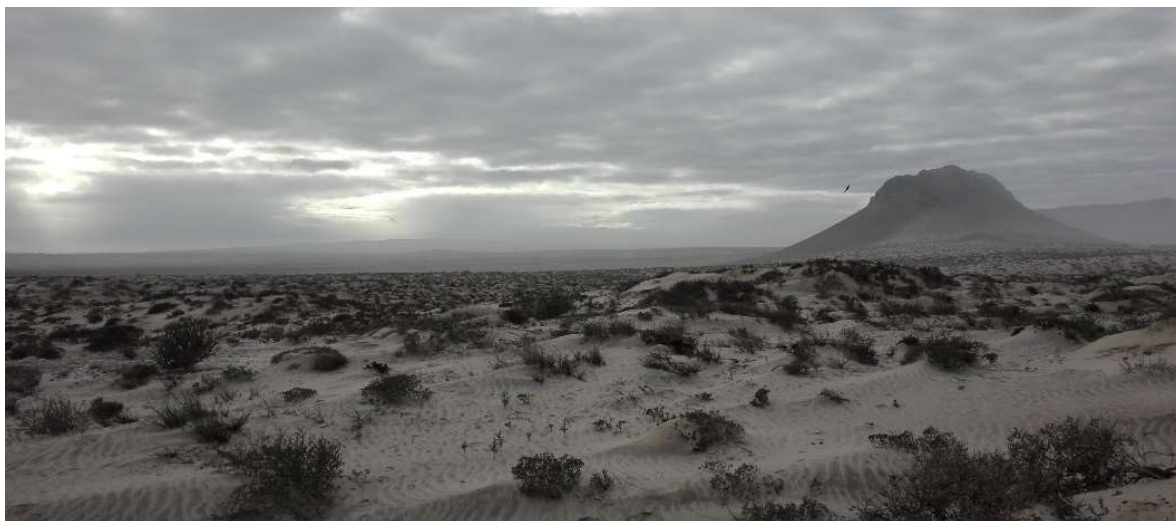
Photo 4-1: Undulating sand dune topography and scattered indigenous vegetation with Boegoeberg North in the background

The surrounding surface area is typically characterised by undulating Aeolian sand dune topography (see Photo 4-1) with longitudinal dune structures. The Aeolian sand is poorly graded and consists of predominantly silty, fine sand with minor gravel and cobbles, which is an erosional product of the local lithology. The sand cover on the site is relatively stabilised by scattered indigenous vegetation.

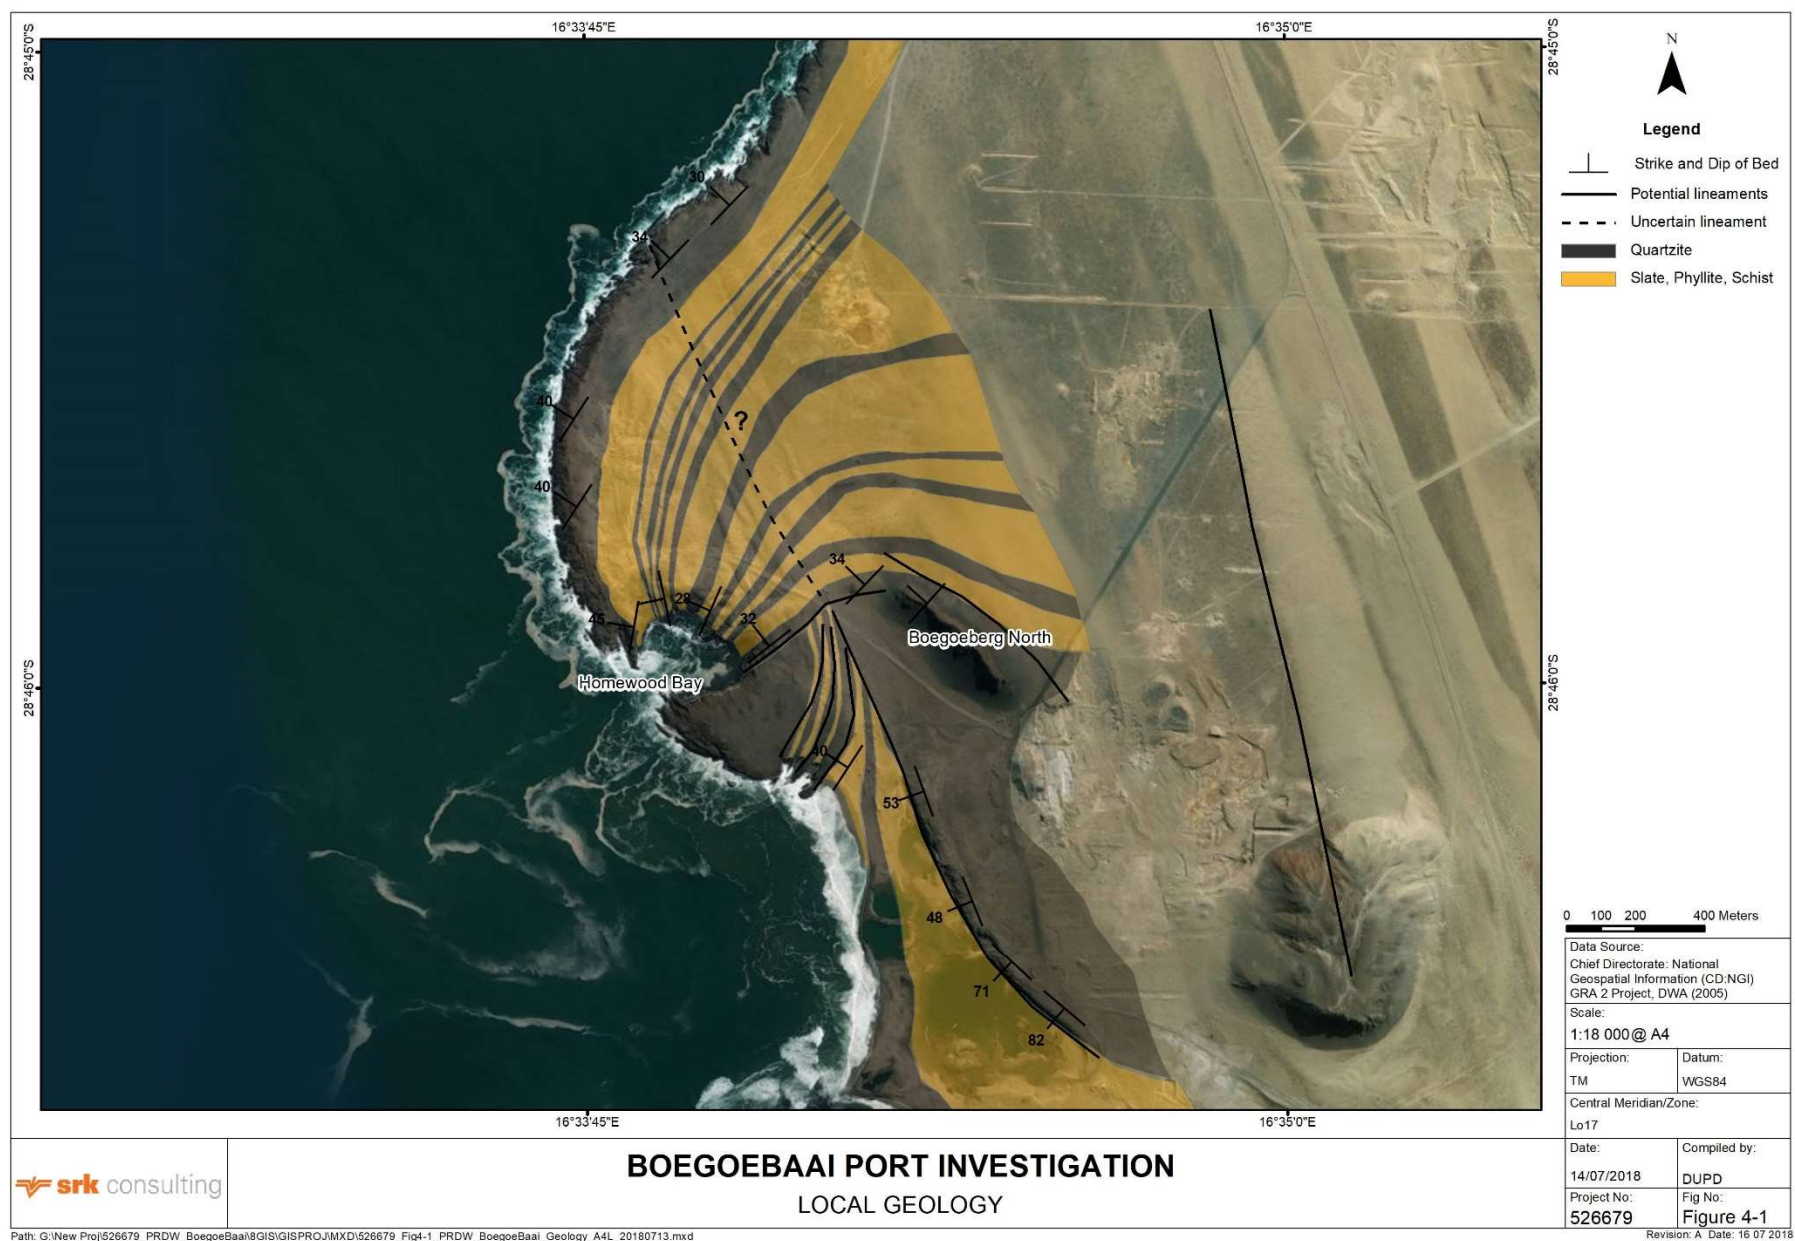
Figure 4-2 indicates the areas mapped and the quarry sites identified. In summary, the following is noted from Figure 4-2:

The structural trend of the metasediments found in the study area has a main bedding (B) azimuth of N 28° W. The cliffs towards the North and West of Boegoeberg (see Photo 4-2) are shallow dipping (ranging between 28° and 40°) at Quarry Site 2 (see Figure 4-2), with more steeply dipping cliffs (ranging between 48° and 82°) towards the South (see Photo 4-3) of Boegoeberg. All the outcrops dip away from Boegoeberg towards the sea. It is therefore inferred that Boegoeberg shows distinctive antiform characteristics (of the Neoproterozoic Gariep Fold Belt). The antiform dips towards the West with the fold hinge slightly leaning towards the South (asymmetrical). This explains the steep dipping outcrop at Quarry Site 1 (see Figure 4-2).

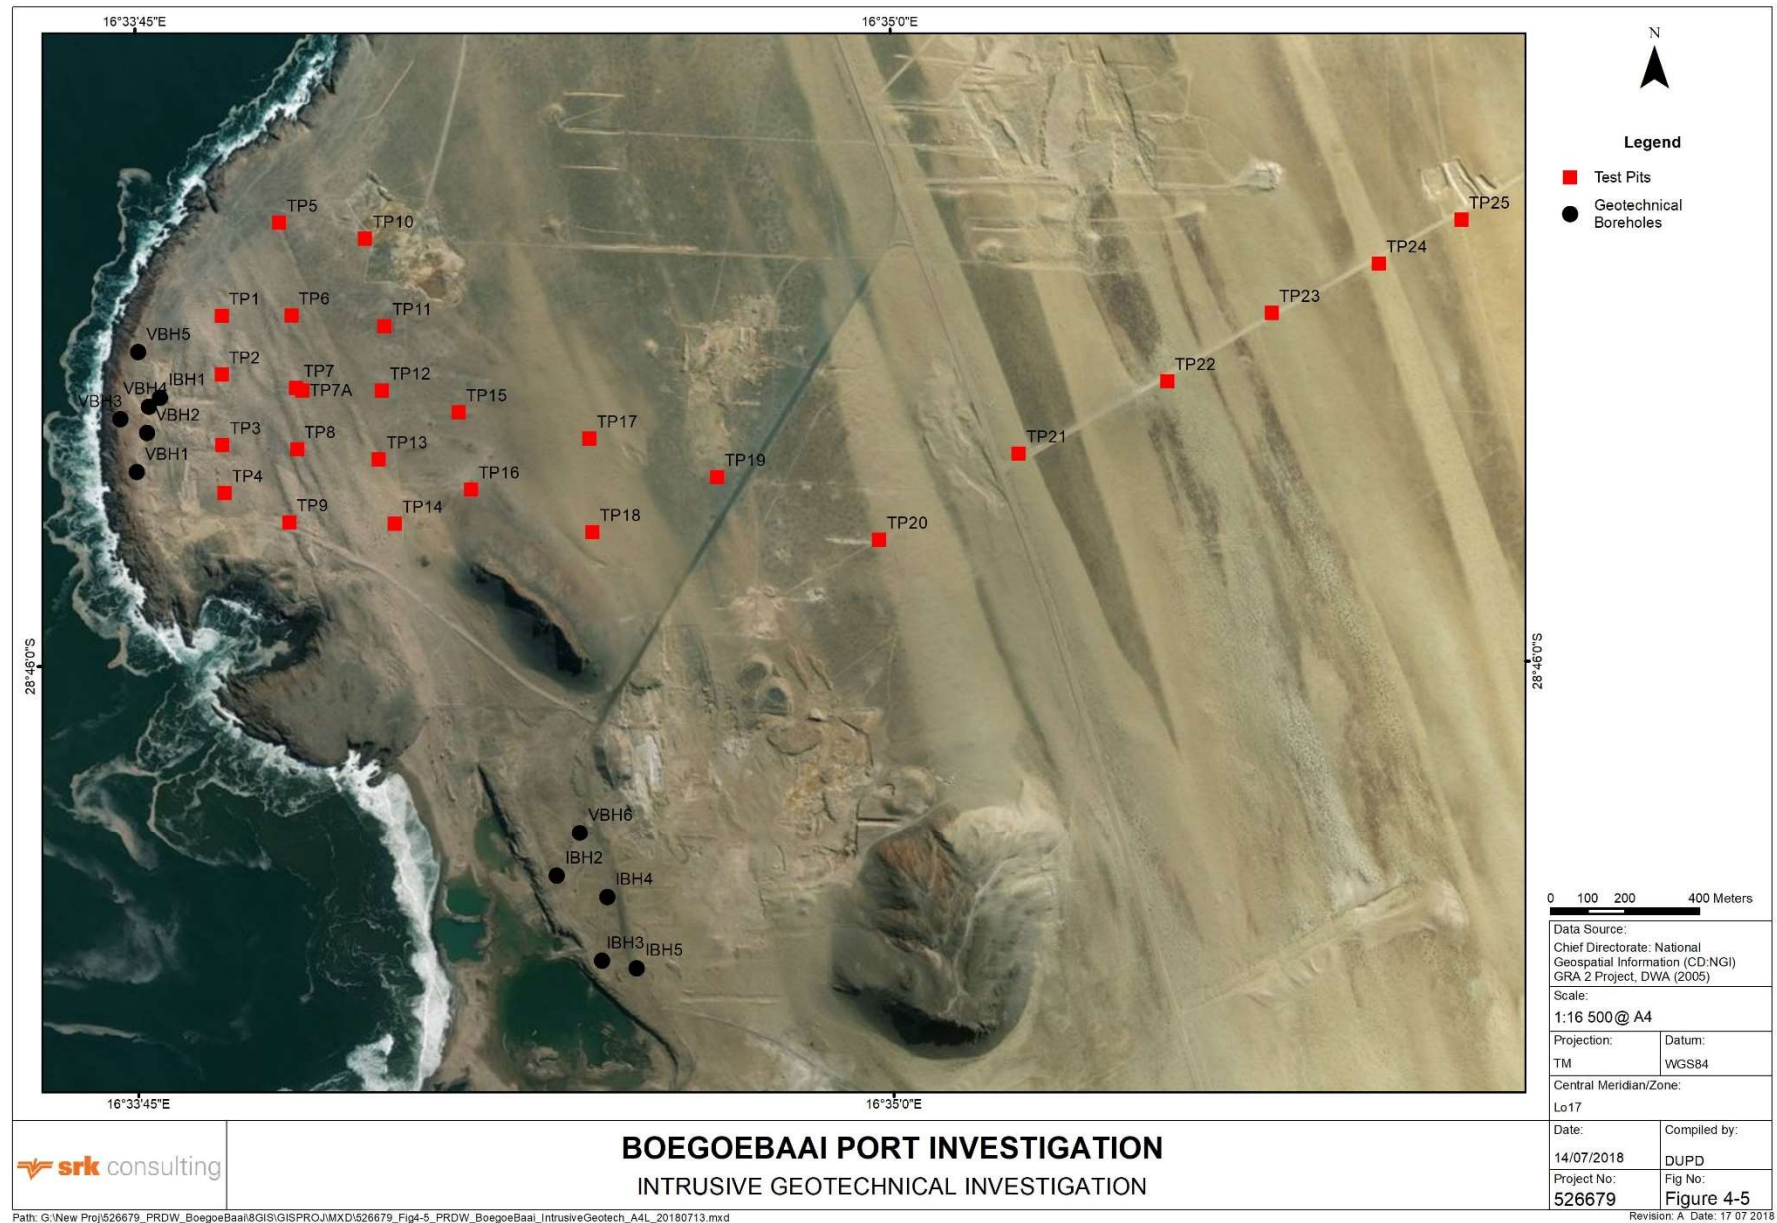
Six vertical and five inclined boreholes (BHs) were drilled across the study area (with reference to Figure 4-5):

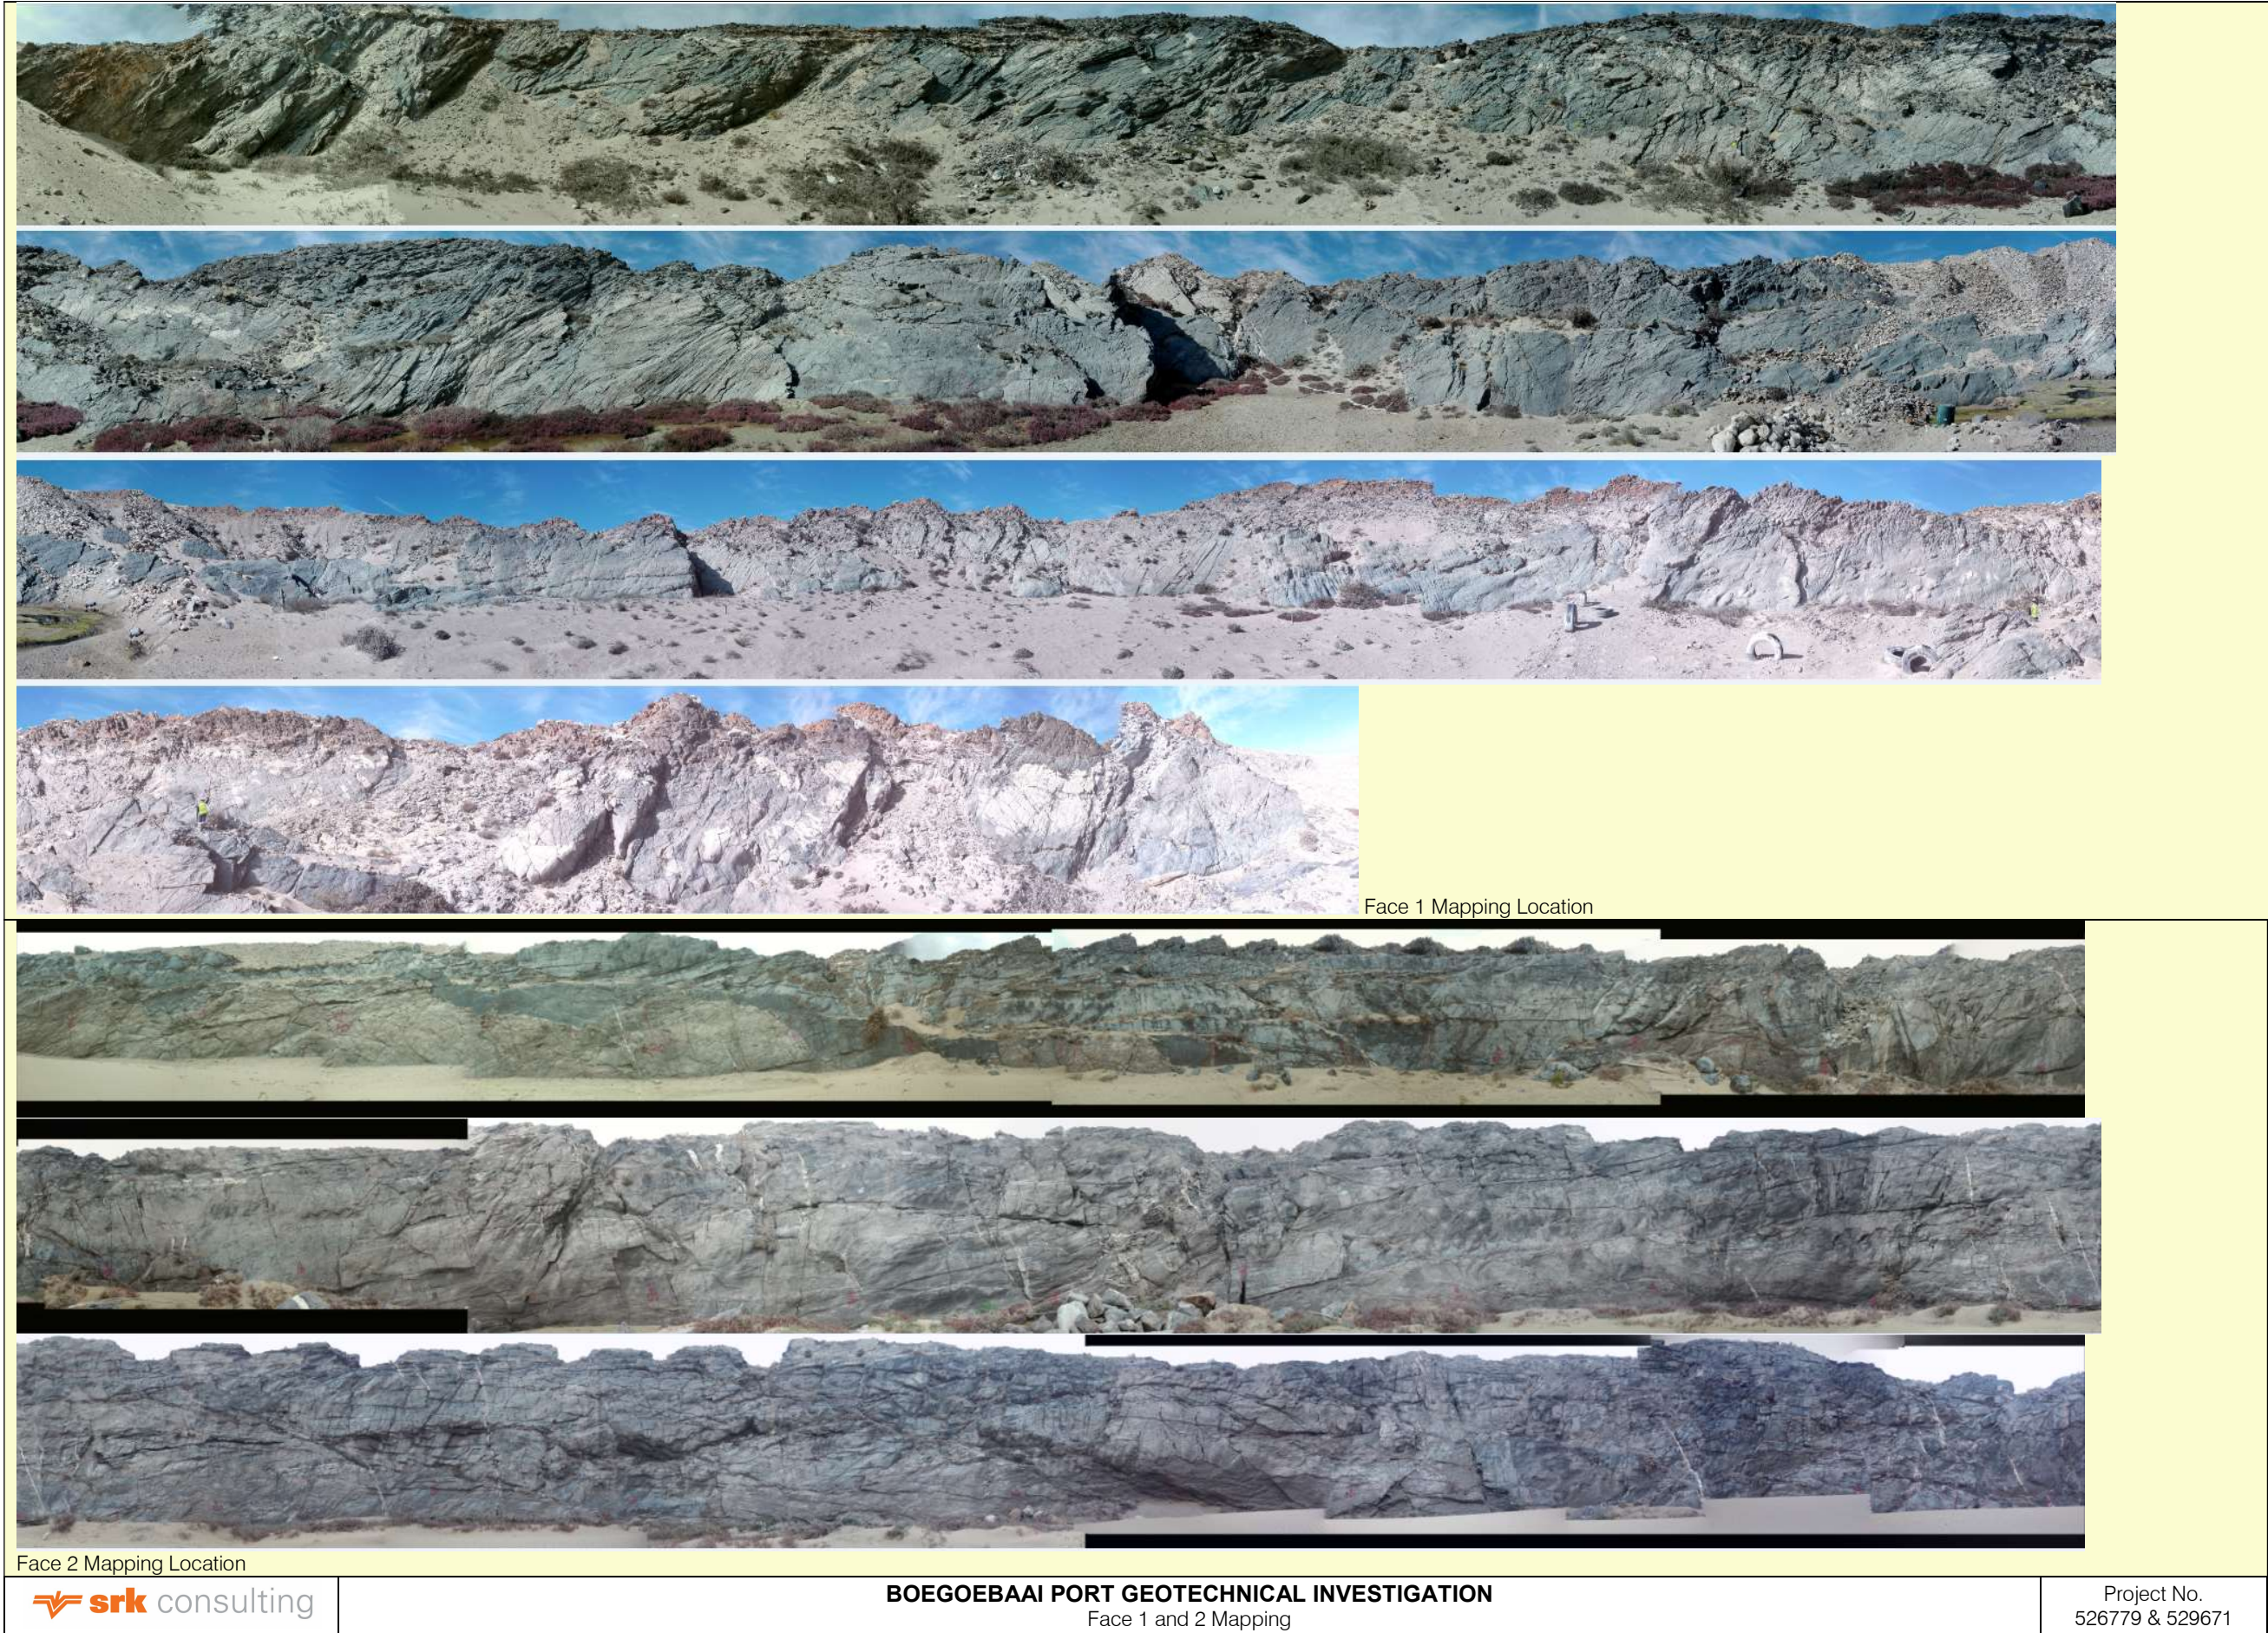
Figure 4-7: A) Face 1 Mapping Images and B) Face 2 Mapping Images

The results showed expected average block sizes for the selected quarry locations to be in the range of 0.50 to 0.65 m³.

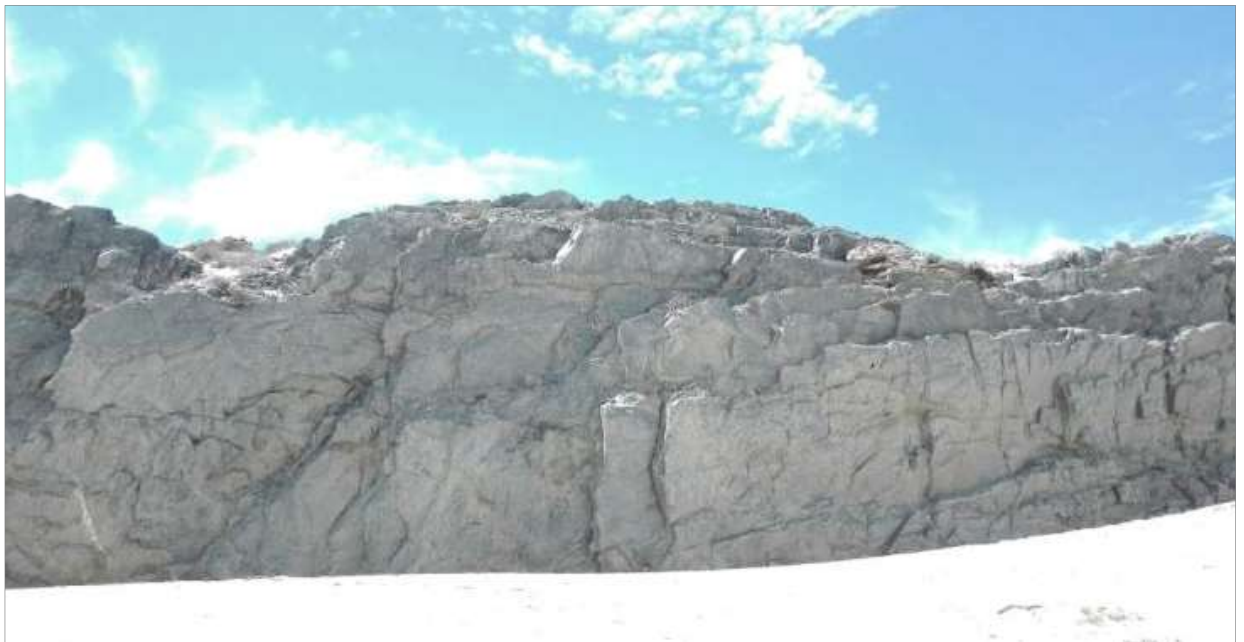
Figure 4-18: Representative face conditions for Quarry Site 2

As Figure 4-18 shows, the rock mass tends to range from blocky to very blocky in localised areas, with 2 – 4 joint sets identified in the different mapping areas (as well as some random joints). The joint conditions range from rough to smooth planar to undulating, often stained with occasional calcite and up to 15 mm clay infill. Based on these general conditions, a range of GSI values (50 – 65) were selected as representative of the face conditions. An analysis was carried out for a 80°, 20m high slope in the quartzite, and results using a GSI input of 50 (lower bound) and the result is presented in Figure 4-19. The results, as expected, for such shallow slopes in hard brittle rock, suggest that no rock mass failure is expected and yields a Factor of Safety (FoS) of >5 that far exceeds general acceptance criteria of 1.2 – 1.5.

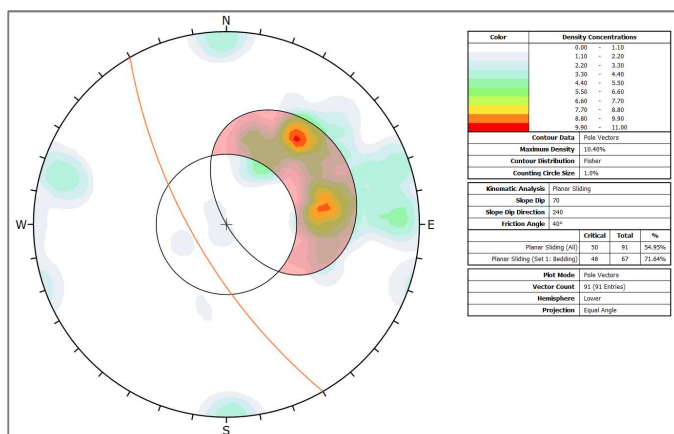
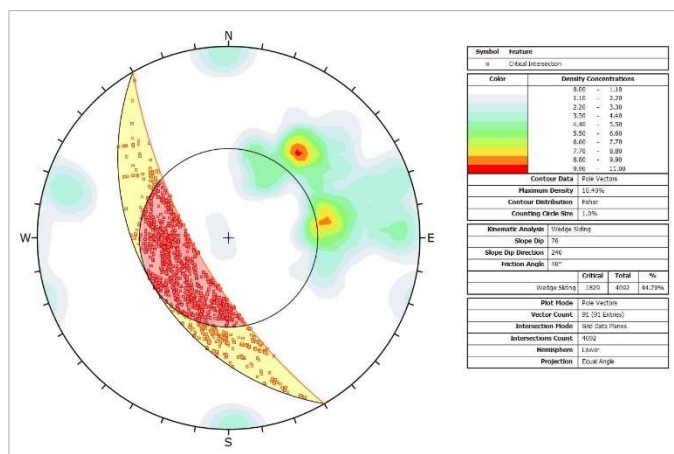
Figure 4-20: Planar and wedge failure analysis for north west dipping quarry face

The Rocplane and SWedge analyses were carried out to determine the FoS of planes and wedges that are expected to form in the face. For RocPlane, joint set J1 was analysed, as it is sub-parallel to the east wall and dips out of the face. It must be noted that due to the absence of reliable joint strength data, conservative joint strength parameters were applied. Cohesion of 0kPa was applied as it is assumed that even if some cohesion is present on these surfaces, this will be significantly reduced during blasting. A friction angle of 40° was applied as a conservative input based on experience in similar material. The results of the analyses is presented in Table 4-12.

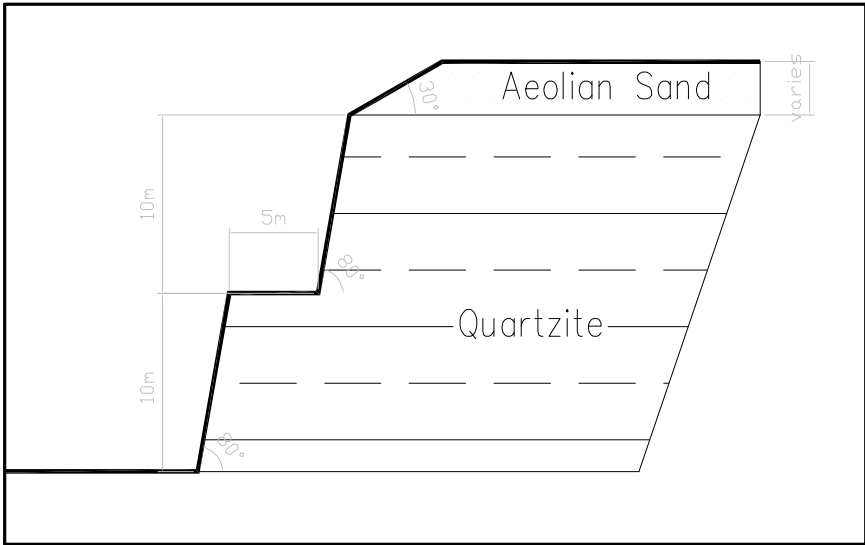
Figure 4-21: Proposed design for the Quarry High Wall

The proposed design for the quarry site is presented in Figure 4-21.

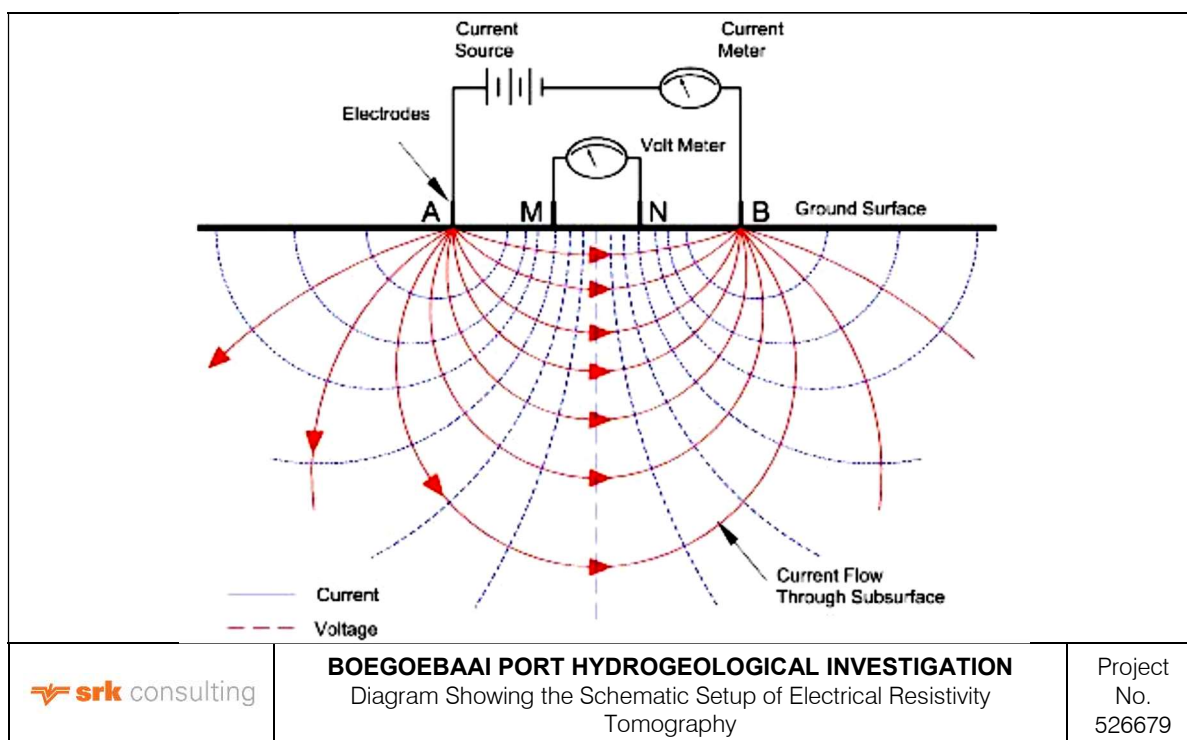
Figure 5-6: Diagram showing the schematic setup of Electrical Resistivity Tomography

The electrical resistivity varies between different geological materials, depending primarily on variations in water content and dissolved ions in the groundwater. Resistivity investigations are therefore used to identify zones with different electrical properties, which can then be used to delineate different geological strata. Resistivity is also called specific resistance, which is the inverse of conductivity or specific conductance. The most common mineral-forming soils and rocks have very high resistivity in dry conditions; as such, the resistivity of soils and rocks is normally a function of the amount and quality of water in pore spaces and fractures contained in the media, as well as the degree of weathering of the formation.
