GEOTECHNICAL INVESTIGATION REPORT  
FOR A PROPOSED NEW MAKHAZA POLICE  
STATION IN CAPE TOWN.

LC021-23. R01

30 November 2023

Prepared for:  
Ukuza Consulting (Pty) Ltd

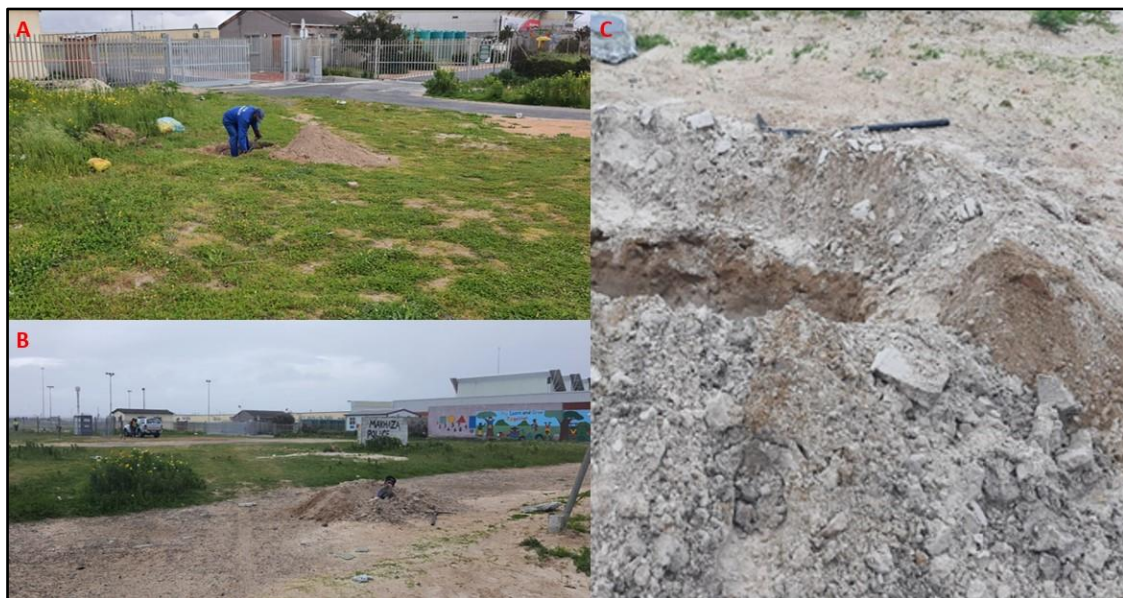
Figure 2: Overview of site conditions: picture A-B showing overview test pit site, C showing material encountered throughout the site.

The project area is located in Makhaza within the City of Cape Town Metropolitan Municipality in the Western Cape Province (Figure 1 and 2). The site comprises of an open field of land and the central coordinates of the site are 34.048346°S and 18.704592°E. The site can be accessed via the M9 Rd, Cekeca Rd and Dibana Road.

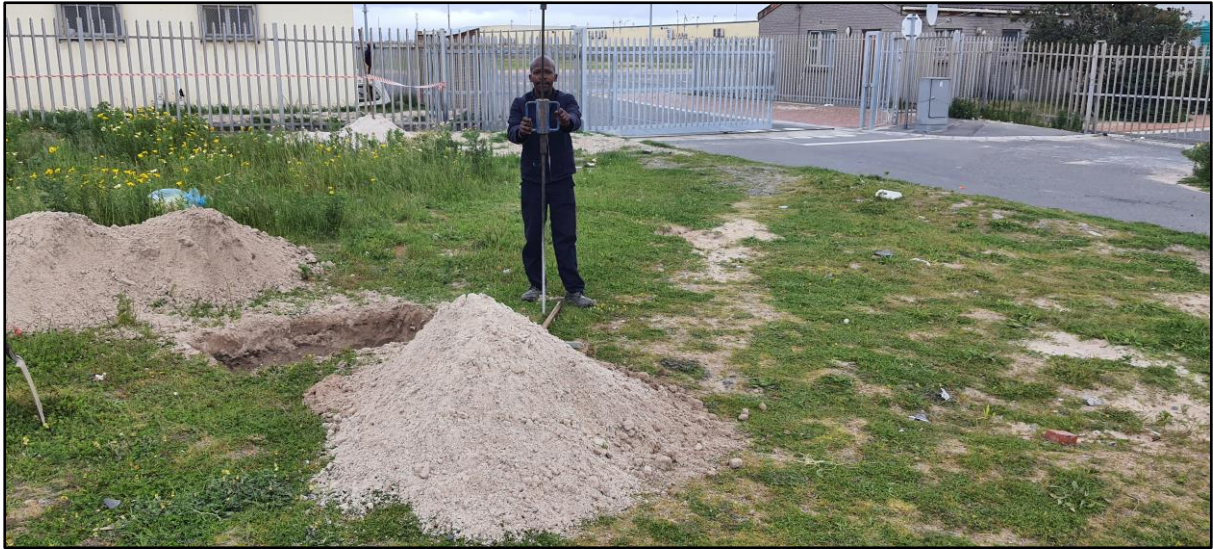
Figure 5: DCP testing conducted on site.

A DCP test was carried out in order to determine the consistency of the respective soil horizons (Figure 5). At each test pit a DCP test was conducted in proximity of the pit. In total twenty-two (22) DCP tests were conducted at preselected points (Table 1).

The DCP tests extended to an approximate depth ranging from 2.4 to 3.0m. The DCP test results are provided in Appendix B.

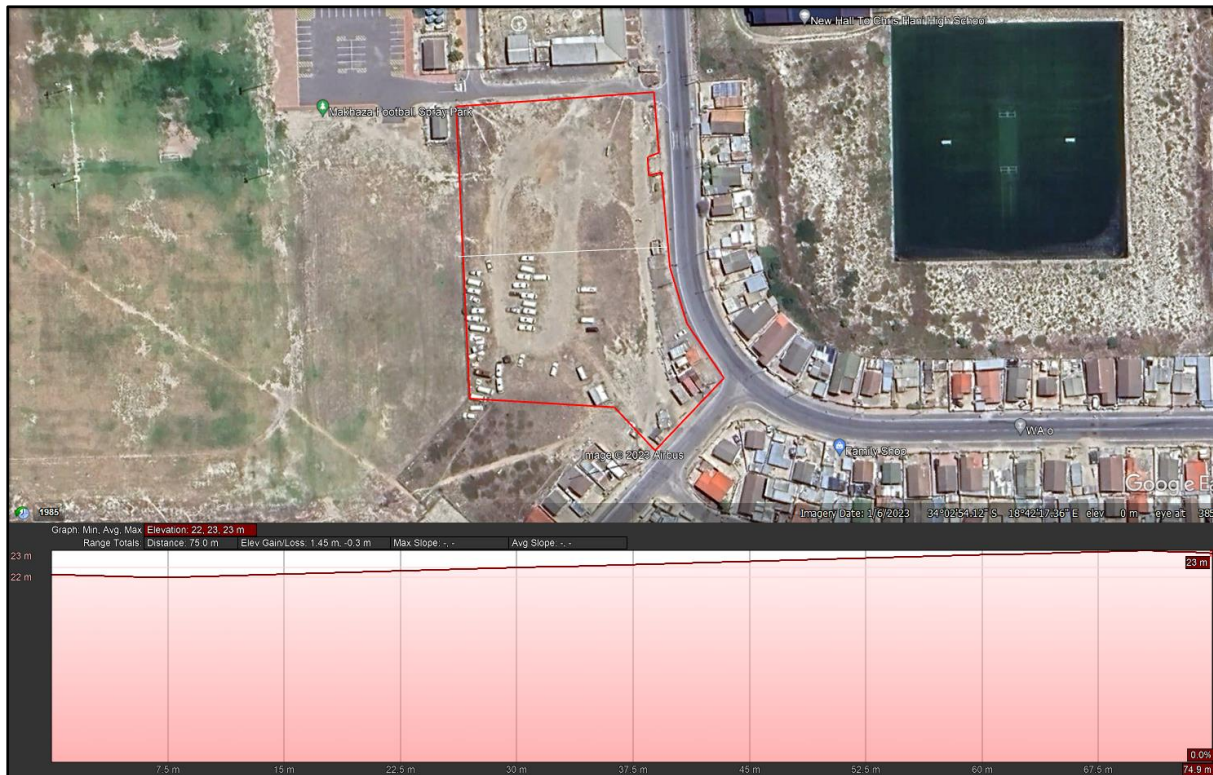
Figure 6: A topographical cross section of the site from east to west direction Google Earth Maps.

The elevation of the investigated area (Figure 6) is generally characterised by a gentle slope with a minimum and maximum elevations of 22m and 23m above mean sea level (AMSL) respectively.

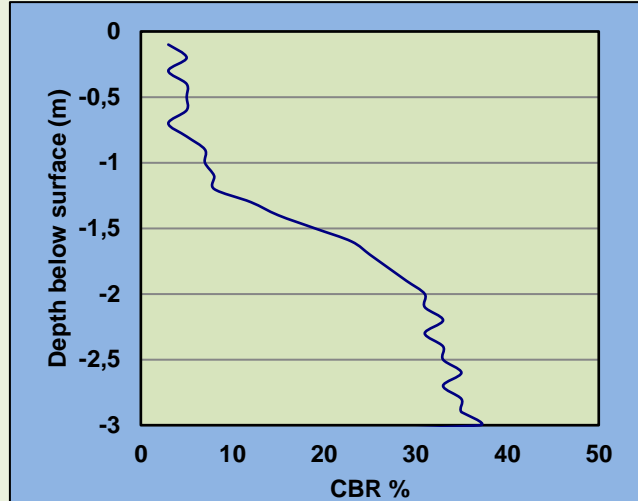
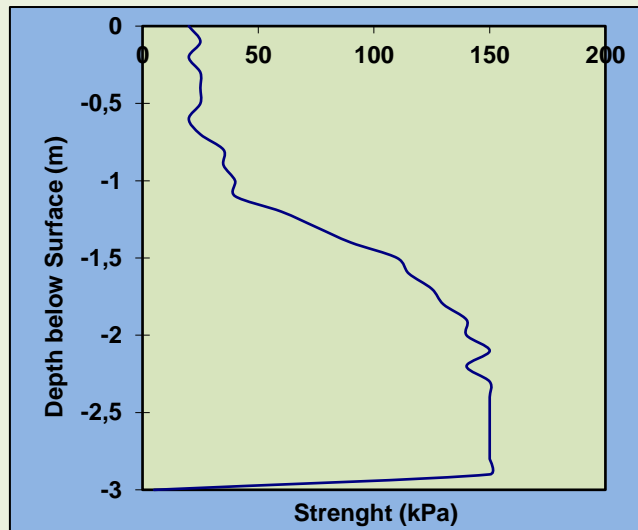
Depth (m)	Blows/ 0.1m	Inferred Consistency	Shear Strength
0			
0,1	2	Loose	30 deg
0,2	3	Loose	30 deg
0,3	2	Loose	30 deg
0,4	3	Loose	30 deg
0,5	3	Loose	30 deg
0,6	3	Loose	30 deg
0,7	2	Loose	30 deg
0,8	3	Loose	30 deg
0,9	4	Med.Dense	30 deg
1	4	Med.Dense	30 deg
1,1	5	Med.Dense	32 deg
1,2	5	Med.Dense	32 deg
1,3	7	Med.Dense	34 deg
1,4	9	Med.Dense	35 deg
1,5	11	Dense	36 deg
1,6	13	Dense	37 deg
1,7	14	Dense	37 deg
1,8	15	Dense	37 deg
1,9	16	Dense	37 deg
2	17	Dense	37 deg
2,1	17	Dense	37 deg
2,2	18	Dense	37 deg
2,3	17	Dense	37 deg
2,4	18	Dense	37 deg
2,5	18	Dense	37 deg
2,6	19	Dense	37 deg
2,7	18	Dense	37 deg
2,8	19	Dense	37 deg
2,9	19	Dense	37 deg
3	20	Dense	38 deg

The results shown here are based on calculations using the DCP test. These are classified as indicative values and need to be verified by other testing methods.

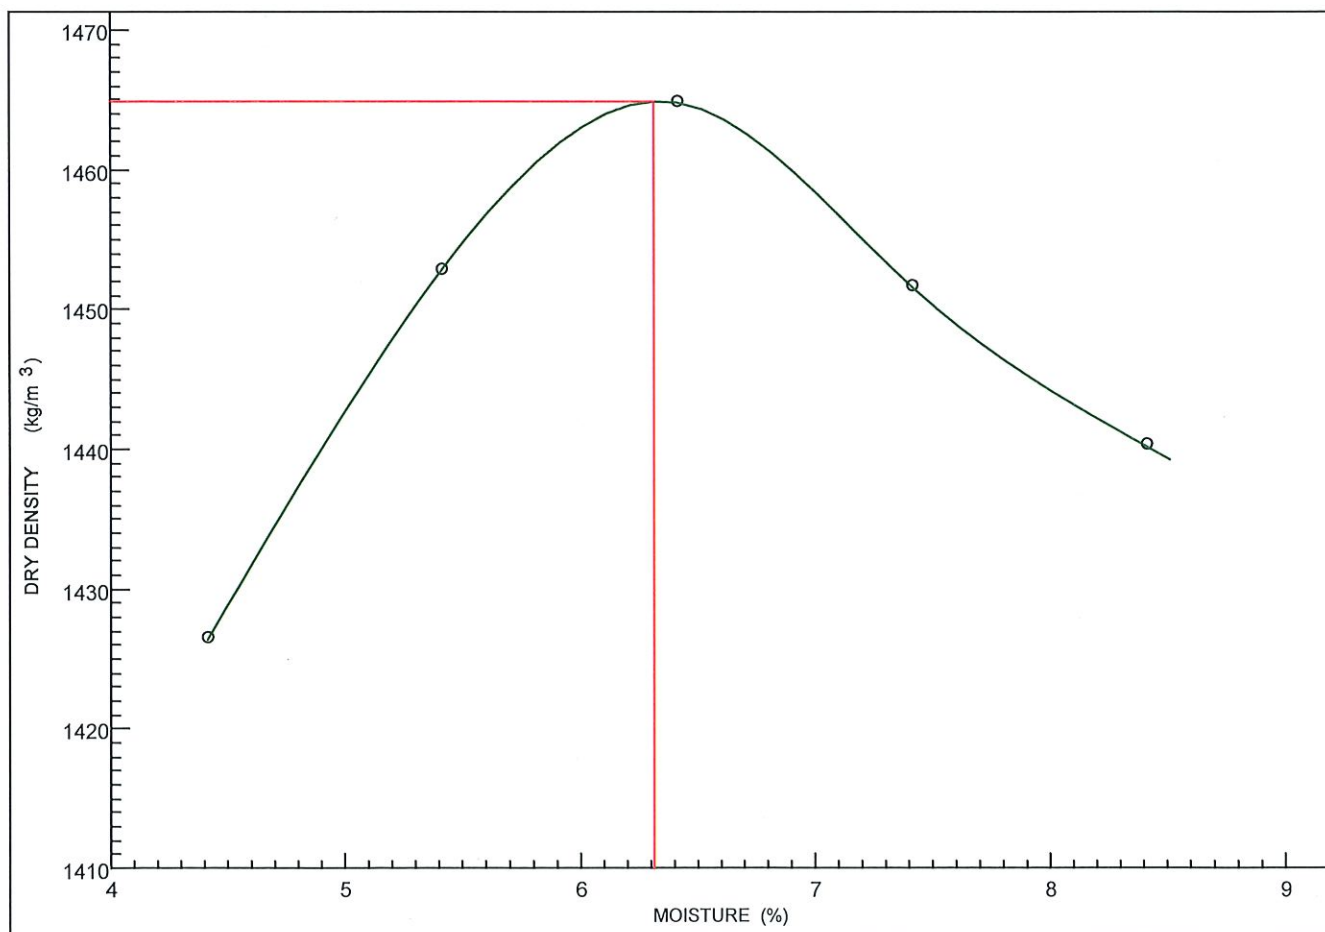
Point No.	1	2	3	4	5			
Moisture (%)	4.4	5.4	6.4	7.4	8.4			
Density ( $\text{kg/m}^3$ )	1426	1453	1465	1452	1440

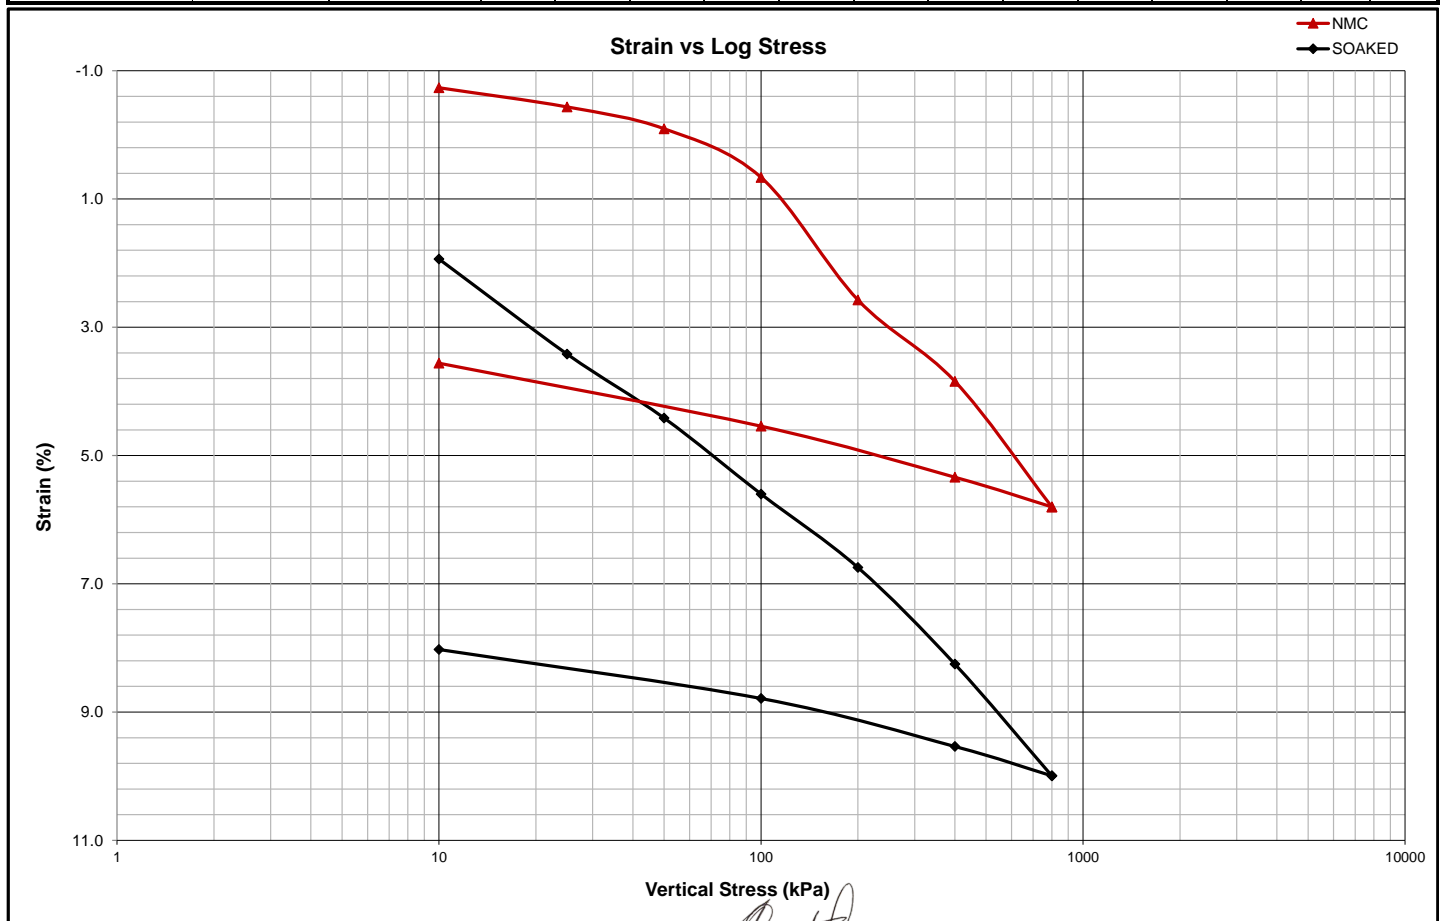
Test Parameters													
Vertical Stress	kPa	10	25	50	100	200	400	800	400	100	10		
Time Elapsed NMC	hr	20	24	24	24	22	8	24	3	3	3		
Time Elapsed Soaked	hr	20	24	24	24	24	24	8	3	3	3		
H <sub>100</sub>	NMC	mm	25.053	24.978	24.894	24.705	24.230	23.914	23.427	23.542	23.740	23.985	
	Soaked	mm	24.555	24.184	23.935	23.638	23.351	22.974	22.538	22.652	22.840	23.031	
Strain	NMC	%	-0.735	-0.435	-0.095	0.663	2.575	3.843	5.801	5.339	4.542	3.561	
	Soaked	%	1.937	3.419	4.415	5.600	6.746	8.252	9.994	9.537	8.788	8.024	
Void Ratio	NMC	-	0.891	0.885	0.879	0.865	0.829	0.805	0.768	0.777	0.792	0.810	
	Soaked	-	0.857	0.829	0.810	0.788	0.766	0.737	0.704	0.713	0.727	0.742	
Mv (1/Mpa)	NMC	-	-	0.198	0.135	0.151	0.192	0.065	0.051	0.012	0.028	0.114	
	Soaked	-	-	1.008	0.413	0.248	0.121	0.081	0.047	0.013	0.028	0.093
