Ref: GG006-21.R01

Date: 18 July 2022

GEOTECHNICAL REPORT FOR THE PROPOSED MGANGENI HALL, NEAR KUMPONDO VILLAGE, KWAZULU-NATAL

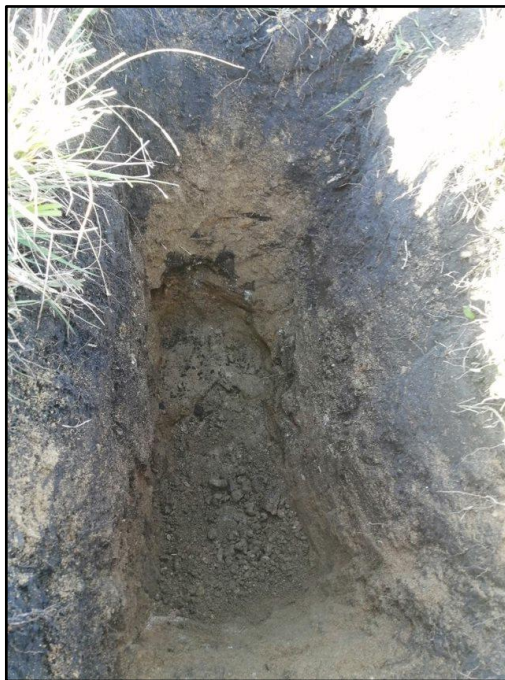
Photograph 3: Material Encountered in TP02

The positions investigated at the site comprised colluvium, residual material and weathered granite rock. Summarised descriptions are given below and detailed descriptions in the test pit profiles in Appendix A.

Colluvial material at the site can be described as dark grey to black, silty CLAY that generally extended to approximate depths in the range 0.3m (TP01) to 0.5m (TP05) begl.

Residual Granite material can be described as dark grey to yellowish brown, clayey GRAVEL that was encountered in all test pits and extended to approximate depths in the range 0.6m (TP01) to 0.9m (TP03) begl.

Weathered Granite material can be described as a yellowish brown, highly weathered, coarse grained, highly fractured, soft rock and was encountered in all five test pits from approximate depths in the range 0.6m (TP01) to 0.9m (TP05) begl.

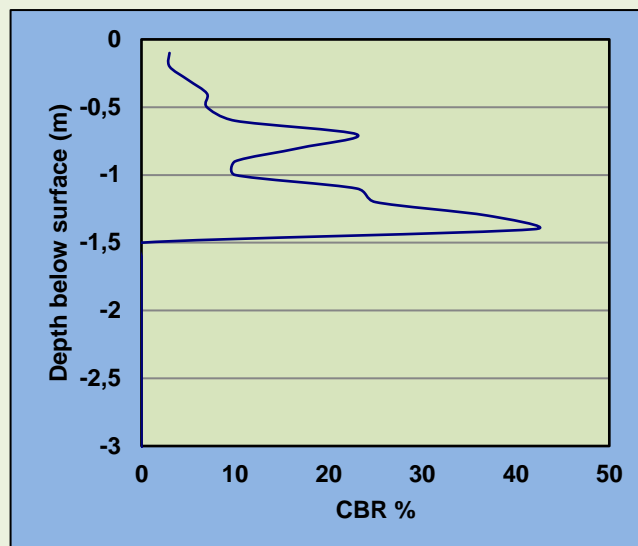
Depth (m)	Blows/ 0.1m	Inferred Consistency	Shear Strength
0			
0,1	2	Soft	20 kPa
0,2	2	Soft	20 kPa
0,3	3	Soft	25 kPa
0,4	4	Soft	35 kPa
0,5	4	Med.Dense	30 deg
0,6	6	Med.Dense	33 deg
0,7	13	Dense	37 deg
0,8	10	Med.Dense	36 deg
0,9	6	Med.Dense	33 deg
1	6	Med.Dense	33 deg
1,1	13	Dense	37 deg
1,2	14	Dense	37 deg
1,3	20	Dense	38 deg
1,4	22	Dense	38 deg
1.5	REF

The results shown here are based on calculations using the DCP test. These are classified as indicative values and need to be verified by other testing methods.

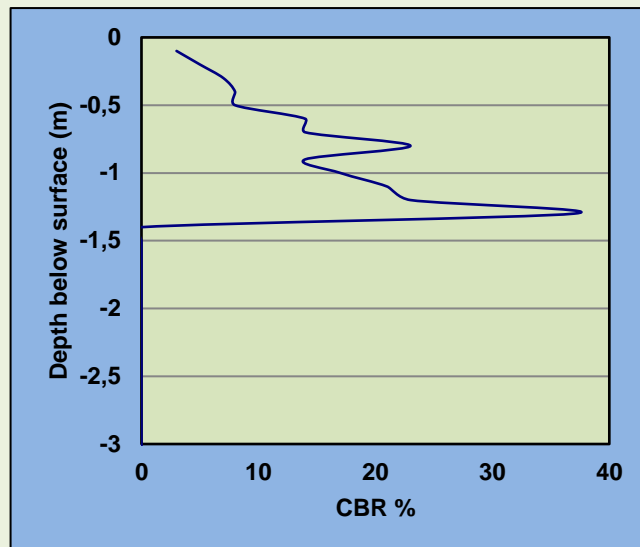
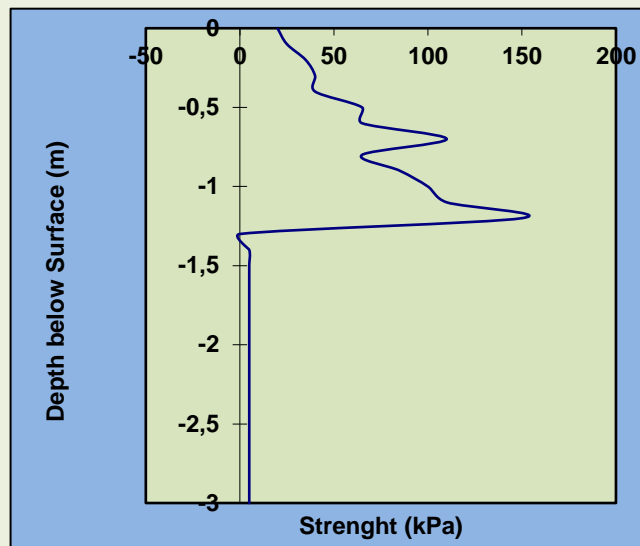
Depth (m)	Blows/ 0.1m	Inferred Consistency	Shear Strength
0			
0,1	2	Soft	20 kPa
0,2	3	Soft	25 kPa
0,3	4	Soft	35 kPa
0,4	5	Firm	40 kPa
0,5	5	Firm	40 kPa
0,6	8	Med.Dense	35 deg
0,7	8	Med.Dense	35 deg
0,8	13	Dense	37 deg
0,9	8	Med.Dense	35 deg
1	10	Med.Dense	36 deg
1,1	12	Dense	36 deg
1,2	13	Dense	37 deg
1,3	20	Dense	38 deg
1,4	15	Dense	38 deg
1.5	REF

The results shown here are based on calculations using the DCP test. These are classified as indicative values and need to be verified by other testing methods.
