# Proposed Erica Substation Boundary Wall, Philippi, Cape Town.

## Aquatic Biodiversity Assessment Report

May 2022

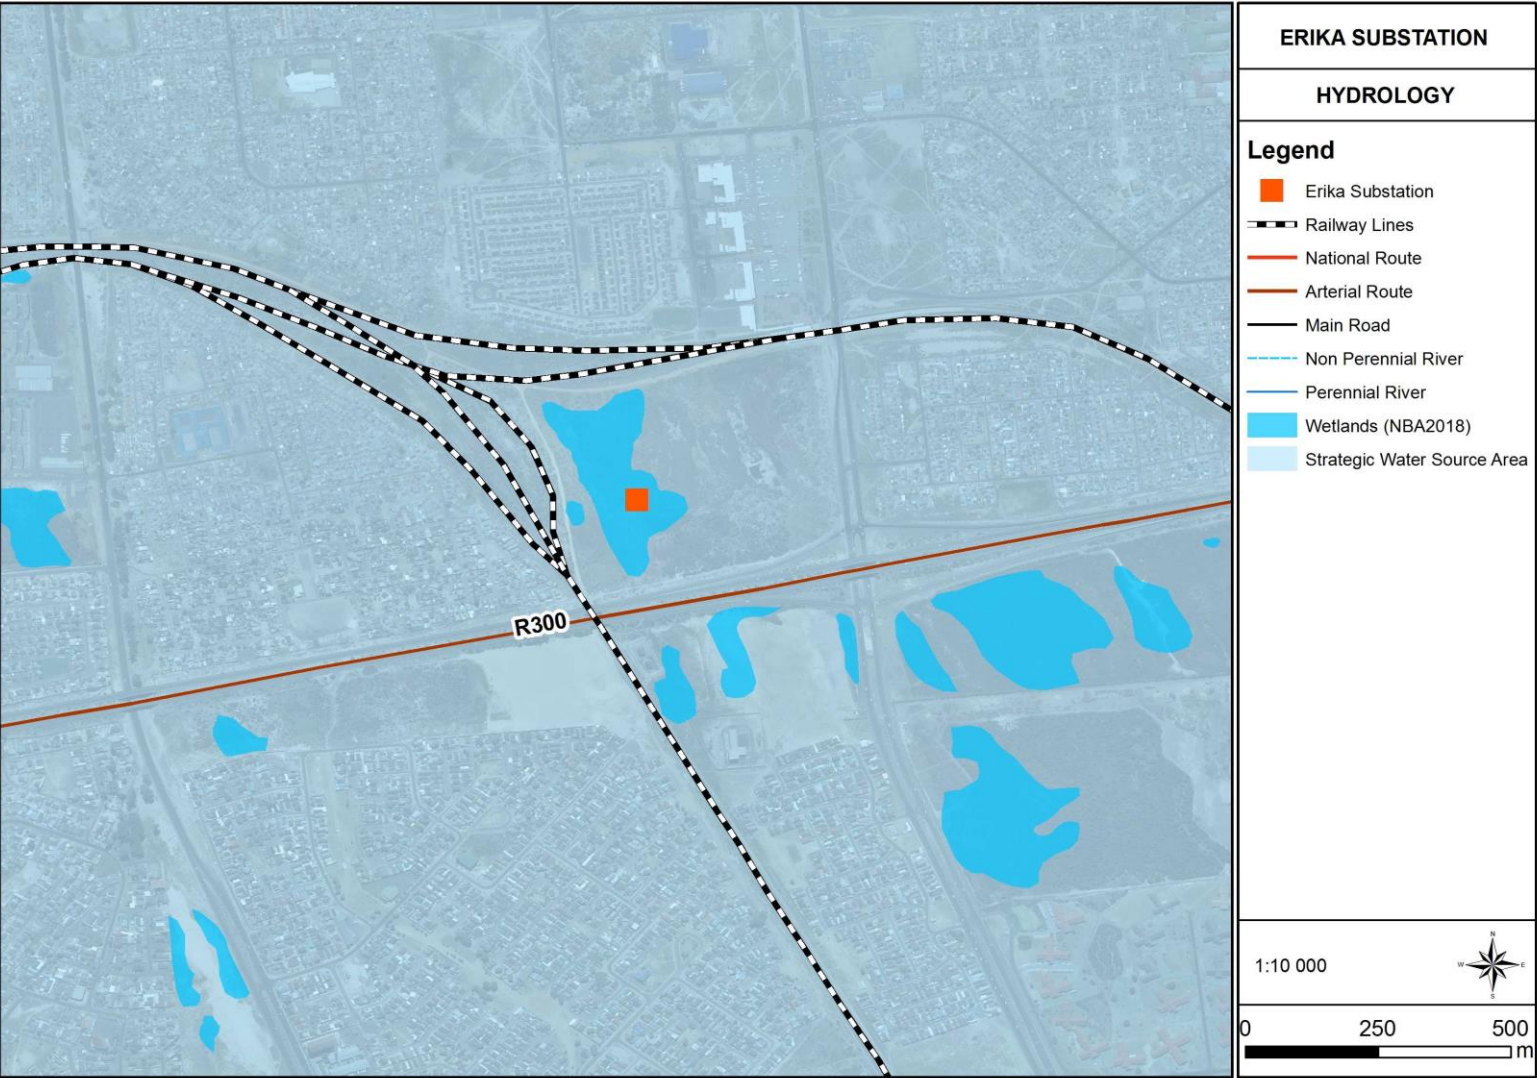
Figure 3: Regional hydrological features relative to the study site.

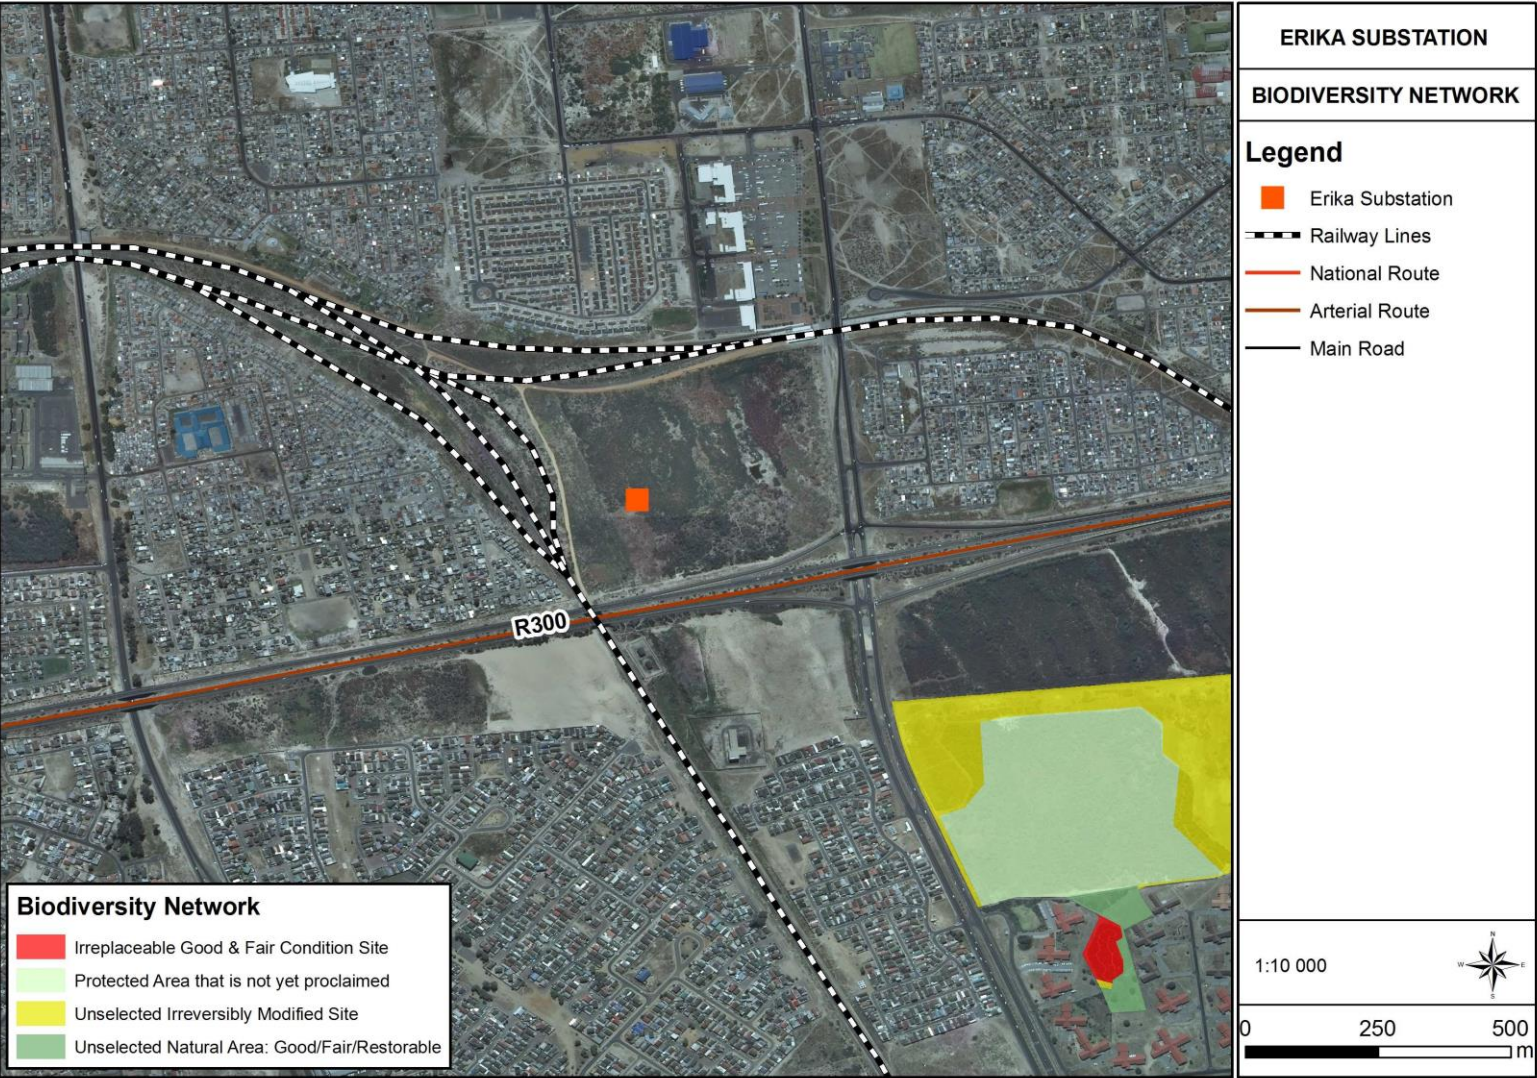
Figure 4: Biodiversity Network Classification.

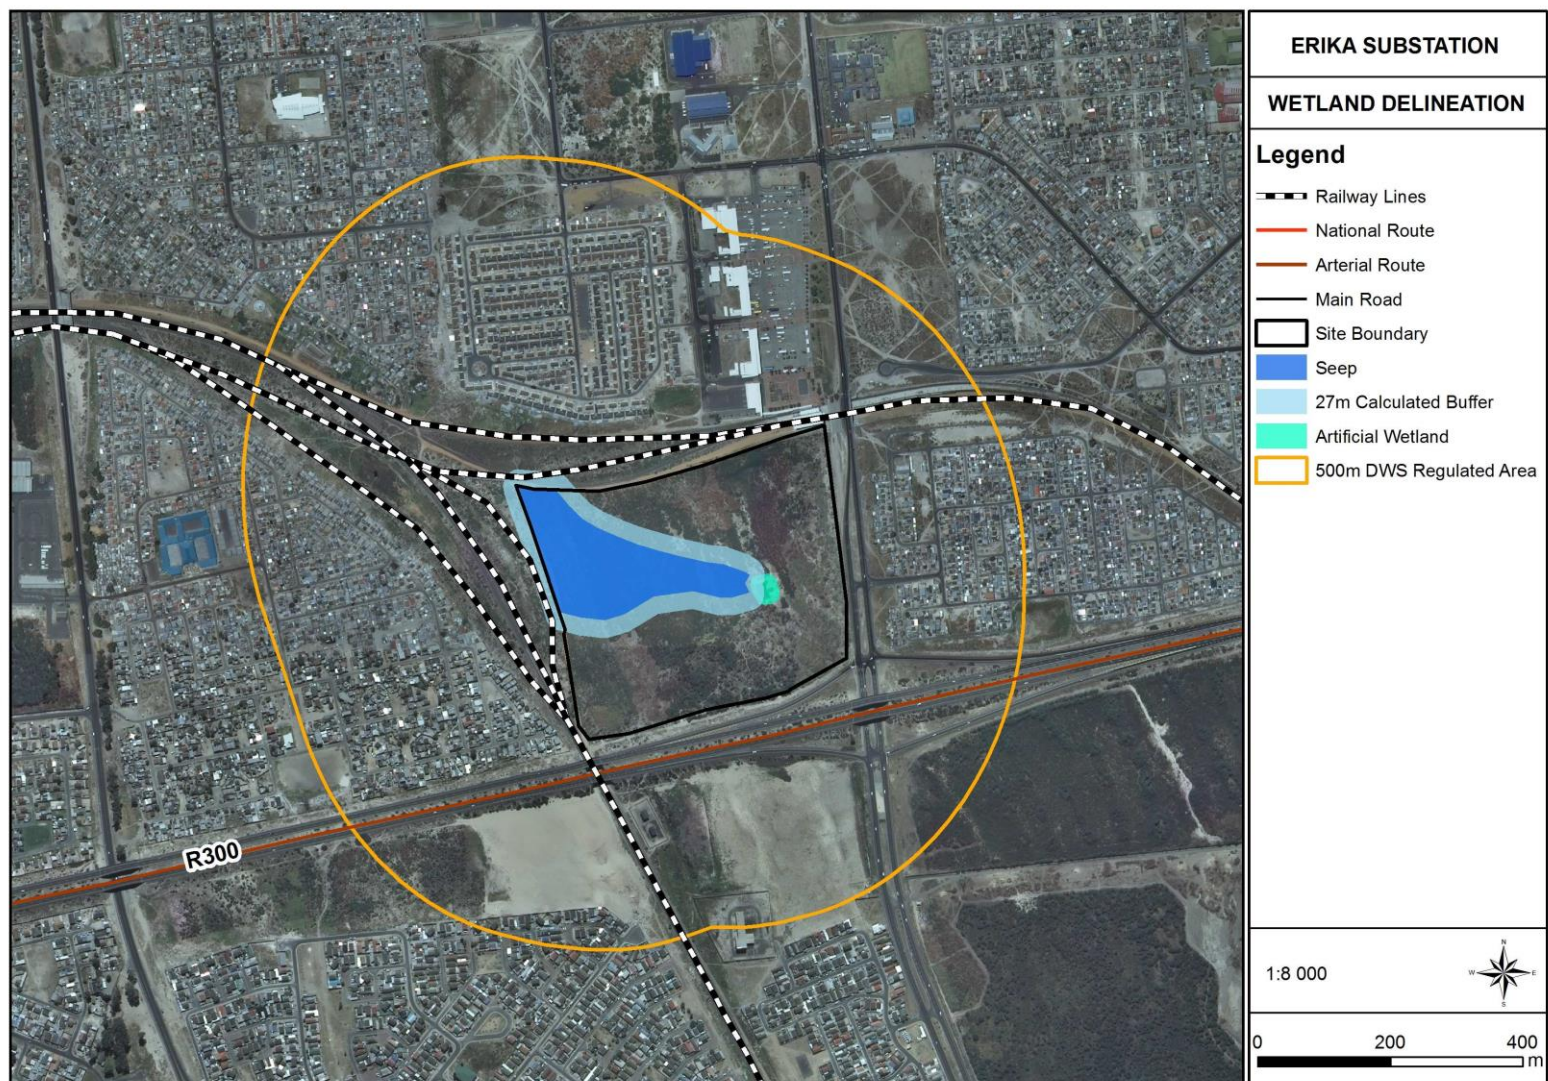
Figure 5: Delineated watercourses, their associated buffer zones and the DWS regulated area relative to the study site.

The characteristics of the wetland are described in detail in Appendix A. Calculated buffer zones following MacFarlane *et al.*, 2015 resulted in a construction phase buffer zone of 15m and an operational phase buffer zone of 27m. The project phases are awarded different buffer zones since the potential impact and mitigation measures for each phase are different. Generally, the larger buffer zone is reflected relative to the layout (MacFarlane *et al.*, 2015). Figure 5 reflects the delineated wetland, its recommended 27 buffer zone and the 500m DWS regulated area.

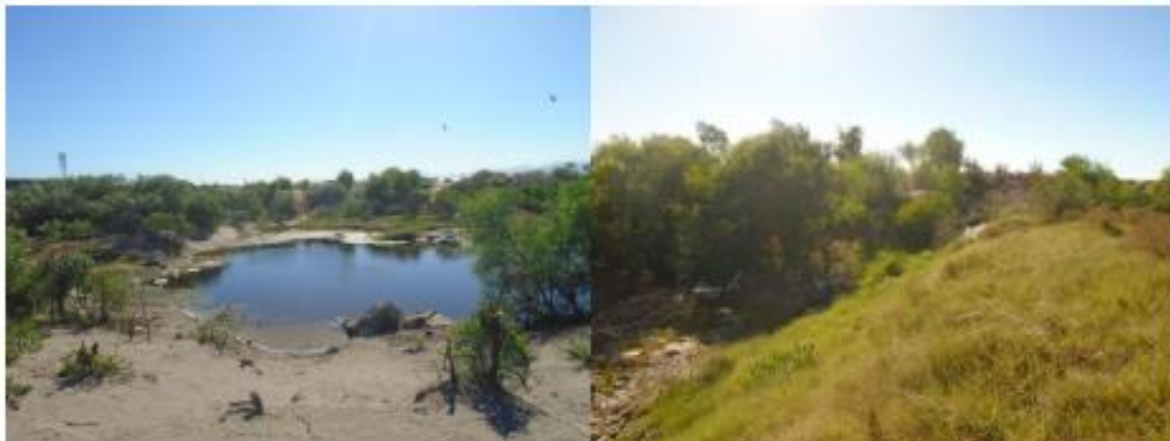
Figure 2. left) Historical excavated "borrow pit" area. right) uneven terrain, with ridges

The site was accessed from Stock Road along the eastern portion of the project site. The site terrain condition appears disturbed, with ridges and various disturbed excavated (dug out) portions, likely used as a borrow pit during road construction (Figure 2). The largest of such an excavated area has formed a pond-like area, which was also noticeable on the aerial image of the site. Also, immediately noticeable in the more central portions of the site are the burnt circular areas, which appear to have been temporary shelters (Figure 4). Large portions of the site covered in Port Jackson (*Acacia saligna*) shrubs, with grasses and other low growing species occurring in wetter soil conditions (Figure 3, Figure 4). In the central portion of the site, large calcrete boulders were also noted (Figure 5).

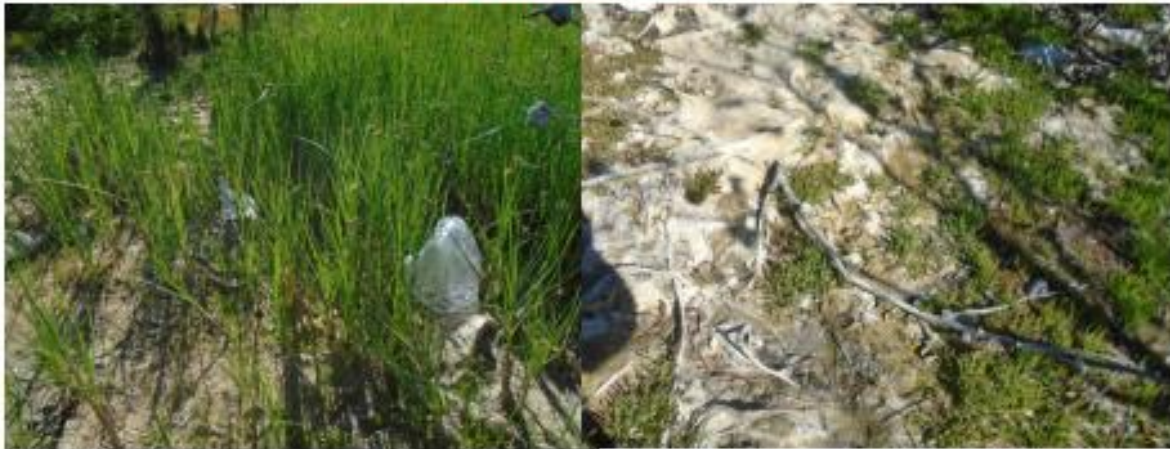
Figure 3. left) Grasses near pond area of historical excavated "borrow pit" area. right) dried algal growth with "succulent-type" / samphire like plants growth on surface along pond area.

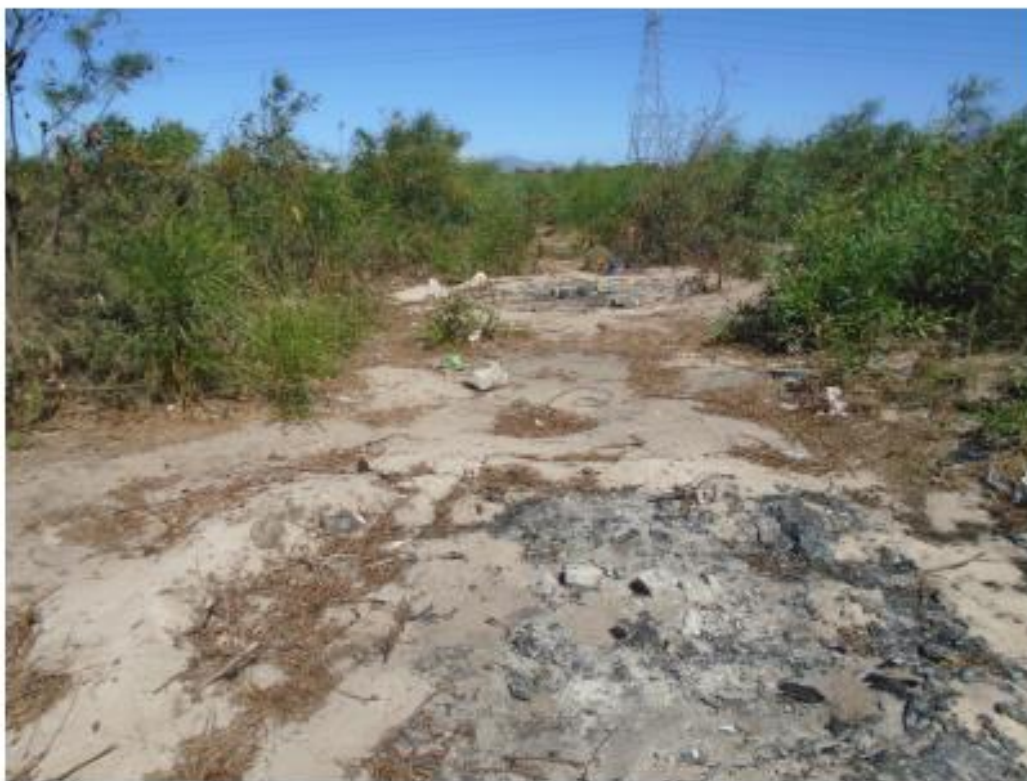
Figure 4. Burnt circular areas of temporary shelters

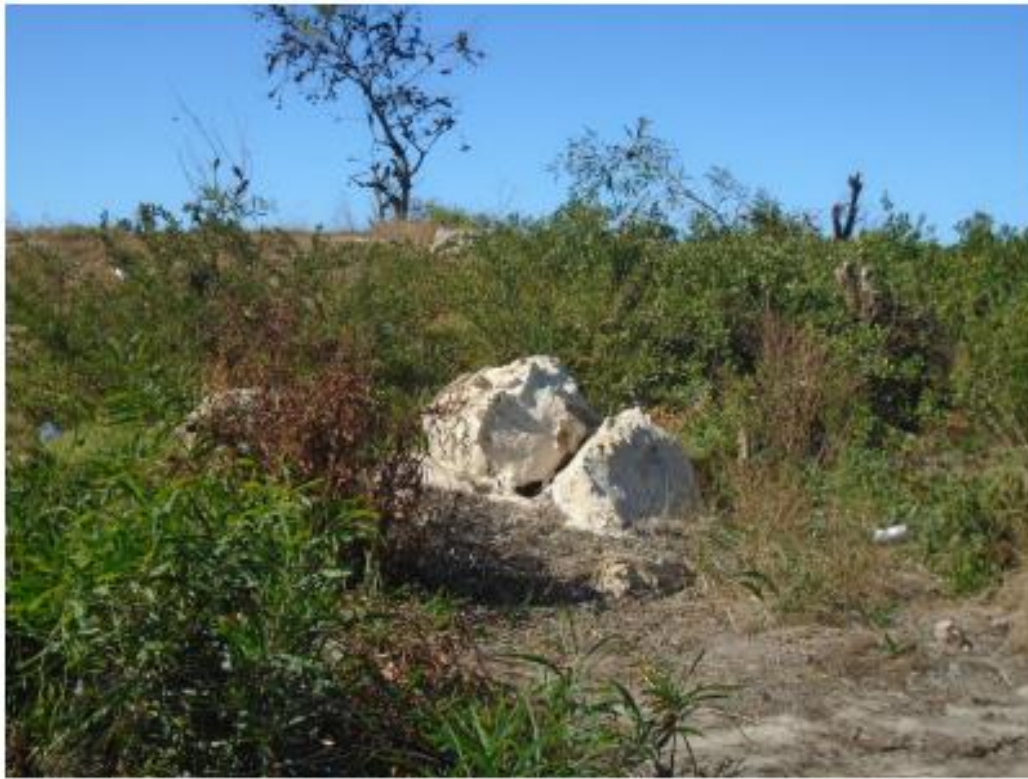
Figure 5. Calcrete boulders in central portion of site

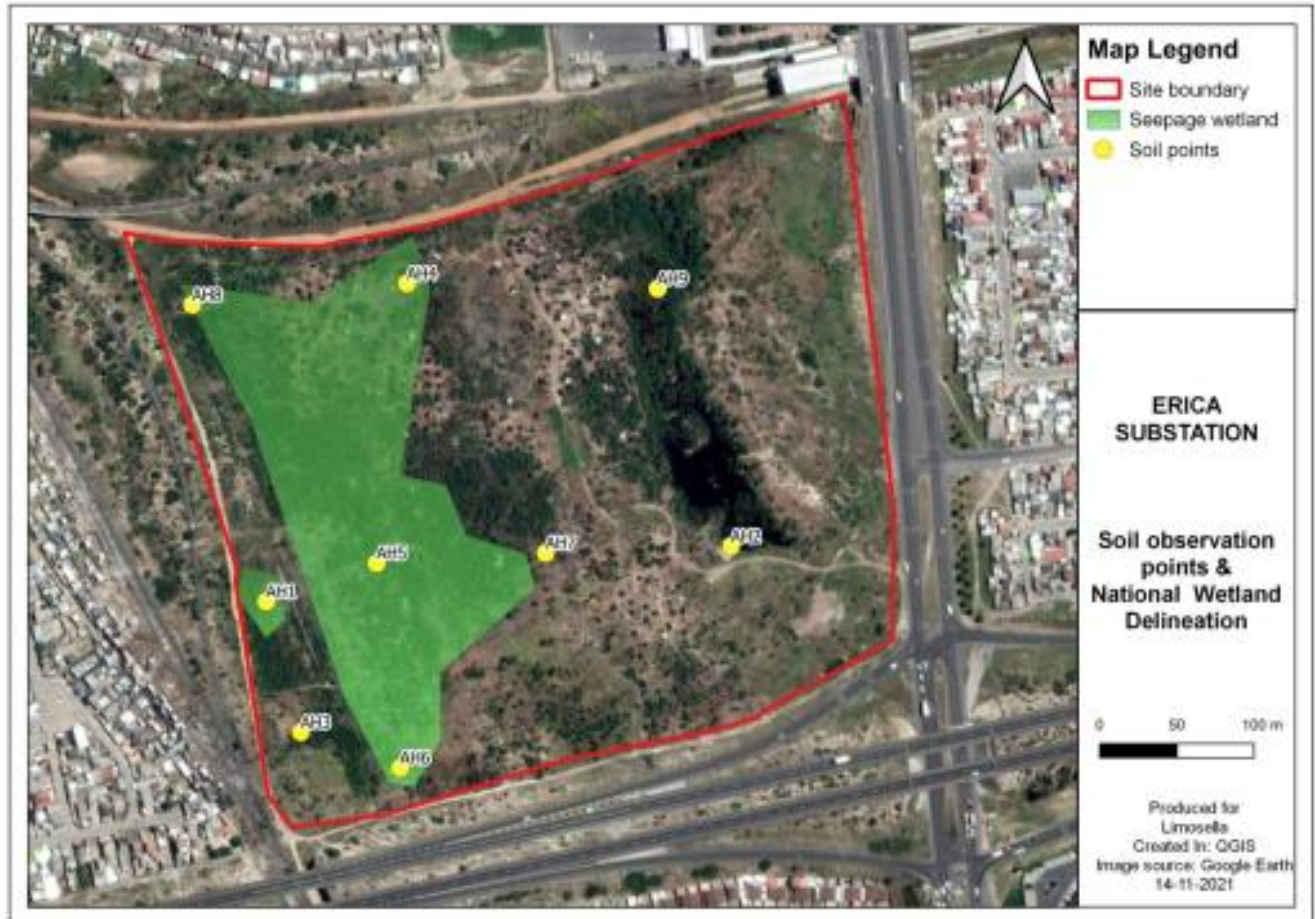
Figure 6. Soil observation points and National Wetland Delineation

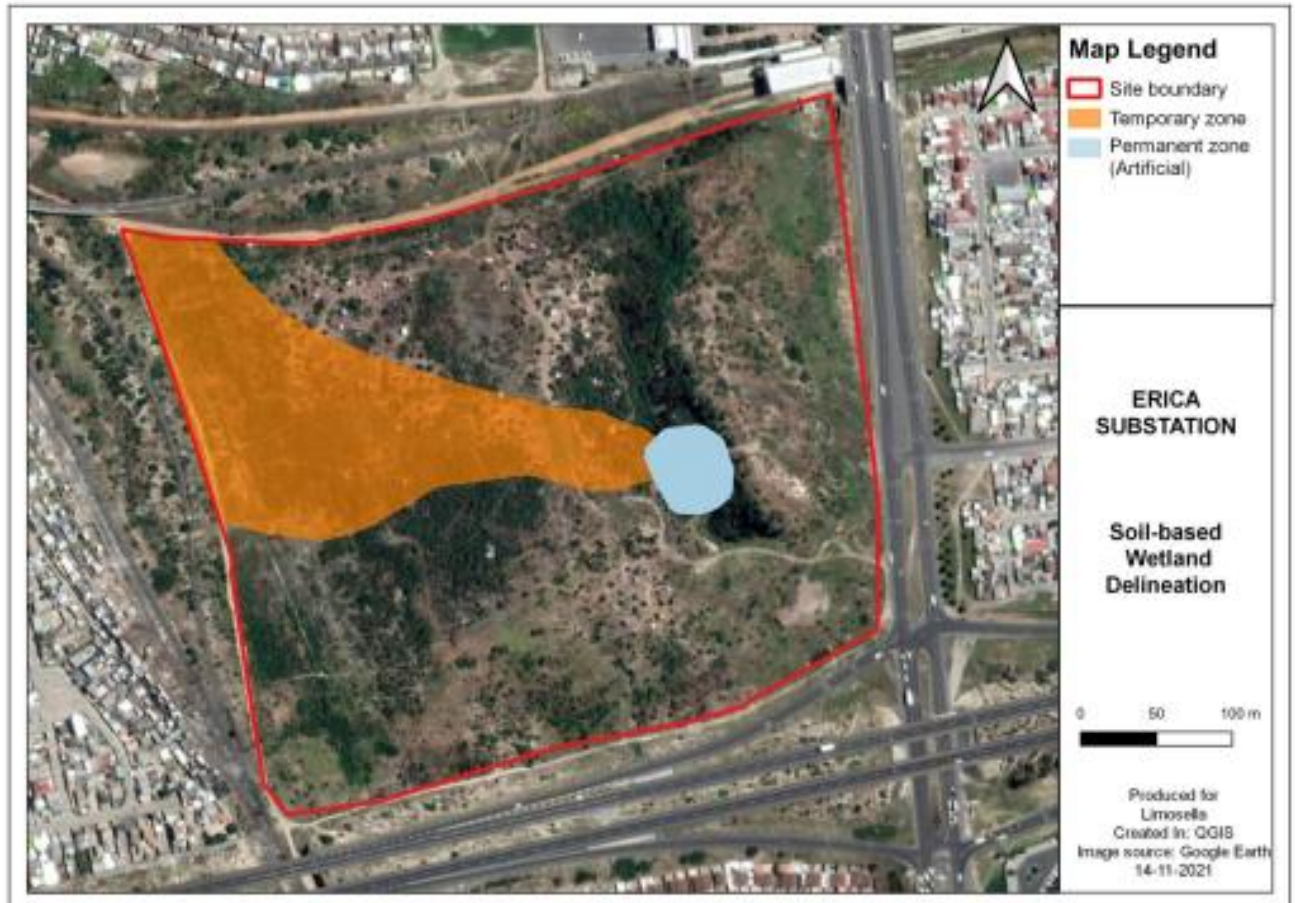
Figure 8. Soil-based wetland delineation of project area

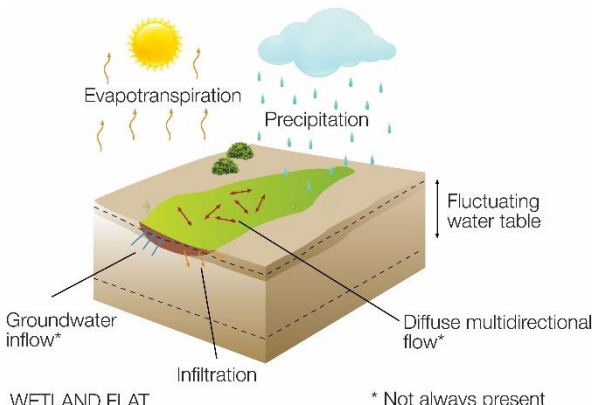
<p>WETLAND FLAT</p> <p>* Not always present</p>	<p>In areas with weakly developed drainage patterns and flat topography, rainfall may not drain off the landscape very quickly, if at all, due to the low relief. In such areas (commonly characterized by aeolian deposits or recent sea floor exposures) the wet season water table may rise close to, or above, the soil surface, creating extensive areas of shallow inundation or saturated soils. In these circumstances the seasonal or permanently high groundwater table creates the conditions for wetland formation.</p>
