**Report to Naidu Consulting on a Geotechnical Investigation carried out for  
the Reinstatement of Mobeni Reservoir No. 2 in Durban, KwaZulu-Natal**

**Project No.: 25-030R01 Rev 3**

**Date Issued: June 2025**

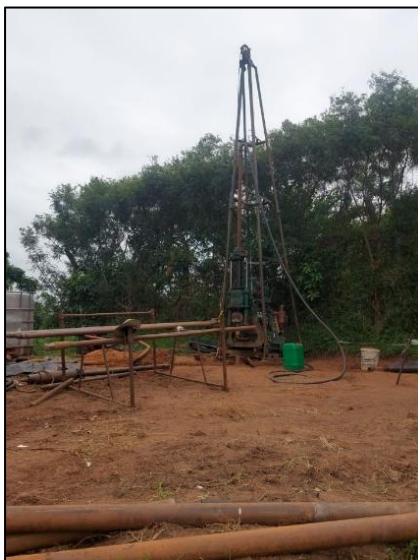
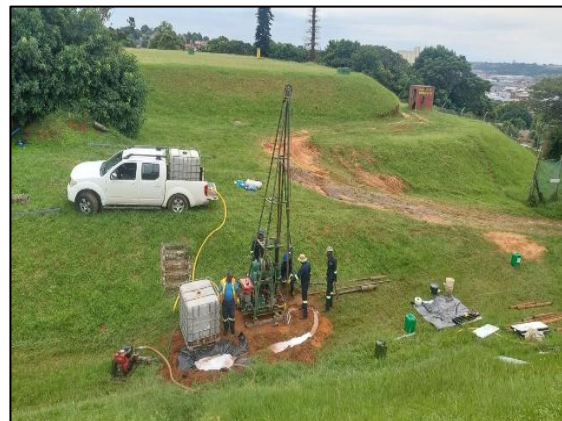
Groundwater monitoring piezometers were installed in BH1 and BH2 once the drilling was completed.

**Plates 1 & 2: Boreholes BH1 and BH2 drilled along the southwestern and northwestern sides, respectively, of Reservoir 2**

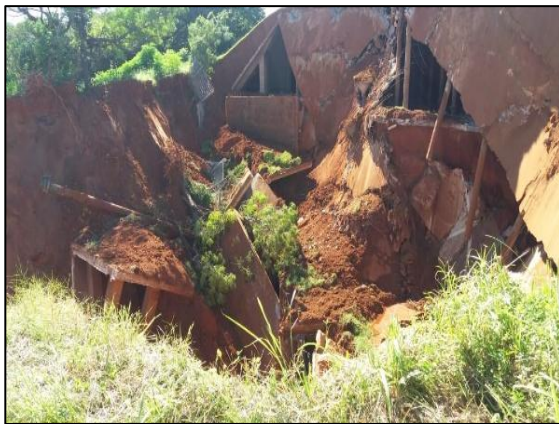
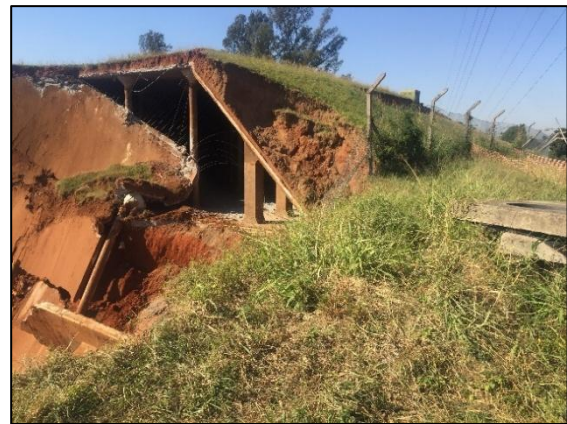
**Plates 3 & 4: Damaged section of the reservoir near the southern corner, showing the platform abruptly truncated by the breach and the inside of the concrete chamber exposed.**

- Existing fill making up the platform beneath the northern part of the damaged reservoir which must be demolished.
- The partially eroded ridge to the west of the reservoir will supply a significant amount of fill, provided it forms part of the site and has the necessary approvals (e.g. environmental) for borrowing.

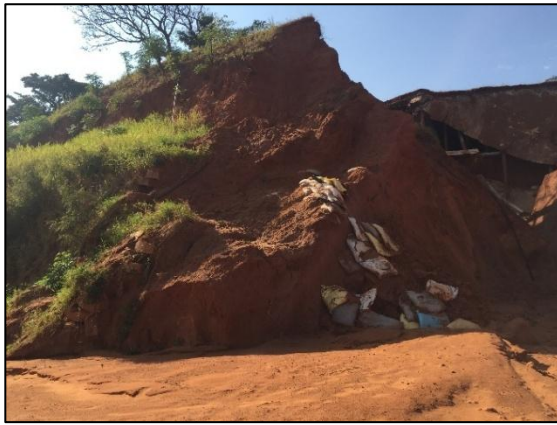
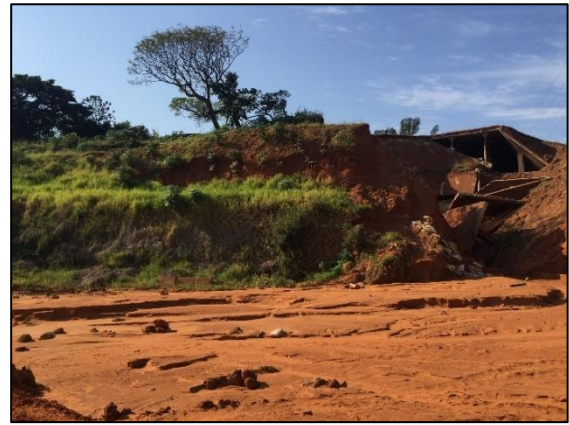
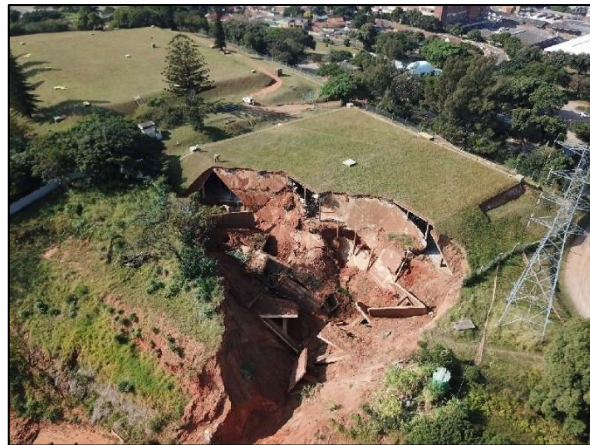
**Plates 5 to 7: Remnants of the natural dune on the west of Reservoir 2 will yield borrow material for the new fill embankment**

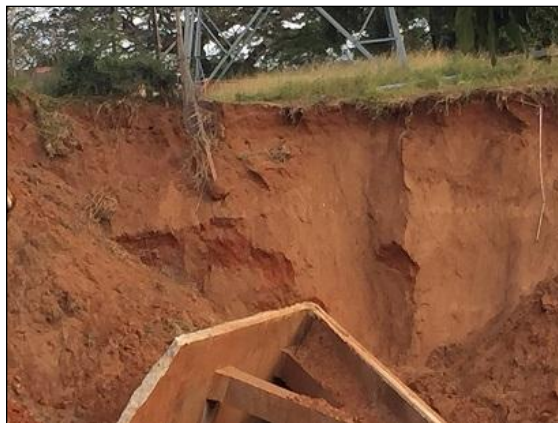
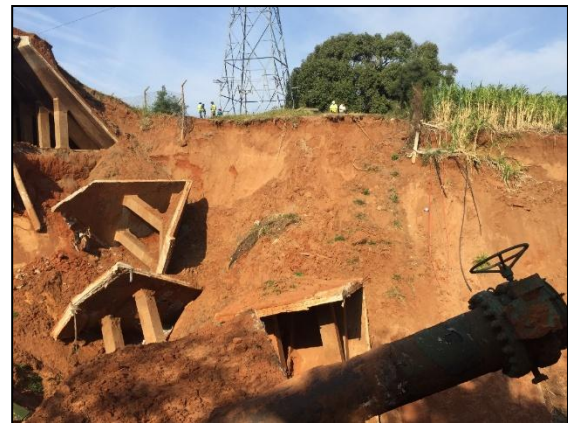
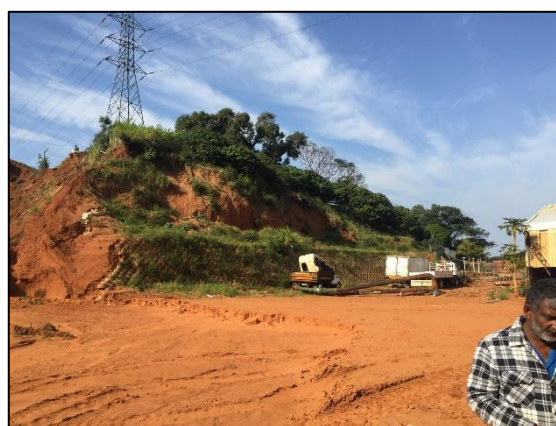
The pylon supporting the high-tension overhead electrical cable is located about 7m from the edge of the slip or erosion face formed by the breaching of the Reservoir No. 2. The excavation face is about 12 to 15m deep and sub-vertical in the upper 8m of the face.

**Plates 8 to 10: Pylon within 7m of the edge of the slipped surface**

Since the previous geotechnical report was submitted in 2019, the pylon has not shown any signs of tilting or deflection which would be expected if the potentially unstable slope below has moved. It must therefore be concluded that it is relatively stable over the medium term.

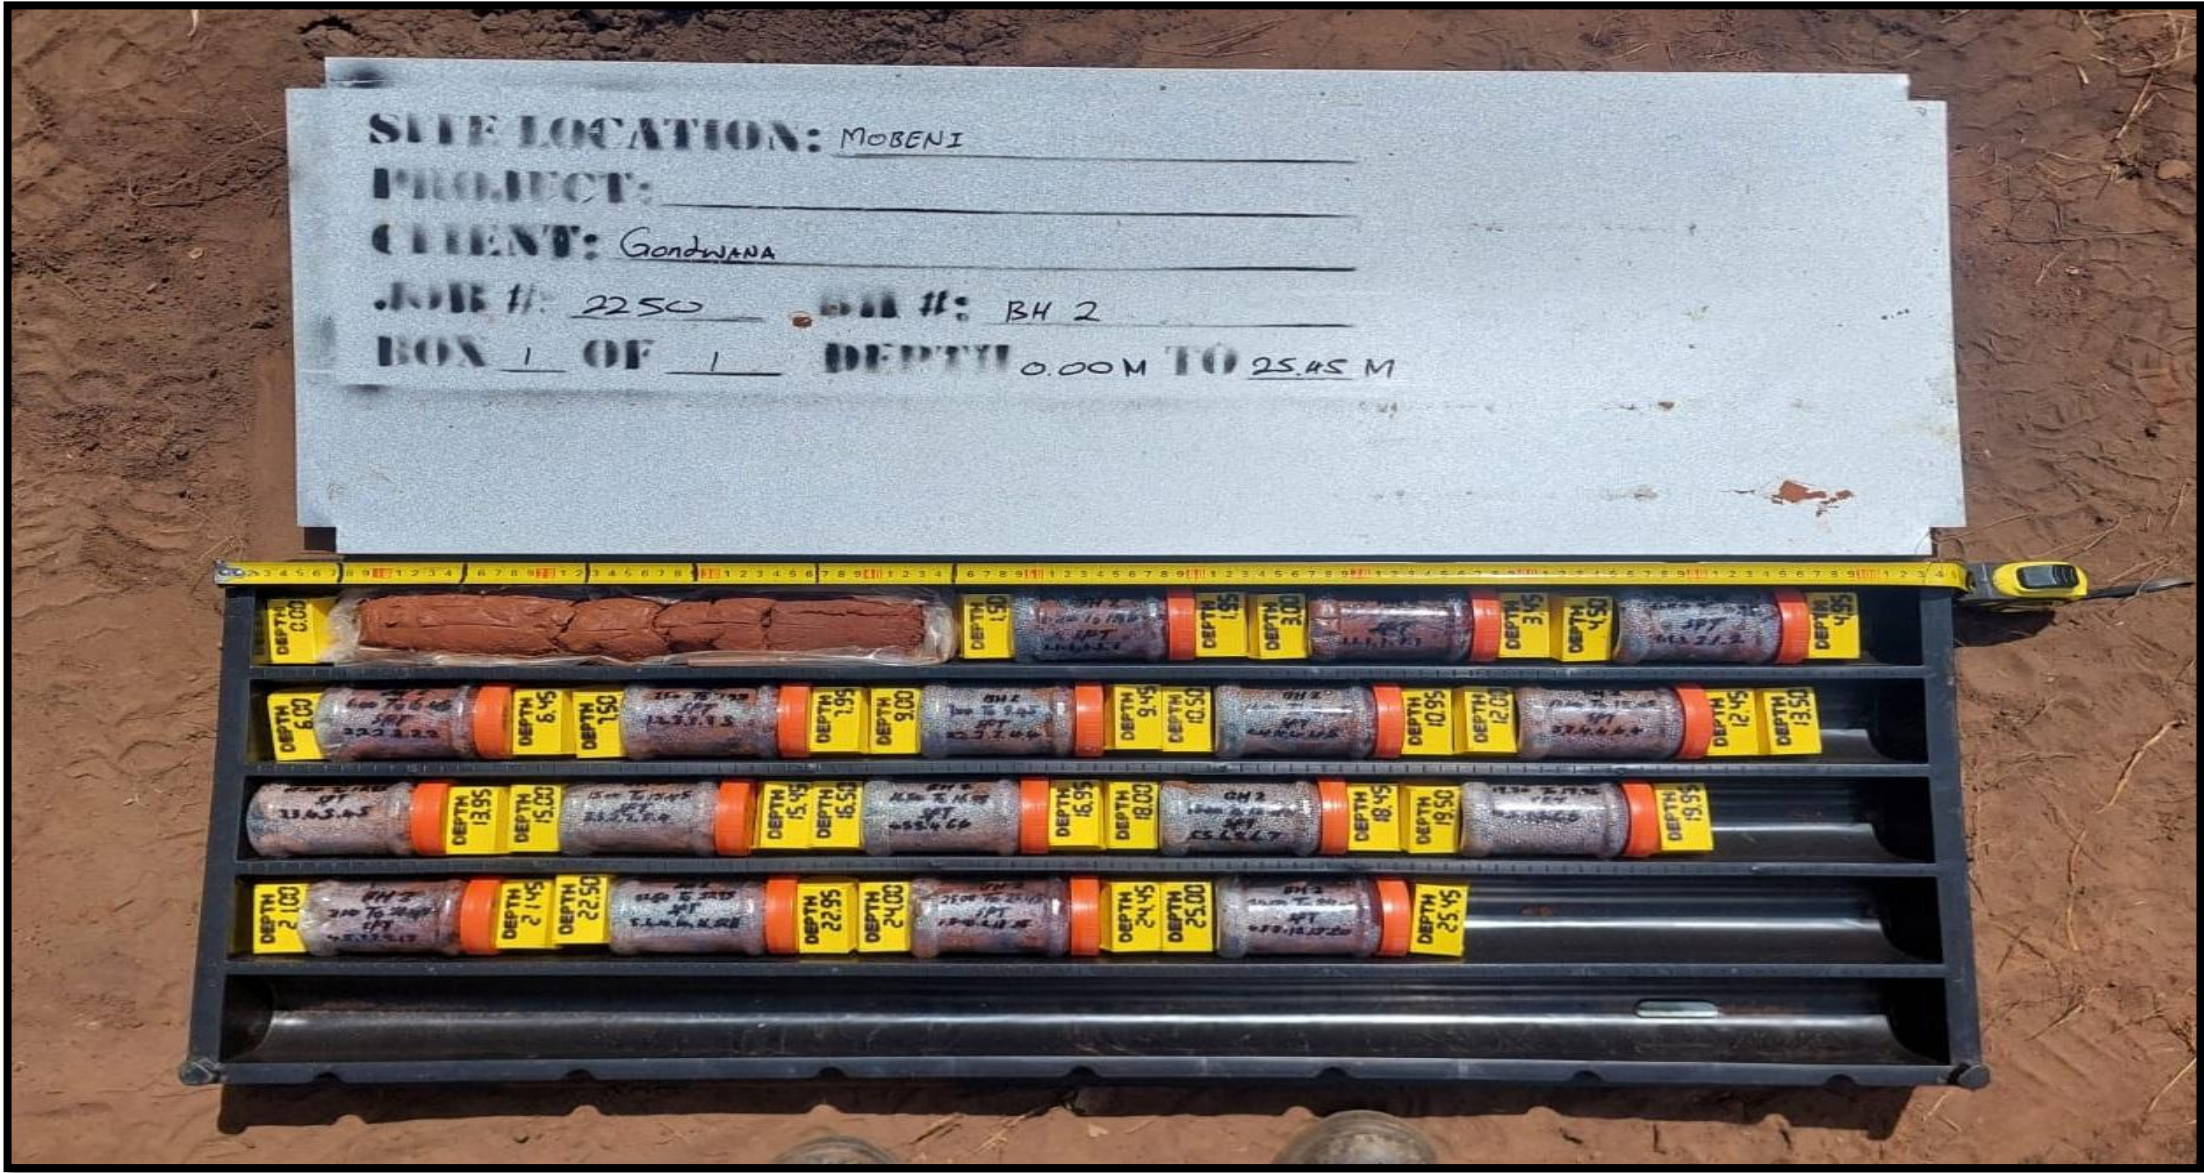
| BOREHOLE | BH2 | BOX | 1 of 1 |

| PROJECT | Reinstatement of Mobeni Reservoir No. 2, Durban | DEPTH (m) | 0,00-25,45 |
