REPORT TO DAMARIS HOLDINGS (PTY) LTD ON THE RESULTS OF A GEOTECHNICAL INVESTIGATION FOR THE PROPOSED UPGRADING OF INTERNAL ROADS FOR OLIEVENHOUTSBOSCH EXT 60, GAUTENG PROVINCE

**PROJECT REF: 3837.R01
REVISION 0
23 March 2026**

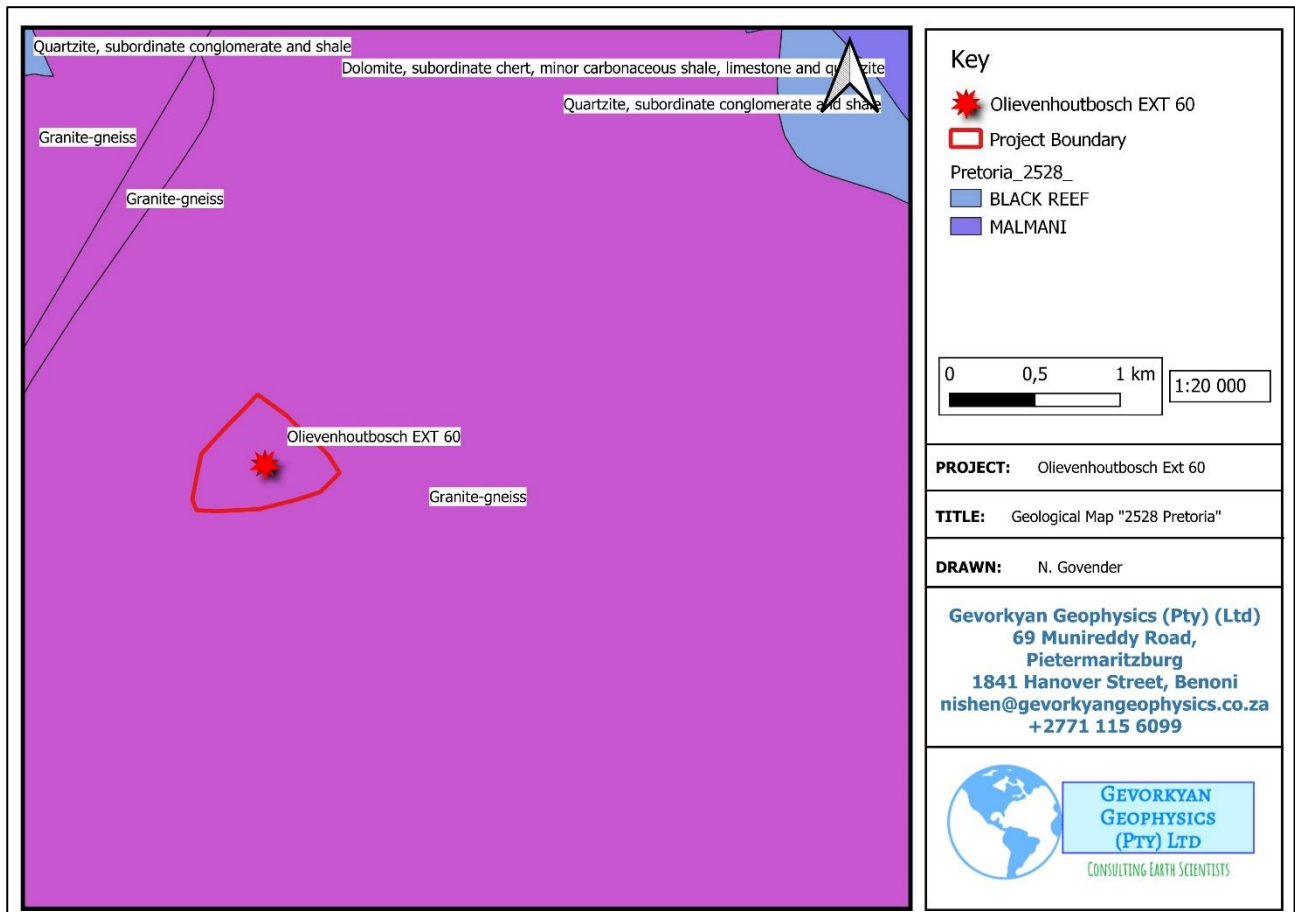
Figure 3: Geological Map "2528 Pretoria"

According to the Geological Map Sheet “2528 Pretoria” as shown in Figure 3, the site is underlain by Halfway House suite granite-gneiss and can be regarded as non-dolomitic.
