**REPORT ON THE GEOTECHNICAL /  
FOUNDING CONDITION FOR THE UPGRADE  
of CARNARVON WASTEWATER  
TREATMENT WORKS - P08403:OXIDATION  
PONDS**

**GEOTECHNICAL INVESTIGATION**

REFERENCE:SLN1028

Document No.: 2025/K250/Doc.

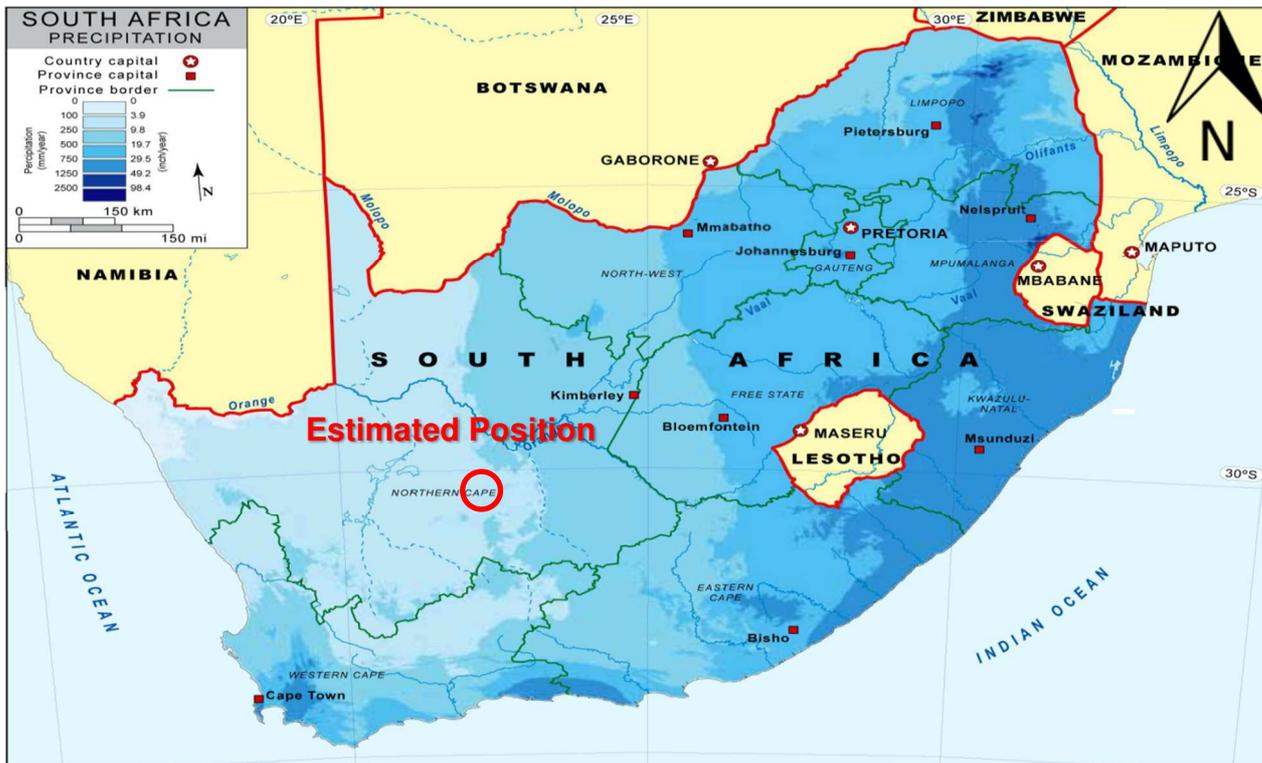
Figure 4 – Precipitation Map of South Africa (BestCountryReports.com)

Colour on Figure 4	Description	Weinert N-Value	Thornthwaite Moisture Index (I <sub>m</sub> )	Typical Mean Annual Rainfall (mm)
Lightest yellow	Arid	> 5	< - 40	< 250
Light yellow	Semi-arid	4 to 5	- 20 to - 40	250 to 500
Yellow	Semi-arid to sub-tropical	2 to 4	- 20 to + 20	500 to 1000
Light blue	Humid tropical	< 2	+ 20 to + 100	> 1000

A climatic N-value of > 5 is associated with arid regions, where mechanical disintegration is the predominant rock weathering mode. A climatic N-value of < 5 is associated with the humid warm areas and a surplus of water, where chemical decomposition is the predominant rock weathering mode.

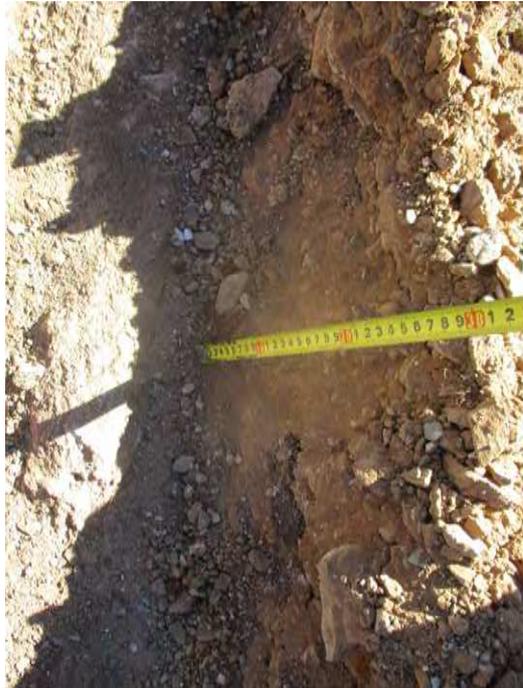
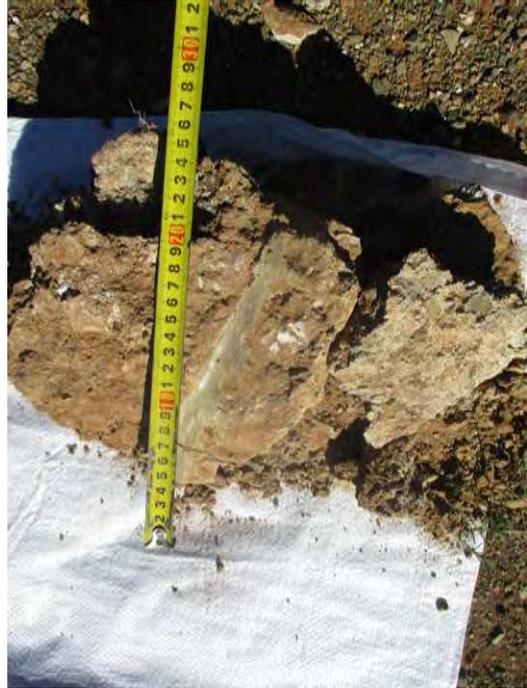
- 1) Disturbed sample 025/1081 taken at 0.115m.
- 2) No groundwater seepage encountered in test pit.
- 3) SOUTH AFRICAN - WGS84 CO-ORDINATE SYSTEM USED.

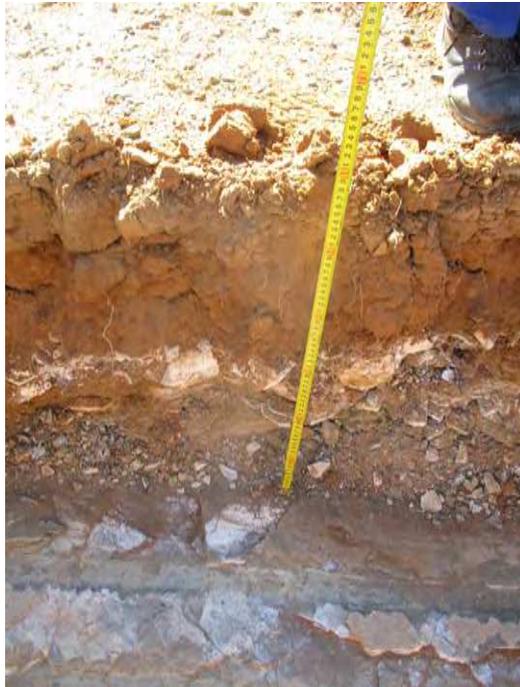
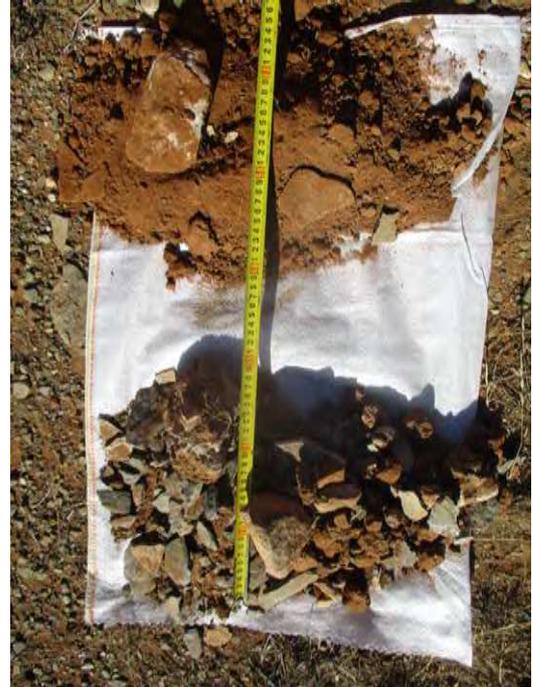
- 1) Disturbed sample 025/1082 taken at 0.120m.
- 2) Disturbed sample 025/1083 taken at 0.400m.
- 3) No groundwater seepage encountered in test pit.
- 4) SOUTH AFRICAN - WGS84 CO-ORDINATE SYSTEM USED.

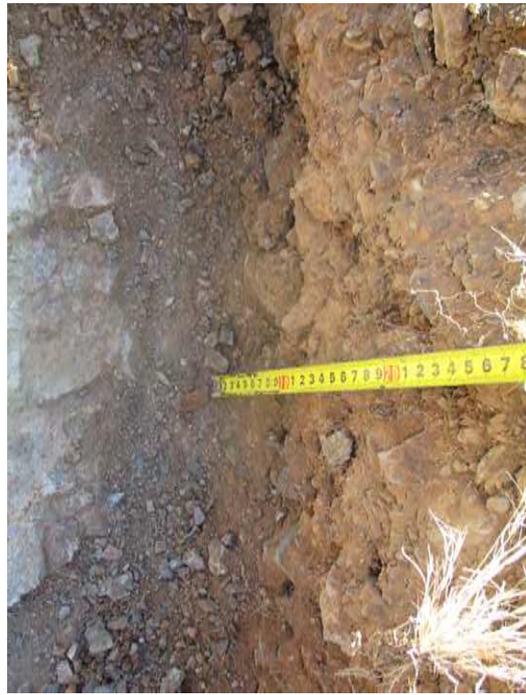
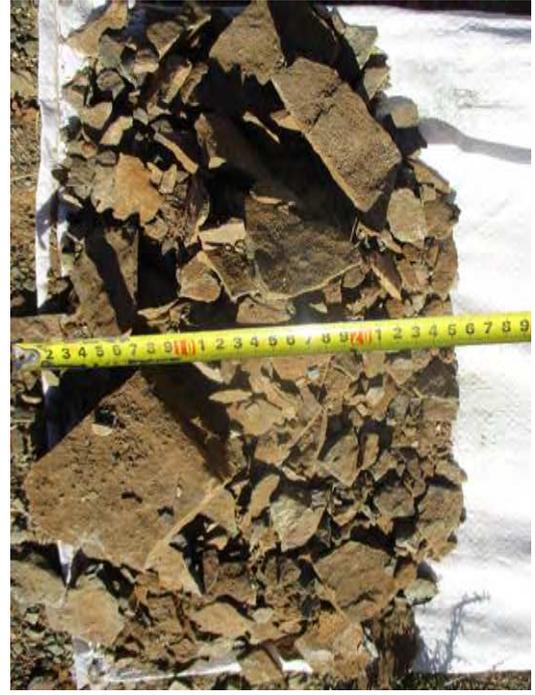
- 1) Disturbed sample 025/1084 taken at 0.150m.
- 2) No groundwater seepage encountered in test pit.
- 3) SOUTH AFRICAN - WGS84 CO-ORDINATE SYSTEM USED.

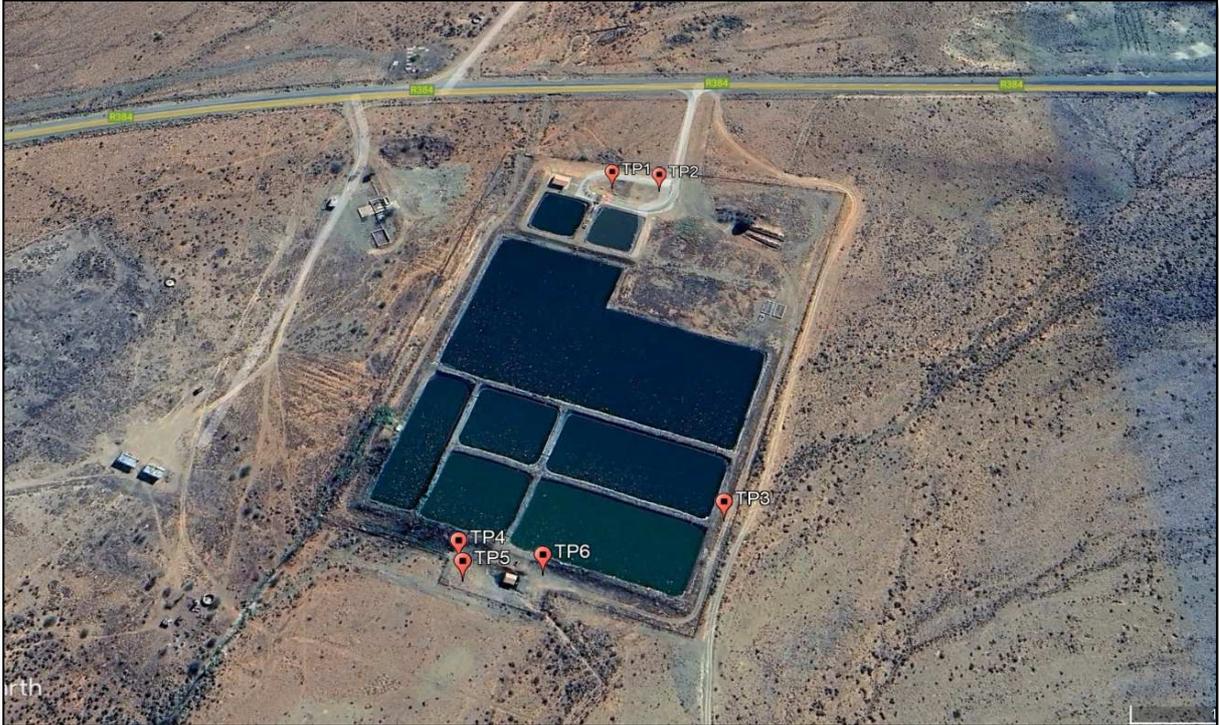
## LAYOUT PLAN

Test Pit 1 23 Y0082068 X3426684

- The approximate size of the investigated site is ±6.7ha.
- Six (6) test pits were excavated at the location specified by the client and is indicated on the Layout Plan (Appendix F). Ten (10) Foundation Indicator samples, seven (7) Maximum Dry Density (MDD) samples and seven (7) California Bearing Ratio (CBR) samples.

Six (6) test pits were excavated at positions indicated on the Location Plan and Layout Plan (Appendices A & F). Ten (10) Foundation Indicator samples, seven (7) Maximum Dry Density (MDD) samples and seven (7) California Bearing Ratio (CBR) samples were obtained from site to determine the Engineering Properties of the materials. The properties of the materials were tested at Simlab (Pty) Limited – Geotechnical Services (Kimberley). Please visit the Simlab website for more information. [www.simlab.co.za](http://www.simlab.co.za)
