Geotechnical Investigation Report

**The Installation of a 400mm Diameter
Sewer Line in R K Khan Within Ward 73
In Chatsworth.**

Umgudulu Projects (Pty) Ltd

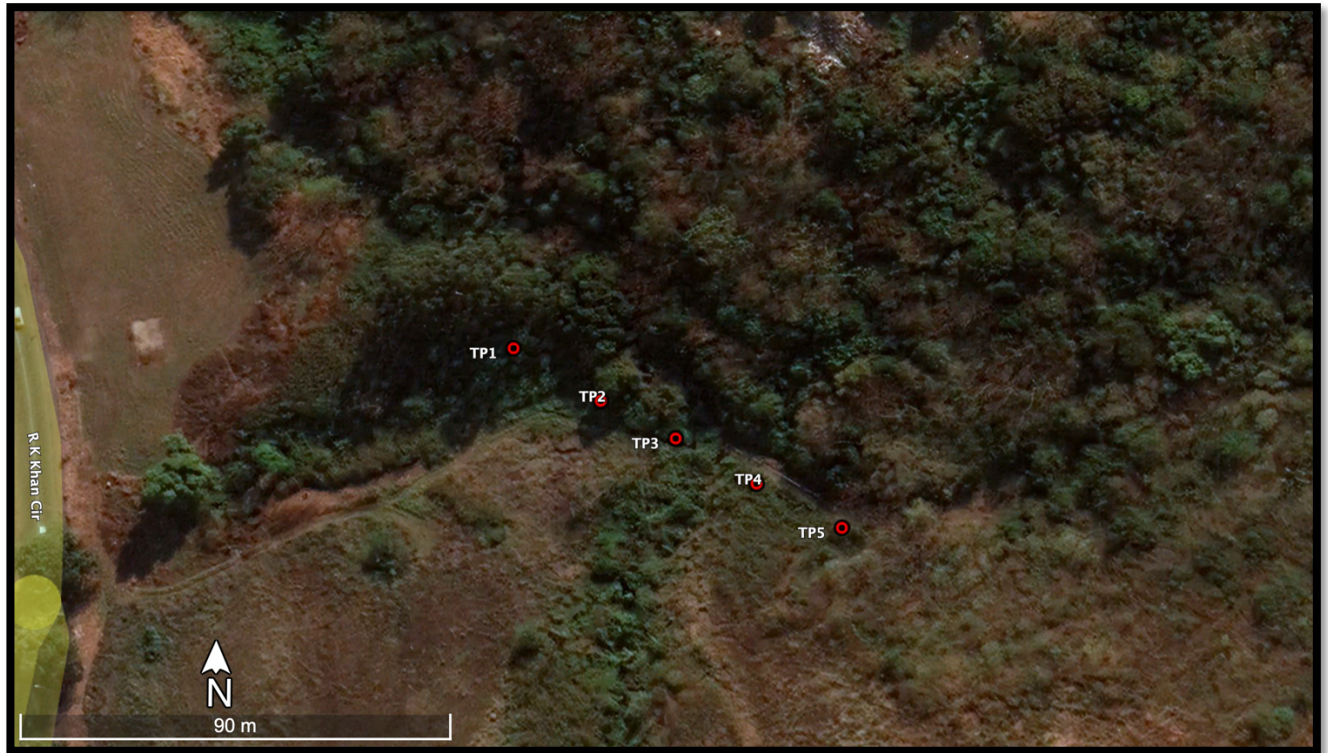
Figure 1: Showing the investigated sewer pipeline route.

The sewer pipeline to be upgraded is located at about 150m north of RK Khan Hospital and 100m east of RK Khan Cir Road in Chatsworth. The existing pipeline is running parallel to the stream as shown in Figure 1 below.
