**EAST LONDON AIRPORT PV FARM:**  
**PROPOSED STORMWATER CONCEPT DESIGN REPORT**

OUR REF NO. 1801691

**JULY 2020**

# **EAST LONDON AIRPORT PV FARM: PROPOSED STORMWATER CONCEPT DESIGN REPORT**

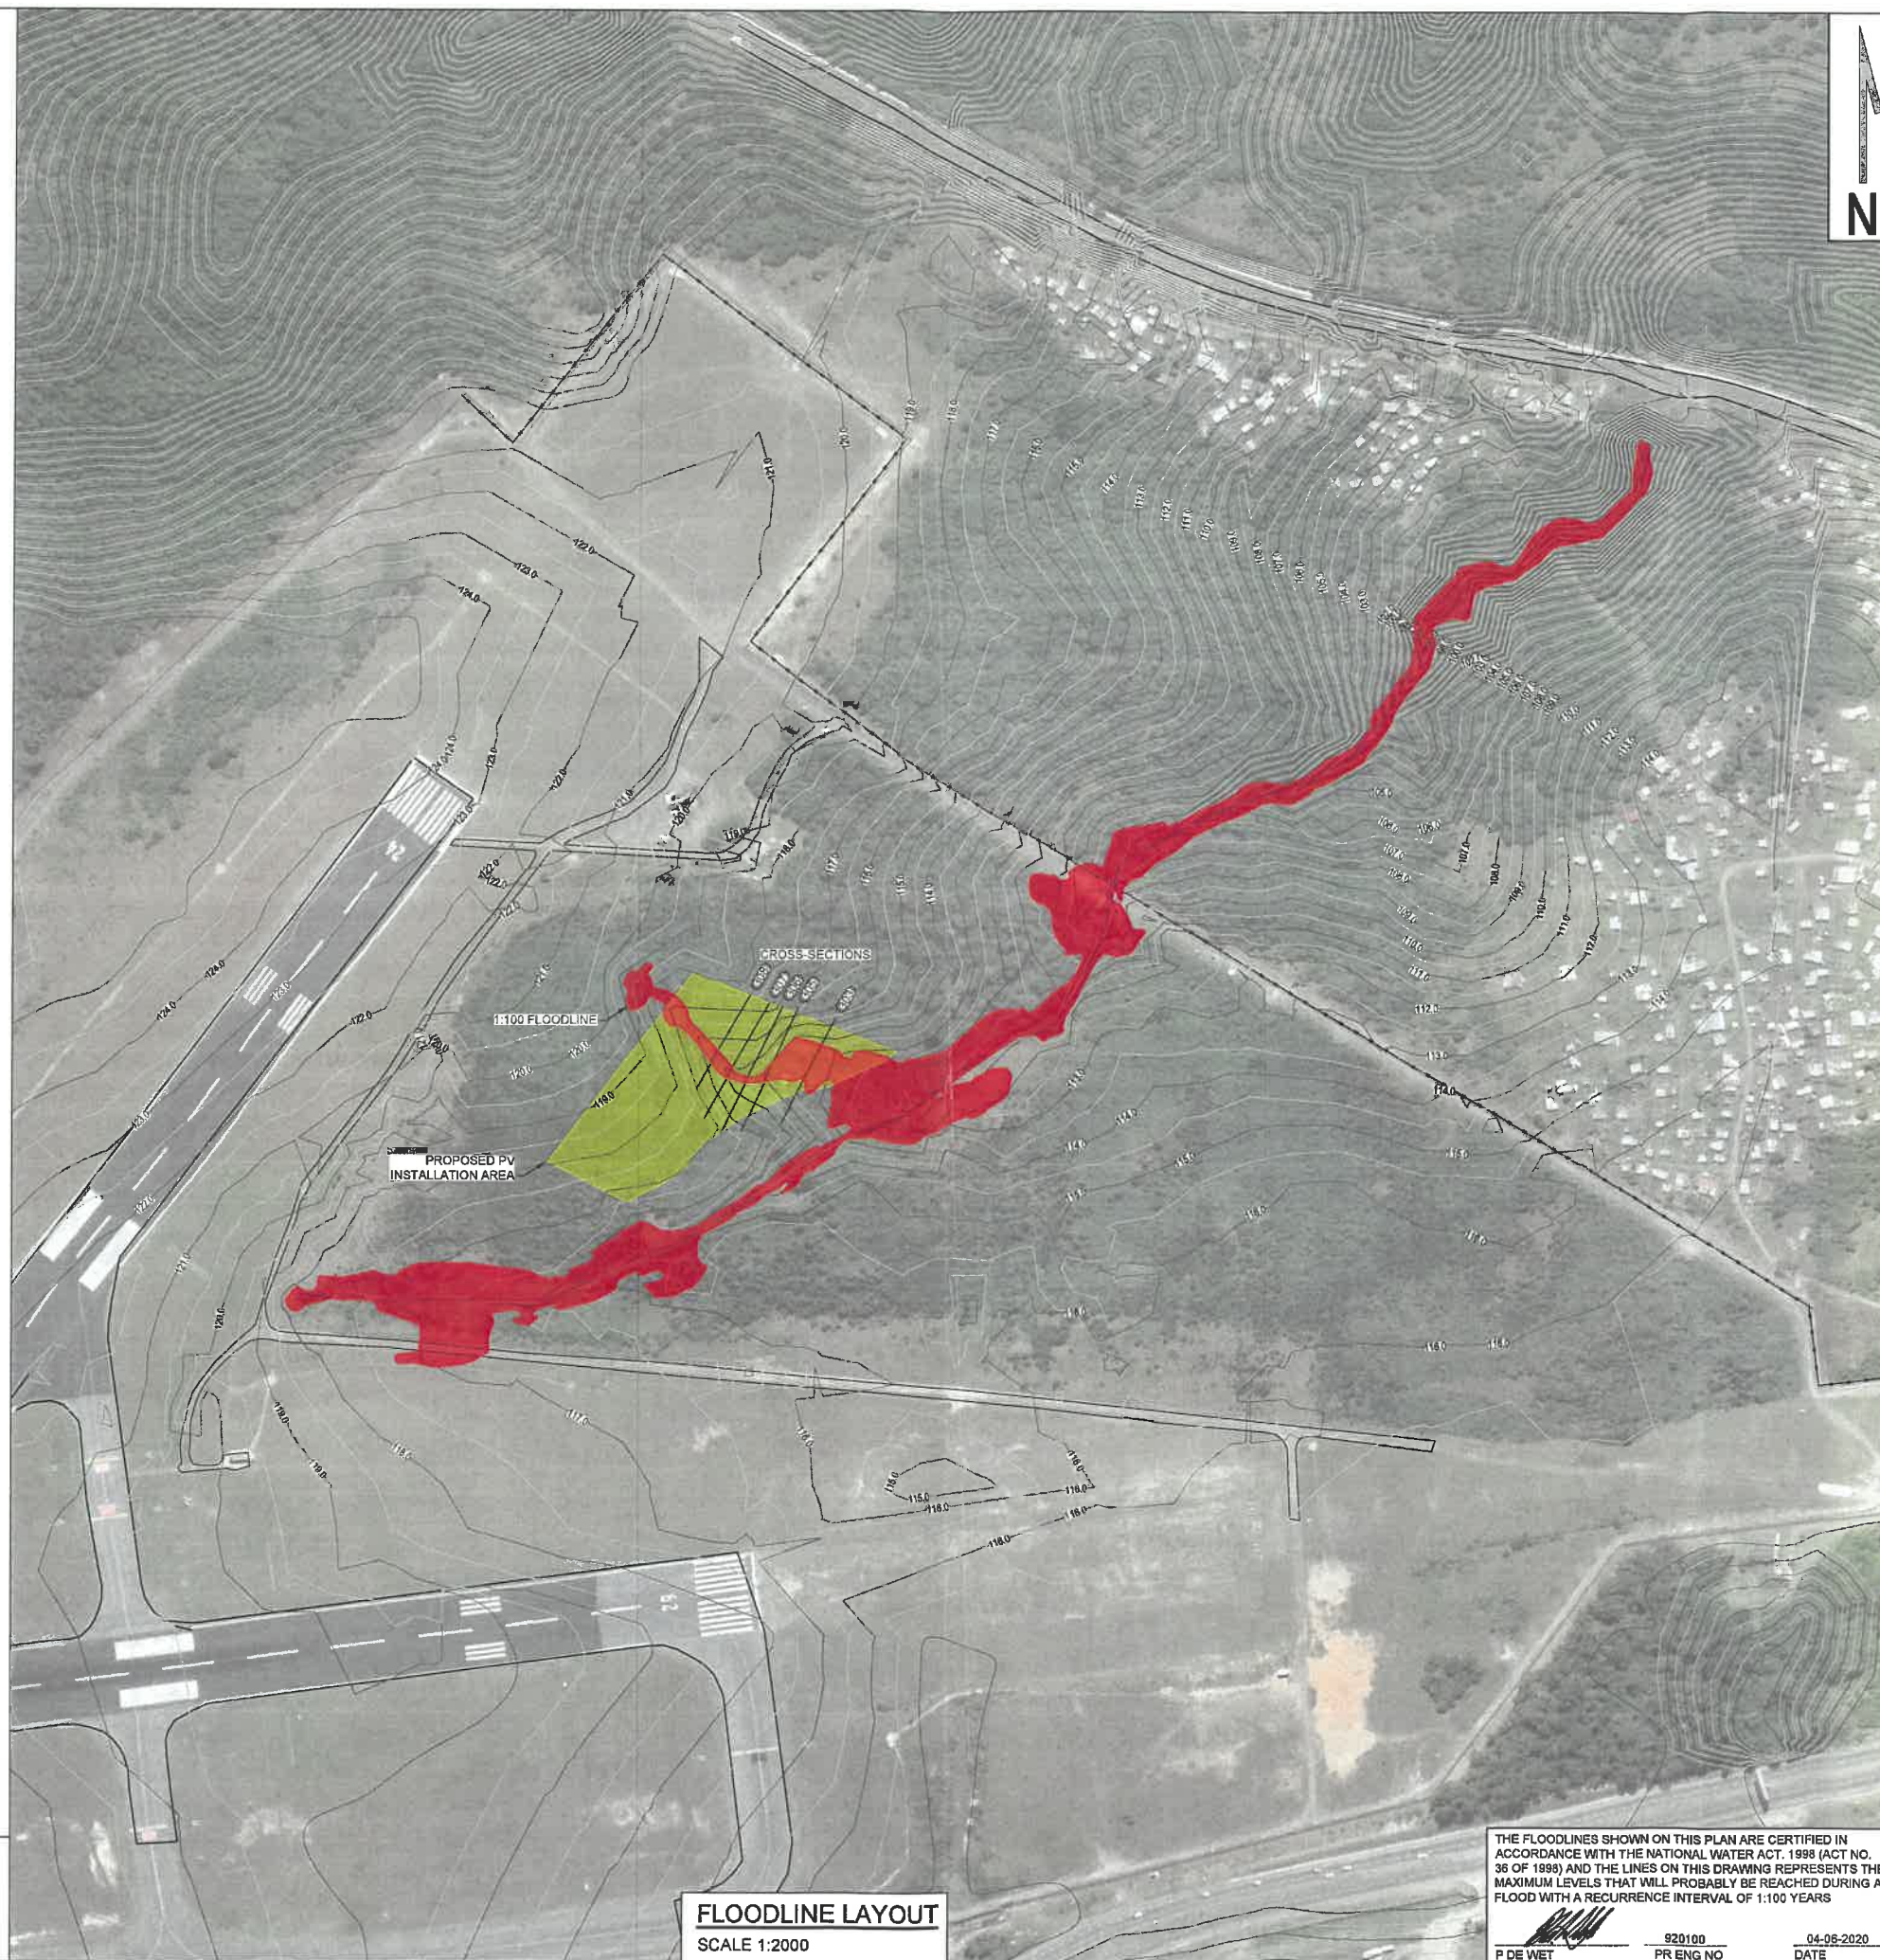
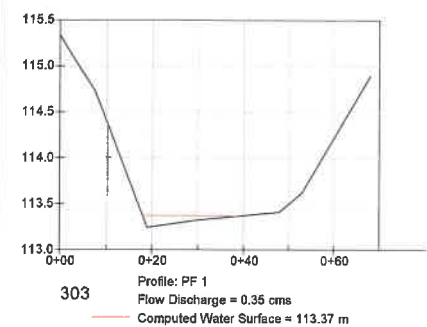
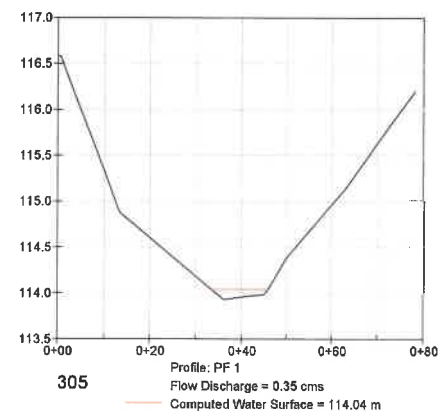
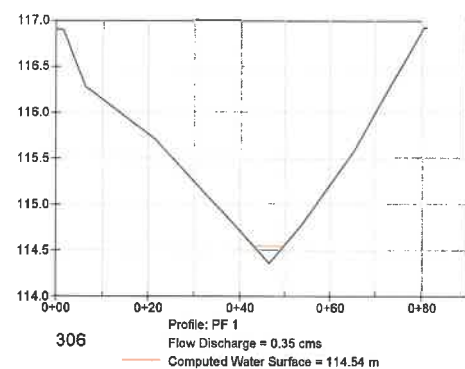
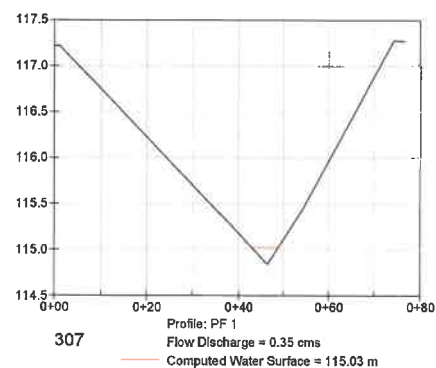
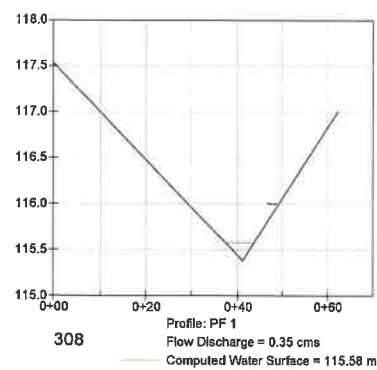
**CROSS SECTIONS**  
SCALE 1:1000

THE FLOODLINES SHOWN ON THIS PLAN ARE CERTIFIED IN ACCORDANCE WITH THE NATIONAL WATER ACT, 1998 (ACT NO. 36 OF 1998) AND THE LINES ON THIS DRAWING REPRESENTS THE MAXIMUM LEVELS THAT WILL PROBABLY BE REACHED DURING A FLOOD WITH A RECURRENCE INTERVAL OF 1:100 YEARS

The current stormwater conditions on site is observed as an overland flow system accumulating into a low-lying wetland/river area. There is no additional formalised installed stormwater infrastructure. The low-lying area is affected by a 1:100 flood influence area as identified in Annexure B.

As stated previously in this report and indicated on the 1:100-year floodline layout plan (Annexure B). There is a flood risk due to the adjacent low-lying area to the site which also intrudes into a portion of the site.

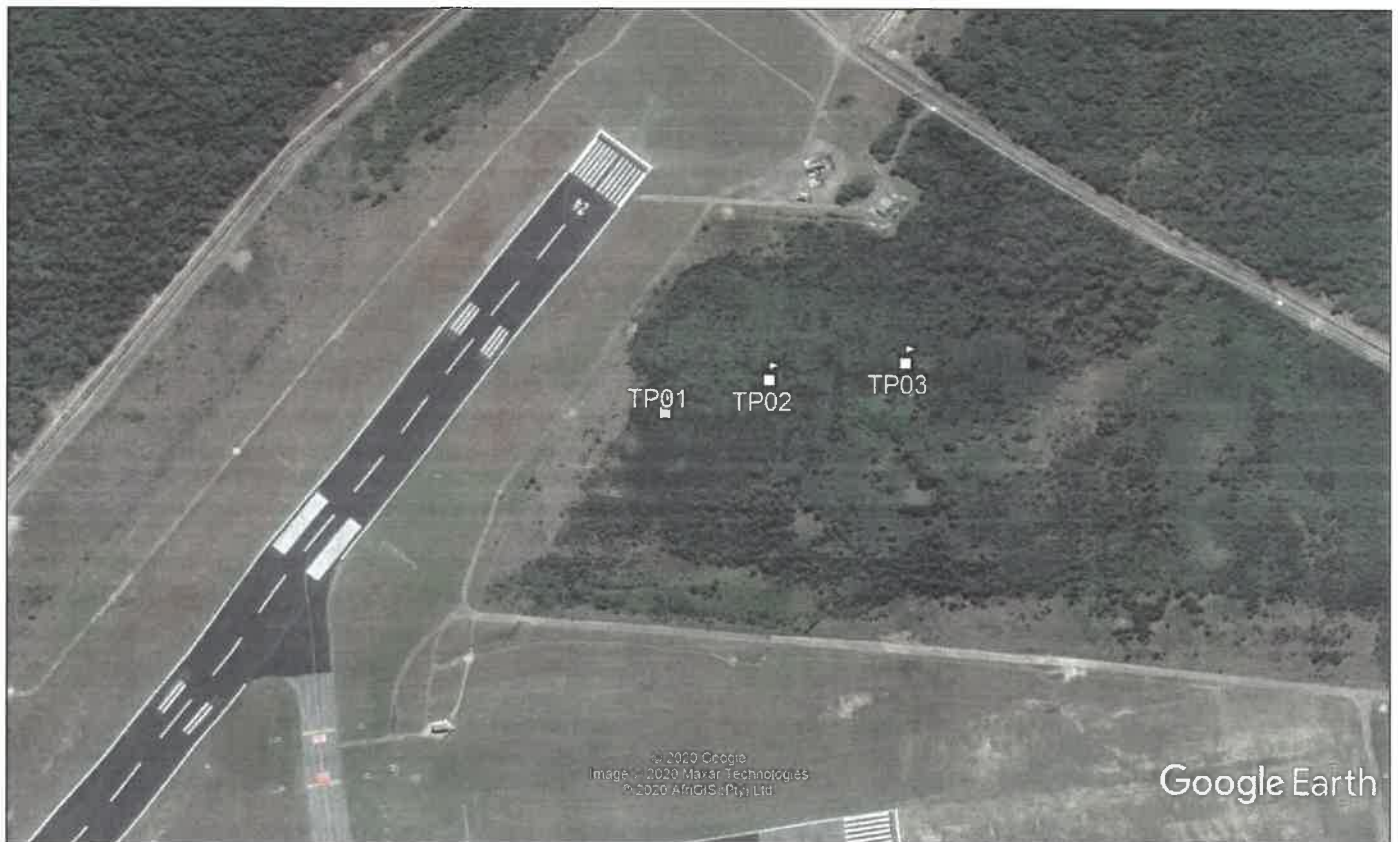
The transported material profiled within the three trial pits varied between sandy silt with some ferricrete nodules and silty clay. The moisture conditions profiled was slightly moist, the consistency firm and the structures intact.

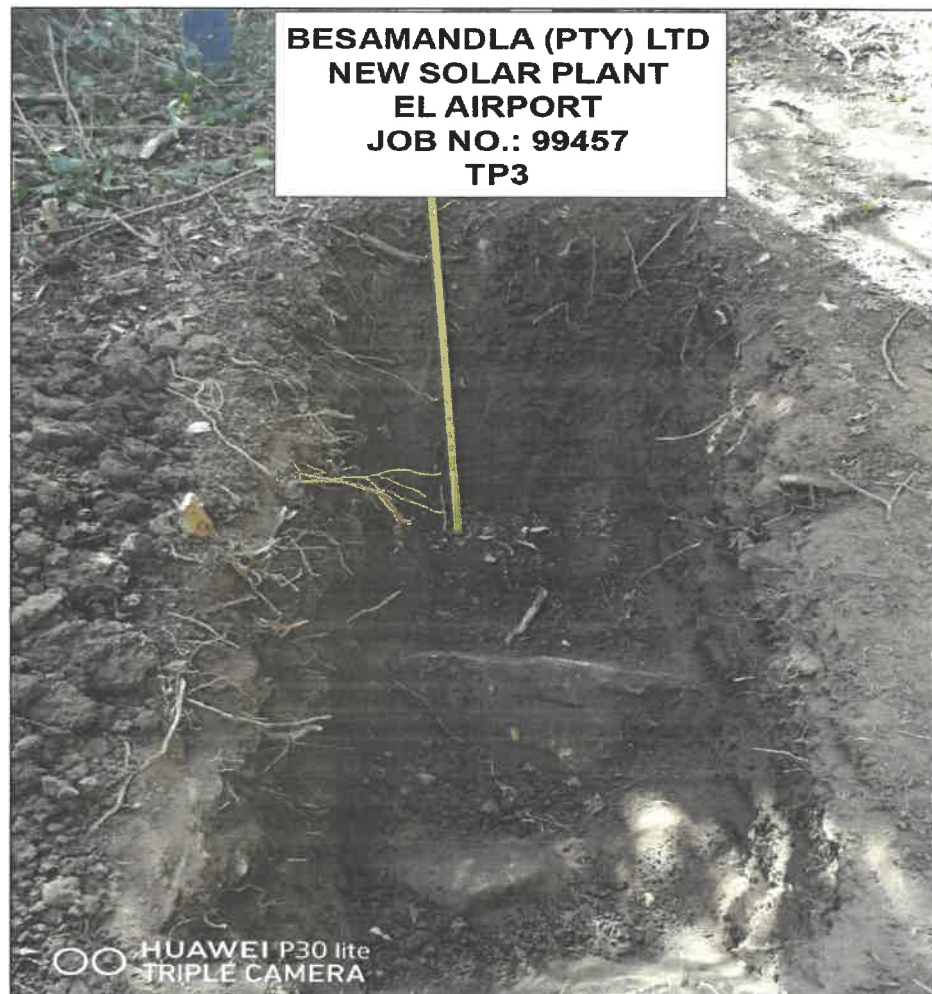
Excavation refusal on boulders in TP3

➤ Trial Pit 1	No ground water	No refusal @ 1500mm
➤ Trial Pit 2	No ground water	No refusal @ 1300mm
➤ Trial Pit 3	No ground water	Refusal @ 700mm on boulders

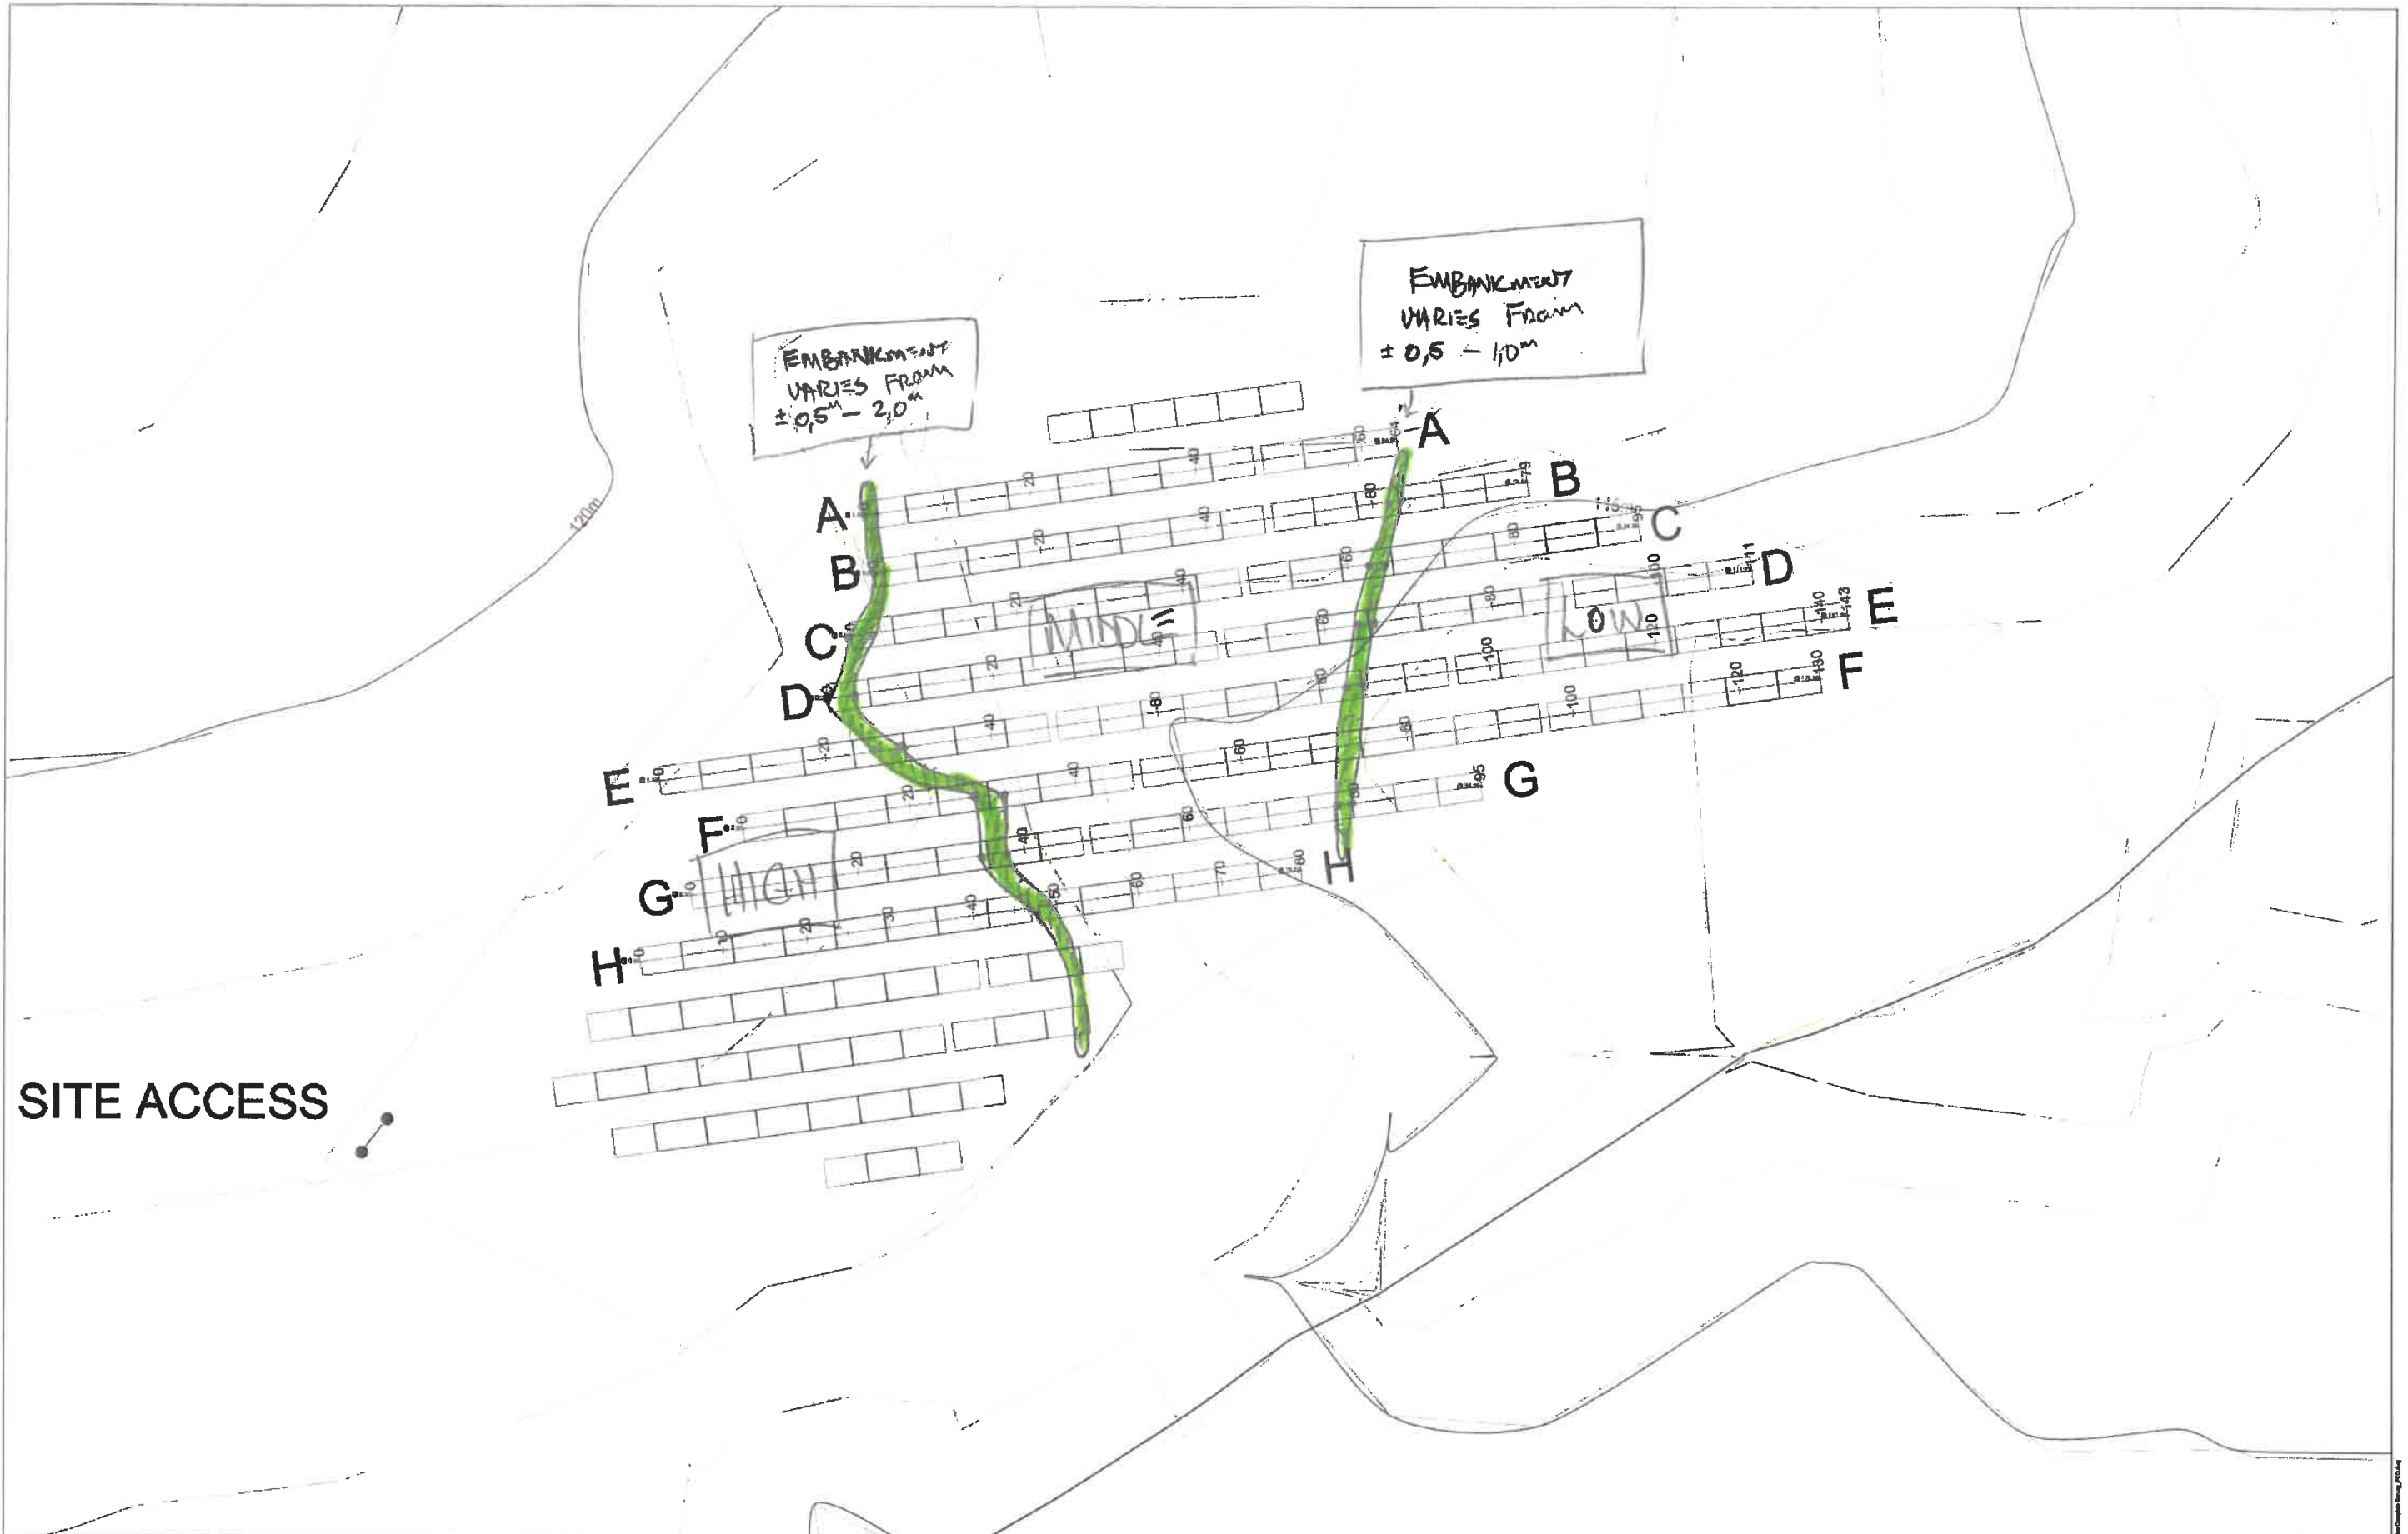
**ANNEXURE E: BULK EARTHWORKS PROPOSAL 2**  
**(BULK CUT)**

EMBANKMENT  
VARIES FROM  
±0.5m - 2.0m

The maximum allowable gradient change for the solar panel mounting system (already delivered to site) is 4%. The site would therefore require additional bulk earthworks fill and/or cut within the low lying 1:100 flood line area (where steeper gradients are observed) intruding into the designated solar site to bring the site of works to the maximum 4% NGL allowable gradients.

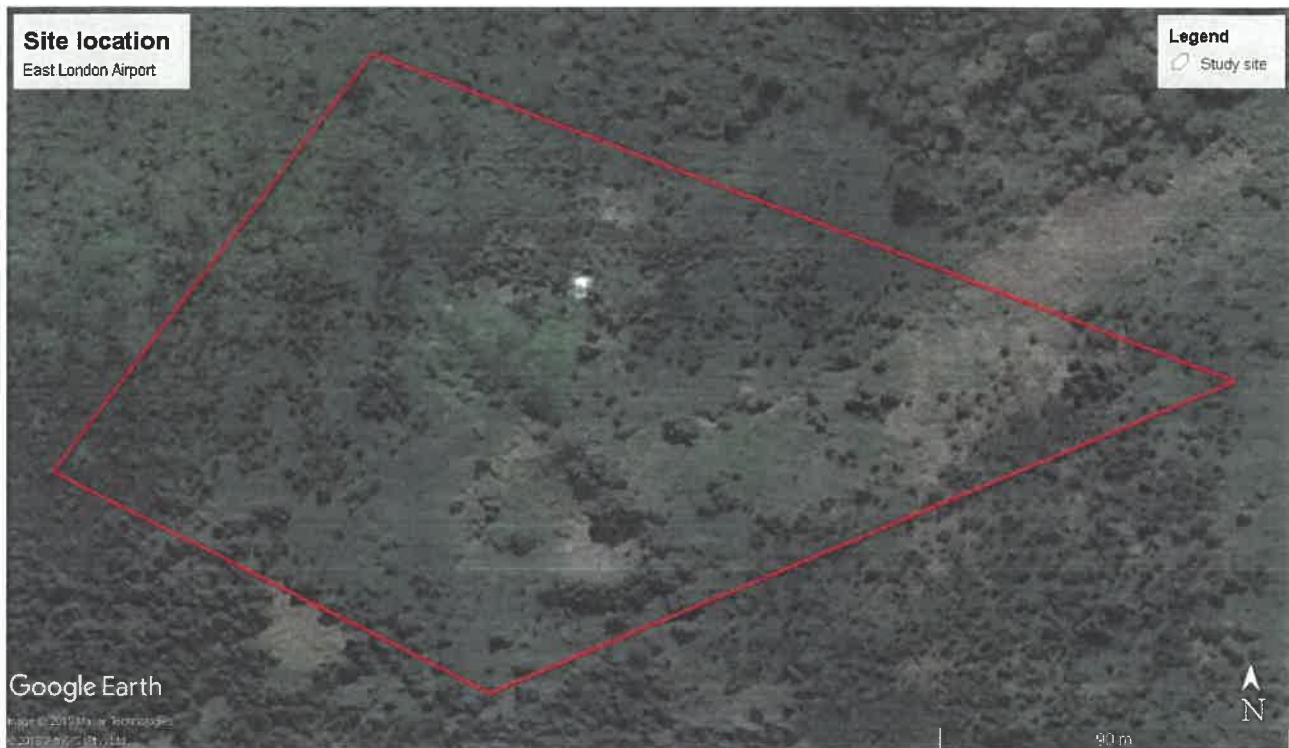
**Figure 4.1. Showing an aerial image of the study site (Google Earth 2019).**

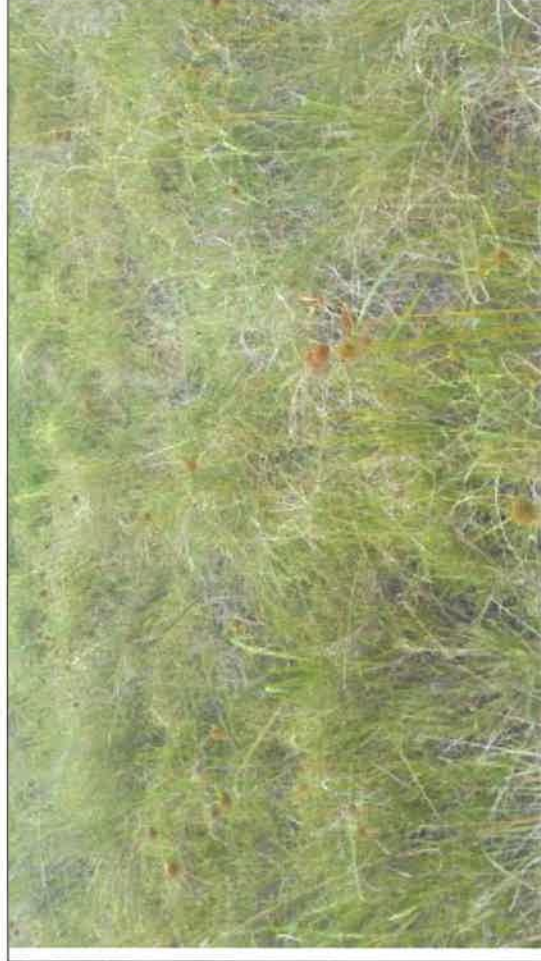
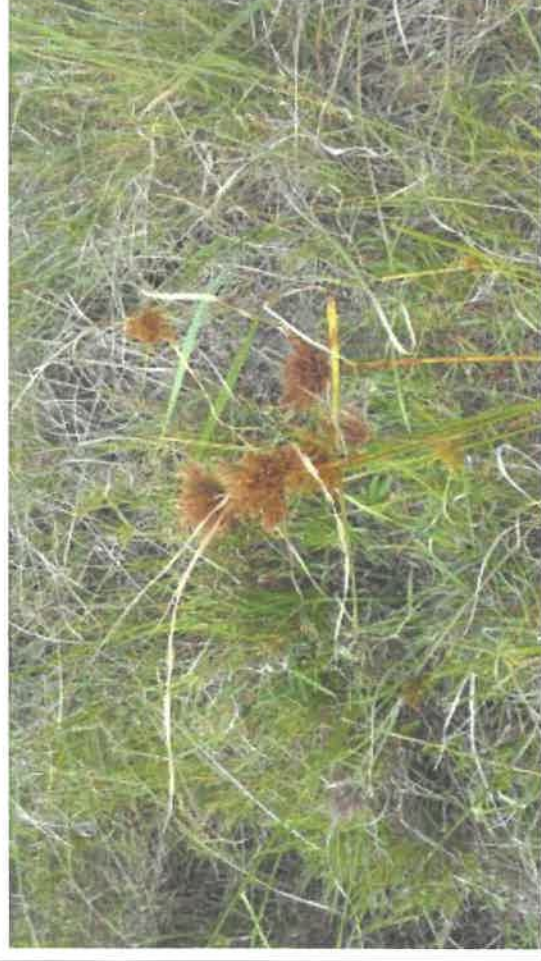
#### 4.1.1.1 Wet grassland

Grassland is not considered as a primary and pristine vegetation type. It is secondary in nature as a result of natural thicket clearing and grassland encroachment. Mucina and Rutherford (2012) identifies the area as thicket vegetation.

Various sedges (*Juncus* sp.) occur in this area indicating periods of soil wetness. The area is NOT considered a wetland even though a small drainage system occur in this area.

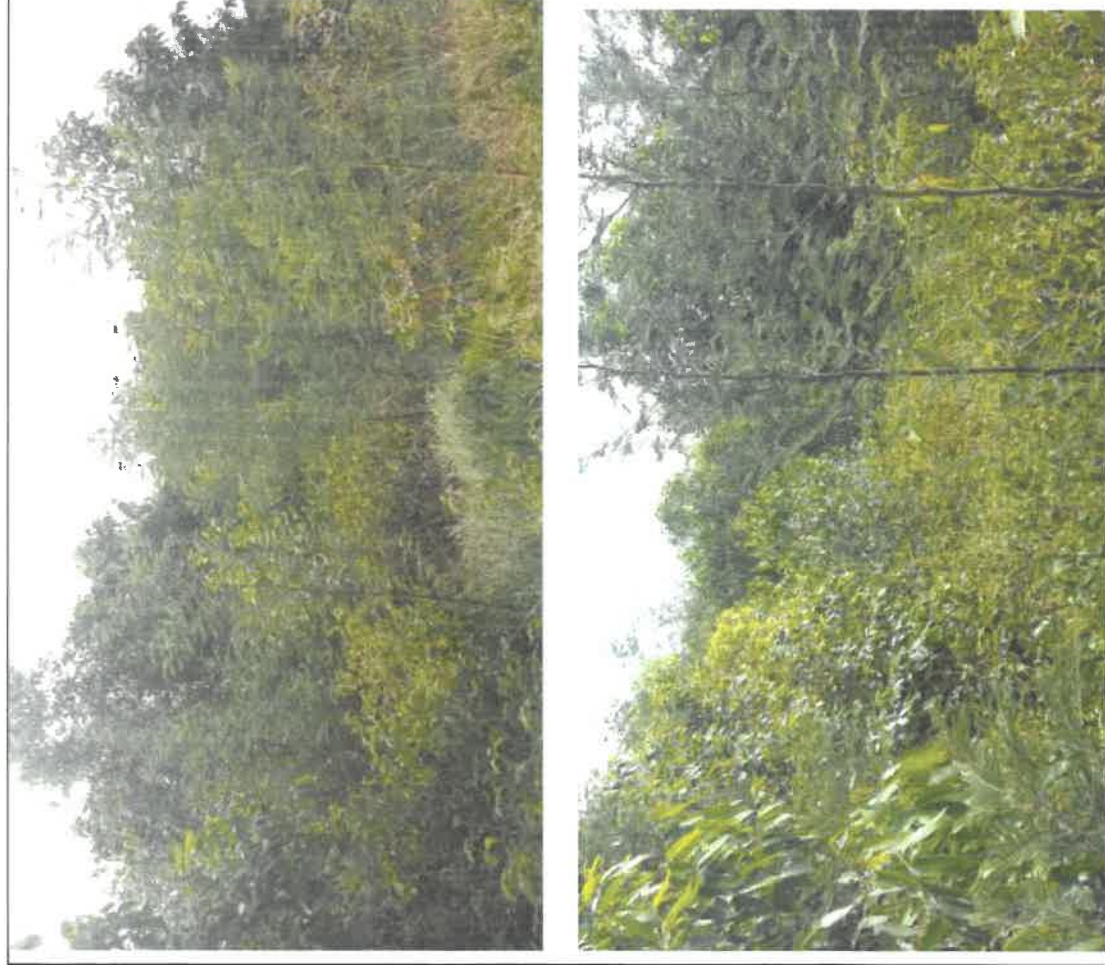
#### 4.1.2 Dense alien vegetation

This area consists almost entirely of alien and invasive tree species and includes:

- Gum trees (*Eucalyptus* sp.)
- Guava trees (*Psidium guajava*)
- Black wattle trees (*Acacia mearnsii*)
- Lantana (*Lantana camera*)
