| CIVIL DESIGN<br>GEOTECHNICAL REPORT | | | | |
| Project Description: | Mashaqiya Solar Project - Nkandla | | | |

This document is the Geotechnical Report for the **Maqhashiya Solar project Nkandla**.

The NED Civil Design Team has been tasked with preparing a geotechnical study where the site's subsurface is evaluated for suitability as founding soils, and the results thereof are presented within this document.

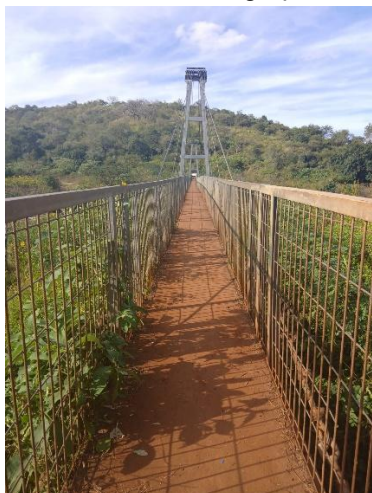
Figure 3: Access bridge to the Maqhashiya Primary School

Provided below is a graphic of the access bridge to the Maqhashiya Primary School

Access to the school is by means of a pedestrian bridge that crosses the Mhlatuze River. A Google Maps graphic is provided below showing an aerial view of the Maqhashiya Primary School.

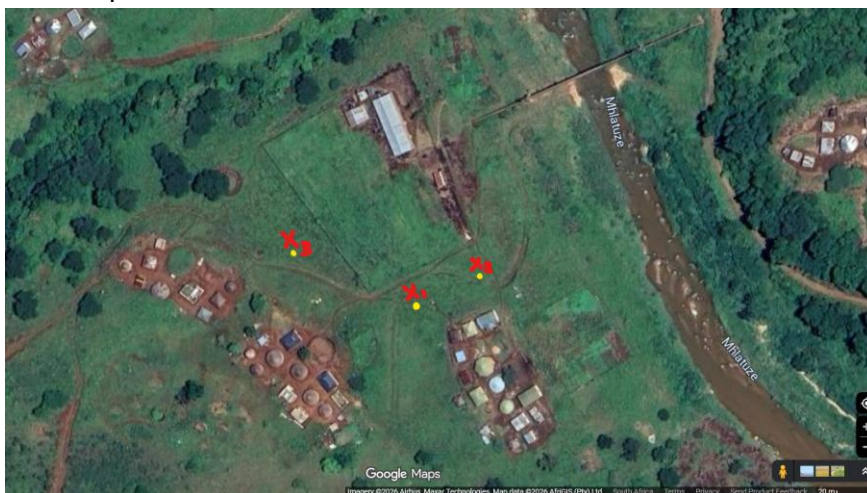
**Figure 6: Zone 1 Map of DCP Test Locations**

In the graphic below, an aerial satellite view is provided of the DCP Test locations denoted as X<sub>i</sub> in respective order.

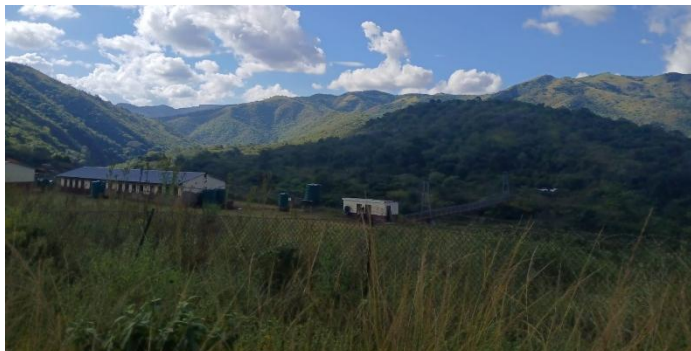
Figure 7: Image of DCP Test at position X<sub>1</sub>

An image is provided below of DCP Test at position X<sub>1</sub>

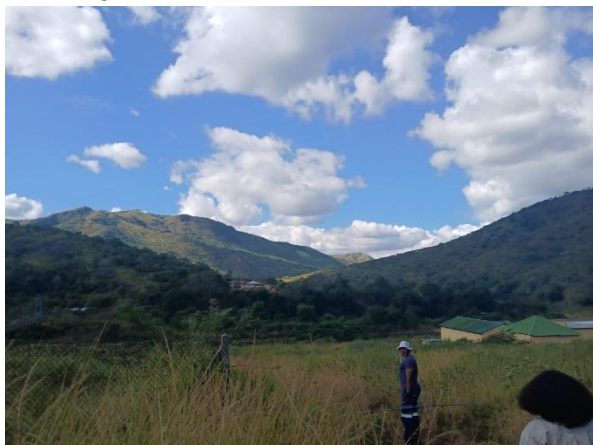
Figure 9: Image of DCP Test at position  $X_3$

An image is provided below of DCP Test at position  $X_3$

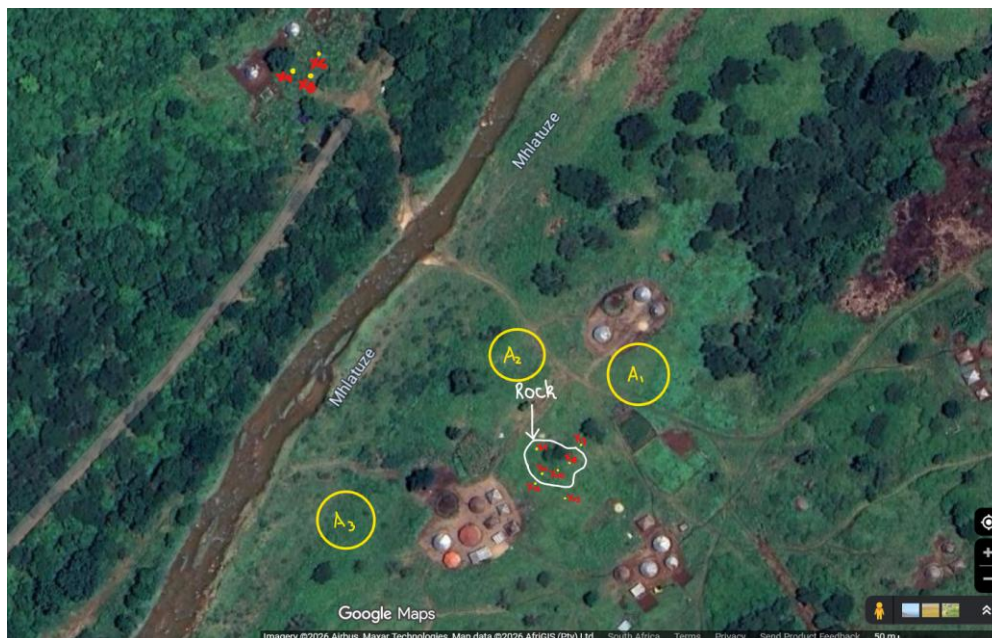
Figure 10: Zone 2 Map of DCP Test Locations

In the graphic below, an aerial satellite view is provided of the DCP Test locations denoted as  $X_i$  in respective order.

It is to be noted that DCP Tests  $X_8$ ,  $X_9$ ,  $X_{10}$ , and  $X_{11}$ , indicated that a large subsurface rock was present at a depth of roughly 500-600mm below NGL.

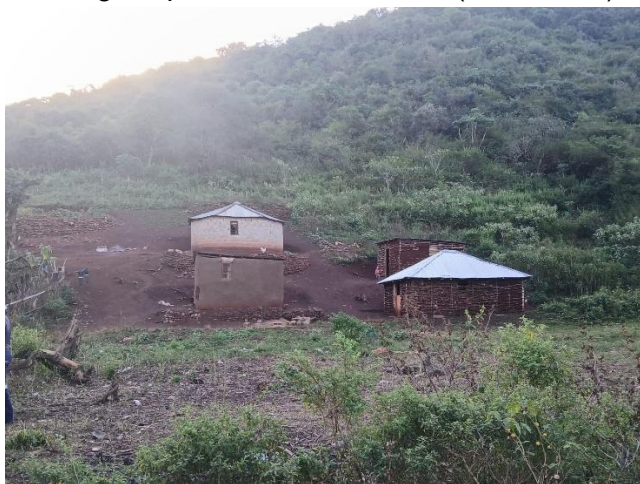
Figure 11: Image of HH(Household)32

An image is provided below of HH (Household) 32

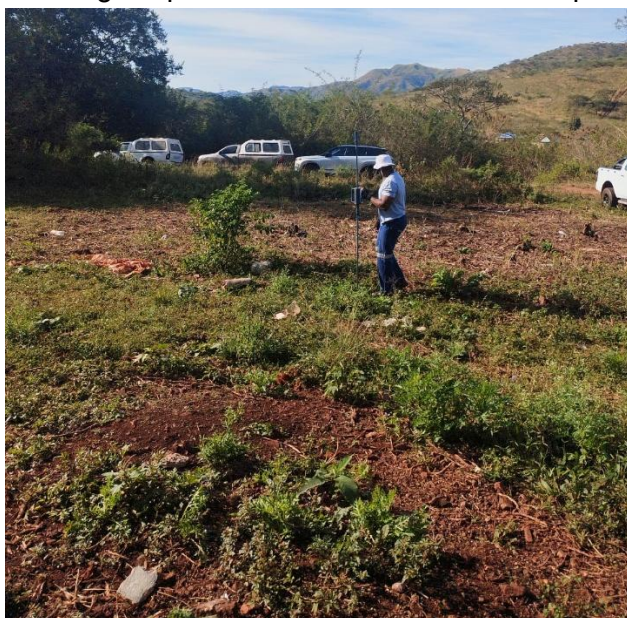
Figure 12: Image of DCP Test at position X<sub>4</sub>

An image is provided below of DCP Test at position X<sub>4</sub>

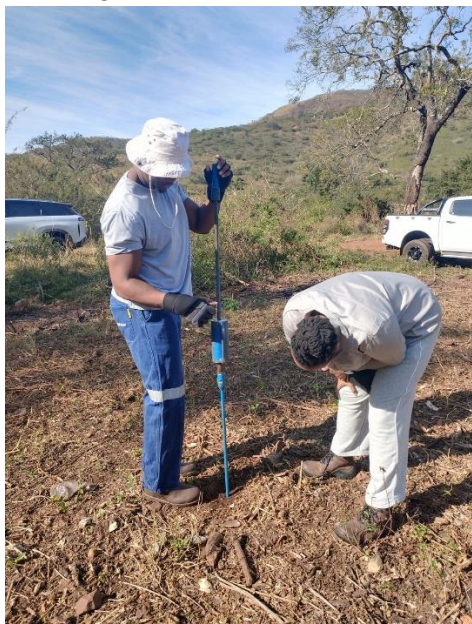
Figure 13: Image of DCP Test at position X<sub>5</sub>

An image is provided below of DCP Test at position X<sub>5</sub>

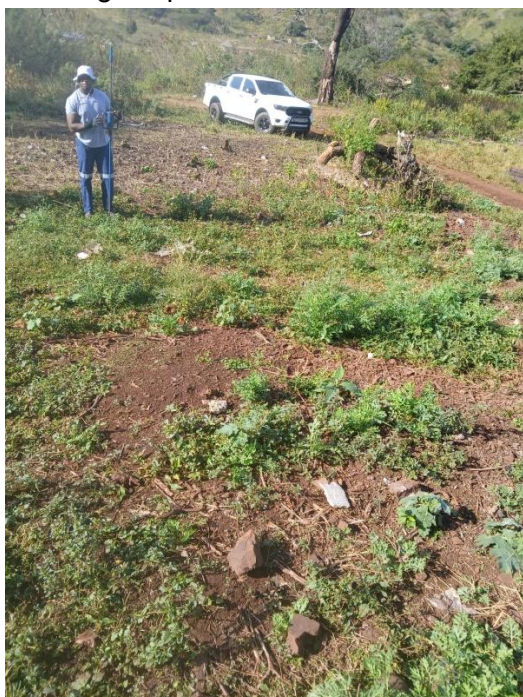
Figure 14: Image of DCP Test at position X<sub>6</sub>

An image is provided below of DCP Test at position X<sub>6</sub>

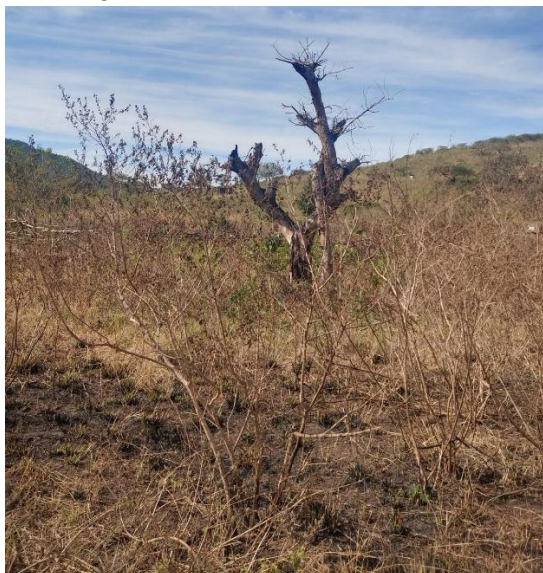
Figure 16: Image of DCP Test at position X<sub>7</sub>

An image is provided below of DCP Test at position X<sub>7</sub>

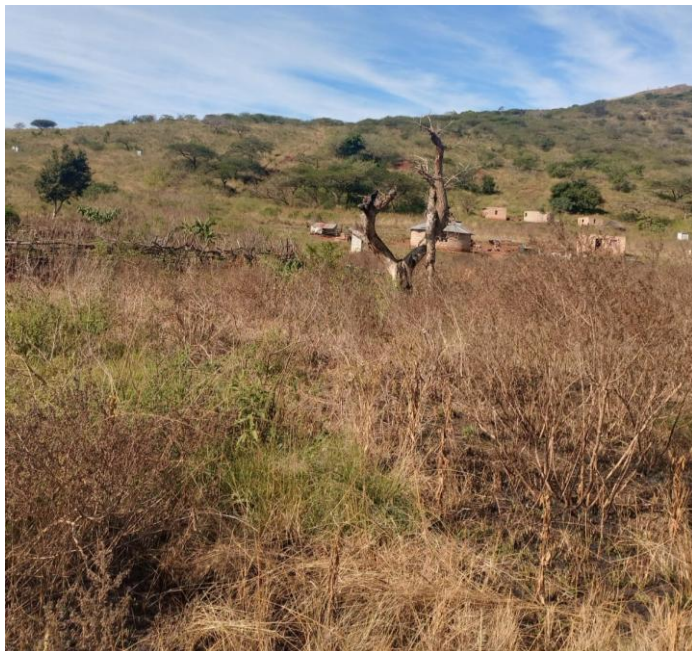
Figure 17: Image of DCP Test at position X<sub>9</sub>

It is to be noted that DCP Tests X<sub>8</sub>, X<sub>9</sub>, X<sub>10</sub>, and X<sub>11</sub>, indicated that a large subsurface rock was present at a depth of roughly 500-600mm below NGL. If there no inclination to drill into the rock and anchor the would-be foundations there within, Positions A<sub>1</sub>, A<sub>2</sub> and A<sub>3</sub> are alternatives for microgrid placement.

An image is provided below of DCP Test at position X<sub>9</sub>

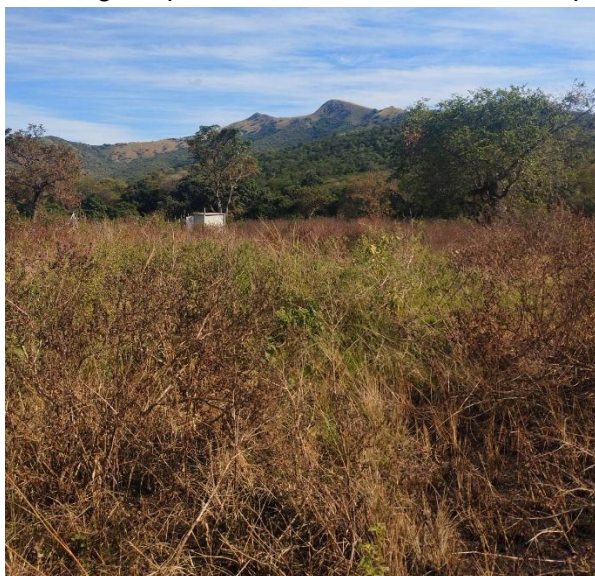
Figure 18: Image of DCP Test at position X<sub>12</sub>

An image is provided below of DCP Test at position X<sub>12</sub>

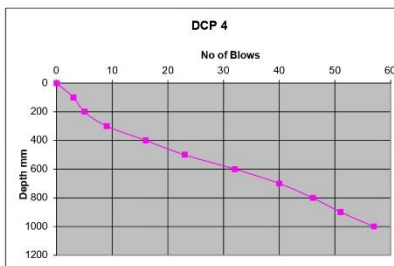
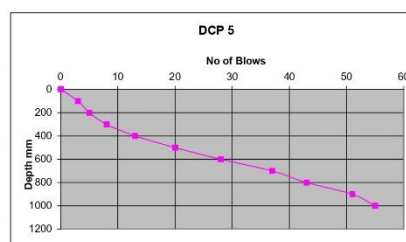
Figure 21: Appendix Zone 2 (HH32) DCP Test Detailed Results

| ZONE 2 (directly on HH32) | | | |
|---|---|---|---|
| 4 | 5.70 | Soil Type 2 | Average DCP no. between the successful tests = 6.93<br>→ Soil Type 2<br><br>However, due to foundations being located on a floodplain...<br><br>∴ Accept site material as <u>Soil Type 3</u> |

DN mm/blow 17.54  
Average DCP No 5.70  
CBR (%) 10.78

ND mm/blow 18.18  
Average DCP No 5.50  
CBR (%) 10.30

DN mm/blow 10.42  
Average DCP No 9.60  
CBR (%) 20.94

- Zone 1 → on field test result = Soil Type 1.  
Accepted result (considering likely foundation flooding) → **Soil Type 2.**
- Zone 2 → on field test result = Soil Type 2  
Accepted result (considering likely foundation flooding) → **Soil Type 3.**
