# DRENNAN MAUD (PTY) LTD

Our Ref: 34223-Rev1

12<sup>th</sup> June 2024

## GEOTECHNICAL INVESTIGATION FOR THE DURBAN LIFTING SHED EXTENSION AND UPGRADE

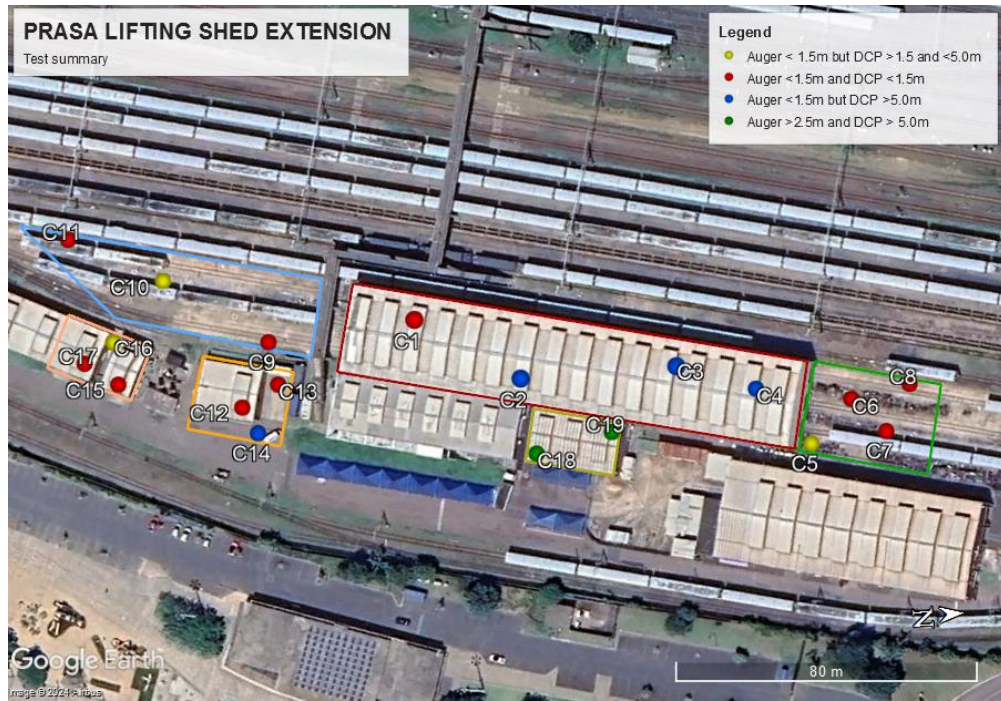
Figure 3: An overview of the depths reached by hand augers and DCP probes in each test position.

In terms of the testing conducted with the cored voids across the site, Figure 3 below provides a summary of the depths achieved by hand auger excavations and DCP probes at each test position is provided in Figure 3.

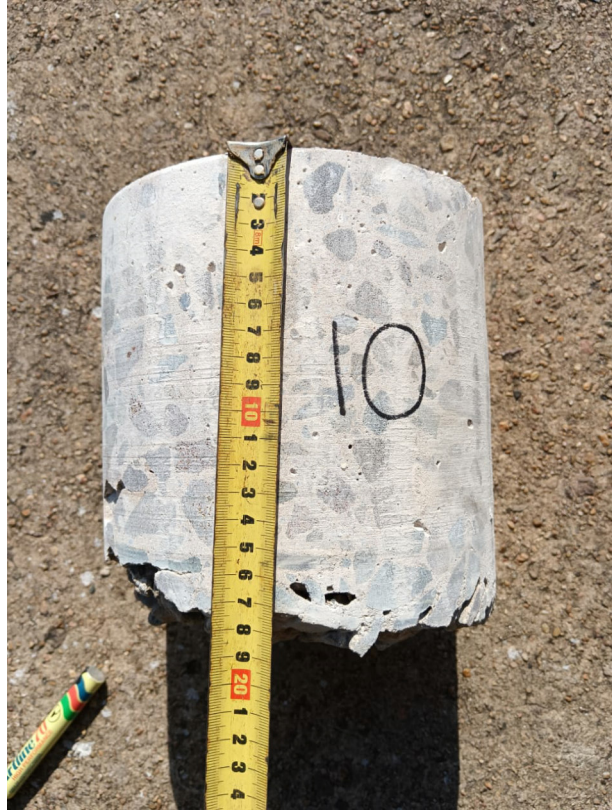
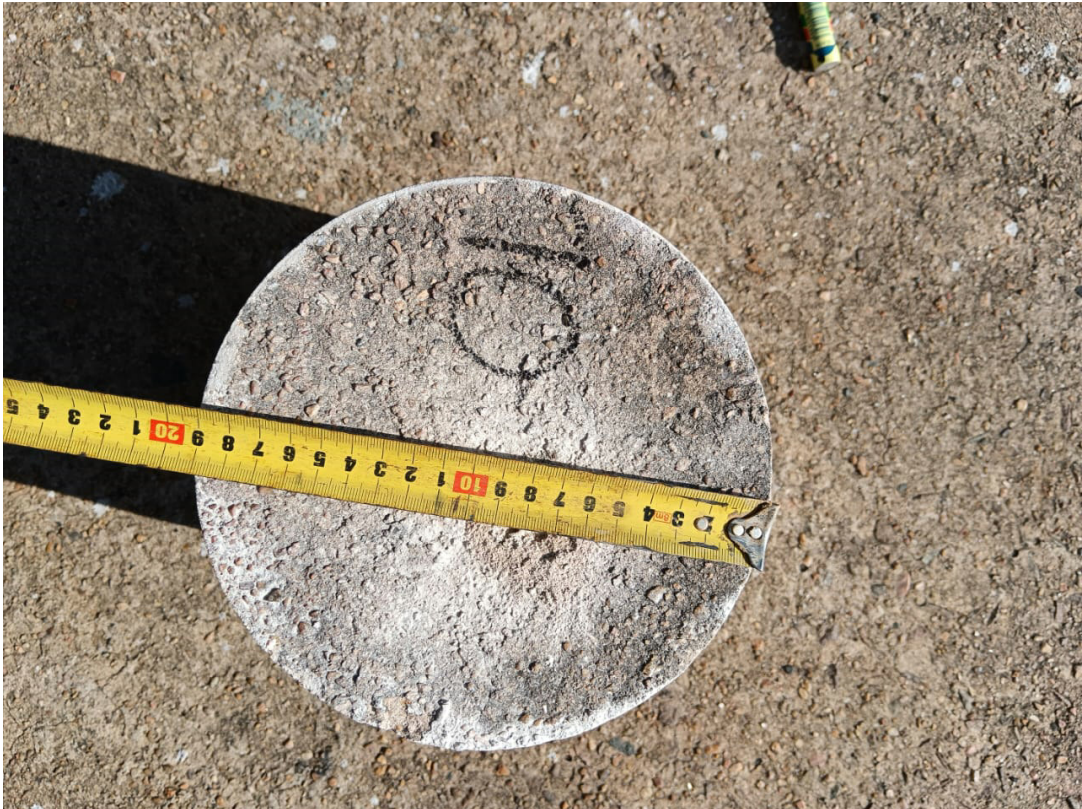
C10.1.jpg

UCS	0.00	Concrete slab with slight voids towards the underside of slab ~ (Hardstand)
BULK	IMC, MC	0.23	Moist to wet, pale yellowish brown, very dense, angular to subrounded, medium to coarse grained <u>GRAVEL</u> aggregate in a matrix of <u>clayey</u> fine to medium grained <u>SAND</u> ~ (Layerworks Fill/Railway Ballast). Containing pebble and cobble sized fragments of hard rock

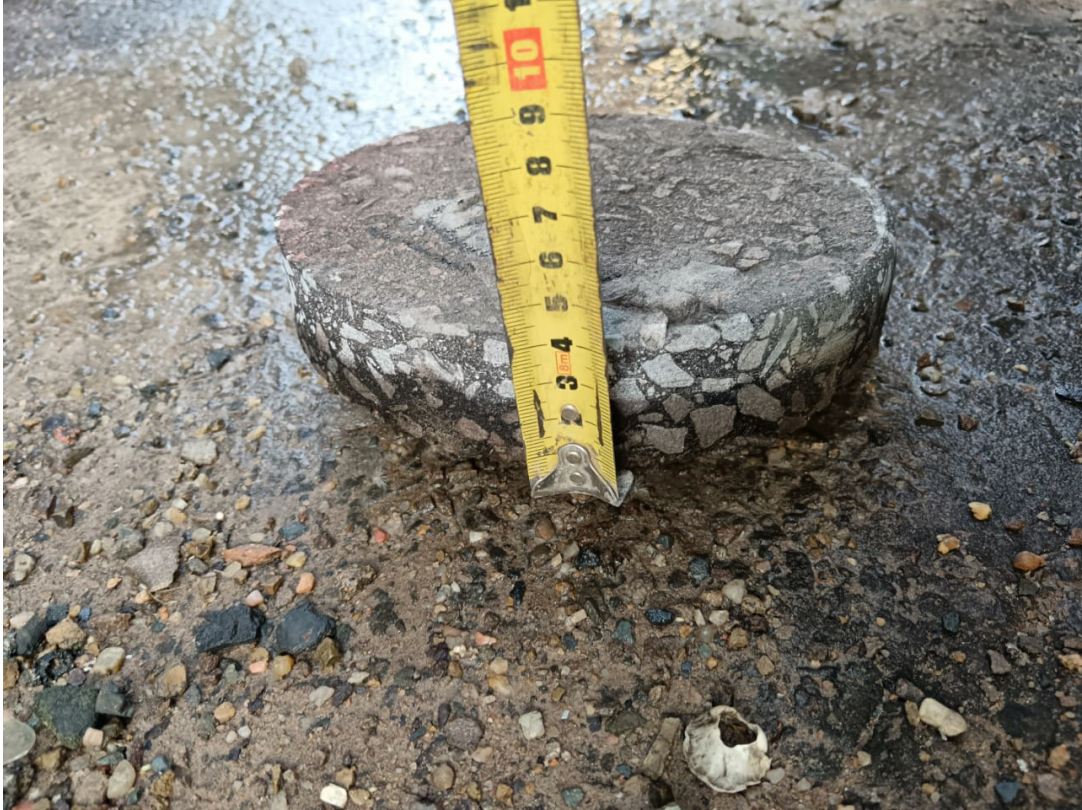
C16.1.jpg

0.75	
<p>NOTES</p> <ol style="list-style-type: none"> <li>1) Hand auger conducted in core 16 within the storage building on the left hand side of lifting shed.</li> <li>2) Hand auger refusal encountered at 0.75m on unknown obstruction. Material hand chiselled to 0.70m (maximum reach).</li> <li>3) No groundwater seepage encountered although DCP rods were wet below 2.70m</li> <li>4) Minor sidewall collapse encountered from 0.60m.</li> <li>5) DCP 16 refusal encountered at 4.38m on unknown obstruction.</li> <li>6) Disturbed bulk mixed sample obtained from 0.04 to 0.52m and 0.52 to 0.68m for foundation indicators (I), Mod AASHTO (M) and CBR (C) testing.</li> </ol>				
SAMPLE DEPTH

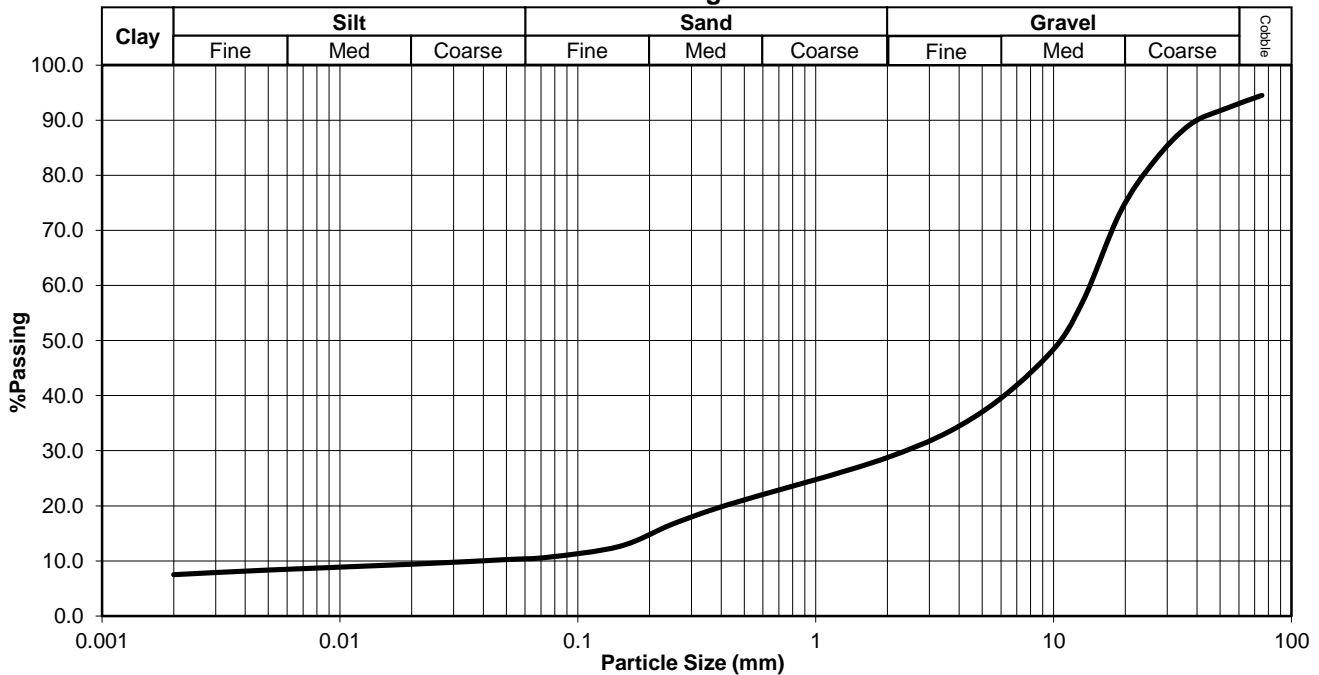
**Grading Curve**

CLASSIFICATION	
Potential Expansiveness	Low
Group Index	0
AASHTO Soil Classification	A - 1 - a
Unified Classification	GP - GM

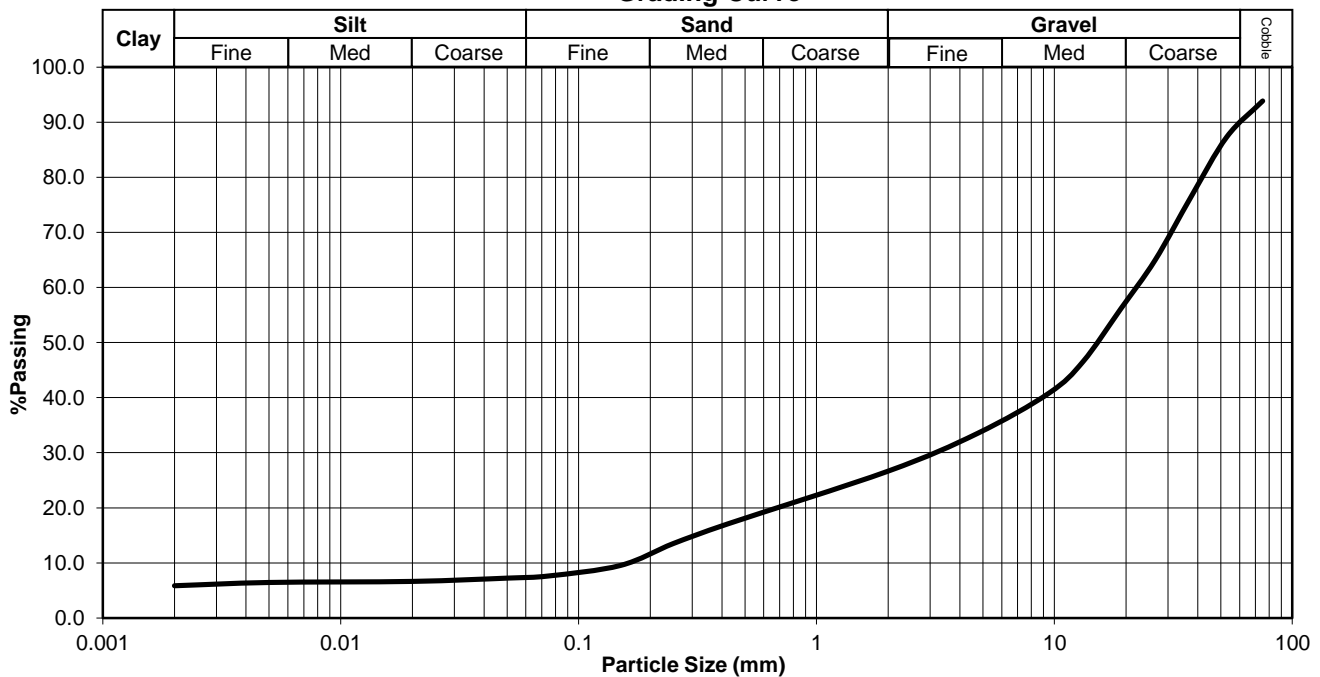
**Grading Curve**

CLASSIFICATION	
Potential Expansiveness	Low
Group Index	0
AASHTO Soil Classification	A - 1 - a
Unified Classification	GW - GM

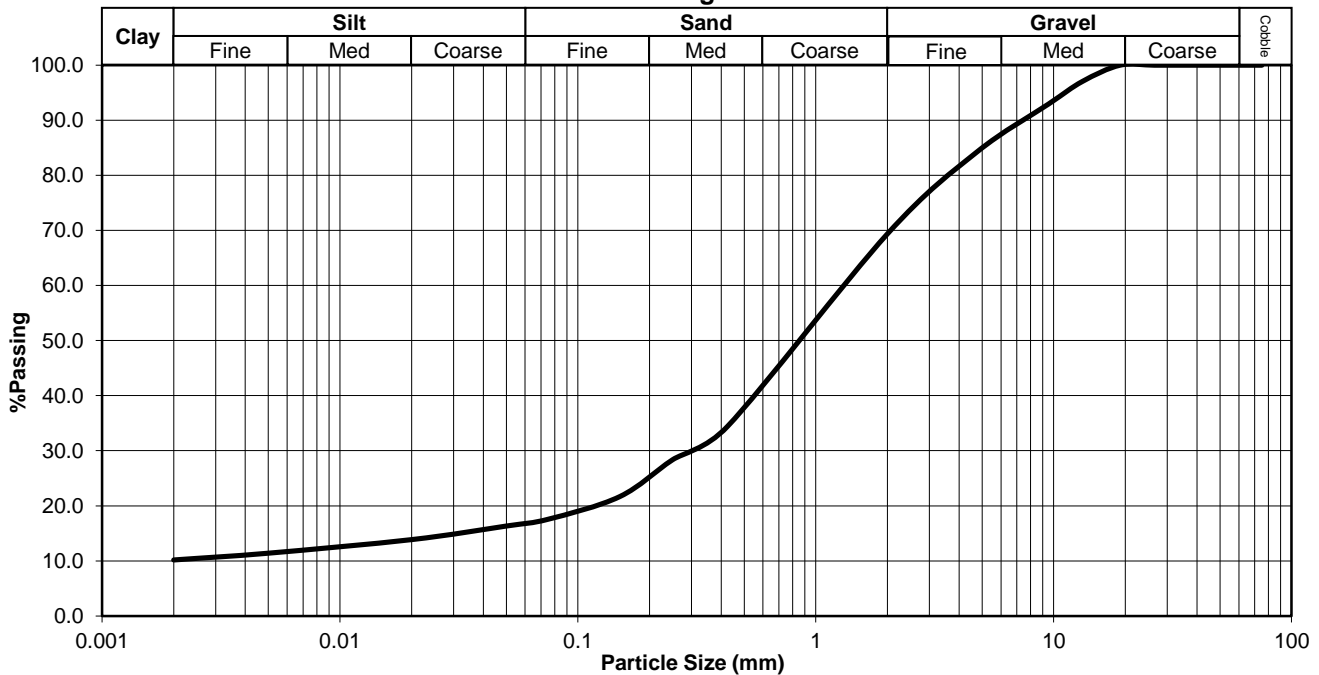
**Grading Curve**

CLASSIFICATION	
Potential Expansiveness	Low
Group Index	0
AASHTO Soil Classification	A - 2 - 4
Unified Classification	SM - SC

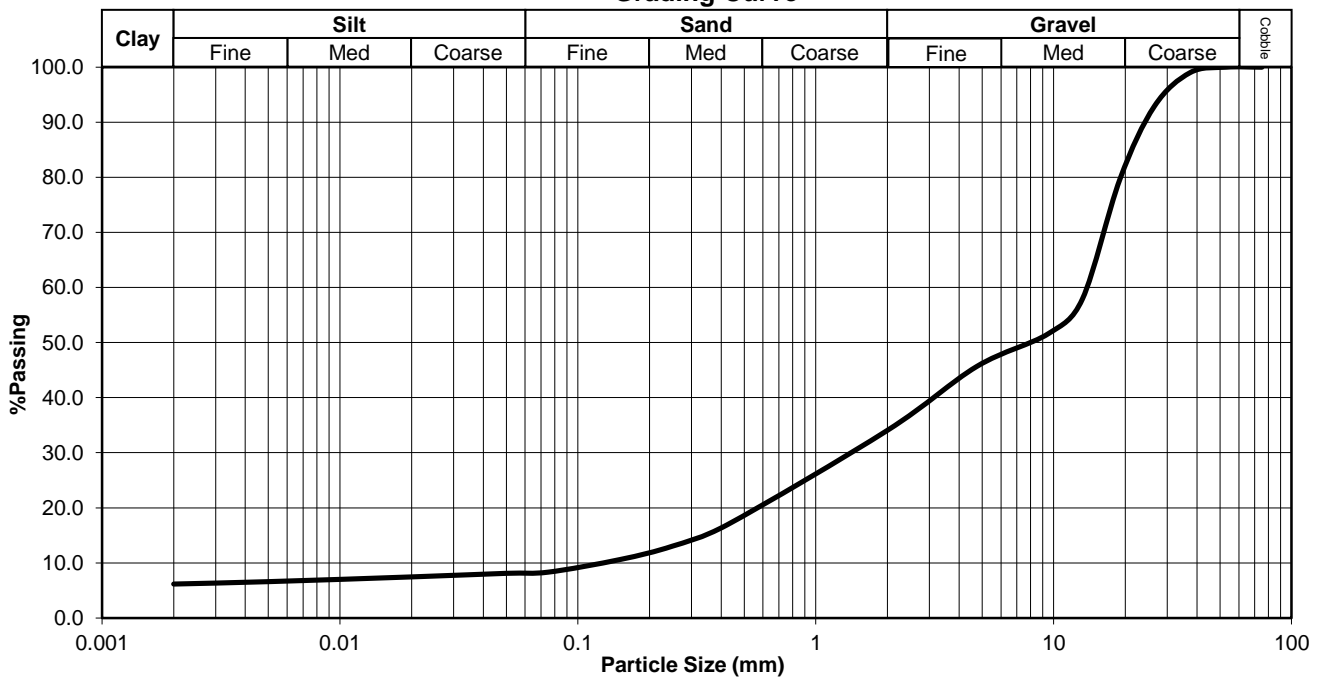
**Grading Curve**

CLASSIFICATION	
Potential Expansiveness	Low
Group Index	0
AASHTO Soil Classification	A - 1 - a
Unified Classification	GW - GM

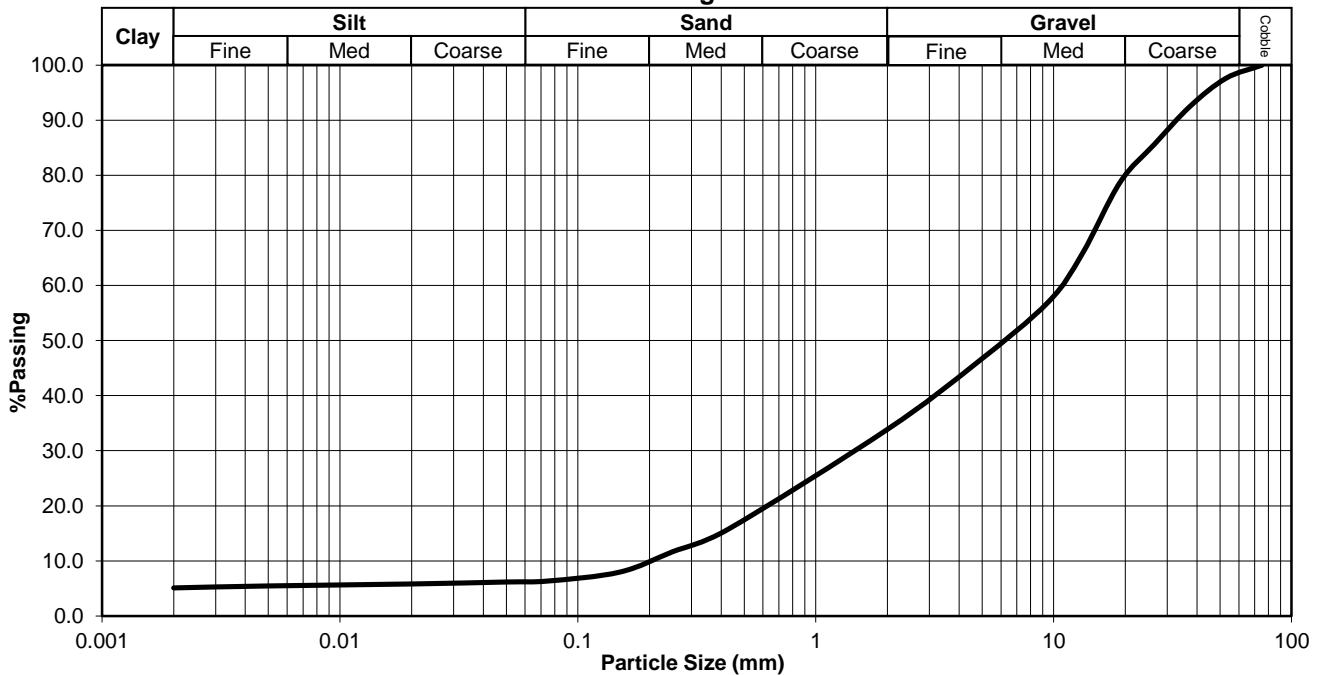
**Grading Curve**

CLASSIFICATION	
Potential Expansiveness	Low
Group Index	0
AASHTO Soil Classification	A - 1 - a
Unified Classification	GP - GM

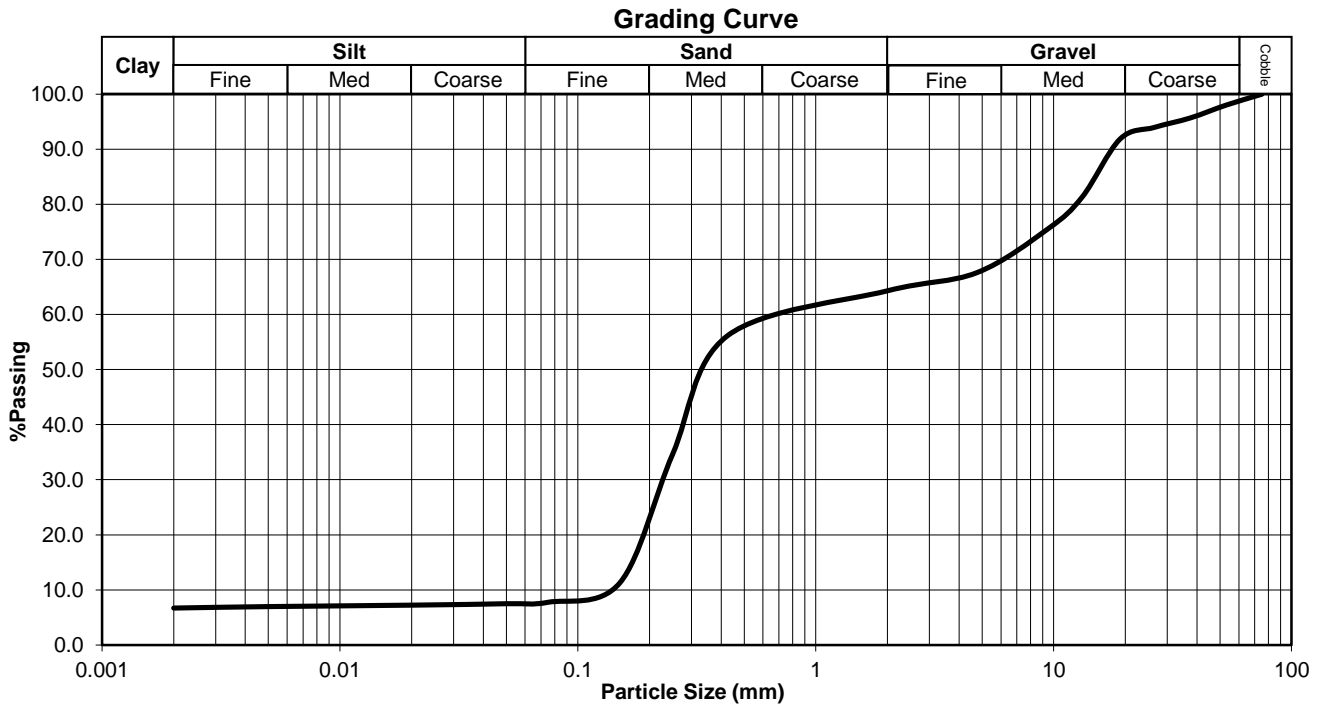
GRADING	
D10 Size (mm)	0.12
Uniformity Coefficient	7.57
Grading Modulus	1.72

CLASSIFICATION	
Potential Expansiveness	Low
Group Index	0
AASHTO Soil Classification	A - 3
Unified Classification	SP - SM

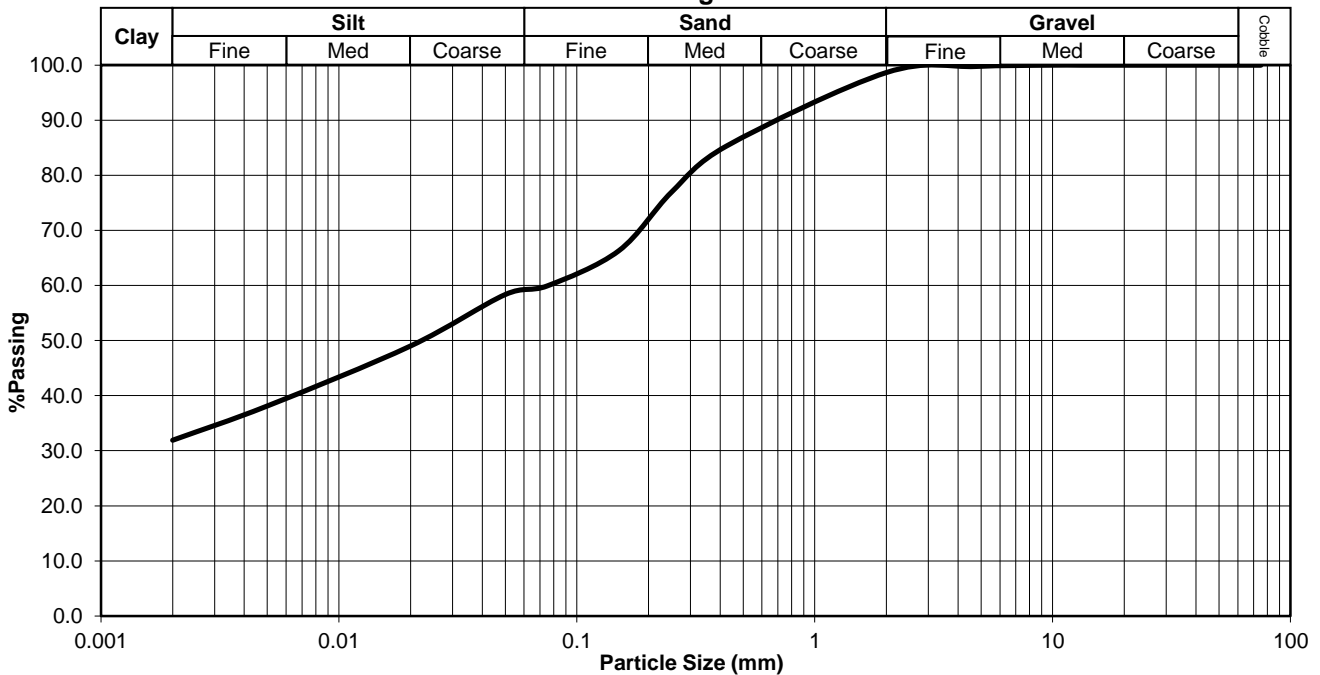
**Grading Curve**

CLASSIFICATION	
Potential Expansiveness	Low
Group Index	1
AASHTO Soil Classification	A - 4
Unified Classification	CL - ML

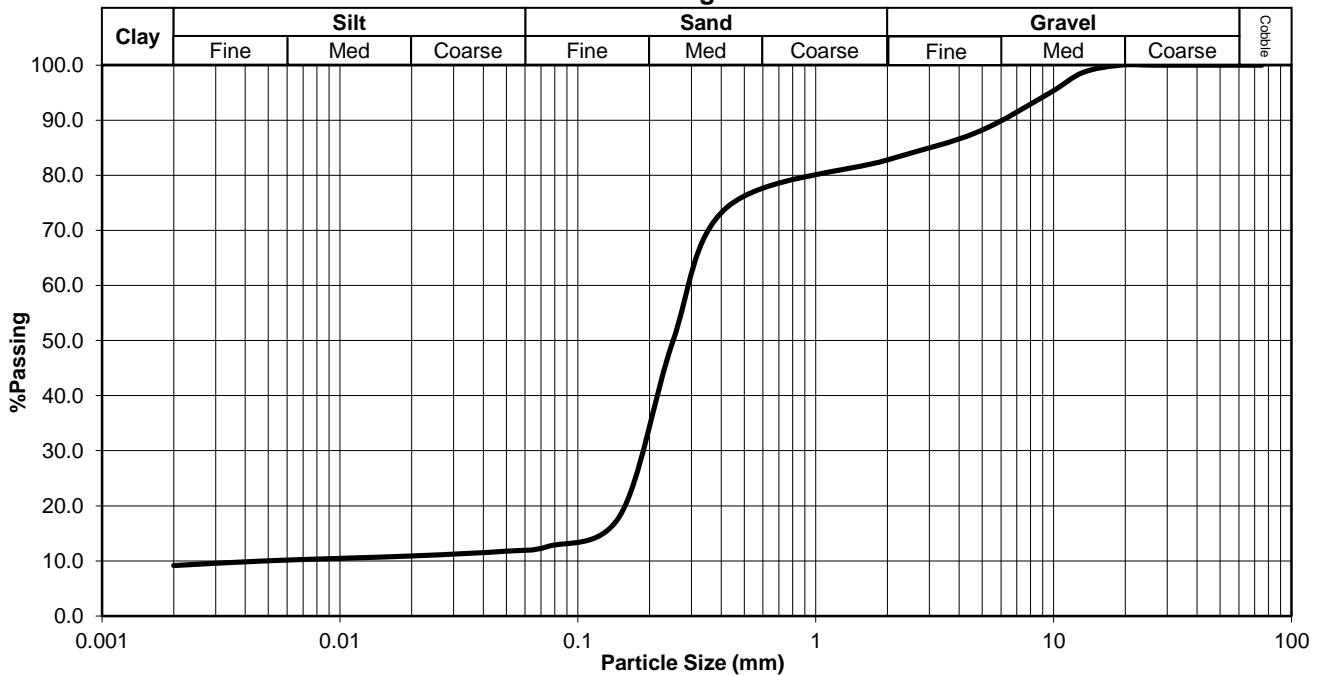
**Grading Curve**

CLASSIFICATION	
Potential Expansiveness	Low
Group Index	0
AASHTO Soil Classification	A - 2 - 4
Unified Classification	SM

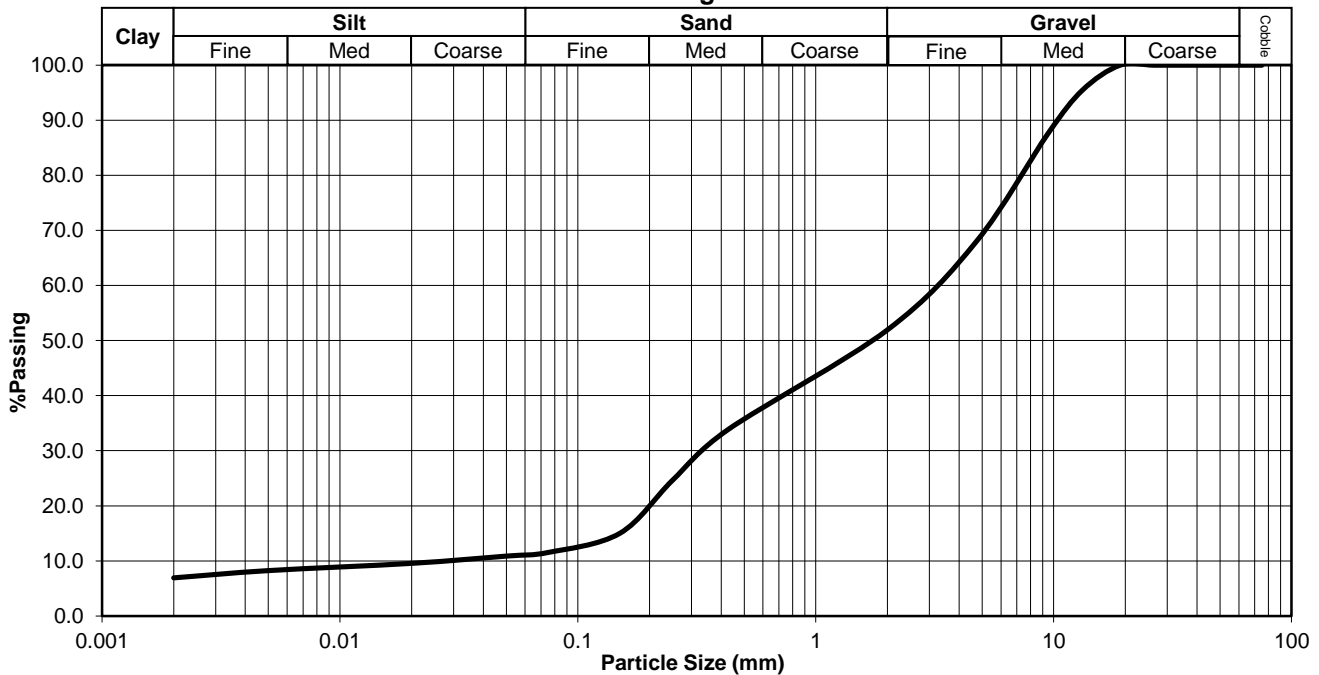
**Grading Curve**

CLASSIFICATION	
Potential Expansiveness	Low
Group Index	0
AASHTO Soil Classification	A - 1 - b
Unified Classification	SW - SM
