Geotechnical Report

**Geotechnical Investigation for the Proposed
Additions and Alterations at 96 Rissik Street,
Transnet office, Johannesburg CBD.**

Geotechnical Investigation for the Proposed Addition and Alterations at the Transnet office on 96 Rissik Street, Johannesburg	
Compiled by Engineering Geologist	Njabulo Mthembu
Reviewed by Snr. Engineering Geologist	Nhlanhla Magigaba

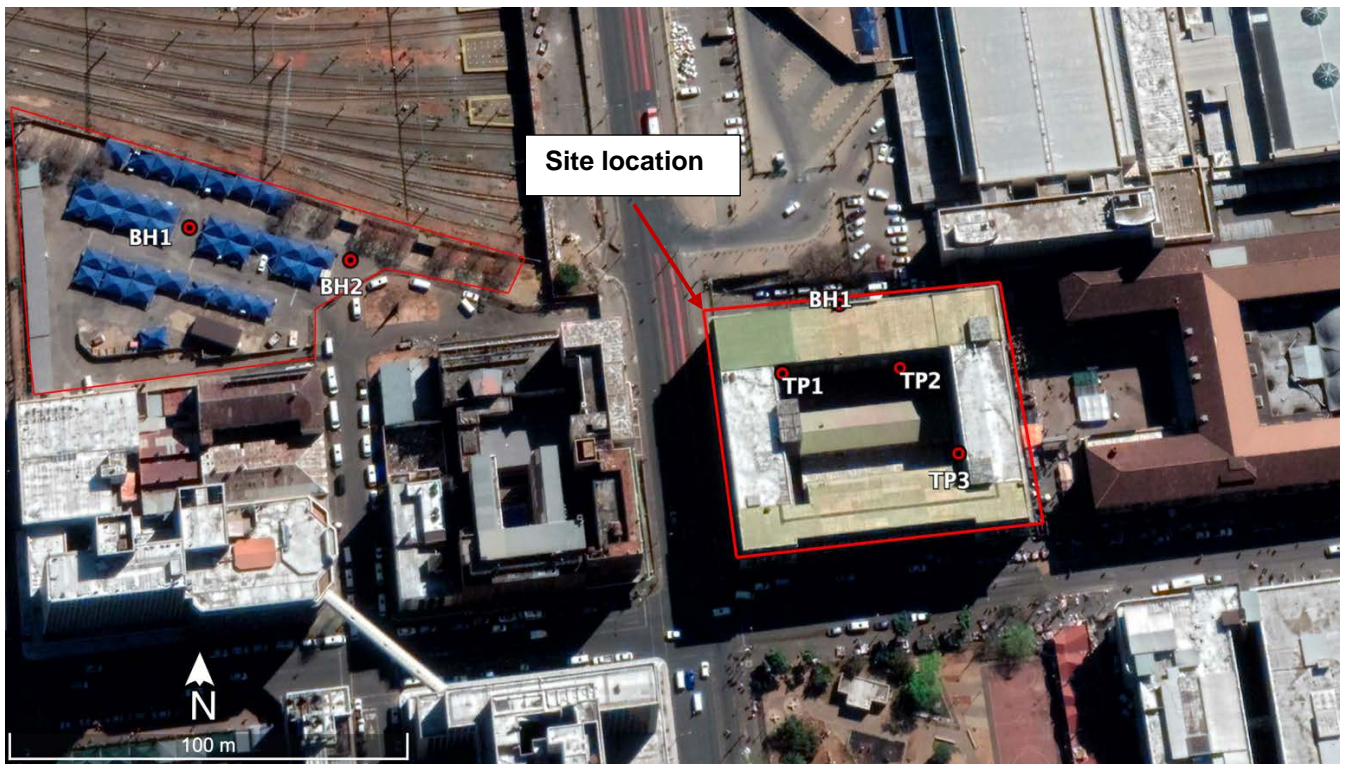
Figure 1: Showing the site boundary in red, test pit, and drilled borehole position.

The site is in an existing Transnet office, on 96 Rissik Street, Johannesburg CBD in the Gauteng Province. It is an existing multi-storey office building. Figure 1 below shows the location of the site area and the positions of the test pits and borehole.

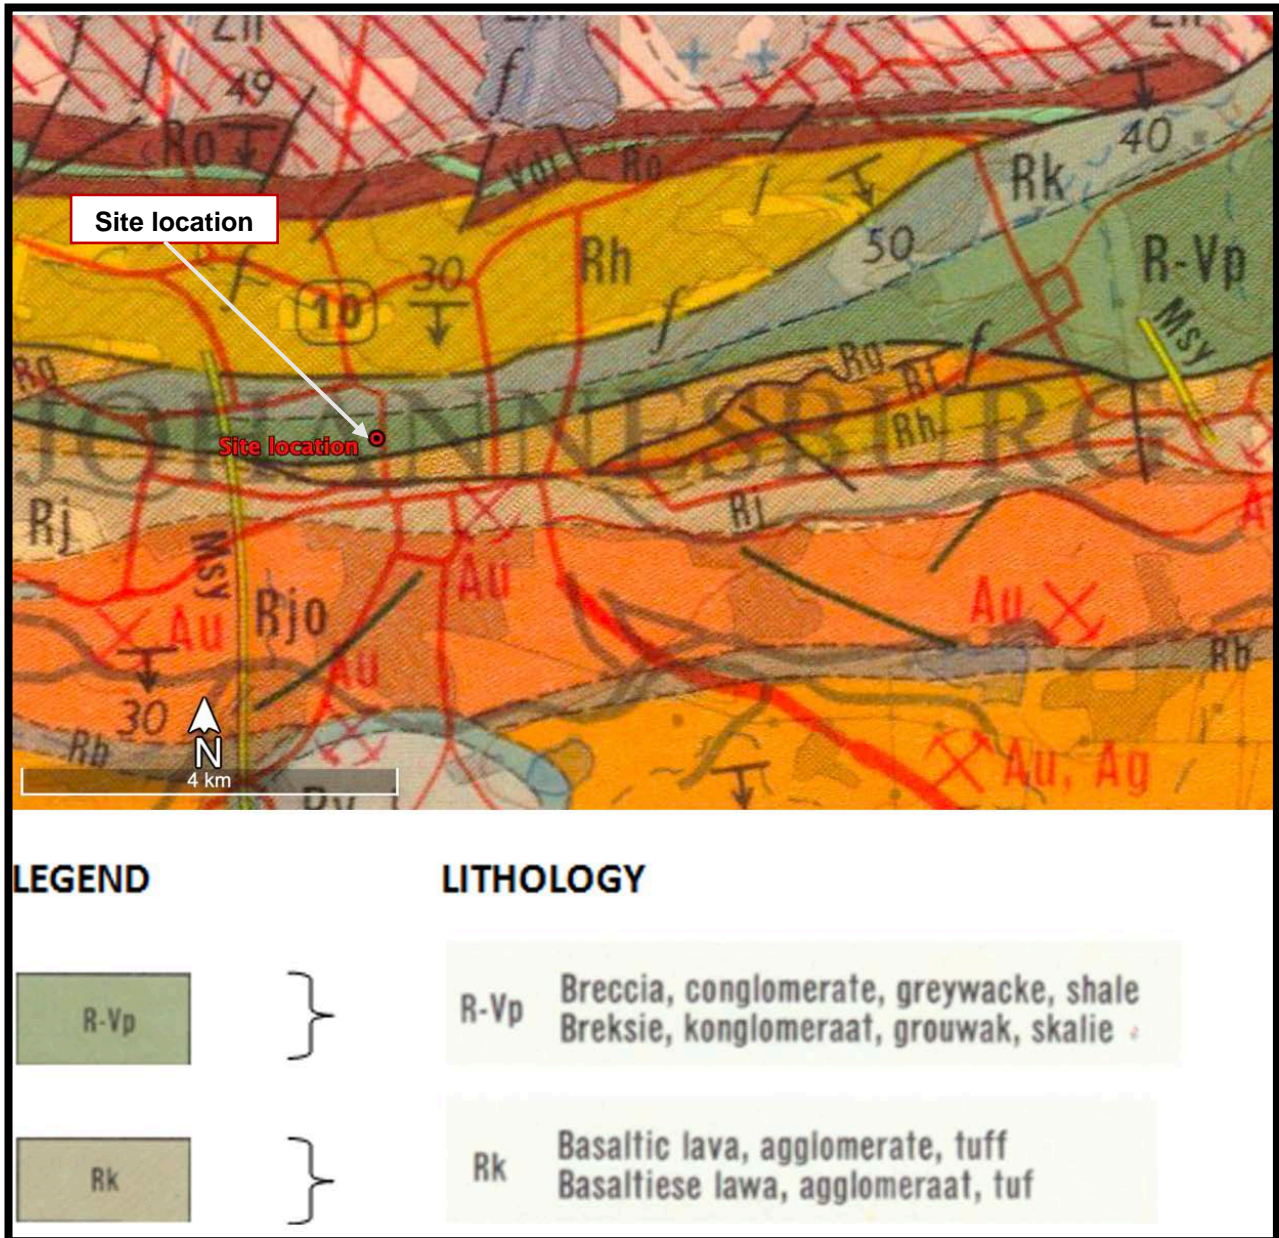
Figure 3: Showing the general geology map of the site, (Geological Survey, 1986).

According to the 1:250 000 geological map of the East Rand Sheet 2628 (Council of Geoscience, 1986), the site area is underlain by breccia, conglomerate, greywacke, and shale (**R-Vp**) of the Platenburg Group, Ventersdorp Supergroup as well as basaltic lava, agglomerate and tuff (**Rk**) of the Klipriviersberg Group, Ventersdorp Supergroup as shown in Figure 3 below.

The geological map (refer to Figure 3) indicates that there was a gold mine within close proximity of the site. Referring to a drawing from the Department of Mine Surveys (DME) in Pretoria, confirmed that the site is undermined from depths between approximately 90m to 240m below EGL. It must be noted that there are existing high rise structures adjacent to this site, as well as offices below the investigated site; it can therefore be presumed that the investigated site is suitable for the proposed development. However, it is advisable that DME be consulted prior to any development.

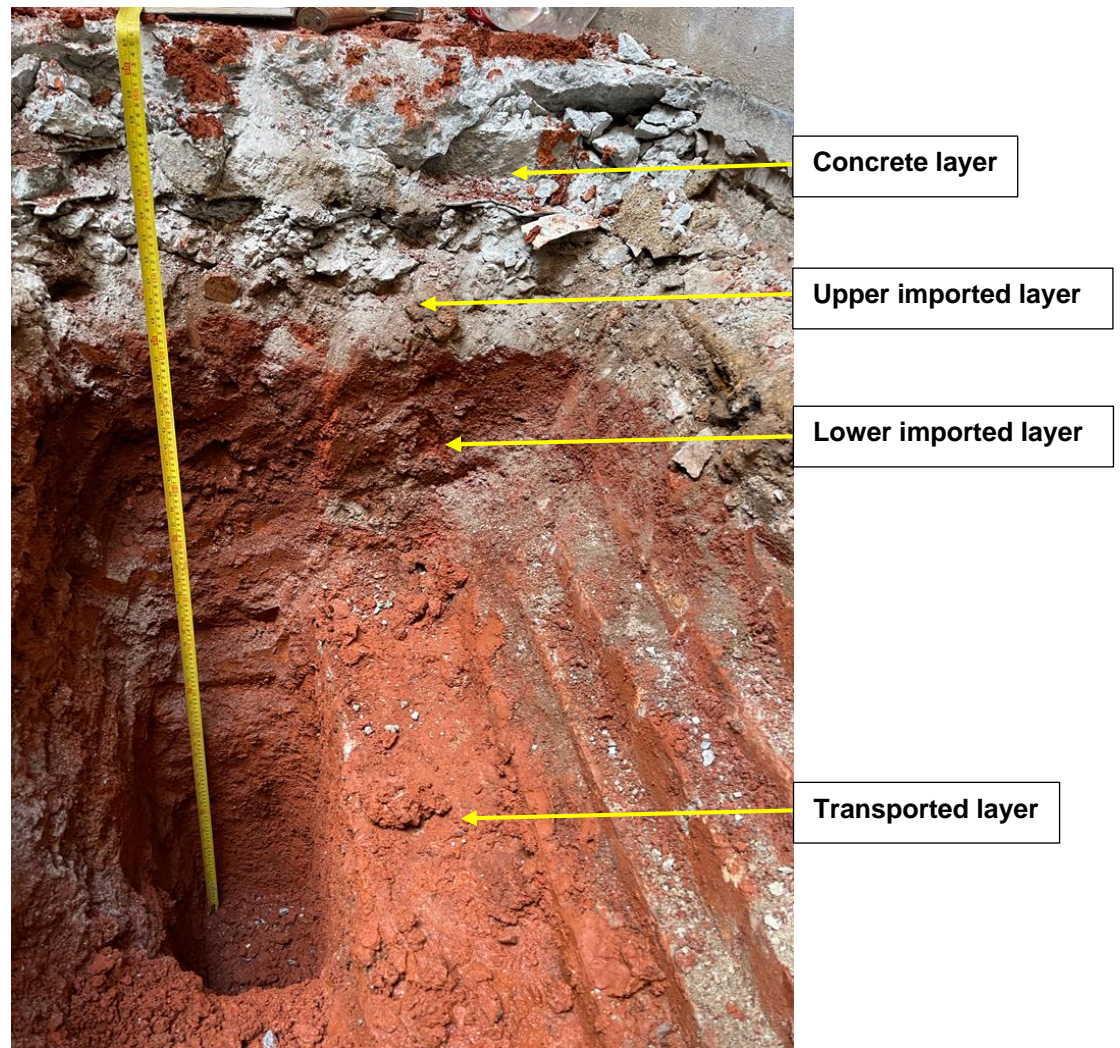
Figure 4: Typical soil profile (TP3)

Test Pit No	Concrete layer (m)	Upper Imported layer (m)	Lower Imported layer (m)	Transported layer (m)
TP1	0 - 0.10	0.10 – 0.20	0.20 – 0.90	0.90 – 2.00
TP2	0 - 0.10	0.10 – 0.25	0.25 – 0.50	0.50 – 2.00
TP3	0 - 0.10	0.10 – 0.20	0.20 – 0.45	0.45 – 2.00

The upper imported layer (engineered fill) underlies the concrete on-site. This layer comprises slightly moist, light grey-brown, gravel in a matrix of fly ash and silty sand. The general consistency of this layer is very dense. This layer extends to an average depth of 0.45m.

The lower imported layer (engineered fill) underlies the upper imported layer on-site. This layer comprises moist, reddish-brown, slightly clayey sand with fine slightly ferruginous gravel and cobbles. The general consistency of this layer is dense. This layer extends to a depth of 0.95m on the test pits.

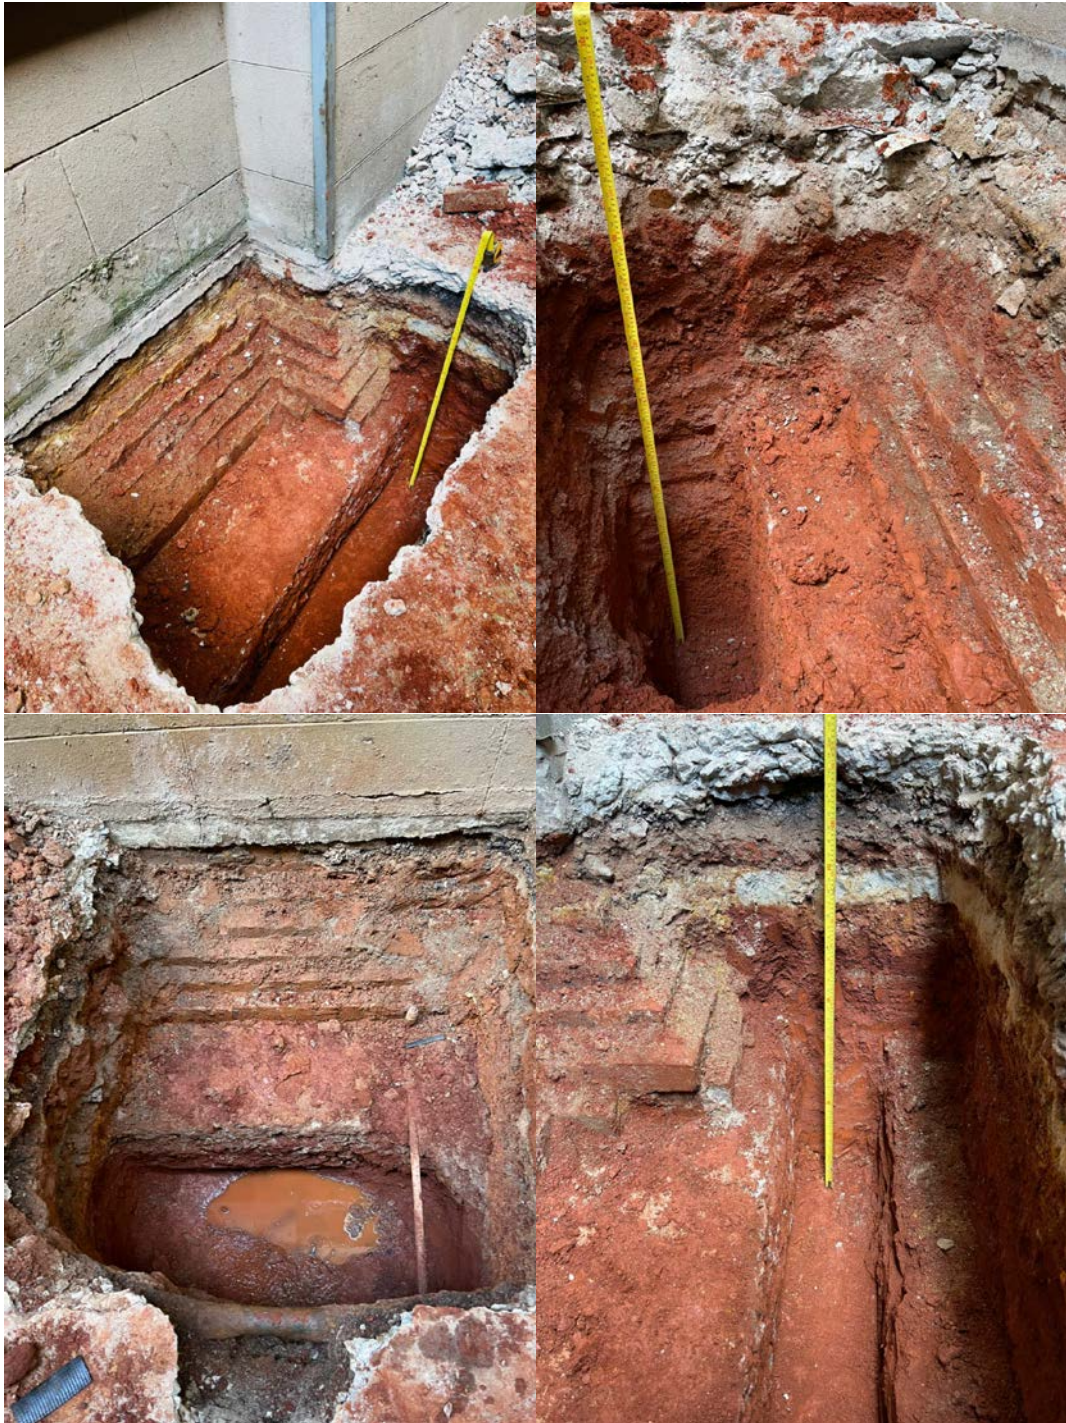
Figure 5: Shows the typical excavated test pits during the site investigation

The investigated area is generally gently sloping. The office building to be upgraded it's a multi-storey structure. At the time of the investigation, the office structure was intact with no visible cracks. The office was being evacuated to allow the construction work to proceed. The typical test pits and foundations condition during the time of investigation is shown in Figure 5 below.

The foundation of the existing structure was exposed using pick and shovel, it was noted that there were bricks around the concrete spread foundation, as shown in Figure 5 above, it was difficult to get the details of the piles (size and length) due to the limitations of the investigation. ***It is presumed that the foundation type is piled raft foundation based on the observations of the shallow investigation and knowledge of the foundations on the adjacent buildings which are placed on a piled raft.*** The typical foundation for the existing structure is as shown in Figure 6 above.

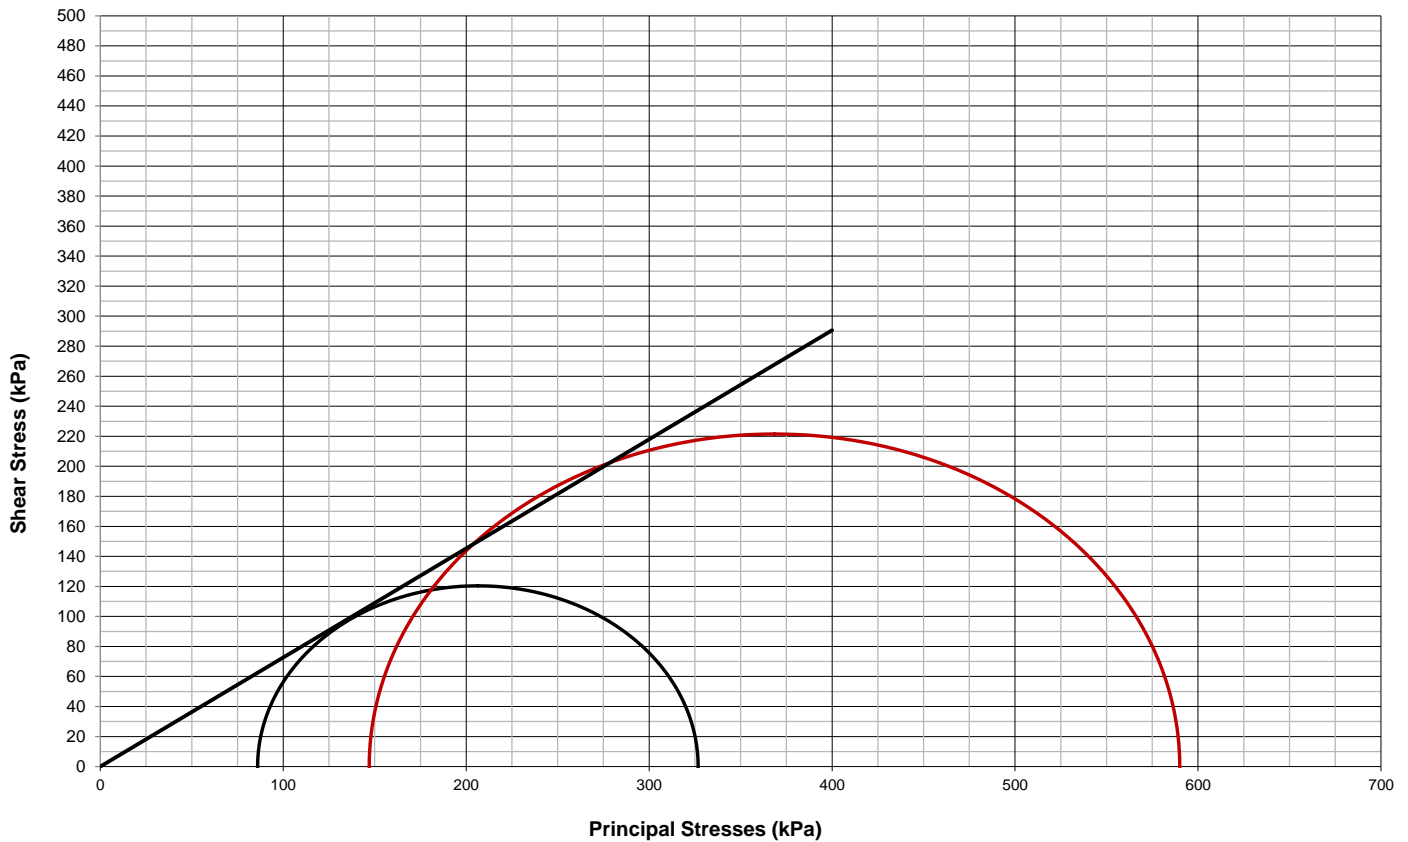
Effective Shear Strength

Angle of Internal Friction	Deg.	36
Cohesion	kPa	0

Hole No.	Depth (m)	Material type	Shear Parameter of Effective Stress		Shear Parameter of Failure	
			Cohesion (kPa)	Friction angle (degrees)	Cohesion (kPa)	Friction angle (degrees)
Transported Layer						
BH1	2.05 - 2.50	Clayey silt	0	36	3	30
Residual Andesite (from adjacent site)						
BH2	16.95 – 18.0	Clayey silt	7	24	5	22

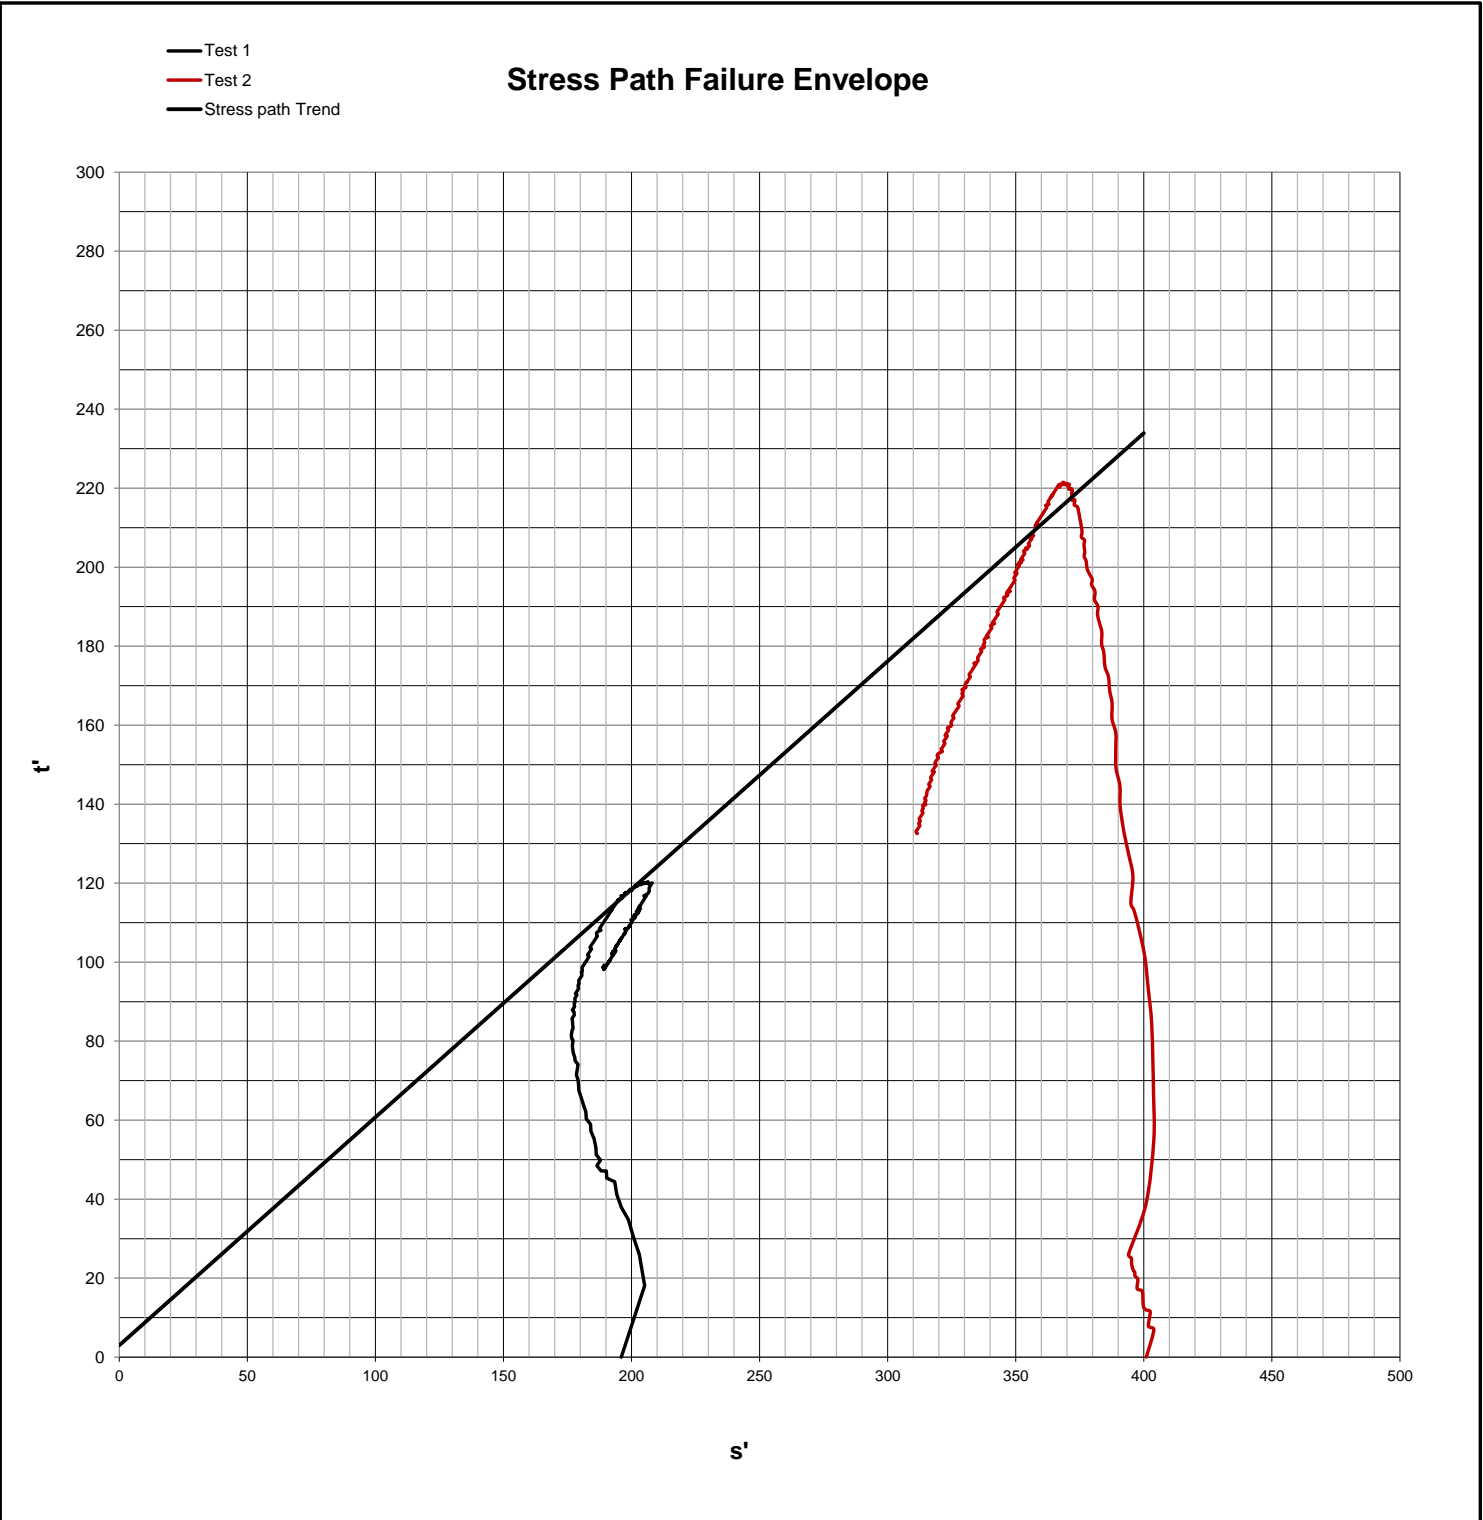
Shear Parameters at Failure		
Angle of Internal Friction	Deg.	30
Cohesion	kPa	3

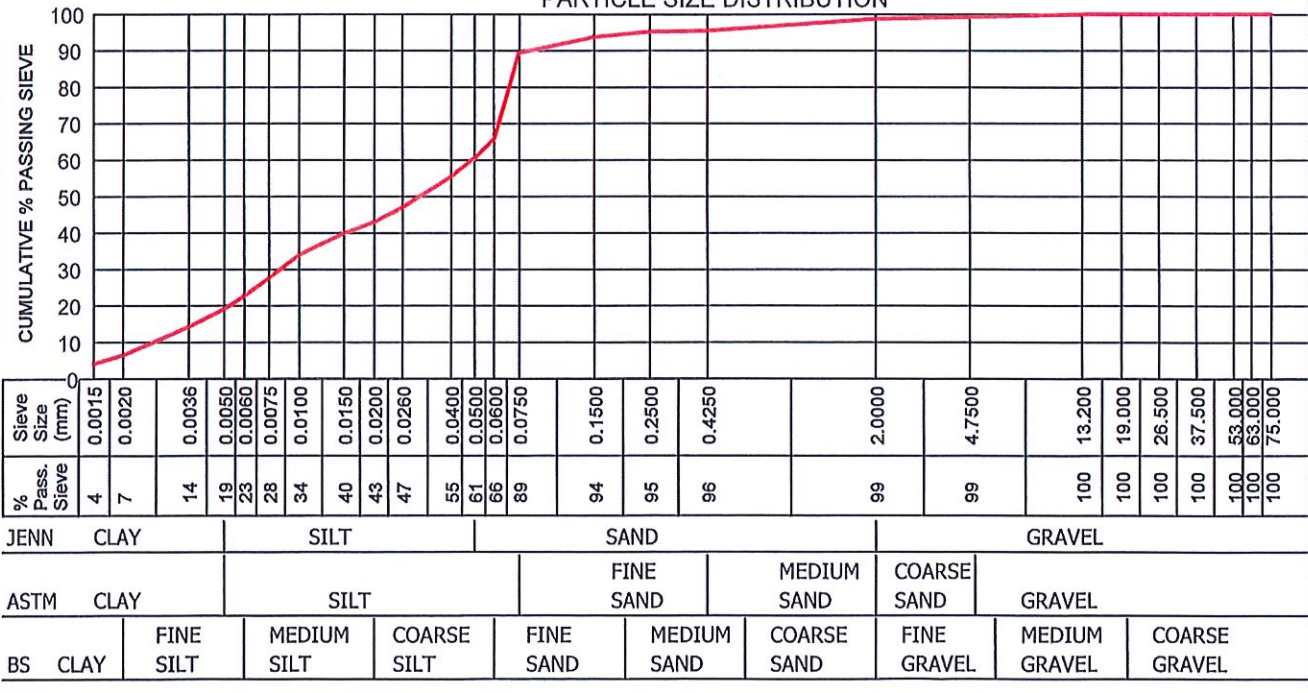
PARTICLE SIZE DISTRIBUTION

Clay (%)	Silt (%)	Sand (%)	Gravel (%)	Classification
Jennings	19.2	41.4	38.1	1.3	SANDY SILT
Astm	19.2	70.1	10.0	0.7	SANDY SILT
British Standard	6.6	59.3	32.8	1.3	SANDY SILT

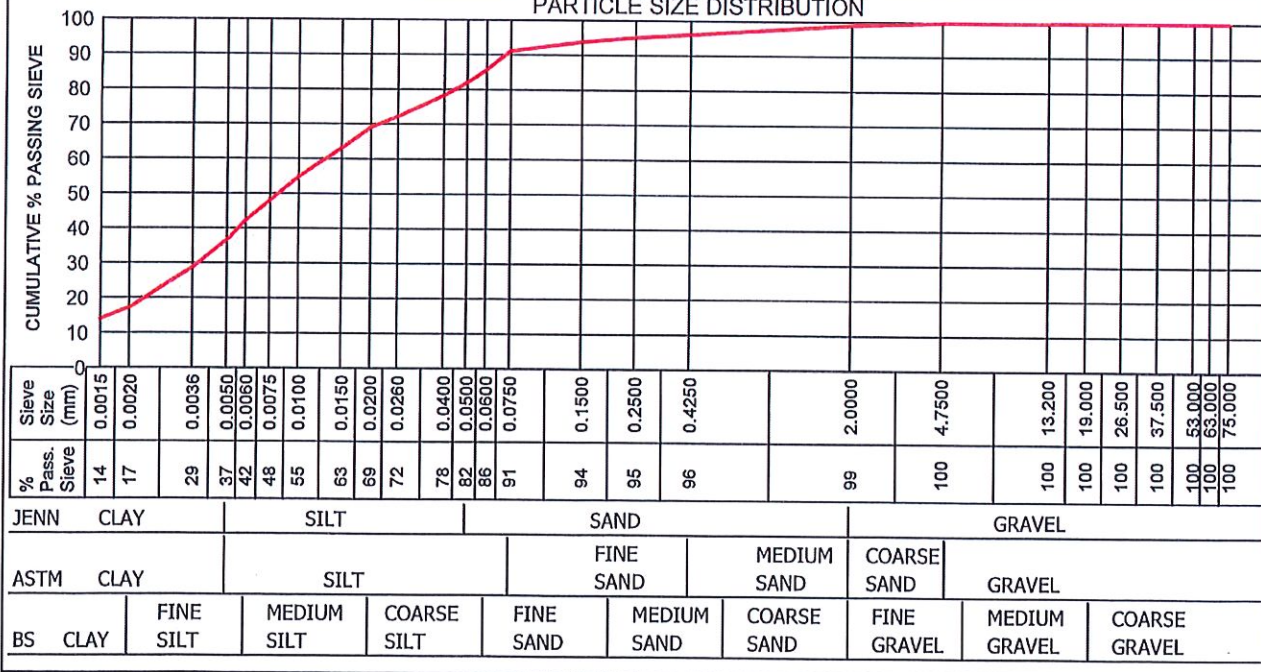
PARTICLE SIZE DISTRIBUTION

Clay (%)	Silt (%)	Sand (%)	Gravel (%)	Classification
Jennings	36.7	45.3	17.0	0.9	SILTY CLAY
Astm	36.7	54.5	8.7	0.1	SILTY CLAY
British Standard	17.3	68.5	13.3	0.9	SANDY SILT
