Council for Geoscience

LANDSLIDE GEOHAZARDS IN SOUTH AFRICA:

**Landslide susceptibility mapping, socio-economic impacts, mitigation
and remediation measures**

Report No.: 2011-0016

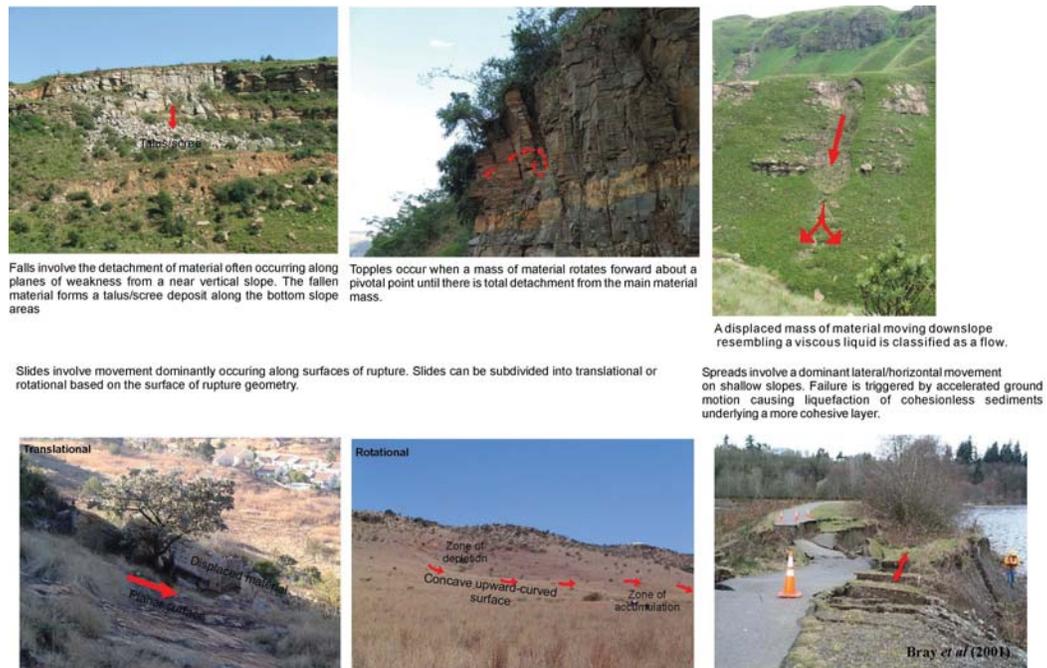
Figure 1: Graphic illustrating various types of landslides.

A landslide is defined by Cruden (1991) as “the movement of a mass of rock, debris, or earth down a slope.” Most frequently used landslide classification systems are based on the type of movement and material (Varnes, 1978 and Cruden and Varnes, 1996). There are five types of landslides; falls, topples, flows, slides (translational and rotational) and lateral spreads. Short descriptions of these landslide types, following Varnes (1978), Cruden and Varnes (1996) and Highland (2004), are provided in Fig. 1.

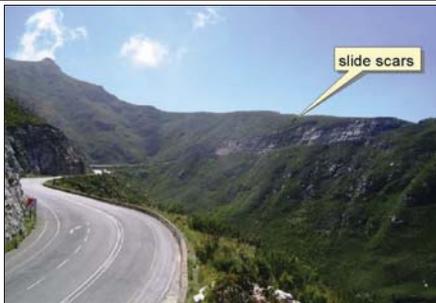
<p>Outeniqua Pass: N12 highway, January 2011 Large rock slides have caused road closures.</p>

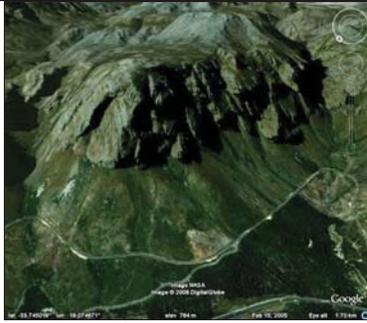
Du Toits Kloof Pass, old N1 route.
Recurring rockfalls & debris flows disrupted traffic

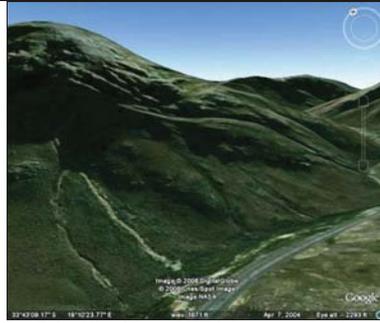
Du Toits Kloof Pass, N1 highway north of tunnel
The June 1991 Molenaars Peak debris flow.

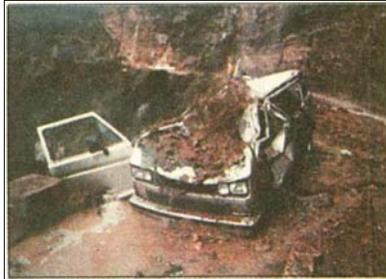
Chapmans Peak Drive, June 1994
Wet debris fall resulted in drivers leg paralysis
[Rapport 20/09/1998]

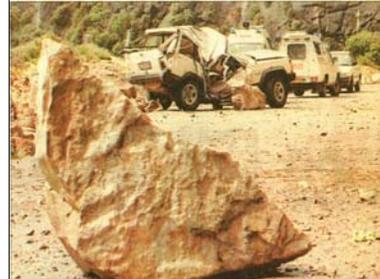
Chapmans Peak Drive, November 1997
Rockfall caused one death
[Sunday Times 18/09/1998]

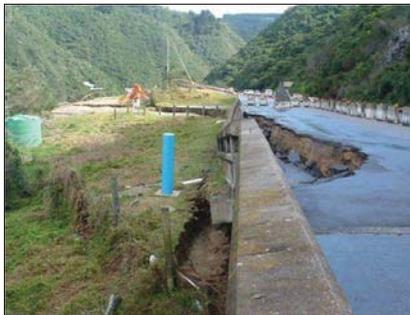
Kaaimans Pass: August 2006: Failure #1 site
Highway, house at left and railway below affected.
[M Mohlabane, BKS]

A recent example of landslide socio-economic impact in South Africa was the damage to the Kaaimans Pass road in 2006. Slope failure resulted in the complete closure of the N2 highway. It initially impacted on all traffic for two days and a further period of two weeks thereafter with respect to heavy vehicles. Local businesses had to bear the cost of a 900km return detour instead of the usual 150km round trip, between George and Knysna. Long haul carriers between Cape Town and Port Elizabeth/East London/Durban were also forced to make lengthy detours via less suitable tarred provincial roads. This incident highlights the necessity for proactive landslide studies and the implementation of expanded mitigation strategies and active monitoring systems. Apart from having serious economic impacts, landslides are often life-threatening. In South Africa, mass movement fatalities occurred during the Merriespruit tailings dam failure in 1994 (Wagener, 1994), the Stanger debris flow of 1987 and recurring rockfalls from the mountain slopes above Chapman's Peak Drive along the Atlantic coastline, have killed road users. It is clear that geohazards, including landslides, should be a primary consideration in all spatial development planning frameworks.

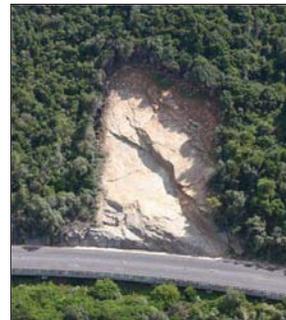
Kaaimans Pass: Failure #2 site
Dip slope translational type failure.
[M Mohlabane, BKS]

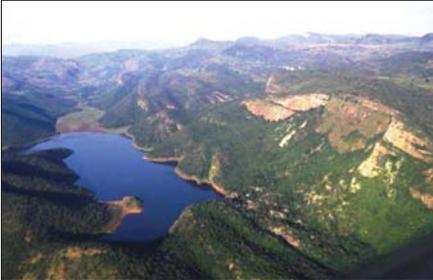
<p data-bbox="440 317 873 388">Aerial view of Lake Fundudzi: A palaeo feature formed by a rock avalanche 20000 years ago. (van der Waal, 1987) [G Chiliza 2008: both images]</p>

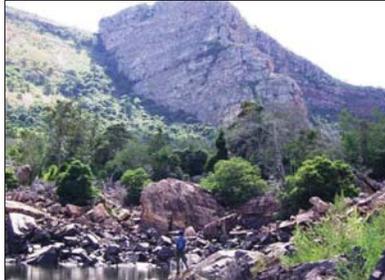
<p data-bbox="932 317 1317 415">The towering quartzite cliff failure scarp above the dammed Mutale River, Soutpansberg mountains. Past seismicity, toe under cutting and rock shear failure occurred.</p>
Province	Description	
KwaZulu-Natal

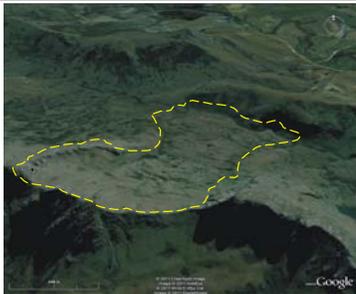
<p data-bbox="440 768 873 793">Aerial view of the Mount Currie Holocene landslide</p>

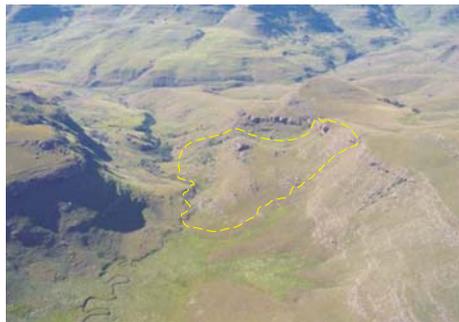
<p data-bbox="440 1115 873 1163">Aerial view of the Meander Stream rotational palaeolandslide in the Giants Castle Nature reserve</p>

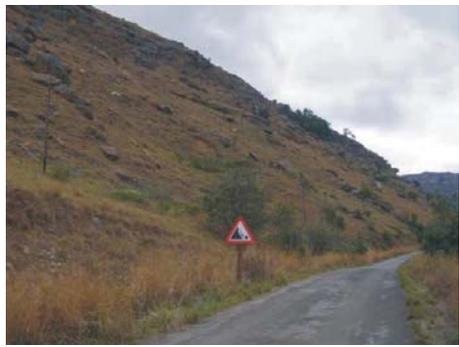
<p data-bbox="440 1577 873 1602">Ongoing rock failures in the Highmoor Nature reserve.</p>

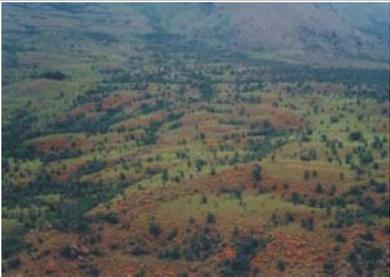
<p data-bbox="927 751 1338 800">Typical widespread hummocky topography characteristic of the Mount Currie palaeolandslide</p>

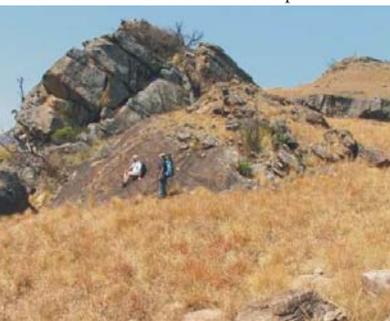
<p data-bbox="927 1121 1338 1190">Large rotated sandstone/mudstone intact blocks dipping into the failed slope at steep angles form part of the Meander Stream palaeolandslide debris</p>

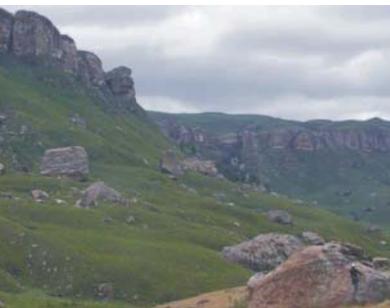
<p data-bbox="927 1528 1338 1598">Widespread rockfall scree characterise many slopes below the distinct Clarens Formation Cliffs in the uKhahlamba Drakensberg mountains</p>

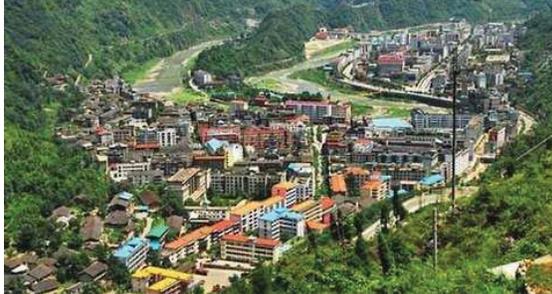
<p data-bbox="412 495 727 516">Beichuan before May 2008 earthquake</p>

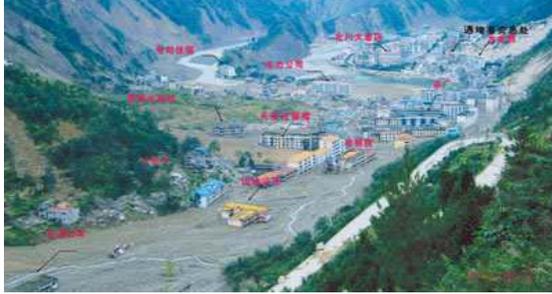
<p data-bbox="412 819 776 840">Beichuan after September 2008 debris flows.</p>	<p data-bbox="1018 401 1351 653">The MMI 5.1 Wenchuan earthquake of May 2008 triggered numerous landslides and rockfalls in Beichuan City. Subsequent heavy rains, in September 2008, further mobilized these loosened materials, resulting in some 72 debris flows and 42 deaths in Beichuan County (Tang C et al, 2009). Some inundated the older parts of Beichuan city, that had previously been evacuated after the May 2008 earthquake triggered events.</p>
Country	Description	
Brazil

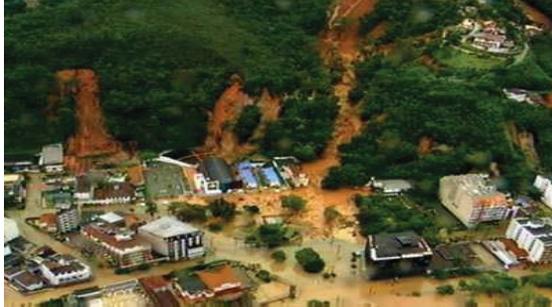
<p data-bbox="412 1228 938 1270">Teresopolis: January 2011: Extensive mud sliding & debris flows [web news site]</p>

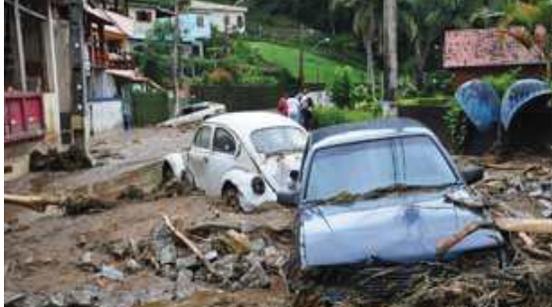
<p data-bbox="412 1585 964 1606">Teresopolis: January 2011: Mass movement damage.[web news site]</p>	<p data-bbox="1018 959 1351 1169">A combination of deeply weathered soils and frequent incidences of high rainfall, often lead to devastating landslides in Brazil. On 12 January 2011 debris flows and mudslides caused 200 tragic deaths and severe infrastructure damage, at Teresopolis village.</p>

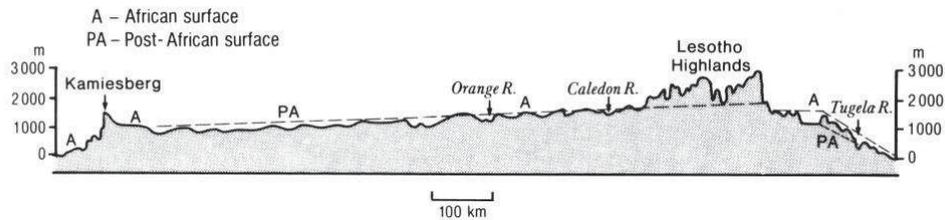
Figure 5 Simplified topographic profile across South Africa showing the steep eastern slope, the Lesotho highlands and the gradual descent towards the west coast (after Moon and Dardis, 1988).

elevation interior plains decreases gradually from east to west (Fig.5, after Moon and Dardis, 1988).

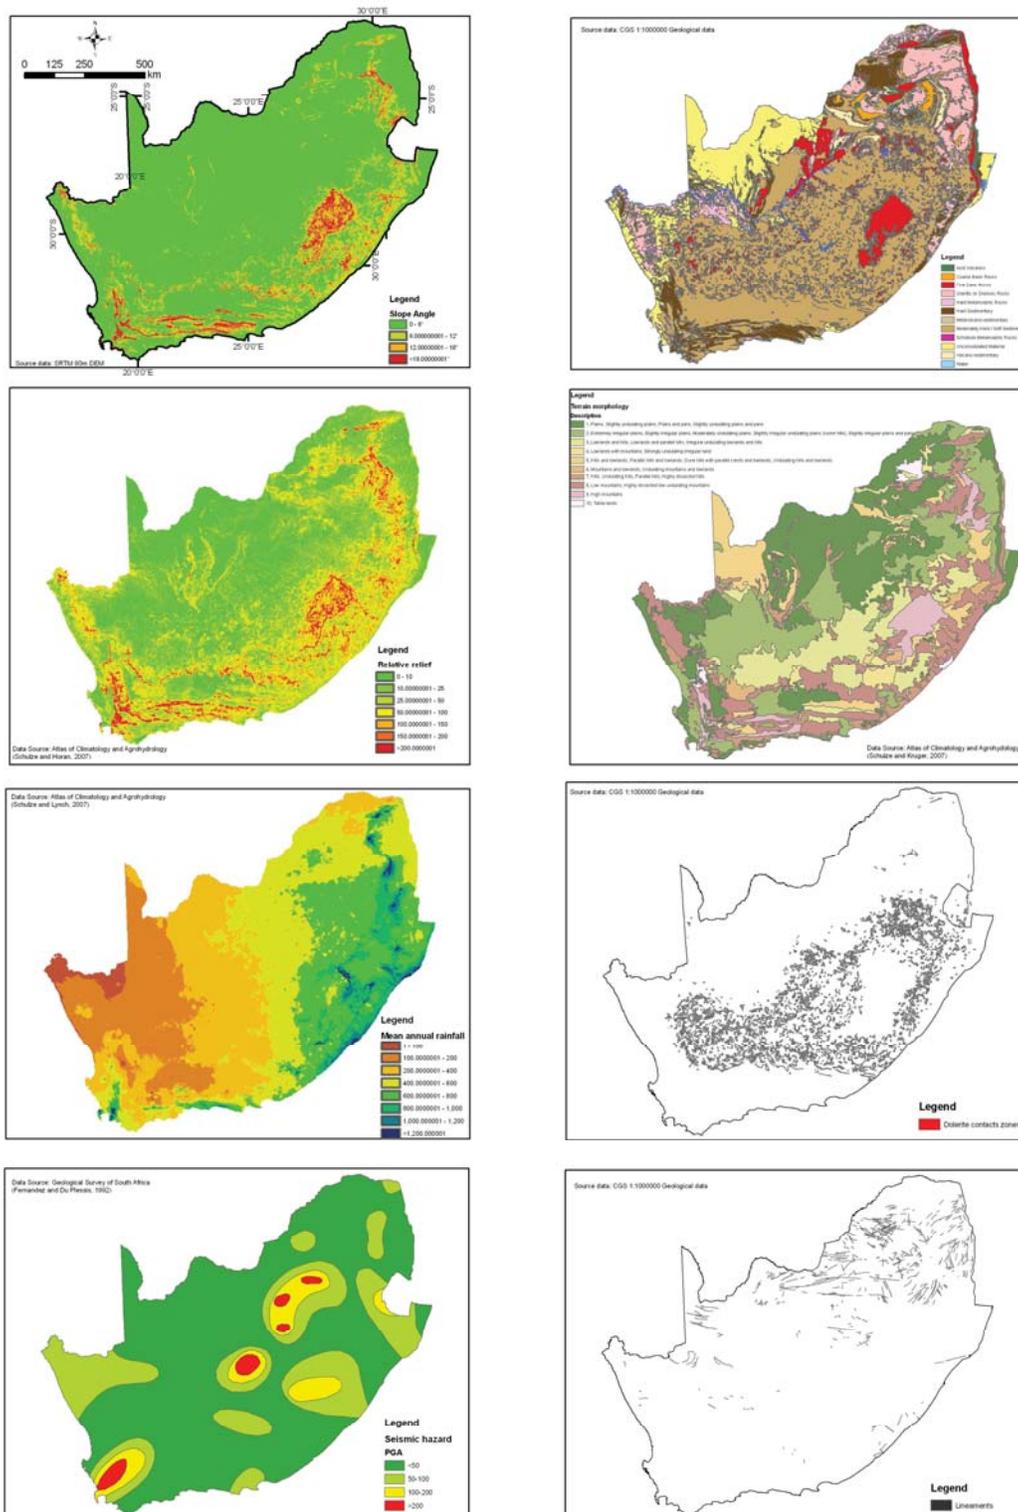
Figure 6 A compilation of the various national landslide causal factor maps. Data sources: SRTM 90m DEM, South African Atlas of Climatology and Agrohydrology, Geological Survey of South Africa, Council for Geoscience 1:1 000 000 geological data.

The major variable that defines the causative force is the angle of the potential sliding surfaces. At local scales it affects the concentration of moisture and the level of pore pressure and is often useful to resolve detailed patterns of instability. At larger scales it controls regional hydraulic continuity and is considered as an important factor for GIS-based landslide susceptibility mapping by many authors. Slope inclination is often grouped into ranges of degrees (Fig. 6) or percentage and special maps showing these ranges may be constructed.

Relative relief (Fig. 6), as explained by Schulze and Horan (2007), is an index of topographic variance or hilliness of an area. Landslide occurrences have been observed to be associated with areas of higher relative relief, typified by the rugged, steep, high elevation mountain ranges in South Africa.

In this study the landslide susceptibility assessments of South Africa used Fernandez and du Plessis (1992) seismic map data. This seismic hazard map (Fig 6) shows peak horizontal ground acceleration (PGA) levels that have a 10 percent probability of being exceeded, at least once, in a period of 50 years.

The study of lineaments may help reveal structural fabrics that could assist in understanding the cause of landslides in a region. Lineaments include tectonic structures, juxtaposed rock units, intrusive dykes and geomorphologic signatures such as topographic breaks. Detailed lineament, fault and dykes studies documented three major trends in the basement and cover rocks of KZN, namely N-S and WNW and ENE (Von Veh, 1995) whereas in the Table Mountain Group, the results of directional analysis showed that there are principally three striking directions: NE-SW, NW-SE, and near E-W (Fig 6).

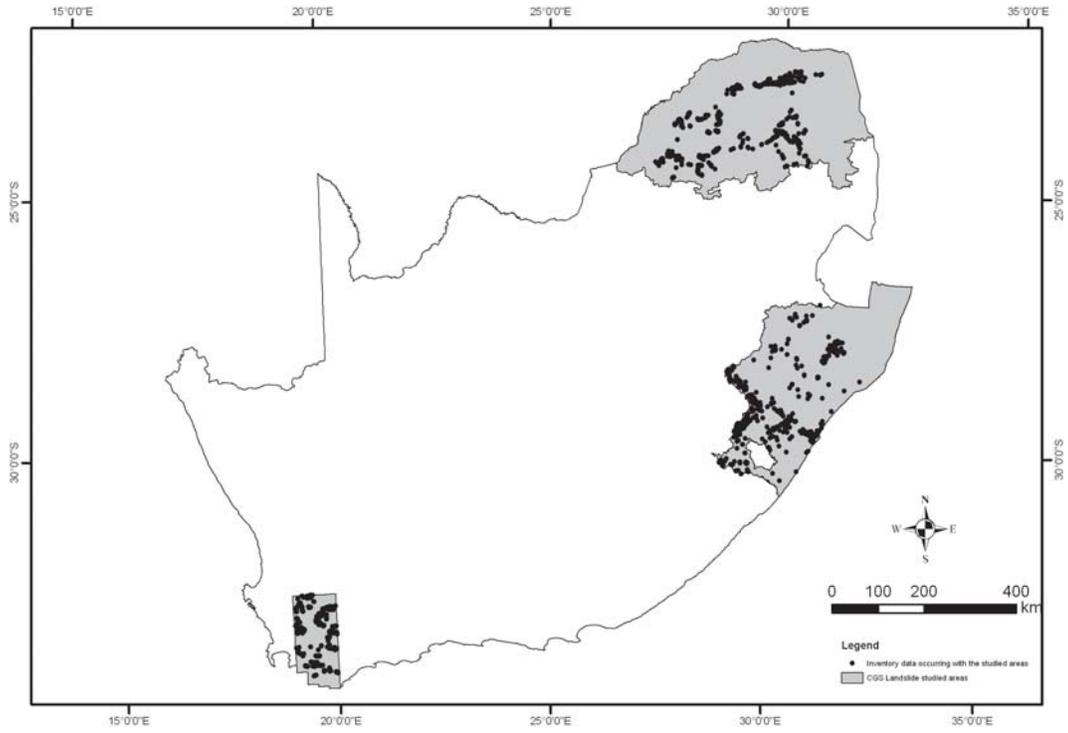
Figure 7 Map showing the inventory data in the areas studied by CGS researchers.

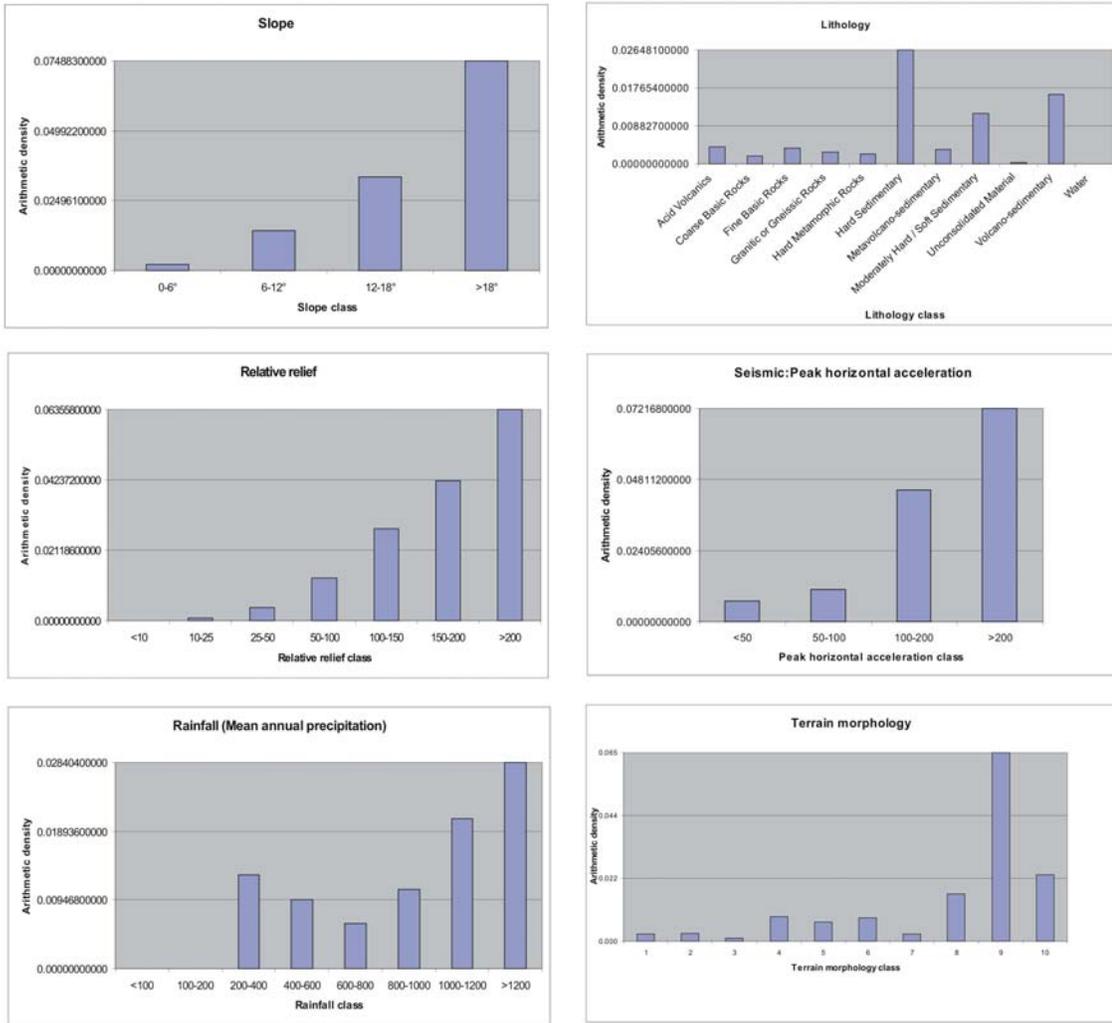
Figure 8 A compilation of graphs showing ranking values of all considered landslide causal factors.

Density graphs of each CF were plotted and categorised to facilitate the assessment of ranking values (Fig. 8). Ranking values of 1, 2 or 3 were assigned relative to the position of each sub-class on the density graph (Fig. 8 and Table 1), where a value of 3 represents areas of highest landslide susceptibility. In ArcGIS Spatial Analyst 9.3 the slope angle, relative relief, geology, rainfall, terrain morphology and seismicity raster datasets were reclassified on a scale of 1 to 3. Dolerite contact zones and lineaments layers were acquired as polylines, therefore their subsequent raster maps were reclassified to create ranked maps based on data presence or absence whereby values of 3 or 0 were assigned respectively.

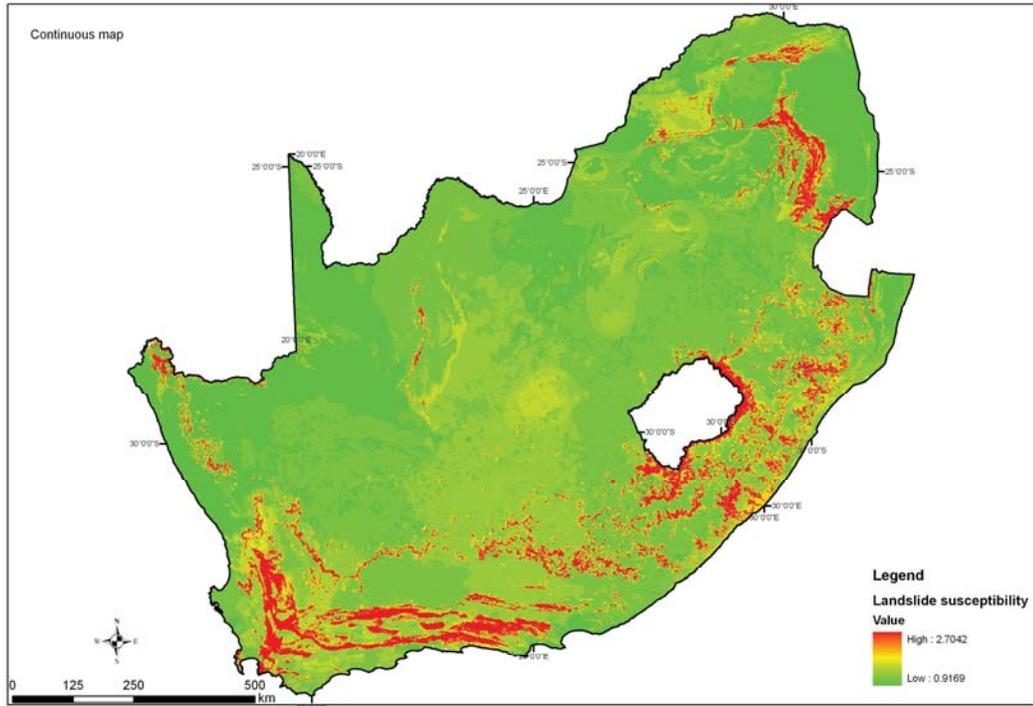
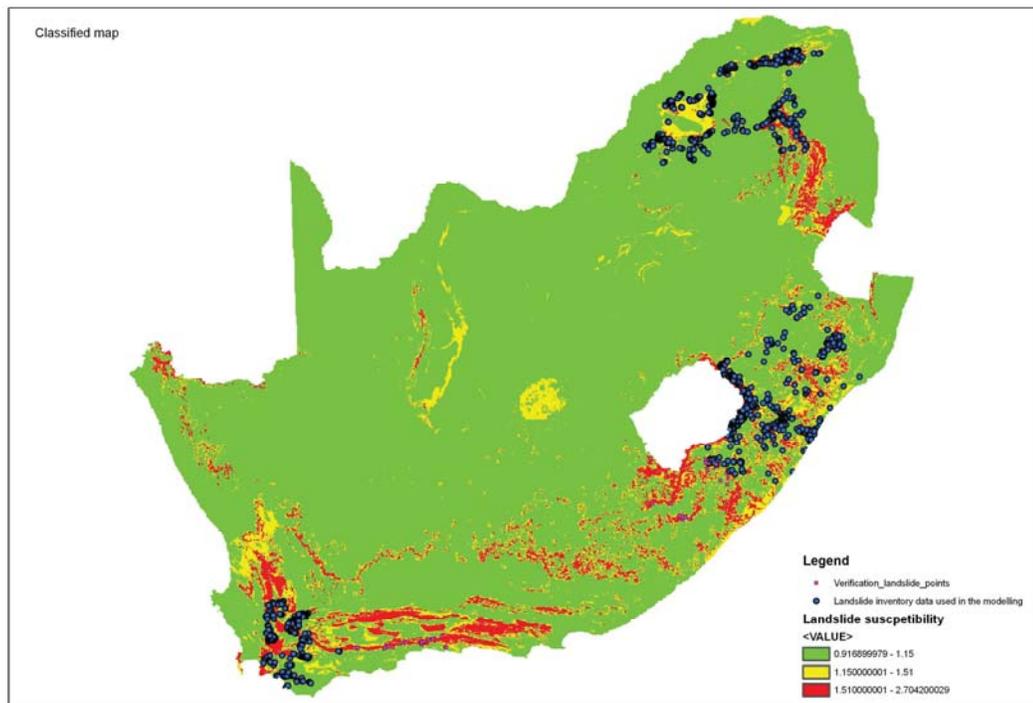
Figure 9 Landslide susceptibility map of South Africa was evaluated using the bivariate statistical method. (Top: continuous landslide susceptibility map and bottom: classed landslide susceptibility map)

The overall quality/accuracy of the landslide susceptibility map created in this study using the bivariate statistical methodology was examined by overlaying the entire CGS landslide inventory data. This map overlay yielded a strong correspondence (Fig 9).

The following eight evidence layers were used: geology; dolerite contact zones; lineaments; mean annual rainfall; relief; seismic hazard; slope; and terrain morphology. The influences of these parameters on the landslide susceptibility are discussed in Section 5. The classes used for the datasets are presented in Table 1. The training set was created from known areas of landslides and is shown in Figure 9. The following section discusses the results obtained

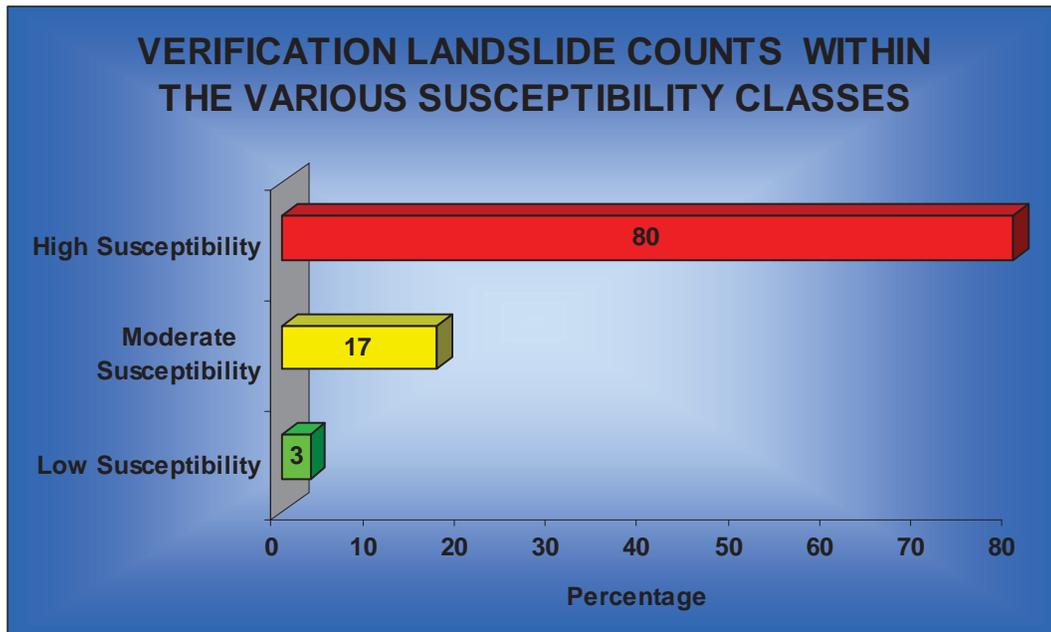
Figure 10 Graph showing percentage landslide verification counts within various susceptibility classes.

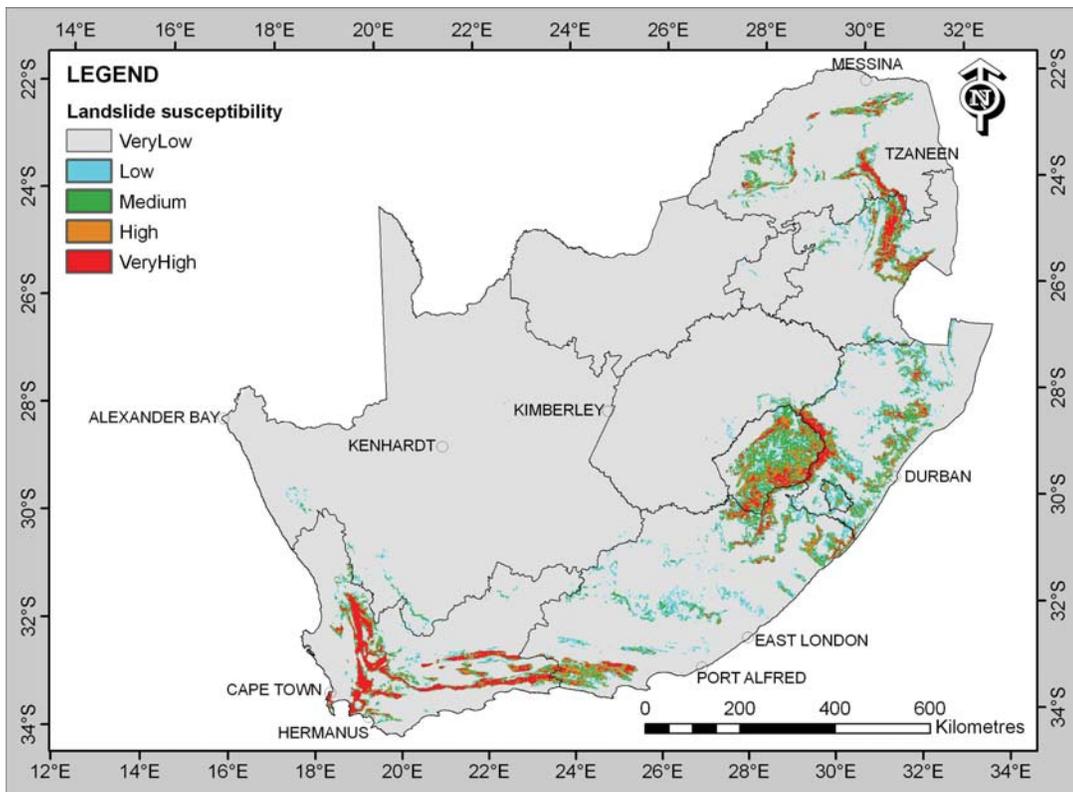
Figure 11 Map showing the probability of landslides occurring in South Africa.

The different weights assigned to the classes were then combined to produce a probability map (Figure 11). The final probability results were classified into five groups using the quantile classification in ArcMap. The probability classes assigned were: 'very low', 'low', 'medium', 'high' and 'very high' and the resulting map is shown in Figure 11. The red areas are highest potential areas and the blue areas have low probability of being effected by slope failure (based on the evidence provided by the data).

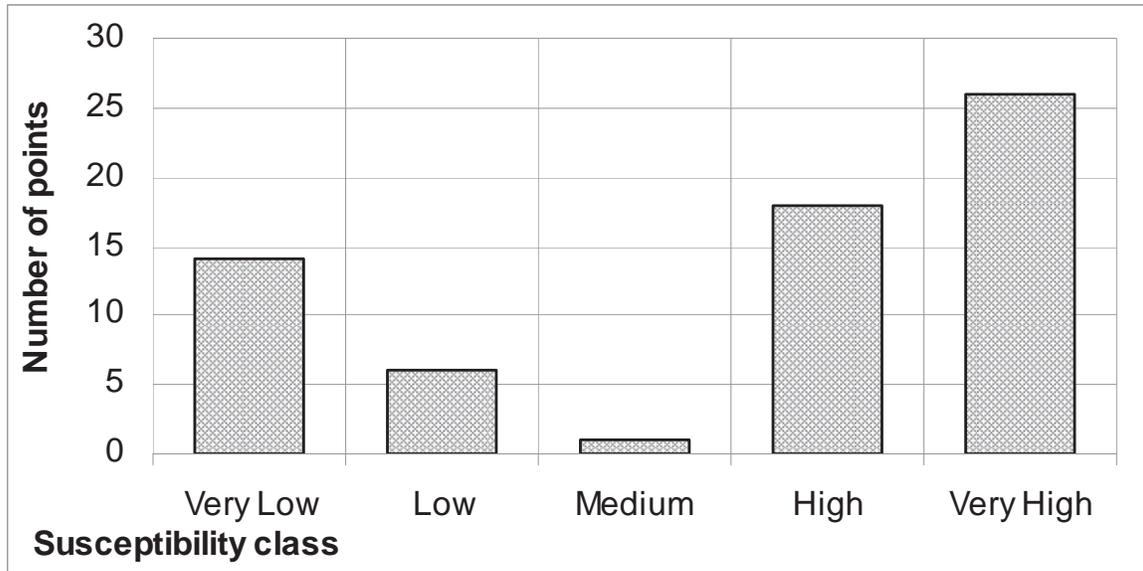
Figure 12 Number of test points in each landslide susceptibility class.

A test sample of landslide points that were not utilised in the WOE modelling was used in the accuracy assessment. Initially, a histogram was created to assess the number of points in each class. 67 % of the test landslide points are in the high and very high classes (Fig 12).

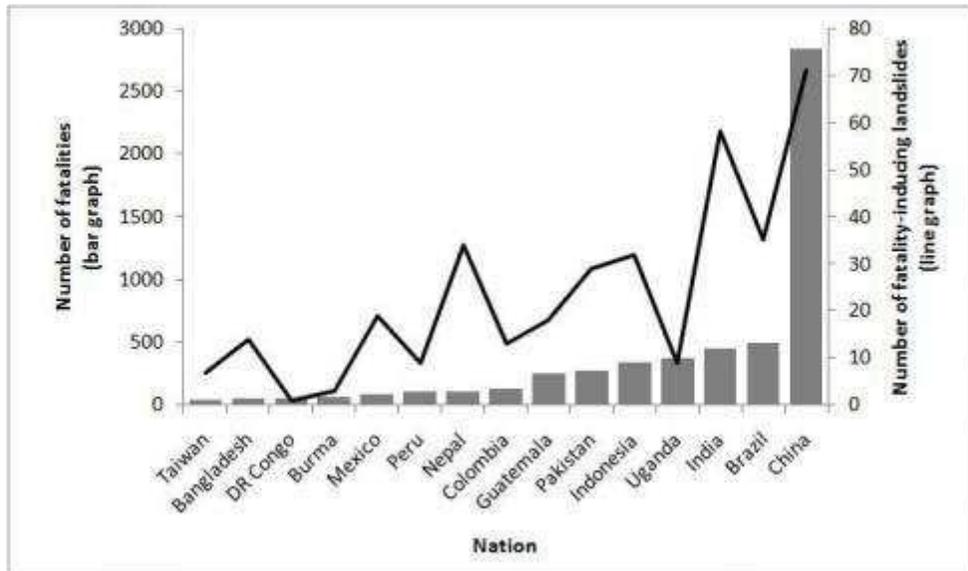
Figure 13 Graph showing landslide deaths and events for 2010 (Taken from: D Petley (2011: online site)

over a recent five year period (Joyce, 2011). Statistics kept by the ILC (Petley, 2011) covering landslide deaths worldwide are shown in Figure 13.

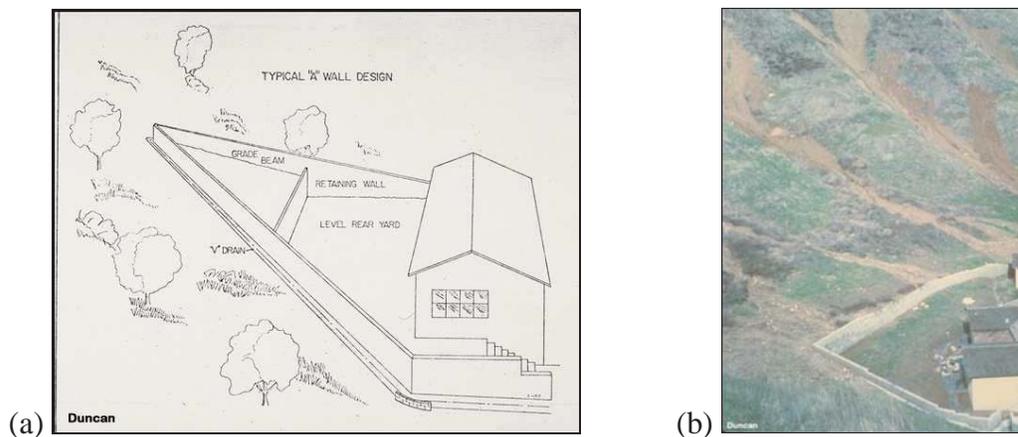
Figure 14 (a) Graphic of the layout of a debris flow diversion wall. (b) Image of a viable option in specific cases.

Recurring shallow landslides and mudslides affect many parts of the USA. Specially designed reinforced concrete walls, incorporating a 'V' shape as shown below, have been installed at great cost to homeowners (Fig.14a, b). Incidences of debris flows at, for example Bettys Bay, Western Cape province South Africa, would justify the incorporation of this type of mitigation measure to counter the hazard of debris flows. The South Peninsula Municipality for example (Anon, 2001), installed a range of debris flow mitigation measures at Monkey Valley in 2001, encompassing flow deflection by sand bags, gabions and geo-fabric berms, after fires devastated stabilizing natural vegetation. Liability for diversion onto neighbour's properties would also need to be considered when employing this technique.

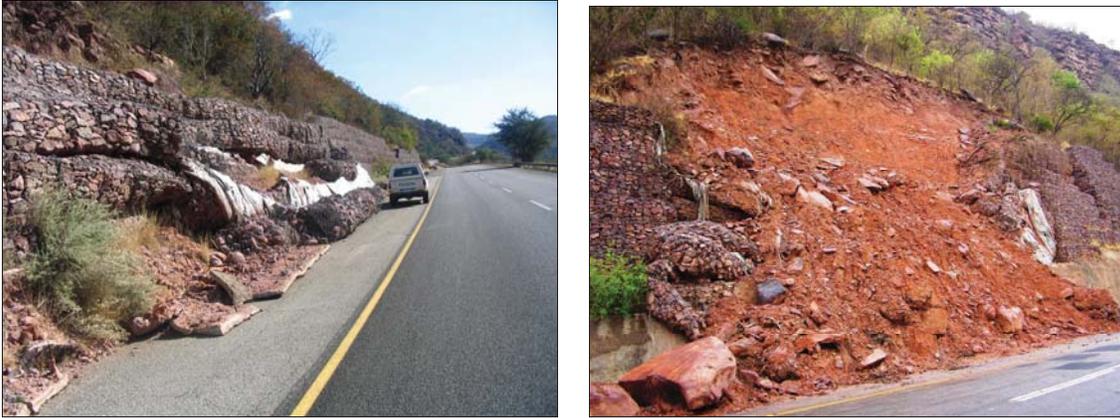
Figure 15 Graphic showing that poor design or maintenance of gabions can lead to recurring public fund expenditures. The images portray a slope remediation effort that was in fact a poor mitigation approach. (Limpopo Province, April 2008: Highway R518 (left and right))

Gabions and geo-textile reinforced walls are often utilized where toe undercutting by road cuts has mobilized inherently unstable slopes (Fig. 15). Correctly engineered and installed applications have proved successful in landslide mitigation worldwide.

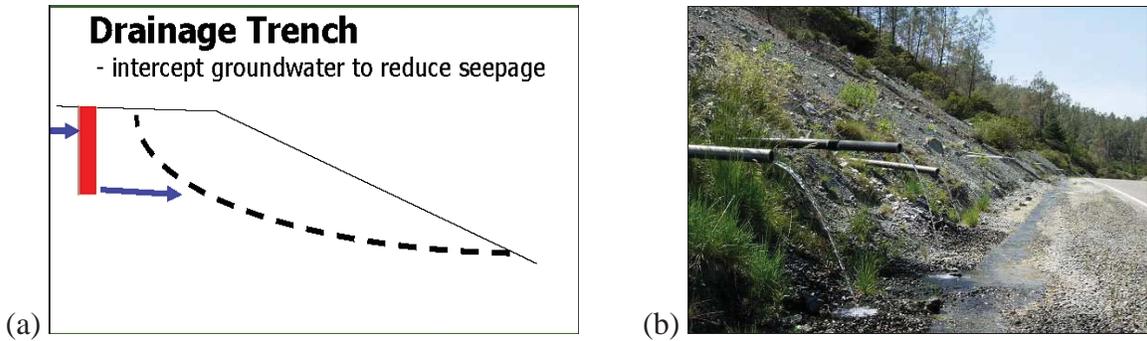
Figure 16 (a) Illustration of surface water diversion to reduce the phreatic surface. This has a positive effect on shear strength. (b) As evident not all drains may be 100% functional. Borehole orientations should optimize joint intersections

Slope dewatering is usually effective in reducing destabilizing forces and improving factors of safety (Fig. 16a, b). These measures are but one facet of a slope mitigation strategy and require thorough design. Either interception and diversion of water at the slope crest, or horizontal or gently inclined drains are installed via boreholes to reduce pore pressures in the slope body or positions of possible circular failure surface formation. Large scale and costly landslide dewatering is undertaken in China and Japan for example, at large landslides, in the form of large diameter adits or deep open wells with radiating collector drains and extraction pumps.

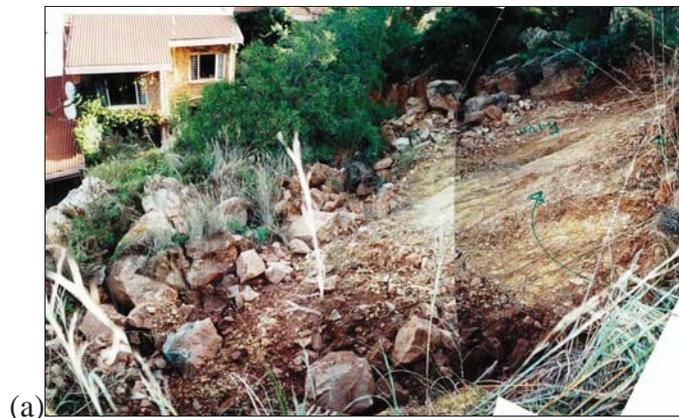
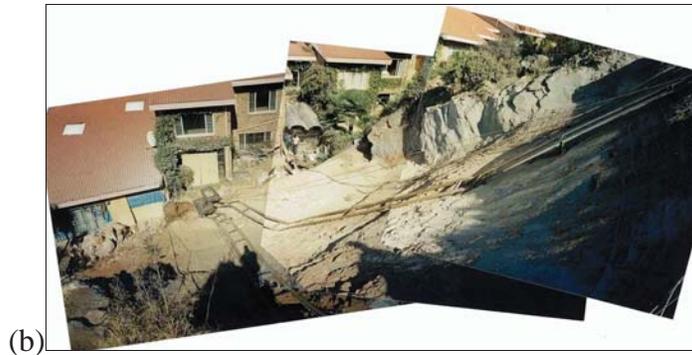
Figure 17 (a) Graphic showing thick quartzite blocks which had slid on a gently wavy, phyllitic, bedding plane daylighting in the slope face. (Bruma Lake, Johannesburg: February 2000). (b) Image taken during post slope clearing inspection: August 2000.

In the Johannesburg, Bruma Lake example shown below (fig. 17 a,b), slope flattening or block pinning should have been undertaken along the entire length of the cut when terracing for the units occurred. Only one early homeowner took this mitigation step. In this instance 18 years of stability allowed garden development on the slope. An extreme rainfall event resulted in a dip slope block glide failure. Liability accepted by the local authority cost them R300 000 to clear the unstable loose debris and gunite the resultant bare rock face. Other remediation and mitigation options were limited in this instance. It is not known if neighbours to the immediate west of the slip undertook any slope stabilization.
