SMITHFIELD MULTI-PURPOSE INDOOR SPORT CENTRE

GEOTECHNICAL INVESTIGATION REPORT

Engineering Geological Site Investigation

Project Title	Smithfield Multi-Purpose Indoor Sport Centre
Client	Free State Department of Sports, Arts, Culture and Recreation
Consulting Engineers	BVi Consulting Engineers- Bloemfontein
Report Description	Engineering Geological Site Investigation
Report Number	GC22/104
Report Version	Final Report

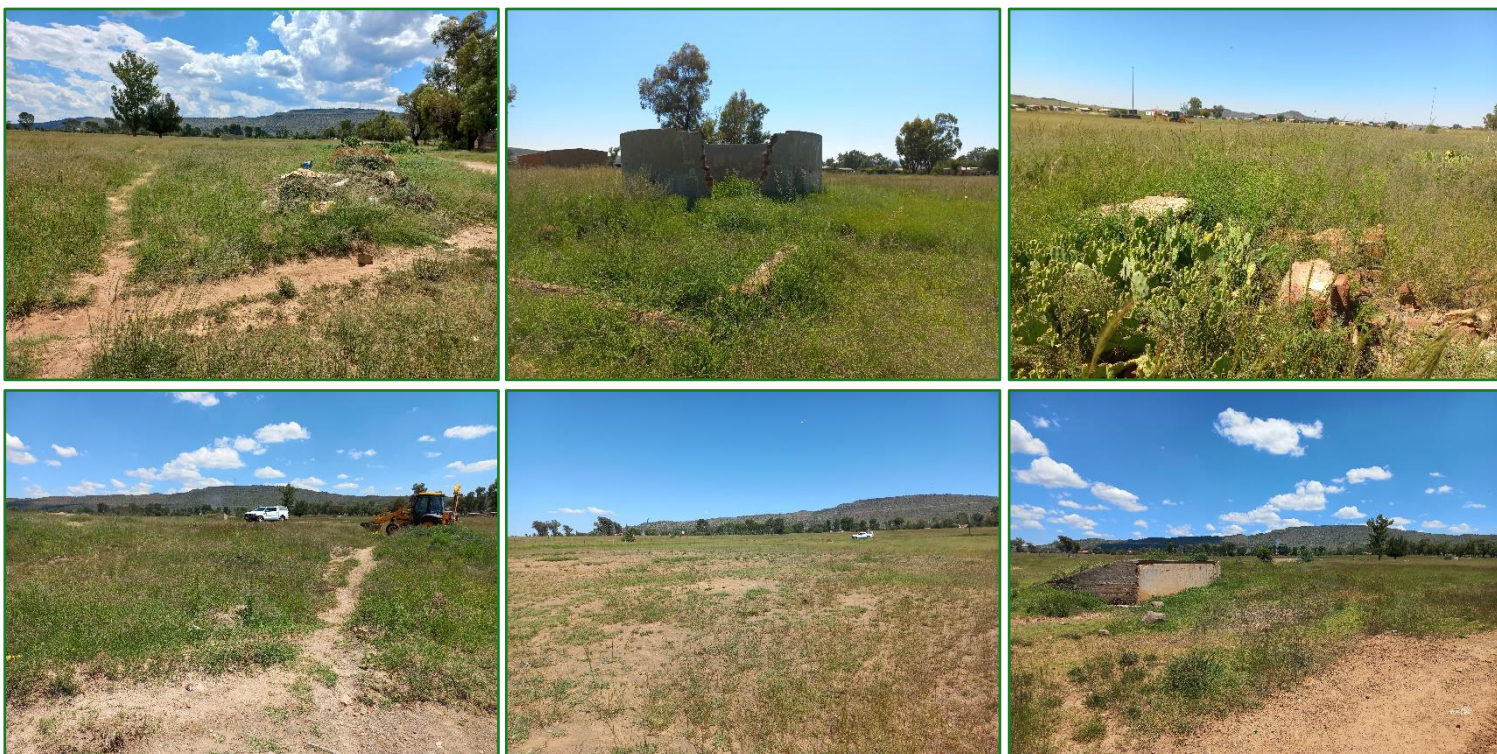
The sites surface was seen to display a **reworked nature** attributed to past and ongoing **human activities** in the area. This reworking was predominantly in the form of **relict infrastructure**, roadways/pathways, soil berms, **scattered heaps of dumped fill** and localised levelled sports fields. The combination of the items raised above have resulted in the formation of an anthropogenically induced undulating landscape, with the occurrence of small-scale anomalies.

The photo series below depicts the reworked surficial nature of the site.

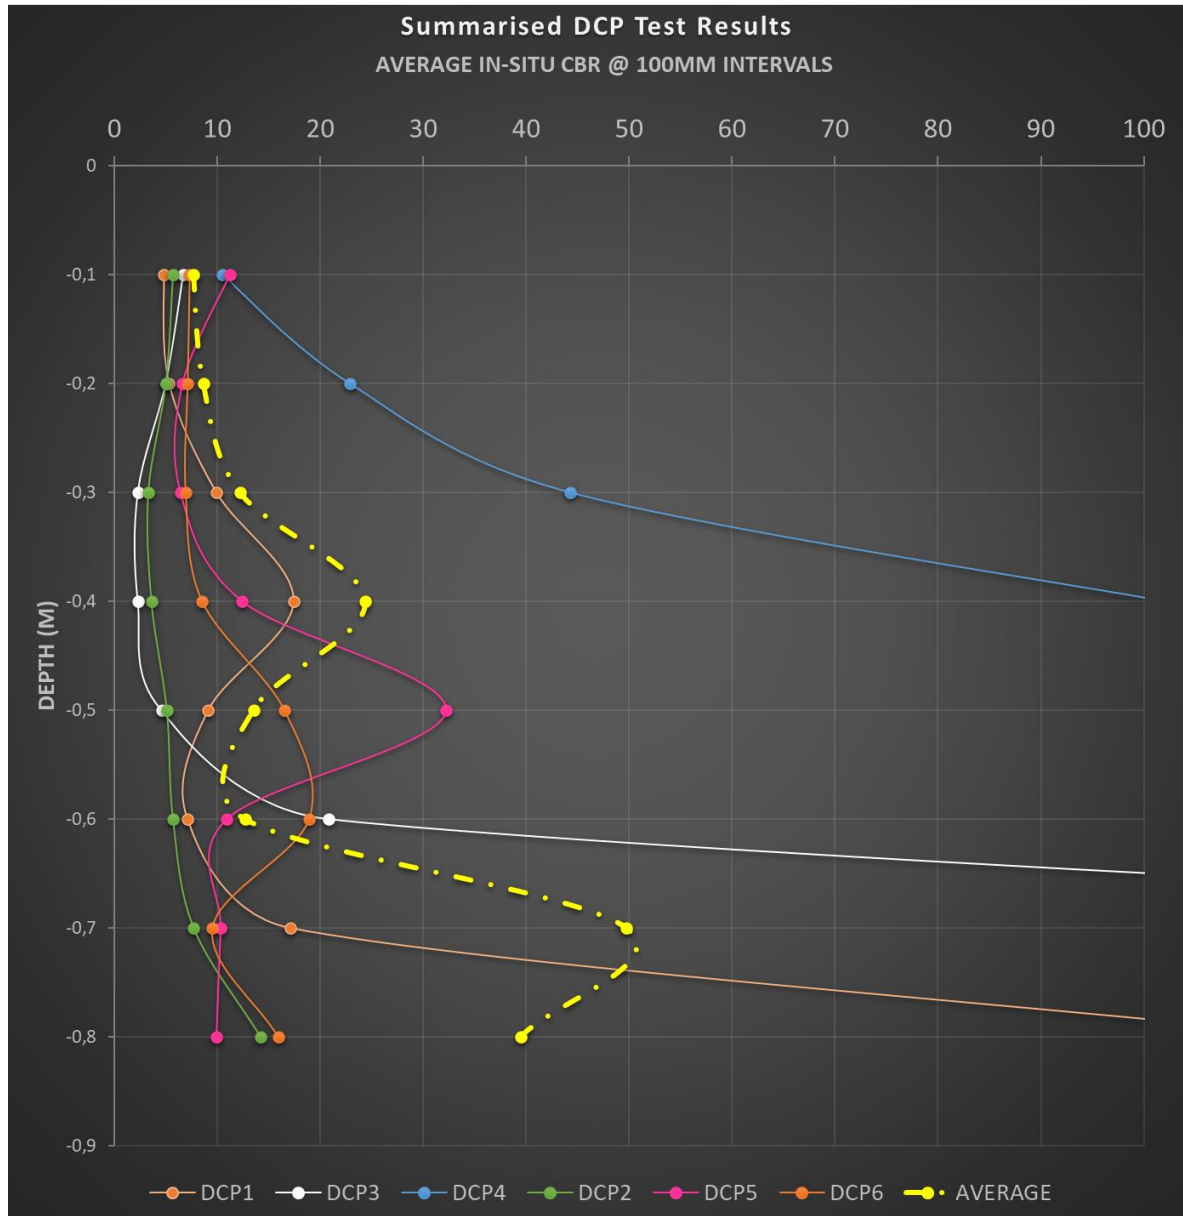
Graph 1: Combined DCP Test Results- Inferred In-Situ CBR

The graph and table overleaf depict the combined DCP test results for the site.

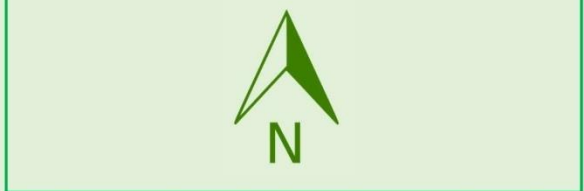
Geological Series Map:
 3026 Aliwal North ; Scale 1 : 250 000

Alluvium
 	Dolerite
 	Sandstone/Mudstone- Tarkastad Formation- Beaufort Group- Karoo Supergroup

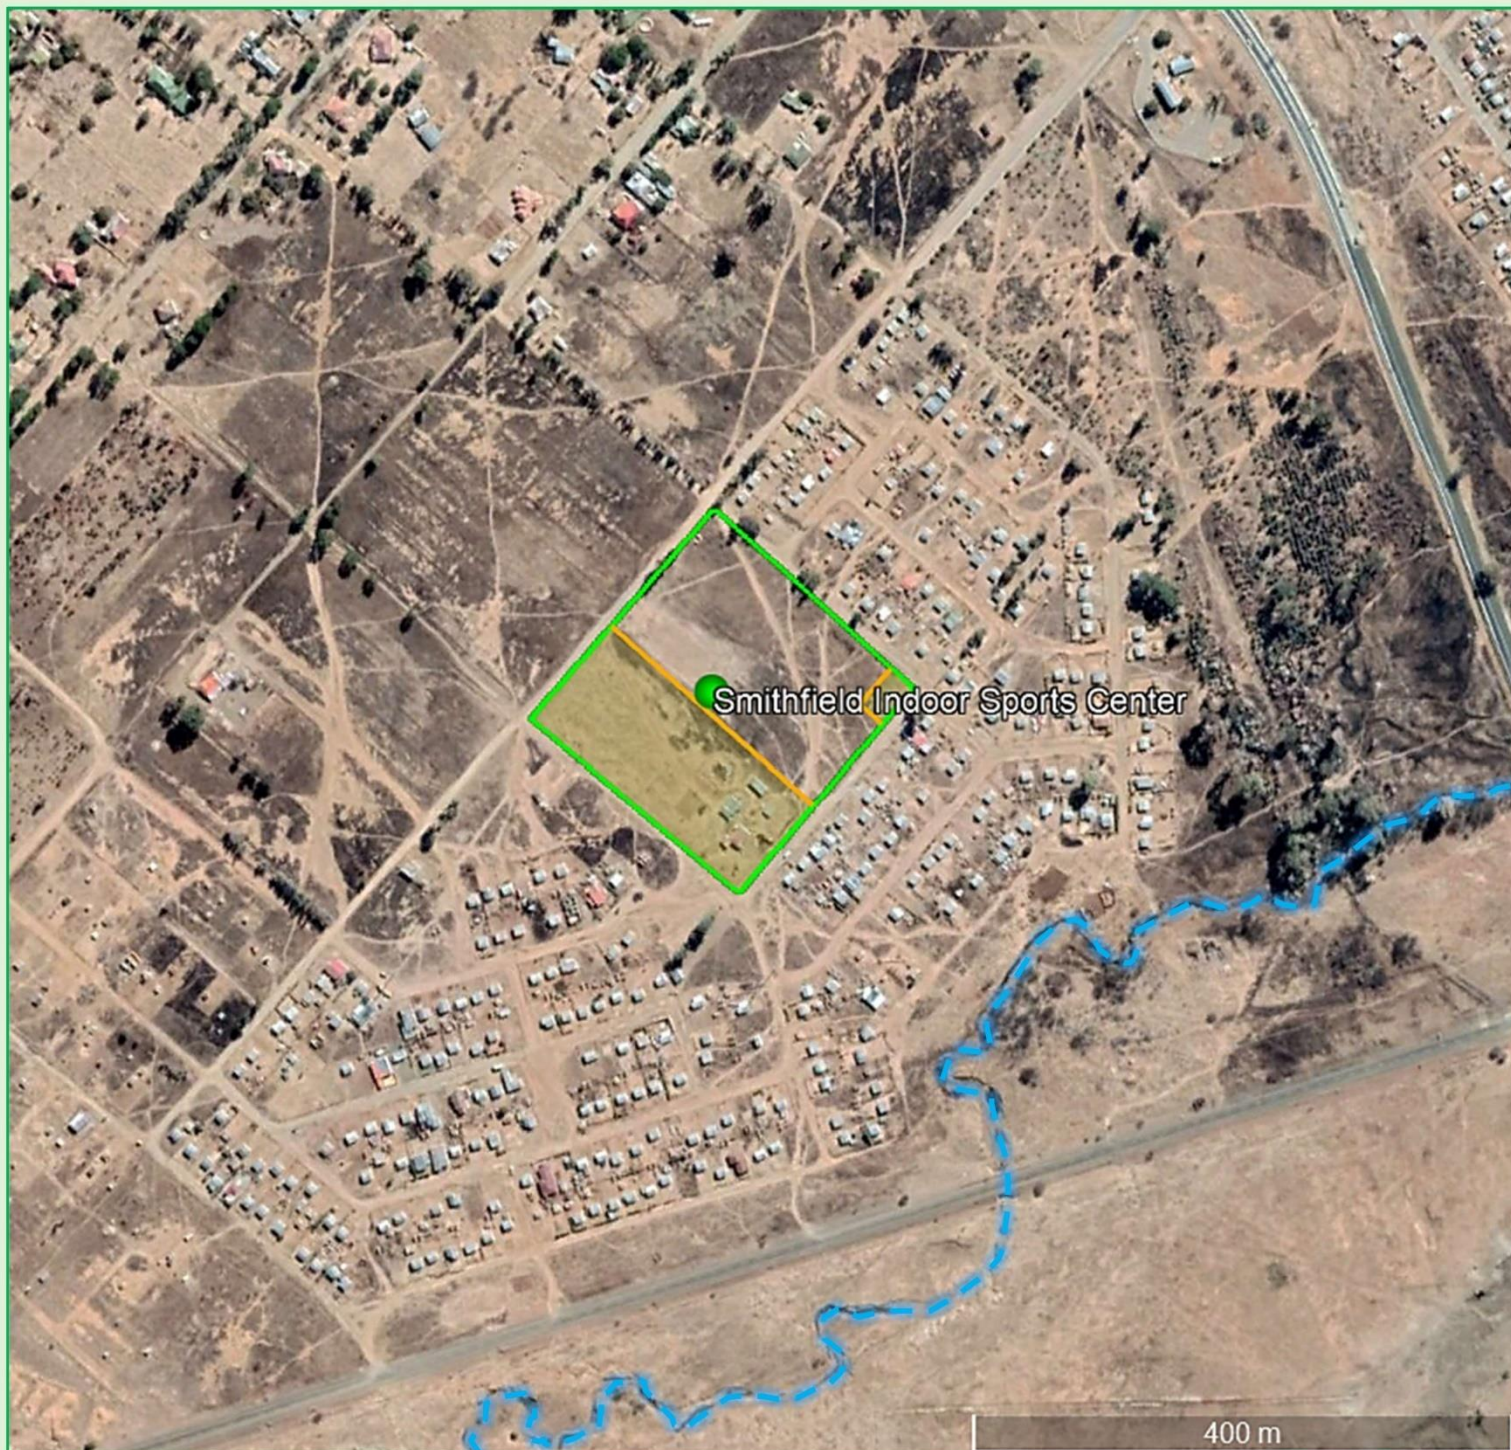
Figure 5

Testing Locations

- Test Pit
- Site Boundary
- Fenced Areas

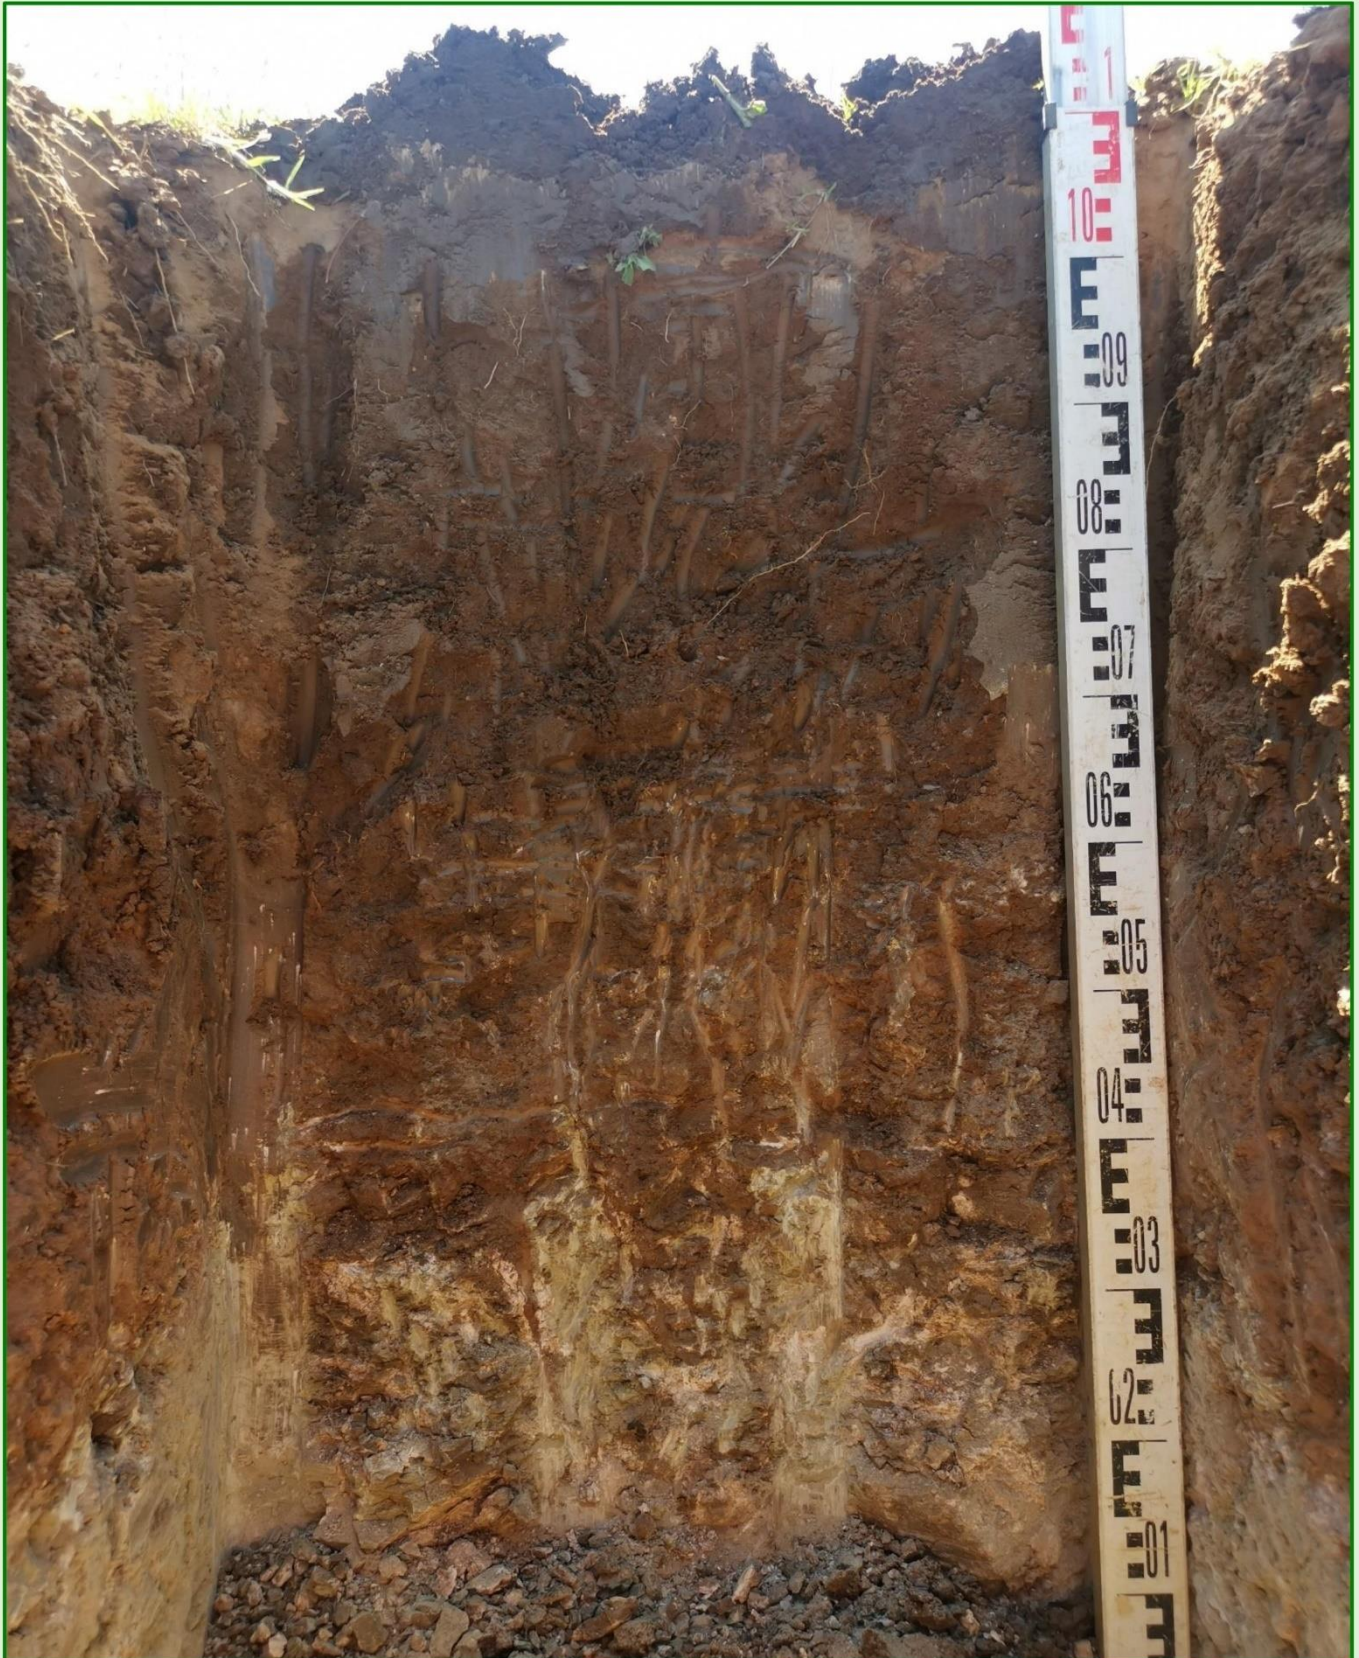
Profile Photo: TP1

Profile Notes		Excavation Description	
Profiled by:	KS Coertzen (Pri.Sci.Nat)	Contractor:	Hire Cor
Groundwater Seepage:	N/A	Machine:	JCB 3CX- TLB Type Light Mechanical Excavator
Excavation Stability:	Sidewalls stable	Excavation Character:	Refusal on weathered sandstone bedrock
Samples Extracted:	1 Disturbed Sample	Date Profiled:	25/01/2022
Elevation (MAMSL):	1397	Coordinates:	30.22198 °S 26.53383 °E

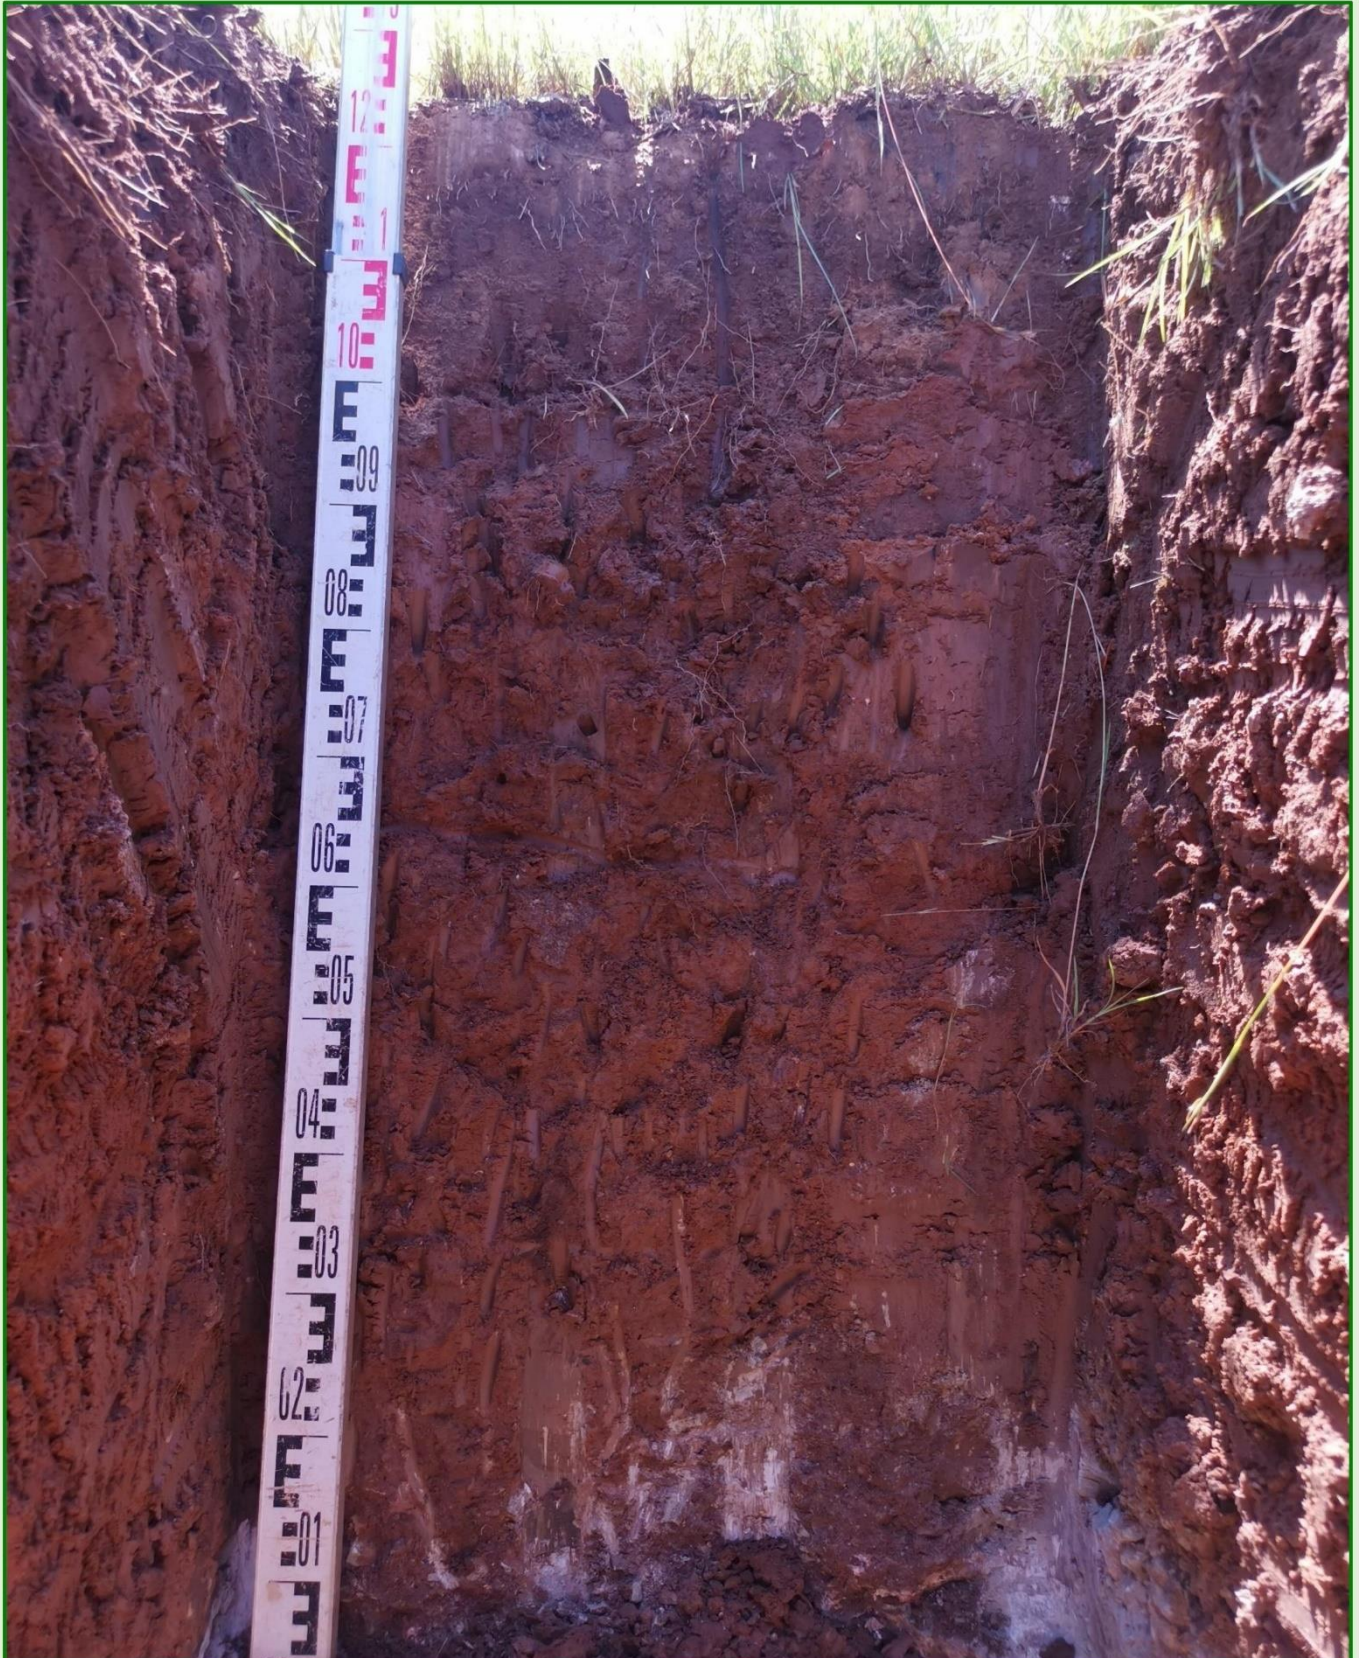
Profile Photo: TP2

Profile Notes		Excavation Description	
Profiled by:	KS Coertzen (Pri.Sci.Nat)	Contractor:	Hire Cor
Groundwater Seepage:	N/A	Machine:	JCB 3CX- TLB Type Light Mechanical Excavator
Excavation Stability:	Sidewalls stable	Excavation Character:	Refusal on weathered sandstone bedrock
Samples Extracted:	1 Bulk Sample, 1 Undisturbed Sample	Date Profiled:	25/01/2022
Elevation (MAMSL):	1396	Coordinates:	30.22176 °S 26.53430 °E

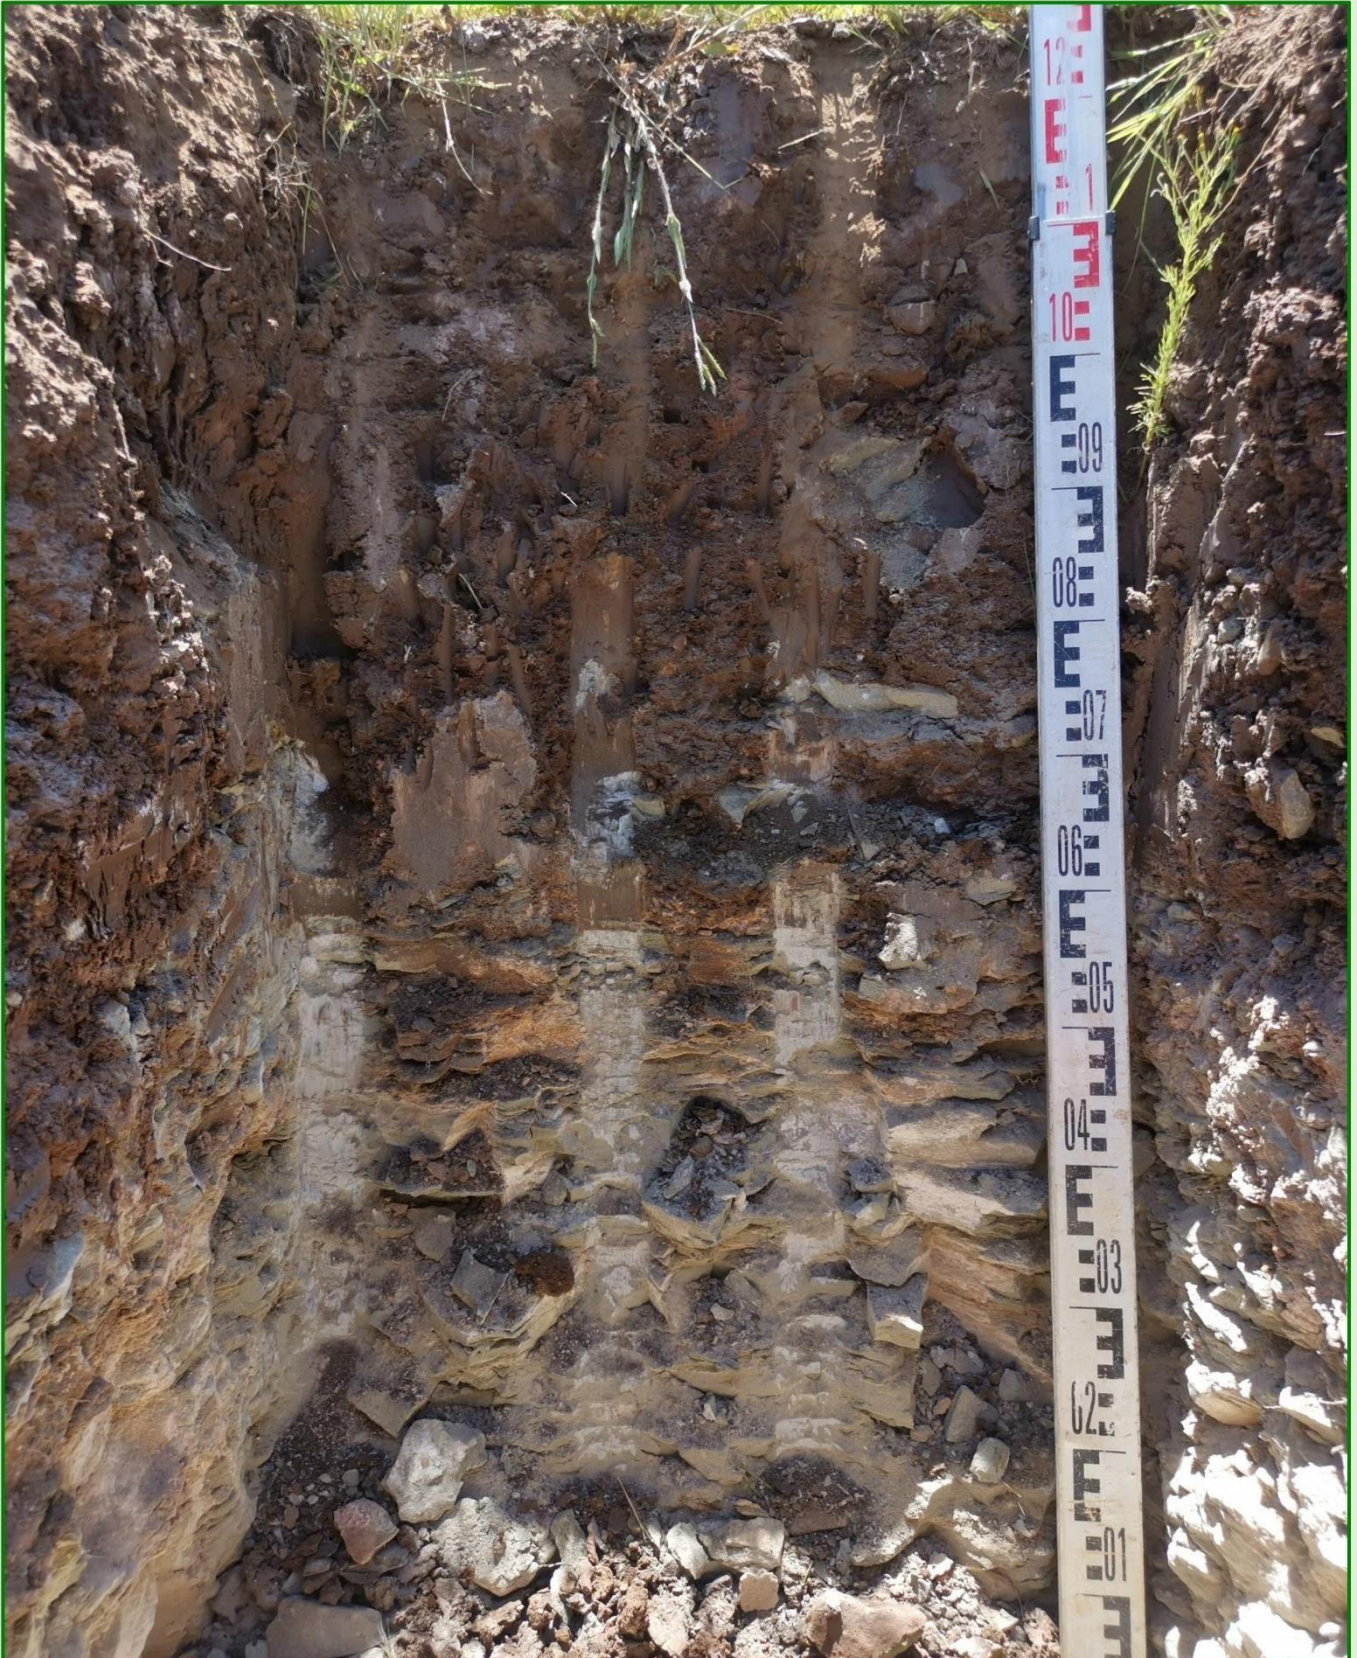
Profile Photo: TP3

Profile Notes		Excavation Description	
Profiled by:	KS Coertzen (Pri.Sci.Nat)	Contractor:	Hire Cor
Groundwater Seepage:	N/A	Machine:	JCB 3CX- TLB Type Light Mechanical Excavator
Excavation Stability:	Sidewalls stable	Excavation Character:	Refusal on weathered sandstone bedrock
Samples Extracted:	1 Disturbed Sample, 1 Undisturbed Sample	Date Profiled:	25/01/2022
Elevation (MAMSL):	1395	Coordinates:	30.22210 °S 26.53442 °E

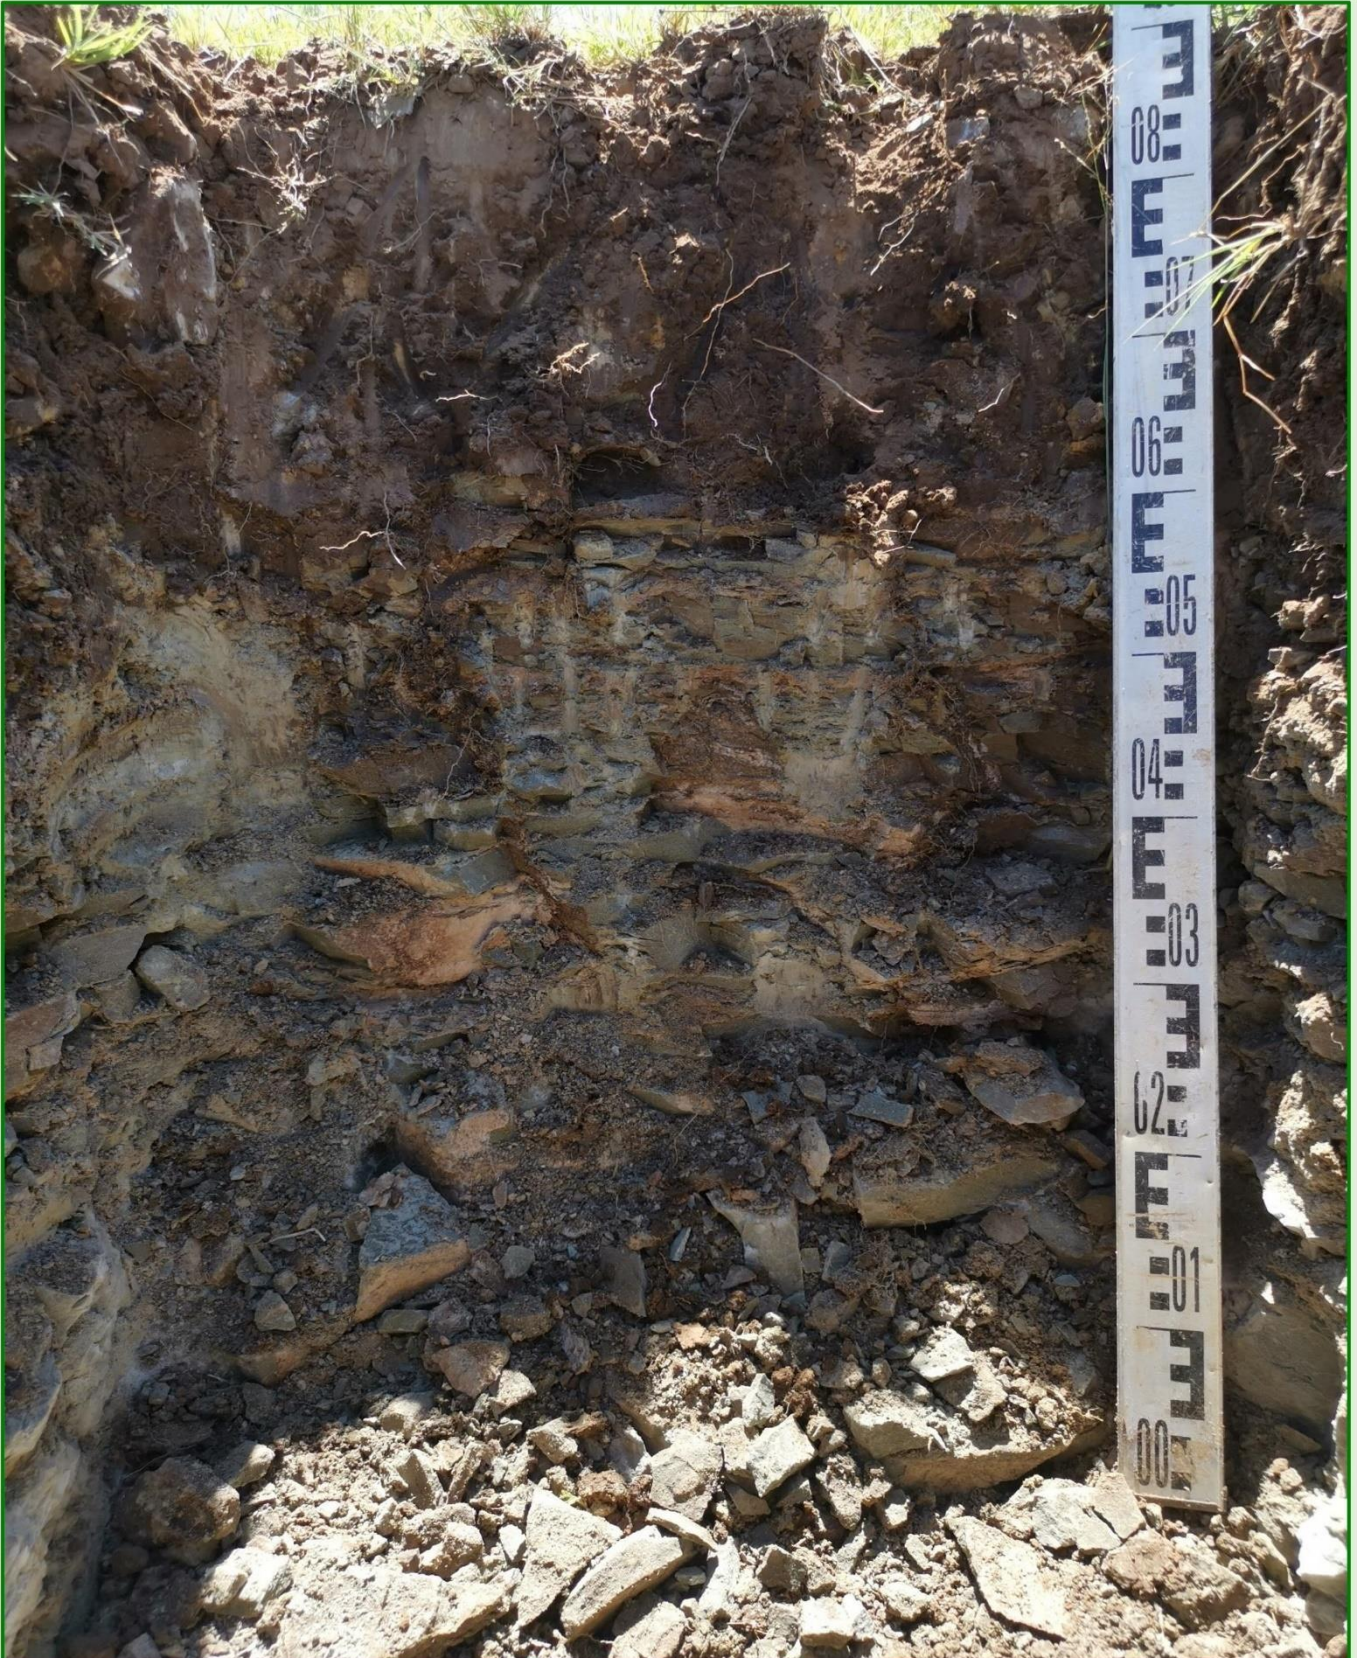
Profile Photo: TP4

Profile Notes		Excavation Description	
Profiled by:	KS Coertzen (Pri.Sci.Nat)	Contractor:	Hire Cor
Groundwater Seepage:	N/A	Machine:	JCB 3CX- TLB Type Light Mechanical Excavator
Excavation Stability:	Sidewalls stable	Excavation Character:	Refusal on weathered sandstone bedrock
Samples Extracted:	1 Bulk Sample	Date Profiled:	25/01/2022
Elevation (MAMSL):	1394	Coordinates:	30.22253 °S 26.53454 °E

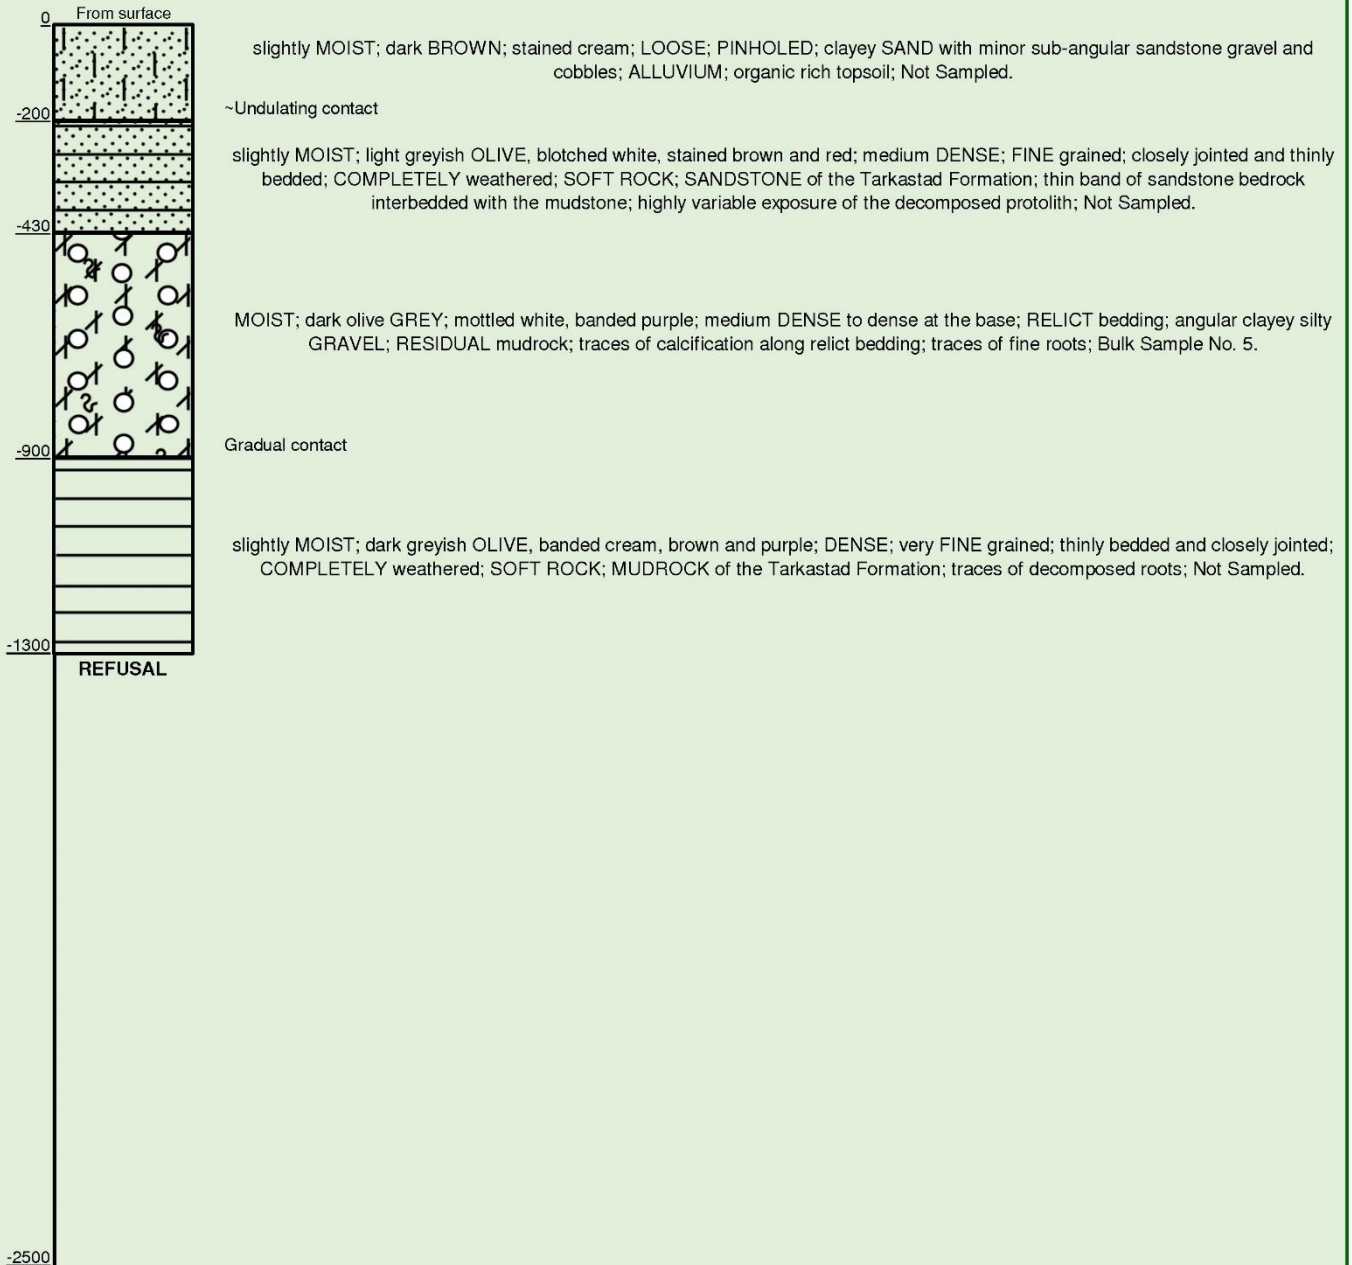
Soil Profile for Test Pit TP5

Profile Notes		Excavation Description	
Profiled by:	KS Coertzen (Pri.Sci.Nat)	Contractor:	Hire Cor
Groundwater Seepage:	N/A	Machine:	JCB 3CX- TLB Type Light Mechanical Excavator
Excavation Stability:	Sidewalls stable	Excavation Character:	Refusal on weathered mudrock bedrock
Samples Extracted:	1 Bulk Sample	Date Profiled:	25/01/2022
Elevation (MAMSL):	1393	Coordinates:	30.22230 °S 26.53506 °E

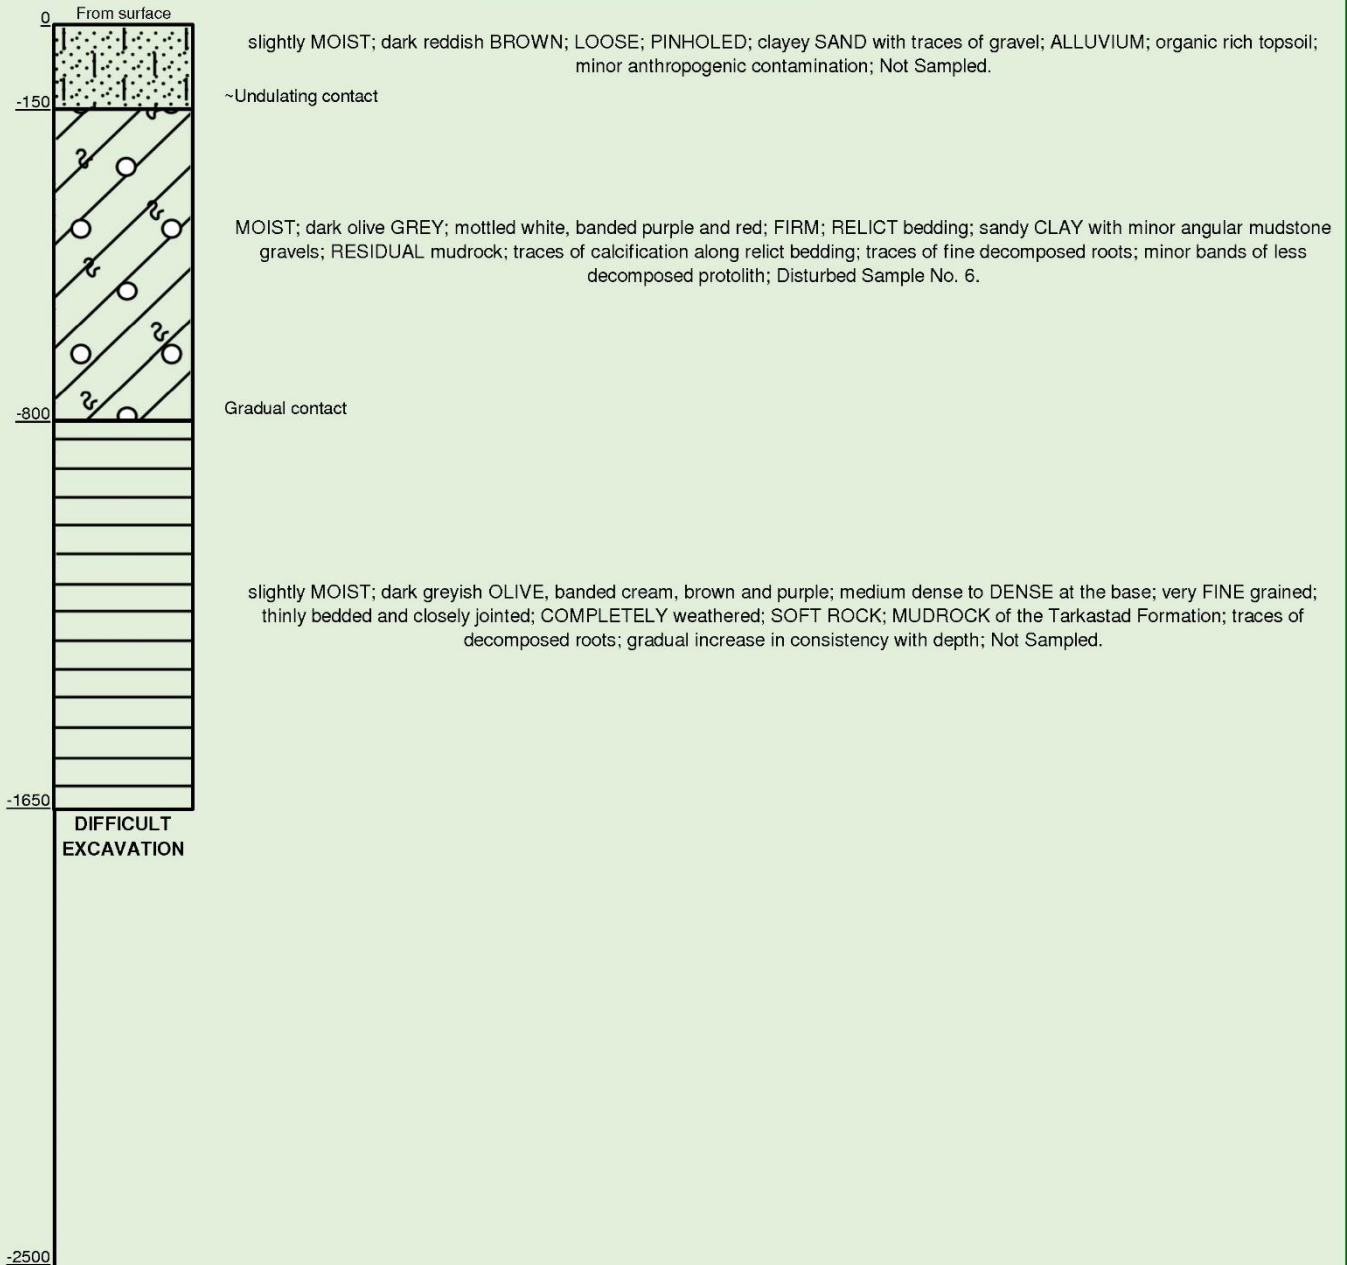
Soil Profile for Test Pit TP6

Profile Notes		Excavation Description	
Profiled by:	KS Coertzen (Pri.Sci.Nat)	Contractor:	Hire Cor
Groundwater Seepage:	N/A	Machine:	JCB 3CX- TLB Type Light Mechanical Excavator
Excavation Stability:	Sidewalls stable	Excavation Character:	Difficult excavation in weathered mudrock bedrock
Samples Extracted:	1 Disturbed Sample	Date Profiled:	25/01/2022
Elevation (MAMSL):	1392	Coordinates:	30.22268 °S 26.53532 °E

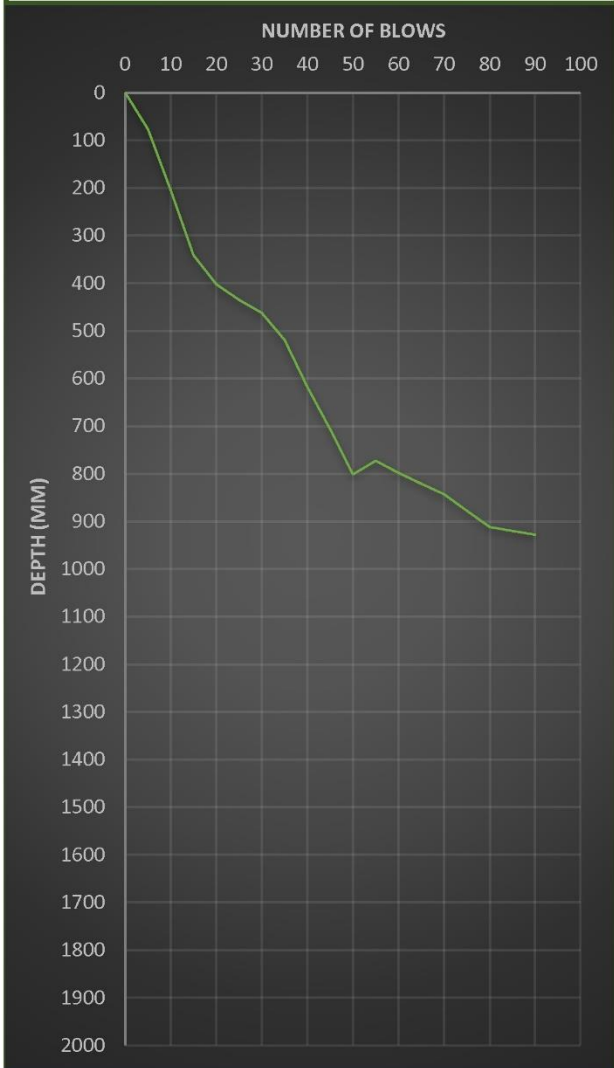
Number of blows vs penetration depth

In-situ CBR vs penetration depth

0 to 200	201 to 400	401 to 600	601 to 800
20,5	19,9	10,4	18,4
801 to 1000	1001 to 1200	1201 to 1400	1401 to 1600
4,3
