# **Final Geotechnical Investigation Report for Dangeni Primary School as Part of the Implementation of Sanitation Programme at Various Schools in the Eastern Cape Province**

# Final Geotechnical Investigation Report for Dangen Primary School as Part of the Implementation of Sanitation Programme at Various Schools in the Eastern Cape Province

Report  
Version – Final

June 2026

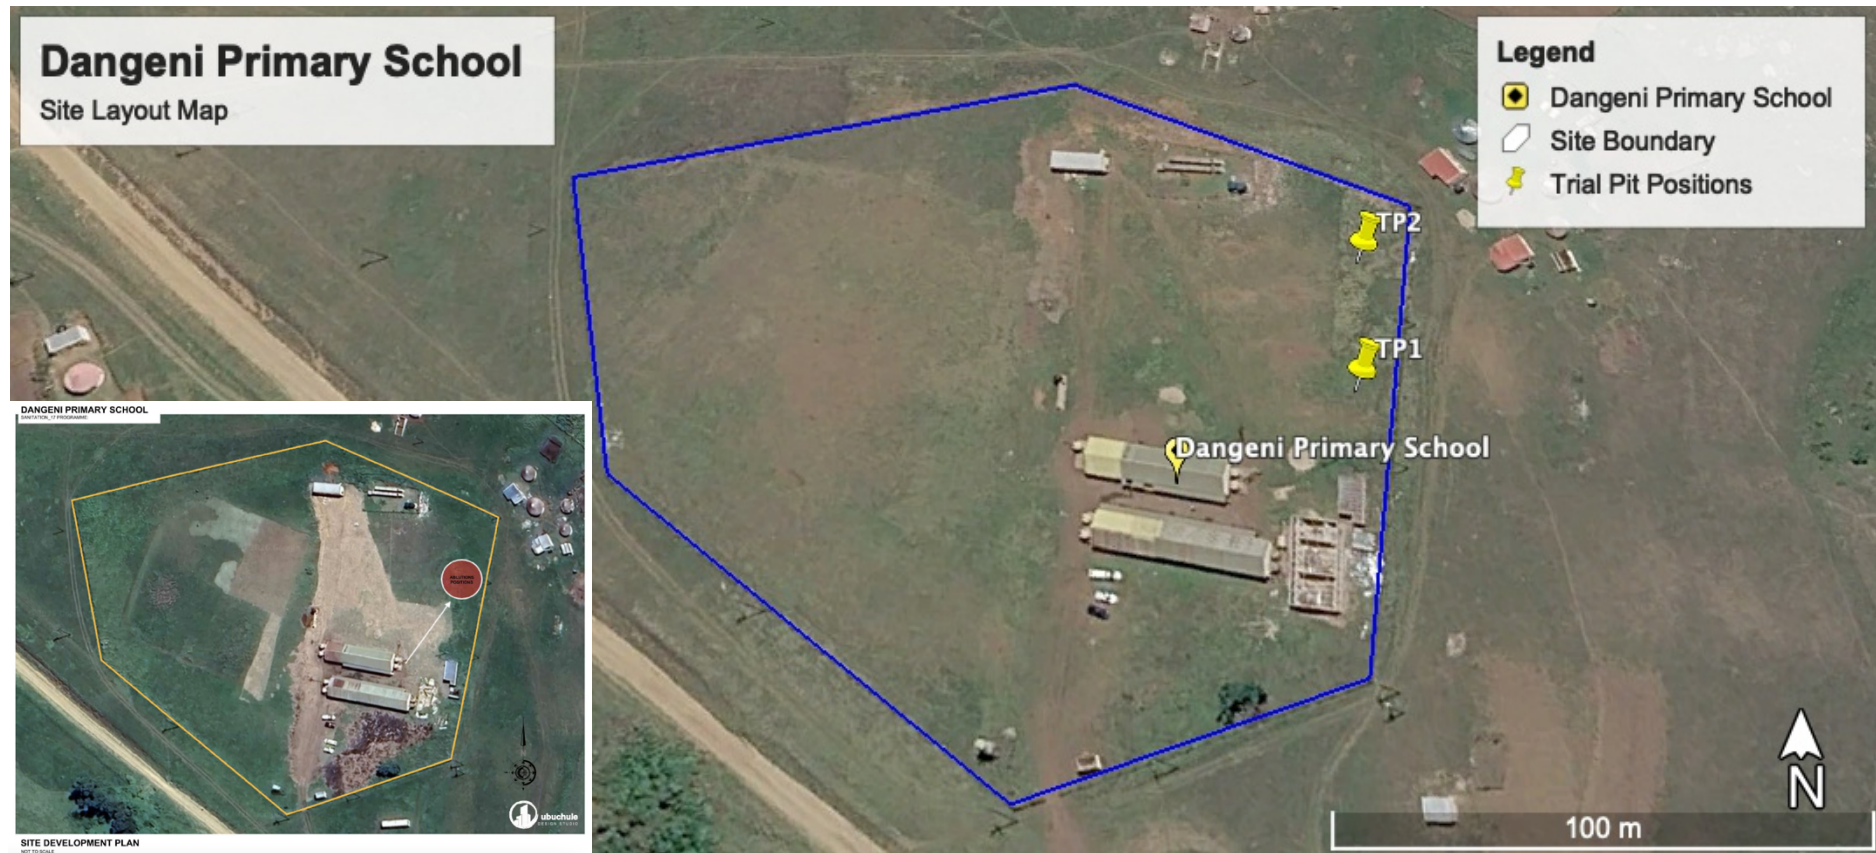
Figure 4-1: Trial pit positions.

These positions are all marked in **Figure 4-1** below as per the provided SDP.

Two trial pits, labelled TP1 and TP2, were excavated manually with pick and shovel at locations designated for the proposed new ablutions, i.e. proposed positions as per SDP. The excavation focused on areas planned for boys, girls and staff. The trial pits were all excavated to a maximum depth of 1.50 meters below the existing ground level (mbgl).

Two Dynamic Cone Penetrometer tests (DCP), designated DCP1 and DCP2, were conducted adjacent to the test pits. The tests were all advanced to a maximum depth of 2.50 mbgl. The tests were done to primarily ascertain excavation classification and to estimate the bearing capacity of the local soils.

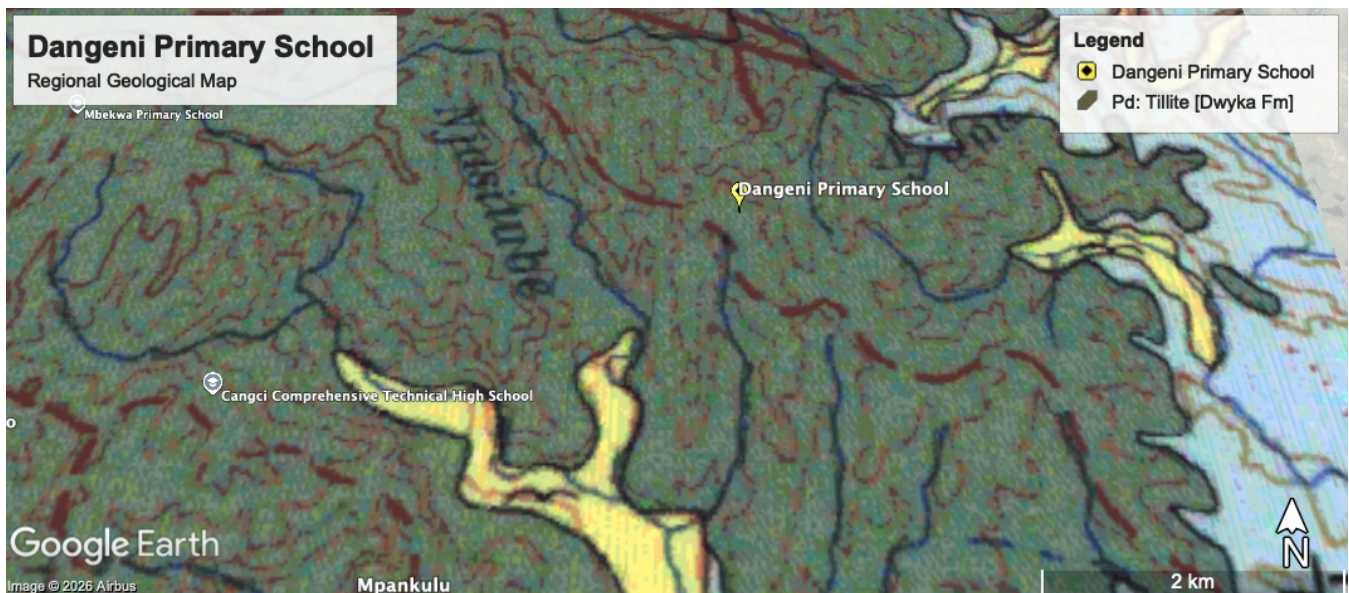
**Figure 5-1: Regional geology of the site.**

According to **3028 Kokstad** 1:250 000 Geological Map Series, the site is underlain by the Dwyka Formation tillites (Pd) as shown in **Figure 5-1** below.

Field investigations show that the site is underlain by colluvial soils which overlie the residual tillite in TP1 and TP2.

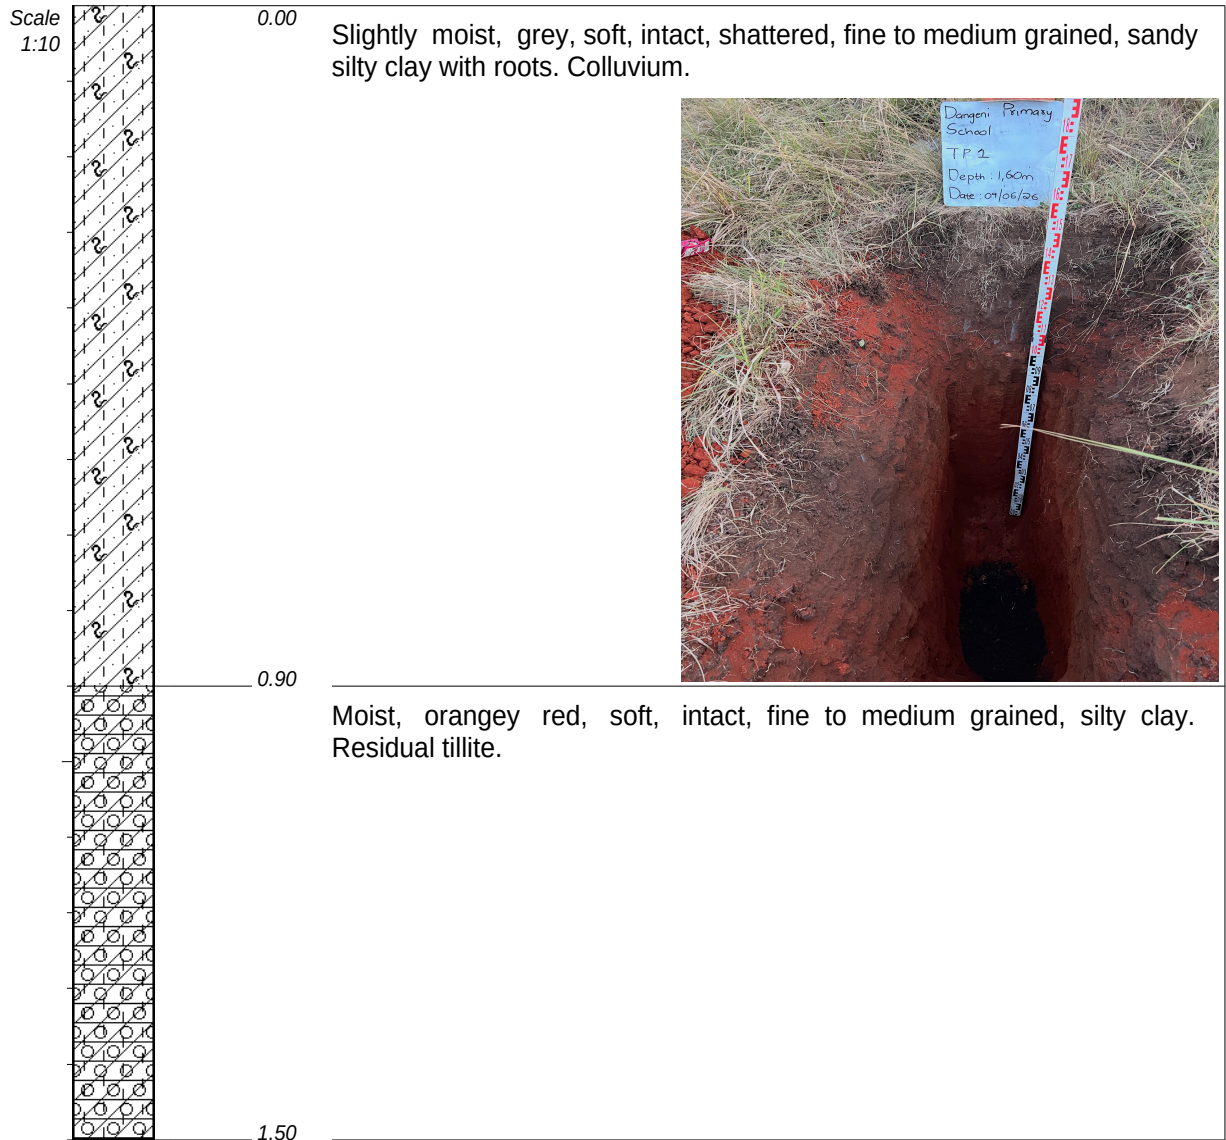
**HOLE No: TP1**

- 1) End of hole at 1.50m on residual tillite.
- 2) No groundwater seepage.
- 3) No sidewall collapse.

This horizon was encountered throughout the site at depths ranging from surface to 0.90m overlying the weathered tillite. It was described as slightly moist, grey, soft, intact, shattered, fine to medium grained, sandy silty clay with roots.

These soils are derived from the complete weathering of the existing underlying bedrock. They were encountered underlying the colluvial soils in all pits at depths ranging from 0.70 to 1.50m below existing ground level. It was described as moist, orangey red, soft, intact, fine to medium grained, silty clay.

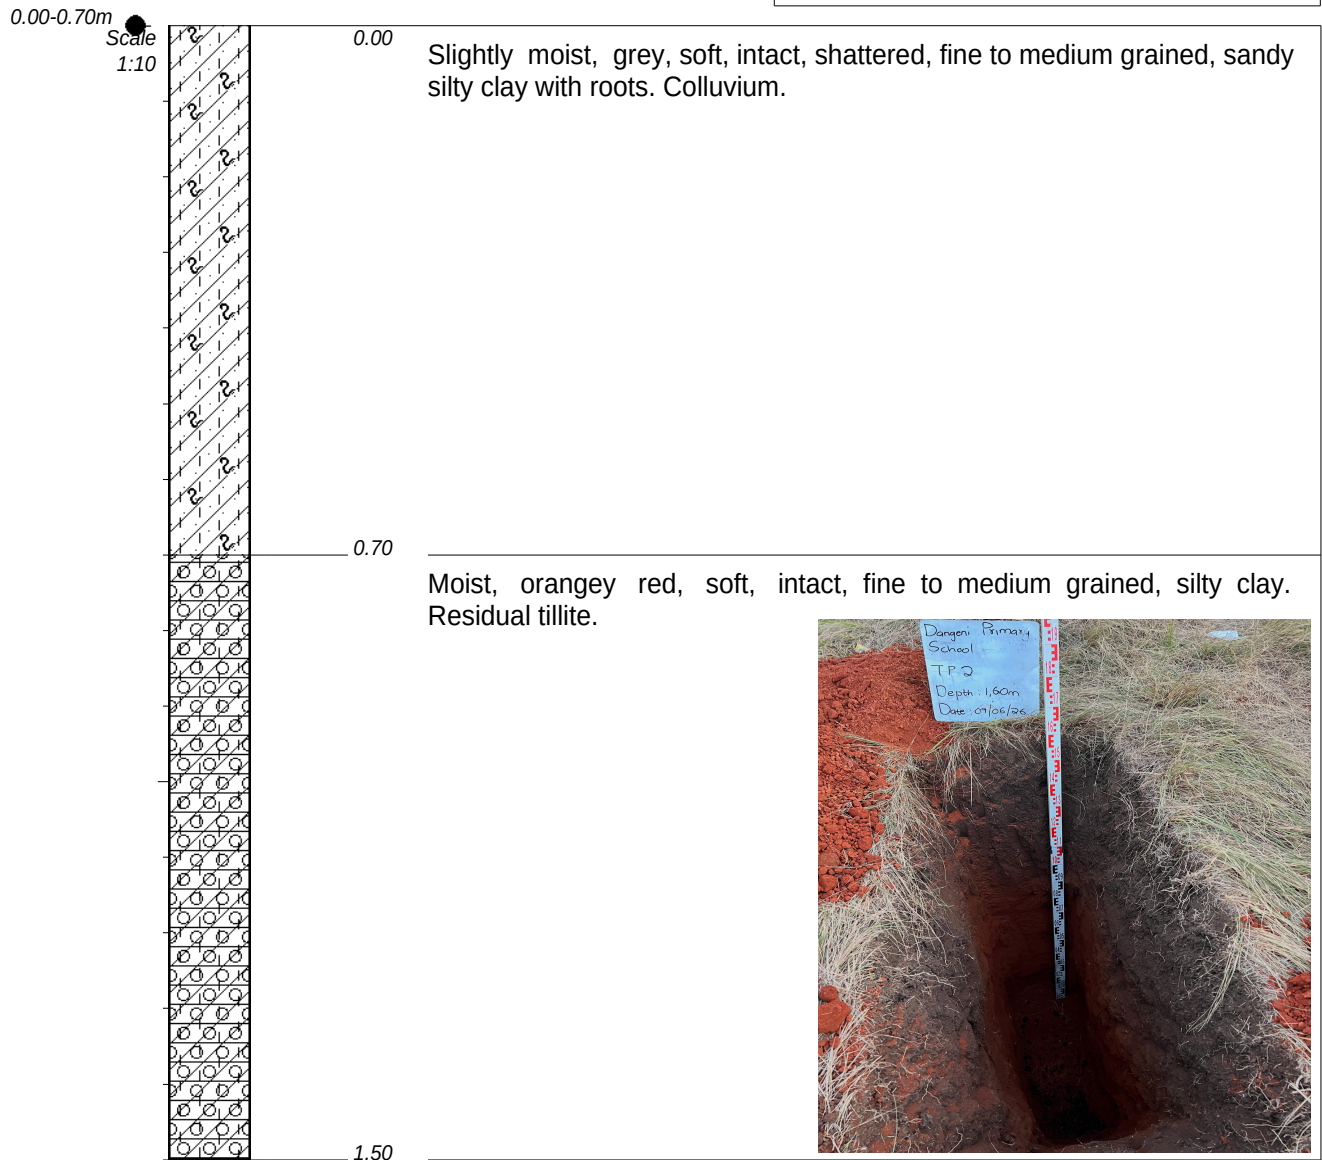
**HOLE No: TP2**

- 1) End of hole at 1.50m on residual tillite.
- 2) No groundwater seepage.
- 3) No sidewall collapse.
- 4) MOD-CBR-ind sample at 0.00-0.70m.

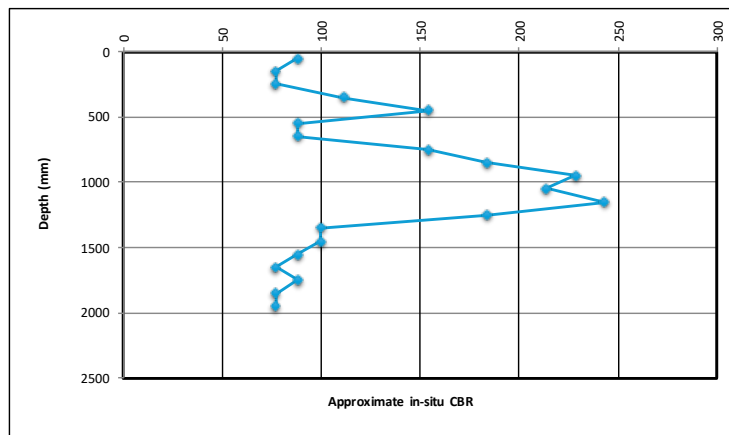
**DCP No.** 1

### APPROXIMATE INSITU CBR FROM DCP

**Hammer size** 8kg with 20mm point

**SPT = 1.2 DN**

Dynamic Cone Penetration can assist in determining the estimated allowable safe bearing pressures (EASBP) of the soils. **Appendix B** shows that EASBP on the colluvial soils ranges between 77kPa to 184kPa and on the residual soils (below 1.00m) it ranges from 77kPa to 243kPa.

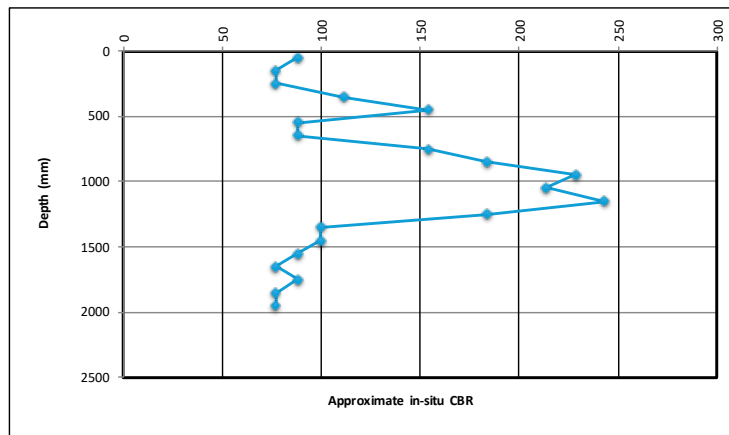
**DCP No.** 2

### APPROXIMATE INSITU CBR FROM DCP

**Hammer size** 8kg with 20mm point

SPT = 1.2 DN

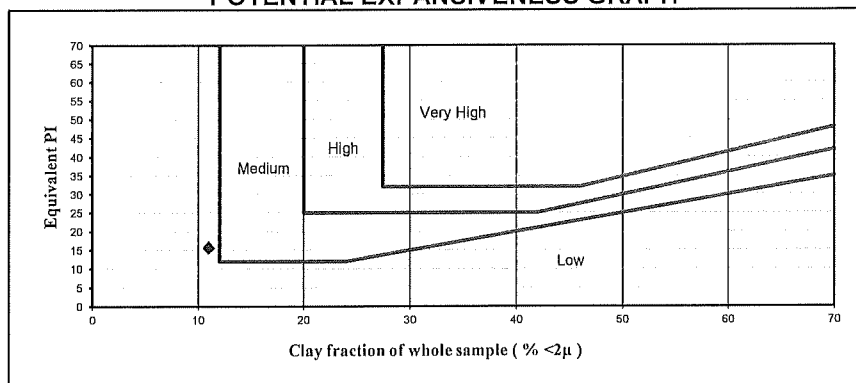
### POTENTIAL EXPANSIVENESS GRAPH

Equivalent PI : 16 Clay fraction of whole sample (% <2 $\mu$ ) : 11

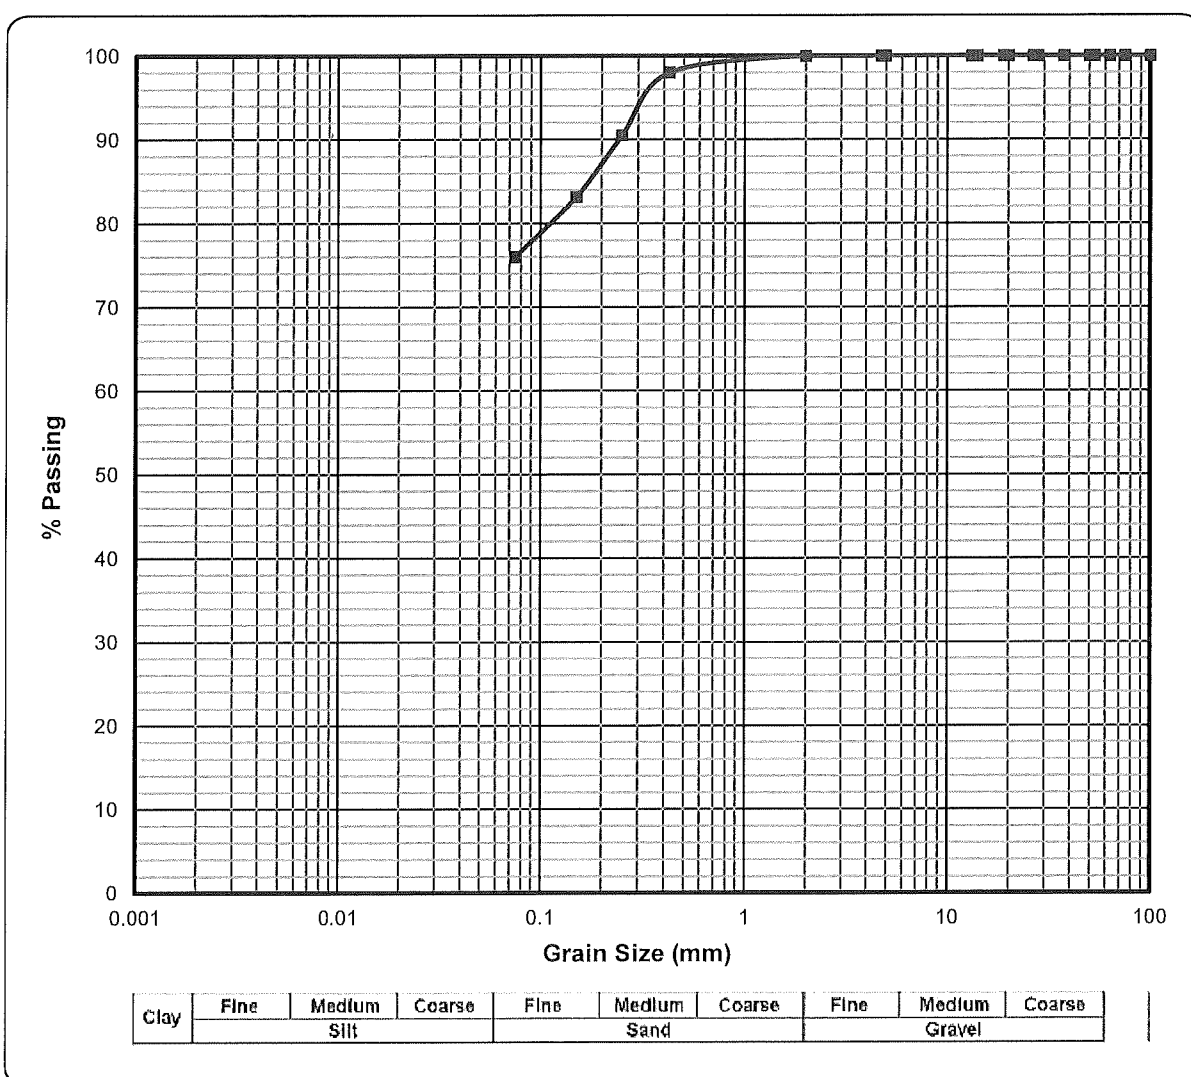
### Grading Curve for Sample T61905 – SANS 3001

Thick Red Line is the Grading Curve (COLTO Classification = Cannot be Determined) (TRH 14 Classification = G9)

The material on site is classified as G9 in terms of TRH14, thus making it suitable for use as general subgrade.

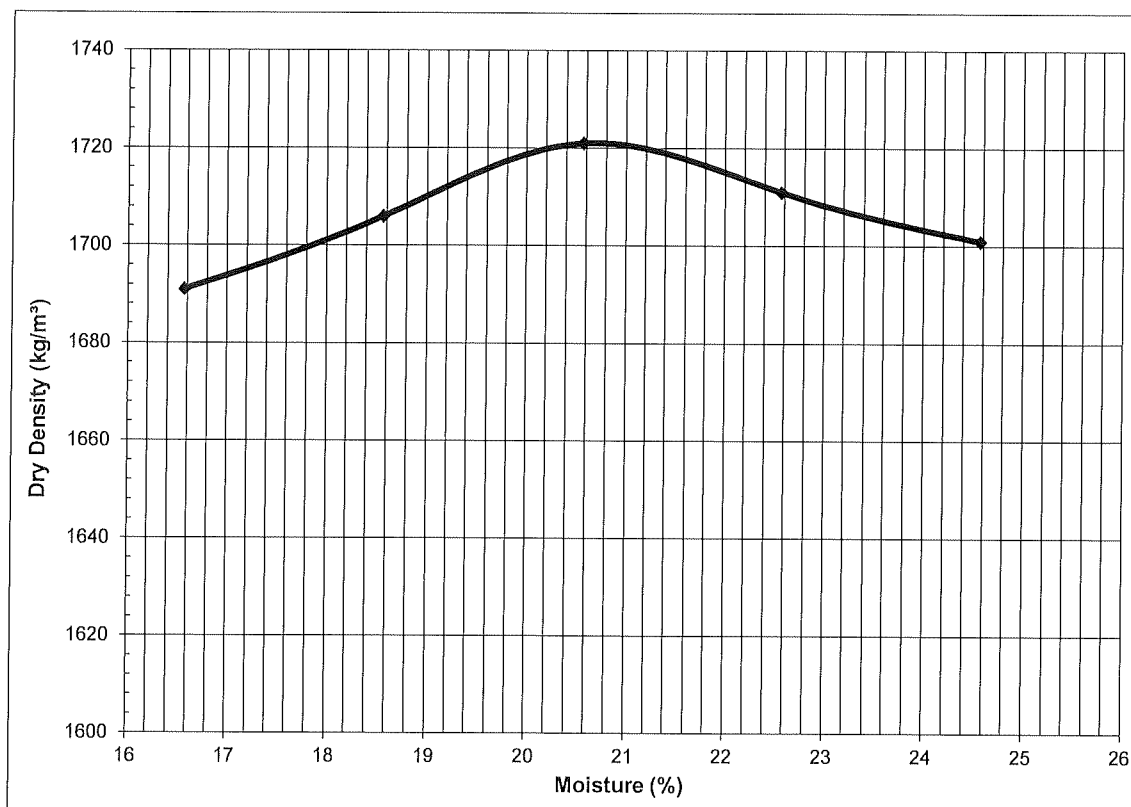
### SANS 3001 Moisture/Density Relationship

| Maximum Dry Density (kg/m <sup>3</sup> ) | 1721 | Optimum Moisture Content (%) | 20.8 |
