## **Draft Geotechnical Investigation Report for Mfundisweni Senior Secondary School as Part of the Implementation of Sanitation Programme at Various Schools in the Eastern Cape Province**

# **Draft Geotechnical Investigation Report for Mfundisweni Senior Secondary School as Part of the Implementation of Sanitation Programme at Various Schools in the Eastern Cape Province**

**Report  
Version – Draft**

**July 2026**

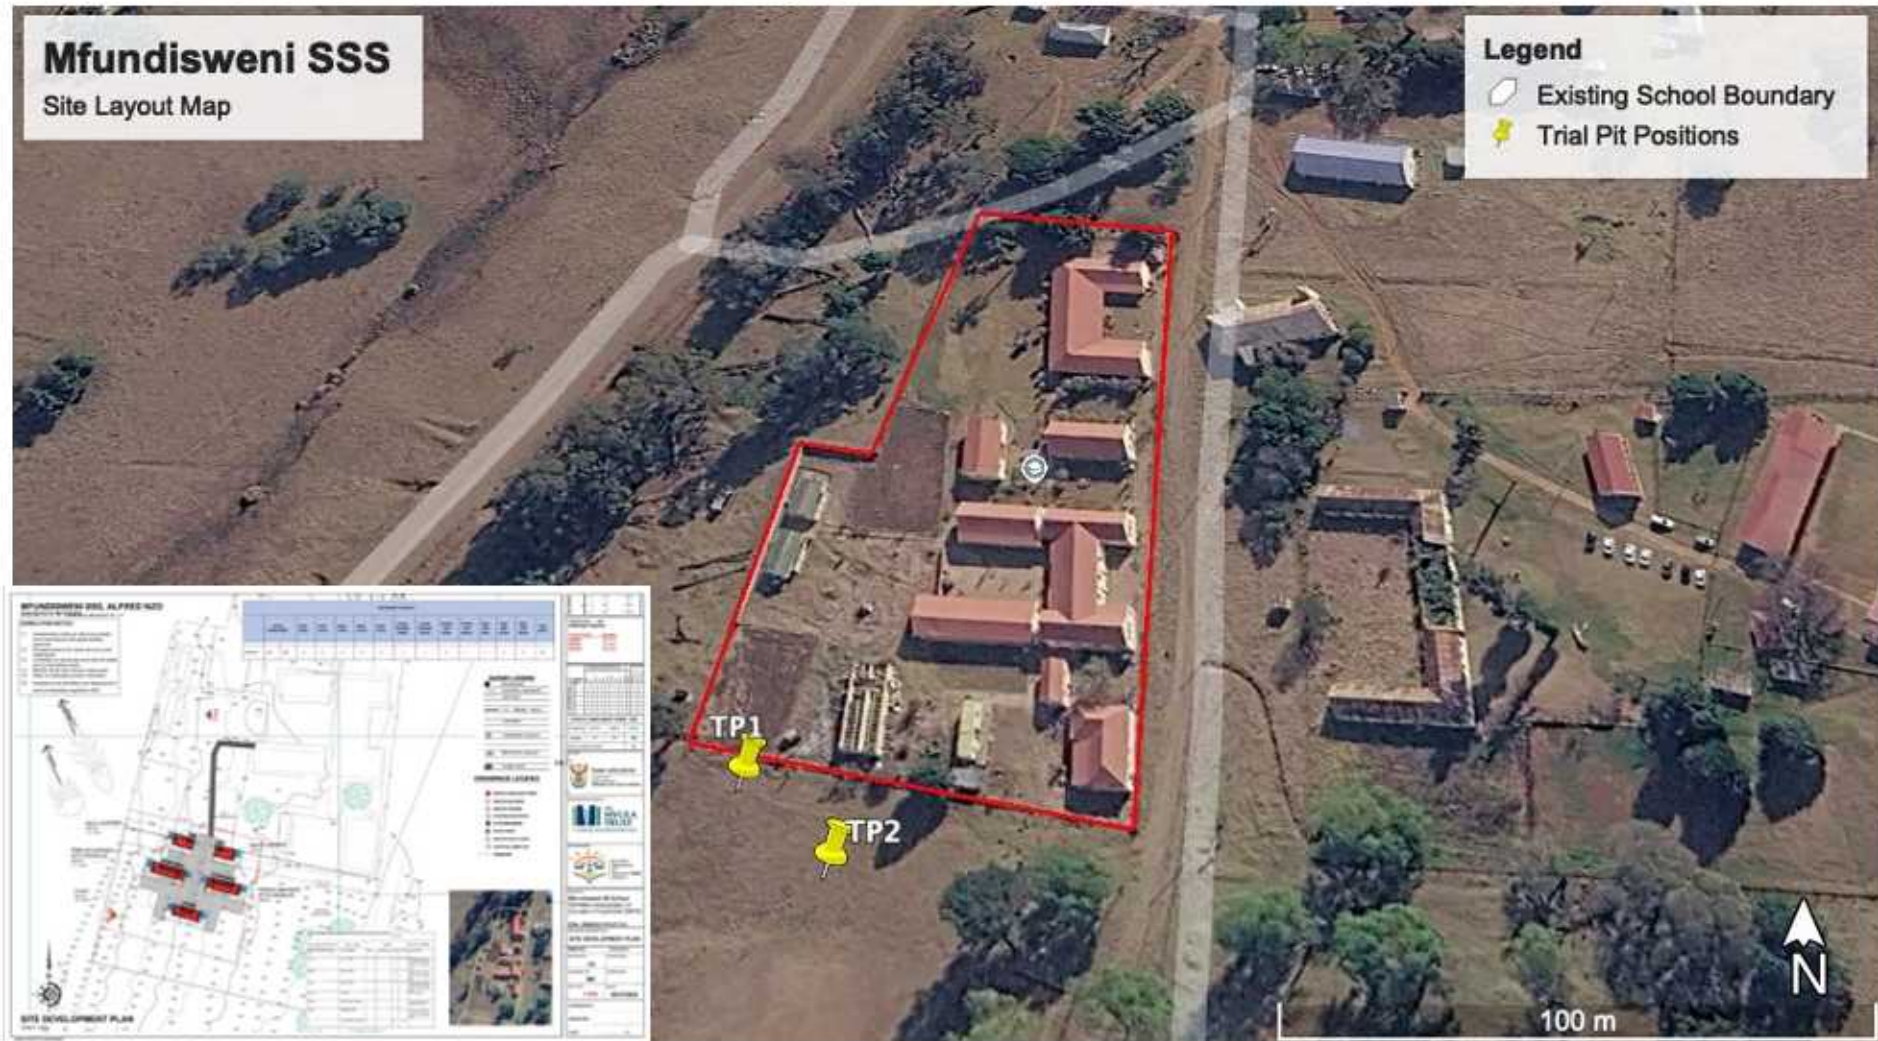
Figure 4-1: Trial pit positions.

- Siting of 2 trial pits using SDP's of where the proposed structures positions:
  - New ablutions (boys, girls, and staff)
- Test pits were excavated using hand tools and profiled by an Engineering Geologist using SANS 633 guidelines.
- Penetrometer tests (DCP) tests were conducted adjacent to each trial pit

These positions are all marked in **Figure 4-1** below as per the provided SDP.

Two trial pits, labelled TP1 and TP2, were excavated manually with pick and shovel at locations designated for the proposed new ablutions, i.e. proposed positions as per SDP. The excavation focused on areas planned for boys, girls and staff. The trial pits were all excavated to a maximum depth of 1.50 meters below the existing ground level (mbgl).
