ETHEKWINI IRPTN

Geotechnical Investigation Report Pinetown

ETHEKWINI IRPTN Geotechnical Investigation Report

12 February 2014

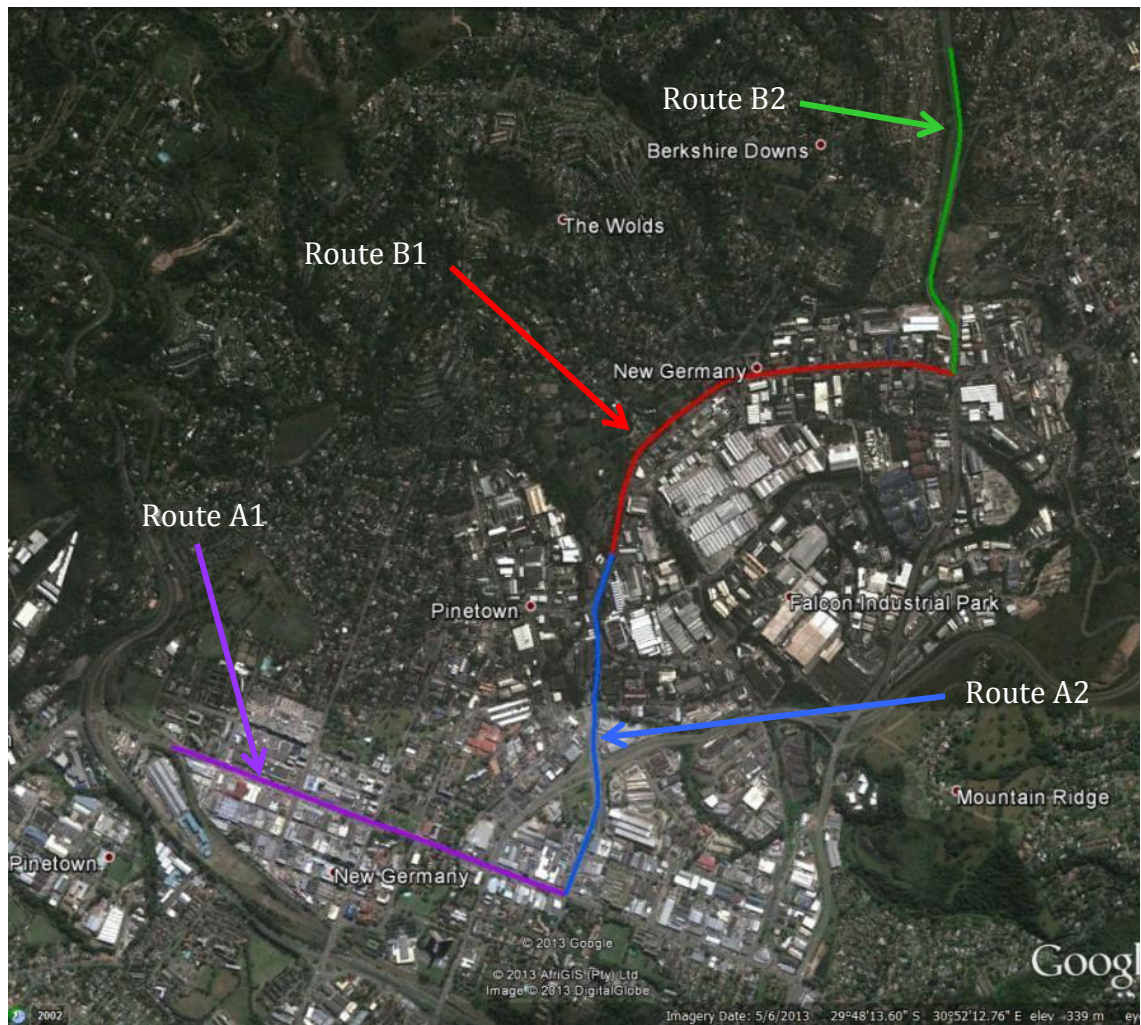
Figure 1: BRT route sections

The route is approximately 6.6km long and is divided by the client into four sections, namely A1, A2, B1 and B2. A locality plan of the site, indicating the four sections is provided in the figure on the next page.

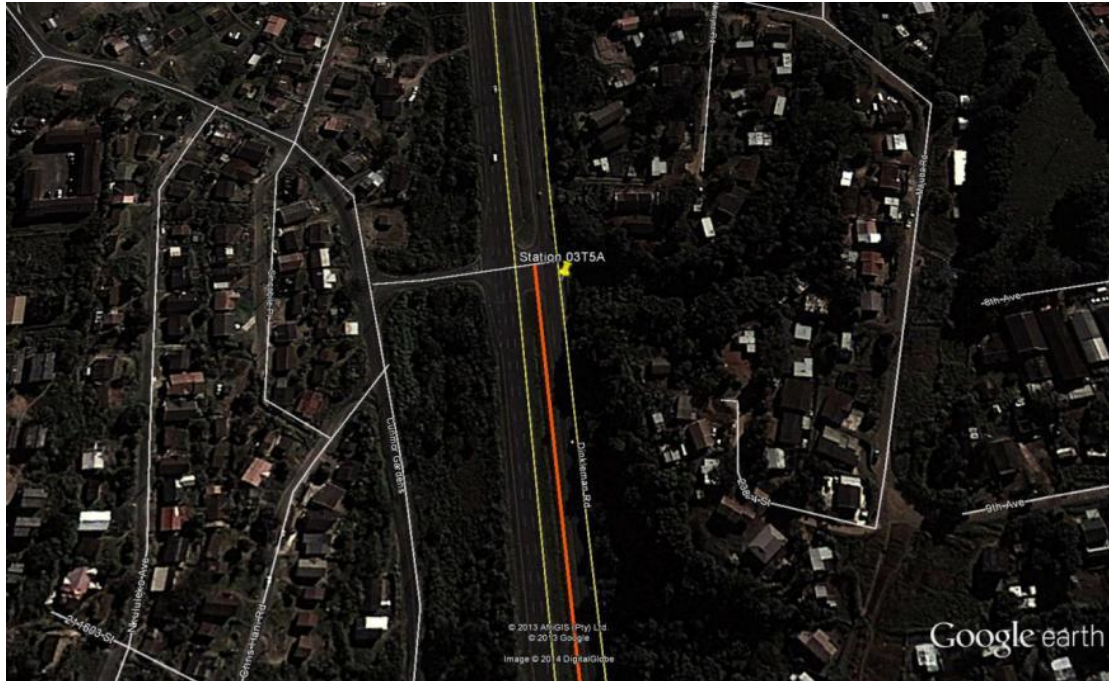
Figure 2: Location plan for Harmony Heights Station.

Harmony Heights Station is located at the beginning of the IRPTN route on Dinkelman Road. A locality plan of the station is provided in Figure 2 on the next page.

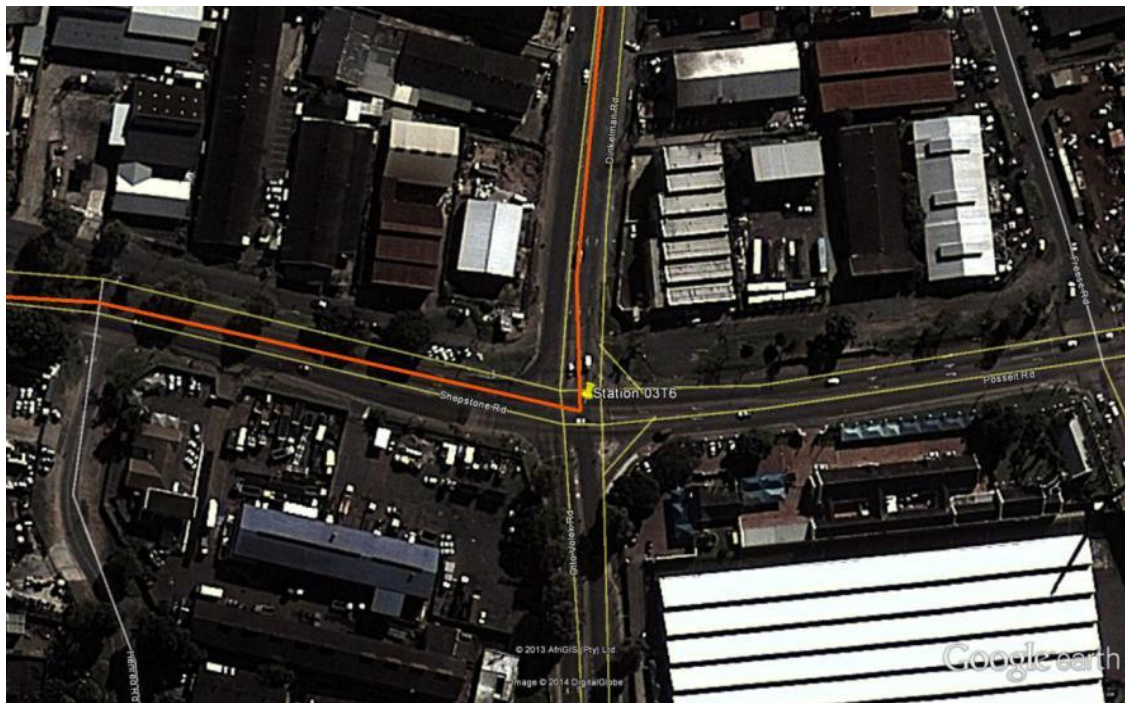
Figure 3: Location plan for Hendred Station.

Hendred Station will be located on the corner of Dinkelman Road and Qashana Khuzwayo Road (formerly Shepstone Road). Please see Figure 3 for a locality plan of the station.

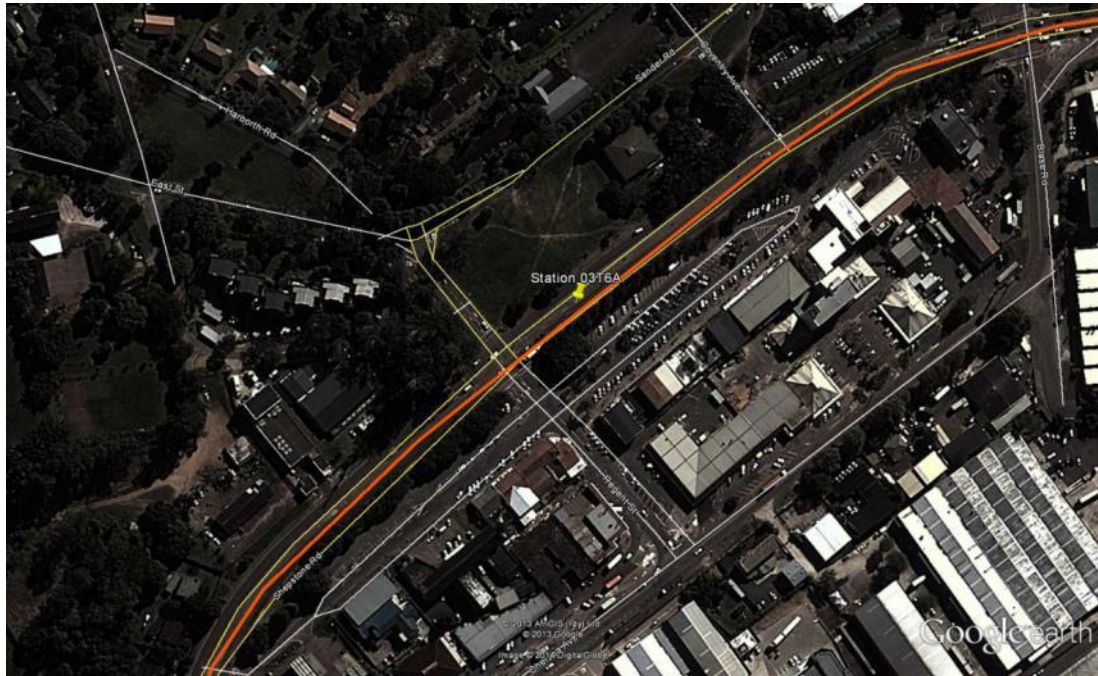
Figure 4: Location plan for Regent Station.

Regent Station is located on Qashana Khuzwayo Road, between the intersections of Coventry Avenue and Regent Street. Figure 4 shows an aerial view of the proposed station, obtained from Google Earth.

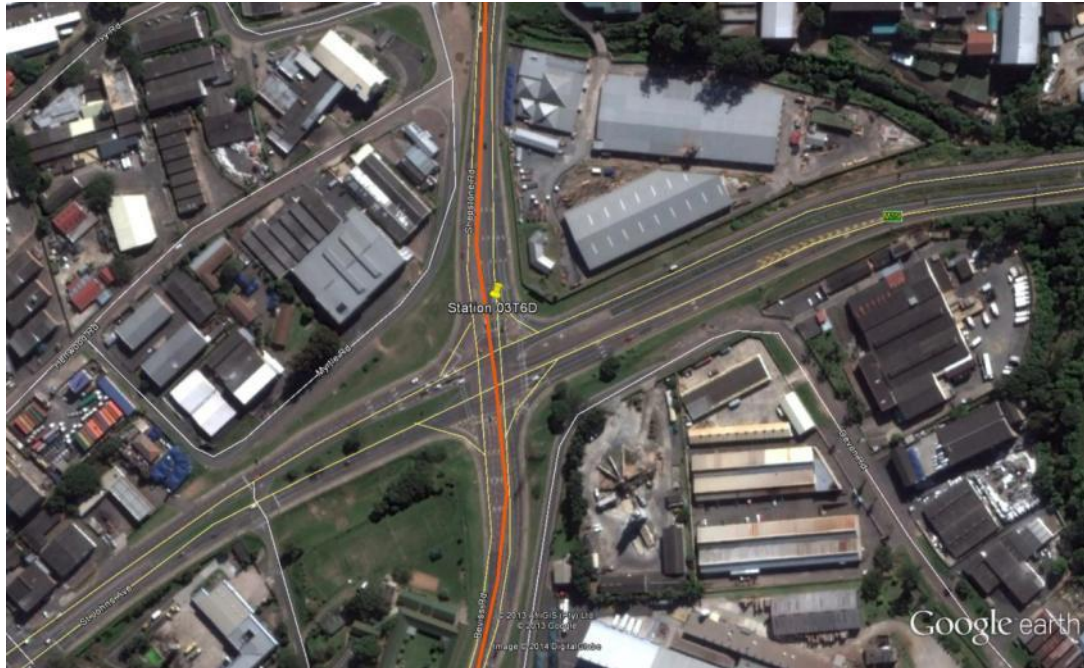
Figure 5: Location plan for Henwood Station.

Henwood Station is located in the vicinity of the Qashana Khuzwayo Road and Saint Johns Avenue intersection.

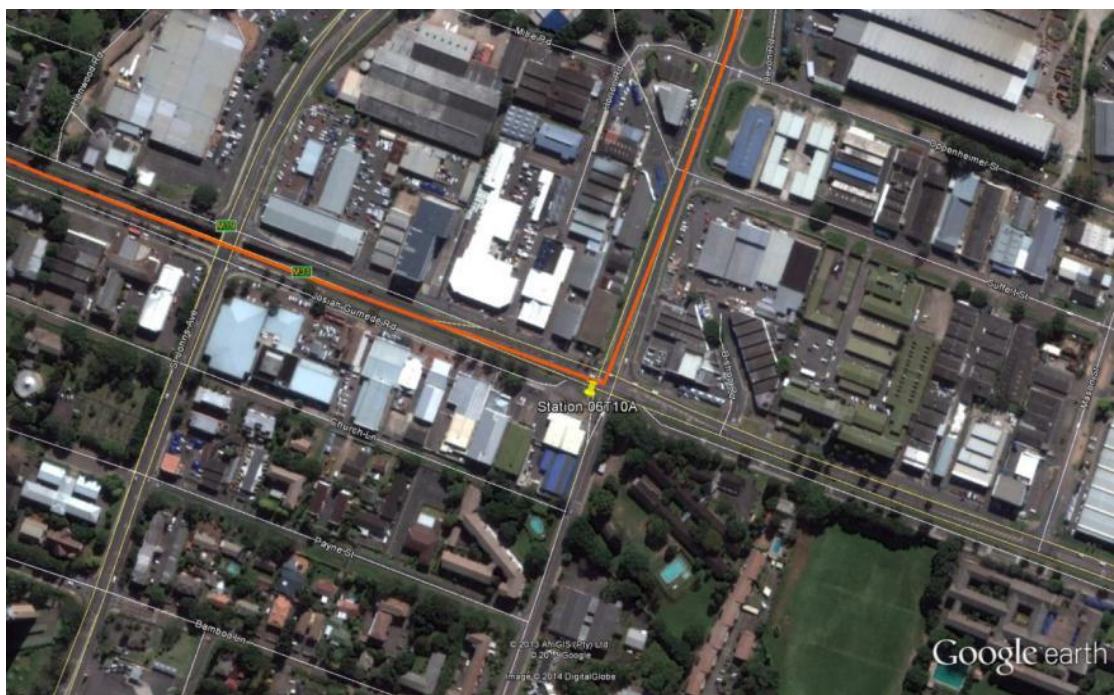
Figure 6: Location plan for Beviss Station.

Beviss Station will be situated in the vicinity of the intersection of Qashana Khuzwayo Road and Josiah Gumede Road. A locality plan of the station is shown in the figure below.

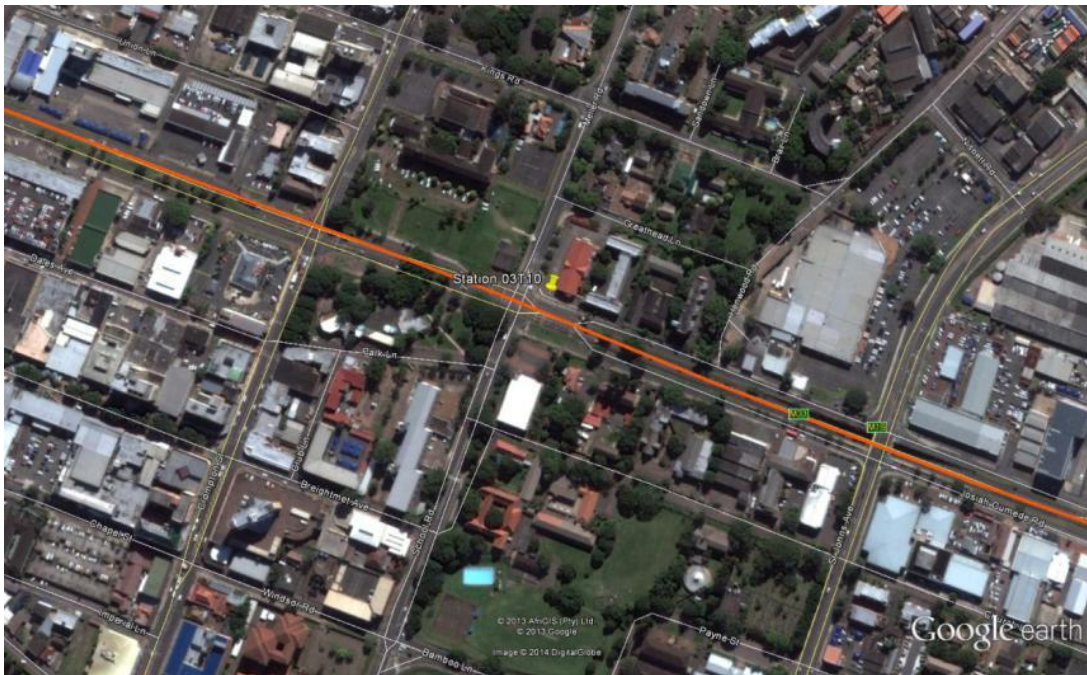
Figure 7: Location plan for Pinetown Civic Station.

Pinetown Civic Station will be located in the vicinity of the intersection of Josiah Gumede Road and Meller Road. A locality plan of the station is shown in the figure below.

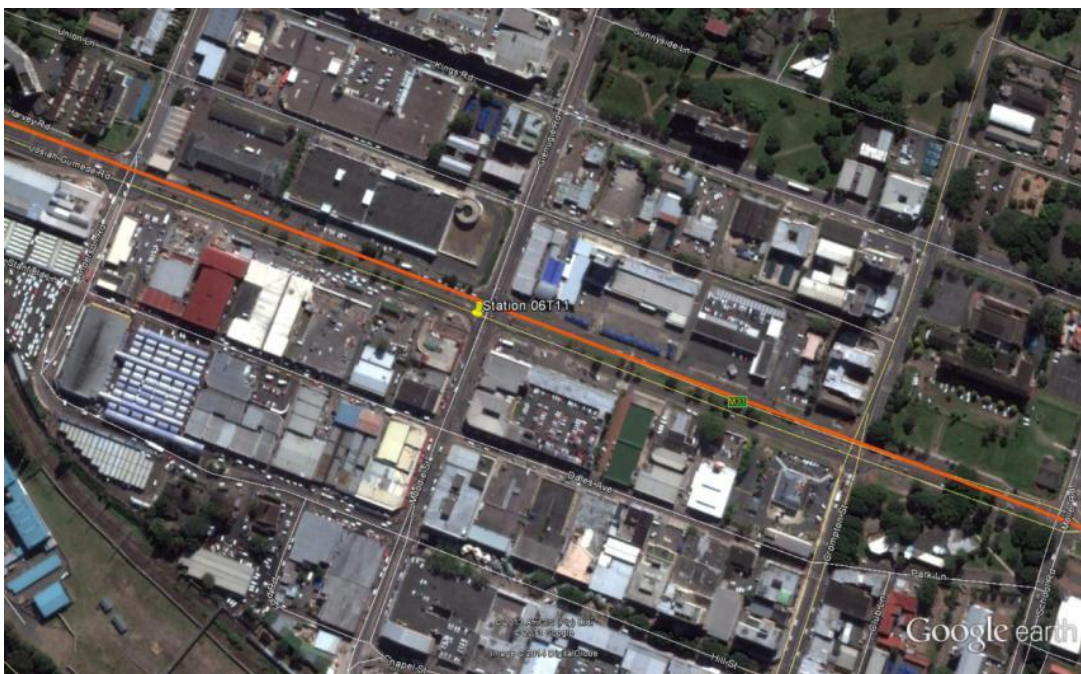
Figure 8: Location plan for Moodie Station.

The proposed Moodie Station will be situated in the vicinity of the intersection of Josiah Gumede Road and Glenugie Road. A plan of the station is provided in Figure 8 below.

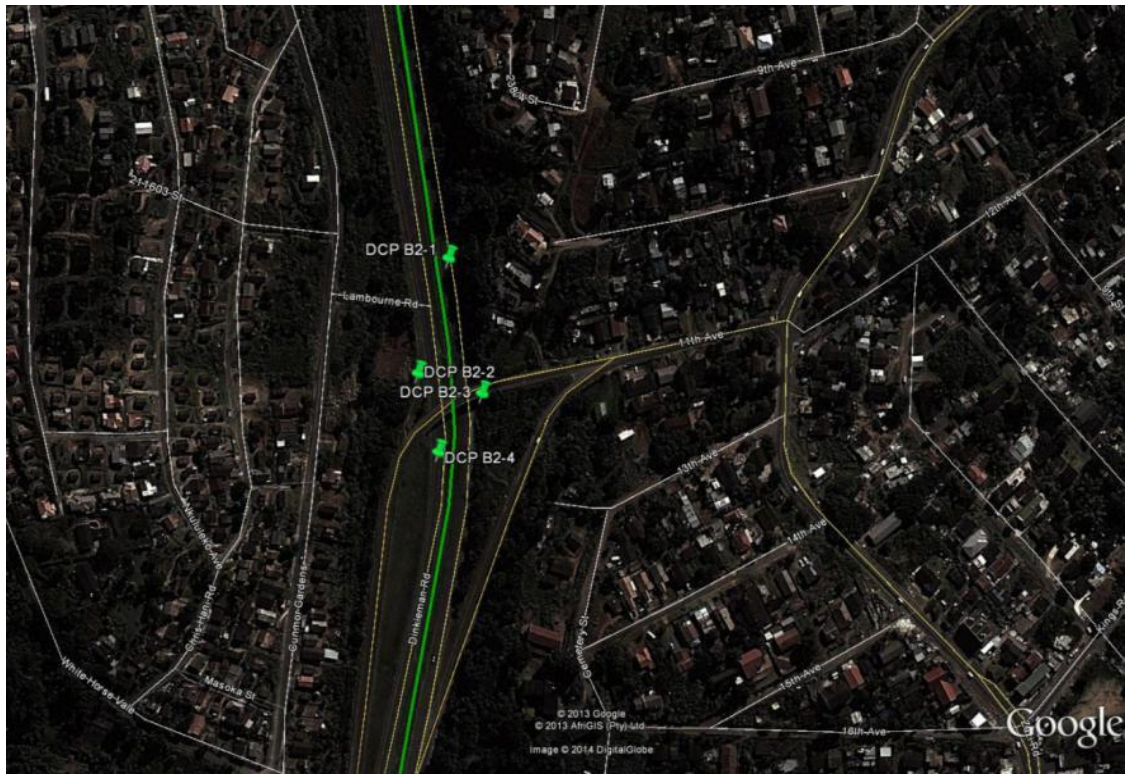
Figure 9: Location of DCP tests conducted for Route B2.

Figure 9 and Figure 10 show aerial views of the off-ramp bridge and surrounding DCP and test pit locations.

Along the course of Route B2, all DCP tests were completed at the bottom of test pits along the route. Low CBR values at the start of the DCP test is in all likelihood due to soil disturbance caused by the TLB during test pit excavation and may not be representative.

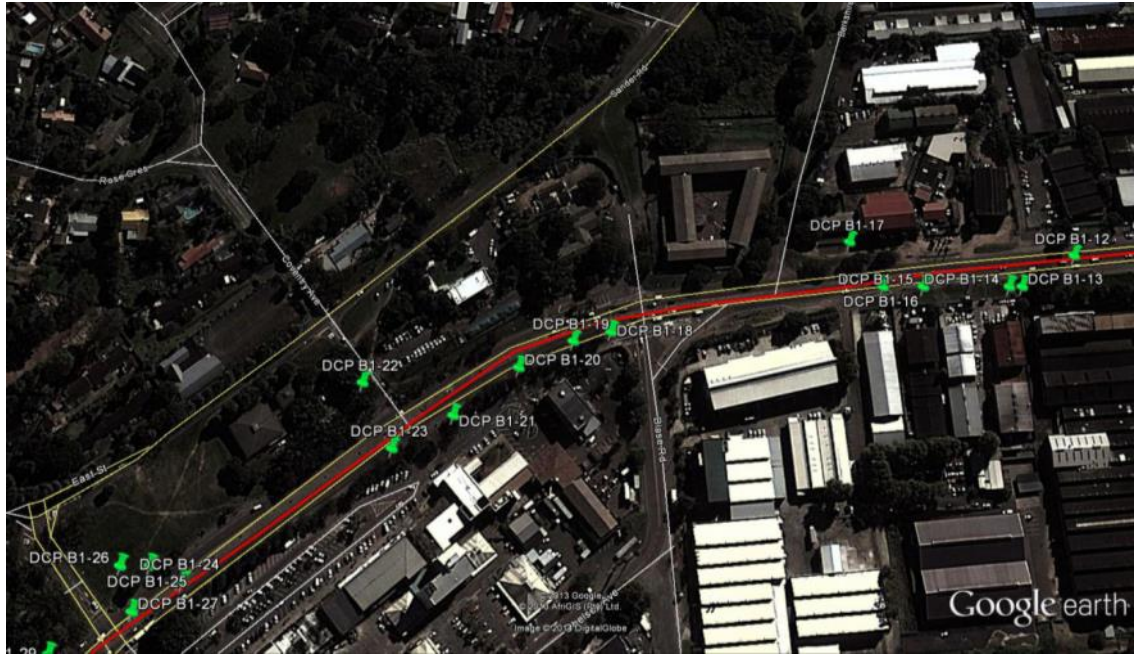
Figure 12: Locations of DCP B1-12 to DCP B1-27 situated along Route B1.

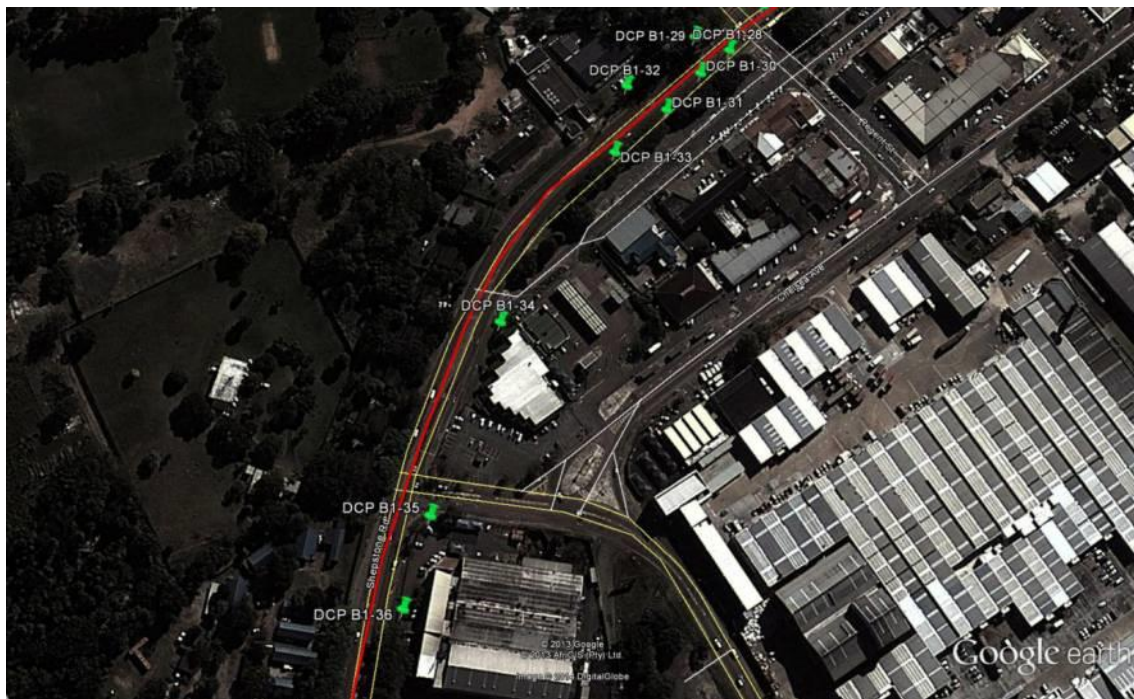
Figure 13: Locations of DCP B1-28 to DCP B1-36 situated along Route B1.

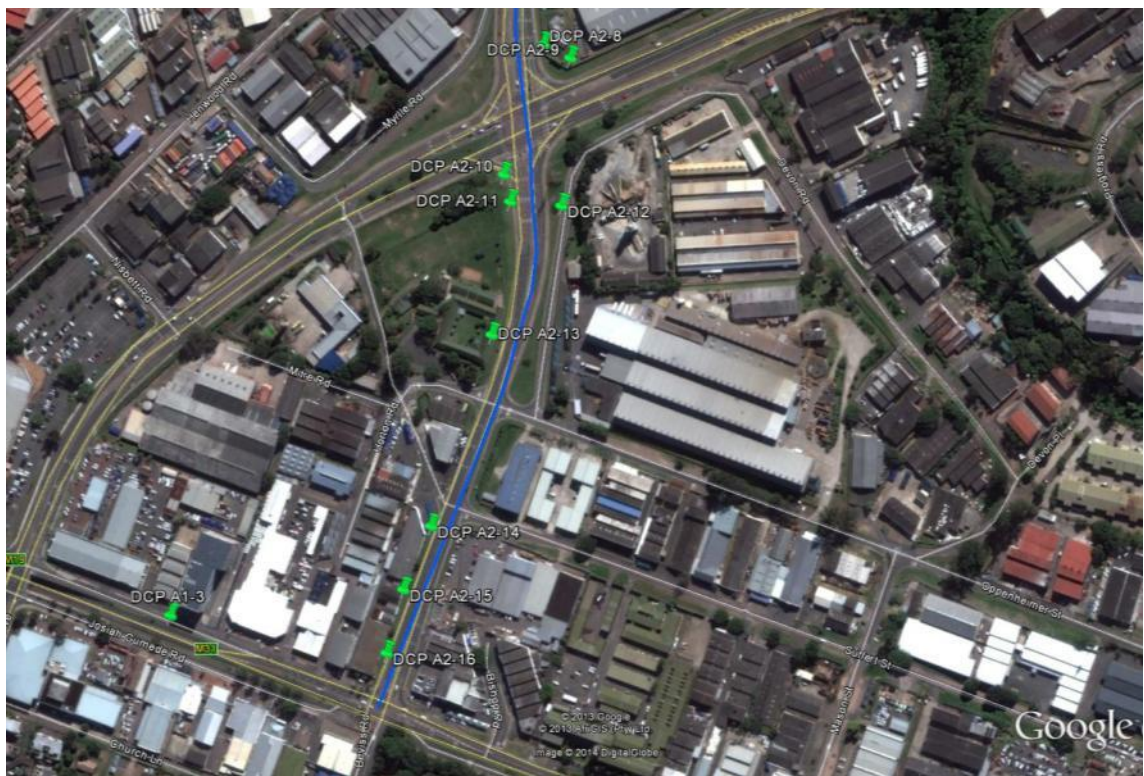
Figure 16: Locations of DCP A2-8 to DCP A2-16 completed for Route A2.

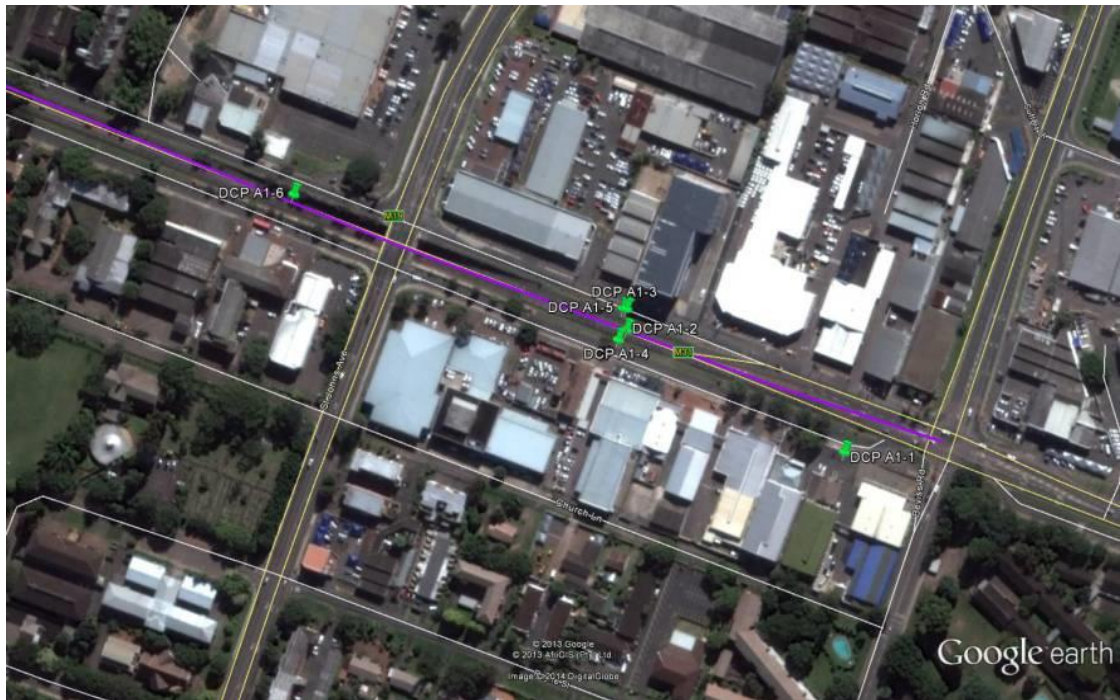
Route A1 commences at the Bevis Road and Josiah Gumede Road intersection and continues along Josiah Gumede Road for approximately 1.8km. Eight DCP tests and seven test pit excavations were conducted for this section. Their locations are shown in the figures on the next page.

Figure 18: Locations of DCP A1-1 to DCP A1-6 completed for Route A1.

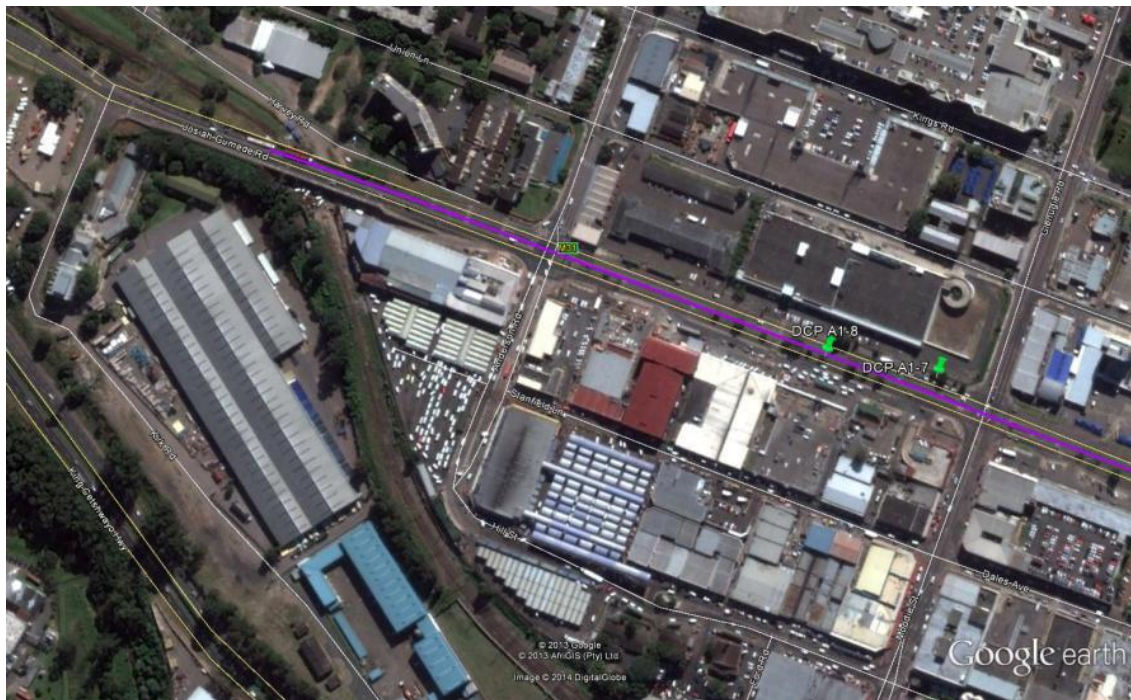
Figure 19: Locations of DCP A1-7 to DCP A1-8 completed for Route A1.

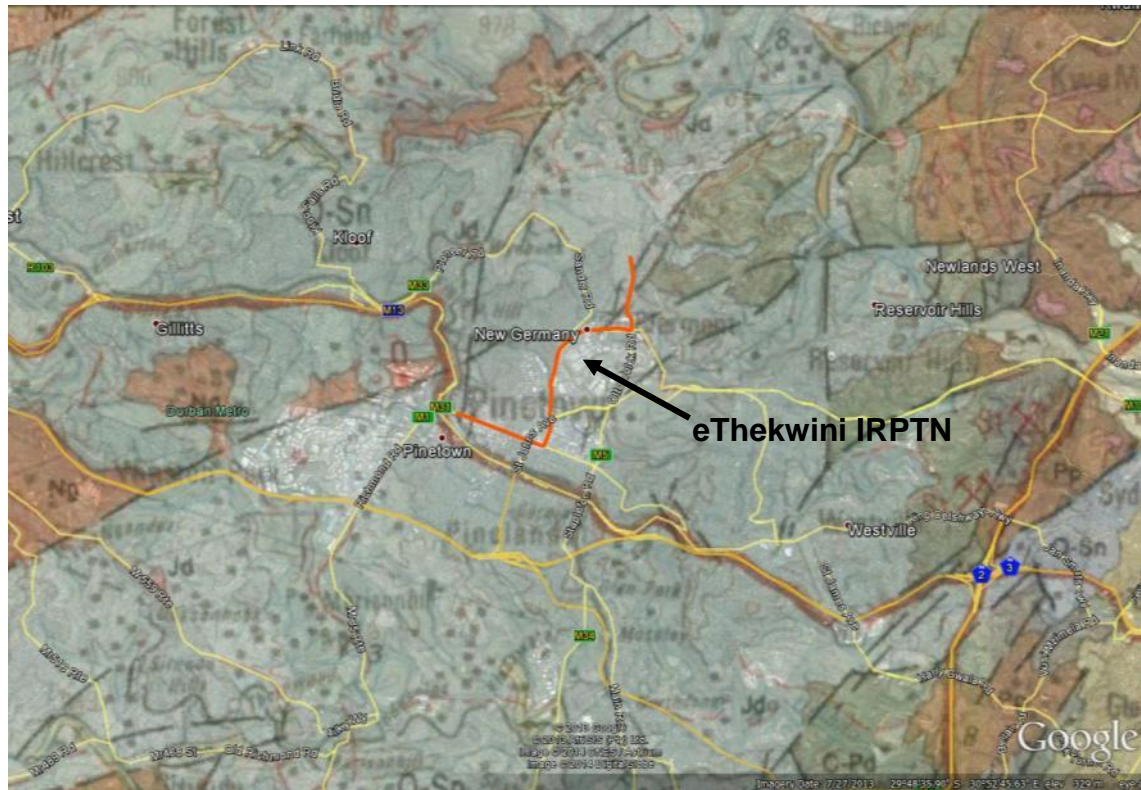
Figure 21: Google Earth image of the site, with the 1: 250 000 geological map 2930 Durban overlain.

The 1:250 000 geological map 2930 DURBAN was overlain in Google Earth, and using the route co-ordinates the geology underlying the route was established. Figure 21 shows the Google Earth image with the geological map and BRT route superimposed.

As seen in Figure 21 the route is directly underlain by O-Sn with Ng and C-Pd encountered in the immediate vicinity. These geological formations are described as:

Red-brown coarse-grained arkosic to sub arkosic sandstone; quartz arenite; micaceous sandstone; small pebble conglomerate; subordinate siltstone; and mudstone of the Natal Group.

Megacrystic biotite granite of the Natal Structural and Metamorphic Province (Structural Succession).

Diamictite; subordinate varved shale and boulder shale of the Dwyka Formation of the Karoo Sequence.
