Supply of Smart Meters – suppliers Engagements

Safety Incident Recall

Description of the Incident

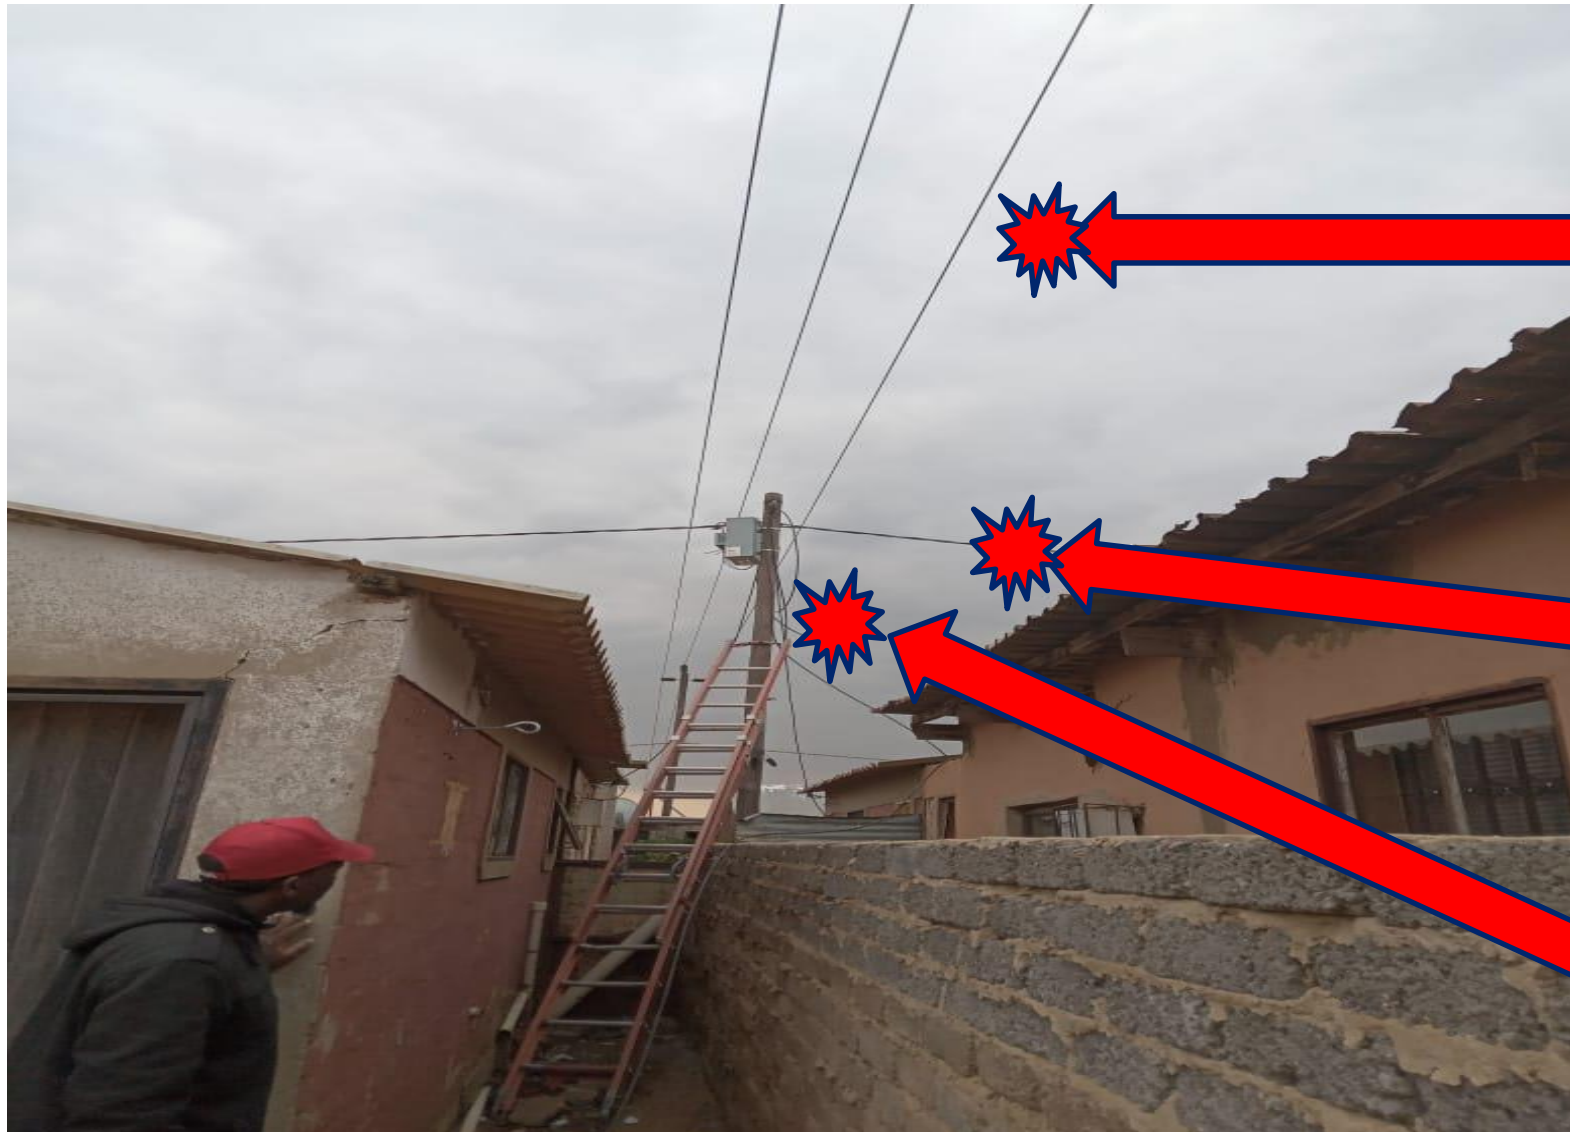
MV Line crossing above the LV line which the injured employee made contact with.

LV line which the employee was working on.

Injured position after incident and ladder position.

- The contractor employee made contact with electricity while stringing the service cable connecting to the ready board in the customer's house.
- The contractor had a valid purchase order, 4503425033.

- The MV line crosses above the LV line which the contractor employee was working on.
- The contractor employee was working under supervision but it was not effective.(No direct supervision.

- The height of the MV Line is not according to the standard.

- Pre-planning was not properly done (Supervisor was busy verifying customer payments).
- The contractor employees identified the risk in terms of safe working clearance between the MV and LV line/pole but did not mitigate or put controls on what to do.
- Contractor employee breached the MV clearance and made contact with the MV line.
- The Contractor Supervisor was not directly supervising the employee at the time of the incident.

- The contractor should inform the CNC every morning before work commences, so that the CNC is aware that there is a contractor working in their area.
- The contractor should have the necessary permit for the job of the current day.
- The safe working clearance was breached and the Contractor did not ask for the line to be switched off as a safety panel.
