GEOTECHNICAL INVESTIGATION REPORT
FOR THE PROPOSED NEW IKAGENG
POLICE STATION IN NORTHWEST, SOUTH
AFRICA.

LC012-23. R01

19 JULY 2023

Prepared for:
Ukuza Consulting (Pty) Ltd

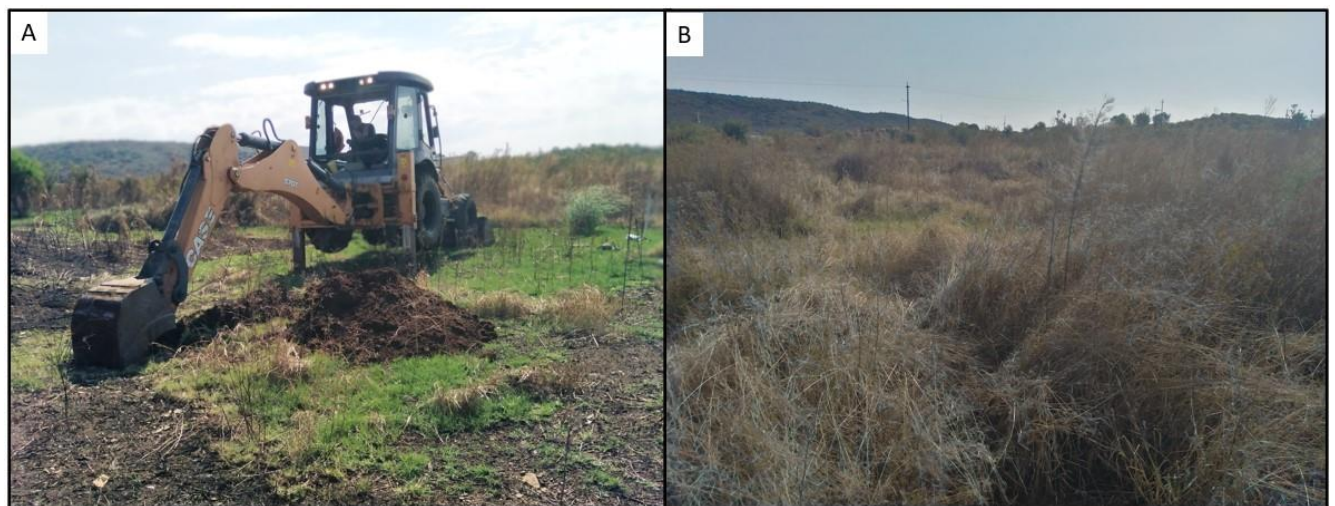
Figure 2: General site condition, with (A) showing TLB excavation and (B) showing a general site view with bushes and grass.

The project area (Proposed Police Station) is situated in Ikageng which is approximately 12 km southwest of Potchefstroom in the Northwest Province (Figure 1). It is located within the Dr Kenneth Kaunda District Municipality. The project area is approximately 3.12 hectares, and it is covered by grass and shrubs (Figure 2). The site can be accessed via the N14 and Mogolodi Street. The central coordinates of the site are [26.739135°S;27.015390°E].

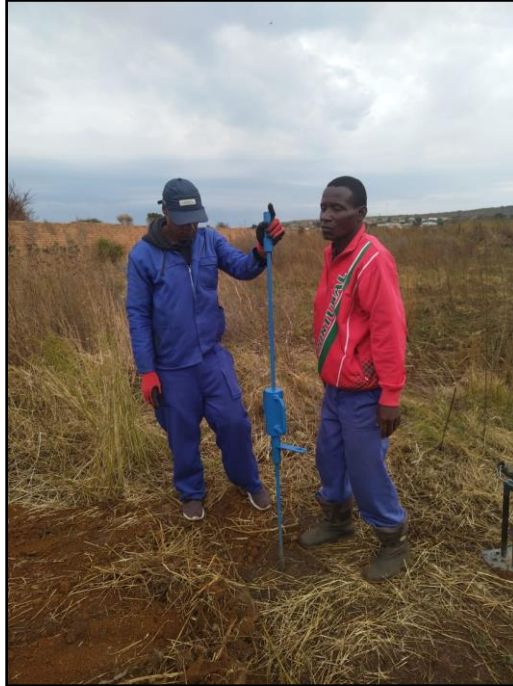
Figure 4: DCP testing conducted on site at TP08.

A DCP test is carried out in order to determine the consistency of the respective soil horizons (Figure 4). At each test pit a DCP test was conducted in close proximity. In total twenty-four DCP tests were conducted at preselected points (Table 1).

The DCP tests extended to an approximate depth ranging from 0.4 to 1.8m. The DCP test results are provided in Appendix B.

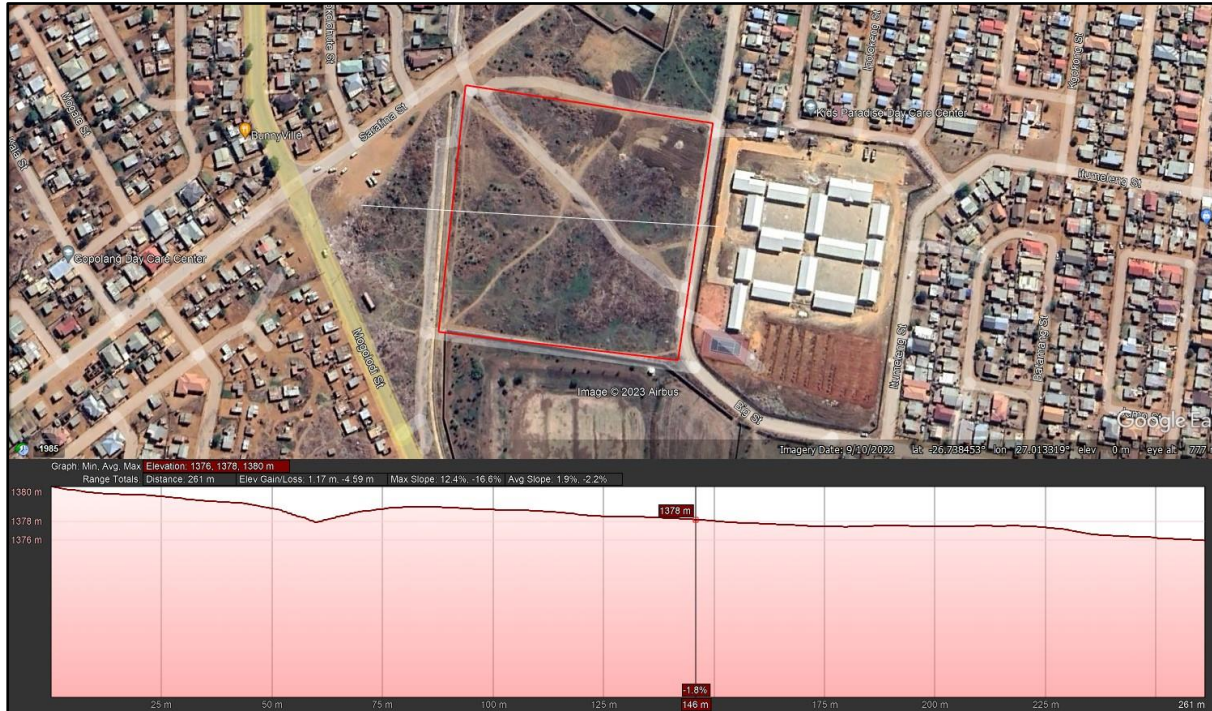
Figure 6: A topographical cross section site from west-east direction Google Earth Maps.

The topography of the investigated area (Figure 6) is generally characterized by a gentle slope with a minimum and maximum elevations of 1376m and 1377m above mean sea level (AMSL) respectively.

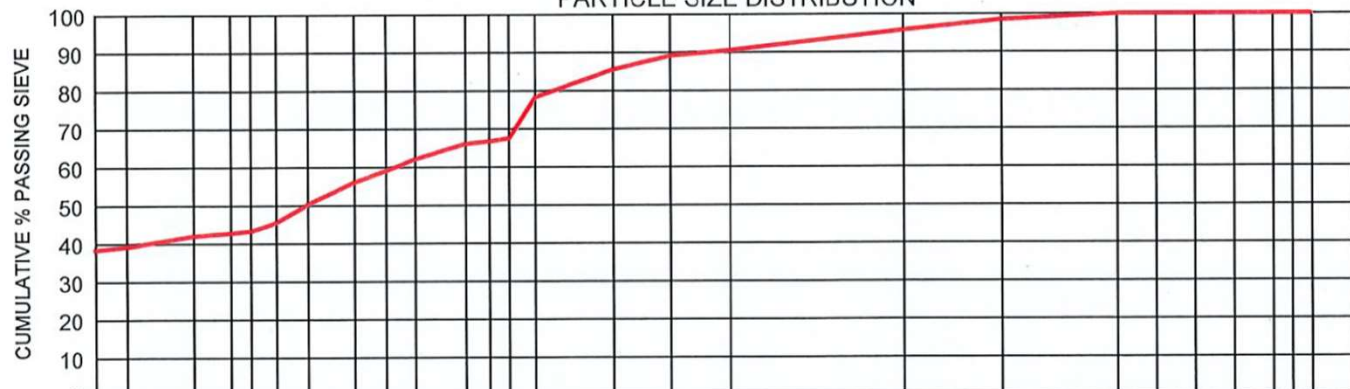
Clay (%)	Silt (%)	Sand (%)	Gravel (%)	Classification
Jennings	42.8	24.0	29.0	4.2	SANDY CLAY
Astm	42.8	35.5	20.2	1.5	SILTY CLAY
British Standard	39.2	28.4	28.2	4.2	SILTY CLAY

Sample No.	: L4524
Hole No.	: TP05
Depth	: 900-1600
Liquid Limit (%)	: 52
Plasticity Index	: 22
Linear Shrinkage (%)	: 11.0
PI of Whole Sample	: 20
P.R.A. Classification	: A-7-5(15)
Unified Soil Classification	: MH
Activity	: 0.51
Heave Classification	: MEDIUM
Grading Modulus	: 0.35
Percentage (<0.002)	: 39.0
Moisture Content (%)	: 17.4

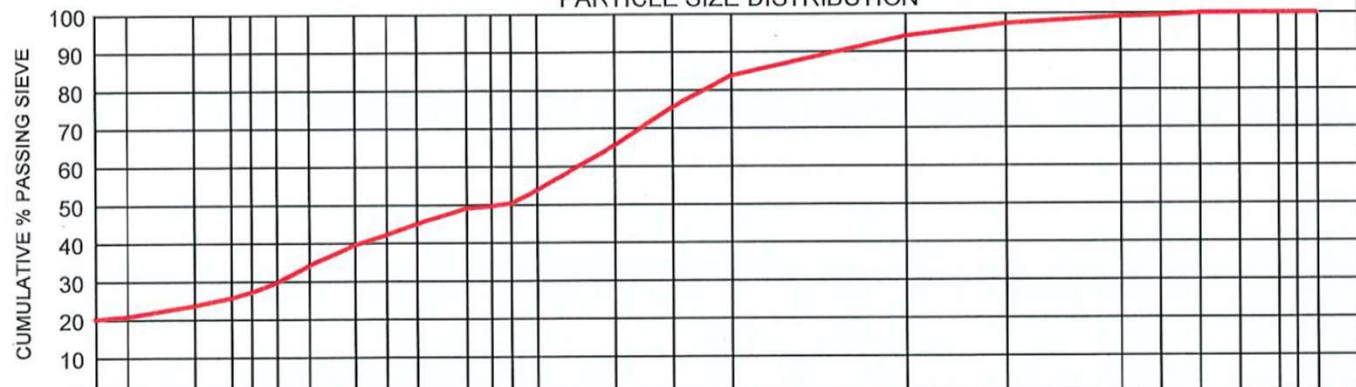
Sample No.	: L4526
Hole No.	: TP07
Depth	: 600-800
Liquid Limit (%)	: 32
Plasticity Index	: 12
Linear Shrinkage (%)	: 6.0
PI of Whole Sample	: 10
P.R.A. Classification	: A-6(5)
Unified Soil Classification	: CL
Activity	: 0.48
Heave Classification	: LOW
Grading Modulus	: 0.68
Percentage (<0.002)	: 21.0
Moisture Content (%)	: 14.2

Sieve Size (mm)	0.075	0.150	0.300	0.600	1.180	2.000	4.750	7.500	15.000	30.000	60.000	75.000
% Pass. Sieve	20	21	24	26	27	30	34	40	42	45	49	50
JENN	CLAY		SILT		SAND		GRAVEL					
ASTM	CLAY		SILT		FINE SAND	MEDIUM SAND	COARSE SAND	GRAVEL				
BS	CLAY	FINE SILT	MEDIUM SILT	COARSE SILT	FINE SAND	MEDIUM SAND	COARSE SAND	FINE GRAVEL	MEDIUM GRAVEL	COARSE GRAVEL

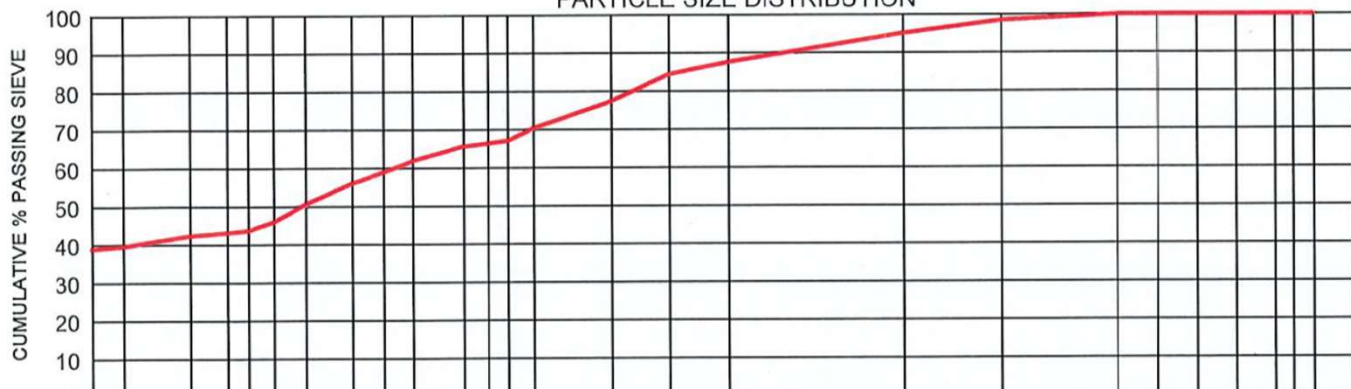
PARTICLE SIZE DISTRIBUTION

Sieve Size (mm)	0.0015	0.0020		0.0036	0.0050	0.0060	0.0075	0.0100		0.0150	0.0200	0.0250		0.0400	0.0500	0.0600	0.0750		0.1500		0.2500		0.4250		2.0000		4.7500		13.200	19.000	26.500	37.500	53.000	63.000	75.000	
% Pass. Sieve	39	40		42	43	44	46	51		56	59	62		66	66	67	70		77		84		88		95		98		100	100	100	100	100	100	100	100
JENN	CLAY			SILT				SAND										GRAVEL																		
ASTM	CLAY			SILT						FINE SAND				MEDIUM SAND			COARSE SAND	GRAVEL																		
BS	CLAY	FINE SILT		MEDIUM SILT		COARSE SILT		FINE SAND		MEDIUM SAND		COARSE SAND		FINE GRAVEL		MEDIUM GRAVEL		COARSE GRAVEL

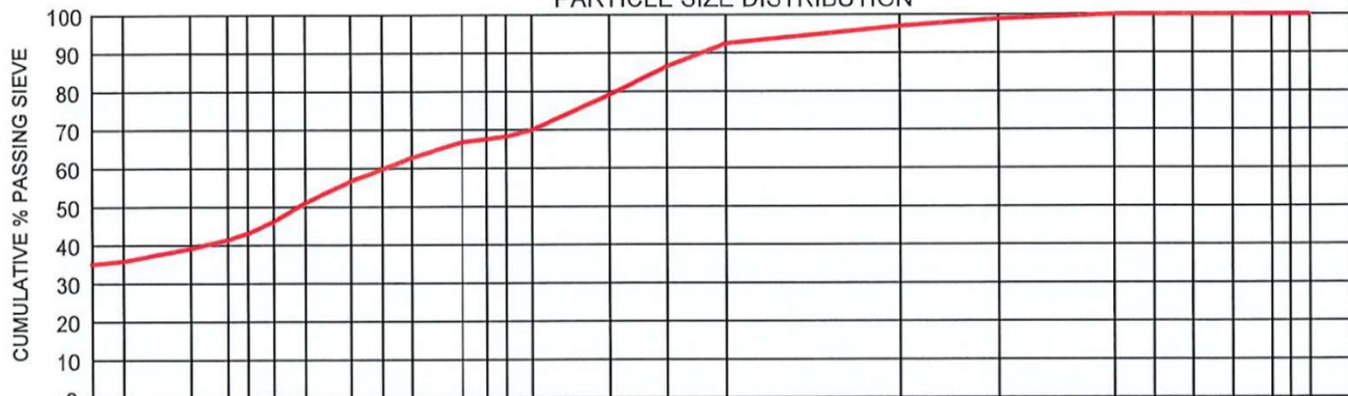
Sample No.	: L4528
Hole No.	: TP13
Depth	: 600 - 1100
Liquid Limit (%)	: 44
Plasticity Index	: 18
Linear Shrinkage (%)	: 9.5
PI of Whole Sample	: 17
P.R.A. Classification	: A-7-6(11)
Unified Soil Classification	: CL
Activity	: 0.47
Heave Classification	: LOW
Grading Modulus	: 0.41
Percentage (<0.002)	: 36.0
Moisture Content (%)	: 16.8

Sieve Size (mm)	0.0015	0.0020		0.0036	0.0050	0.0060	0.0075	0.0100	0.0150	0.0200	0.0260		0.0400	0.0500	0.0600	0.0750		0.1500	0.2500	0.4250		2.0000		4.7500		13.200	19.000	26.500	37.500	53.000	63.000	75.000
% Pass. Sieve	35	36		39	41	43	46	51	57	60	63		67	68	68	70		79	86	92		97		99		100	100	100	100	100	100	100
JENN	CLAY		SILT				SAND										GRAVEL															
ASTM	CLAY		SILT				FINE SAND				MEDIUM SAND		COARSE SAND	GRAVEL																		
BS	CLAY	FINE SILT	MEDIUM SILT	COARSE SILT	FINE SAND	MEDIUM SAND	COARSE SAND	FINE GRAVEL	MEDIUM GRAVEL	COARSE GRAVEL
