# **Final Geotechnical Investigation Report for Zinyosini Senior Secondary School as Part of the Implementation of Sanitation Programme at Various Schools in the Eastern Cape Province**

Report  
Version – Final

June 2026

iLZ\_26\_056\_Zinyosini SSS

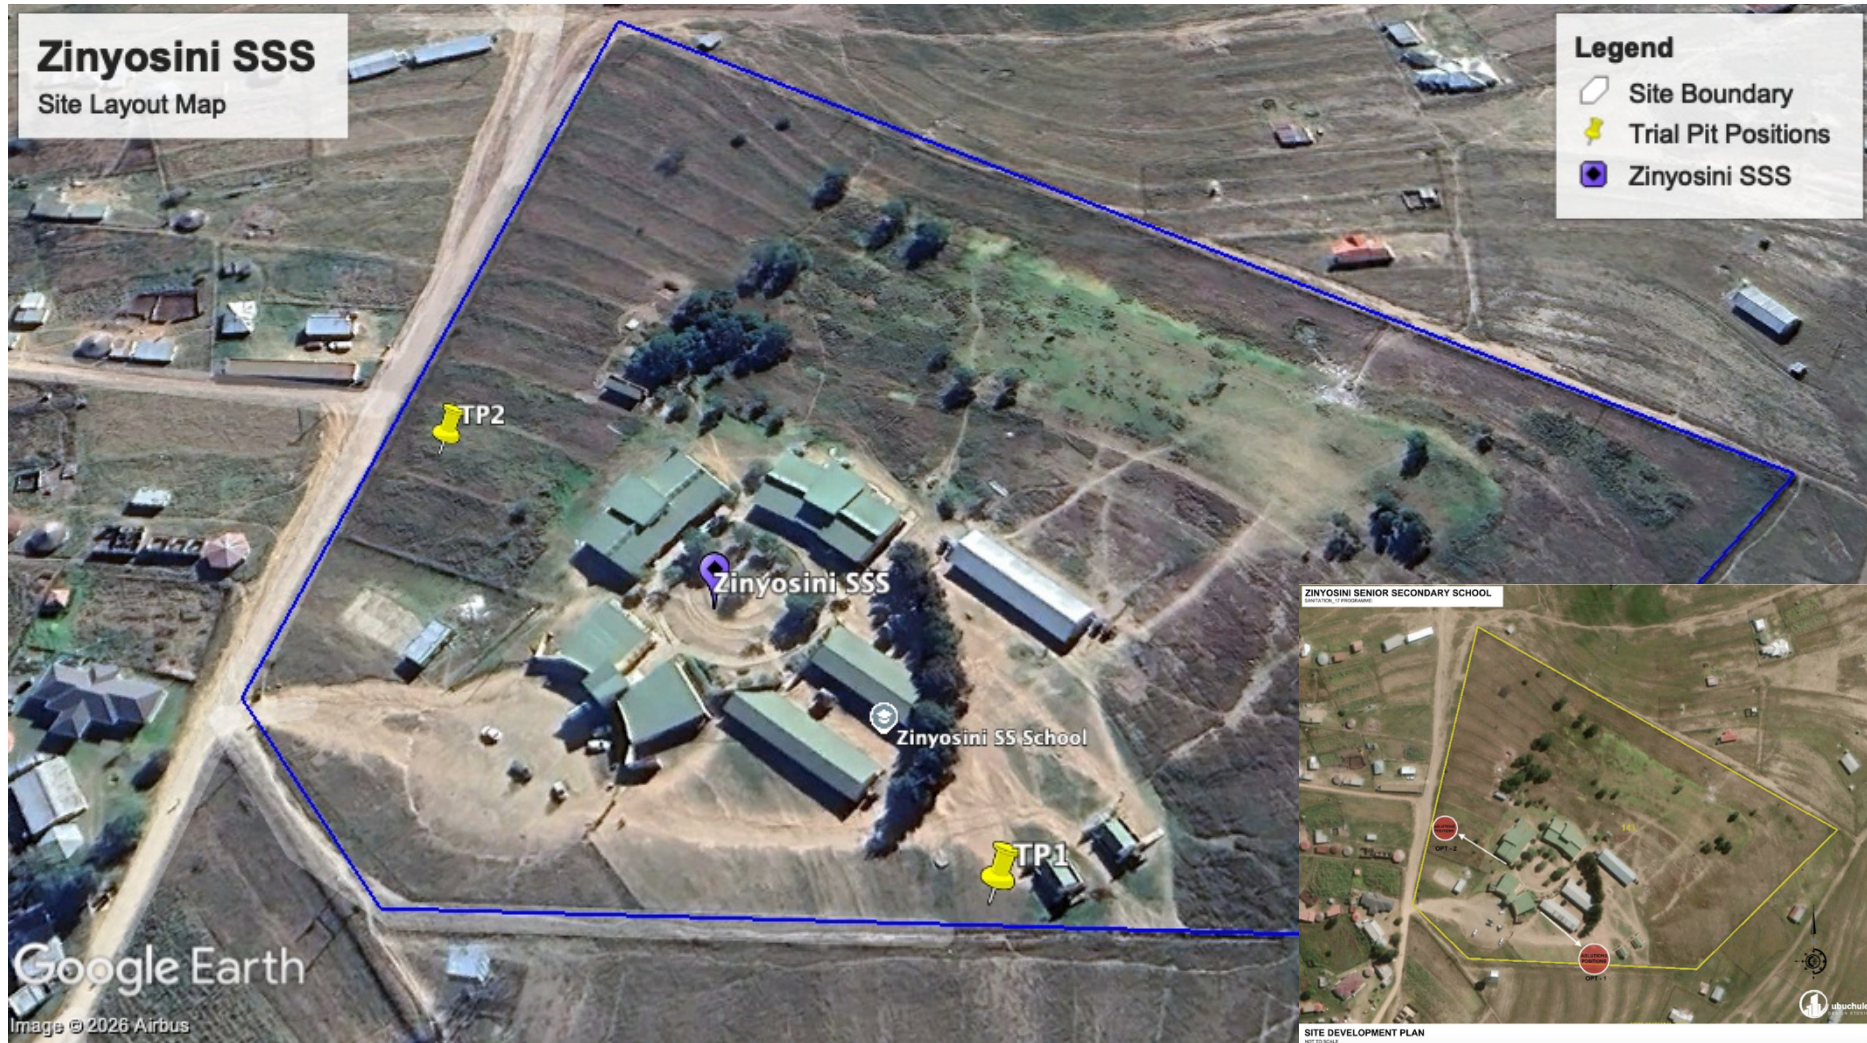
**Figure 4-1: Trial pit positions.**

- Siting of 2 trial pits using SDP's of where the proposed structures positions:
  - New ablutions (boys, girls, and staff)
- Test pits were excavated using hand tools and profiled by an Engineering Geologist using SANS 633 guidelines.
- Penetrometer tests (DCP) tests were conducted adjacent to each trial pit

These positions are all marked in **Figure 4-1** below as per the provided SDP.

Two trial pits, labelled TP1 and TP2, were excavated manually with pick and shovel at locations designated for the proposed new ablutions, i.e. proposed positions as per SDP. The excavation focused on areas planned for boys, girls and staff. The trial pits were all excavated to a maximum refusal depth between 0.60 and 0.75 meters below the existing ground level (mbgl).

Two Dynamic Cone Penetrometer tests (DCP), designated DCP1 and DCP2, were conducted adjacent to the test pits. The tests were all advanced to a maximum refusal depth between 0.50m and 0.70m below existing ground level. The tests were done to primarily ascertain excavation classification and to estimate the bearing capacity of the local soils.

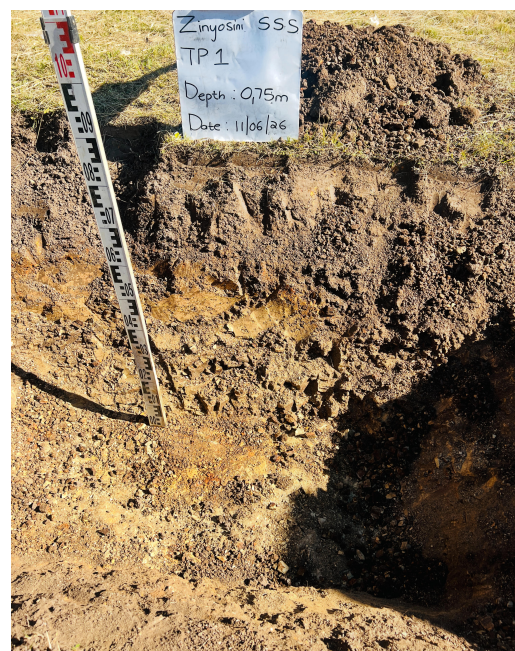
**HOLE No: TP1**

- 1) Refusal at 0.75m weathered mudstone.
- 2) No groundwater seepage.
- 3) No sidewall collapse.

**CONTRACTOR :**  
**MACHINE :** Pick and Shovel  
**DRILLED BY :**  
**PROFILED BY :** A Mdlalose  
**TYPE SET BY :** A Mdlalose  
**SETUP FILE :** STANDARD.SET

**ELEVATION :**  
**X-COORD :** 29.134973°  
**Y-COORD :** -31.088645°

This horizon was encountered throughout the site at depths ranging from surface to 0.30m overlying the weathered mudstone. It was described as slightly moist, light brown, firm, intact, fine to grained, slightly gravelly silty sand with roots.

The weathered tillite was encountered underlying the colluvial soils at depths ranging from 0.30 to 0.75m below existing ground level. It was described as orangey brown to greenish grey, completely to highly weathered, highly fractured, fine grained, very soft to soft mudstone.
