**REPORT TO TLS ENGINEERS AND PROJECT MANAGERS ON THE  
RESULTS OF A GEOTECHNICAL MATERIALS INVESTIGATION FOR THE  
PROPOSED REHABILITATION OF ROAD M89 IN WARD 18,  
MSUNDUZI MUNICIPALITY**

**REPORT REFERENCE: SGE-060-2020.REP01**

**Date: 28 July 2020**

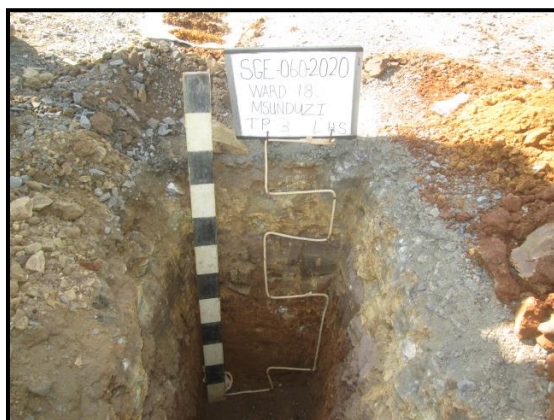
Plate 3: TP3

The geology along the gravel road is generally characterised by a gravel wearing course layer, subgrade fill gravelly sand layer, insitu (natural) clayey soils and completely to highly weathered dolerite bedrock at depth.

Plates 3 and 4: Typical subsoil layers encountered along the road

**Regarding the above, the reddish brown silty clay in-situ materials at formation level are considered poor subgrade. However, decomposed dolerite in-situ subgrade is anticipated to classify as G7 – G8 according to TRH14 (but additional laboratory testing will be required to confirm this during construction).**

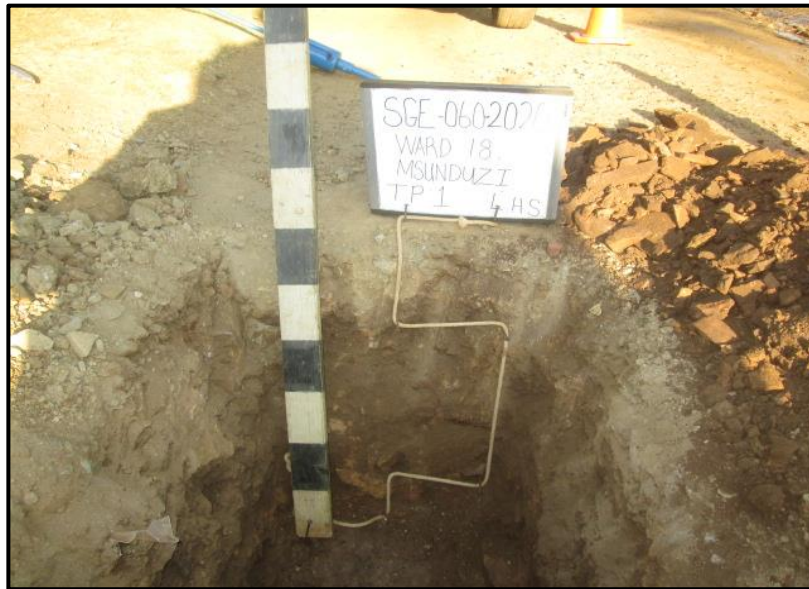
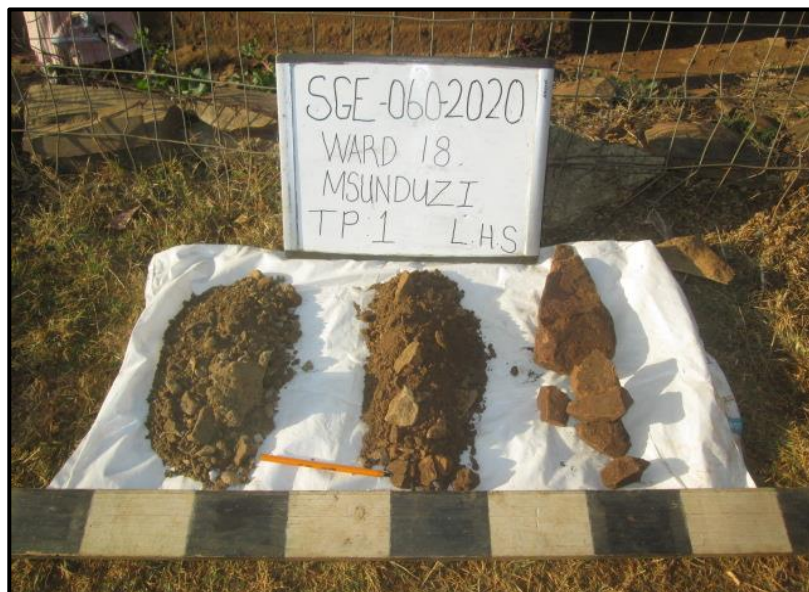
0.00m-0.15m

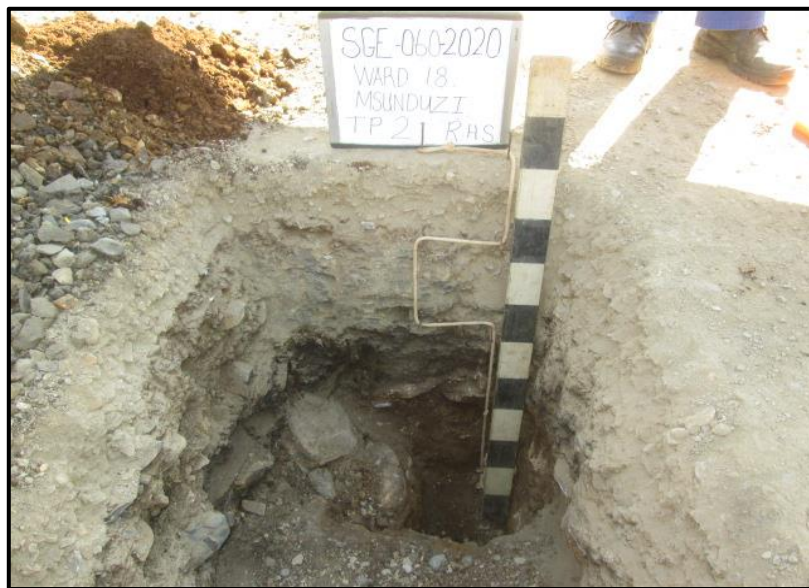
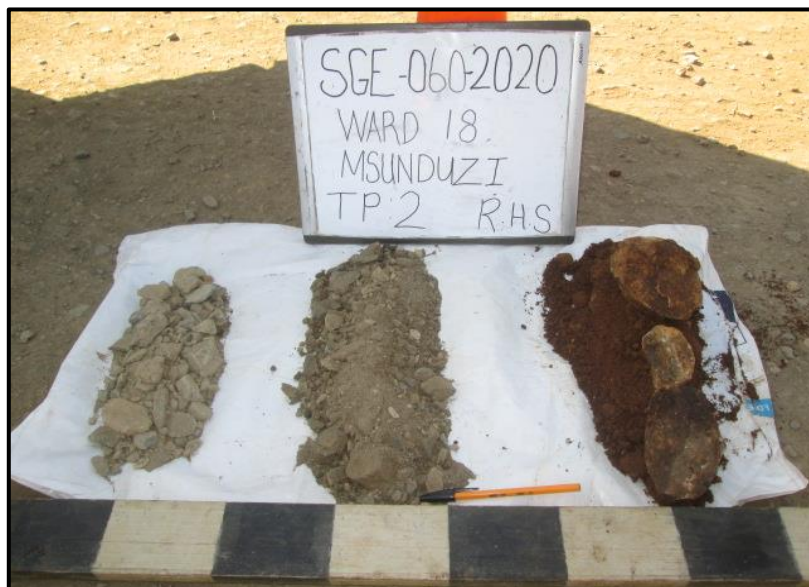
**HOLE No: TP 2**

Slightly moist, light grey, medium dense to dense, uniform, sandy GRAVEL - WEARING COURSE.

Slightly moist, grey to greyish brown, medium dense to dense, uniform, sandy GRAVEL - OLD WEARING COURSE.

Yellowish brown, stained orange, completely to highly weathered, medium to coarse grained, highly fractured, extremely soft to very soft rock - DECOMPOSED DOLERITE - SUBGRADE INSITU.

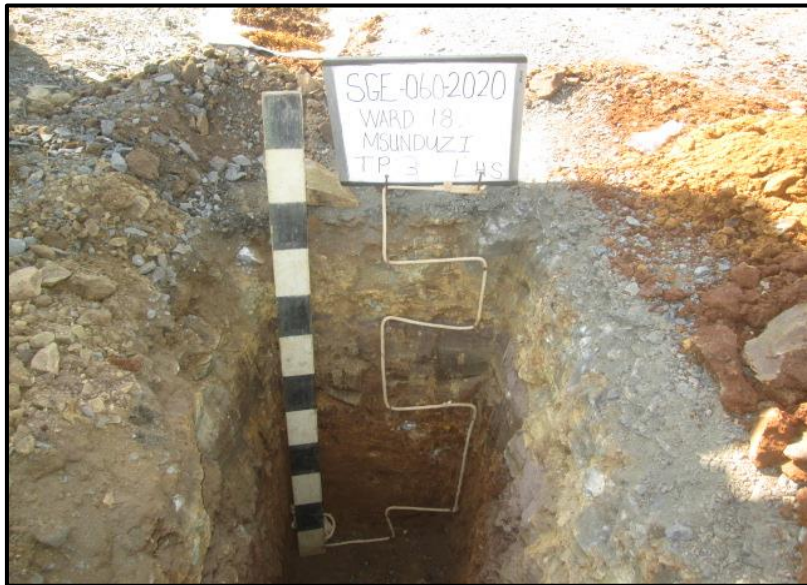
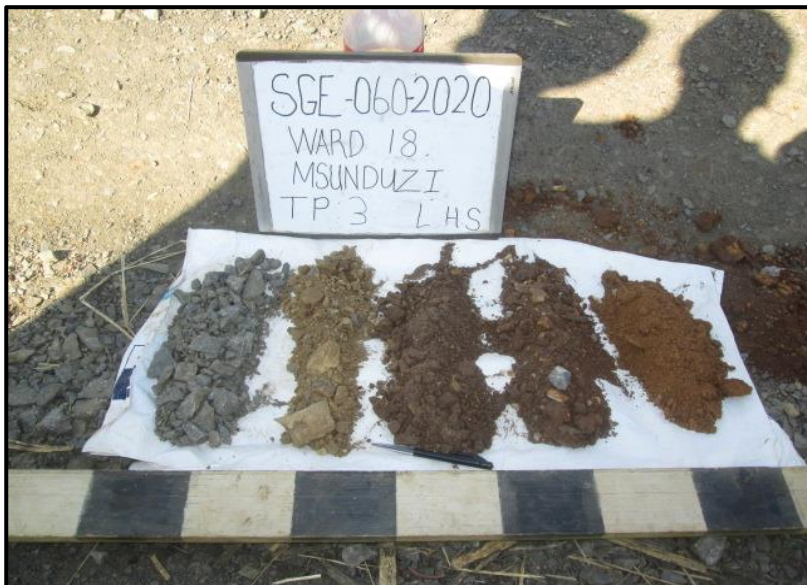
**HOLE No: TP 3**

- 1) Depth of water table: Not encountered.
- 2) Sample taken at:  
 S1 0.50m-0.90m (2 x Bulk).
- 3) Final depth at 1.00m.

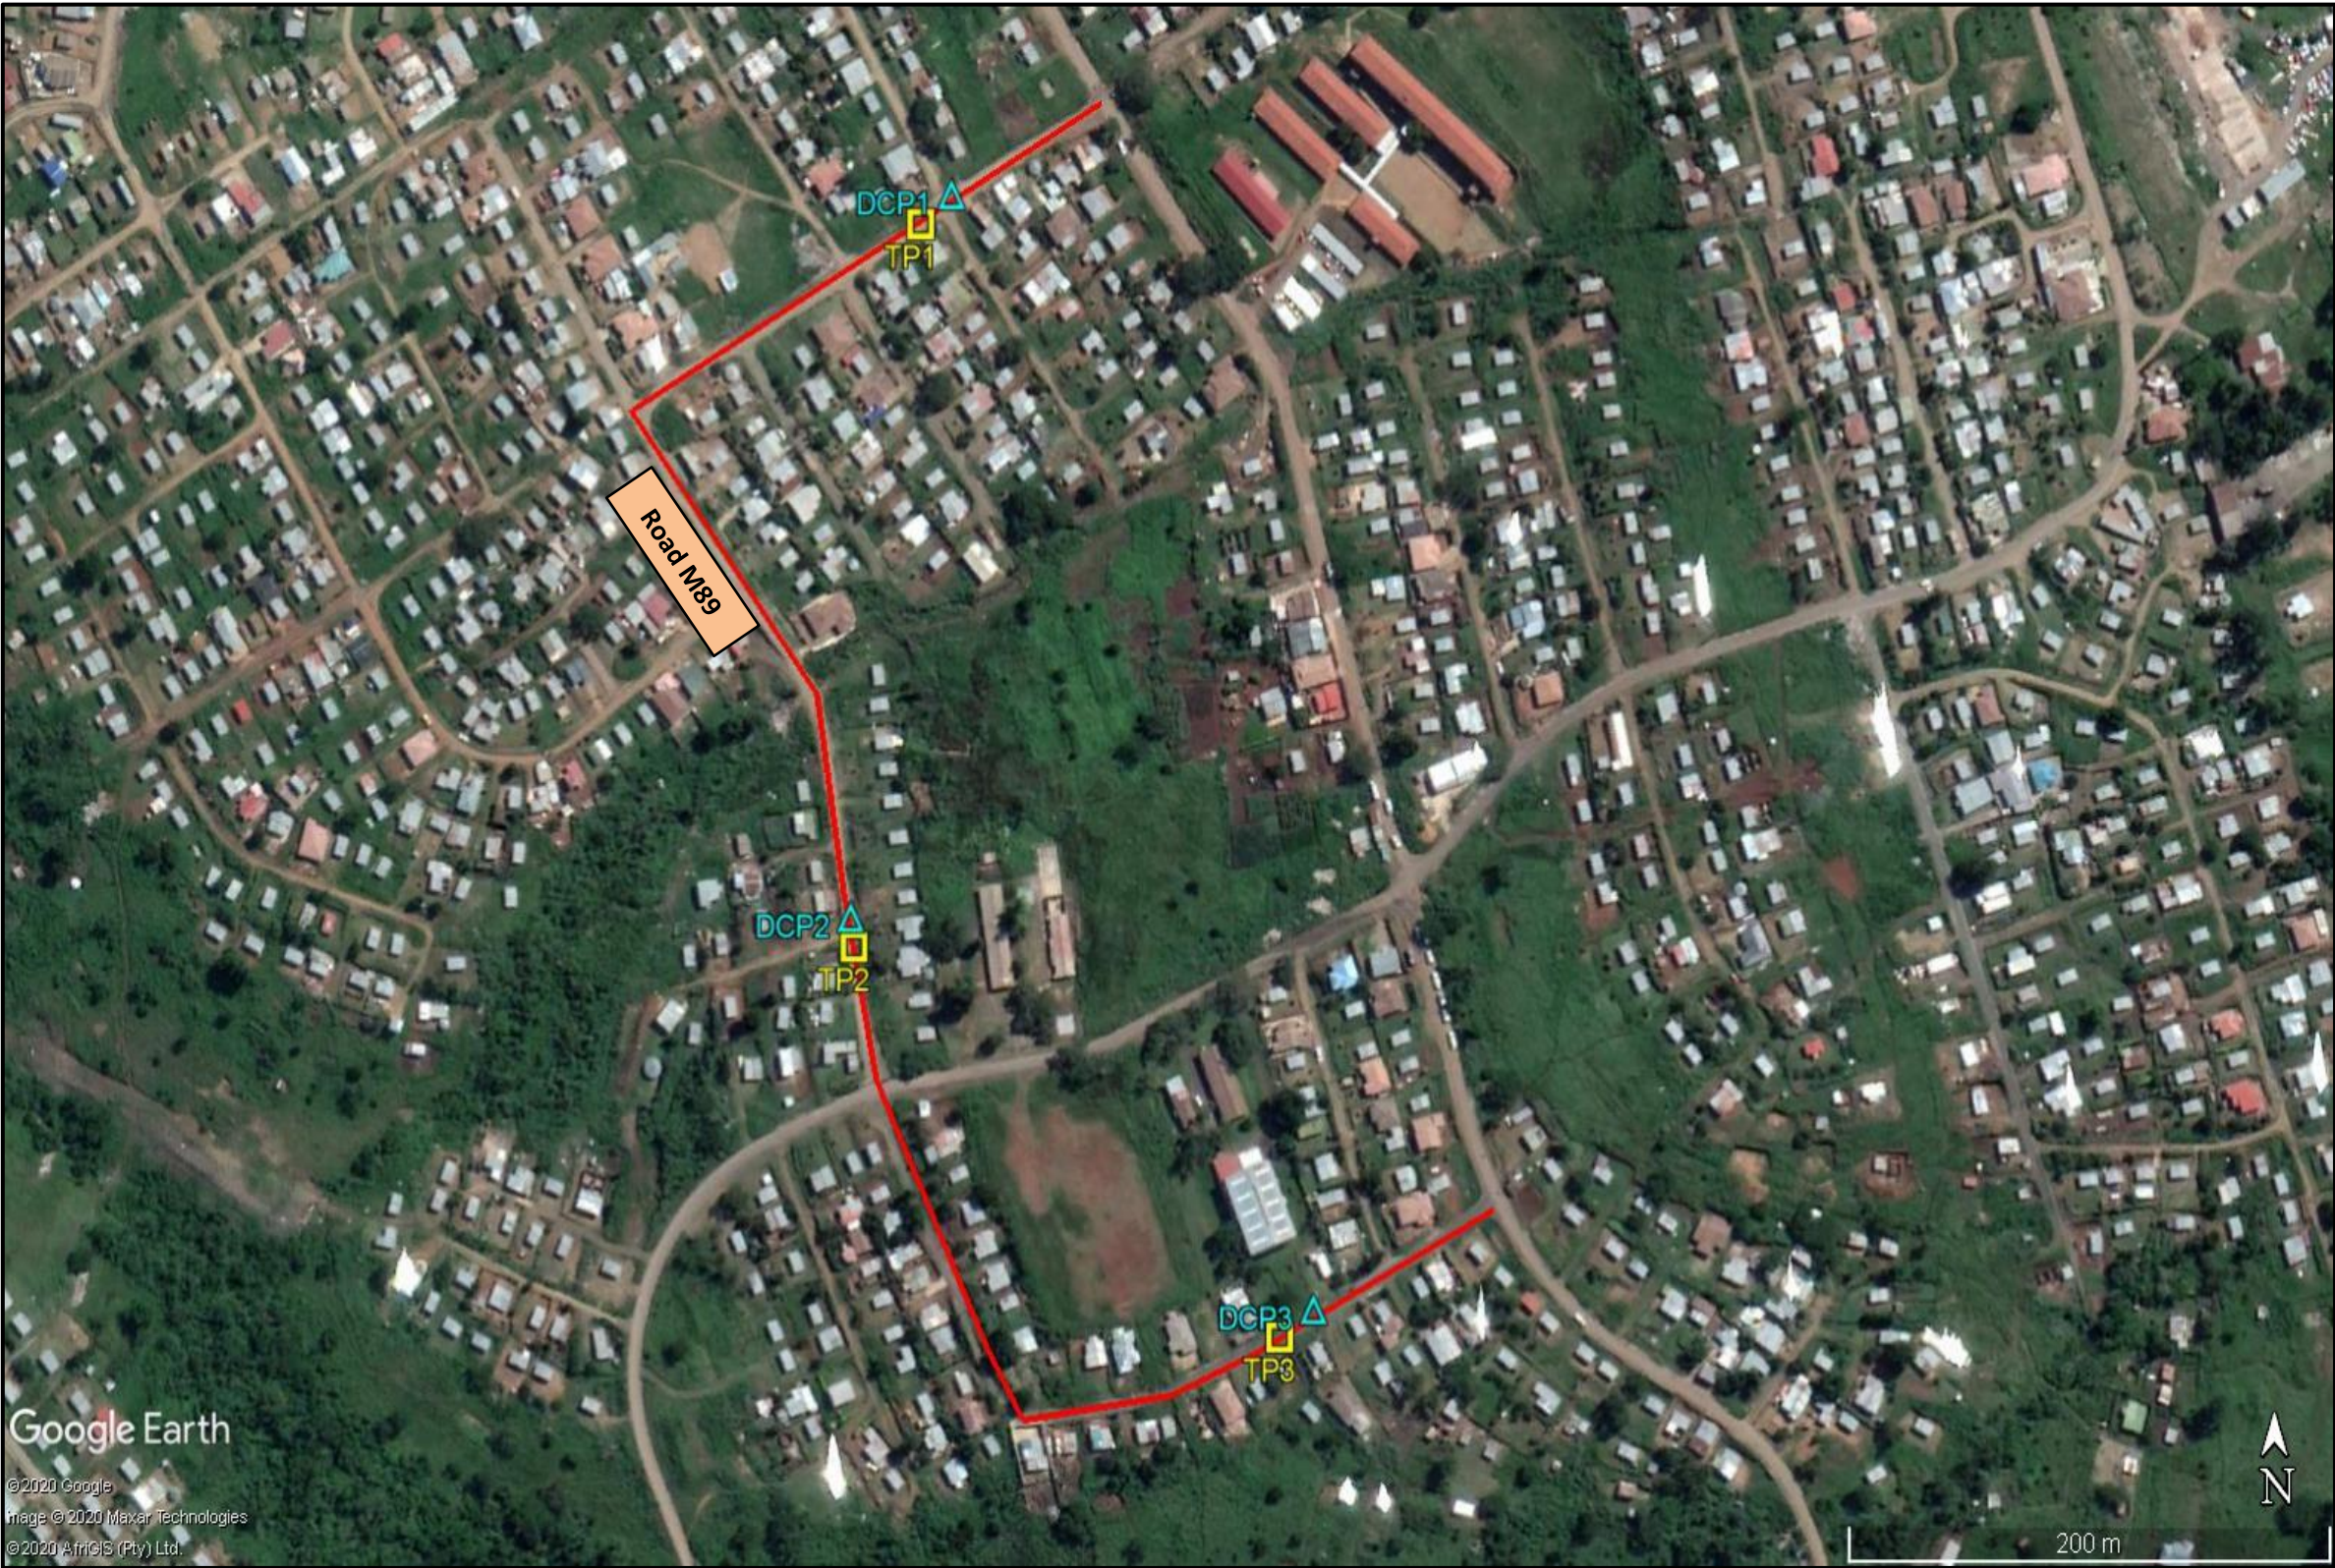
**TP1** – Approximate position of Test Pit

**DCP1** – Approximate position of CBR Dynamic Cone Penetrometer (DCP) Test

Three (3No.) Test Pits, designated TP1 through TP3, were excavated by hand at the approximate positions indicated in Figure 1.

Three (3No.) CBR Dynamic Cone Penetrometer (DCP) tests, designated DCP1 to DCP3, were carried out at the approximate positions indicated in Figure 1. The DCP tests were advanced to a final depth of 1.0 below EGL or equipment refusal.
