Coega Development Corporation

Port of Durban Validation | Demolition Phase 1

Demolition Strategy – Rev B

Reference: RP-N-0003

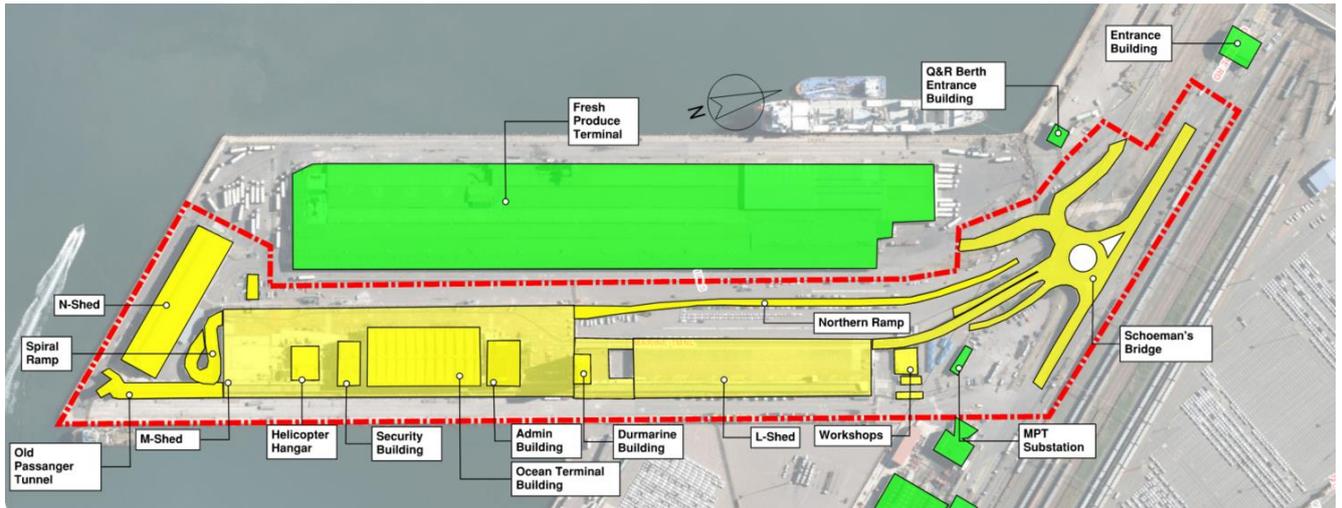
Figure 2: Key plan of buildings to be demolished on T- Jetty, focus on phase 1

The extent of demolition, as well as description of each building, is provided in a separate report. These are reproduced in the images below for ease of reference.

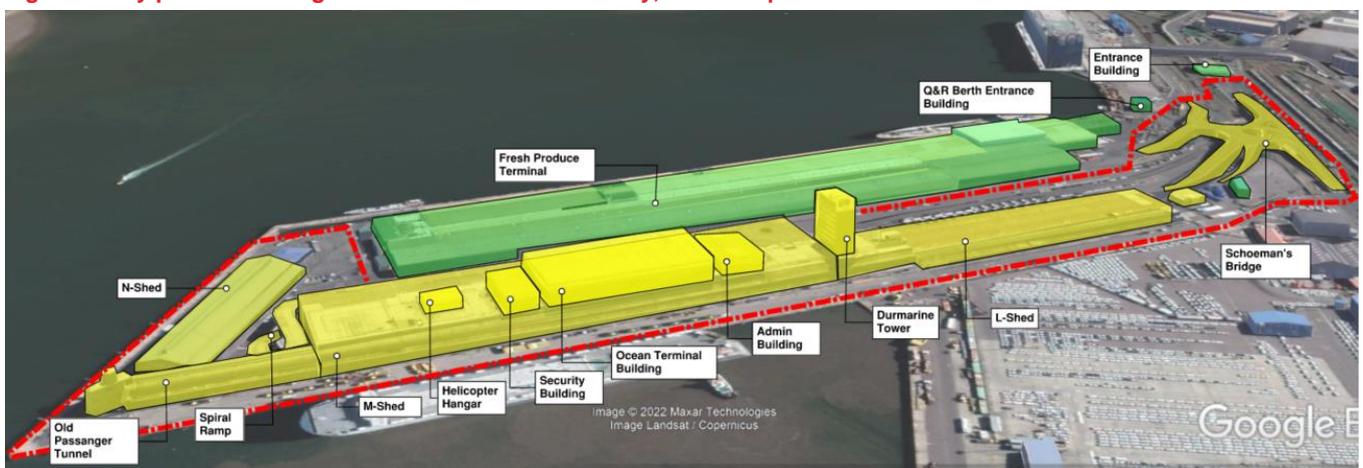
Figure 3: 3d Render of structures to be demolished during phase 1

The demolition involves the superstructure only, up to the top of foundation. Substructure is not to be demolished and removed. Furthermore, all in-ground services to remain, and not be removed.

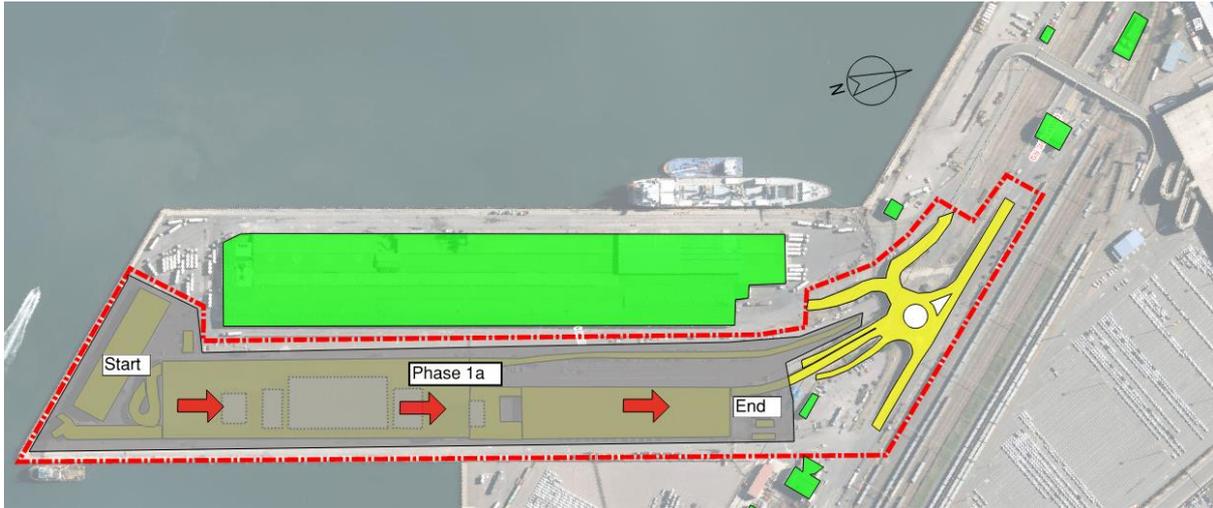
Figure 4: Illustration of buildings demolished during phase 1a

- Demolition is to commence on the southern tip of T-jetty, progressing in a northerly direction, beginning with N shed and the old passenger tunnel, M shed and associated structures, Durmarine tower, and finally L-shed and adjacent structures. This will complete phase 1a of demolition.
- Phase 1b will be the demolition of Schoeman's bridge and elevated roads.

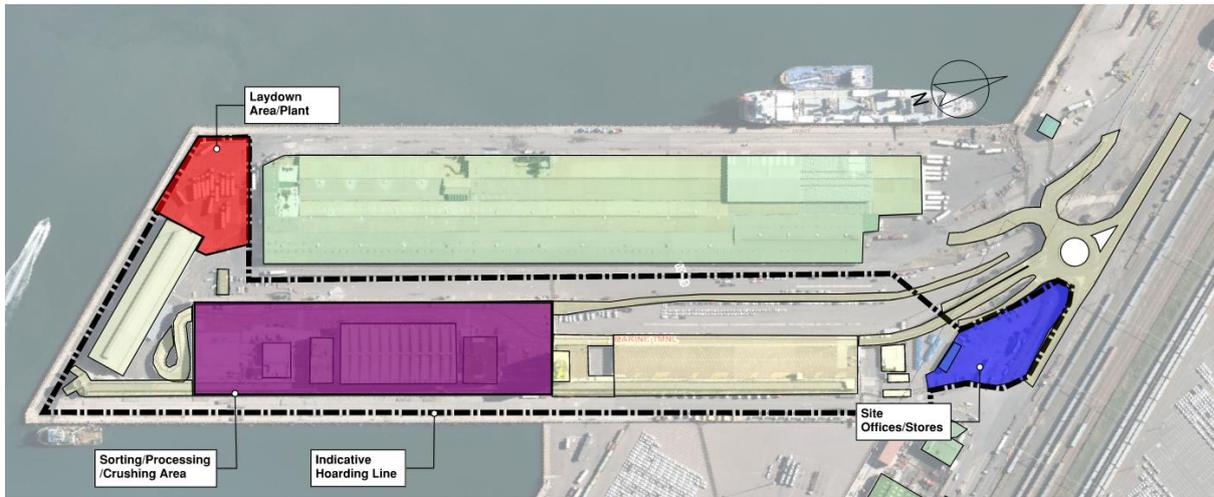
Figure 6: Phase 1a hoarding and site plan

The hoarding line along FPT is indicatively shown. Whilst it is envisaged that temporary hoarding will be installed along the full length, an opportunity exists to utilise the existing fence between the

FPT ring road and L/M sheds as the hoarding. Maximising demolition space along this line is also key to facilitate demolition of higher structures, particularly the Durmarine Tower.

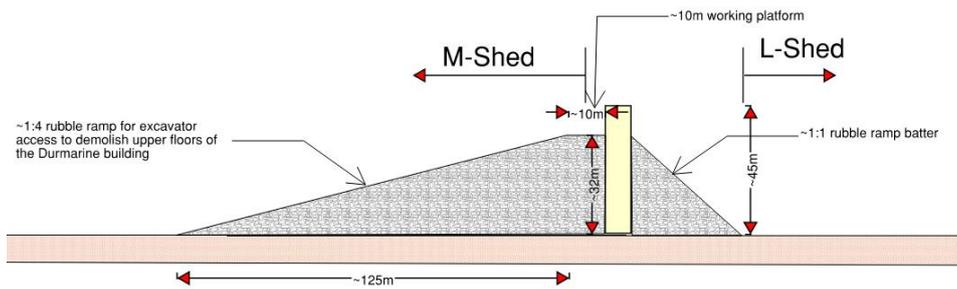
Figure 10: Illustrative Long sector through ramp for Durmarine Demolition

The ramp for the Durmarine demolition is to be created using the available rubble on site. The ramp and associated batters will need to be designed by the demolition contractors' temporary works designer to ensure safety and stability.

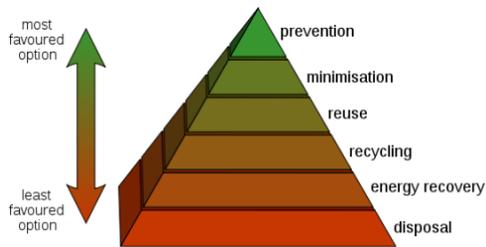
Figure 12: Waste management strategy

It is expected that best practice will be implemented in dealing with waste generated through the demolition process. A comprehensive waste management plan is expected to be produced by the contractor incorporating principles of recycling as illustrated in the image below.

As discussed earlier in this report, the intention is for the contractor to maximise the salvageable material obtained through the demolition. This will naturally result in the incorporation of the waste management strategy.

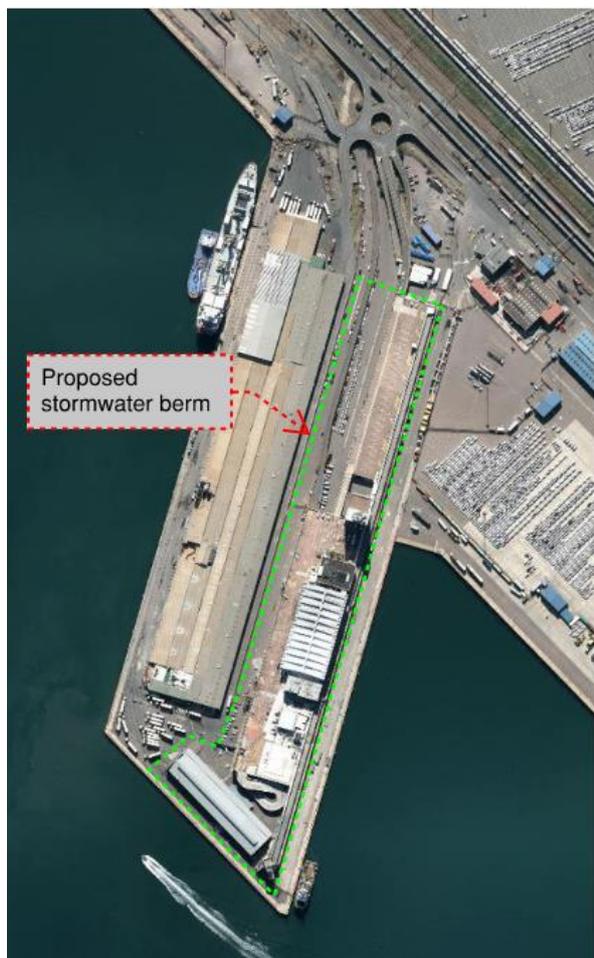
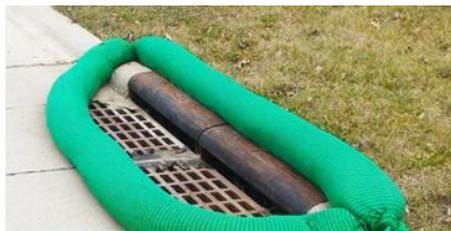
Figure 13: Proposed Berm extents (left) and berm options (right)

Image of water tube protecting grating

Image of water tube

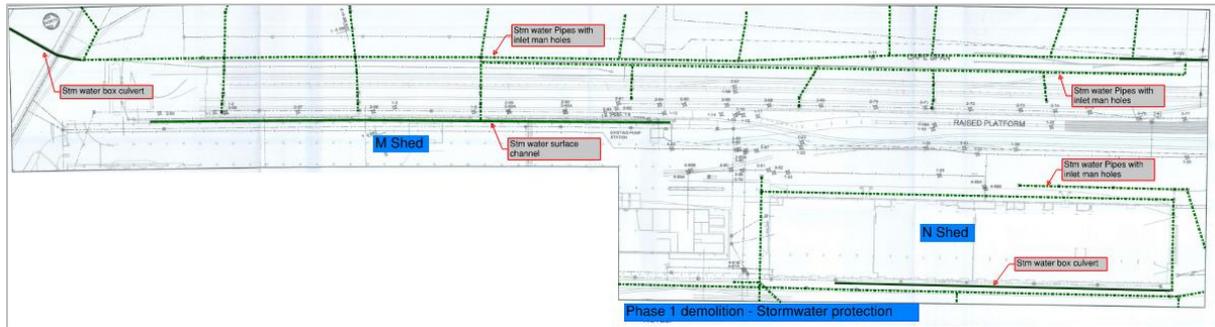
Figure 14: Stormwater management during demolition

All existing stormwater gratings to be fitted with sand/silt screen to prevent debris from entering the system.

All stormwater runoff must be directed towards the existing stormwater inlet sand gratings within the site boundary.

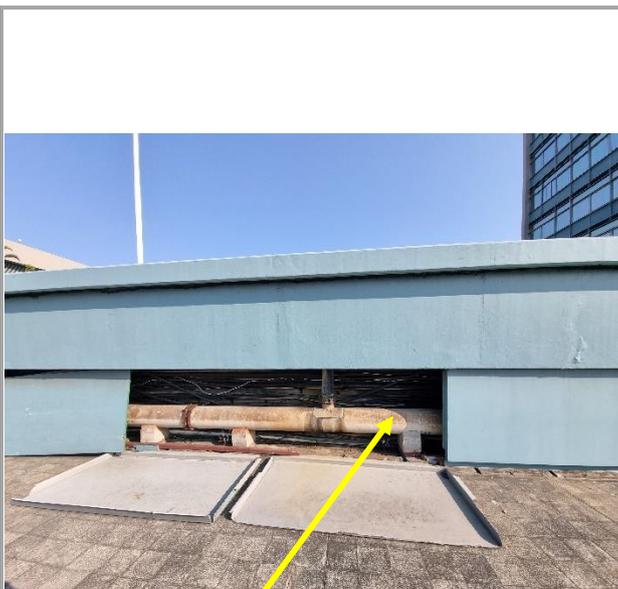
Asbestos Cement Pipe

- 1) If possible, leave undisturbed.

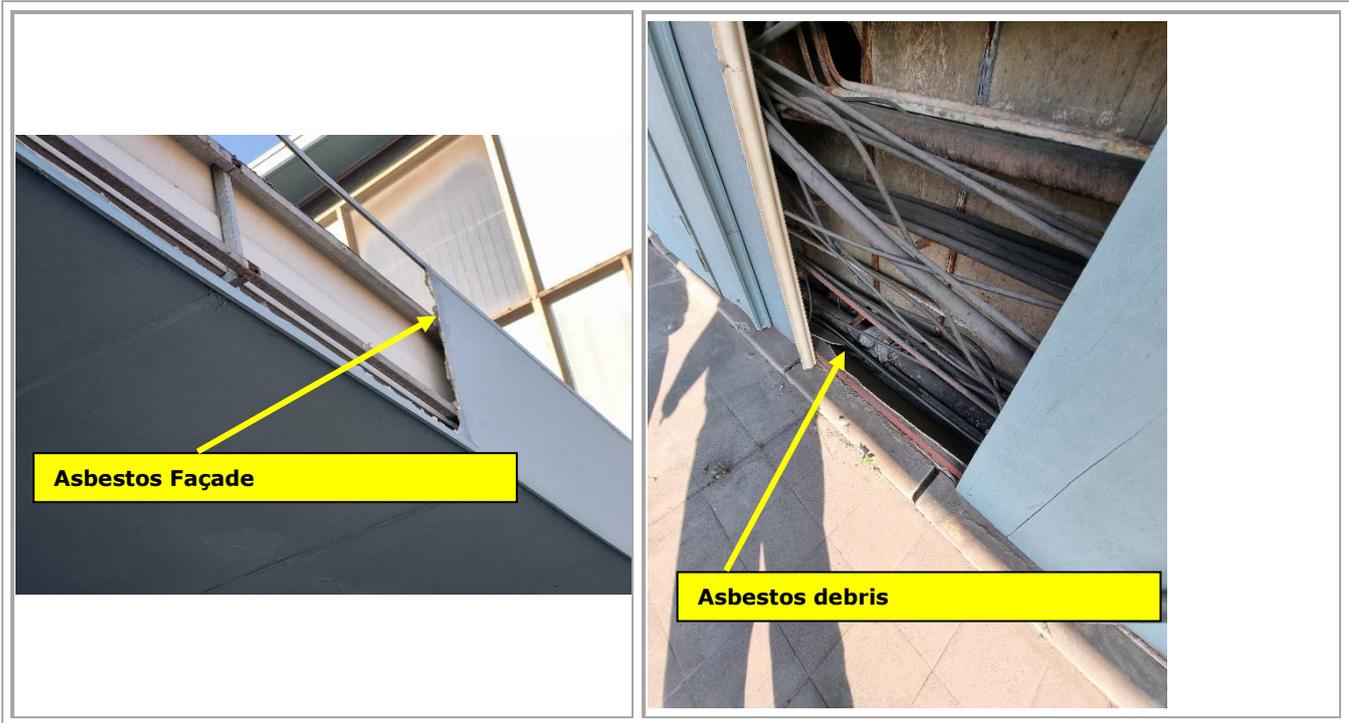
Department / Building name:	9 Storey Building				
Location of Asbestos:	Material Type:	Approximate Quantity in m² / LNM (Linear Metre):	Condition of Asbestos:	Probability of Disturbance:	Risk Rating:
Side louvres – Above Canteen	Asbestos containing Louvres	80m ²	Moderately Bonded	Rare	A2
Observations:					
ACM is not sign-posted / labelled as recommended in the Asbestos Abatement Regulations, 2020. Some damage to louvres observed (see photo below)					
Recommendations:					
If possible, leave undisturbed. Affix signage in a conspicuous location, refer to Annexure 1 for signage requirements.

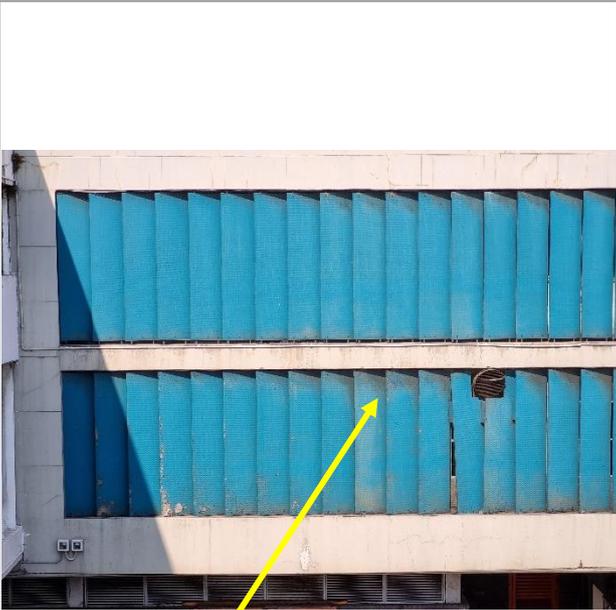
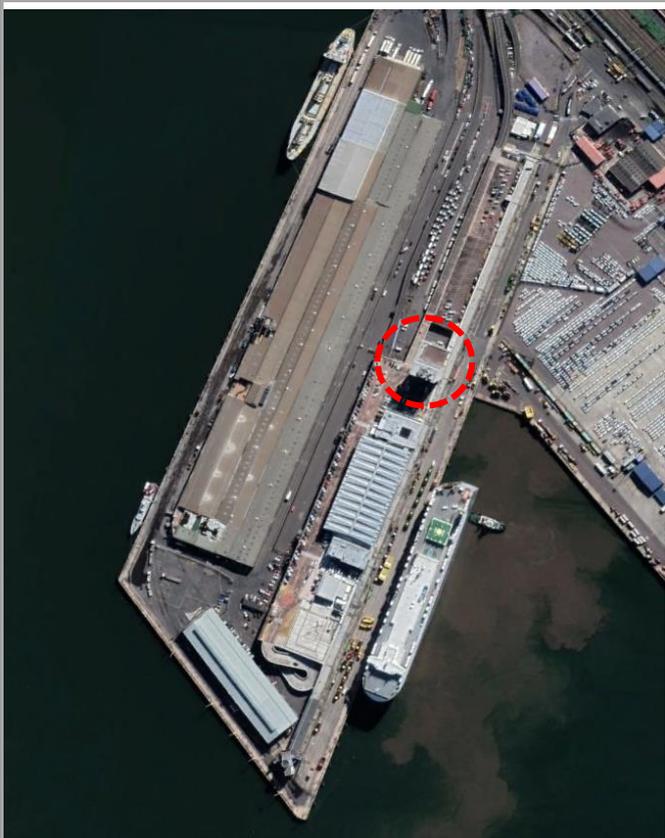
Asbestos Containing Louvres

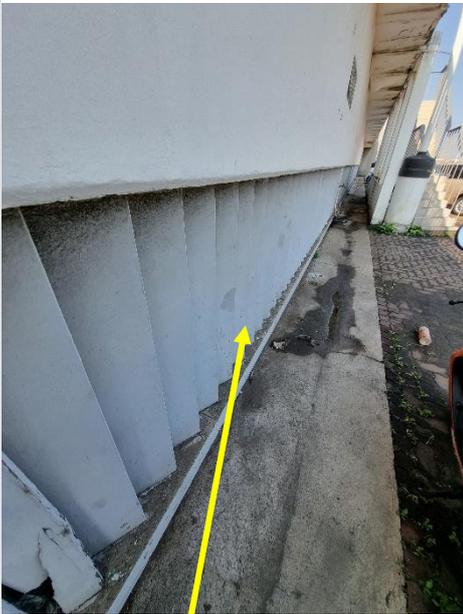
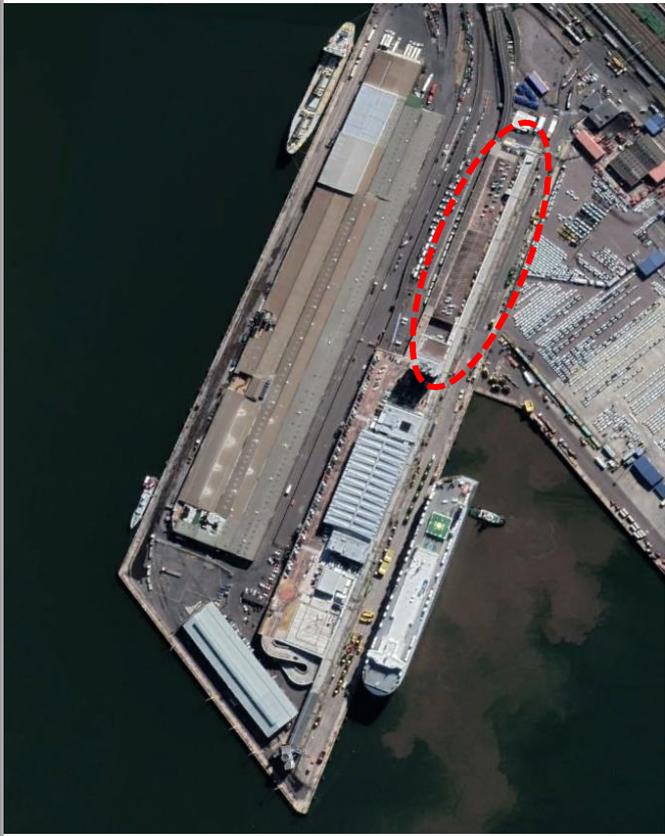
Department / Building name:		L Shed			
Location of Asbestos:	Material Type:	Approximate Quantity in m² / LNM (Linear Metre):	Condition of Asbestos:	Probability of Disturbance:	Risk Rating:
Side louvres –	Asbestos containing Louvres	140 LNM	Poorly to Moderately Bonded	Medium Disturbance	C3
Observations:					
ACM is not sign-posted / labelled as recommended in the Asbestos Abatement Regulations, 2020. Some damage was noted on some of the louvres.					
Recommendations:					
If possible, leave undisturbed. Replace broken pieces with non-asbestos containing material. Affix signage in a conspicuous location, refer to Annexure 1 for signage requirements.

Asbestos Containing Louvres

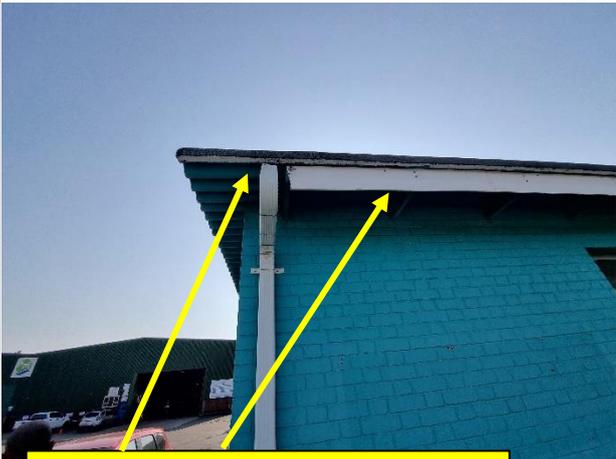
Department / Building name:		N Shed - Ablutions			
Location of Asbestos:	Material Type:	Approximate Quantity in m ² / LNM (Linear Metre):	Condition of Asbestos:	Probability of Disturbance:	Risk Rating:
Roof	Corrugated Asbestos Cement Sheets	90m ²	Well to Moderately Bonded	Rare	A2
Fascia/Barge Boards	Asbestos containing Fascia Boards	40 LNM			A2
Observations:					
ACM is not sign-posted / labelled as recommended in the Asbestos Abatement Regulations, 2020.					
Recommendations:					
If possible, leave undisturbed. Affix signage in a conspicuous location, refer to Annexure 1 for signage requirements.

<p>Asbestos Containing Barge Boards and sheeting</p>
