### **Bridge & Marine**

### **Design criteria**

### Design ship characteristics

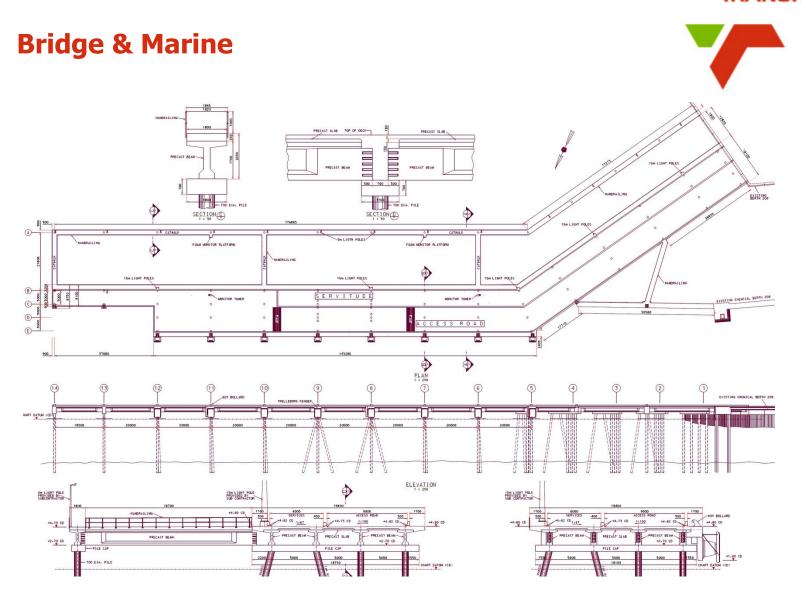
### Possible structures considered

- Gravity Structures
  - Dolphin structure with caissons
  - Anchored sheetpile wall
  - Block or counterfort wall structure
- Piled Structure
  - Due to poor soil conditions the only viable solution
