May 2017

ESKOM HOLDINGS SOC

Tutuka Ash Disposal Facility Extension Geotechnical Investigation Report

Report Number: 1658666-310335-1

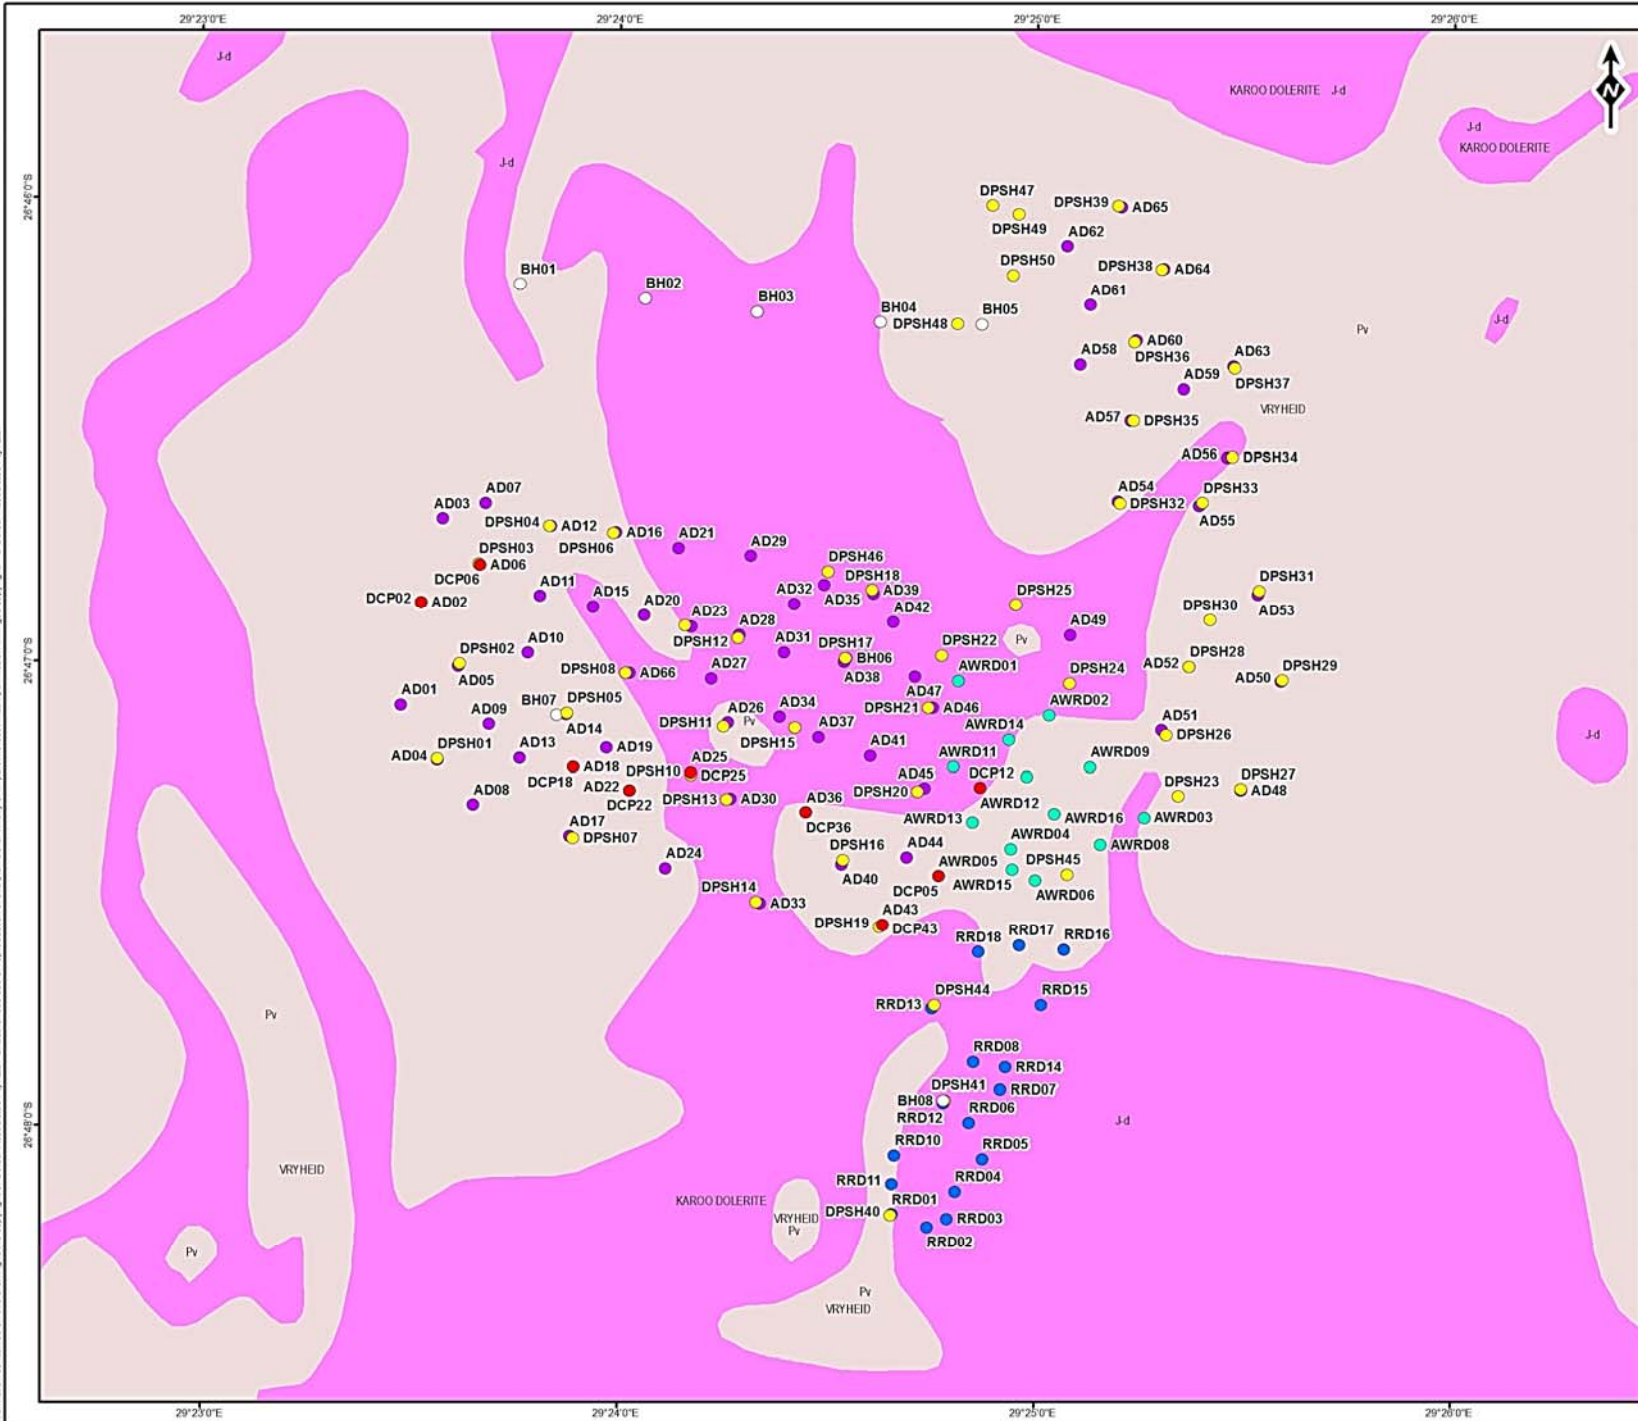
- LEGEND**
- Ash Dump
 - Borehole
 - Dynamic Cone Penetration
 - Dynamic Probe Super Heavy
 - Pollution Control Dams
 - Runoff Return Dams
- RSA250k_Litho_Chronostratigr...

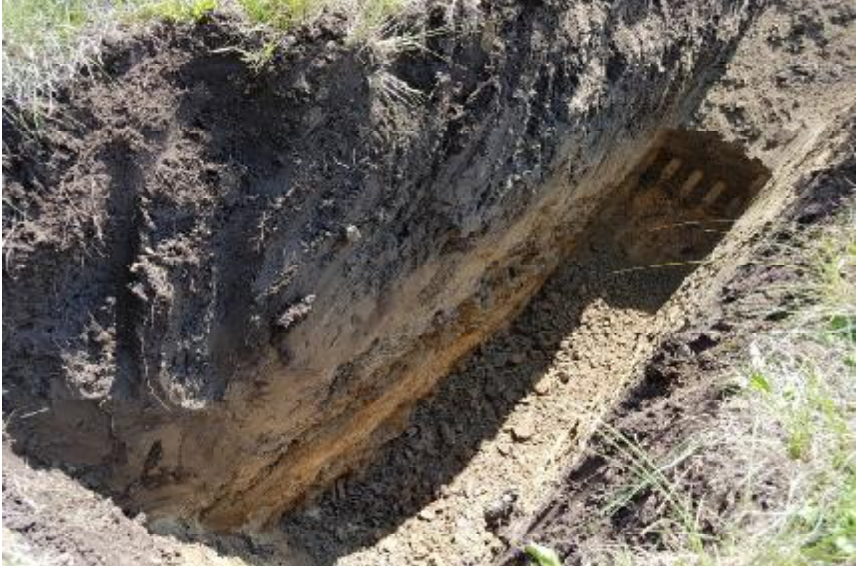
Table 3: AD03

Description	Photo
<p>AD03 Total depth is 2.3 m</p>

A photograph of a test pit showing soil layers. The top layer is dark brown, followed by a lighter brown layer, and then a darker, more textured layer at the bottom. The pit is dug into the ground, and some vegetation is visible around the edges.
<p>AD03 Material from 0 to 2.3 m</p>

Scale	Legend	Depth	Description
0.5		0.00	Moist, dark brown to grey, <u>firm</u> , shattered, silty CLAY. ALLUVIUM.
1.0		0.70	Moist, dark brown becoming grey, <u>stiff</u> , shattered, silty CLAY with minor sand. SHEETWASH.
1.5		0.90	Slightly moist, light yellowish brown, <u>stiff</u> , shattered and slickensided, silty CLAY with minor sand. RESIDUAL SHALE.
2.0		1.10	Yellowish brown, medium weathered, very fine grained, laminated and fissile, closely jointed, <u>soft rock</u> SHALE.
2.5		2.30	Refusal at 2.3 m
3.0			End of log
3.5

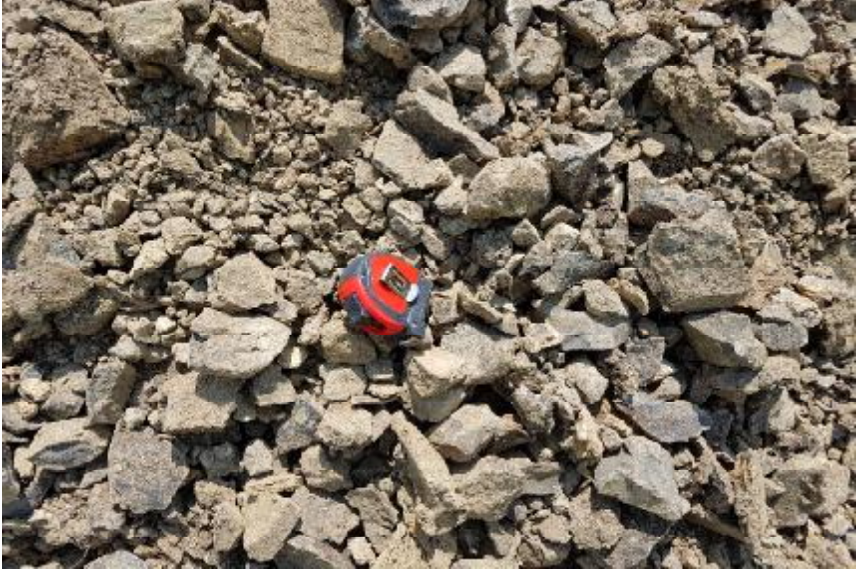
A photograph of a pile of rocks of various sizes, ranging from small pebbles to larger boulders. A red and blue measuring tape is placed on the rocks in the center of the frame for scale.

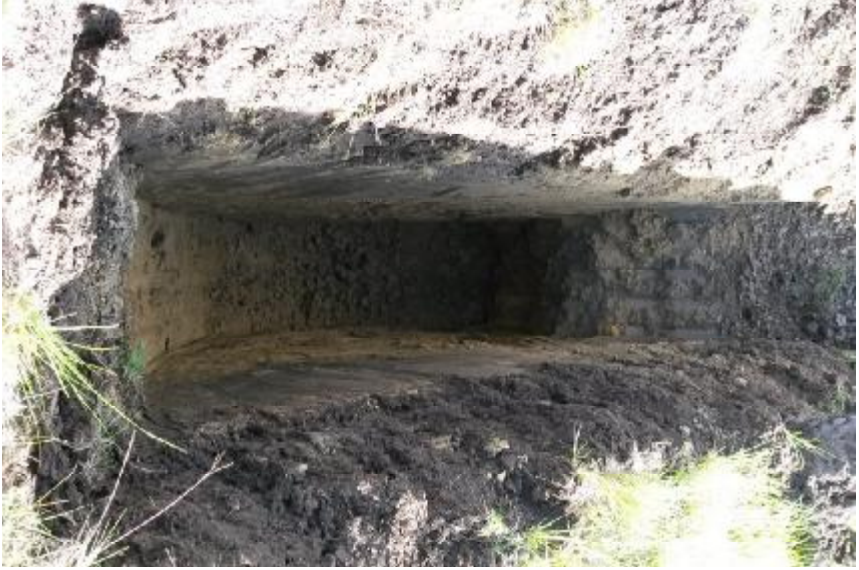
Table 4: AD04

Description	Photo
<p>AD04 Total depth is 3.25 m</p>

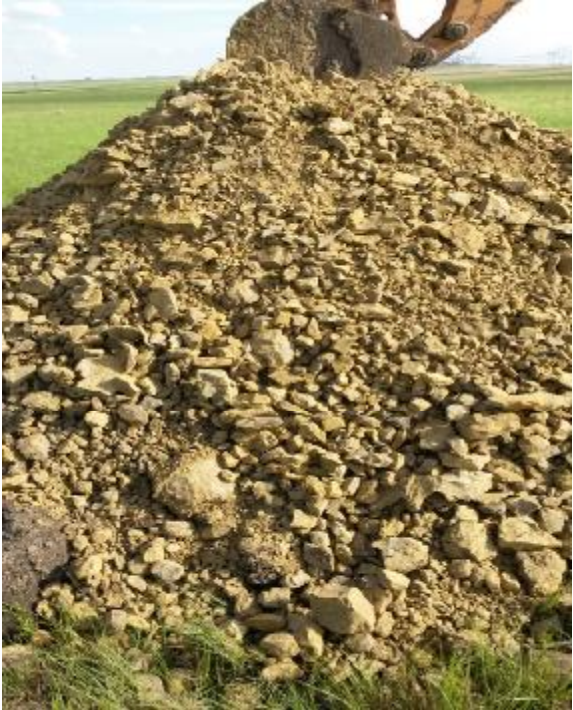
<p>AD04 Material from 0 to 3.25 m</p>

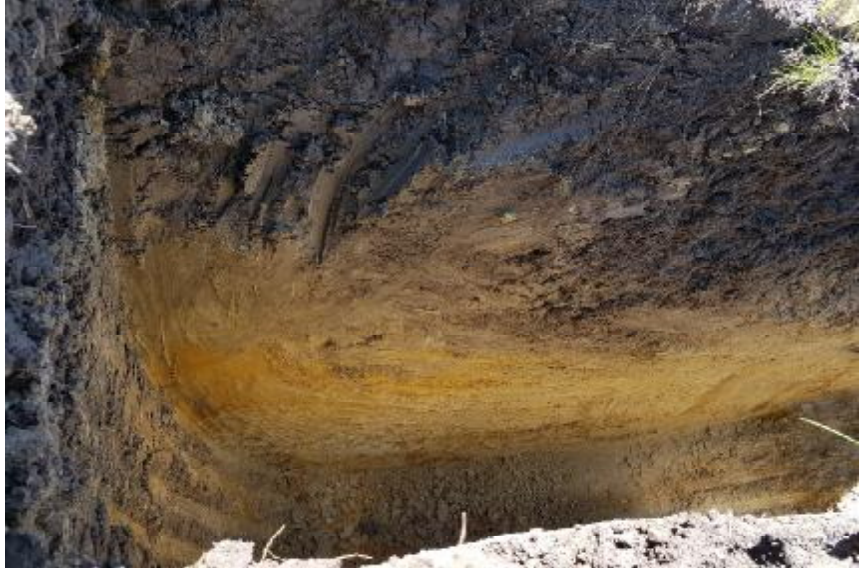
Table 8: AD08

Description	Photo
<p>AD08 Total depth is 3.05 m</p>

A vertical cross-section of a test pit. The top layer is dark, almost black, soil. Below this is a thick, uniform layer of light brown, silty soil. At the bottom, there is a thin, dark, and more textured layer. The pit is surrounded by a gravelly or rocky ground surface.
<p>AD08 Material from 0 – 3.05 m</p>

Scale	Legend	Depth	Description
		0.00	Moist, dark brown, <u>very soft to soft</u> , shattered, silty CLAY with traces of rootlets. SHEETWASH.
0.5		0.40	Moist, dark grey becoming speckled black, <u>firm to stiff</u> , shattered and moderately slickensided, silty CLAY. SHEETWASH.
1.0		0.75	Slightly moist, olive grey speckled black, <u>stiff</u> , shattered and slickensided, silty CLAY with minor sand. RESIDUAL SHALE.
1.5		1.60	Greenish, highly weathered, very fine grained, laminated and fissile, closely jointed, <u>very soft to soft rock</u> SHALE.
2.0		2.0	
2.5		2.5	
3.0		3.0	
		3.05	No Refusal
3.5			End of log

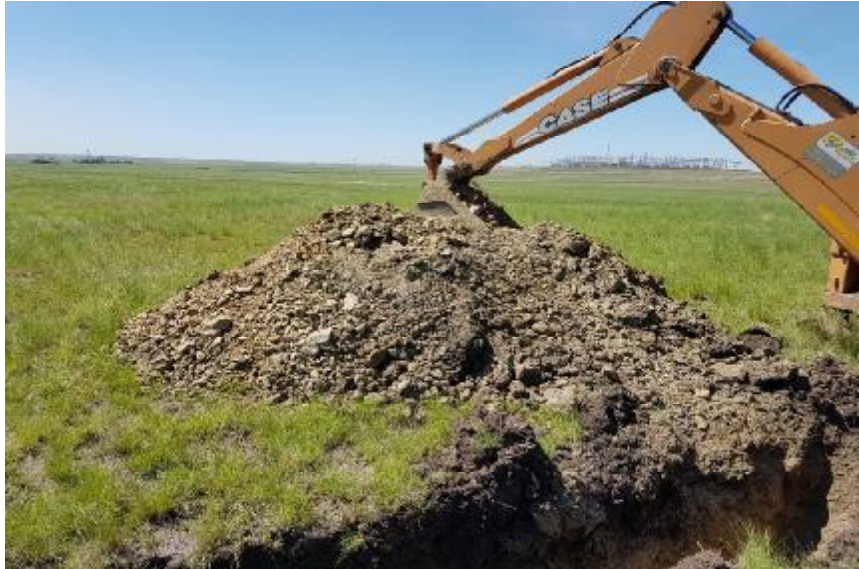
An orange CASE excavator is shown from the side, dumping a large pile of dark, clumpy soil onto a green grassy field. The excavator's arm and bucket are visible, and the word 'CASE' is printed on the side of the boom. The background shows a clear blue sky and a flat horizon.

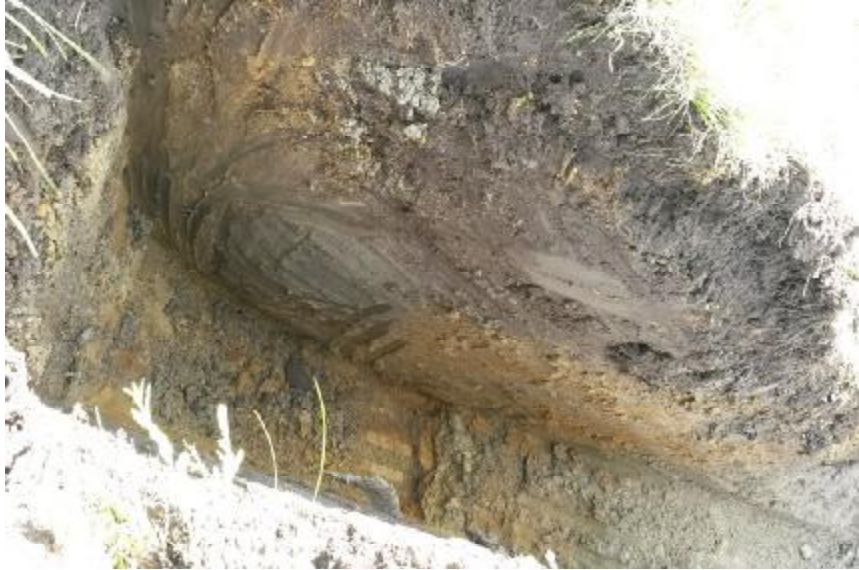
Table 9: AD09

Description	Photo
<p>AD09 Total depth is 3.05 m</p>

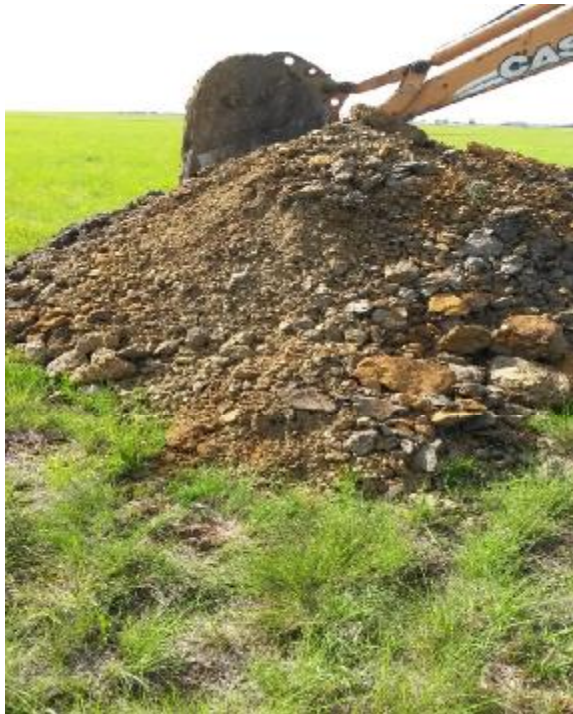
<p>AD09 Material from 0 to 3.05 m</p>

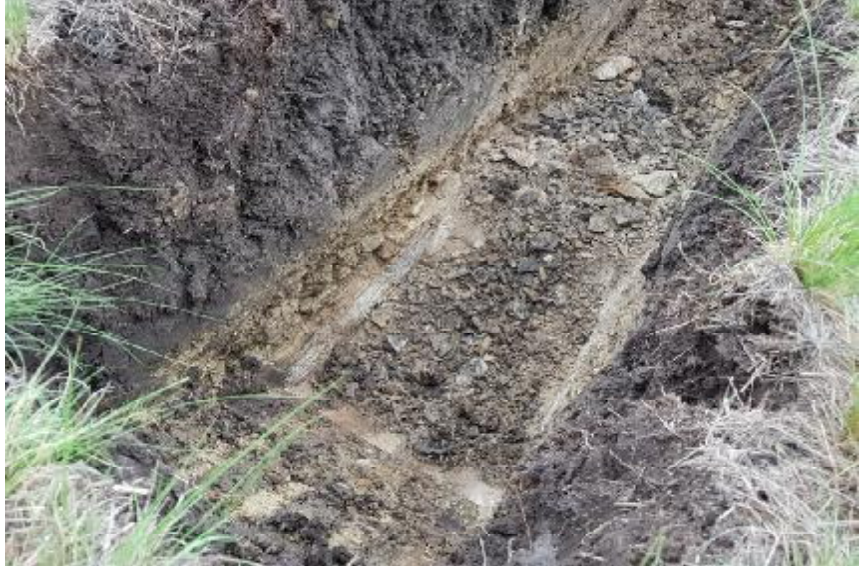
Table 24: AD27

Description	Photo
<p>AD27 Total depth is 1.30 m</p>

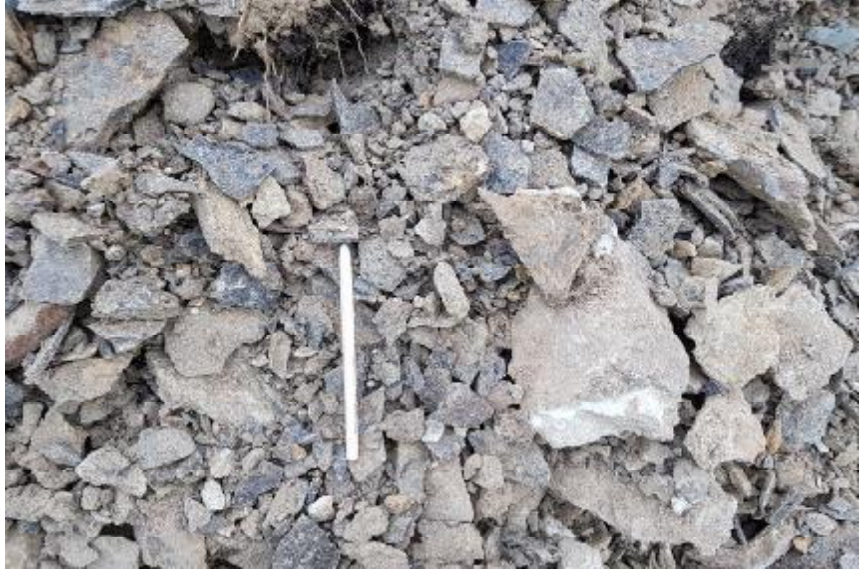
<p>AD27 Material from 0 to 1.30 m</p>

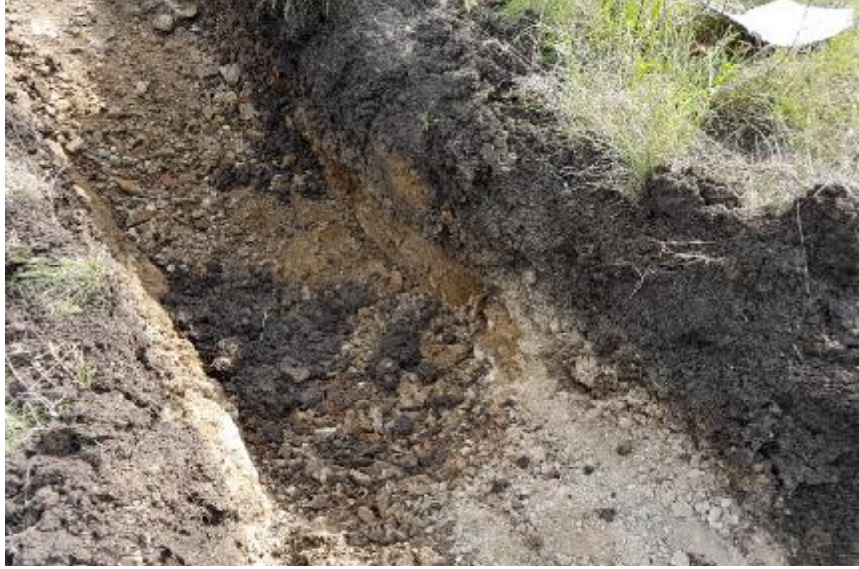
Table 26: AD29

Description	Photo
<p>AD29 Total depth is 0.85 m</p>

A photograph showing a cross-section of a test pit. The soil is dark brown and appears to be composed of various layers, including what looks like a silty clay layer and a more sandy or silty layer. There is some vegetation on the right side of the pit.
<p>AD29 Material from 0 to 0.85 m</p>

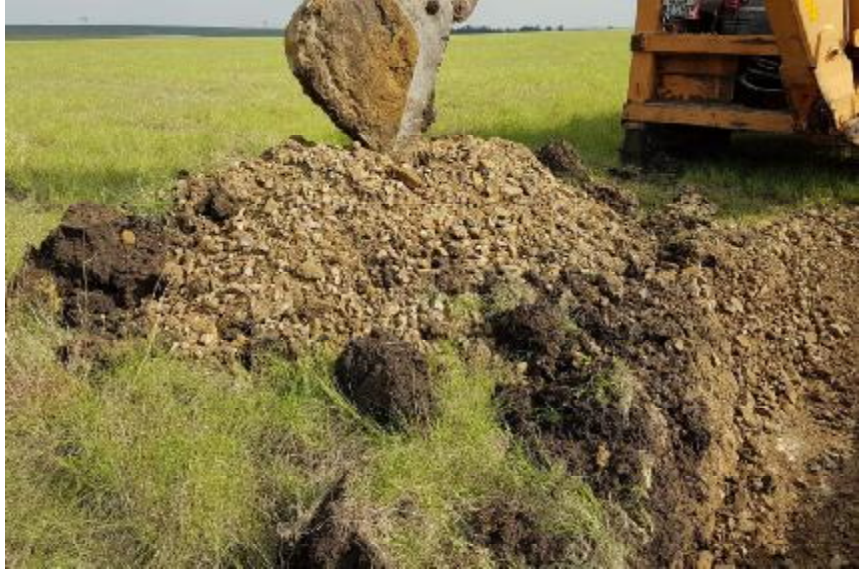
A photograph showing a large pile of soil material, likely the material from the test pit. The soil is dark brown and appears to be composed of various layers. A yellow excavator bucket is visible in the background, and there is a large rock or piece of debris on top of the pile. The background shows a green field.

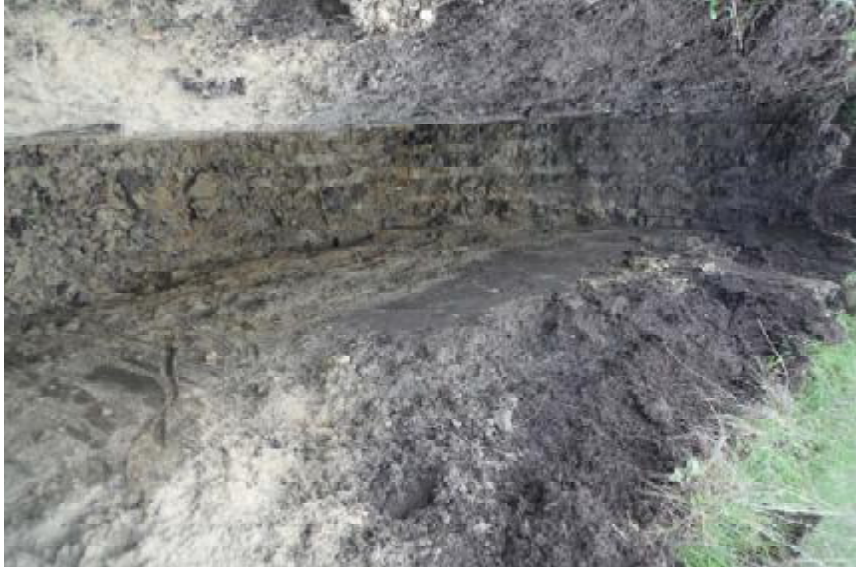
Description	Photo
AWRD15 Total depth is 2.70 m

A photograph of a test pit excavation. The pit is rectangular and shows several distinct soil layers. The top layer is dark brown, followed by a lighter, more silty layer, and then a darker, more textured layer. The bottom of the pit is uneven and appears to be composed of loose soil and some roots. The surrounding area is grassy.

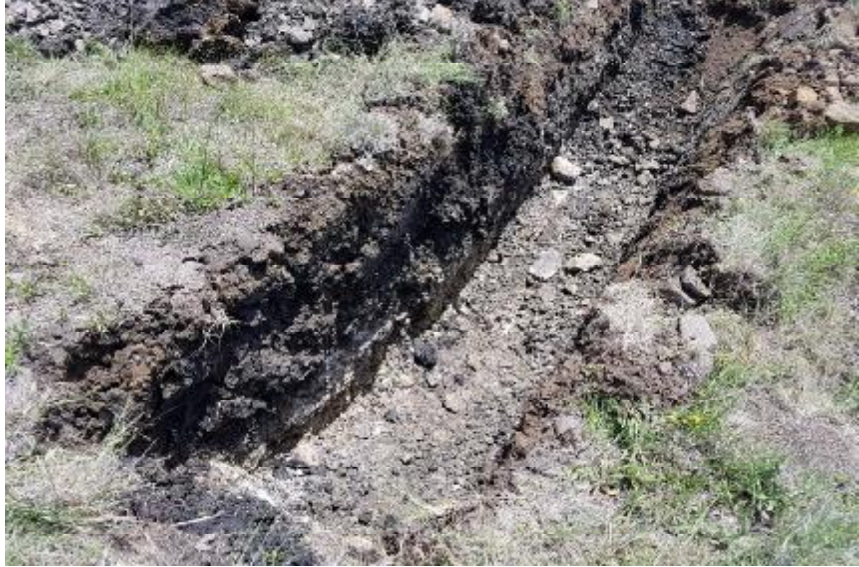
Table 82: RRD05

Description	Photo
<p>RRD05 Total depth is 1.20 m</p>

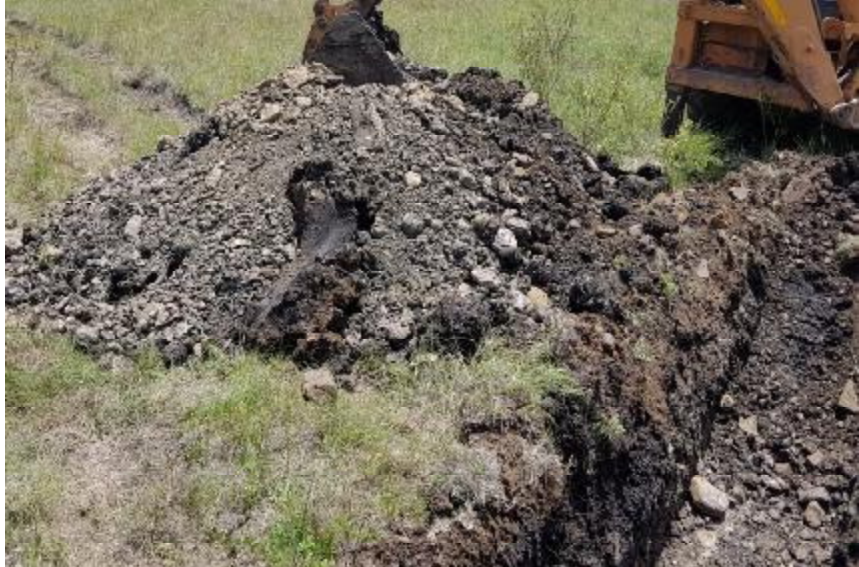
<p>RRD05 Material from 0 to 1.20 m</p>

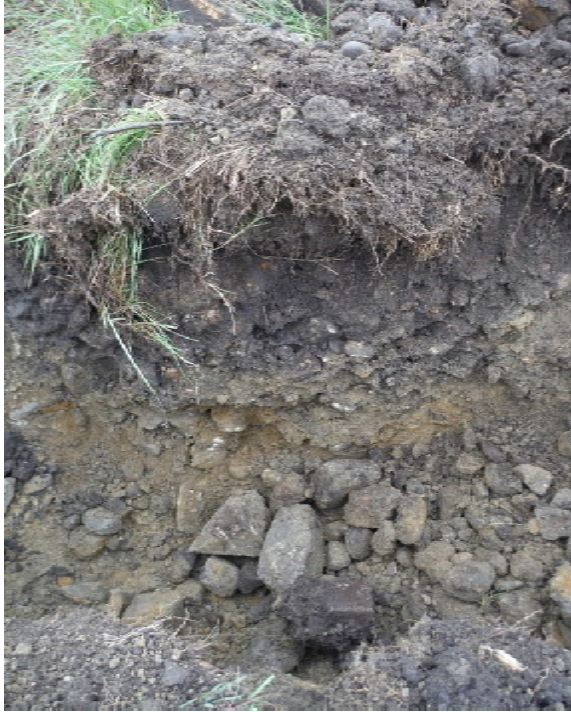
Description	Photo
RRD11 Total depth is 1.40 m

A vertical photograph of a test pit. The top layer shows dark, moist soil with a dense network of roots. Below this is a layer of lighter-colored, more granular soil. The bottom portion of the pit is filled with numerous dark, angular rocks of various sizes, some embedded in a sandy matrix.

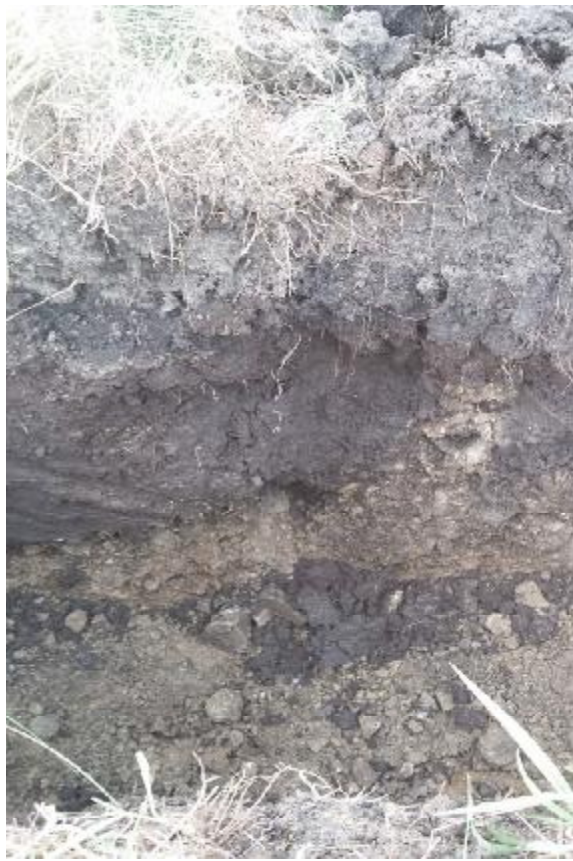
Description	Photo
RRD13 Total depth is 1.5 m

A vertical photograph of a test pit excavation. The soil profile shows a top layer of dark, moist soil with visible roots and some organic matter. Below this is a layer of lighter, brownish soil, followed by a layer of dark, silty soil. The bottom of the pit is composed of dark, silty soil with some small rocks and debris. The pit is surrounded by dry, yellowish grass and some green plants at the edges.

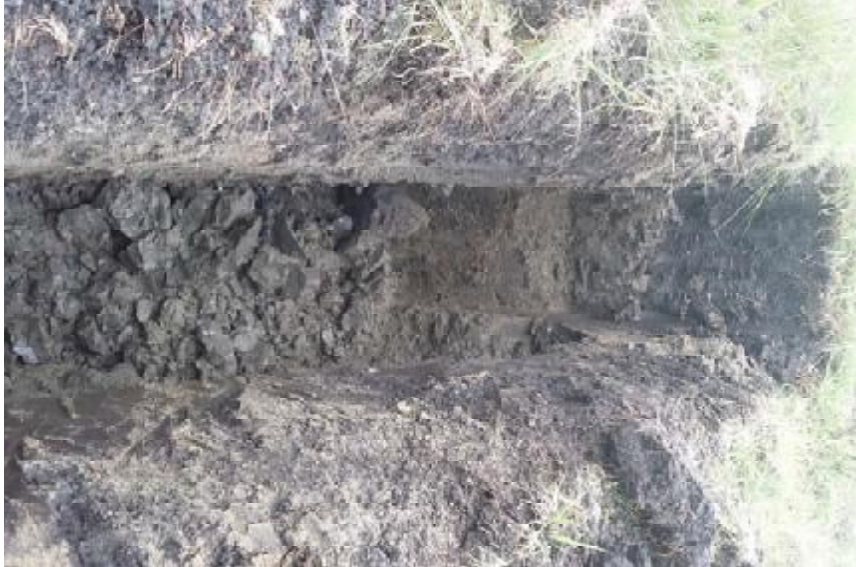
Description	Photo
RRD14 Total depth is 3.30 m

A photograph of a test pit (RRD14) showing a cross-section of soil. The top layer is dark, moist soil with some roots. Below this is a layer of lighter, more granular soil. The bottom of the pit shows a layer of dark, silty soil. The pit is approximately 3.30 m deep.

The soil horizons mark the transitions between the transported soils and the underlying in situ soil material, comprised of decomposed rocks. They are cohesive in nature and intensely structured. A high moisture content caused side wall collapse in some test pits e.g. test pits RRD 18 and RRD 14. The general description of these soil is as follows:

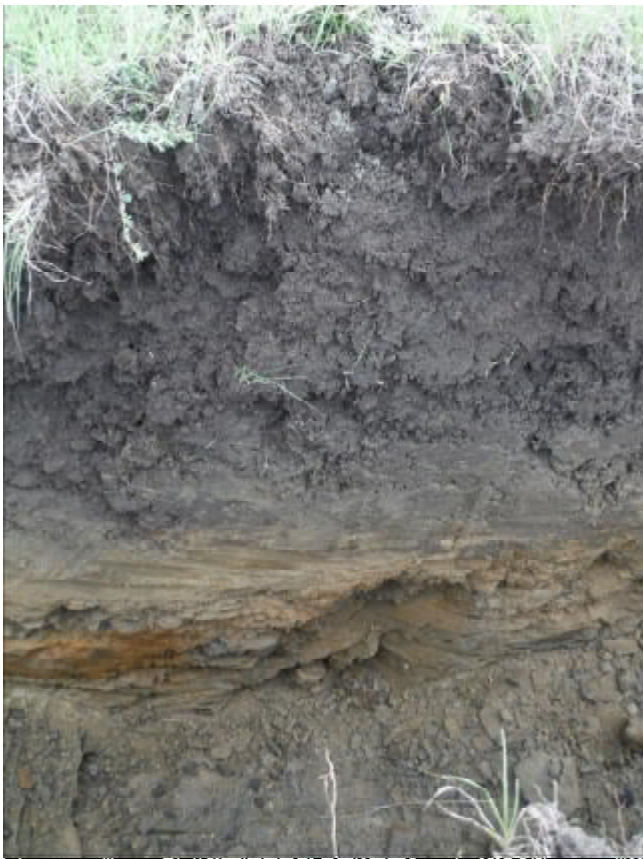
Table 92: RRD16

Description	Photo
<p>RRD16 Total depth is 1.50 m</p>

A vertical photograph of a test pit. The top of the pit shows dark, rich soil with some green grass and roots. Below this is a layer of lighter, more silty soil. At the bottom, there is a distinct, wavy, brownish layer, possibly representing a different soil type or a root zone. The pit is approximately 1.50 m deep.

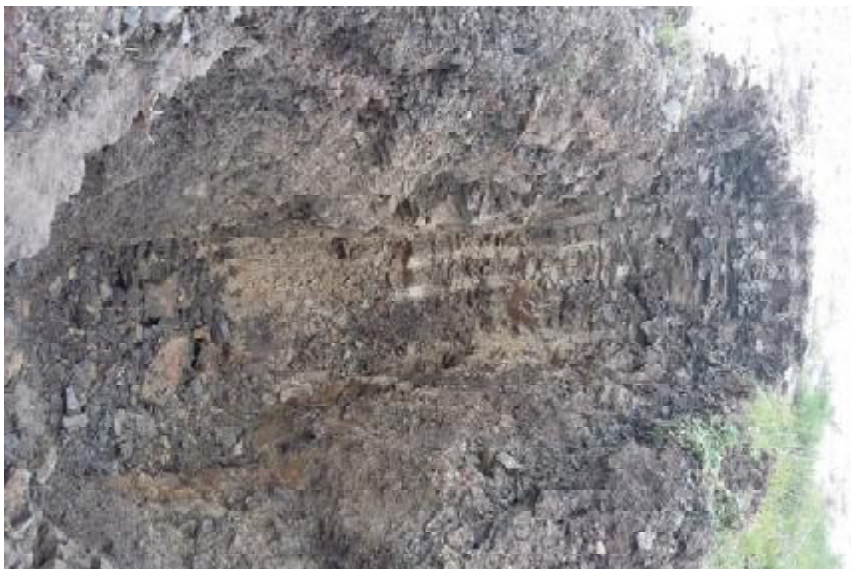
Table 93: RRD17

Description	Photo
<p>RRD17 Total depth is 3.0 m</p>

A vertical photograph of a test pit. The soil profile shows several distinct layers. At the top, there is a thin layer of light-colored, silty soil. Below this is a thicker layer of dark brown, silty soil. The middle section consists of a layer of reddish-brown soil with some horizontal layering. The bottom portion of the pit is filled with dark, fragmented material, likely rock or highly weathered soil, with some green vegetation growing at the base.

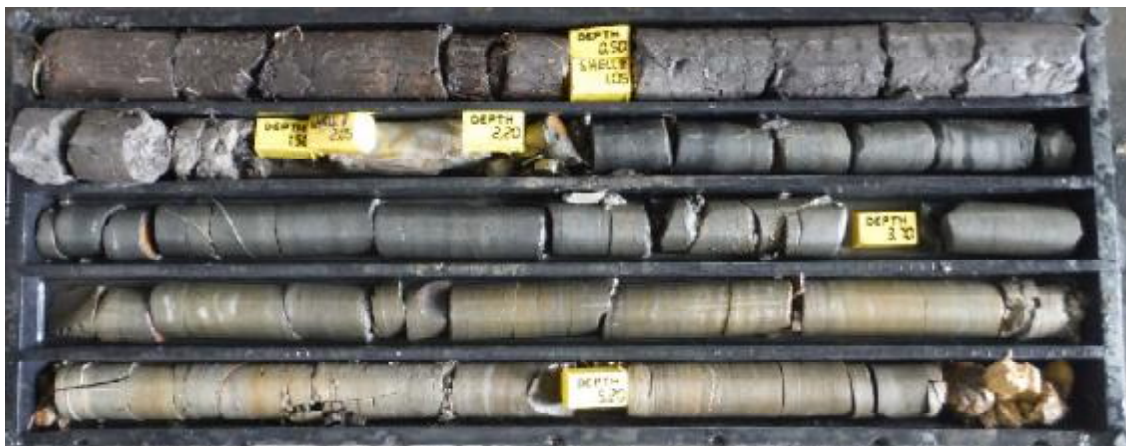
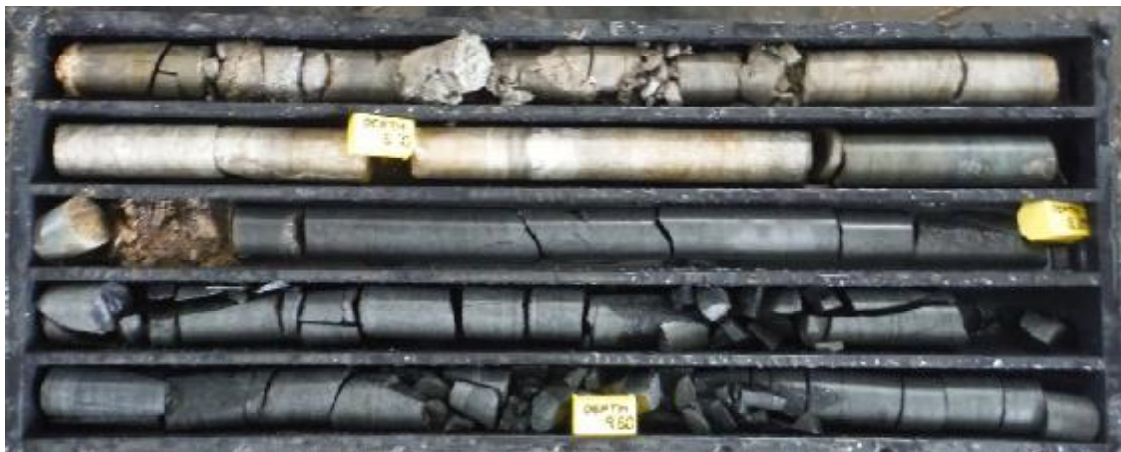
Client	Eskom
Site/ Project Name	Tutuka Power Station
BH Number	BH 06
Core Box Number	Box 01 to Box 02
Drill Run Length	0.00-9.6 m
Drilling Contractor	Geopractica Drilling
Date Drilled	11-11-2016 to 13-11-2016

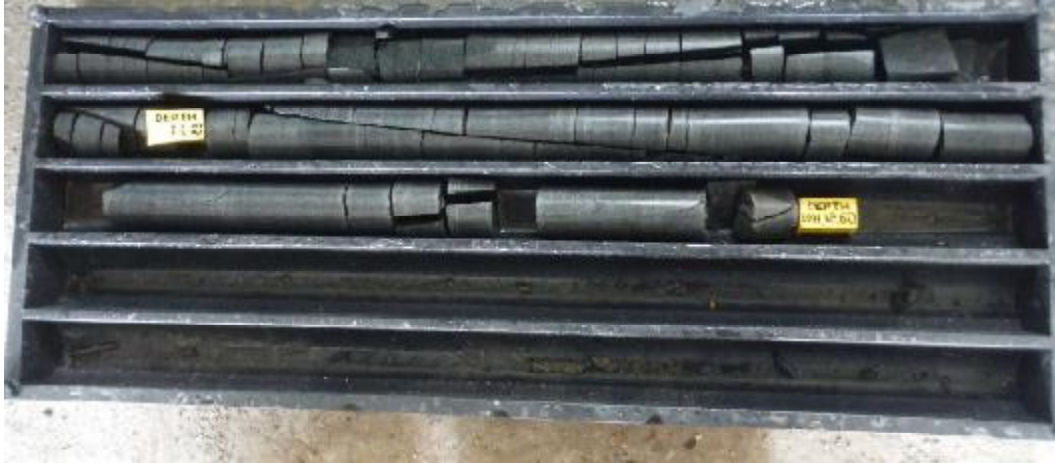
Client	Eskom
Site/ Project Name	Tutuka Power Station
BH Number	BH 06
Core Box Number	Box 03
Drill Run Length	9.6-12.6 m
Drilling Contractor	Geopractica Drilling
Date Drilled	11-11-2016 to 13-11-2016

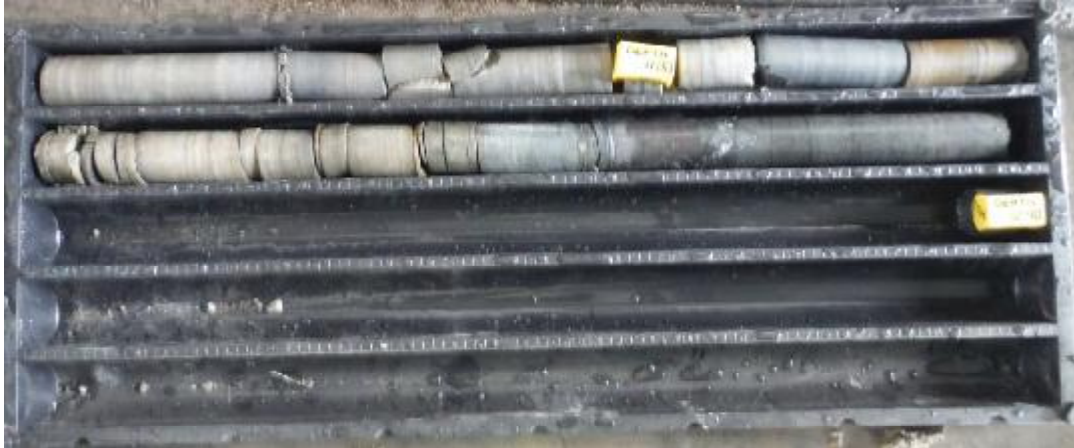
Client	Eskom
Site/ Project Name	Tutuka Power Station
BH Number	BH 07
Core Box Number	Box 03
Drill Run Length	9.6-12.4 m
Drilling Contractor	Geopractica Drilling
Date Drilled	14-11-2016 to 17-11-2016

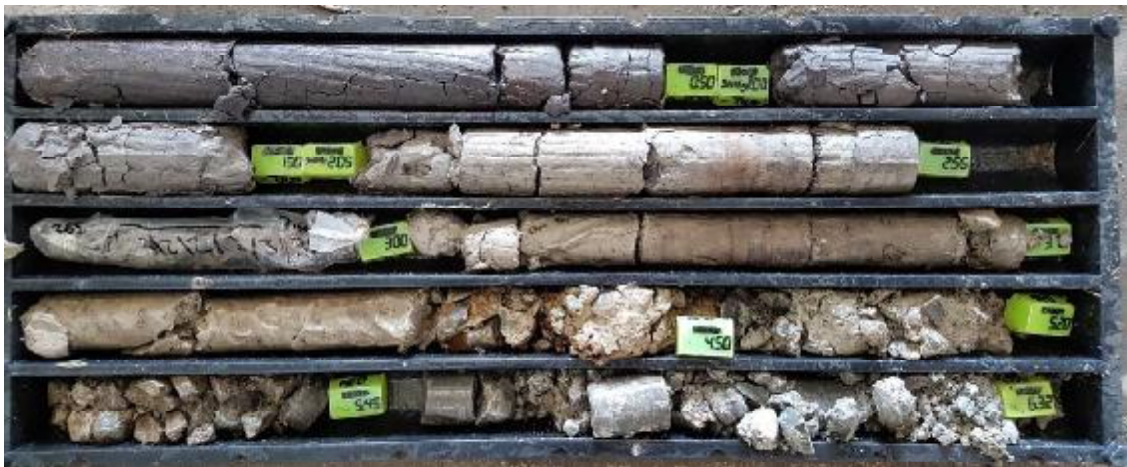
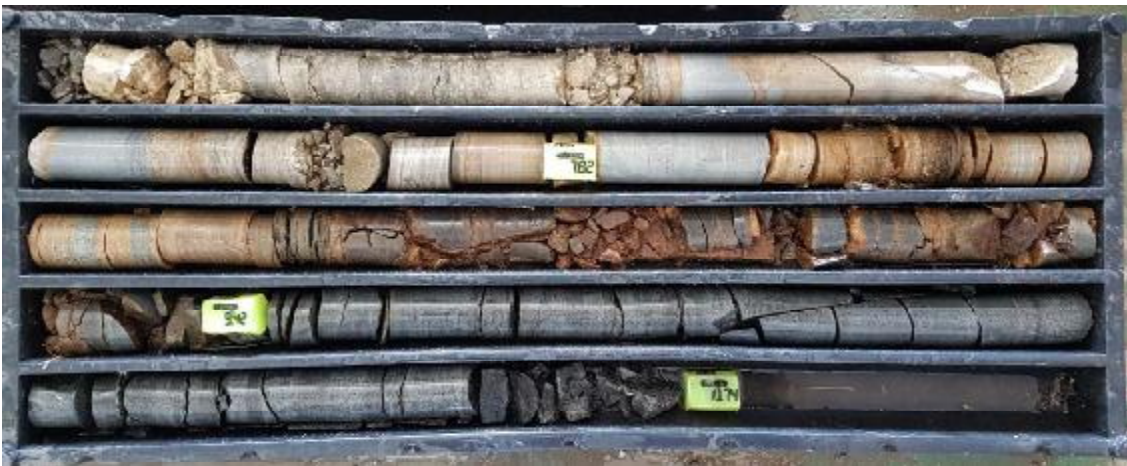
Client	Eskom
Site/ Project Name	Tutuka Power Station
BH Number	BH 08
Core Box Number	Box 01 to Box 02
Drill Run Length	0.00-10.74 m
Drilling Contractor	Geopractica Drilling
Date Drilled	14-11-2016 to 18-11-2016

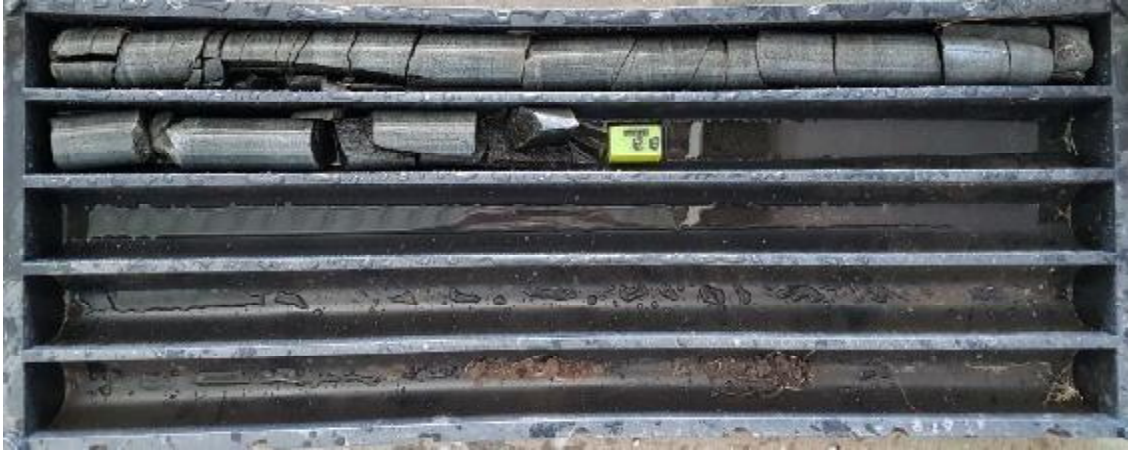
Client	Eskom
Site/ Project Name	Tutuka Power Station
BH Number	BH 08
Core Box Number	Box 03
Drill Run Length	10.74-12.18 m
Drilling Contractor	Geopractica Drilling
Date Drilled	14-11-2016 to 17-11-2016

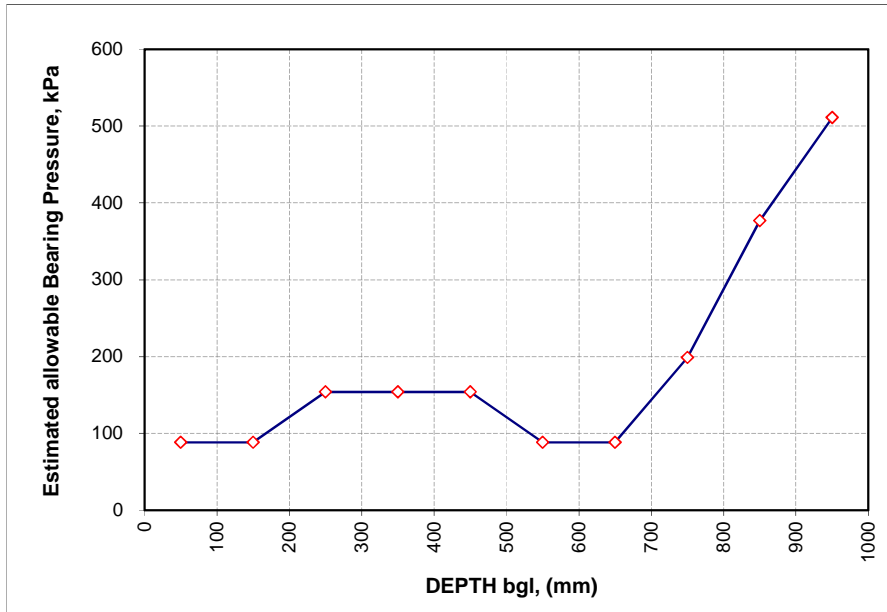
DCP No: **AD02** Location: **Tutuka Power Station** 1499
 note: **EASBP** from **Terzaghi** & Peck p4 for 25mm settlement

SPT mm/blow	DCP DN	Consistency
< 5	132-210	Very Dense
5 - 10	78-132	Dense
10 - 30	25-78	Med Dense
30 - 75	10 25	Loose
75 -100	<10	Very Loose

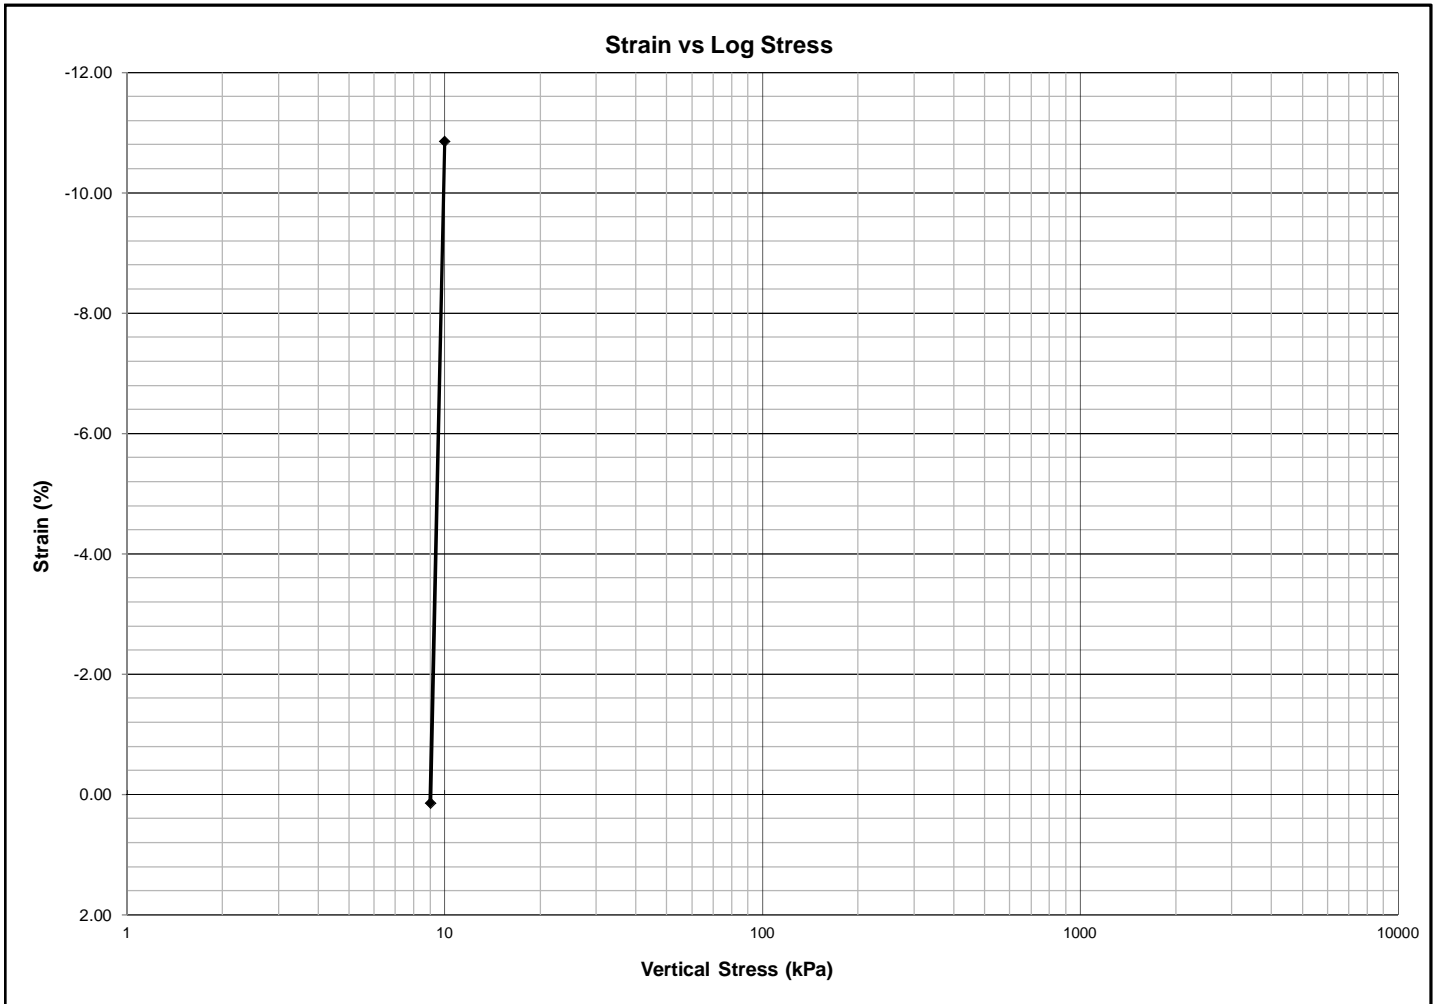
Test Parameters													
Vertical Stress	kPa	9	10										
Time Elapsed	hr	1	48										
H ₁₀₀	mm	25.364	28.157										
Strain	%	0.142	-10.856										
Void Ratio	-	0.827	1.028										
Mv (1/Mpa)	-	-	-

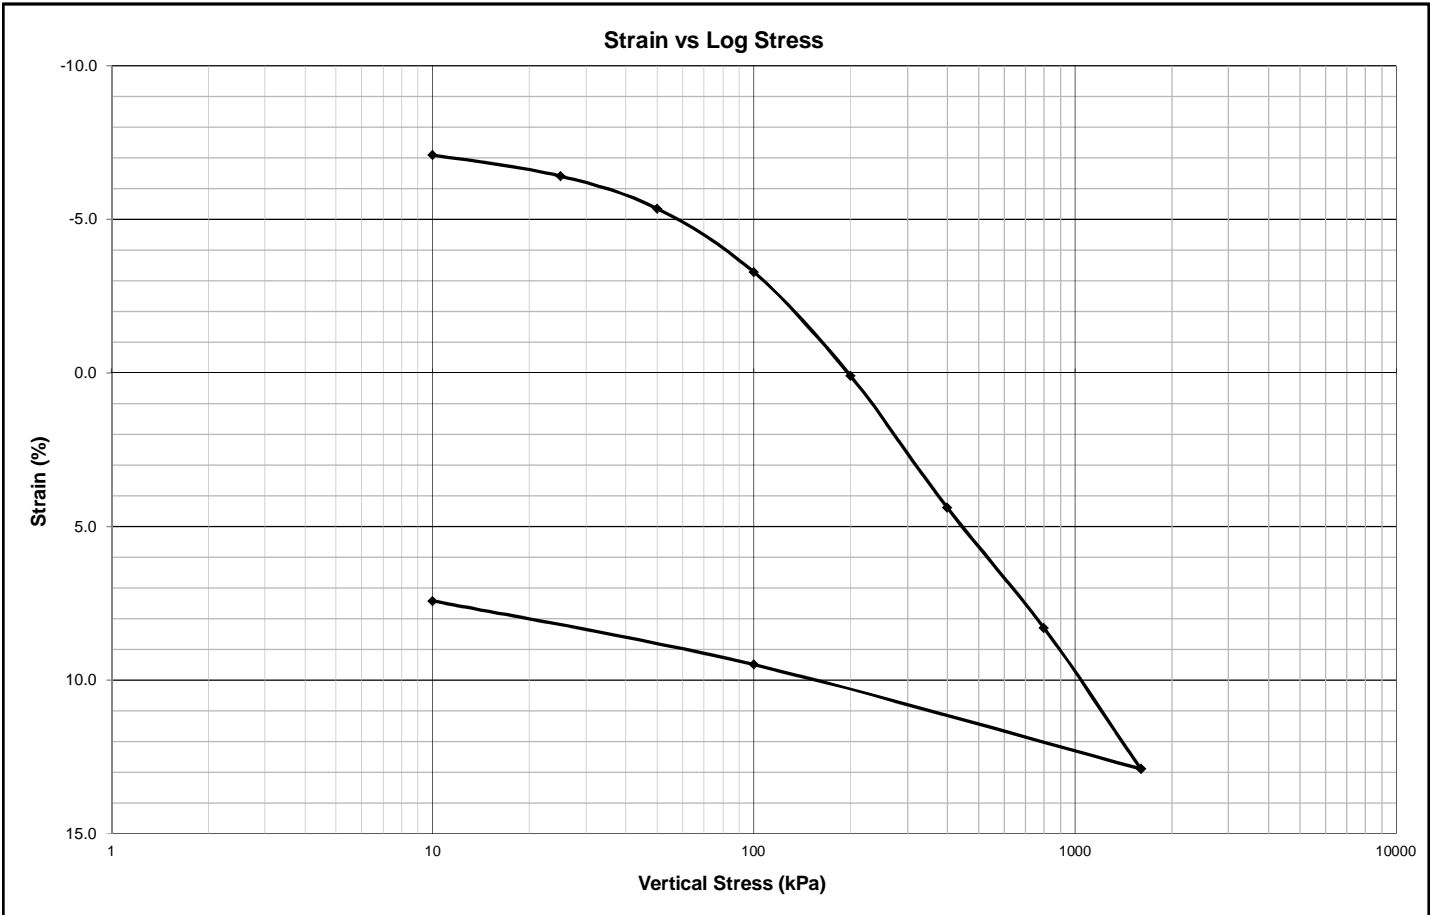
Test Parameters													
Vertical Stress	kPa	10	25	50	100	200	400	800	1600	100	10		
Time Elapsed	hr	24	24	24	24	24	24	24	24	2	2		
H ₁₀₀	mm	27.203	27.026	26.757	26.233	25.372	24.282	23.291	22.125	22.986	23.512		
Strain	%	-7.097	-6.401	-5.341	-3.279	0.109	4.402	8.305	12.895	9.503	7.432		
Void Ratio	-	1.098	1.085	1.064	1.023	0.957	0.873	0.797	0.707	0.773	0.814		
Mv (1/Mpa)	-	-	0.433	0.3984	0.3916	0.328	0.2149	0.1021	0.0626	0.026	0.2543

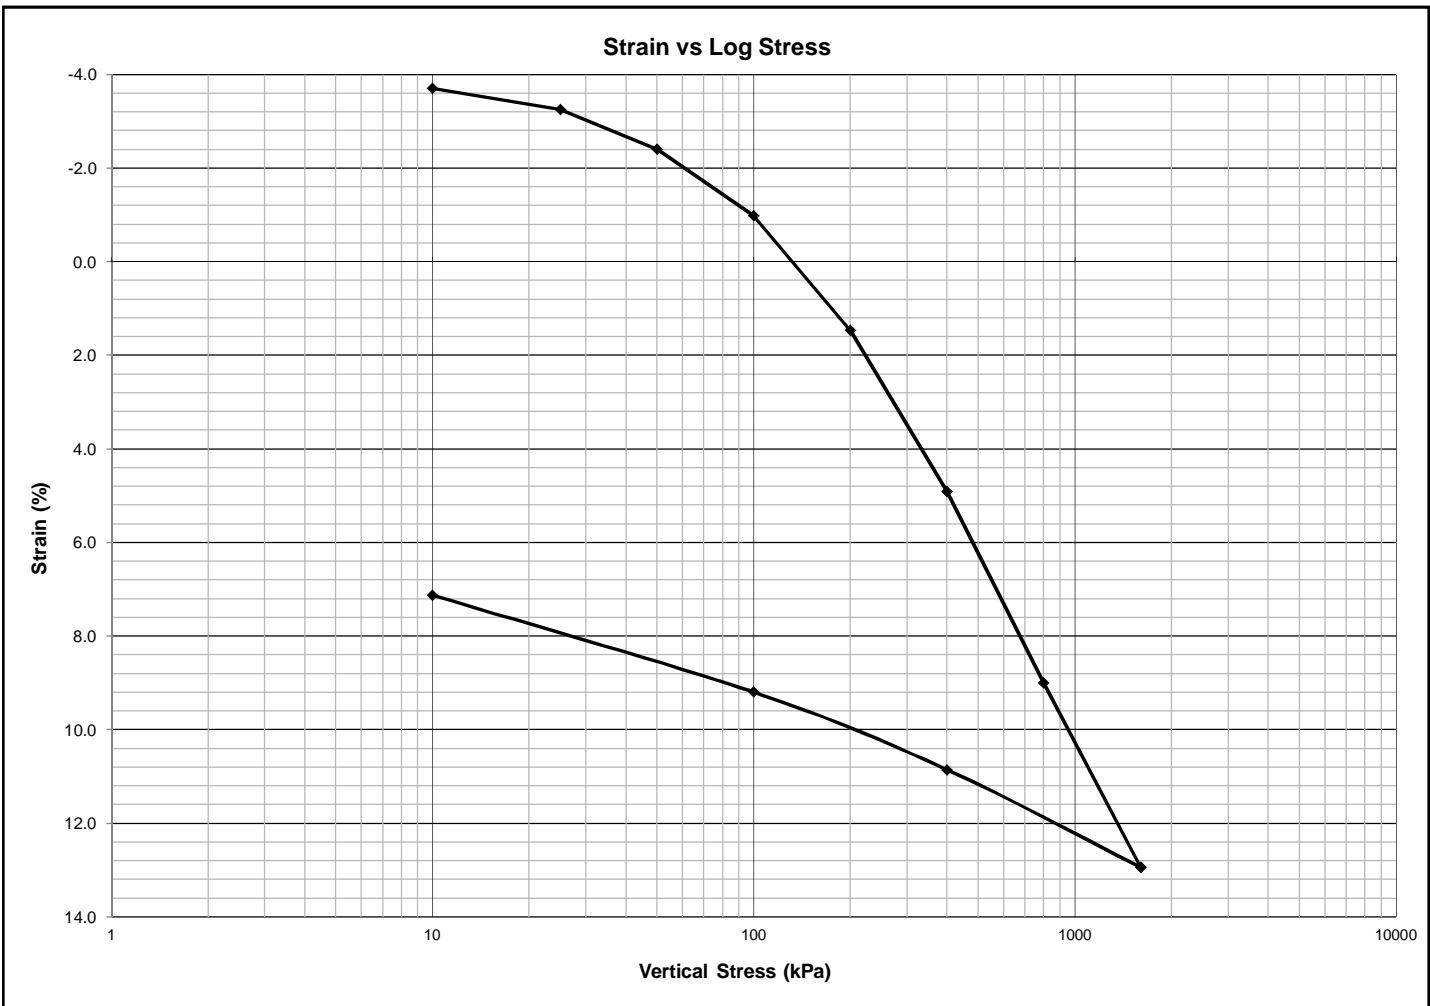
Test Parameters														
Vertical Stress	kPa	10	25	50	100	200	400	800	1600	400	100	10		
Time Elapsed	hr	24	24	24	24	24	24	24	24	2	2	3		
H ₁₀₀	mm	26.341	26.228	26.010	25.649	25.028	24.154	23.113	22.114	22.643	23.065	23.591		
Strain	%	-3.703	-3.259	-2.402	-0.980	1.464	4.905	9.002	12.938	10.853	9.194	7.123		
Void Ratio	-	0.661	0.653	0.639	0.616	0.577	0.522	0.460	0.402	0.432	0.455	0.486		
Mv (1/Mpa)	-	-	0.296	0.343	0.284	0.244	0.172	0.102	0.049	0.017	0.055	0.23
