May 2017

ESKOM HOLDINGS SOC

Tutuka Ash Disposal Facility Extension Geotechnical Investigation Report

Report Number: 1658666-310335-1

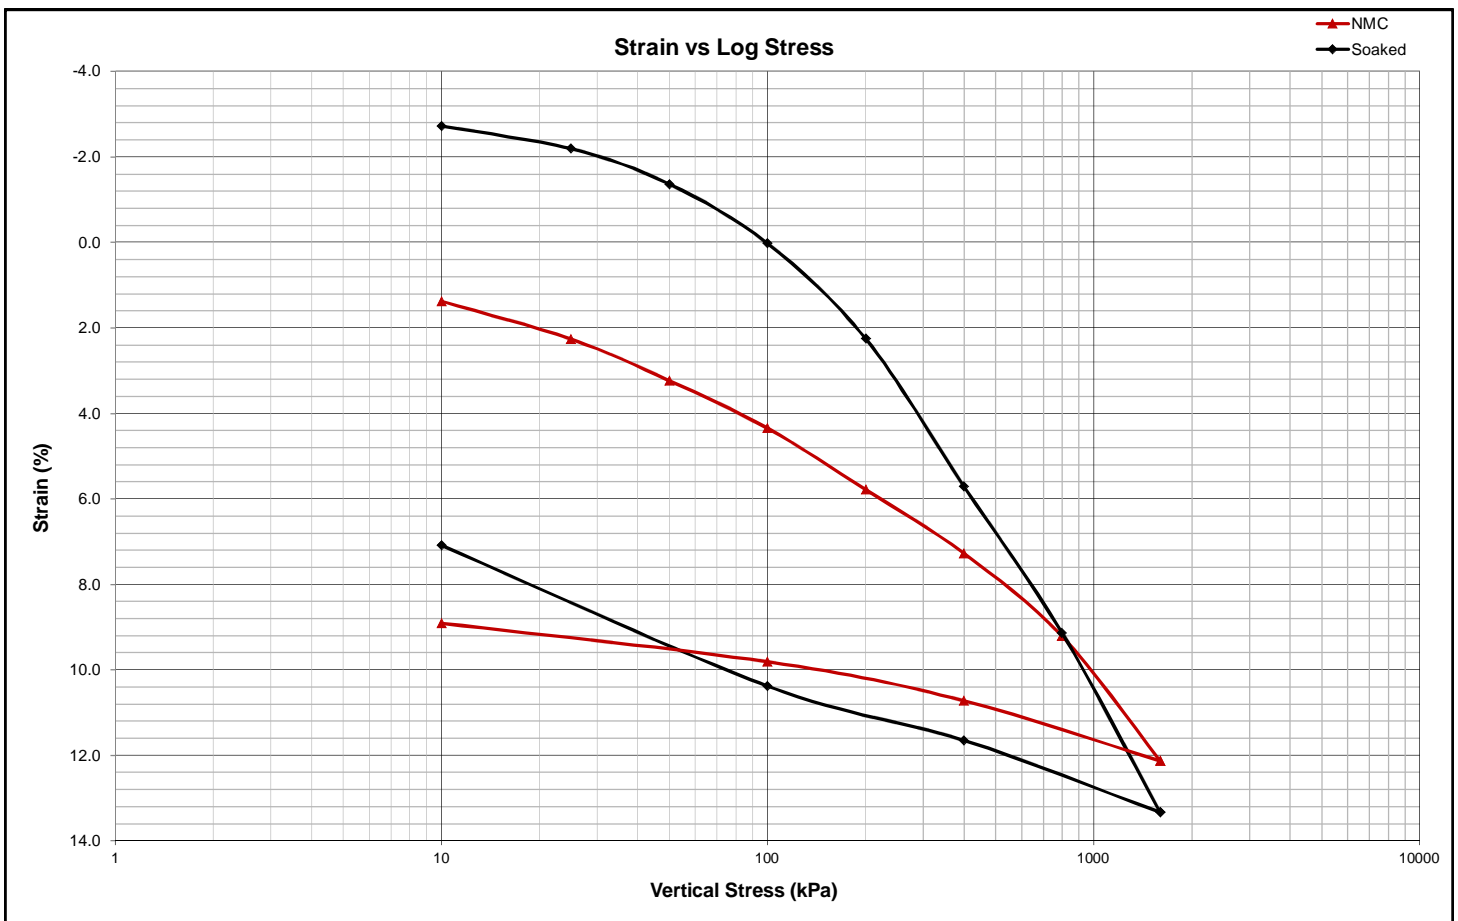
Sample Parameters		Unit	NMC	Soaked	Remarks
Moisture Content	Before Test	%	11.7	10.9	Complete test specimen
	After Test	%	8.5	15.6	Complete test specimen
Dry Density		Kg/m ³	1821	1738	
Void Ratio		-	0.430	0.498	
Degree of Saturation		%	71.1	56.8	
Initial Specimen Height		mm	25.4	25.4	
Relative Density (SG)		-	2.604		Determined

Test Parameters														
Vertical Stress	kPa	10	25	50	100	200	400	800	1600	400	100	10		
Time Elapsed	hr	24	24	24	24	24	24	24	24	2	2	3		
H ₁₀₀	NMC	mm	25.050	24.824	24.578	24.295	23.930	23.552	23.060	22.318	22.676	22.907	23.136	
	Soaked	mm	26.090	25.956	25.746	25.393	24.826	23.951	23.078	22.012	22.441	22.763	23.598	
Strain	NMC	%	1.377	2.268	3.238	4.352	5.789	7.277	9.215	12.133	10.725	9.816	8.914	
	Soaked	%	-2.717	-2.189	-1.361	0.028	2.259	5.706	9.142	13.337	11.651	10.383	7.094	
Void Ratio	NMC	-	0.410	0.397	0.384	0.368	0.347	0.326	0.298	0.256	0.276	0.289	0.302	
	Soaked	-	0.539	0.531	0.519	0.498	0.464	0.413	0.361	0.298	0.324	0.343	0.392	
Mv (1/Mpa)	NMC	-	-	0.602	0.397	0.230	0.150	0.079	0.052	0.040	0.013	0.034	0.111	
	Soaked	-	-	0.343	0.324	0.274	0.223	0.176	0.091	0.058	0.016	0.048	0.408

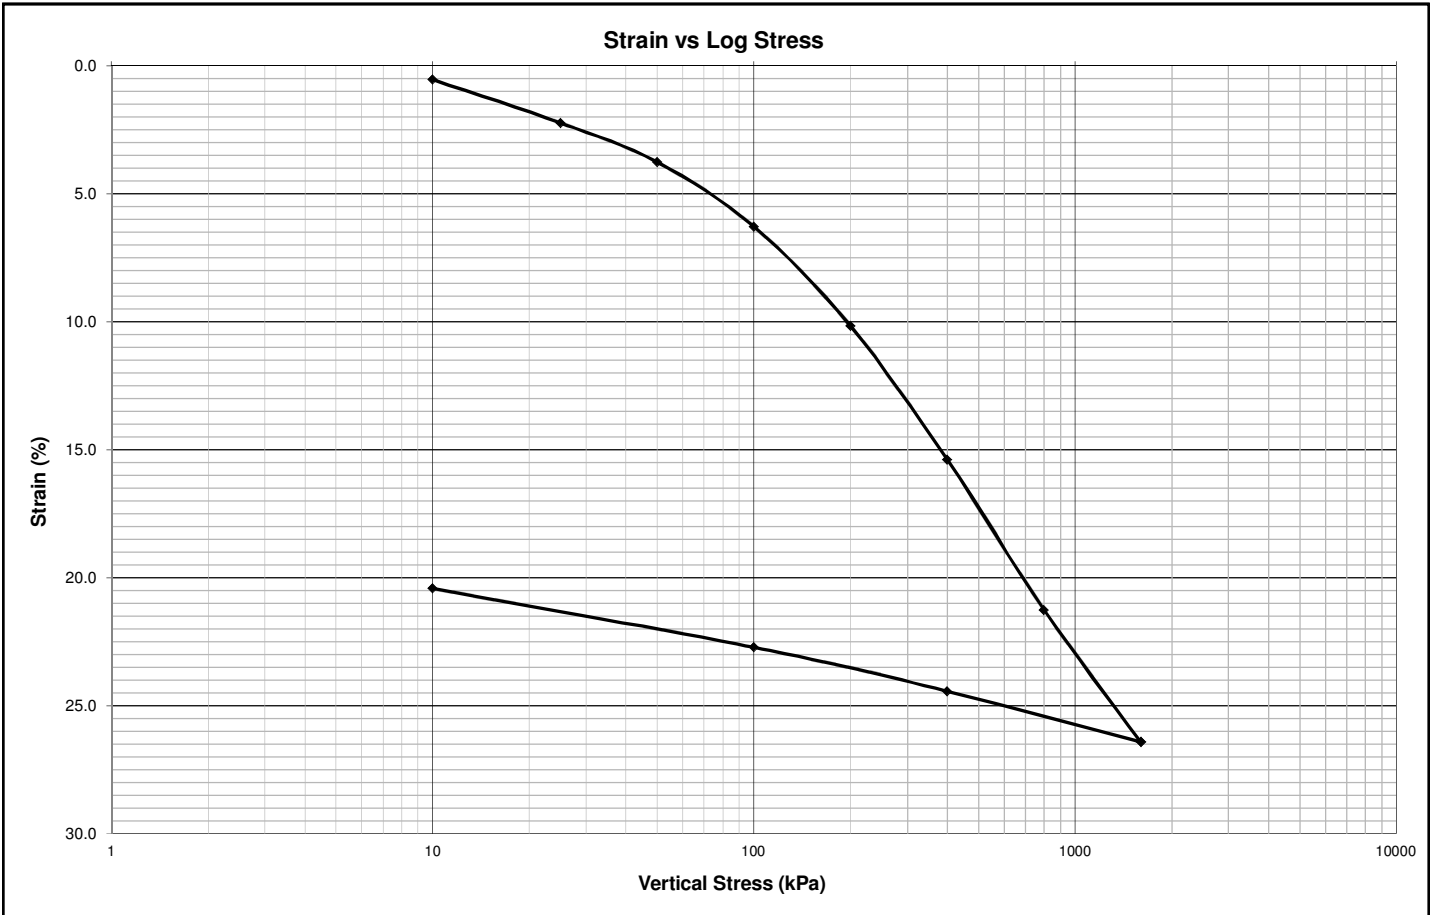
Sample Parameters	Unit	Value	Remarks	Test Remarks
Moisture Content	Before Test	33.5	Complete test specimen	Undisturbed sample
	After Test	26.4		
Dry Density	Kg/m ³	1349		
Void Ratio	-	0.876		
Degree of Saturation	%	96.6		
Initial Specimen Height	mm	25.4		
Relative Density (SG)	-	2.531	Determined

Test Parameters														
Vertical Stress	kPa	10	25	50	100	200	400	800	1600	400	100	10		
Time Elapsed	hr	24	24	24	24	24	24	24	24	2	2	3		
H ₁₀₀	mm	25.261	24.830	24.442	23.802	22.815	21.492	19.999	18.686	19.192	19.626	20.212		
Strain	%	0.550	2.240	3.770	6.290	10.180	15.390	21.260	26.430	24.440	22.730	20.420		
Void Ratio	-	0.866	0.834	0.805	0.758	0.685	0.587	0.477	0.380	0.418	0.450	0.493		
Mv (1/Mpa)	-	-	1.1364	0.6254	0.5235	0.4147	0.29	0.1736	0.0821	0.0226	0.0753	0.3322

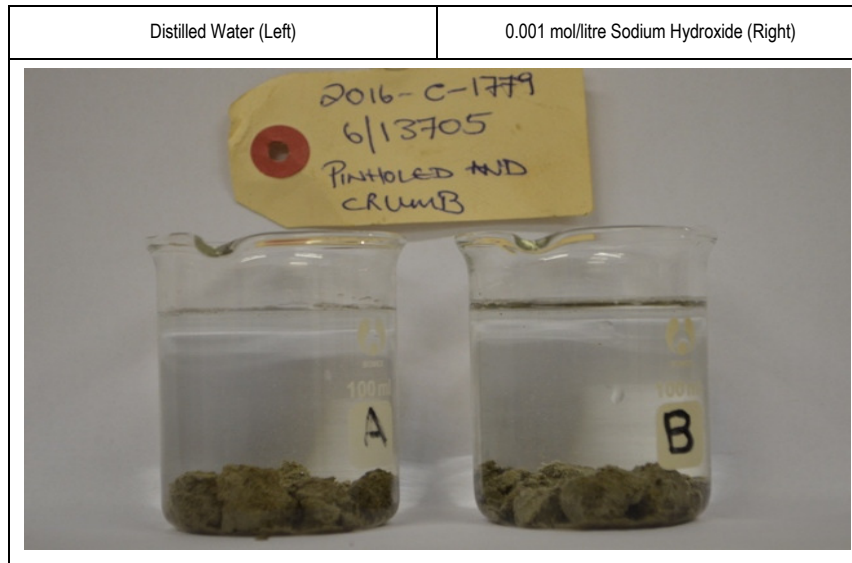
Elapsed Time: Zero Minutes

Client Name:	Geostrada	Date sampled/tested on site:	-
Client Contact:	Hennie Barnard	Sample Receive Date:	23-Jan-17
Project:	2016-C-1779	Laboratory Sample Number:	17/124
Order Number:	200.044	Report Revision:	Rev 0
Laboratory Project Number:	B656	Report Date:	28-Feb-17
Client Sample Number/Reference:	AD58	Tests:	Crumb Test (BS1377:Part 5:1990.6.3)
Sample Position/Depth:	0.7-0.8m	Remarks:	-
